MINING INSPECTION REPORT

Name of Operator: Seven Western Mining
Name of Mine: Capitan Iron Mine
Address: Sections 10, 11, 14, 15 T 8S, R 14E (UTM 13S 0443463, 3720211)
Permit Number: LI005ME
Commodity: Magnetite Iron <input checked="" type="checkbox"/> SURFACE <input type="checkbox"/> UNDERGROUND
Date of Inspection: September 25, 2003
Time of On-Site Inspection: 1:00 – 2:00 pm
Weather Conditions: sunny, cool
Purpose of Inspection: Annual Inspection
Inspector: Mickey Jojola
Present During Inspection: Erik Monroe, NMED
ENFORCEMENT ACTION TAKEN: NOTICE OF VIOLATION: # _____ YES: ___ NO: <input checked="" type="checkbox"/> CESSATION ORDER: _____ YES: ___ NO: <input checked="" type="checkbox"/>
Time: On-Site: <u>1.0</u> Permit Review: <u>0.5</u> Travel: <u>4</u> Report Writing: <u>0.5</u>
TOTAL INSPECTION TIME: <u>6</u> HOURS
NOTE: To get to the site, go north from Capitan on State Highway 246. About 5.5 miles from town, go right (east) on a Forest Road that has a cattle grate but no gate. Just follow the main Forest Road to the mine. There are no locked gates.

INSPECTION
3/20/07
Capitan Iron Mine

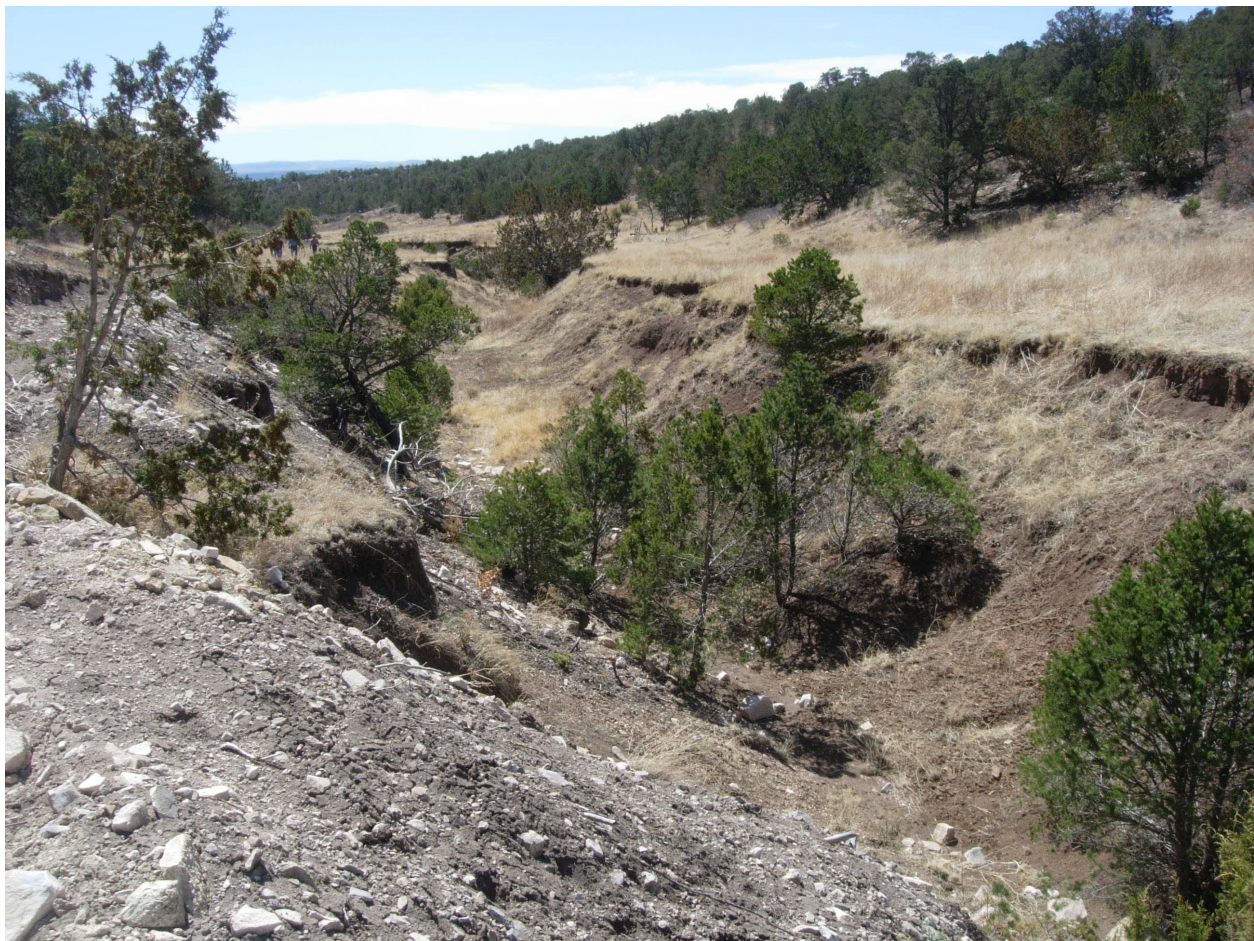
Two holes were drilled approximately ¼ mile from the mine permit boundary. A road was constructed to access the drilling area. Rock and debris from the construction of the road was placed in an existing arroyo next to the drill sites. Drill cuttings were also placed in the arroyo. See photos below.

Rock from drill road pushed into existing undisturbed arroyo

Abatement actions according to the CO issued March 30, 2007.

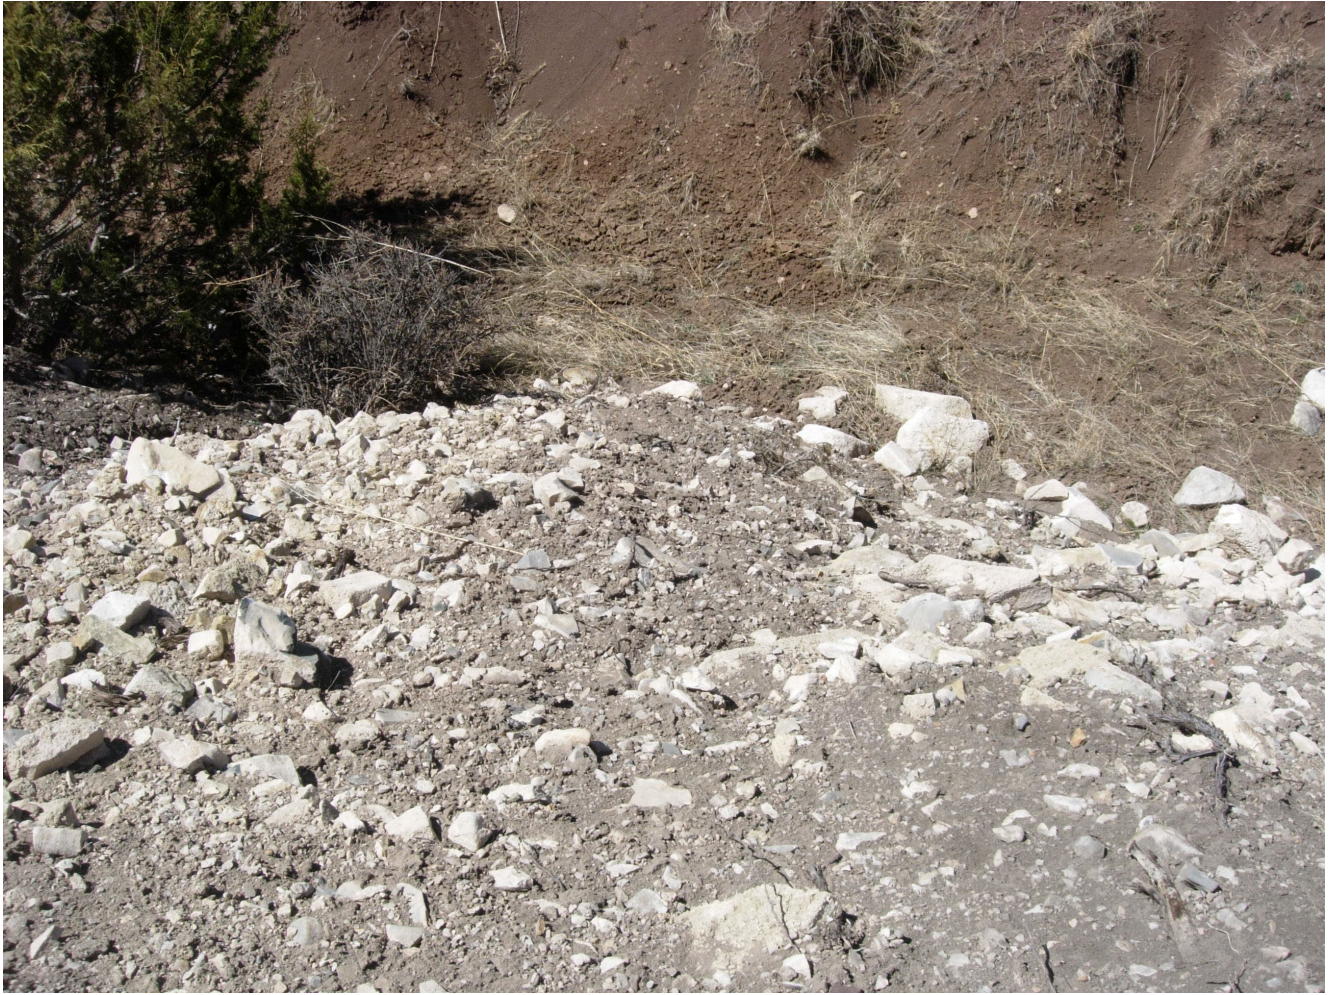
Rock from road cut pushed into existing undisturbed arroyo

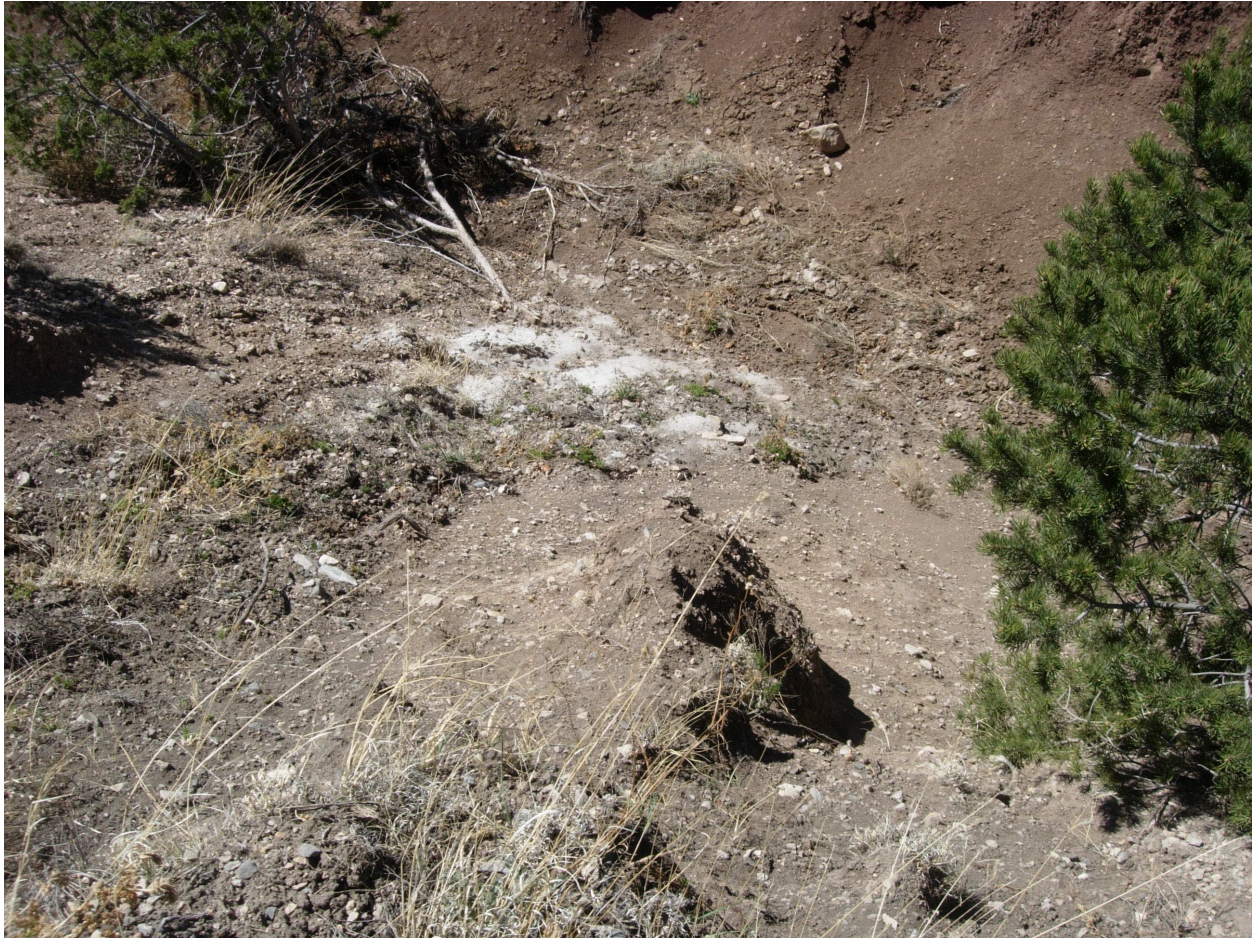
Drill cuttings placed into undisturbed arroyo

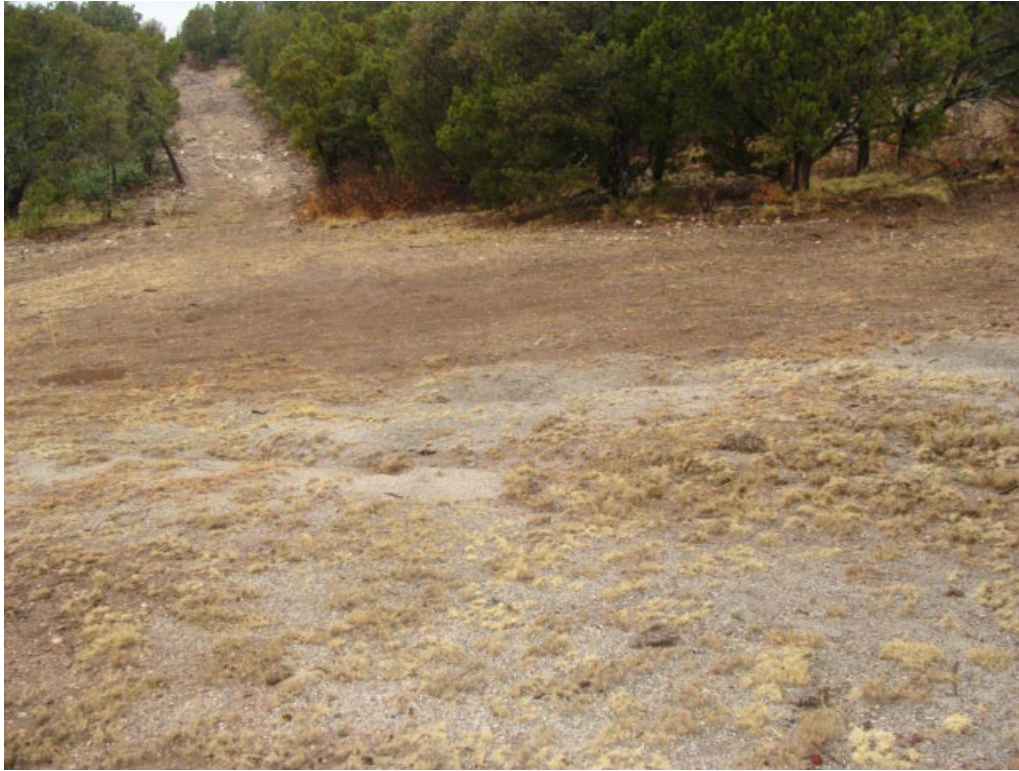
I drove to the east side of the pit and parked. I walked through the pit and around the perimeter and found no evidence of mining, or exploration, activities. I also walked to the area downhill and east of the pit to check on the progression of the reclamation/re-seeding that was completed at the end of summer 2008. Walked out to the west of the pit where the quansa hut is located. No signs of mining/exploration activity. The reclaimed areas are stable and no excessive erosion was observed.

The two photos below are of the most challenging area(s) of the reclamation to the east and downhill of the pit. The first is looking west uphill toward the pit area. The second photo is looking east across the orroyo where on drill hole was drilled right next to the arroyo.
