**MINING INSPECTION REPORT**

**June 1, 2011 INSPECTION REPORT**  
**Illegal Mining Otero County, Cinco de Mayo and Iron Queen Mine**

**INSPECTION REPORT**  
**June 22, 2011**  
**Gulf Coast Environmental-Oro Grande**

**August 1, 2011**  
**Iron Duke Mine PAP site visit**

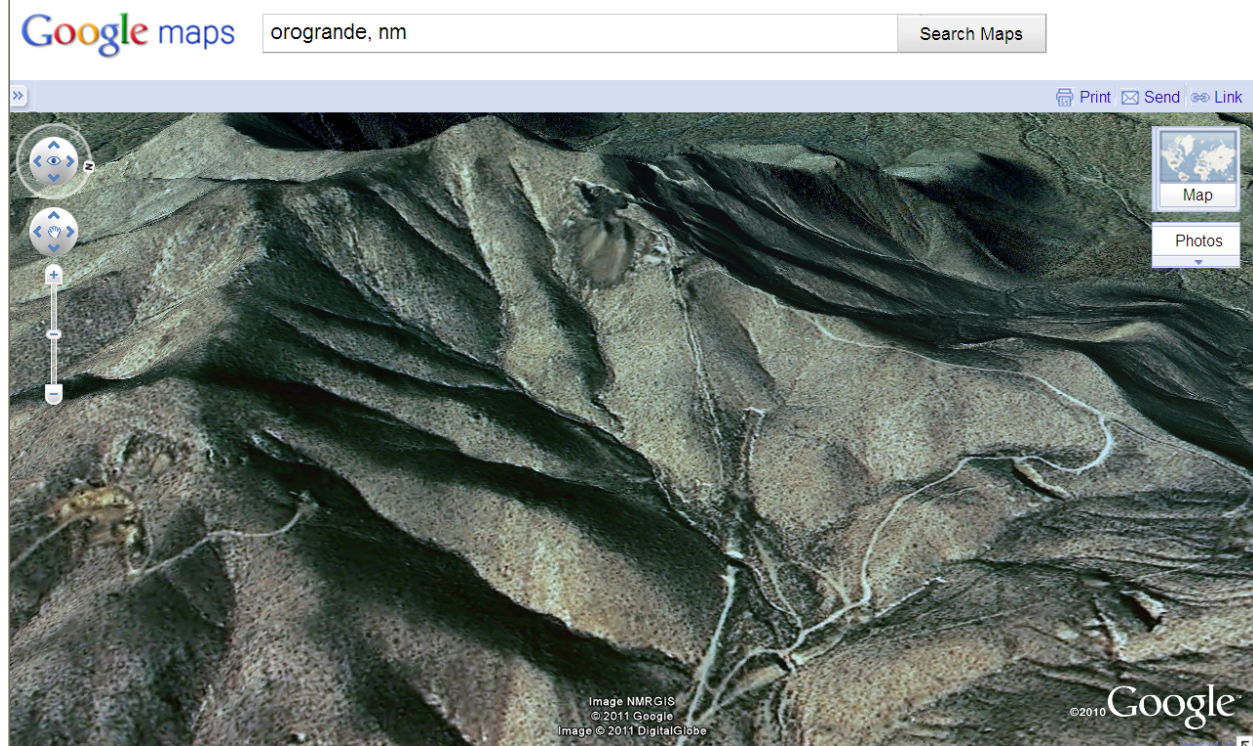
Google earth image below is looking west, waste rock pile observed being mined can be seen in the upper-middle portion of the image

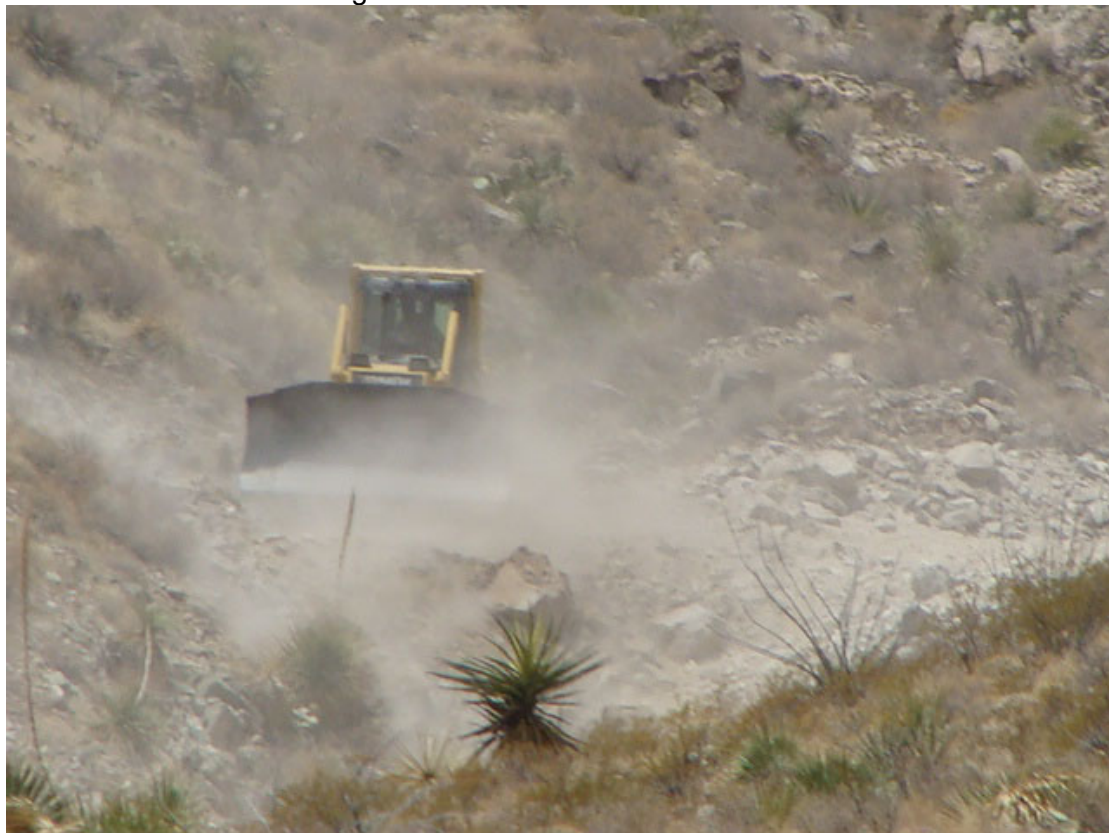
A large dozer and a track hoe were on site (Cinco de Mayo) moving a waste pile of material, from just below the mine, in preparation to run the material through a crusher. Upon asking, the operators of the equipment told us the operator had a mining permit. When asked to provide a copy of said permit the equipment operator provided us with two business cards (Randy Bouldin and David Davidson). Another contractor was present to provide the rock crusher and screening equipment. All present told us Randy Bouldin was managing the operation, though he was not present, and the access roads had been cut over the course of the last two weeks.. The equipment operator (Omar) also told us David Davidson was the "environmental consultant" and if contacted could also vouch for the fact the activities were permitted. I made it clear to the equipment operators that the activities they were involved with were unpermitted. I left a copy of my business card with the contractors and asked that they request Randy and/or David call me.

Photo below of active mining

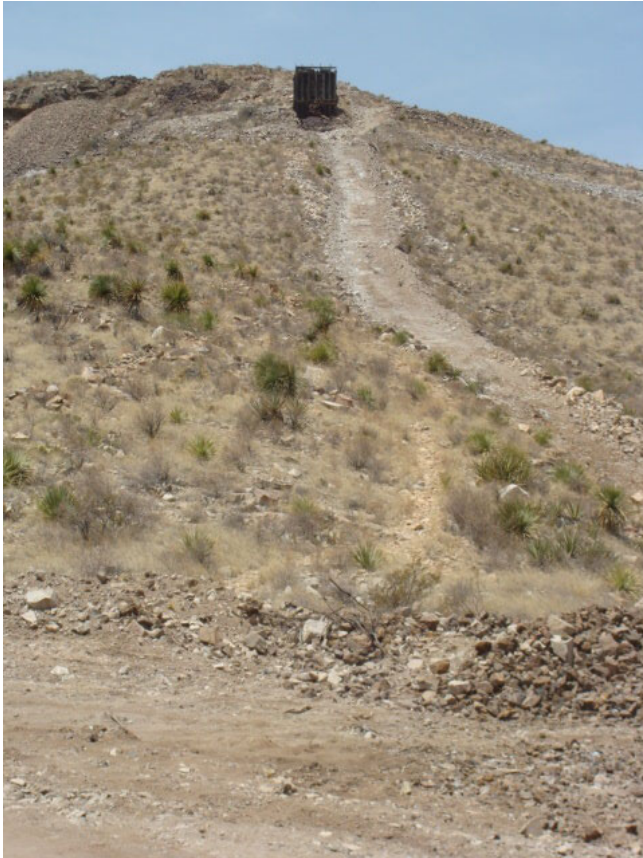
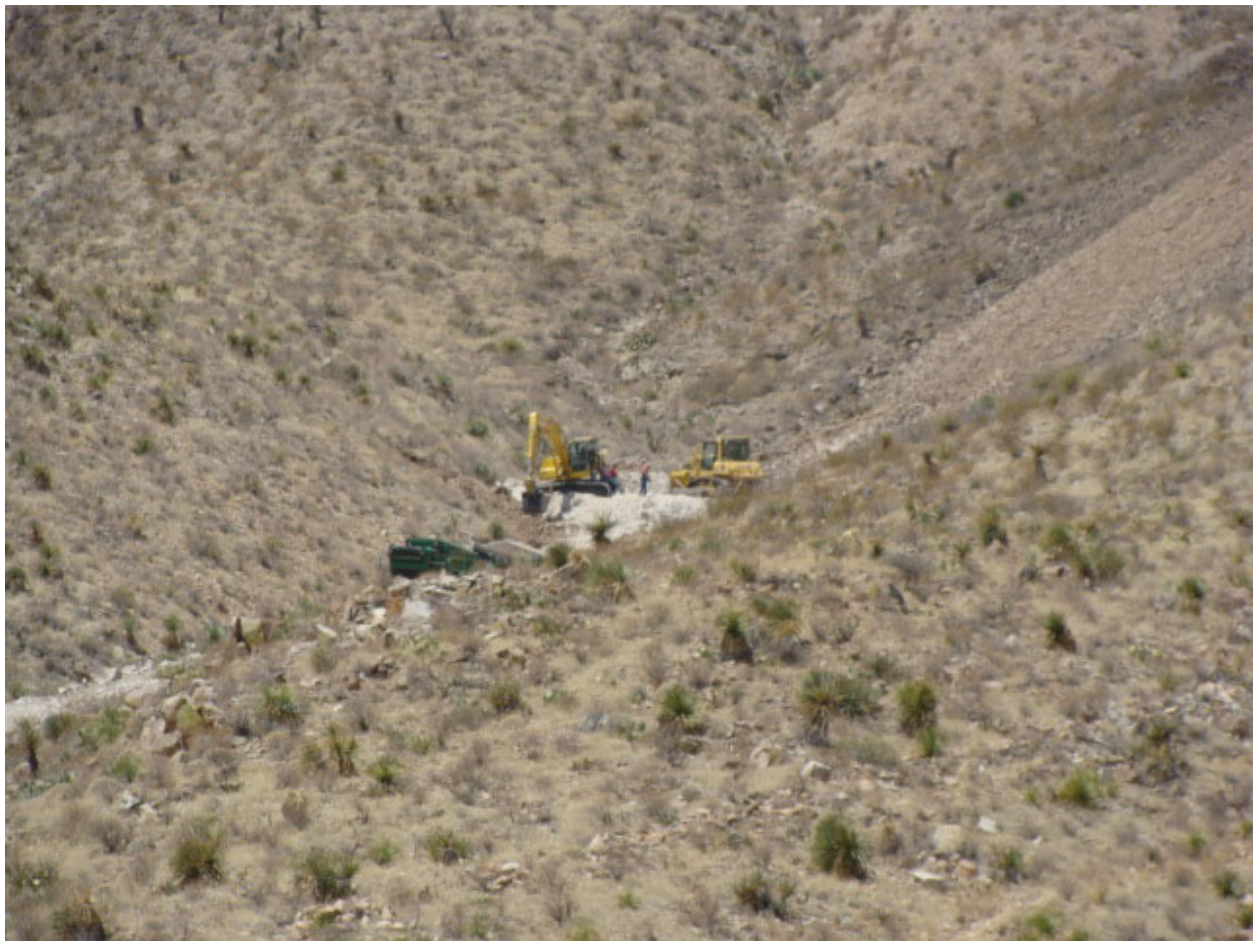
In addition to the disturbance associated with the 2 mile access road, there were also new earthen cuts going up the steep hillside in order to access the materials to be mined. I did not take precision measurements of these other disturbances associated with mining and processing, but estimate them between two and three acres. All disturbance combined could exceed 5 acres total.

Several photos of associated disturbance and working equipment.

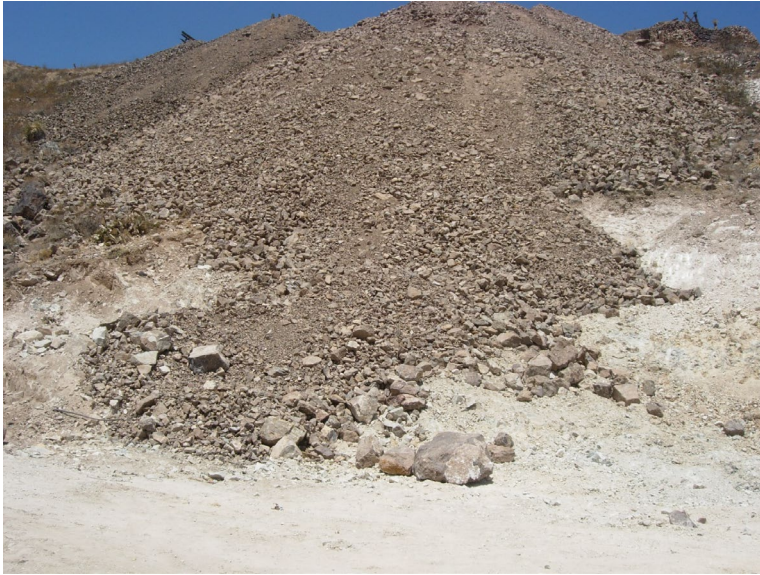
Waste rock and ore piles on location.

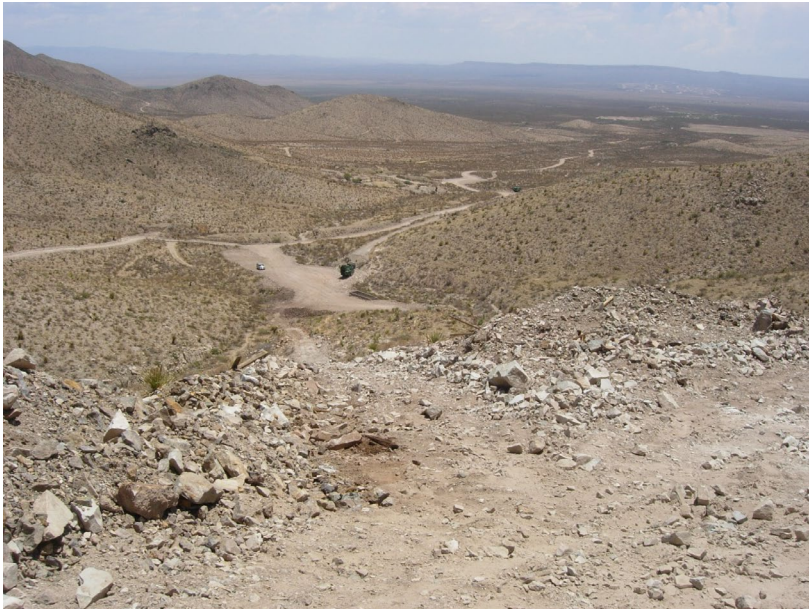
View from atop the project area. Note the newly bladed road approaching the site and newly moved materials at the upper portion of the project area.

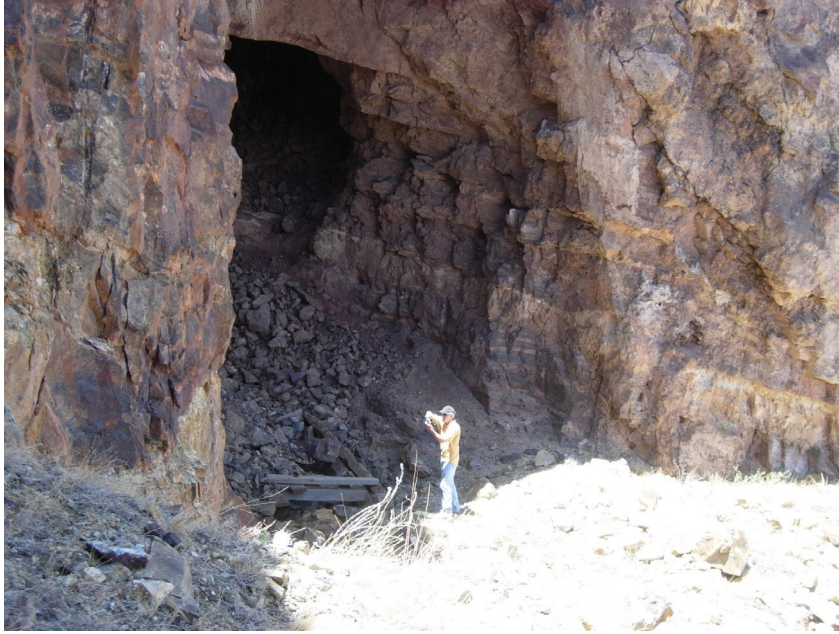
site.

Existing adit at the project

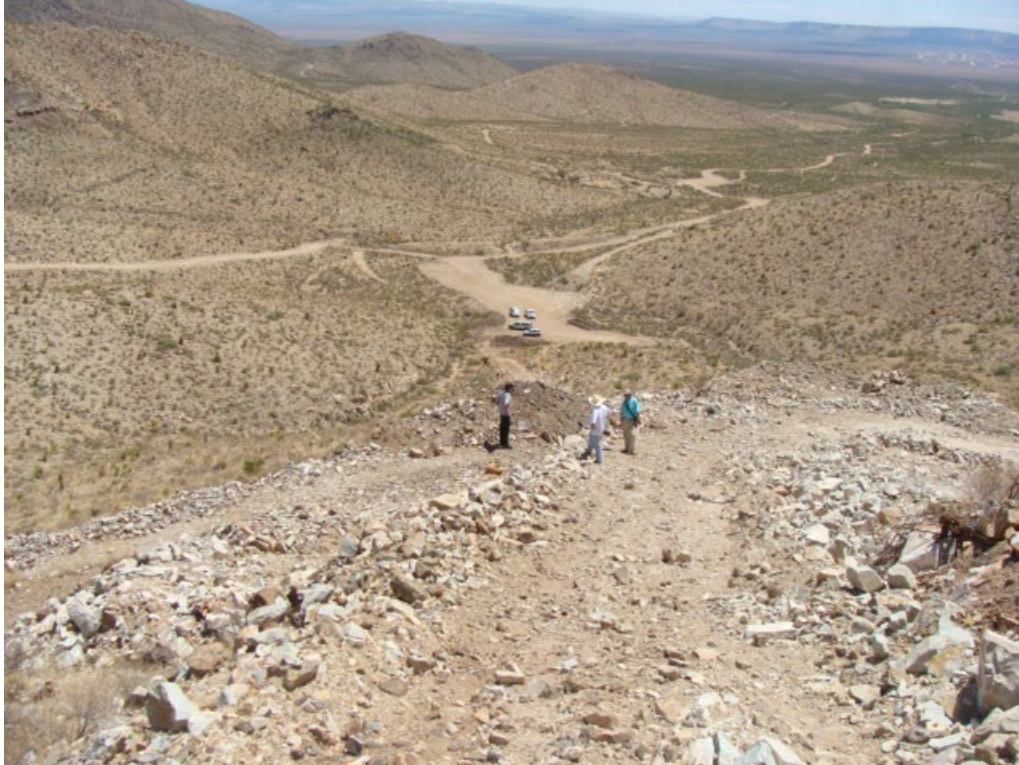
The 3 mile road leading, west from the highway, to the Iron Duke Mine has been eroded in a couple of locations due to recent rains. The operator acknowledged they would have to re-grade portions of this road in order to get equipment to the site. This road crosses both SLO and BLM lands. Last report is that neither SLO or BLM have yet granted access/right-of-way.

Below, view of main access road to mine, lower staging area, and upper access to the SE pile.

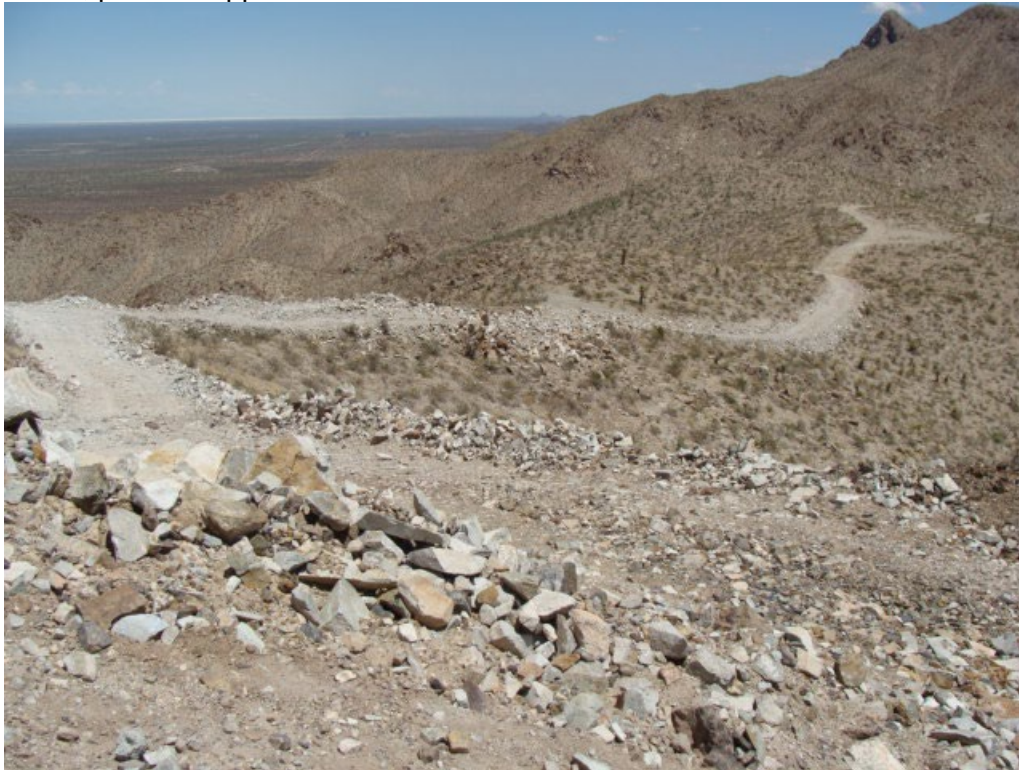
The SE pile has an associated, and previously-constructed, staging area constructed at the toe of the pile. There's also access for reaching the top of this pile as evidenced in the file photos. As mentioned above, the NE and NW piles do not have access in place and none is proposed in the PAP.

Below, photo of upper access to the Iron Duke Mine SE Pile

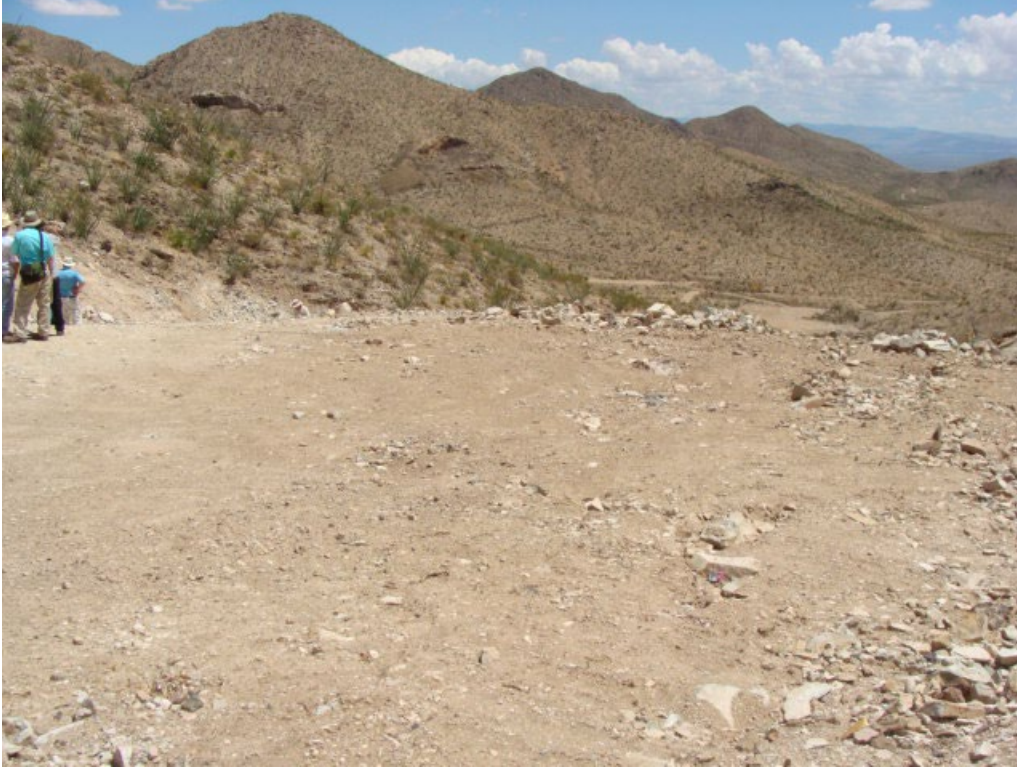
Below, view of upper staging at the toe of the SE Pile at Iron Duke Mine

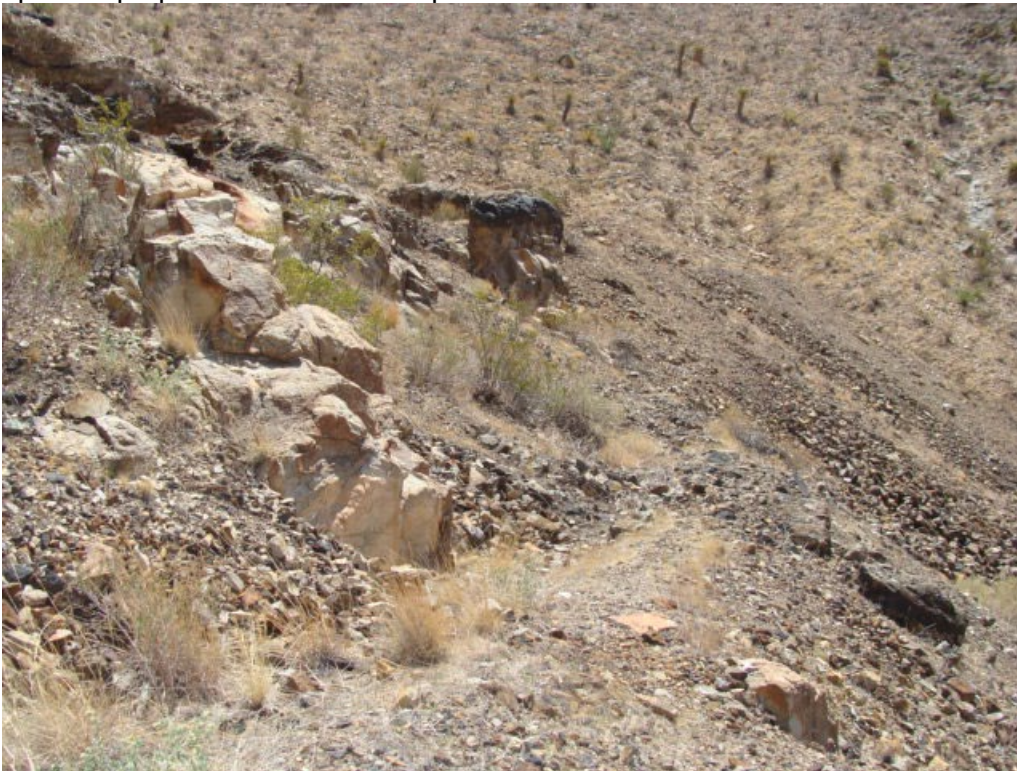
The PAP states the operator intends to remove three (3) existing waste rock piles (SE, NE, and NW piles) to be processed in El Paso. However, the PAP only proposes access to the most accessible pile, referred to as the SE pile. Furthermore, the PAP does not include the access disturbances that occurred prior to submittal of the PAP, such as the access road leading in from the highway to the mine site. In response to my question about the lack of access for the NE and NW piles the operator admitted to not having any planned access but would when the project progresses. The associated technical comment letter, to the operator, will ask to provide more information about accessing the NE and NW piles.

Below, view of the NW Pile, no vehicle access exists to this pile, and none is proposed though the operator proposes to remove this pile.

Provide technical comments to the operator requesting additional information/commitments.
