MINING INSPECTION REPORT

| Name of Mine: | Center Mine |
| Permit Number: | GR028RE |

**January 14, 2015
Center Mine**

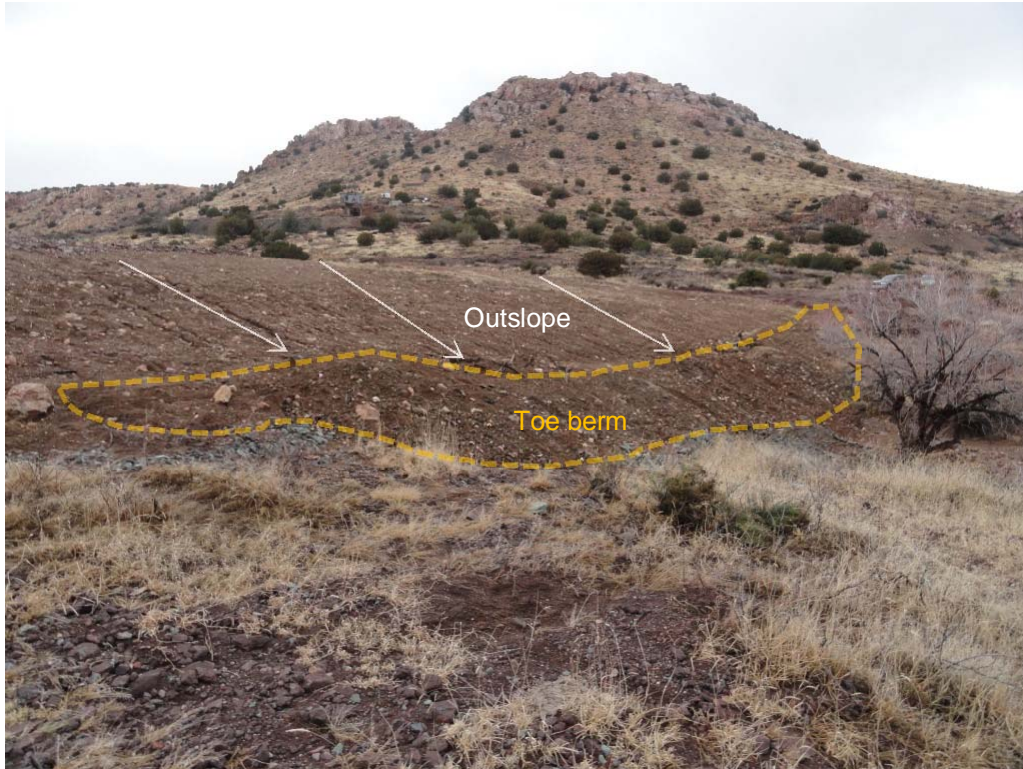
MMD, NMED, and Allyson Siwik of GRIP arrived on site and met with Bill Hanson, the operator of the site. The former tailings pond had been fully covered with borrow soil obtained from a nearby source. The outslope showed some rilling, however most of the erosion was occurring in a toe berm at the bottom of the tailing outslope. Storm water appears to collect behind the toe berm, build up, then break through the berm. This toe berm may not be necessary. It may be better to evenly distribute the soil across the toe and perhaps implement a temporary erosion control measure like straw waddles on the outslope until vegetation becomes established. The top surface of the tailings reclamation is a little irregular with some minor ponding evident. This could be corrected during re-seeding. A drainage trench was cut on the east side of the tailings reclamation to direct surface water runoff around the reclamation. Drainage is circuitous but is generally toward the southwest where the ephemeral arroyos join to Pennsylvanian Canyon and then to Carlisle Canyon

Toe berm at base of outslope of tailings reclamation; looking approximately NE

Discuss with NMED and BLM any corrective actions needed prior to the release of financial assurance for the reclamation completed to date.

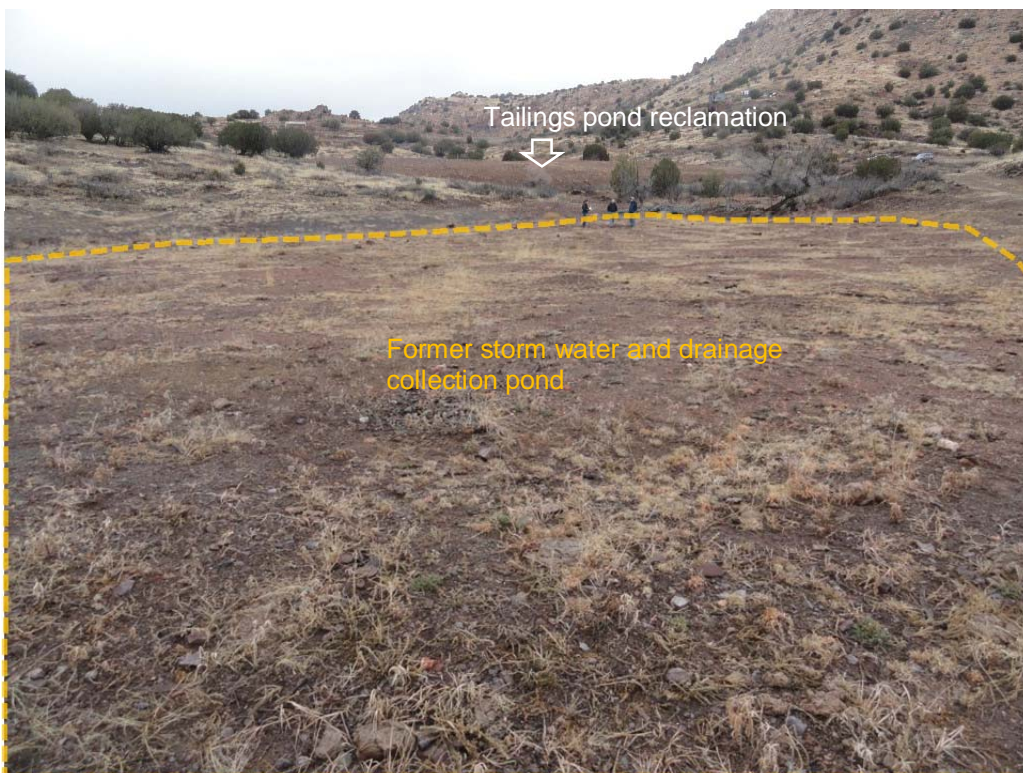
The former storm water pond to the south of the tailings had been reclaimed about a year ago and showed some good revegetation. The former storm water pond area appeared stable.

Storm water pond reclamation; looking approximately North toward tailing pond

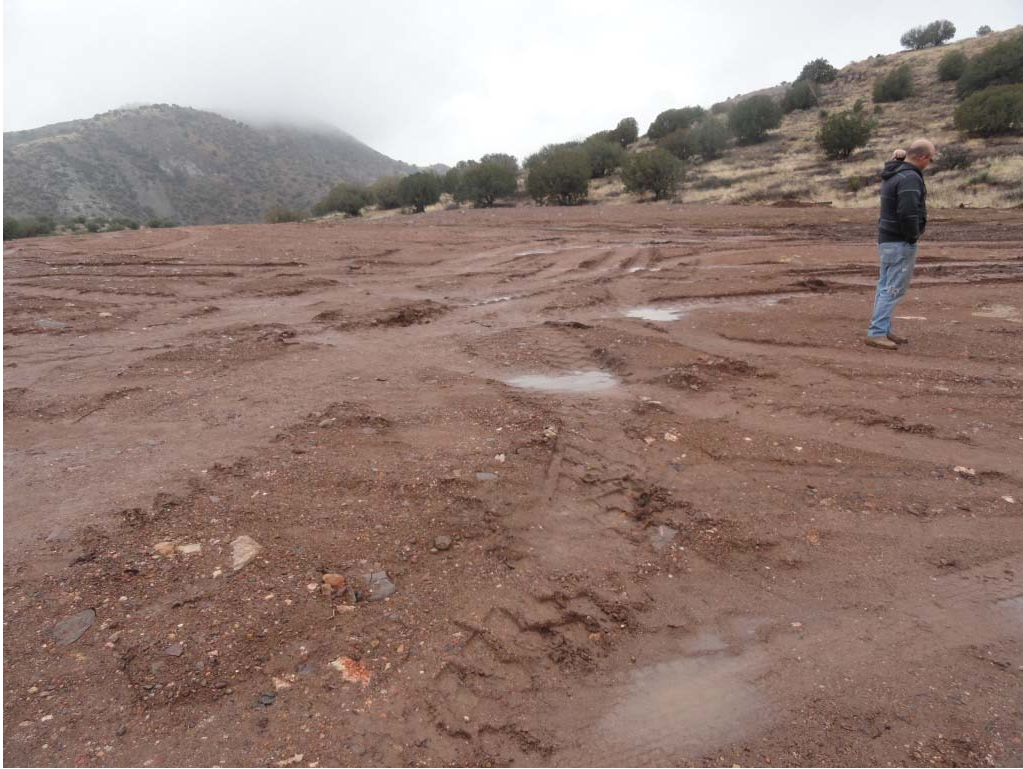
Tailings top surface reclamation; looking approximately SW

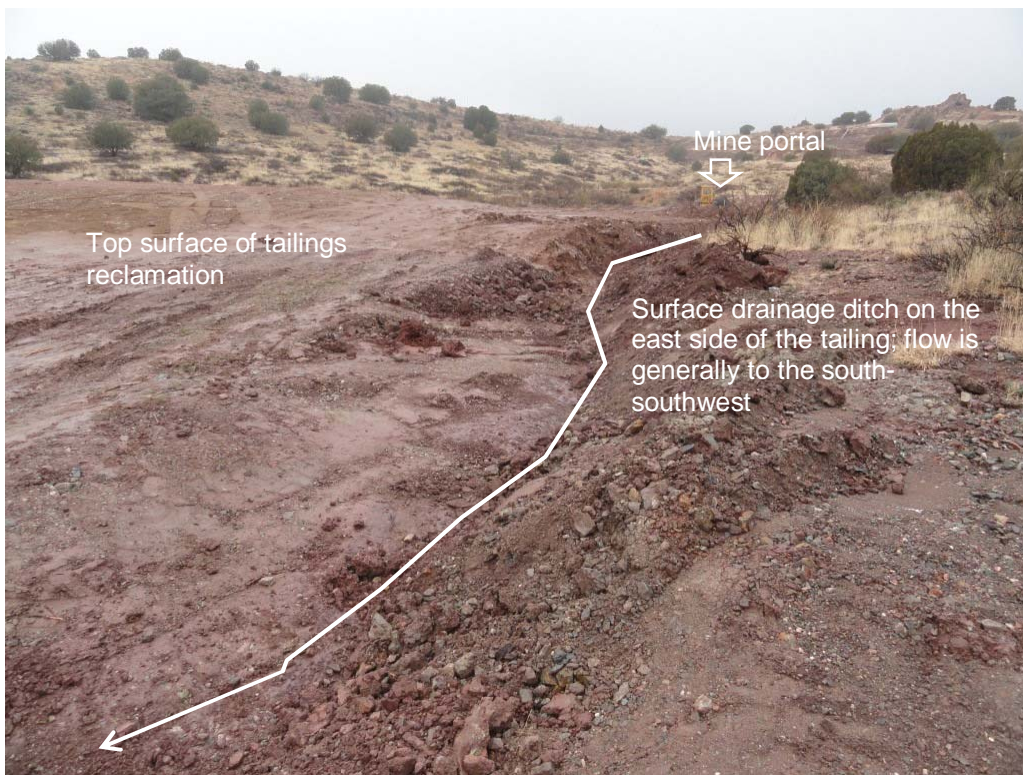
Drainage trench along east side of tailings reclamation; looking approximately North

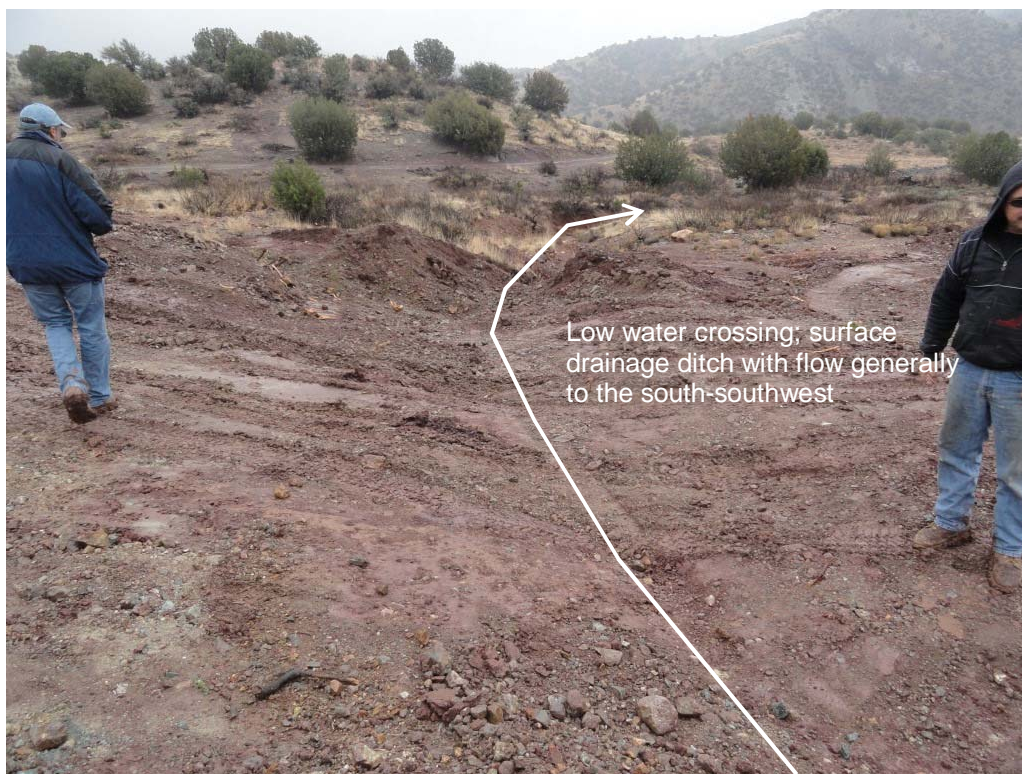
Low water crossing from road to tailings area; looking approximately South

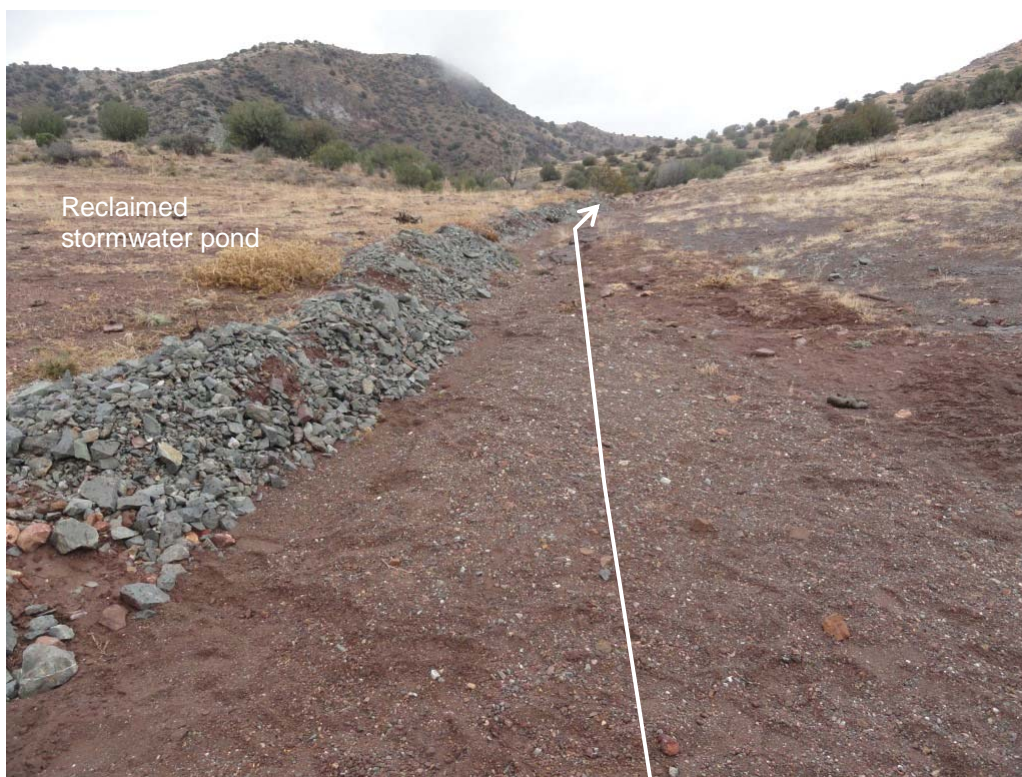
Ephemeral arroyo between the tailings reclamation and the reclaimed stormwater pond; looking approximately Southwest

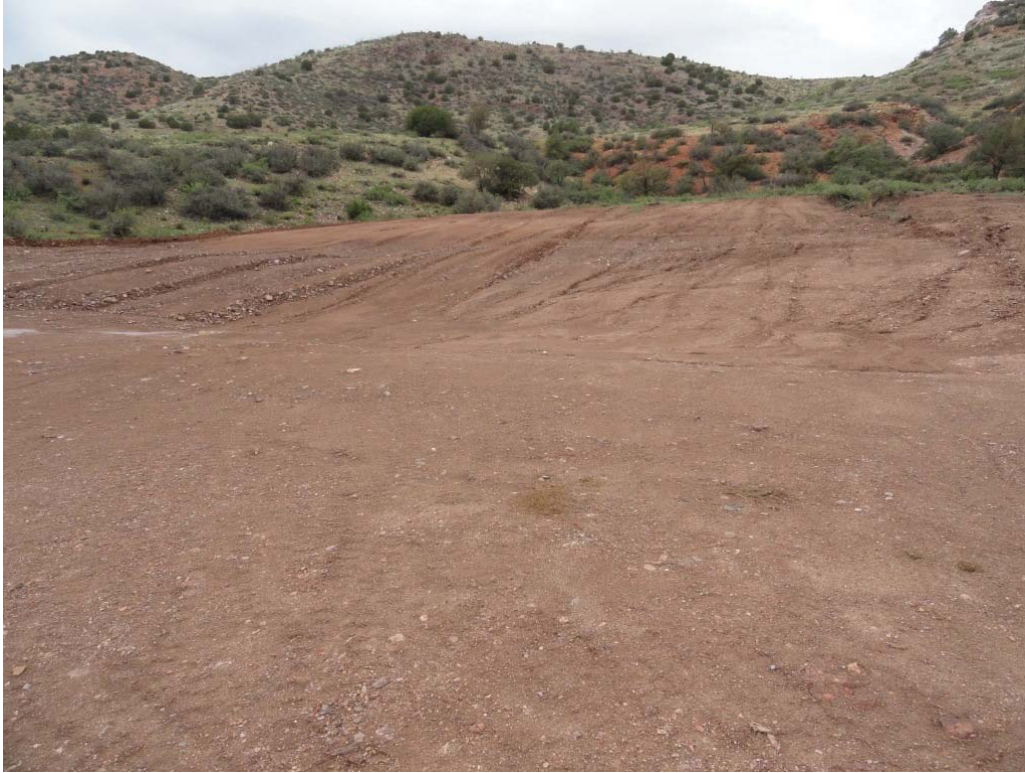
Borrow area for tailings reclamation
