MINING INSPECTION REPORT

Name of Operator: El Capitan Precious Metals Inc.	
Name of Mine: Capitan Iron Mine	
Address: Sections 10, 11, 14, 15 T 8S, R 14E (UTM 13S 0443463, 3720211)	
Permit Number: LI005ME	
Commodity: Magnetite Iron <input checked="" type="checkbox"/> SURFACE <input type="checkbox"/> UNDERGROUND	
Date of Inspection: 4/22/2015	
Time of On-Site Inspection: 1030AM to 12 PM	
Weather Conditions: cool/partly cloudy	
Purpose of Inspection: Inspection bi-annual	
Inspector: Chris Eustice	
Present During Inspection: Randy Bouldin, Davena Crosley, Holland Shepherd	
ENFORCEMENT ACTION TAKEN: NOTICE OF VIOLATION: # _____ YES:___ NO:___ CESSATION ORDER: _____ YES: <u>X</u> NO:___	
Time: On-Site: <u>1.5</u> Permit Review: <u>0.5</u> Travel: <u>7</u> Report Writing: <u>1</u>	
TOTAL INSPECTION TIME: <u>10</u> HOURS	
NOTE: To get to the site, go north from Capitan on State Highway 246. About 5.5 miles from town, go right (east) on a Forest Road that has a cattle grate but no gate. Just follow the main Forest Road to the mine. There are no locked gates.

INSPECTION
4/22/2015
Capitan Iron Mine

INSPECTION
10/1/2015
Capitan Iron Mine

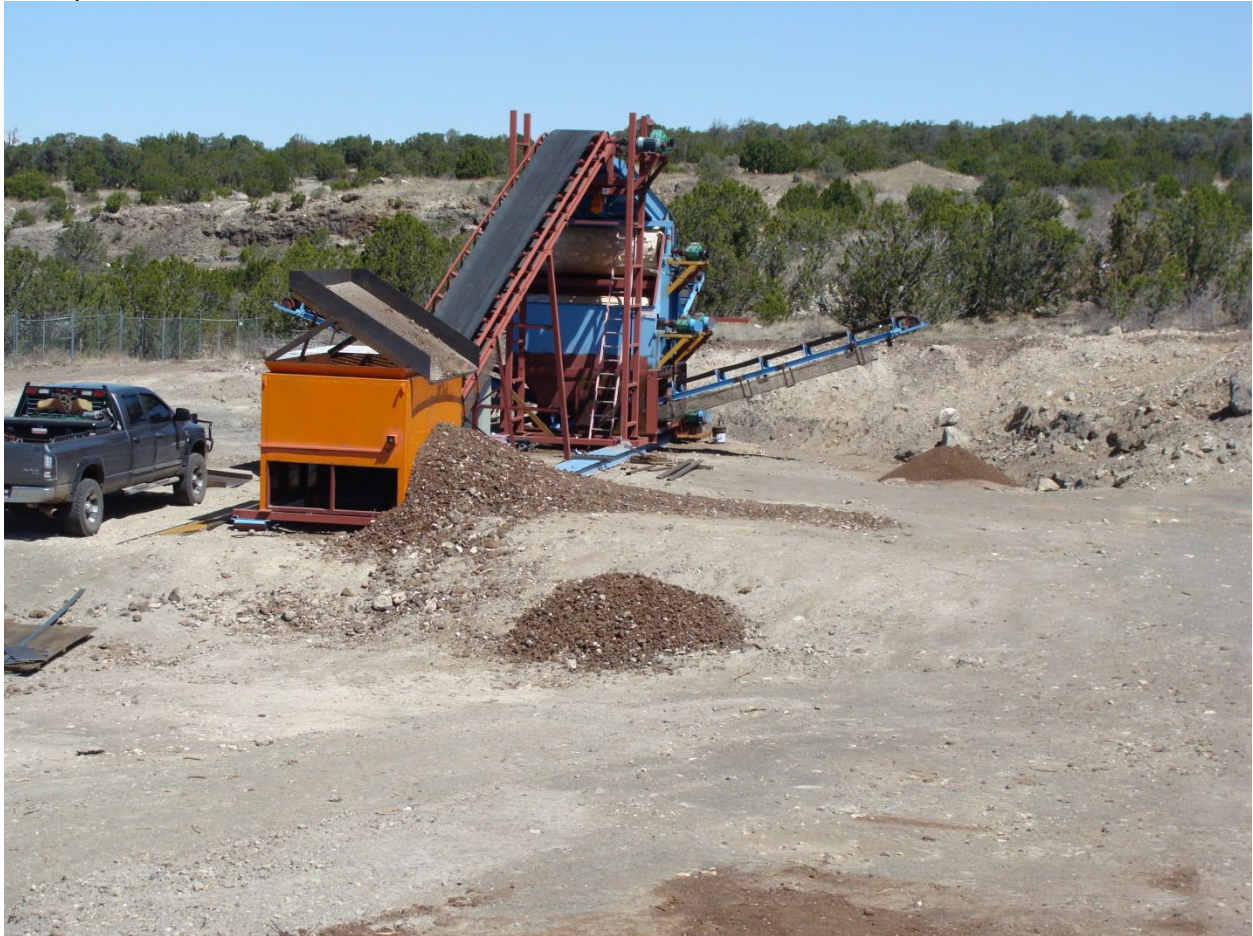
Arrived at the site a few minutes past 1030AM. I accompanied the operator's representatives to observe a newly installed magnetic separator. The separator is not yet running and mining is still inactive as the operator attempts to complete the modification of the permit.

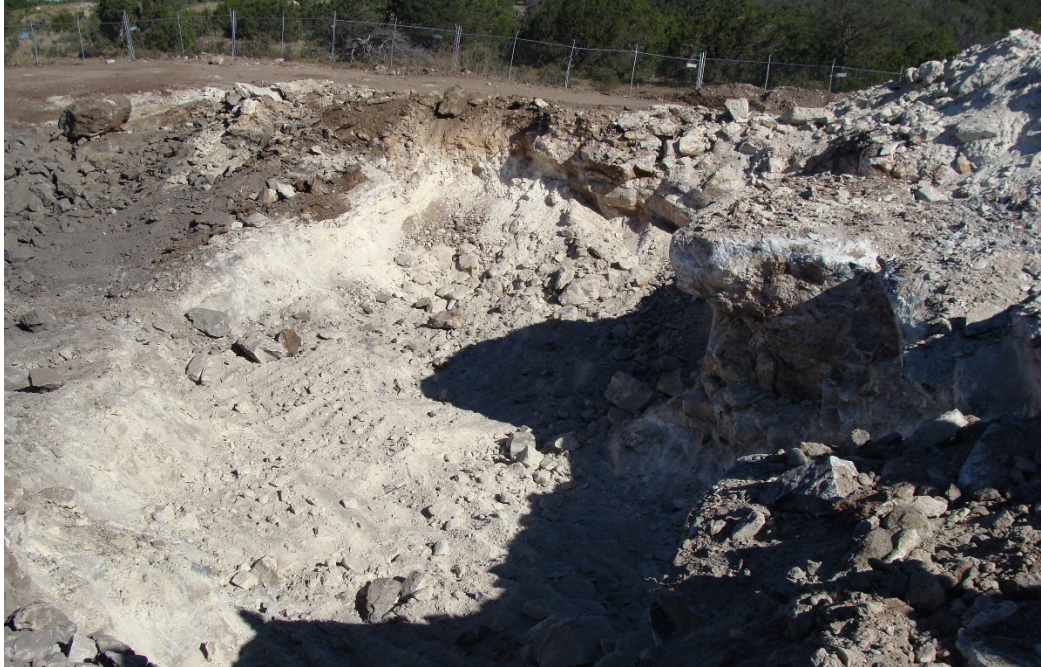
The mining is occurring in a pit created by using a pneumatic hammer mounted on a trackhoe. The current dimensions of the active pit is approximately 30 feet in length, 20 feet in width, and a maximum depth of 7 feet. I walked the perimeter (fenced) of the disturbance limit. All operations and associated disturbances are occurring within the permitted disturbance limit. There was no evidence of the use of explosives. Furthermore, the operator is adamant that they do not use explosives.

Photo below is the current active pit, approximately 30' (L) X 20'(W) X 7' (D)

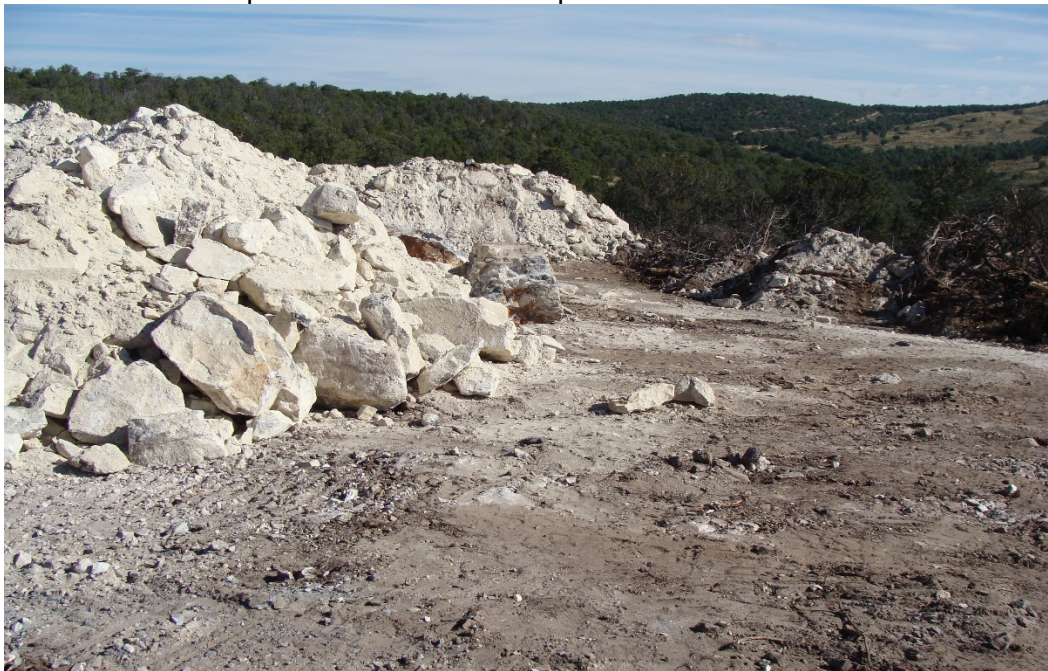
Overburden material is separated in to two piles. One pile is boulder caliche and limestone material that are large and will be used for backfilling the pit. Another pile is salvaged top soil and fines rejected from the magnetic separator. This material will be used for covering the site prior to seeding.

Photo below is the pit backfill material stockpile.

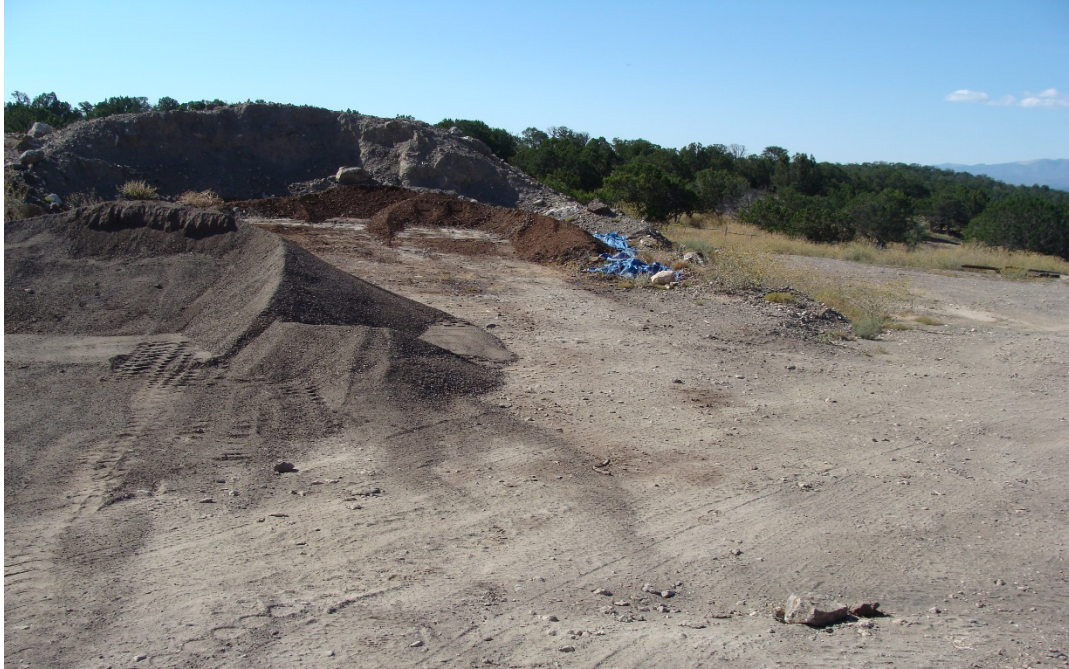
Photo below is the cover material stockpile

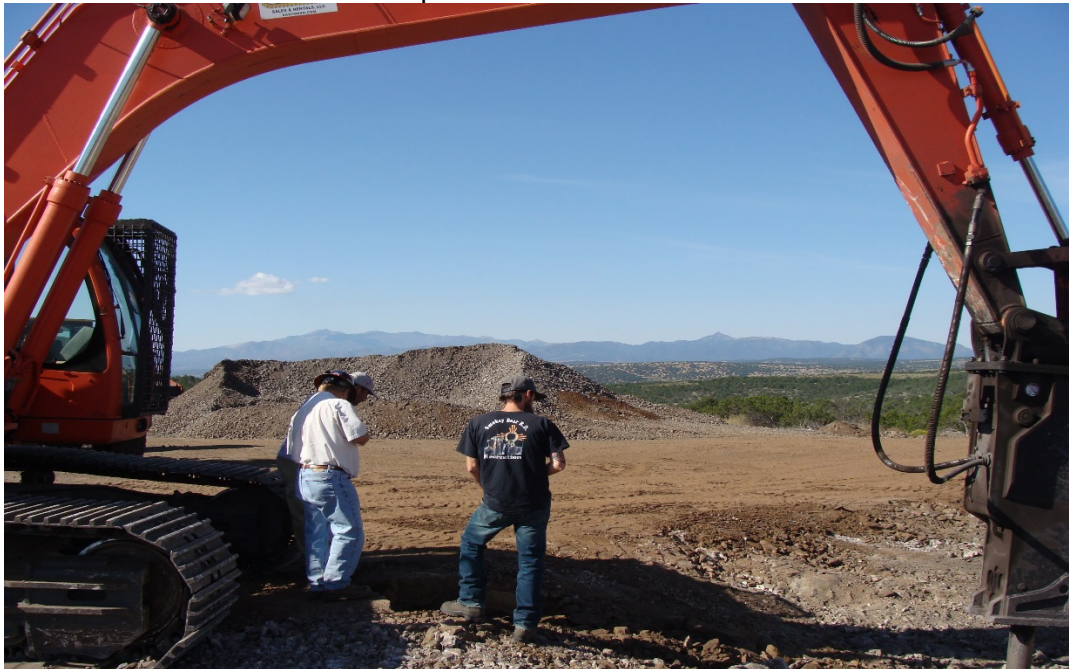
The processing equipment consists of the trackhoe and pneumatic hammer, a 4 inch minus screen, and a combination crusher and magnetic separator. The equipment is still laid out in the same pattern as it was during the April 2015 inspection. Processed concentrate is piled next to the separator and is approximately 3 cubic-yards in volume.

Photo below is the trackhoe and pneumatic hammer.
