**INSPECTION**  
**3/25/2016**  
Capitan Iron Mine

**INSPECTION NARRATIVE:**

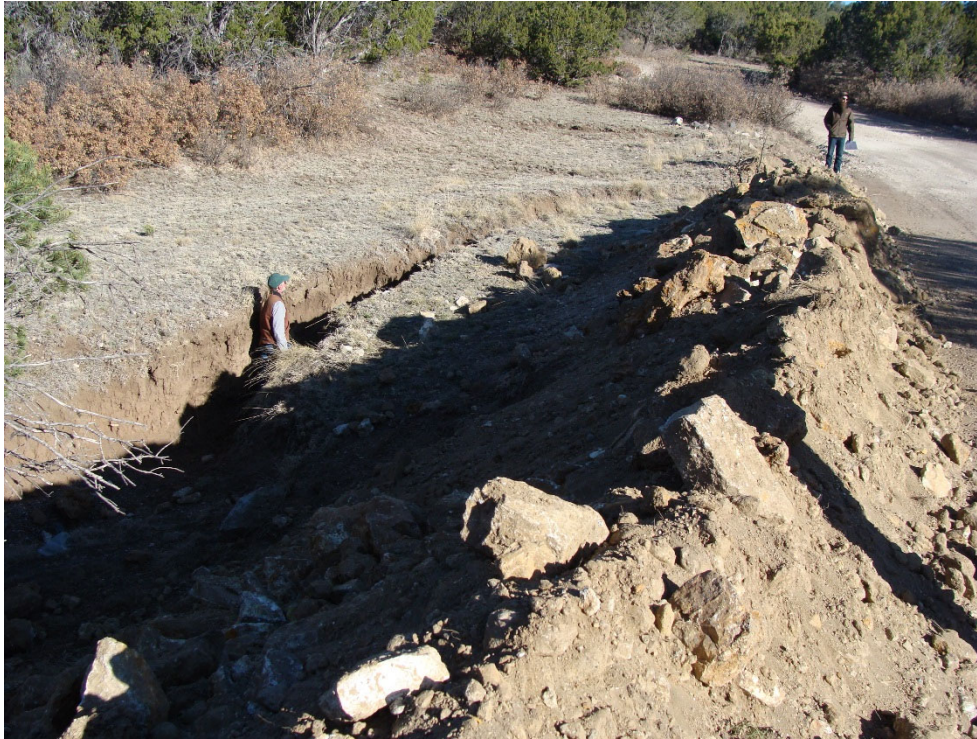
However, where the access road has bends and turns the operator has constructed berms on the downhill side of the access road. These berms are clearly constructed out of mine waste as acknowledged by the operator’s representative. Additionally, the operator has pushed some of the mine waste, or berm material, down in to an unnamed arroyo/drainage. Placement of mine waste in to a drainage without a permit may be construed as violating Section 404 and/or 401 of the Clean Water Act for the discharge of dredged or fill material in waster of the United States. This will be reported to the New Mexico Environment Department for their consideration of enforcement action(s) if any.

Head cut receives road drainage near fill area. Berm is mine waste.

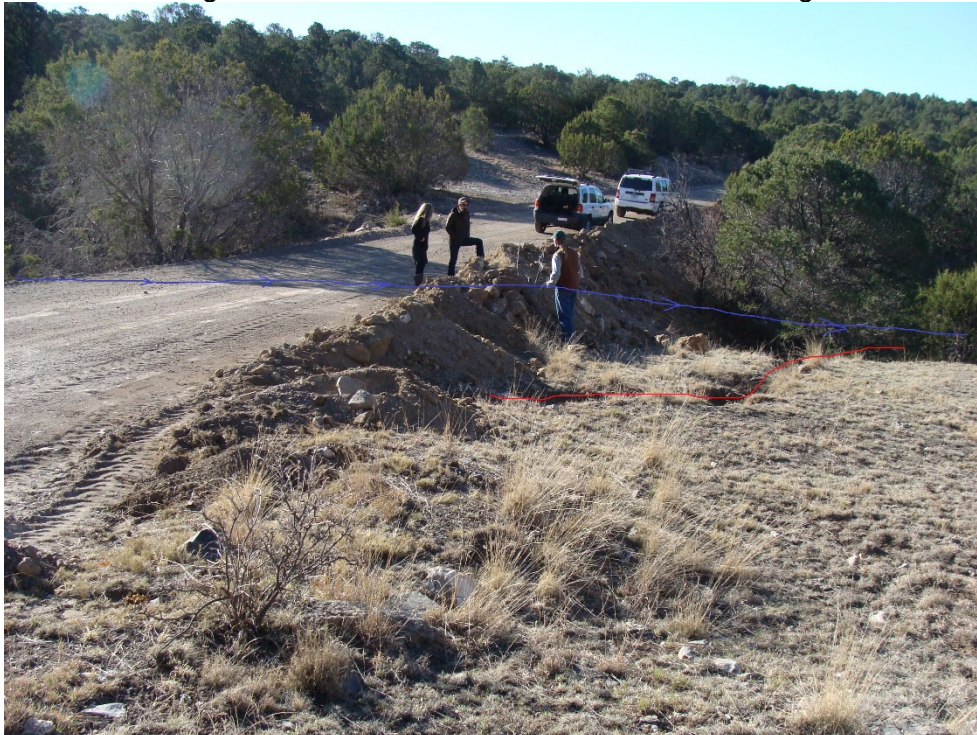
Photo below is constructed berm using mine waste that has been placed in drainage. Blue line demarks drainage channel axis. Red line demarks head cutting due to road drainage.

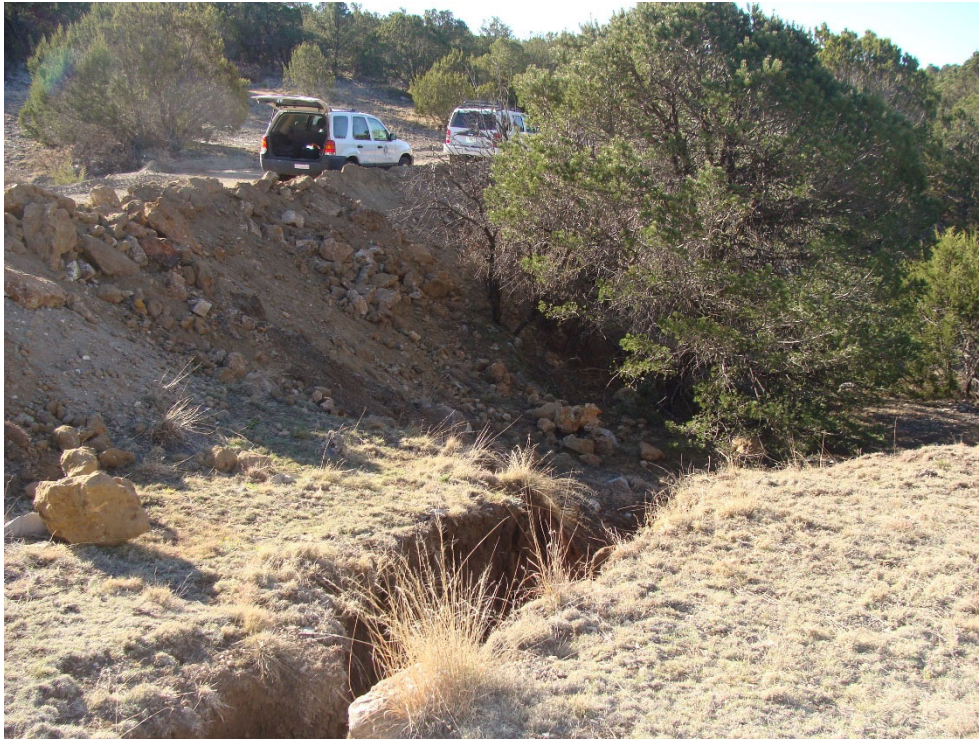
Photo below additional view of fill in channel

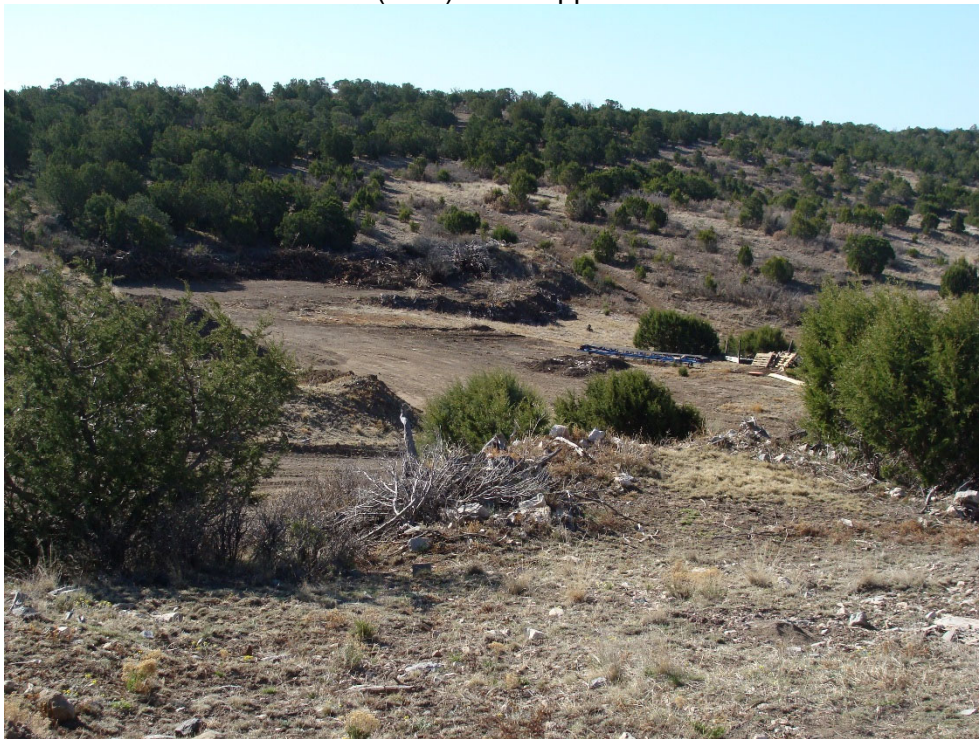
The operator has placed a cyclone fence around the approved 5 acre limit of disturbance. However it was observed that mined and processed materials have been placed outside the approved disturbance limit and fence. Furthermore, some clearing and grubbing has occurred outside the approved 5 acre limit of disturbance.

Below is disturbance outside (west) of the approved disturbance limit

Discuss with management and consider a Notice of Violation(s), penalty, and remedy.

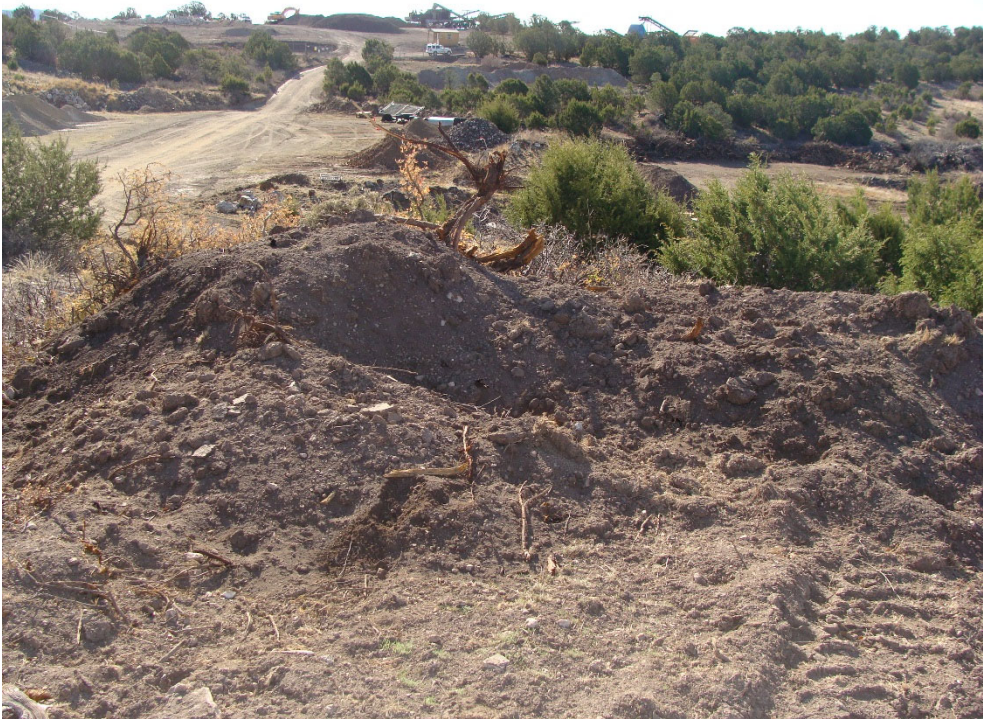
Below photo of disturbance outside (west) of approved disturbance limit

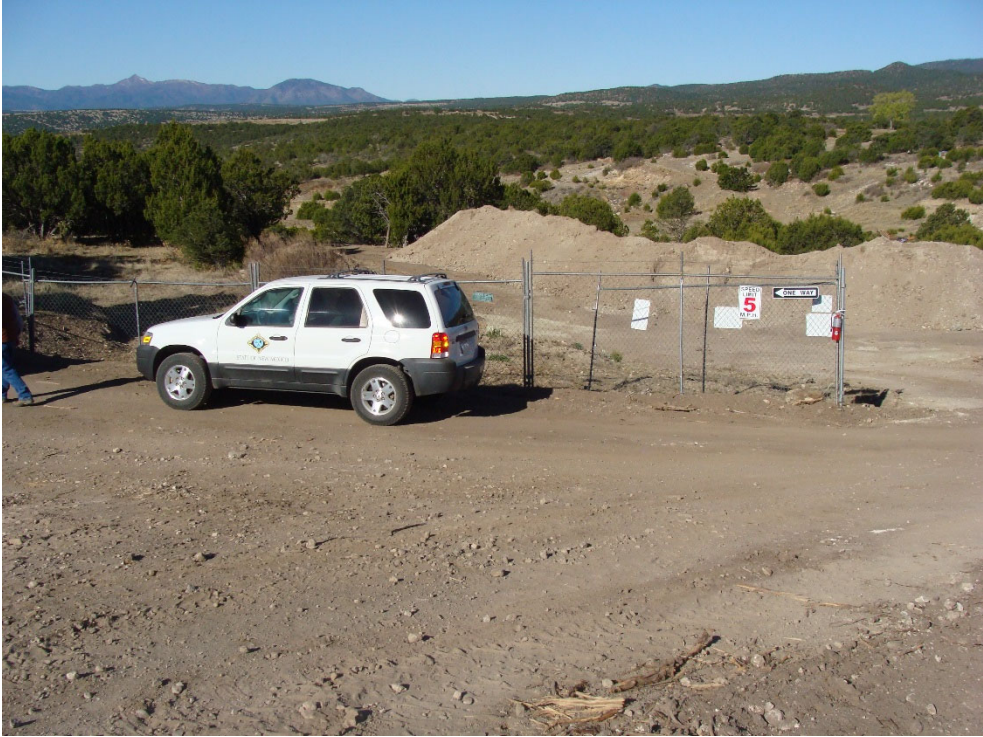
Stockpiled material outside (west) the fenced disturbance limit.

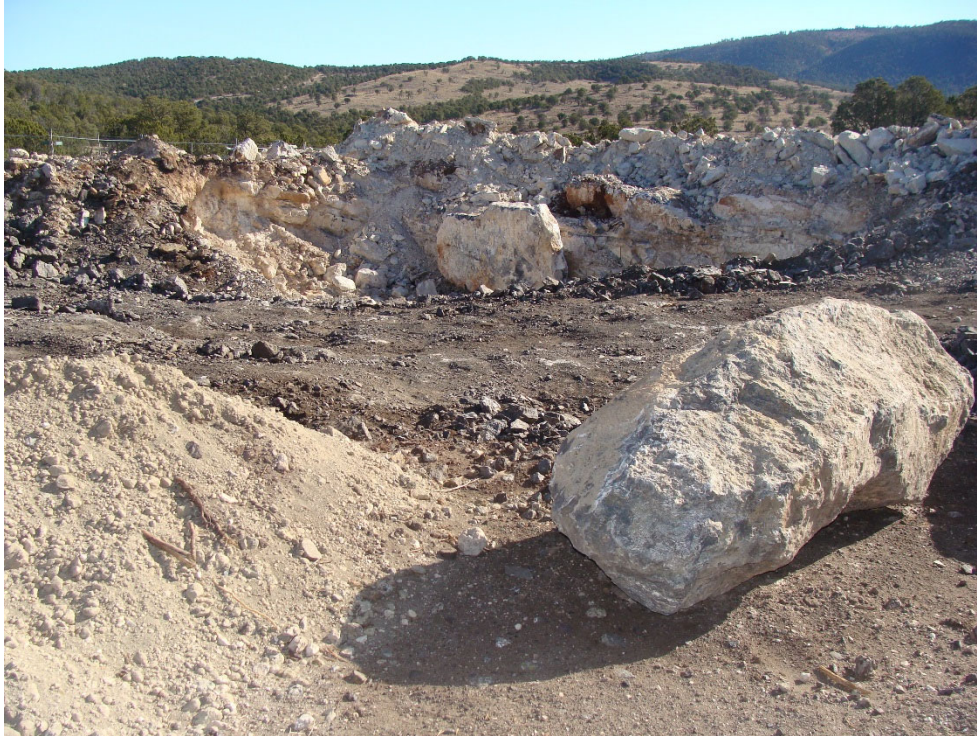
The mining is occurring in a pit created by using a pneumatic hammer mounted on a trackhoe. The current dimensions of the active pit is approximately 30 feet in length, 20 feet in width, and a maximum depth of 7 feet. I walked the perimeter (fenced) of the disturbance limit. There was no evidence of the use of explosives. Furthermore, the operator is adamant that they do not use explosives.

Photo below is the current active pit March 25, 2016.
