**MINING INSPECTION REPORT**

<b>Name of Operator:</b>	Gulf Coast Mining Group, LLC
<b>Name of Mine:</b>	Iron Duke Mine
<b>Address:</b>	20701 Scottsdale Rd., #107-293, Scottsdale, Az. 85255
<b>Permit Number:</b>	OT006MN
<b>Commodity:</b> hematite & magnetite	<input checked="" type="checkbox"/> <b>SURFACE</b> <input type="checkbox"/> <b>UNDERGROUND</b>
<b>Date of Inspection:</b>	January 9, 2018
<b>Time of On-Site Inspection:</b>	3:15 PM – 4:45 PM
<b>Weather Conditions:</b>	overcast, +/- 65°F, no wind
<b>Purpose of Inspection:</b>	bi-annual
<b>Lead Inspector:</b>	Mike Thompson
<b>Present During Inspection:</b>	MMD: Mike Thompson    NMED: n/a
<b>Operator:</b>	Three workers from JL Industries
<b>ENFORCEMENT ACTION TAKEN:</b>	None
<b>NOTICE OF VIOLATION: #</b>	_____ <b>YES:</b> _____ <b>NO:</b> <input checked="" type="checkbox"/>
<b>CESSATION ORDER:</b>	_____ <b>YES:</b> _____ <b>NO:</b> <input checked="" type="checkbox"/>
<b>Time: On-Site:</b>	<u>1.5 hrs</u> <b>Permit Review:</b> <u>1</u> <b>Travel:</b> <u>8 hrs</u> <b>Report Writing:</b> <u>1</u>

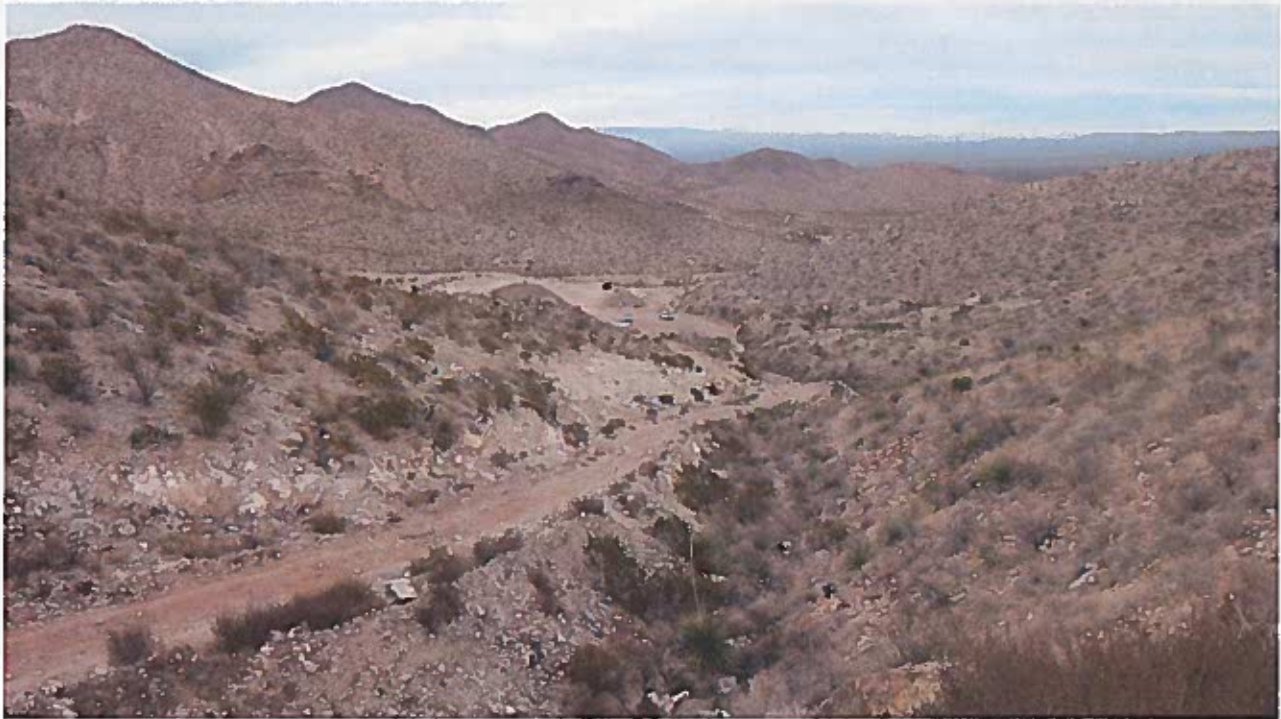
4. The permit area consists of four patented mining claims: Iron Duke, Cinco de Mayo, Virginia and Barbara. But a staging pad and a road were created in 2010 or 2011 (before the permit was approved) that links the bottom pad with the Iron Duke waste rock pile that is mostly on BLM land. It is unclear if the BLM ever authorized the pad and road and why they were not included permit area boundary.

Access Road to Iron Duke on BLM land

- Need to resolve the issues of mining activity outside of the permit boundary on BLM land and adjust the permit boundary if necessary.
- The financial assurance needs to be updated.
- The Permittee needs to establish a reference area and submit it to MMD for approval.

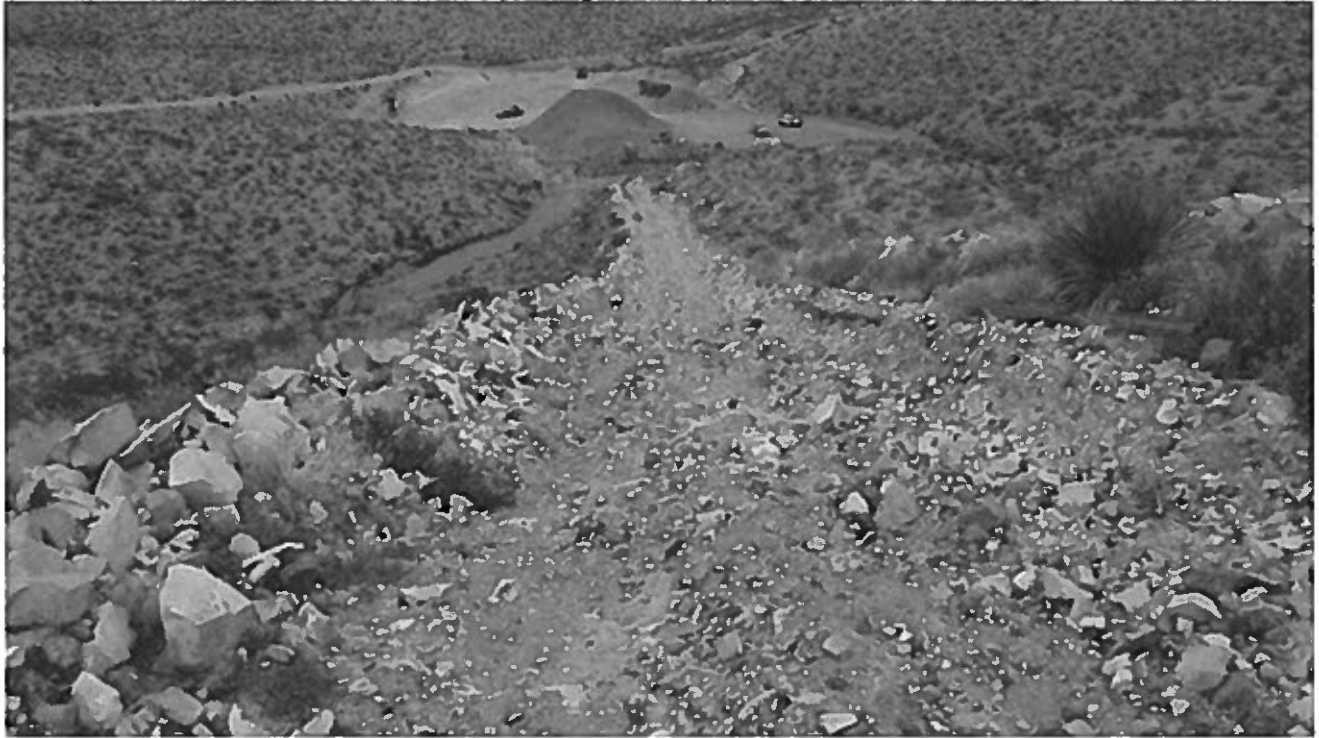
Cat Path – Old Rail Grade, Now Road (looking downhill)

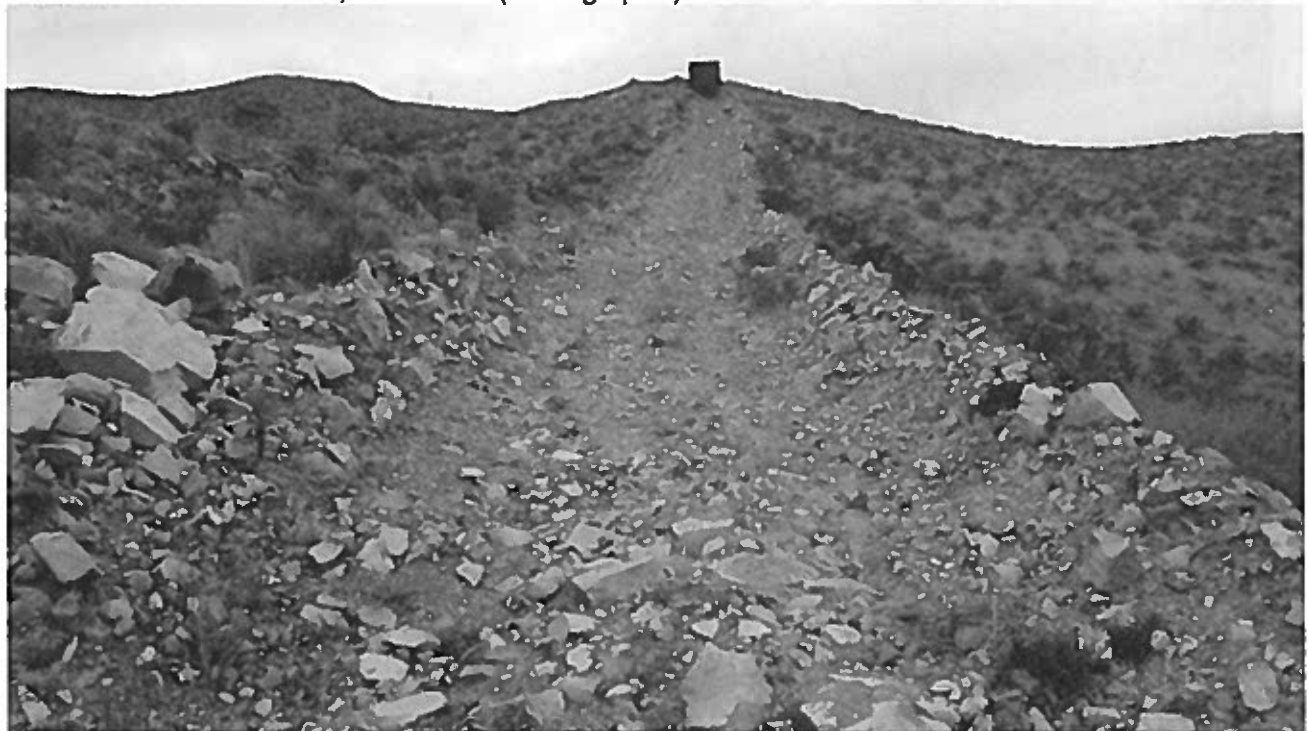
Cat Path – Old Rail Grade, Now Road (looking uphill)
