**MINING INSPECTION REPORT**

<b>Name of Operator:</b> Rio Grande Resources, Inc. (RGR)
<b>Name of Mine:</b> Mt. Taylor Mine
<b>Address:</b> Approx. 20 miles north of Grants (UTM 13S 0260351, 3914011)
<b>Permit Number:</b> CI002RE
<b>Commodity:</b> Uranium <span style="margin-left: 150px;"><u>    </u> SURFACE</span> <span style="margin-left: 50px;"><u>X</u> UNDERGROUND</span>
<b>Date of Inspection:</b> June 11, 2018
<b>Time of On-Site Inspection:</b> 10:30 am – 1:15 pm
<b>Weather Conditions:</b> Partly cloudy, 80°F
<b>Purpose of Inspection:</b> Biannual/reactivation inspection.
<b>Lead Inspector:</b> David Ohiri
<b>Present During Inspection:</b> MMD – David Ohiri, Kevin Myers; RGR - Joe Lister, Bruce Norquist.
<b>ENFORCEMENT ACTION TAKEN:</b> None <b>NOTICE OF VIOLATION: #</b> <u>    </u> <b>YES:</b> <u>    </u> <b>NO:</b> <u>X</u> <b>CESSATION ORDER:</b> <u>    </u> <b>YES:</b> <u>    </u> <b>NO:</b> <u>X</u>
<b>Time: On-Site:</b> <u>2.75</u> <b>Permit Review:</b> <u>1</u> <b>Travel:</b> <u>5</u> <b>Report Writing:</b> <u>1</u>

**BI-ANNUAL INSPECTION****June 11, 2018****Mount Taylor Mine****PERMIT UPDATE:**

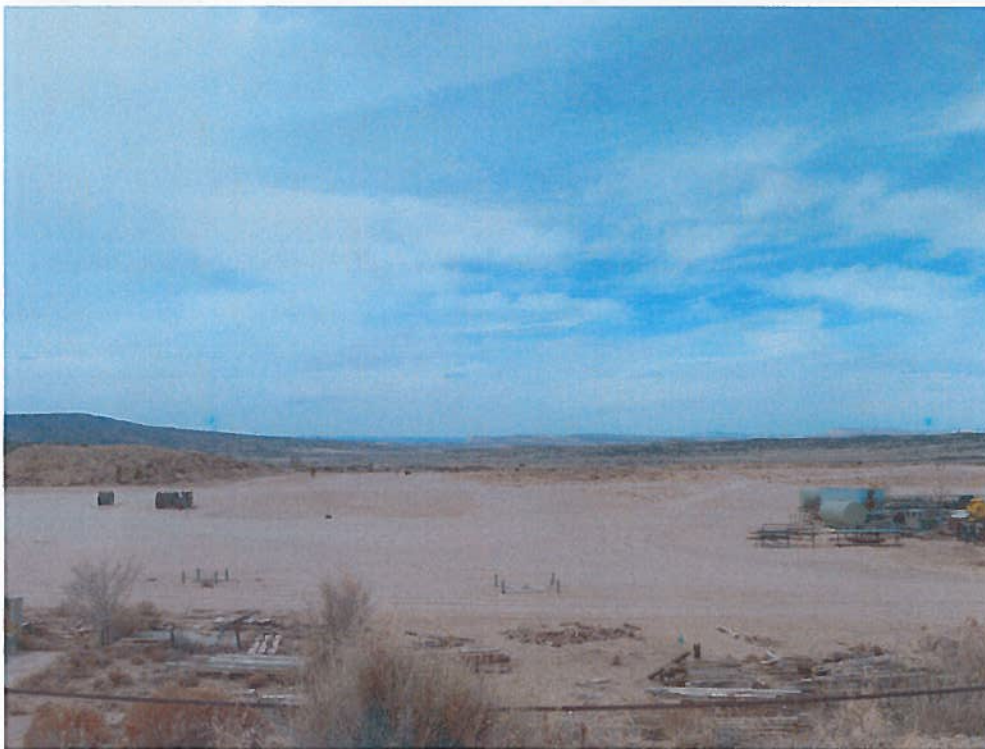
North Top Surface of Waste Rock Pile on April 5, 2018 (looking west)

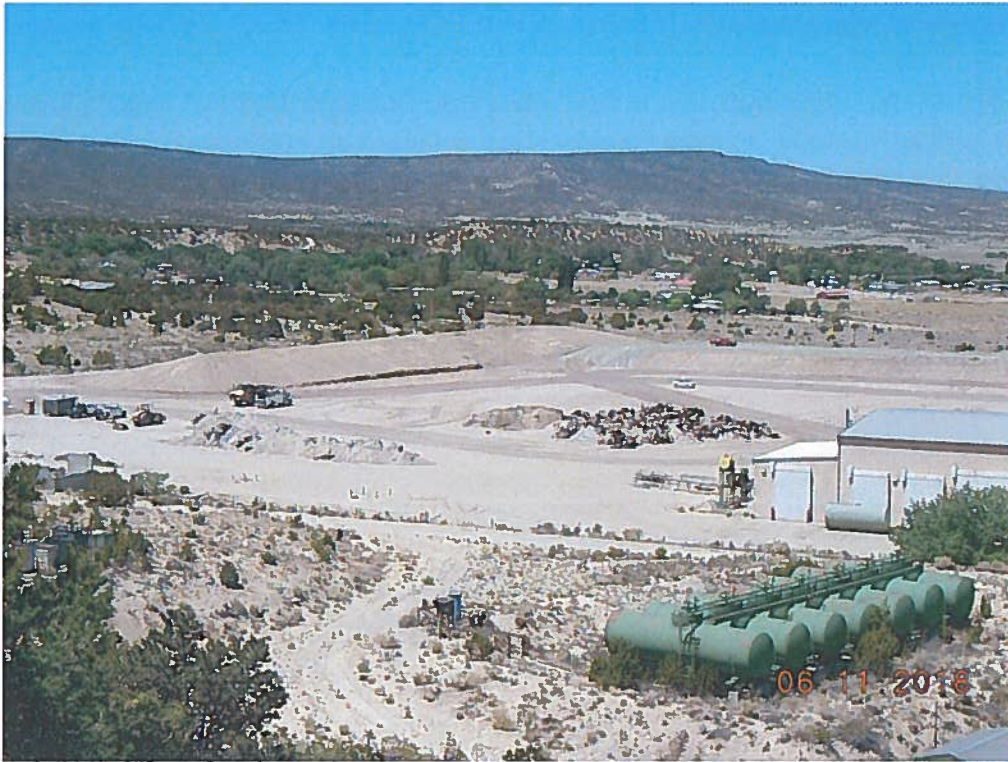
Top Surface of Waste Rock Pile on June 11, 2018 (looking southwest)

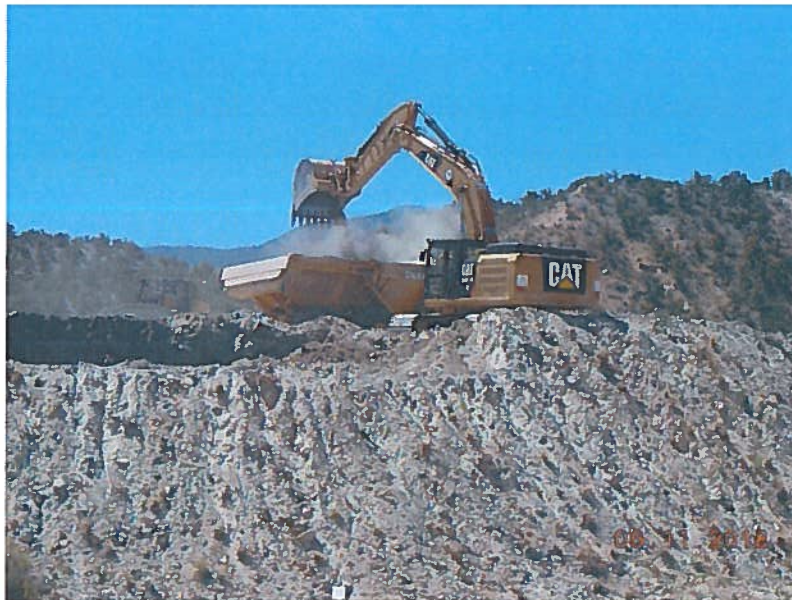
Cat excavator loading waste rock (gray color) from waste rock pile into haul truck

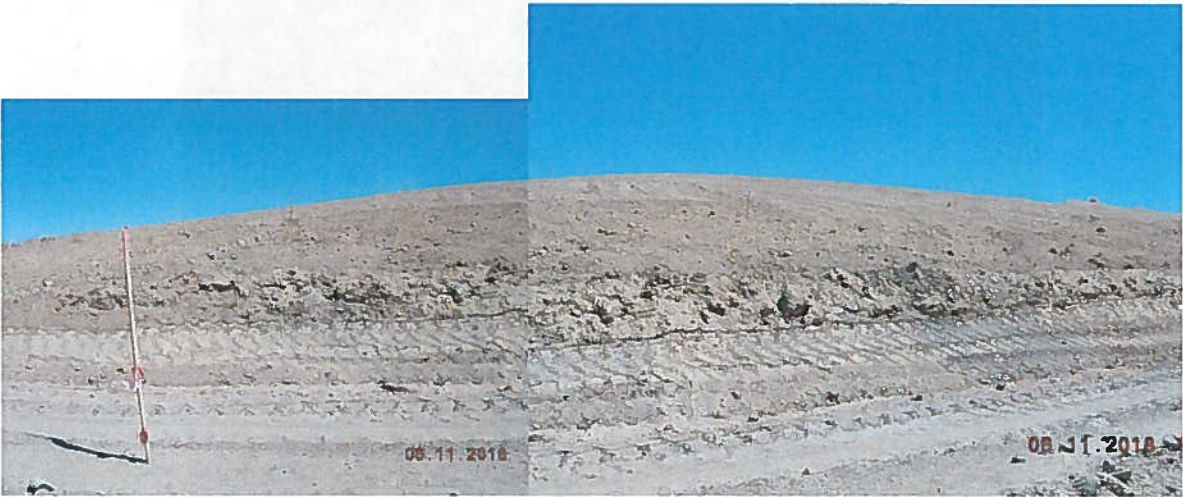
South facing waste rock pile rough graded to approx. 5H:1V gradient (brown color shaft muck)

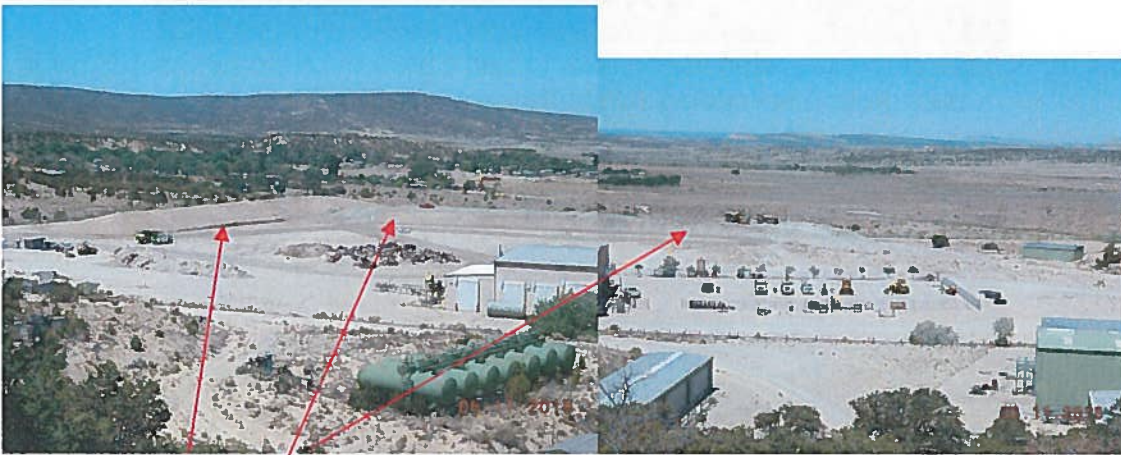
Bruce reported that regrading work to build the lined-disposal cell in the top surface of the waste rock pile had started approx. 3-weeks earlier (see photos). The earthmoving contractor, Enviroworks, was operating a Cat 330 excavator, along with two Cat 740B haul trucks and a Cat D8 dozer to build the disposal cell. The excavator was pulling back the west outslope of the waste pile (see photo). The west outslope of the waste rock pile will be graded to a 5H:1V gradient and stormwater BMP's will be installed along the toe area. A water truck was also in operation. Rough grading waste being done using grade stakes that a surveyor was placing. Bruce said that a Cat D6 dozer will be brought in to perform the fine grading on the waste rock pile and that it will be equipped with a CAES GPS grade control system (similar to those used at the reclamation work done at the Freeport-McMoRan mines in Silver City) for greater precision. The lined-disposal cell within the waste rock pile that will receive the sediments from the treatment ponds when they are excavated and re-built. The brown shaded materials observed in the waste rock pile area is shaft muck and the gray shaded materials are waste rock according to Bruce (see photos). The rough grading of the south facing slope of the waste rock pile was nearing completion according to Bruce (see photos).

Regrading and building the Disposal Cell berms on the Waste Rock Pile

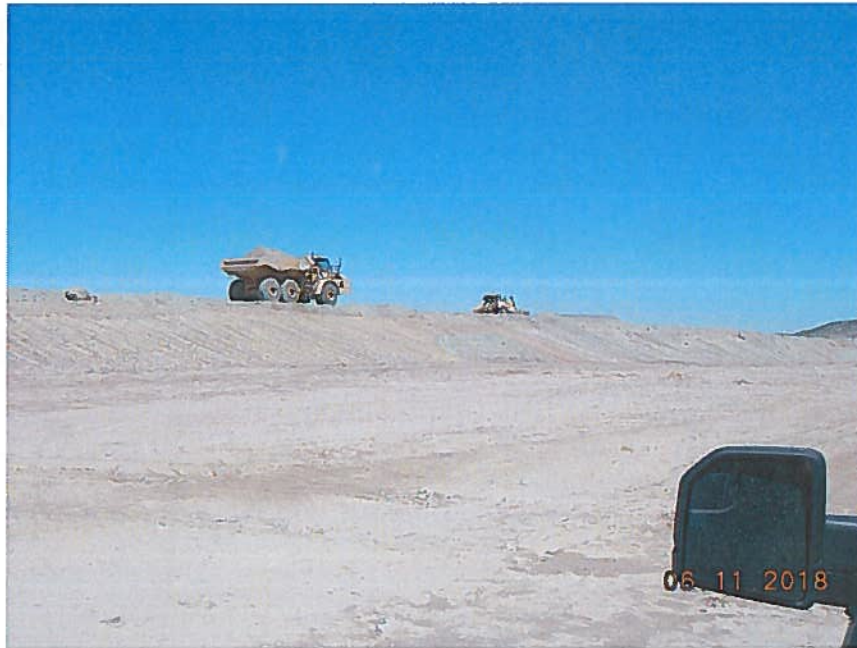
Haul truck delivering excavated waste rock to berm area of Disposal Cell (dozer in background spreading waste rock material for the berm)

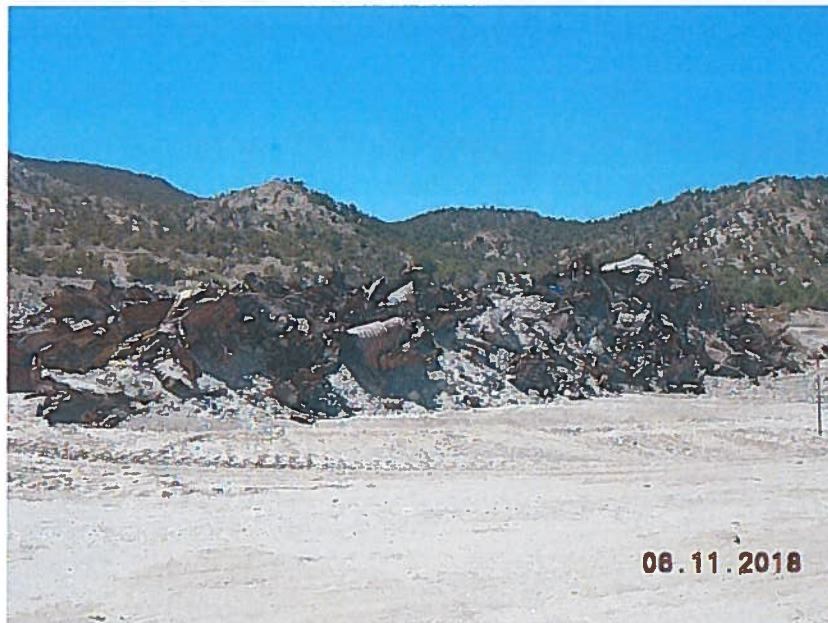
During regrading of the waste rock pile debris such as vent bag and vent duct work was removed from the waste rock pile and is being staged for proper disposal according to Bruce (see photo). Bruce said that the on-site radiation safety was being managed by ERG.

Vent bag and ductwork debris excavated from the Waste Rock Pile

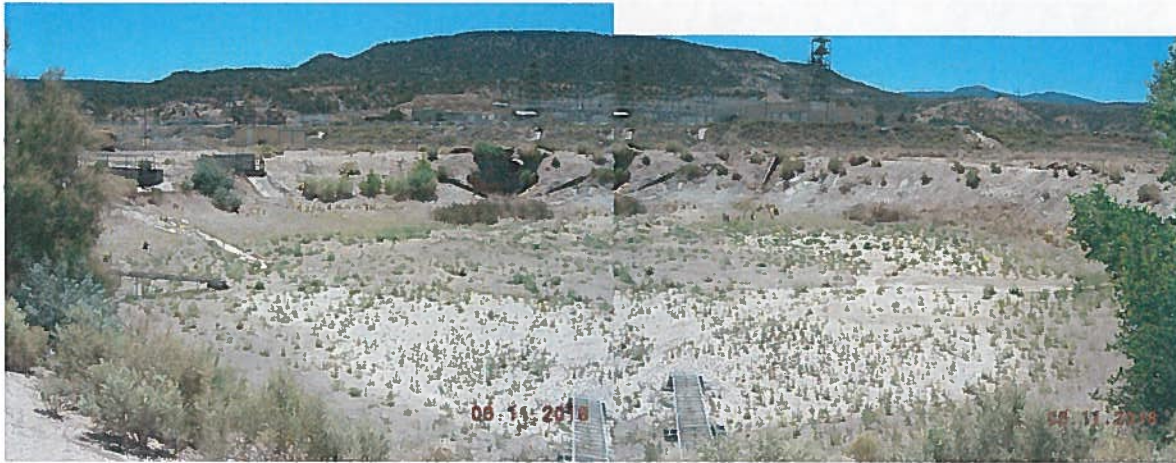
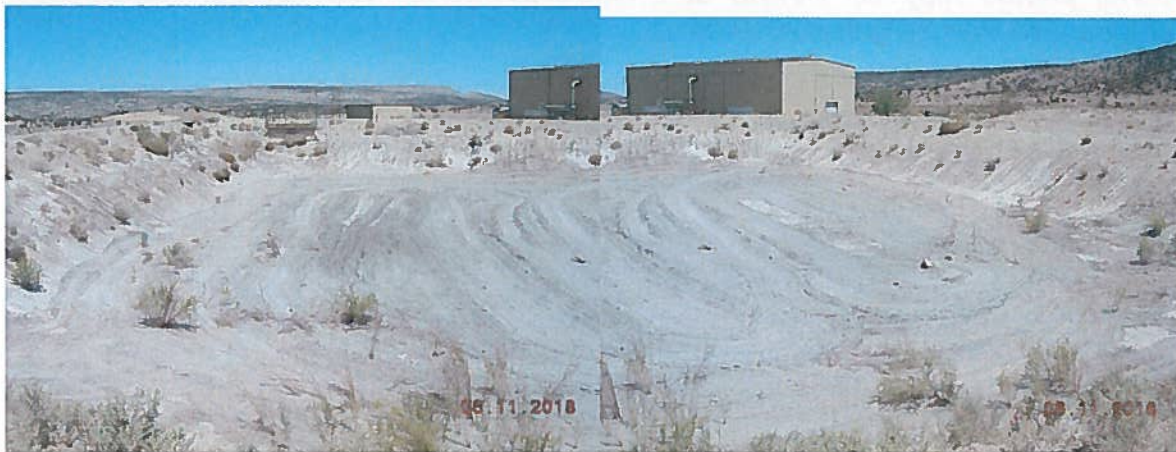
Water Treatment System Pond 2

Ponds 2 and 3 were inspected (see photos). Bruce said that the water management structures at Pond 2 will be demolished and replaced. The plan is to excavate sediments from Pond 3, place them in the lined-disposal cell and then double-line the pond with a HDPE liner with a leak detection system. Then Pond 2 will be renovated including a double HDPE liner and leak detection system. The rolls of HDPE liner material and the geo-mesh interlayer material was already being delivered and staged near the ion

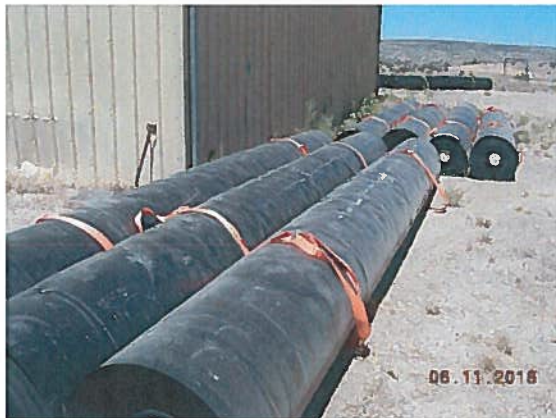
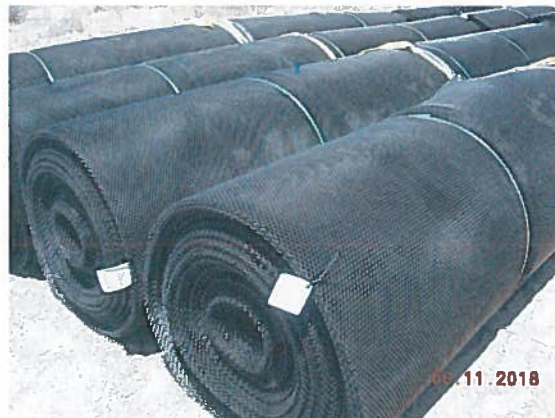
Rolls of HDPE Liner and Geo-mesh staged at Water Treatment System

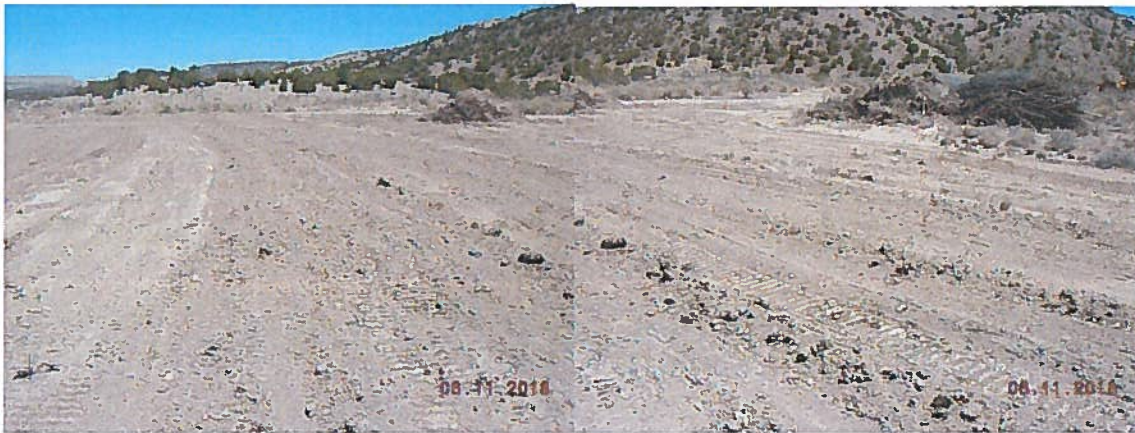
The west side of the cover borrow material area had been grubbed of vegetation and was undergoing further material testing for use as the clay-liner material for the disposal cell (see photos).

West Portion of Borrow Area grubbed for clay liner source material
