RE: Summit Mine; Permit No. GRO11ME; Waste Facility Slide; Revised Corrective Action Plan

Pyramid Peak Mining LLC (PPM), hereby, submit a revised Corrective Action Plan (CAP) to address the failure of a development material stockpile (DMS) and operations area at the Summit Peak Mine (Mine). The CAP was requested by the New Mexico Energy, Minerals and Natural Resources Department, Mining and Minerals Division (MMD) on August 31, 2017.

To:	Andrew Conover	Date:	July 17, 2018
Company:	Pyramid Peak Mining, LLC	From:	Karena Carpenter Edward Wellman, PE NM #18364
Subject:	Analysis of Summit Mine DMS Dump Instability and Proposed Remediation Plan	Reviewed by:	John Tinucci
		Project #:	511800.030

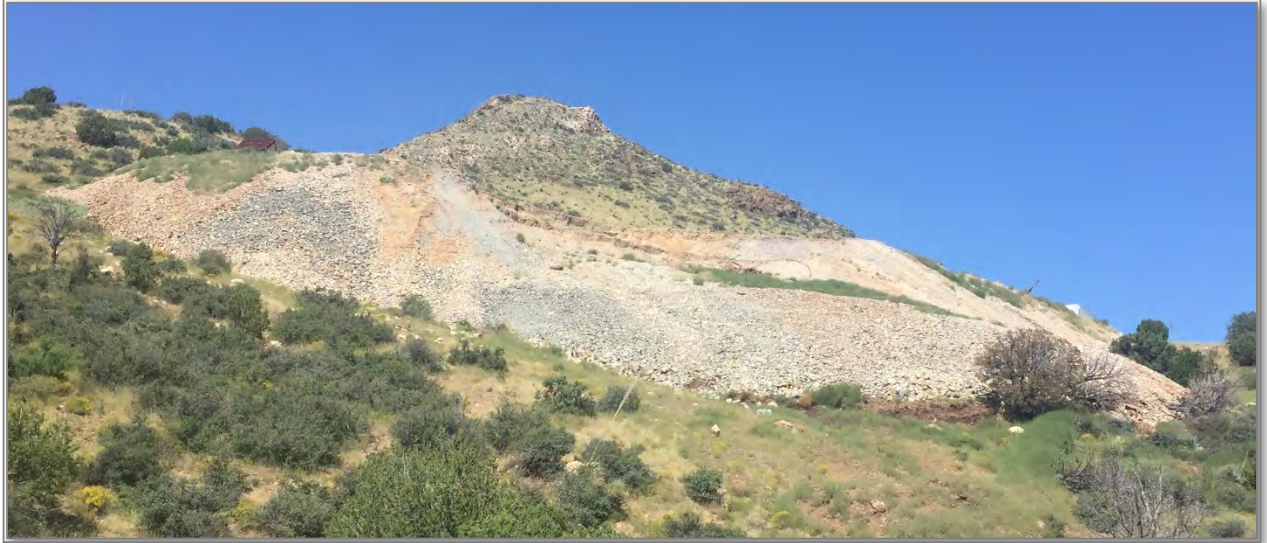
Photograph 1: DMS Slide Looking Northwest

The DMS has undergone two separate failures. The first and most significant failure occurred during early 2017. An approximately 250-foot wide section of the DMS toe moved downgradient a maximum of 150 feet. The slide is shown in **Photograph 1**. All photographs are contained in **Attachment B**. The slope failed at the highest point of the DMS and toe movement resulted in a highwall forming in the facility crest (**Photograph 2**). Tension cracks formed on the DMS surface after the slide (**Photograph 3**). In the aftermath of the slide, PPM initiated a monitoring program on the tension cracks to identify the risk of further movements. In addition, equipment which was located near the slide area was relocated to the north.

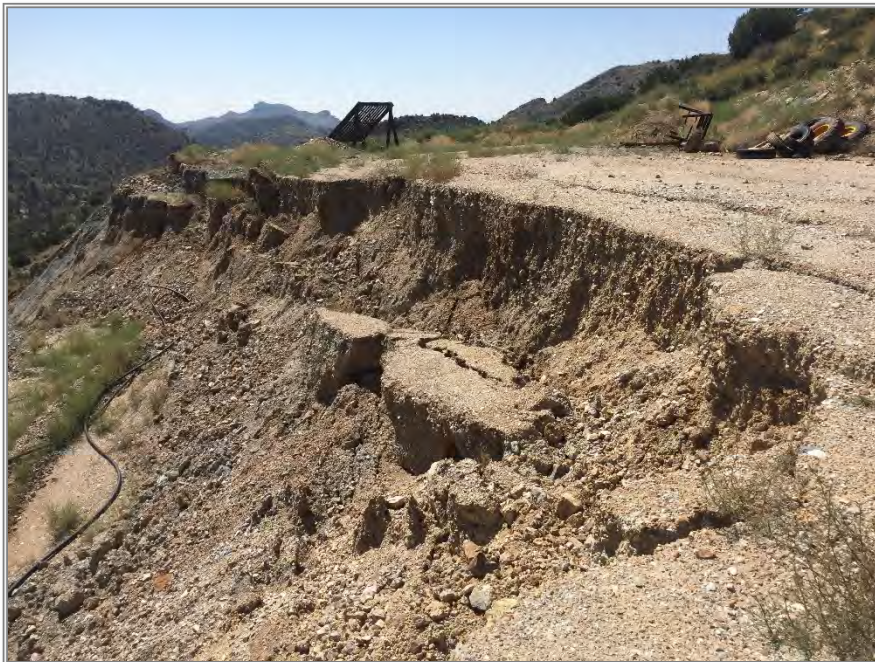
Photograph 2: Highwall and Tension Cracks

A second smaller slide occurred in the fall of 2017 during the rainy season. The second slide was limited in extent and consisted of minor downgradient movement of the toe and additional failures of the highwall. Additional tension cracks became visible on the facility surface.

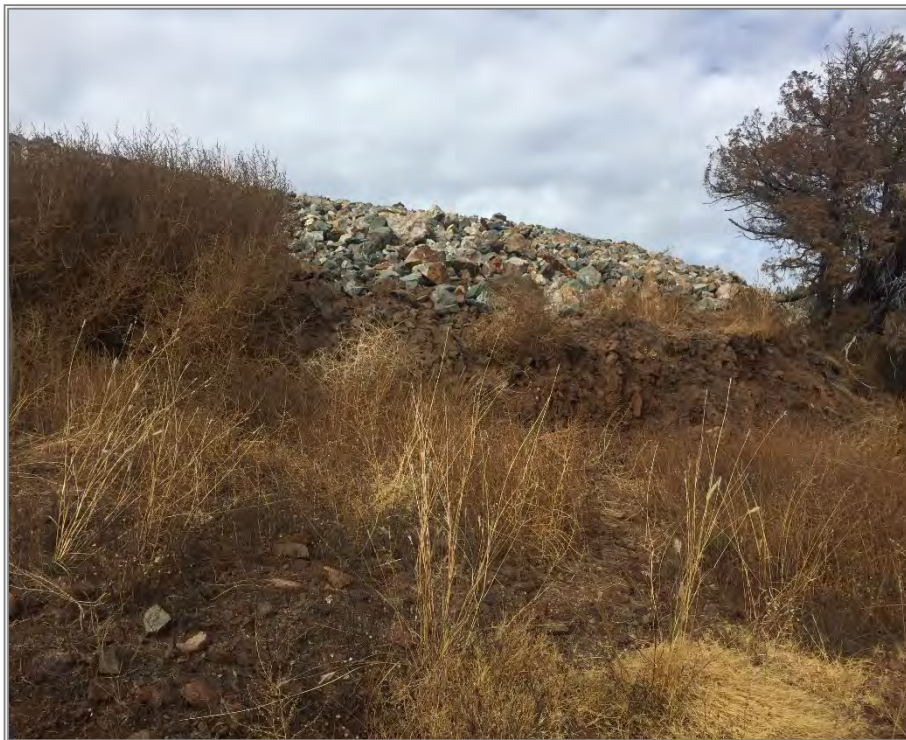
Photograph 4: Alluvial Material at Toe

As the DMS moved, alluvial materials were pushed in front of the advancing face creating a thick visible layer under the toe (**Photograph 4**). The soil was found to be saturated with infiltrated water, which in some locations was actively seeping (**Photograph 5**). Based on inspections of the stockpile toe and soil analysis PPM concluded that the slides were likely the result of meteoric water infiltration through the facility which wetted up the native alluvial material reducing cohesion and strength. The alluvial material remains saturated, but seeping has stopped with decreased precipitation.

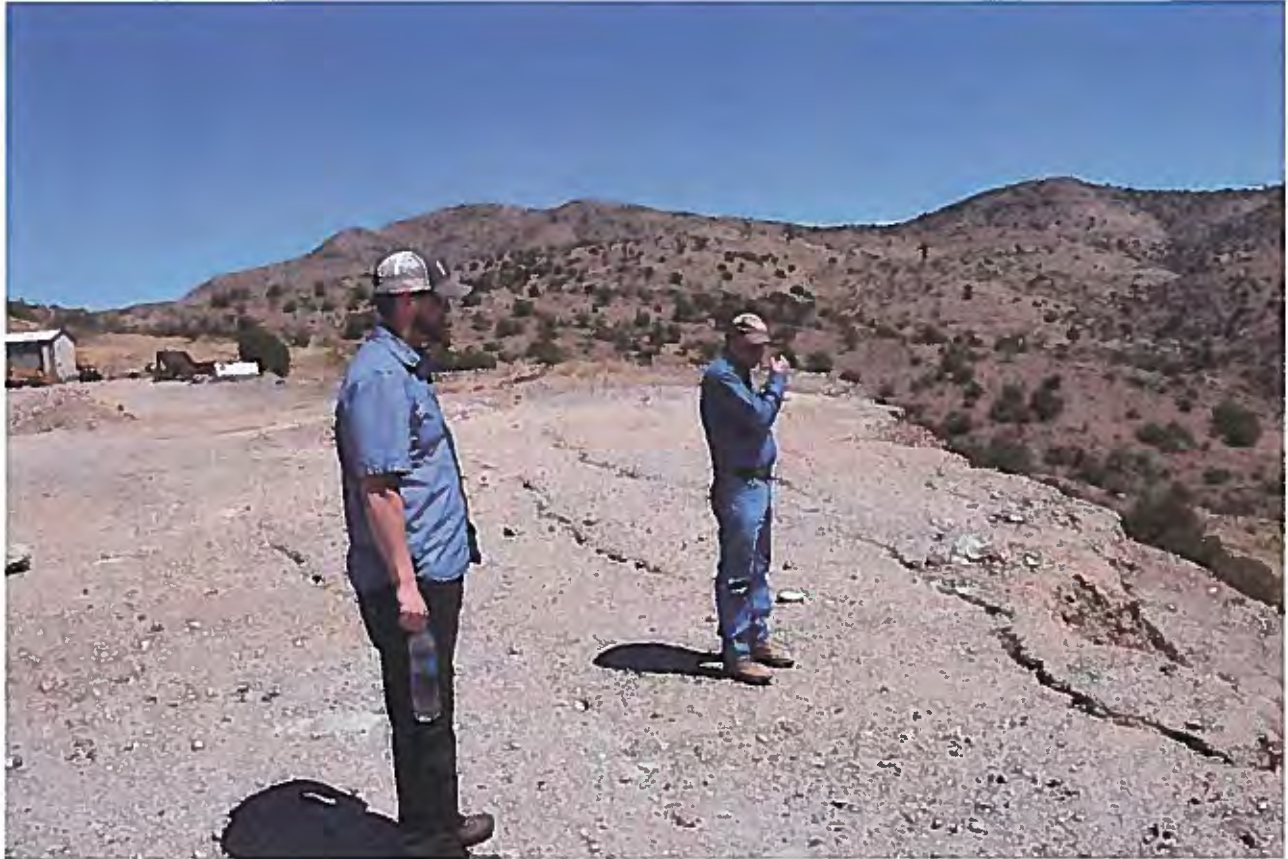
Figure 1: Tension Cracks at the Top of the DMS Failure

The DMS has undergone two separate failures. The first and most significant occurred during early 2017. An approximately 250-foot wide section of the facility toe moved downgradient a maximum of 150 feet. The slope failed at the highest point of the facility and toe movement resulted in a highwall forming in the facility crest. Tension cracks formed on the DMS surface after the slide. In the aftermath of the slide, PPM initiated a monitoring program on the tension cracks to identify the risk of further movements. In addition, equipment which was located near the slide area was relocated to the north.

A second lesser slide occurred during the fall of 2017 during the rainy season. The second slide was limited in extent and consisted of minor downgradient movement of the toe and additional failures of the highwall. Additional tension cracks became visible on the facility surface. The tension cracks observed at the crest of the slope are illustrated on Figure 1. The tension cracks are located at the 5560 ft elevation and a location map of the post failure topography is shown on Figure 2.

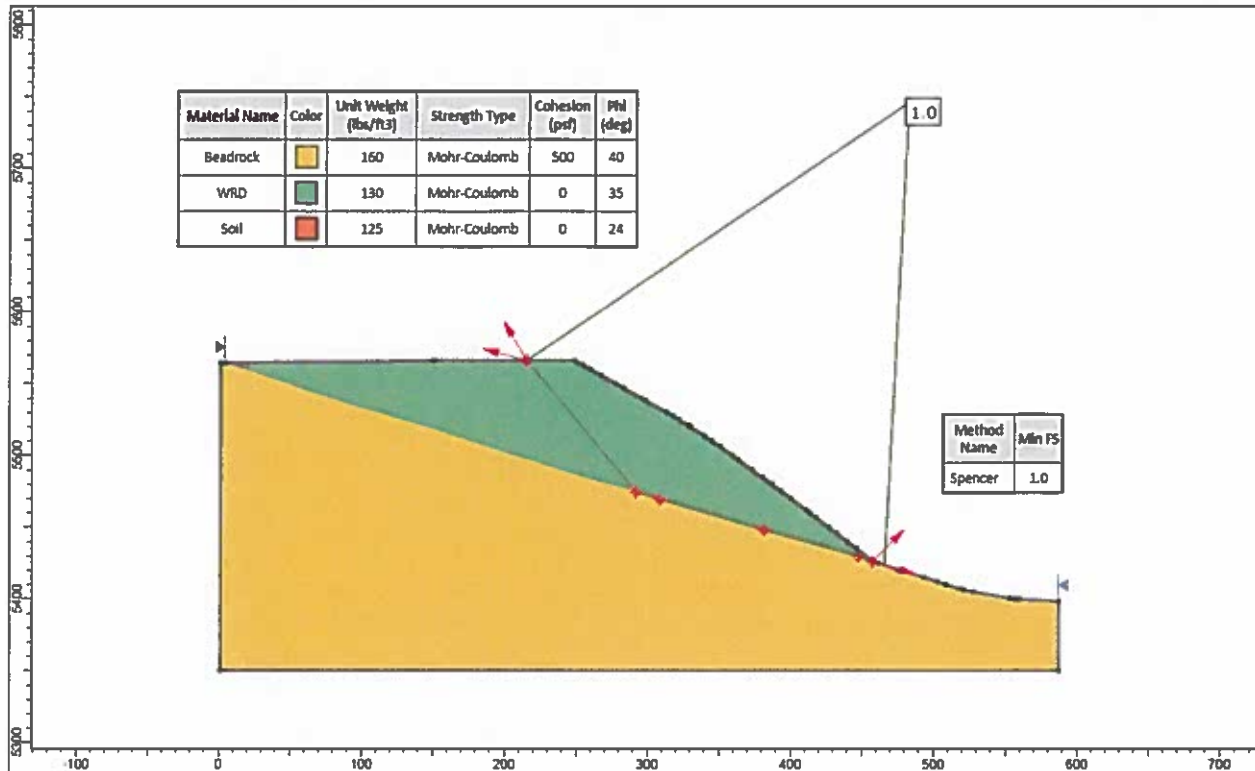
Figure 3: Back-Analysis Section 1

Based on the back-analysis results, SRK estimates that the foundation soil layer below the DMS dump has the following Mohr-Coulomb properties for an effective stress analysis:

- Angle-of-internal friction = 24 degrees; and
- Cohesion = 0 to 50 psf.

The back analysis was conducted using the limit equilibrium method and the FOS was computed with Spencer's method of slices (Spencer, 1967) Analysis of the post failure geometry using these properties, indicate that the FOS may range from 1.0 to 1.2, without remediation. The soil foundation layer controls the critical surface and failure geometry. The back-analysis section is illustrated on Figure 3.

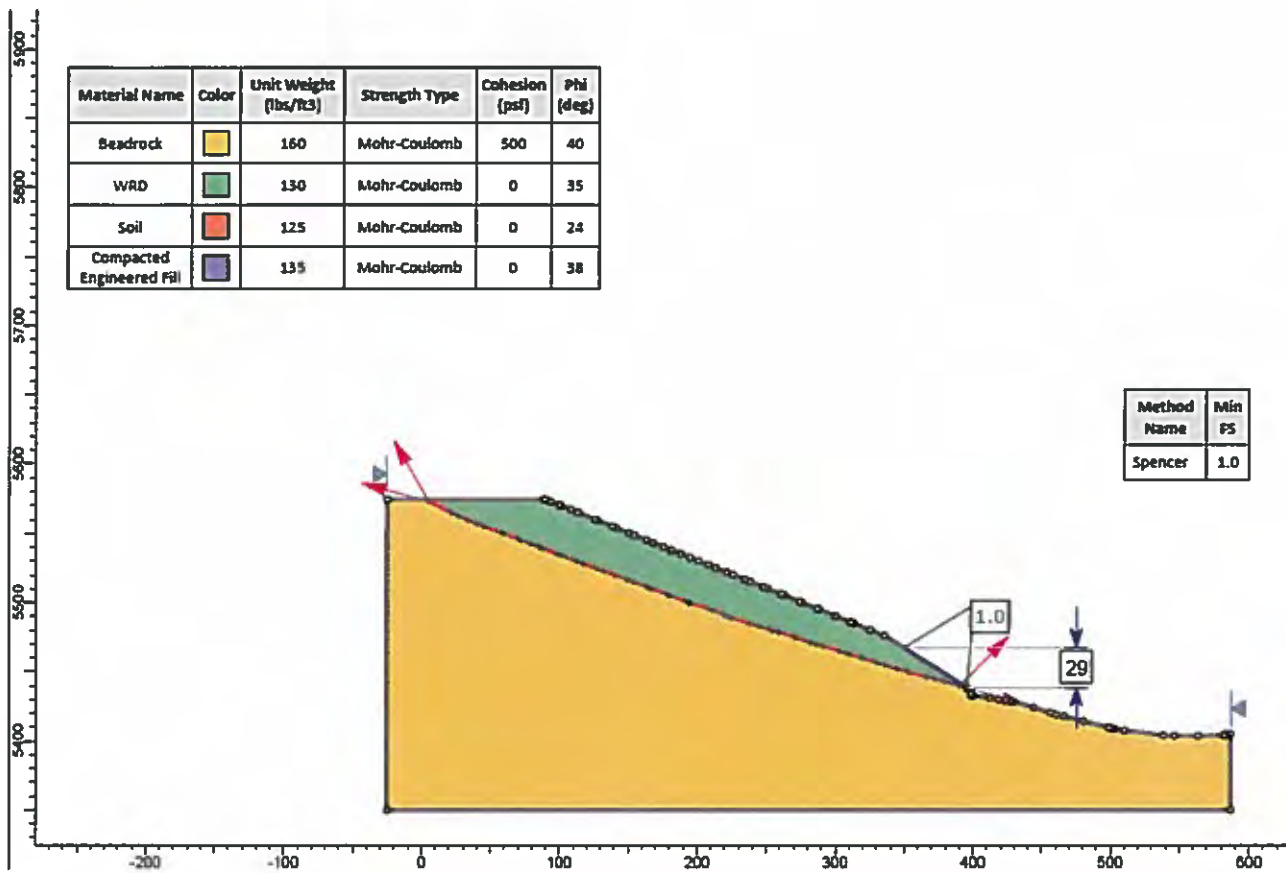
Figure 5: Minimum FOS of 1.0 during construction

There is a risk of addition slope movement and failures during construction of the keyway and remediation program. This is a result of the daylighting the existing weak soil foundation, below the existing DMS dump.

When the keyway is excavated the FOS will approach limit equilibrium (i.e., FOS of 1.0). A critical surface with may develop at the toe of the slope as illustrated in Figure X. Failure cracks and movement of the slope is possible during construction and excavation of the keyway. A slope monitoring and observation will be required for construction safety during the remediation. This monitoring plan should focus on observing the slopes for tension crack development, and may include the use of prisms, pin-sets, and wireline extensometers.

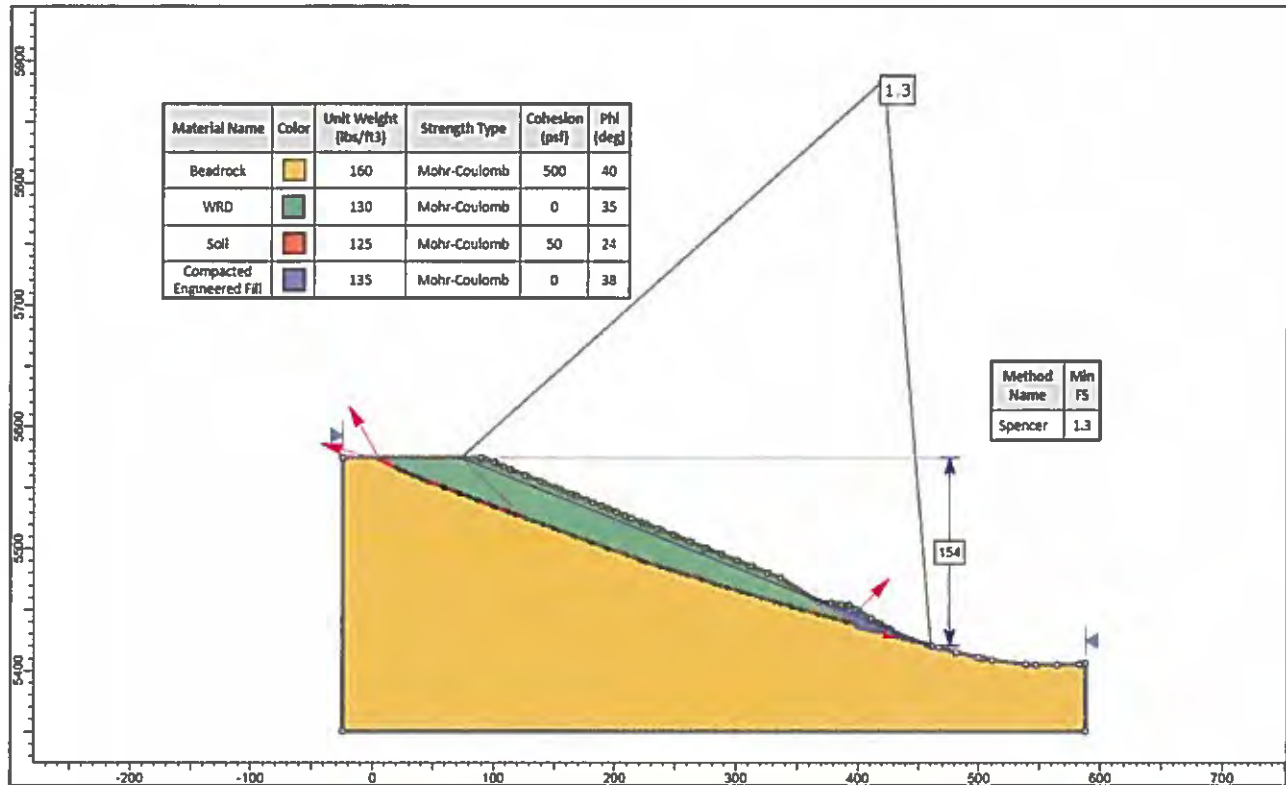
Figure 6: Section 1 Stability Analysis Results

Section 1 is cut through the engineered fill buttress on the north end of the DMS dump. The critical surface on Section 1 starts at the toe of the buttress, and then continues along foundation soils, until it breaks through to just behind the crest of the regraded slope. The minimum FOS is 1.3 as shown on Figure 6. The height of the critical surface is approximately 150 feet.

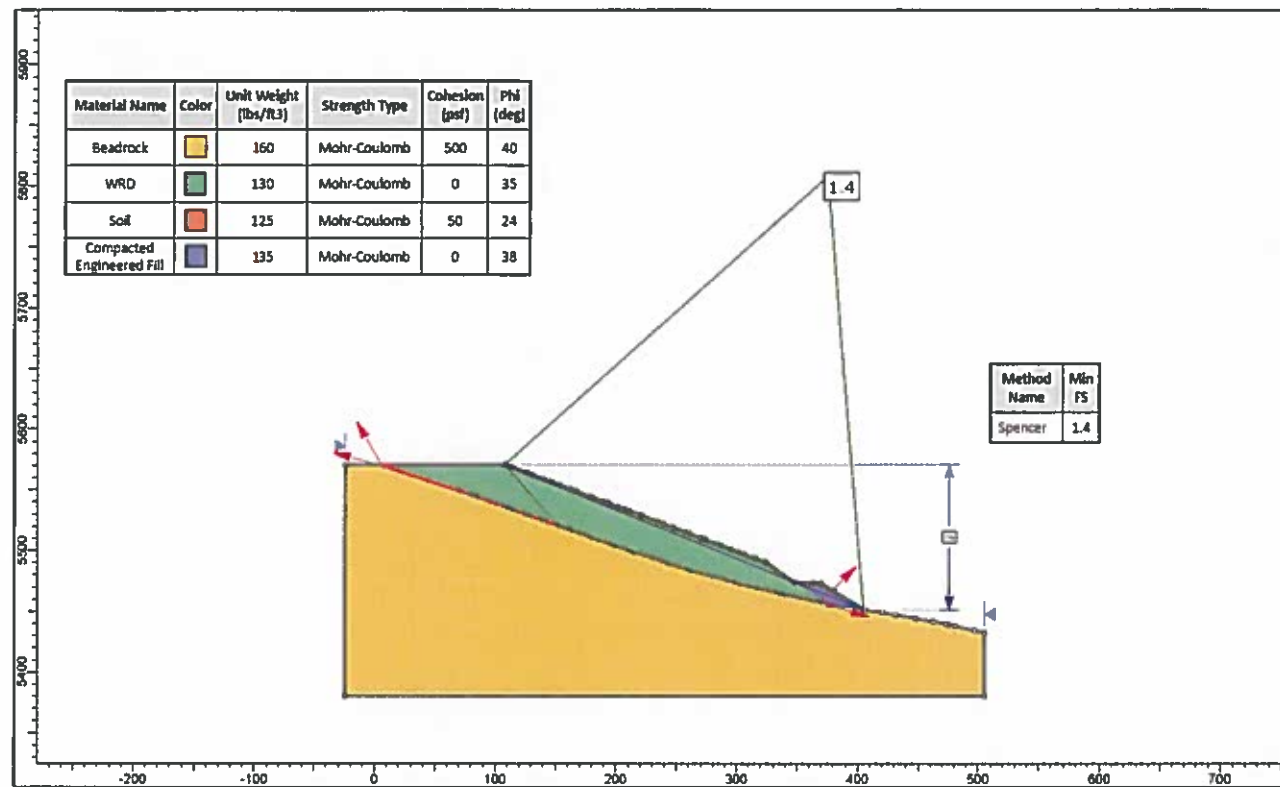
Figure 7: Section 2 Stability Analysis Results

Section 2 is cut obliquely to the slope through the engineered fill buttress. The critical surface on Section 2 starts at the toe of the buttress and then continues along foundation soils, until it breaks through to just behind the crest of the regraded slope. The minimum FOS is 1.4 as shown on Figure 7. The height of the critical surface is approximately 120 feet.

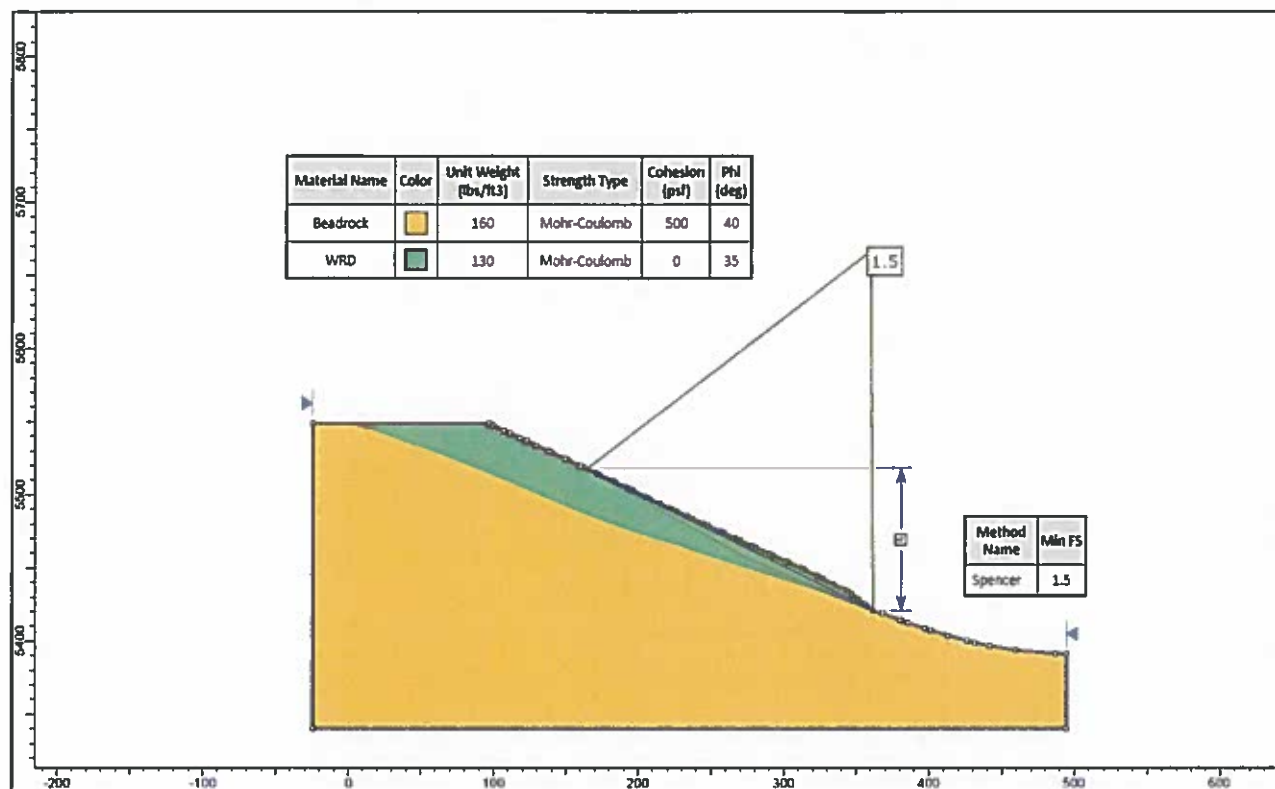
Figure 8: Section 3 Stability Analysis Results

Section 3 is on the south end of the proposed remediation. Foundation soils will be removed at this location and the area cleared and grubbed of vegetation. As a result, the critical surface does not pass through the rock foundation. The critical surface on Section 2 starts at the toe of the fill slope and extends two-thirds of the way up the slope through the new DMS dump fill area. The minimum FOS is 1.5 as shown on Figure 8. The height of the critical surface is approximately 100 feet.
