MINING INSPECTION REPORT

Name of Operator:	Gulf Coast Mining Group, LLC
Name of Mine:	Iron Duke Mine
Address:	Sections 3 and 4, Township 22 S, Range 8 E
Permit Number:	OT006MN
Commodity: hematite & magnetite	<input checked="" type="checkbox"/> SURFACE <input type="checkbox"/> UNDERGROUND
Date of Inspection:	October 8, 2019
Time of On-Site Inspection:	12:40 PM – 2:00 PM
Weather Conditions:	slight clouds, 73°F
Purpose of Inspection:	Annual
Lead Inspector:	Jenn Johnson
Present During Inspection:	DJ Ennis, Carmen Rose (MMD), David Davidson (Gulf Coast Mining Group)
ENFORCEMENT ACTION TAKEN: None	
NOTICE OF VIOLATION: # _____ YES: ____ NO: <input checked="" type="checkbox"/>	
CESSATION ORDER: YES: ____ NO: <input checked="" type="checkbox"/>	
Time: On-Site: <u>1.5 hrs</u> Permit Review: <u>2</u> Travel: <u>2</u> Report Writing: <u>2</u>	
TOTAL INSPECTION TIME: <u>7.5</u> HOURS	
NOTE: Turn left onto a dirt road 3 miles north from Orogrande on US-54. Follow the dirt road west for almost 3 miles until you reach a gate. Go through the gate to get to the mine site.

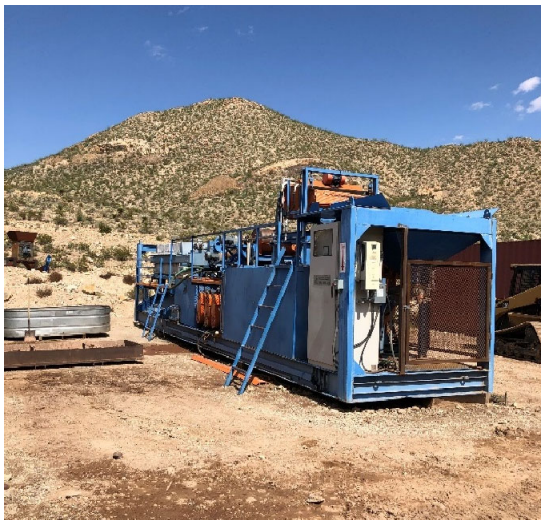
Figure 1: New Ball Mill (NE)

We met David Davidson at the mine and he drove us around the site. There were workers sampling 55 gal drums for the customer in Europe. The new ball mill was on site and there were no signs of water discharge from the mill. There were two shipping containers which hold the

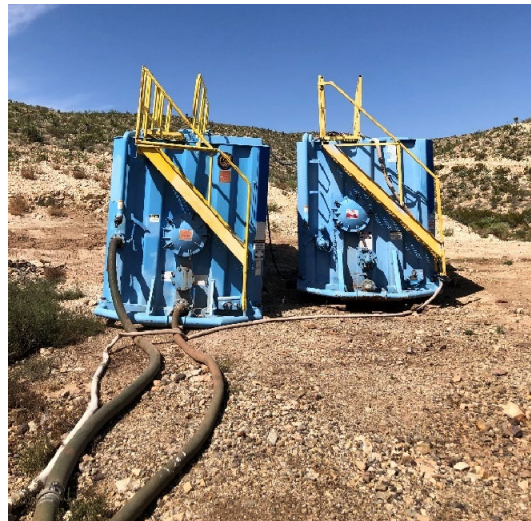
Figure 2: Water Containers (W)

water for the mill. Since it is a closed loop system any suspended solids are removed through sedimentation. This occurs in the containers and it is unclear if it is ever cleaned out. 1 ton of material can be processed in a day through the mill and the mine processes about 60 ton/year.

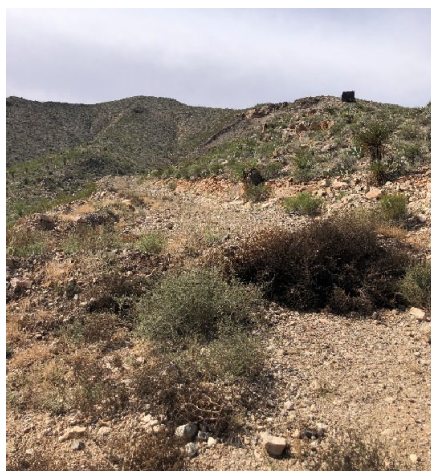
Figure 4: BLM Road (SW)

There was a berm blocking vehicles from using the BLM road which has not been reclaimed. The operator explained that the BLM does want it reclaimed but that they were not given a deadline. The operator plans to reclaim it when the dozer is back at the mine. Once they have processed the stockpile by the mill, they will rent a D9 dozer from Albuquerque.

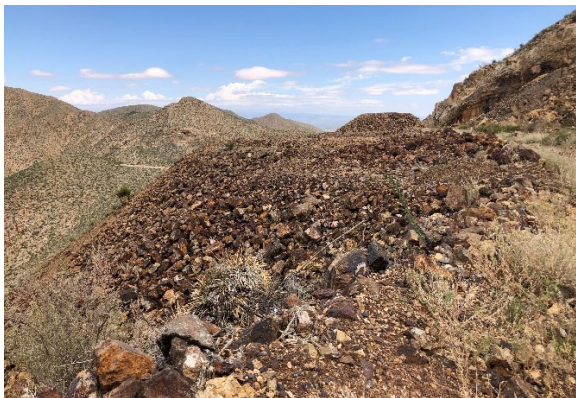
Figure 7: Phase II Pile (NE)

David took us up to where phases II and III of mining will take place. Waste rock from historic mining will be excavated and processed through the ball mill for both phases similar to the current phase of mining. Since the waste rock piles are on the other side of the mined caverns a new road will probably have to be constructed to haul the material to the site. The mine plan is to start phase II in about 5 years and phase III in 10 years.
