MINING INSPECTION REPORT

October 9, 2019
Capitan Iron Mine Site Visit

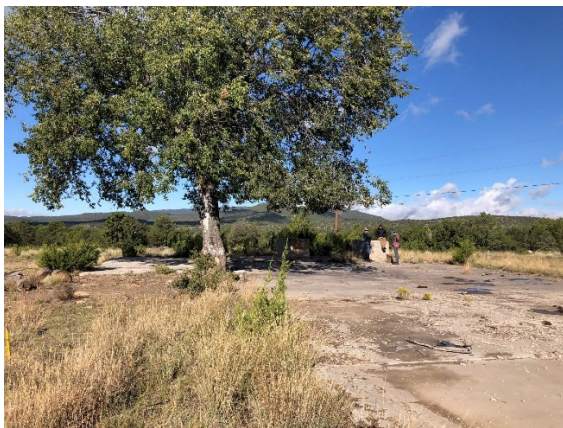
MMD met a representative from the US Forest Service at the site. The processes that both agencies would have to go through to get the concrete pad reclaimed were discussed. Both agencies will do some more research on the joint bond and then have a meeting sometime in November.

Figure 1: Concrete Pad (W)

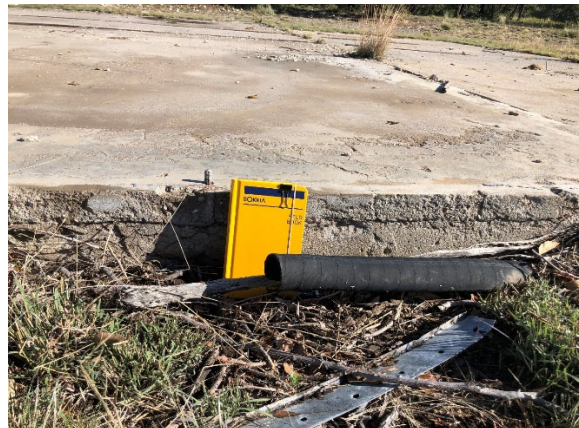
Figure 2: Concrete Pad Thickness (N)

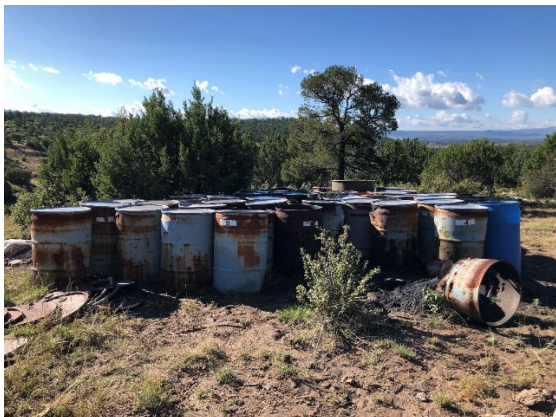
There were several 55-gallon drums clustered by the road going towards the pit from the concrete pad. Some were falling apart spilling its contents. These drums are noted in previous site visit images.

Figure 3: 55-gal Drums next to road (S)

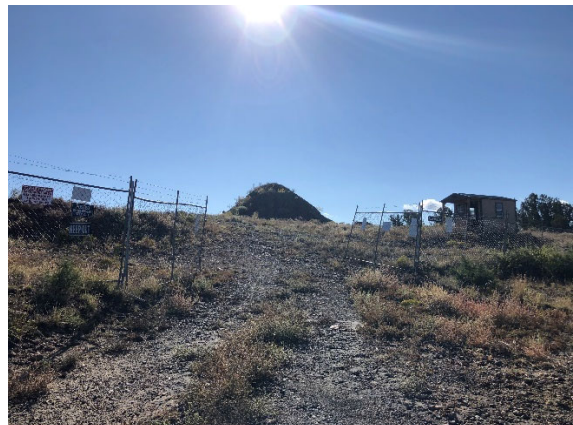
The gate to the pit and screener was open and the fence had fallen over on the north side of the enclosure. There were 12 super sacks of material as well as 25 5-gallon buckets with fines. Most of the piles had significant vegetation growth as well as the pit. There was not any signs of recent disturbance.

Figure 4: Open Gate (E)

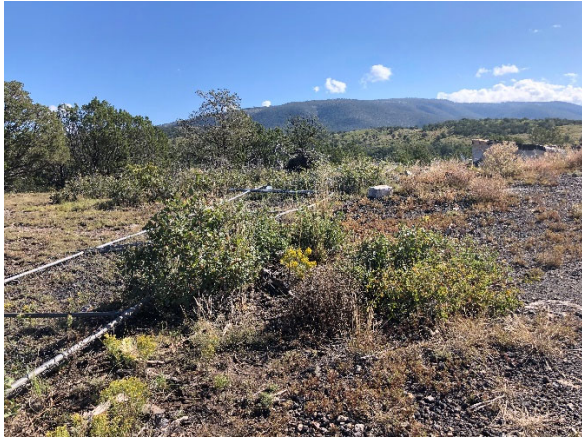
Figure 5: Fallen North Fence (E)

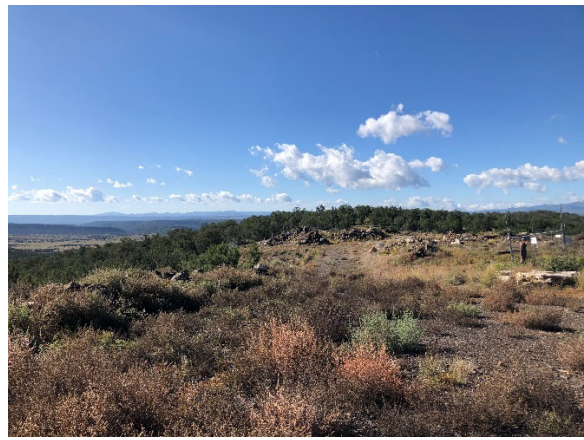
Figure 6: Enclosure Area (S)

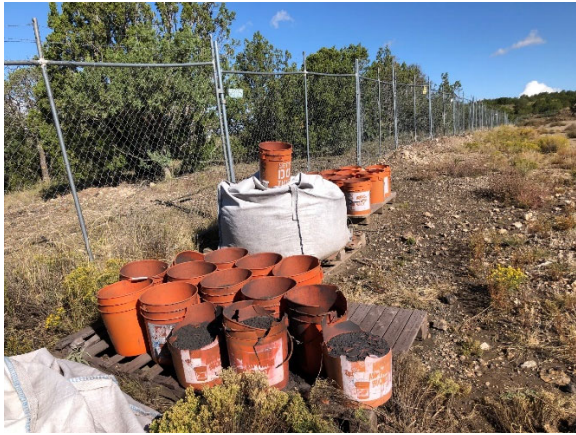
Figure 7: 5-gal Buckets of Fines (N)

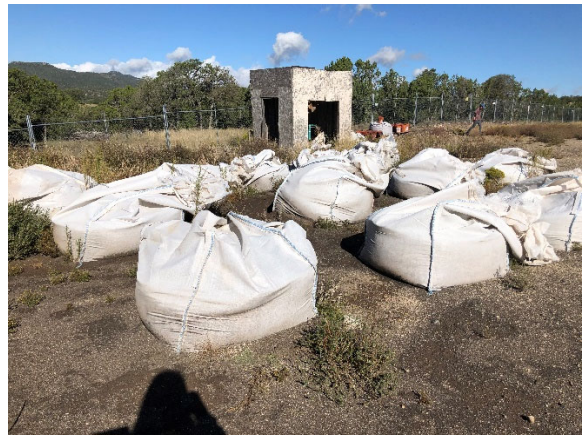
Figure 8: Super Sacks of Fines (NW)

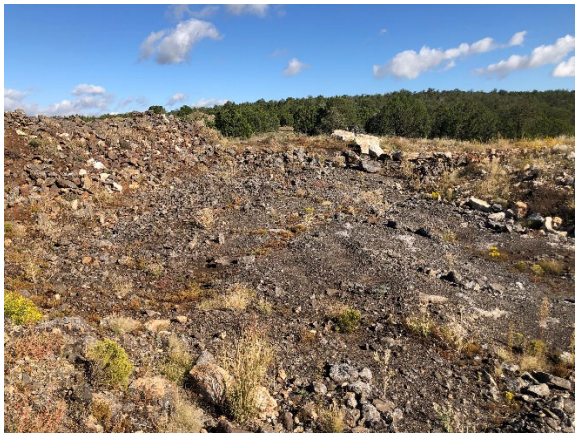
Figure 9: Pit (N)

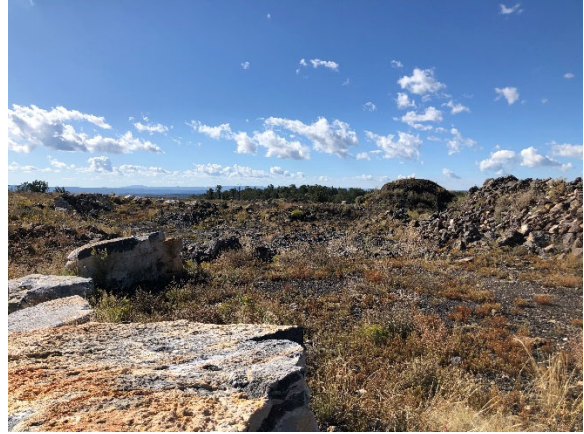
Figure 10: Pit (S)

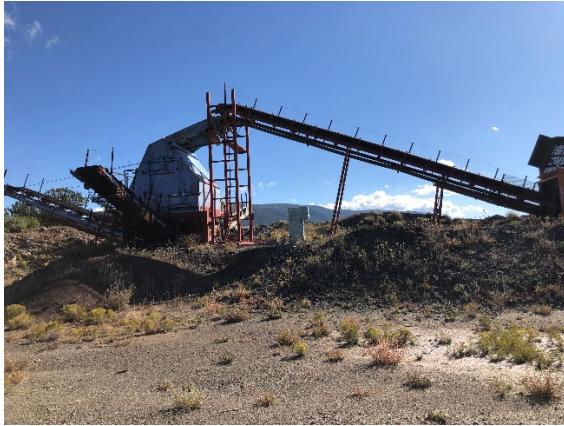
Figure 11: Screen (E)

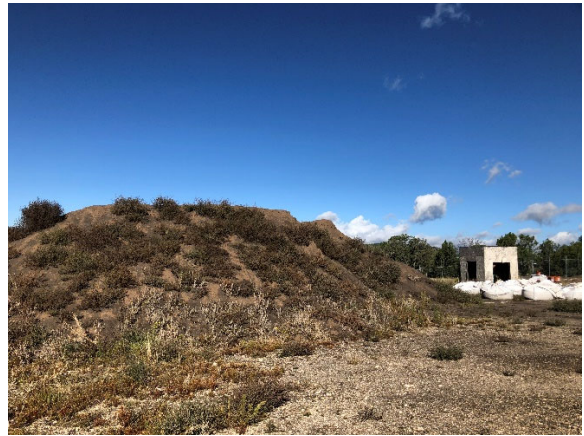
Figure 12: SW Pile with Vegetation Growth (W)
