**RE: Jones Hill (Tererro) Exploration Project Access – Road Maintenance Plan**

Please accept this letter and attached figures as a road maintenance plan to repair the damaged road sections proposed for use to access the Jones Hill (Tererro) Exploration Project west of the Pecos Canyon, via Indian Creek.

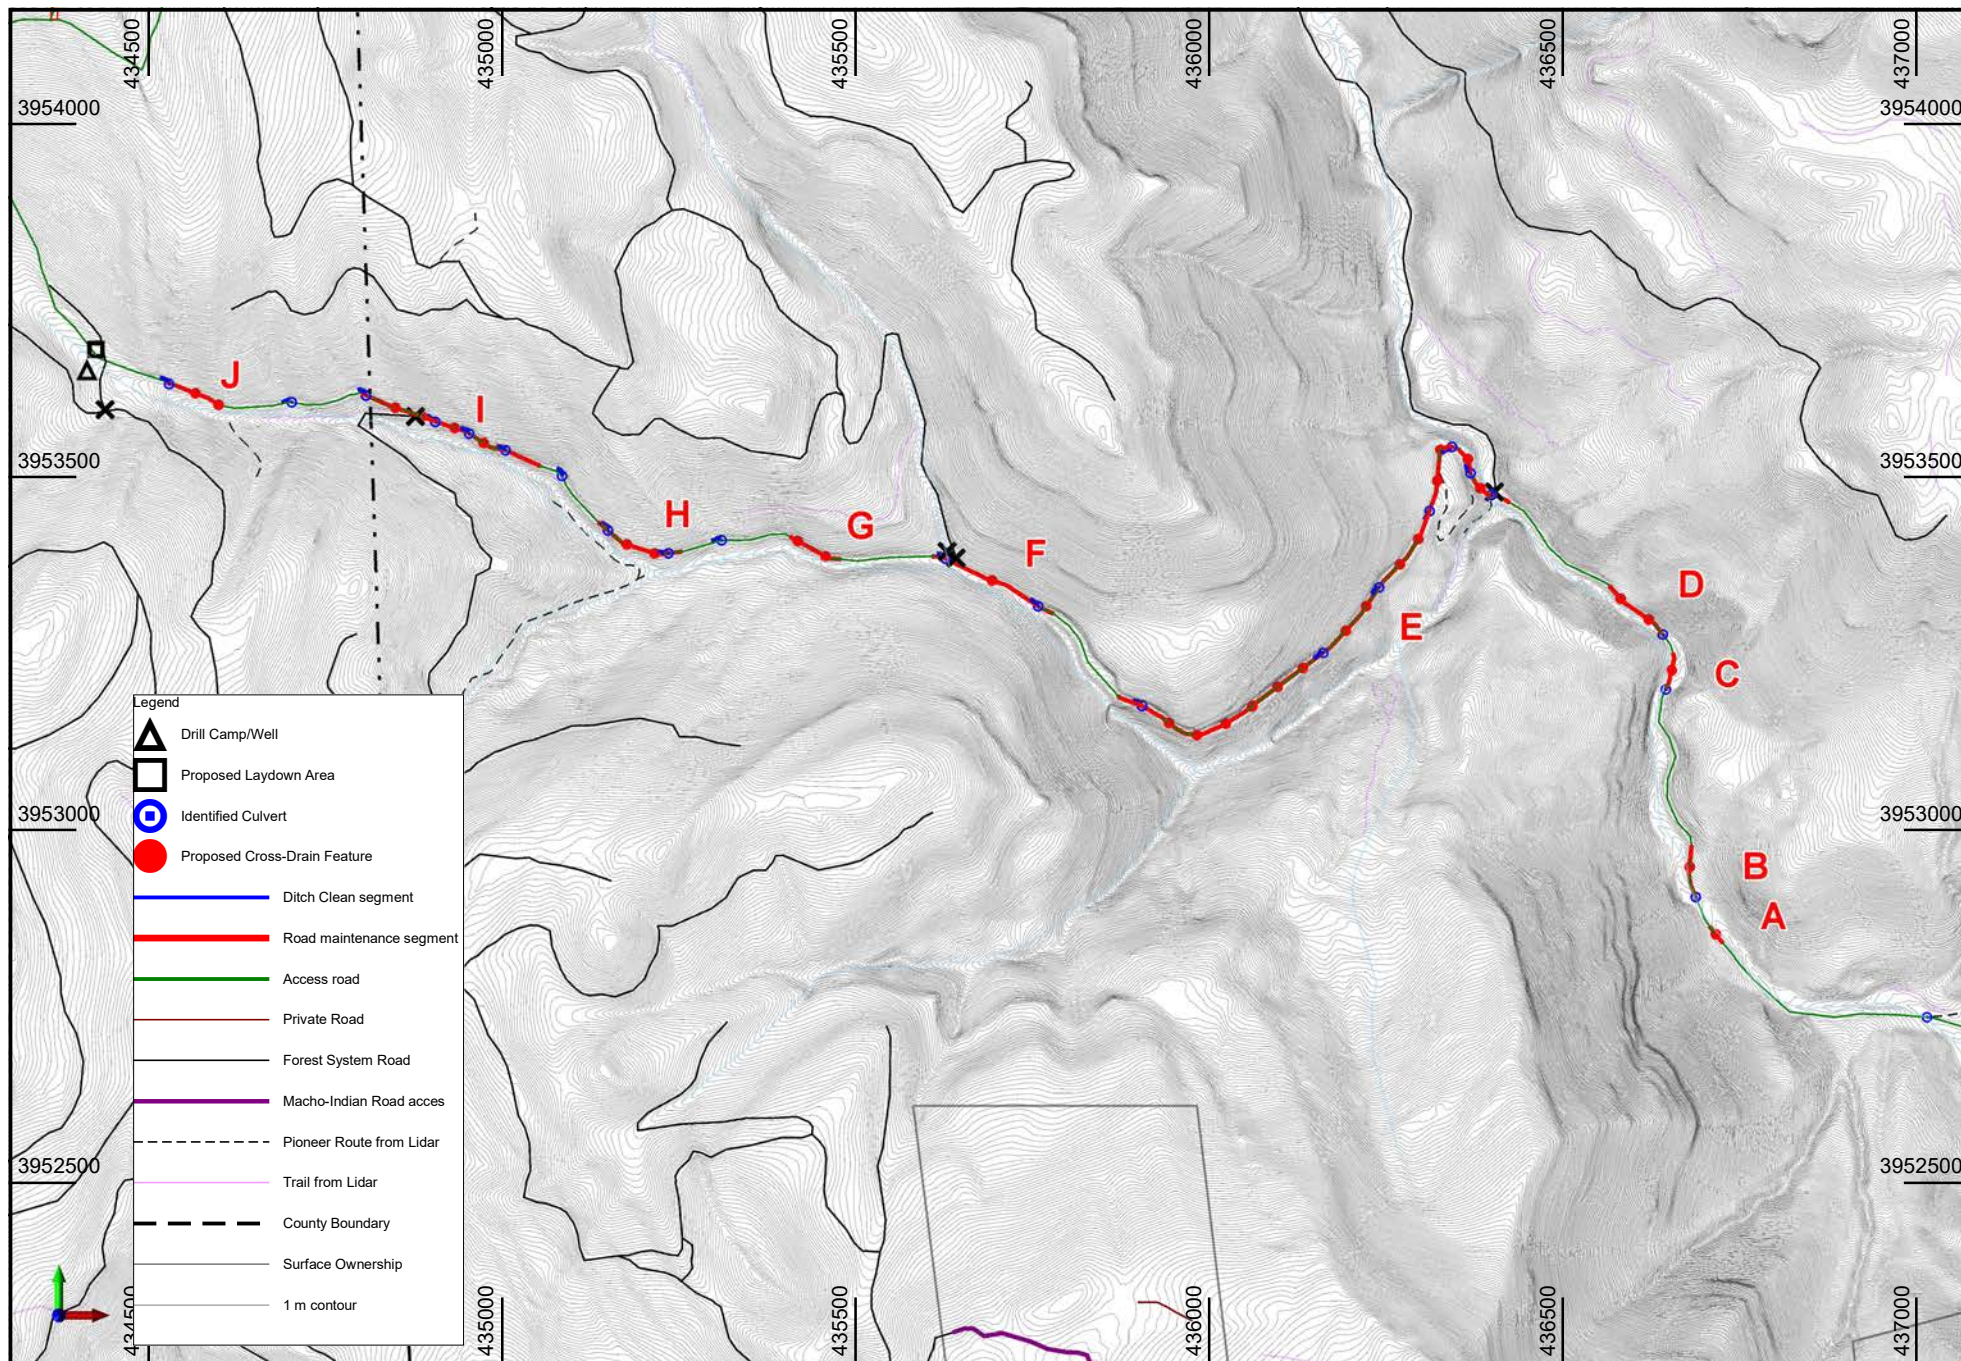
Photo 8: Water causing rutting on roadbed in proposed maintenance segment F. Two distinct types of aggregate apparent in bottom left rut.

Segments F through J (see Figure 10 and Figure 11) are proposed for motorgrading and drivable waterbar construction. Like segment E, there is a geotextile separating an aggregate layer from the native subgrade for a majority of these segments. Prior to roadbed shaping, the aggregate will be scraped and the geotextile will be removed and disposed of offsite. After roadbed shaping and drivable waterbar with armored leadoff ditch construction is complete, the scraped aggregate will be replaced. Segment F has water on the roadbed from a damaged road junction which will be blocked via non-drivable waterbar. Blocking the water source and re-directing it through its intended culvert will be accomplished early in the maintenance of the access road, so that by the time the other segment F work begins, the road will have had time to dry.
