MINING INSPECTION REPORT

Name of Operator: Rio Grande Resources, Inc. (RGR)
Name of Mine: Mt. Taylor Mine
Address: Approx. 20 miles north of Grants (UTM 13S 0260351, 3914011)
Permit Number: CI002RE
Commodity: Uranium <input type="checkbox"/> SURFACE <input checked="" type="checkbox"/> UNDERGROUND
Date of Inspection: April 6, 2021
Time of On-Site Inspection: 10:30 am – 2:00 pm
Weather Conditions: Partly Cloudy, 75°F
Purpose of Inspection: Mine permitting (Mod. 20-1) and Mine Closeout inspection.
Lead Inspector: David Otori
Present During Inspection: MMD – David Otori; RGR - Bruce Norquist
ENFORCEMENT ACTION TAKEN: None NOTICE OF VIOLATION: # _____ YES:___ NO: <u>X</u> CESSATION ORDER: YES:___ NO: <u>X</u>
Time: On-Site: <u>3.50</u> Permit Review: <u>1</u> Travel: <u>5</u> Report Writing: <u>1</u> TOTAL INSPECTION TIME: <u>10.5</u> HOURS
NOTE: Mt. Taylor Uranium Mine is located NE of the Town of San Mateo, UTM 13S 0260351, 3914011 on the San Mateo Quad. This inspection was not concurrent with the inspection of another mine.

MINE CLOSEOUT INSPECTION

Mount Taylor Mine

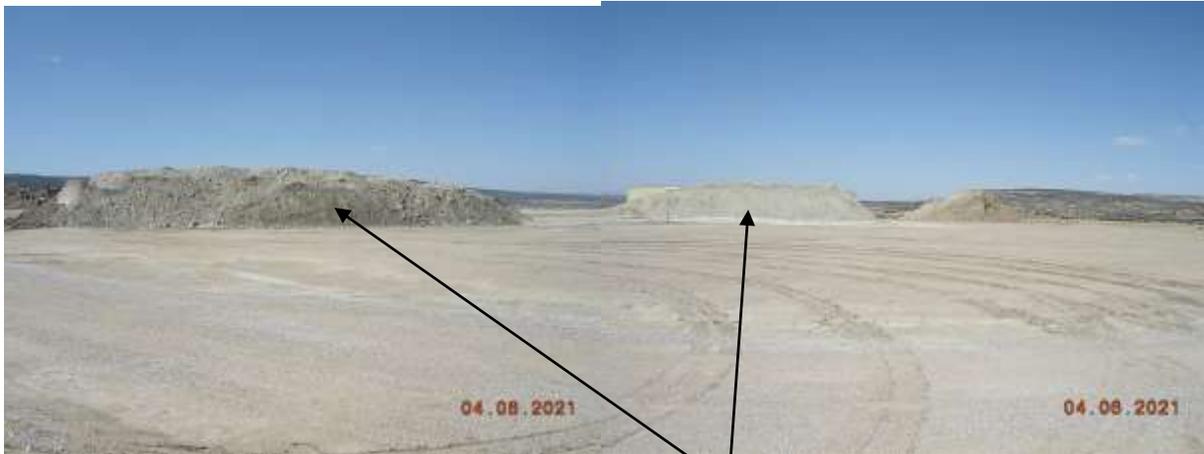
The low-grade ore from the ore pile continues to be shipped to the White Mesa Mill in Blanding, Utah at the rate of about 5 trucks per day, 5 days a week. The remaining ore pile has been consolidated into two smaller piles. The thickness of the underlying ore pad was estimated by RGR to be two to three feet thick after drilling a hole using an auger in the center of the ore pad. According to Bruce approx. 2,000 tons of the ore is being transported per month and he predicts at this rate the ore pile removal will be completed in July 2021. A transport truck arrived and loaded during the inspection.

Ore Pile looking west (two consolidated piles)

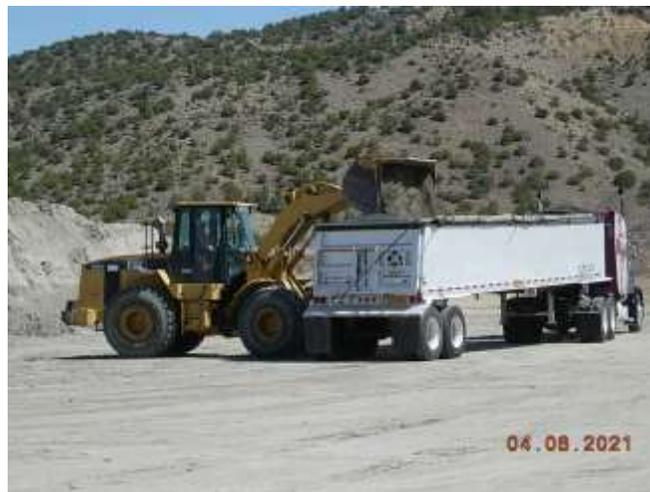
Loading ore into haul truck

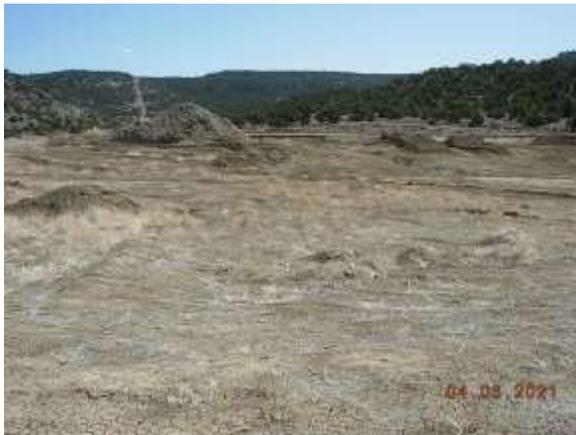
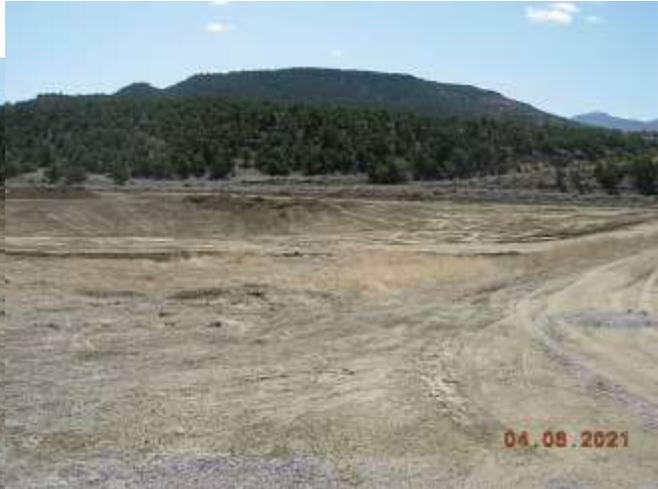
This was the source of the clay material used for lining and capping the disposal cell in the South Waste Rock Pile (SWRP). A pile of clay material that will be used as the capping material is piled in the center of the borrow area. The diversion ditch located below the borrow area will collect stormwater from the borrow area during reclamation.

Borrow Area A looking east

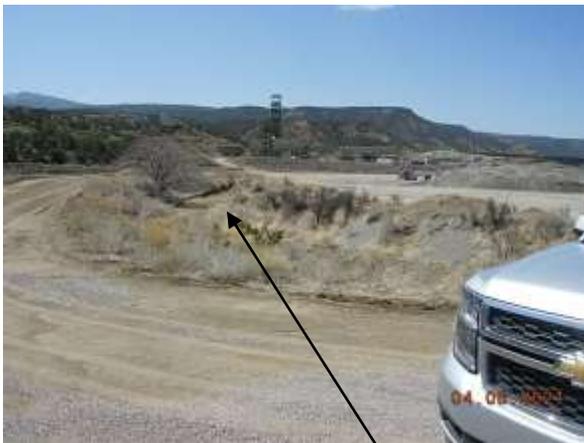
Borrow Area Diversion Ditch

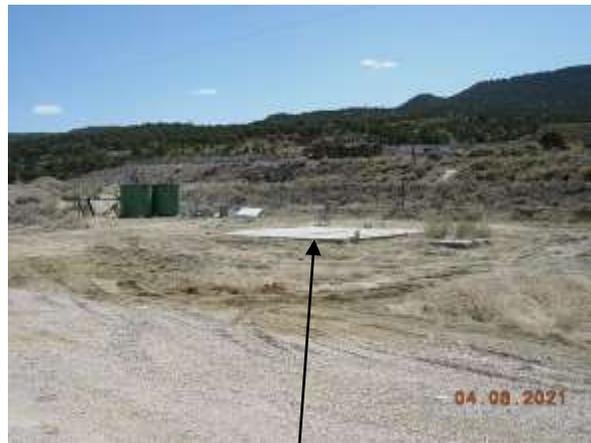
The flocculant building has been demolished except for the concrete foundation (see photo).

Flocculant Building Foundation

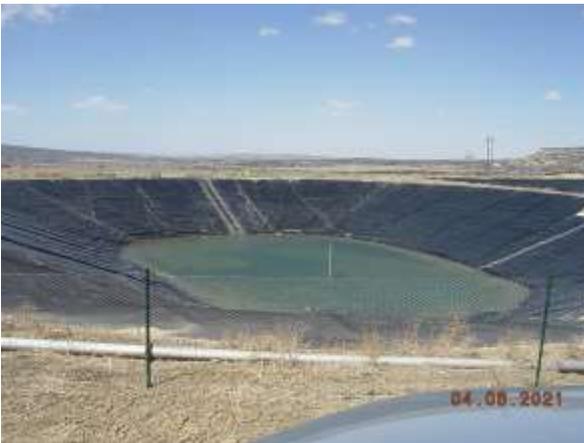
The double HDPE-lined water treatment pond 2 has been emptied due to some minor leaks that were detected by the leak detection system and the liner is being repaired (see photo). The water from pond 2 has been transferred to the adjacent lined pond 3. A 2-ft. tall chicken wire fence was constructed around ponds 2 and 3.

Lined Pond 2

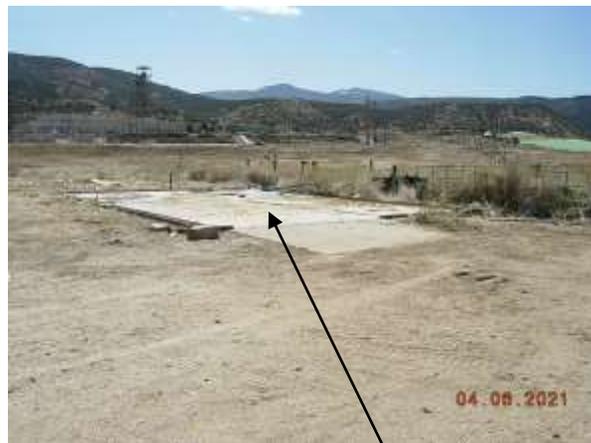
The Barium Chloride has been demolished except for the concrete foundation (see photo).

Barium Chloride Building Foundation

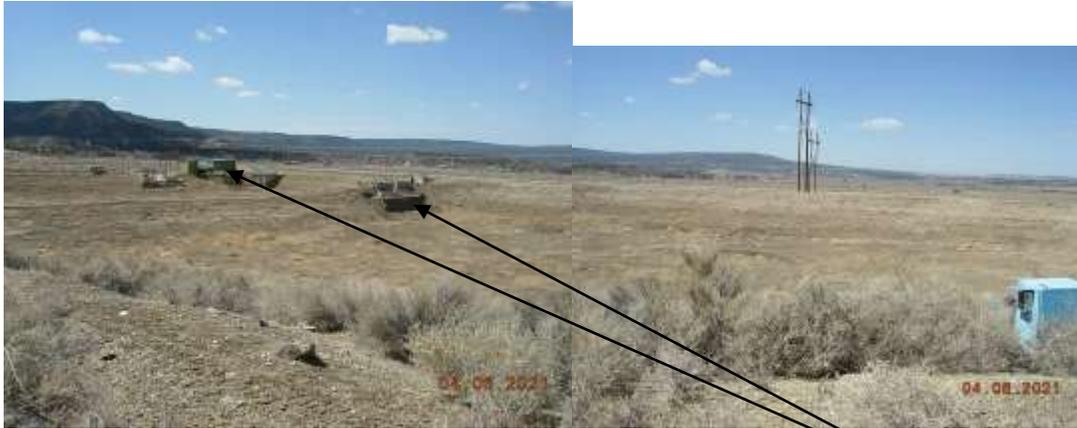
Ponds 4, 5, 6 and 7 have been excavated of contaminated sediments with the sediments placed in the existing disposal cell. The concrete drain structures will be demolished and placed in the expanded disposal cell.

Water Treatment Ponds 4, 5, 6, and 7 and concrete structures

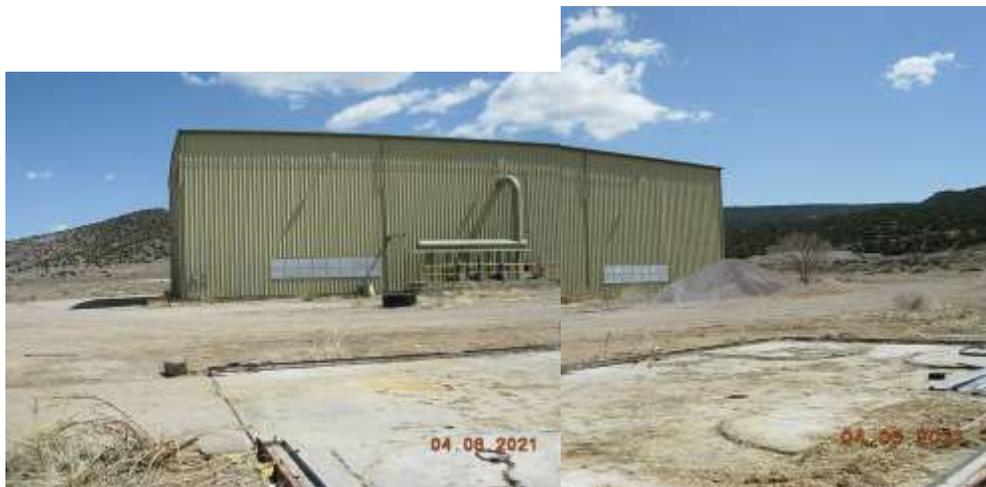
The ion exchange building will be demolished once the ion exchange system has been removed.

Ion Exchange Building

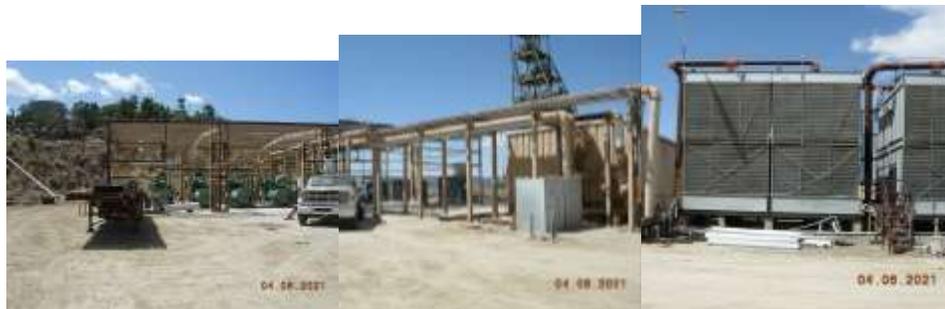
These buildings & facilities are in the process of being demolished.

York Chiller, Pump Building and Cooling Towers

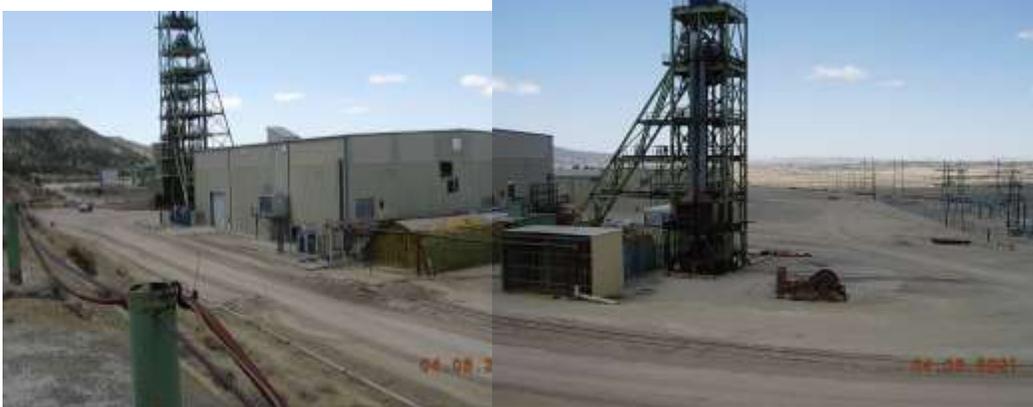
The head frames will be demolished and the Hoist House is proposed to be retained for the commercial PMLU.

24-Ft. Headframe (left), Hoist House and 14-Ft. Headframe (right)

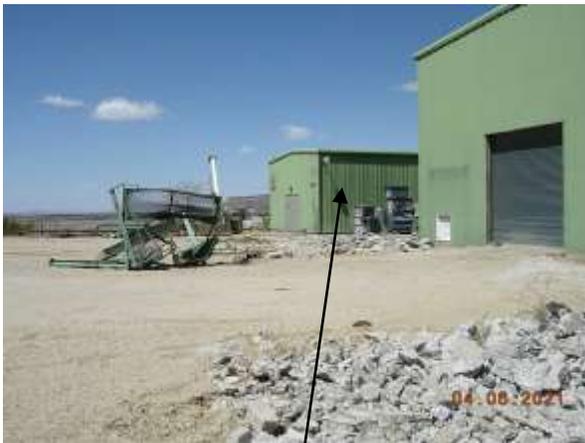
Electrical Building (left)

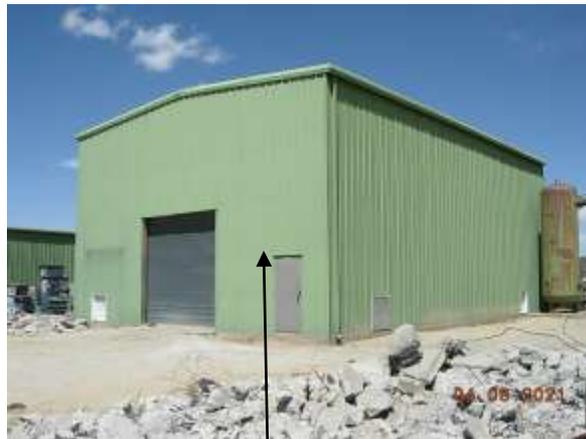
Compressor Building

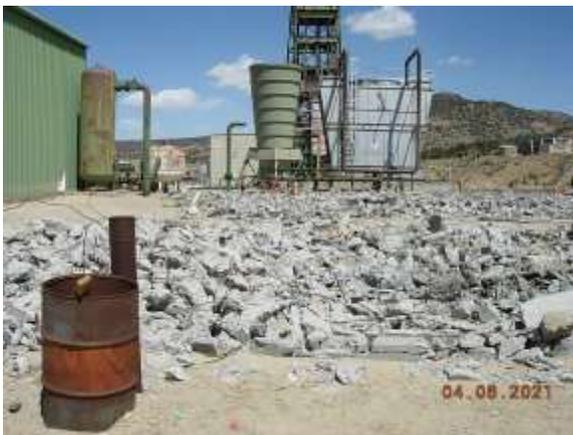
The Water Treatment Building has been demolished and the concrete foundation has been broken up. The Compressor Building will be demolished and the Electrical Building is proposed to be retained for the commercial PMLU.

Water Treatment Building foundation

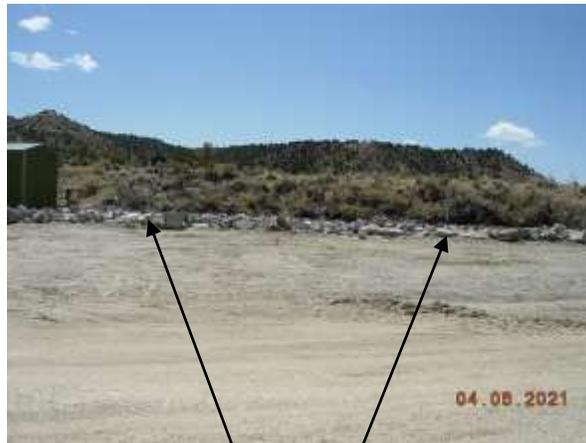
The concrete foundations of these facilities remain after the Carpenter Shop and the Diesel Storage Tanks had been removed.

Carpenter Shop foundation

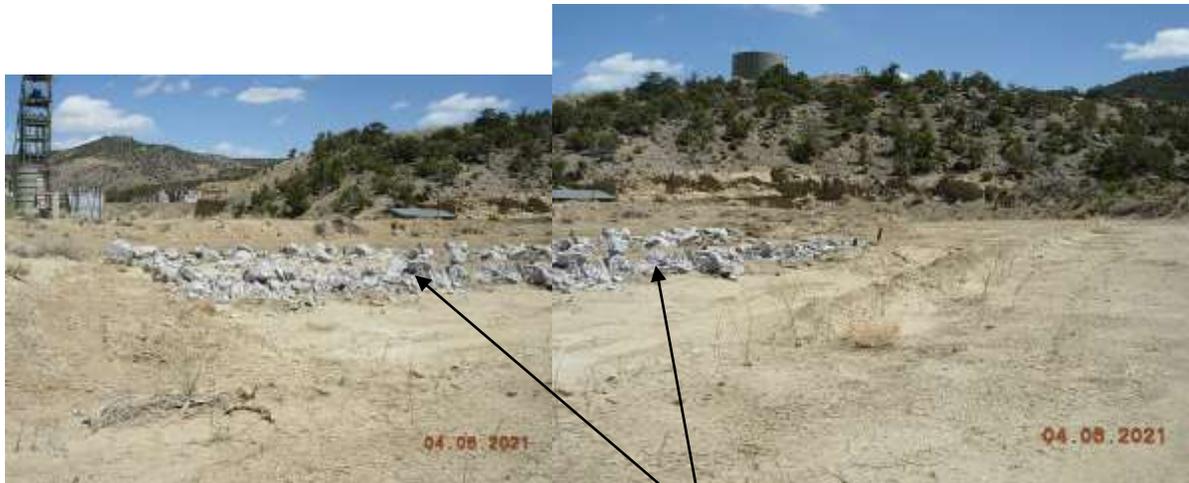
Diesel Storage Tanks foundations

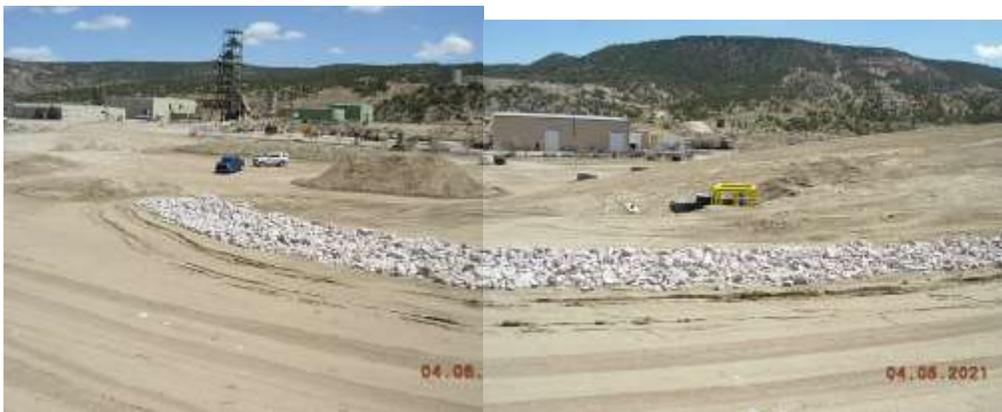
SWRP & Disposal Cell rip rap drainage structures under construction looking east

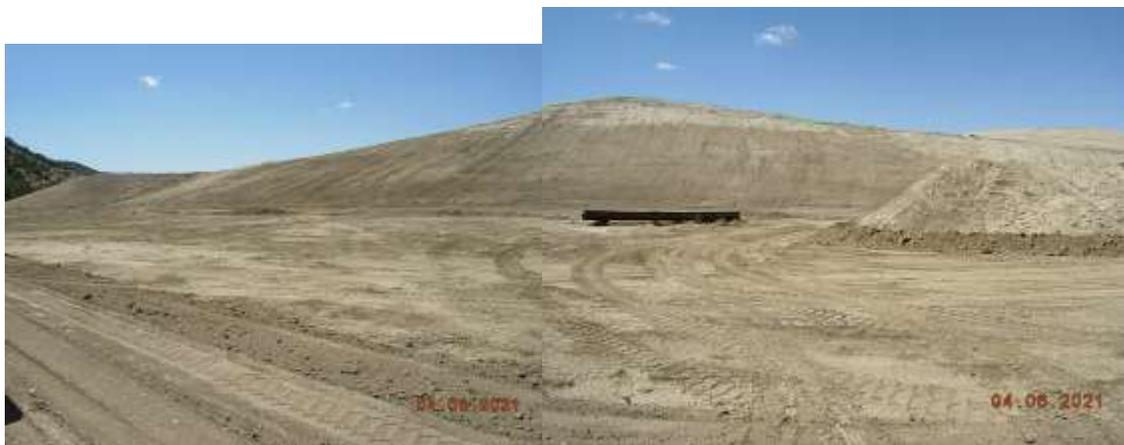
continue construction of the proposed expansion area that will be located to the east of the existing SWRP and disposal cell. The east side of the existing disposal cell that will be extended has been covered with a one-foot-thick layer of clay to contain the contaminated materials that have been placed there. Rip rap drainage structures are being constructed for stormwater handling on the disposal cell and SWRP. The west side of the disposal cell slopes have been covered with a 2-ft.-thick clay cap, radon and gamma measurements have been taken and confirmed that the surface of the clay cap meets the joint MMD/NMED radiation cleanup guidelines, and green erosion blankets have been temporarily placed to prevent erosion before the vegetative cover material is placed over the clay cap.

Disposal Cell (covered) looking west

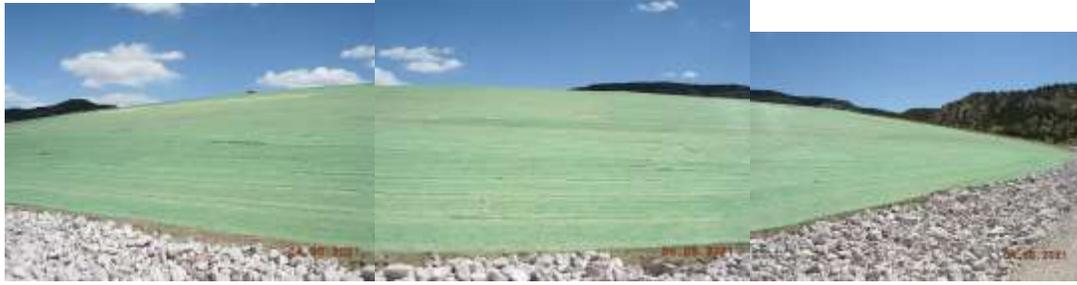
SWRP & Disposal Cell West Slope with erosion blankets

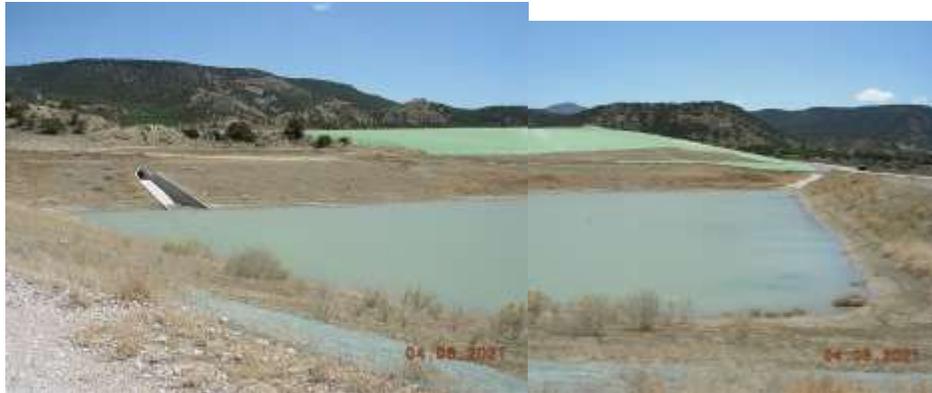
The clay-lined South Stormwater Pond appeared partially filled. A pair of ducks were observed on the pond.

South Stormwater Pond

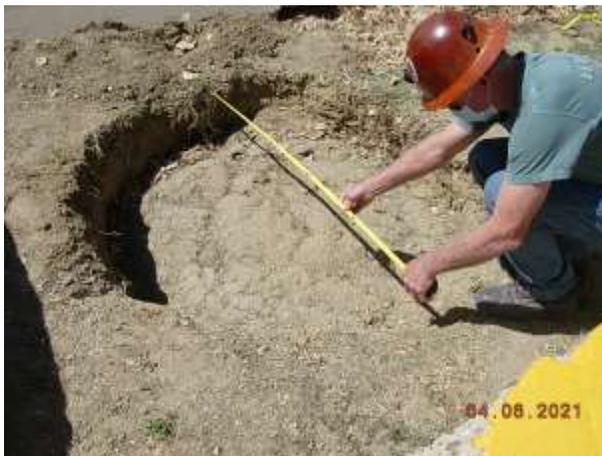
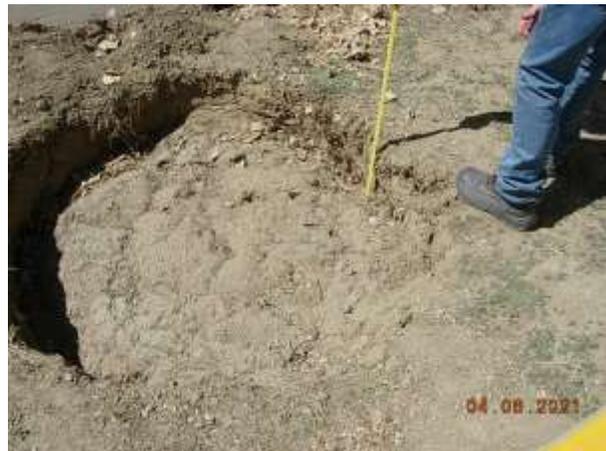
The approx. 5-ft diameter sinkhole that was reported to MMD, NMED and Cibola County was inspected. The landowner who was not present had told the Cibola County investigators that the original sink hole was approximately 4-5 feet deep and that it was backfilled with loose soil in early March, 2021. Since that time the backfill appears to have settled approximately 8 inches to 1 ft. The sinkhole is located along the side of the San Mateo village road and the local road dept. has placed concrete road barriers, cones and tape to keep the public from accidentally encountering the sinkhole. According to the local residents who spoke with Bruce Norquist of the Mt. Taylor Mine an old 2-inch water supply line is buried approximately 15 ft. away from the sink hole, the newer 6-inch community water supply line is located on the other side of the man road approximately 45-feet away. There is an un-occupied house located approx. 20-feet away and the septic tank for the house is located approx. 30-ft. away from the sinkhole. There was no other sign of any ground subsidence in the nearby area. An old acequia runs approximately 100-feet away to the north of the sinkhole and the road has a runoff ditch that extends along the roadside and come close to the sinkhole. Bruce reported that the area received approx. a foot of snow within the last 3-weeks. The sinkhole is approx. round in cross-section leading to suspicion that it was originally a well or sump that had been dug there in the past. The landowner said to Bruce that they would continue to monitor the sinkhole for further settlement or expansion. Bruce said that according to mine records there are no underground mine workings associated with the Mt. Taylor Mine within approx. a mile of the sinkhole.

Sink Hole in San Mateo

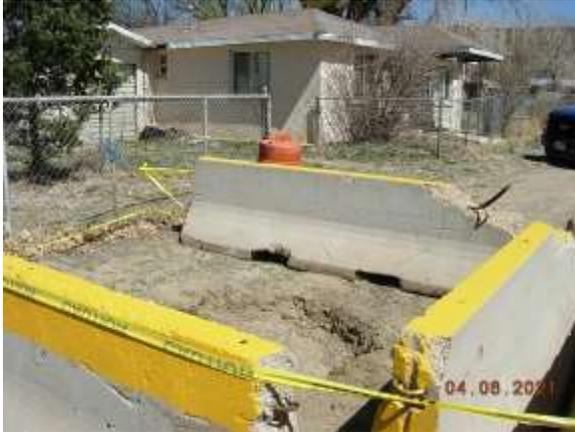
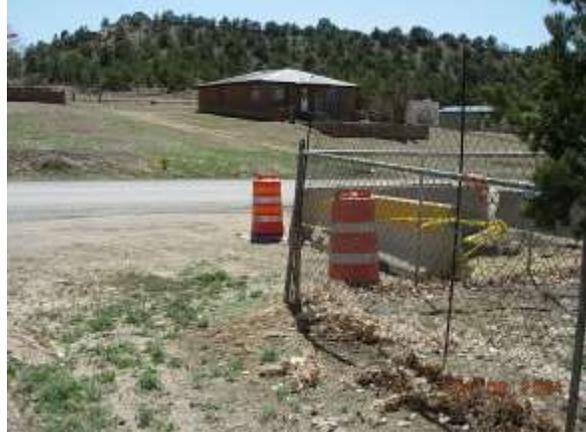
Sink Hole in San Mateo looking toward adjacent house (left photo) and away (right photo)
