RIO GRANDE RESOURCES CORPORATION

Subject: Submission of the Construction Quality Assurance Report (CQAR) of the Disposal Cell: Section 9.E.1.a, Permit CI002RE, Rev. 13-2; Mt. Taylor Mine

CONSTRUCTION QUALITY ASSURANCE REPORT ("CQAR") WASTE ROCK PILE / DISPOSAL CELL MT TAYLOR MINE RIO GRANDE RESOURCES CORP. (RGR)

5/7/2021

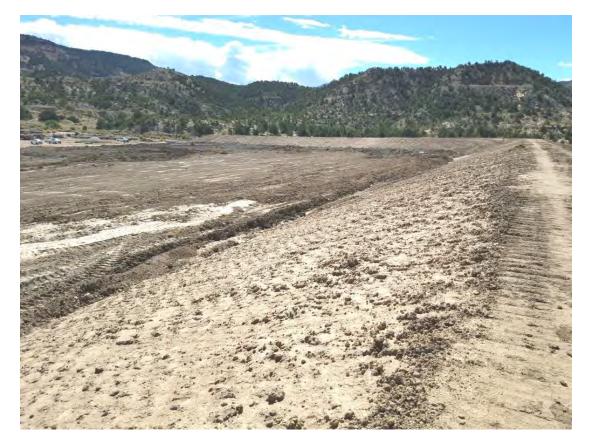
Photo 1 - Clay liner of disposal cell, under construction, from west berm of cell

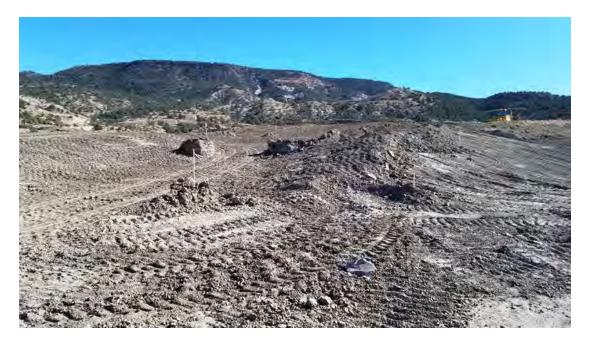
Photo 2 - Contaminated sediment in place in disposal cell, nearing capacity in the 11.5 acre footprint

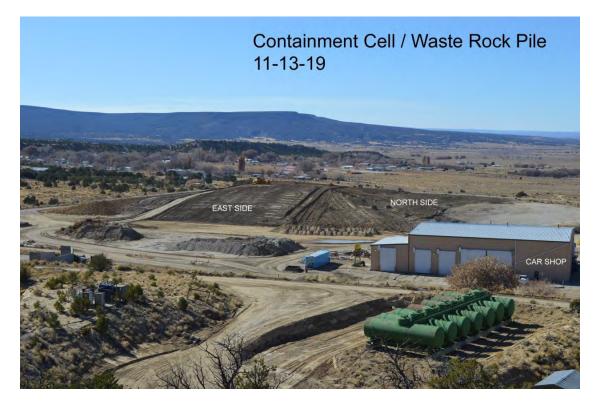
Photo 3 - Disposal cell near capacity with 11.5 acre footprint, looking west

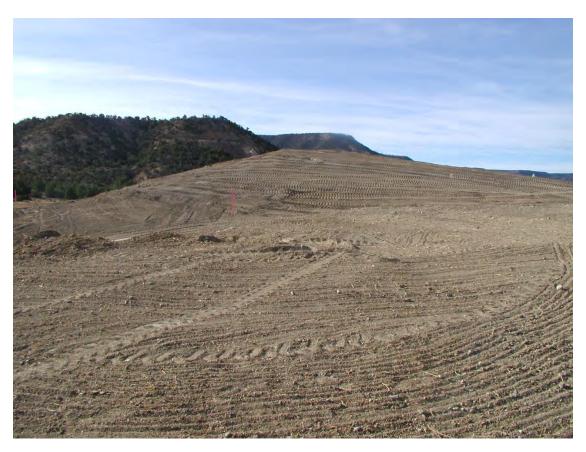
Photo 4 - Final grading of contaminated sediments and soil in disposal cell prior to cover placement

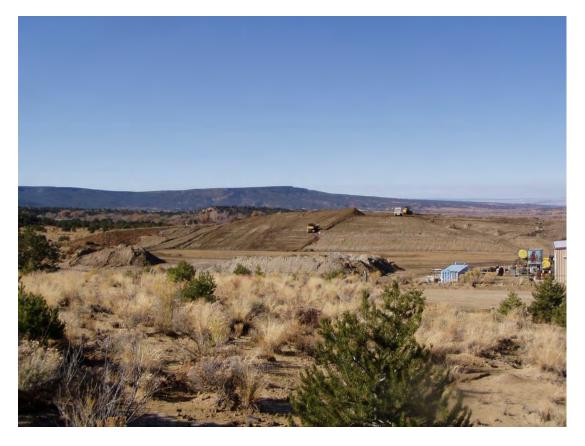
Photo 5 – Radon barrier being placed of the east slope of the disposal cell

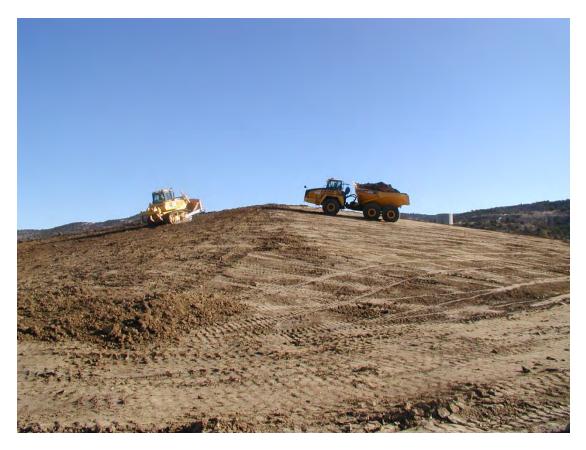
Photo 6 – Cover placement on the top of the disposal cell

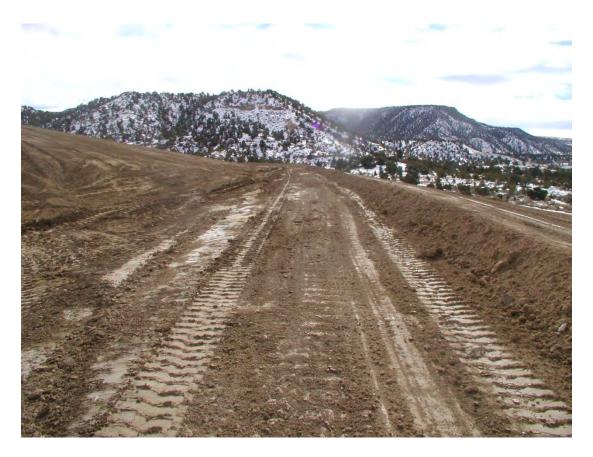
Photo 7 – West slope bench under construction.

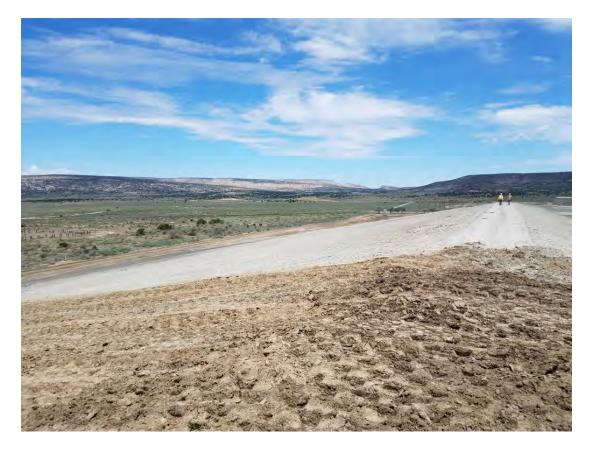
Photo 8 - West slope of waste pile with radon barrier partially in place.

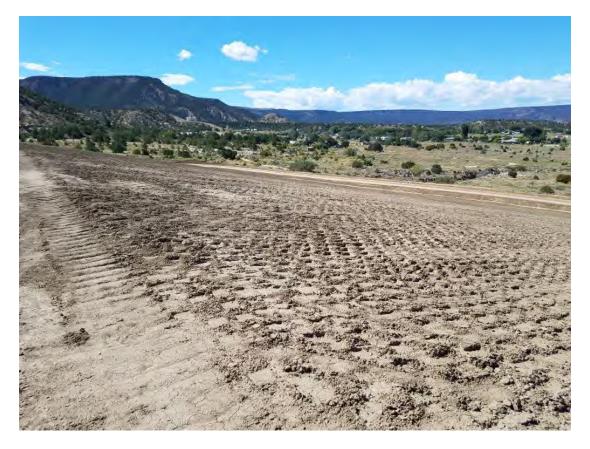
Photo 9 - West slope of waste pile with radon barrier in place

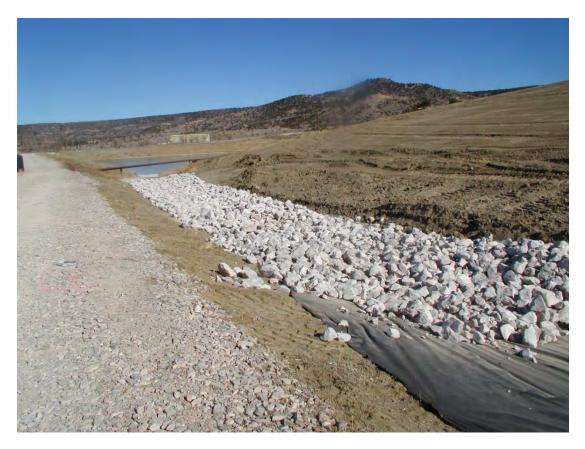
Photo 10 – Riprap placement in drainage ditch at toe of west slope of waste pile

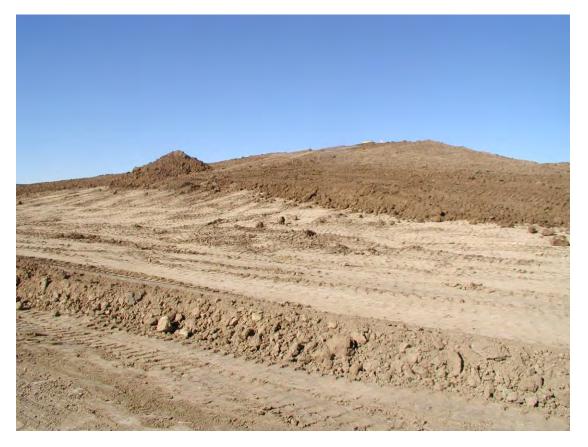
Photo 11 – Growth media being placed on west slope of disposal cell.
