LAC MINERALS (USA) LLC

RE: Waste Rock Pile Maintenance Summary of Work

Re: CHMRP WRP Cover Maintenance

Daniel B. Stephens & Associates, Inc. (DBS&A) is pleased to provide LAC Minerals (USA) LLC (LAC) this letter report documenting cover maintenance to the North Slope waste rock pile (WRP) at the Cunningham Hill Mine Reclamation Project (CHMRP) located in Santa Fe County, New Mexico. On October 19, 2022, representatives from the New Mexico Environment Department (NMED) and the Mining and Minerals Division (MMD) of the Energy, Minerals and Natural Resources Department visited the site to inspect the WRP cover. The agencies identified 11 locations requiring maintenance during their visit. They visited the site a second time on November 7, 2022 and identified 3 additional locations requiring maintenance. Figure 1 shows the 14 locations identified by the agencies. LAC completed the needed maintenance at these locations between November 7 and 28, 2022, as described in this letter report.

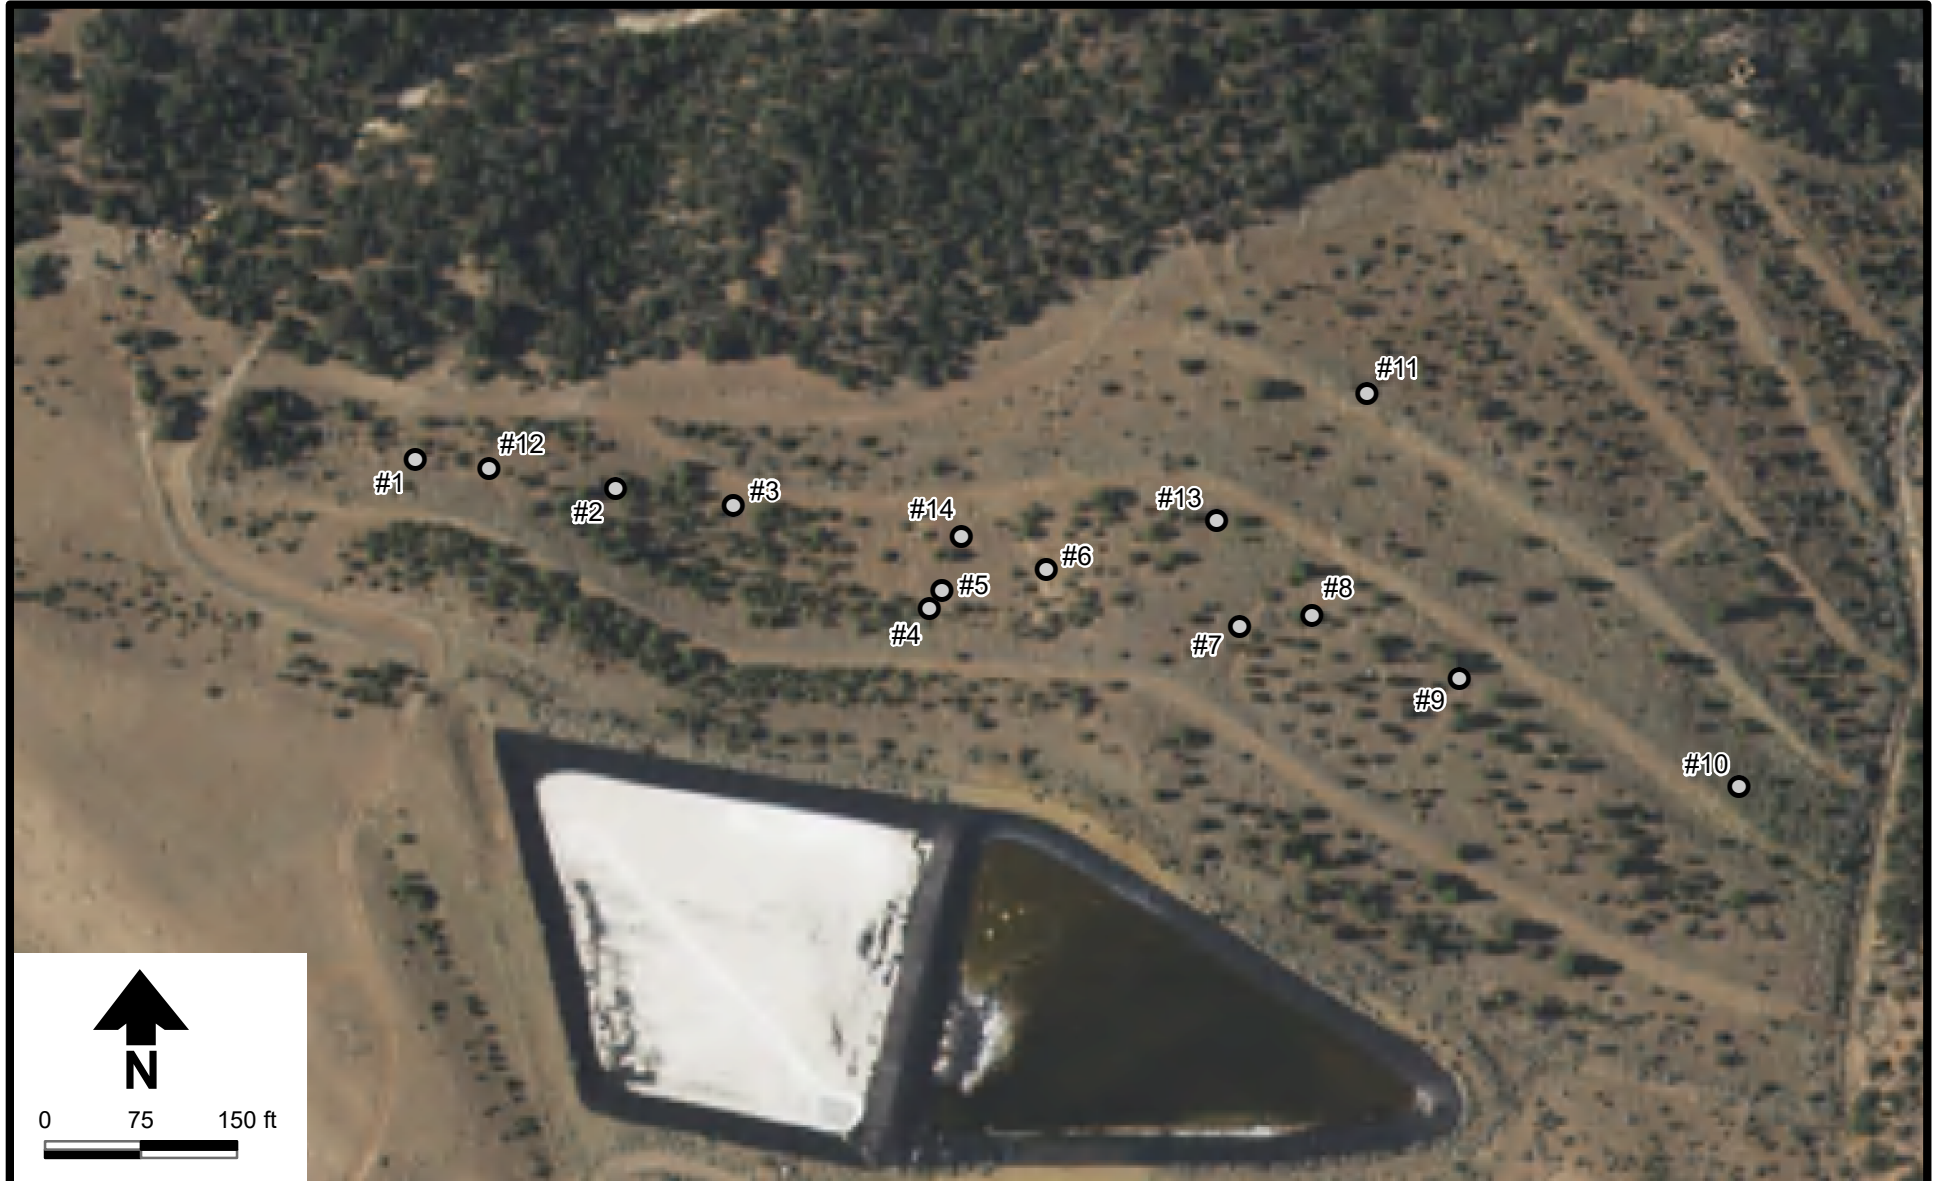
Figure 1

CUNNINGHAM HILL MINE RECLAMATION PROJECT
**North Slope Cover
Repair Locations**

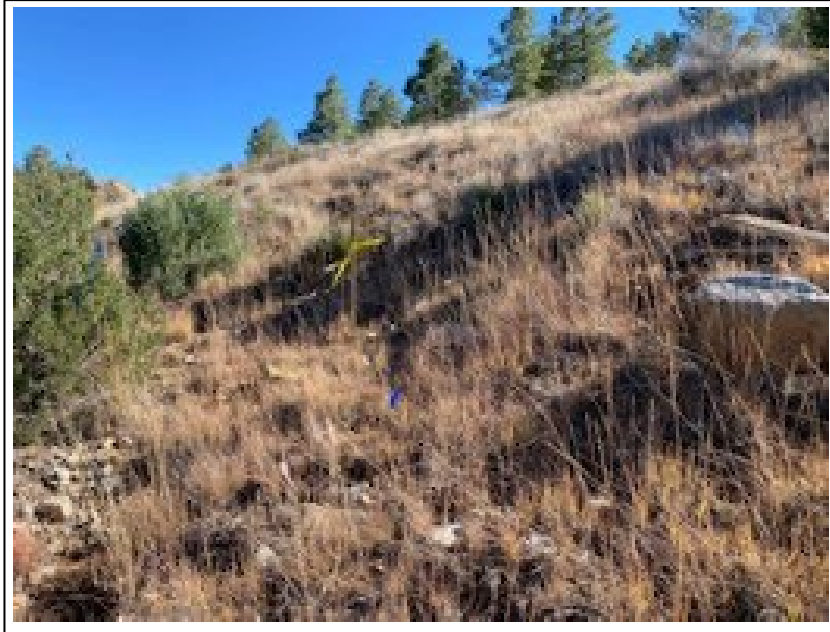
1. WRP location 1 prior to completion of repairs

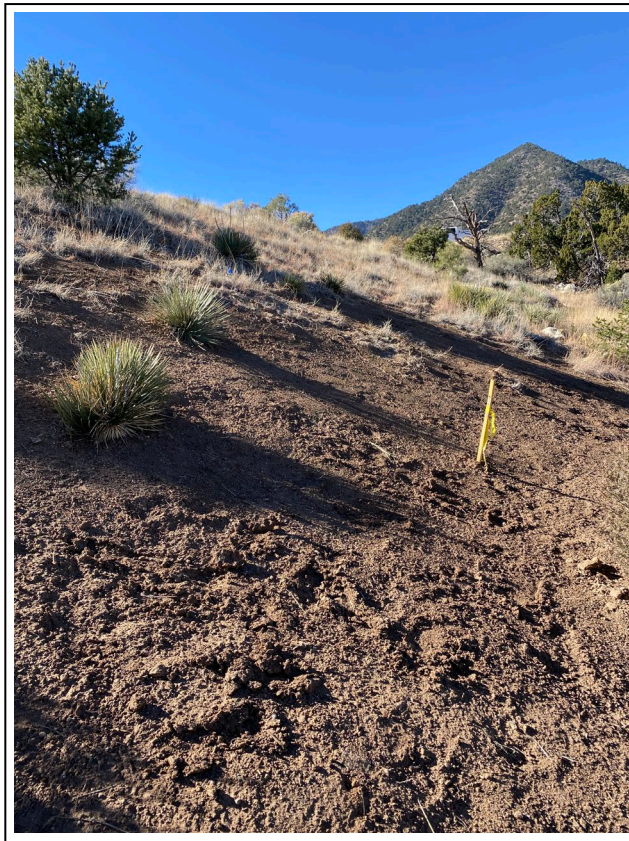
2. WRP location 1 after completion of repairs

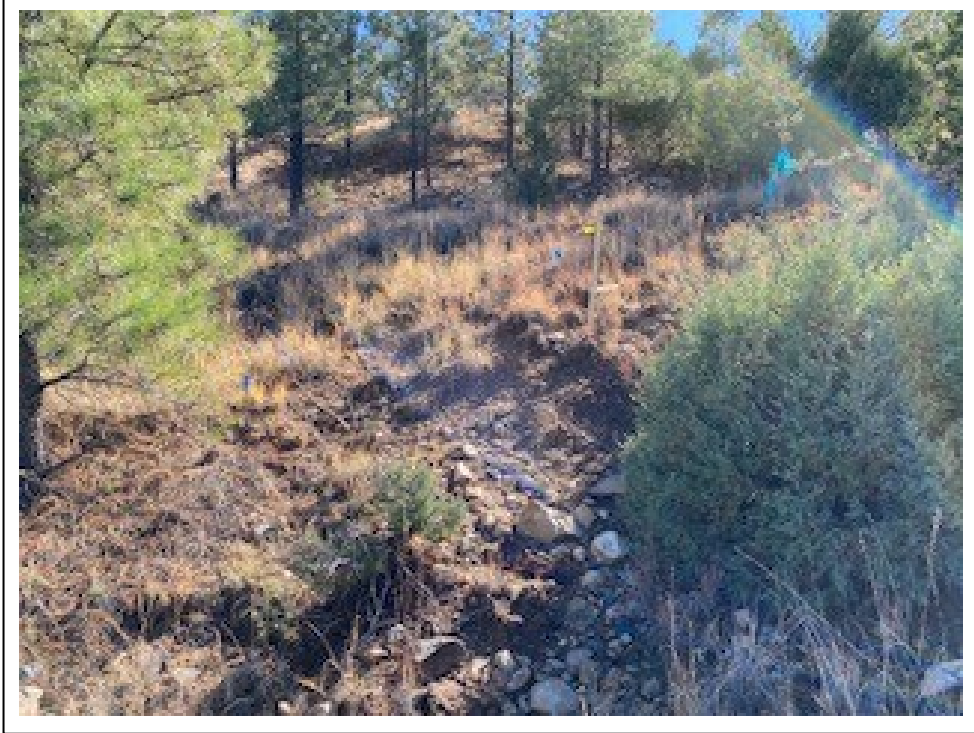
3. WRP location 2 prior to completion of repairs

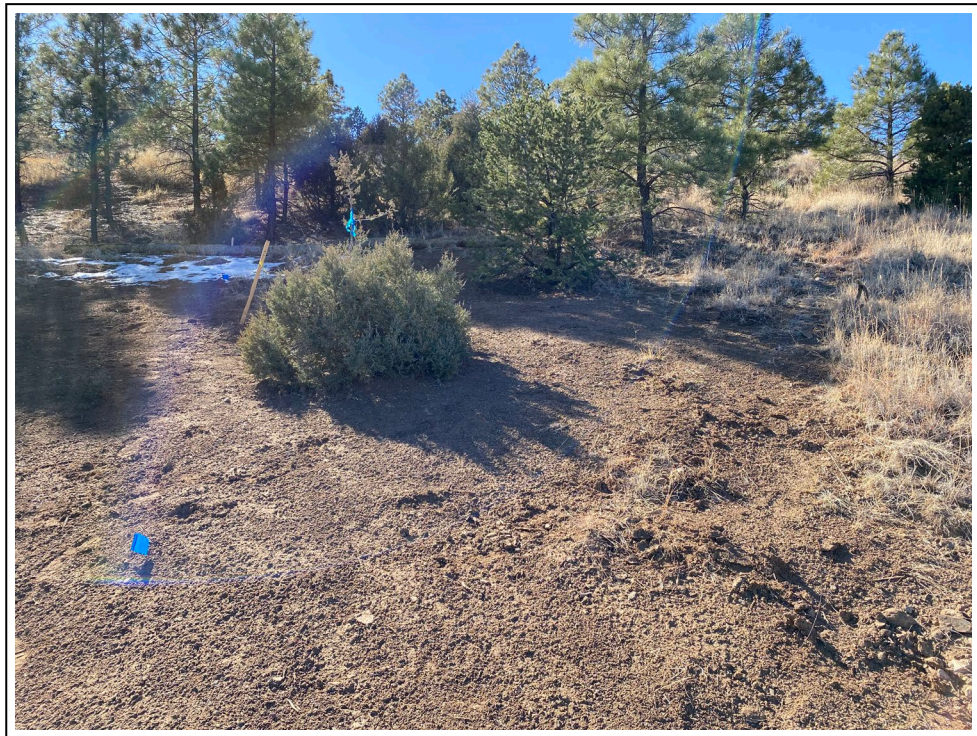
4. WRP location 2 after completion of repairs

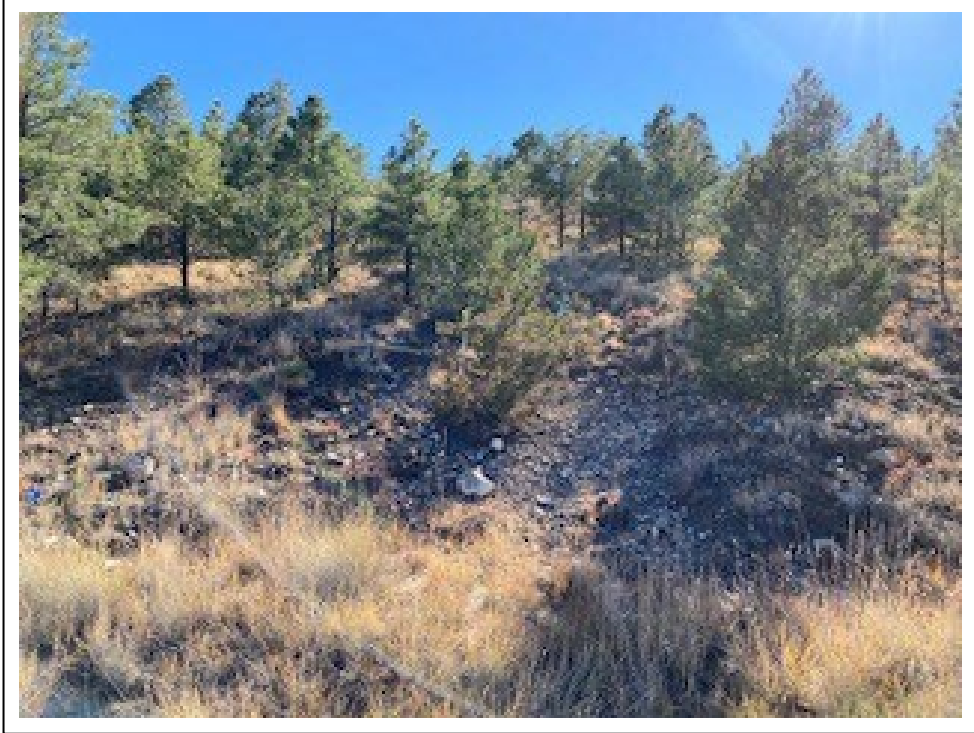
5. WRP location 3 prior to completion of repairs

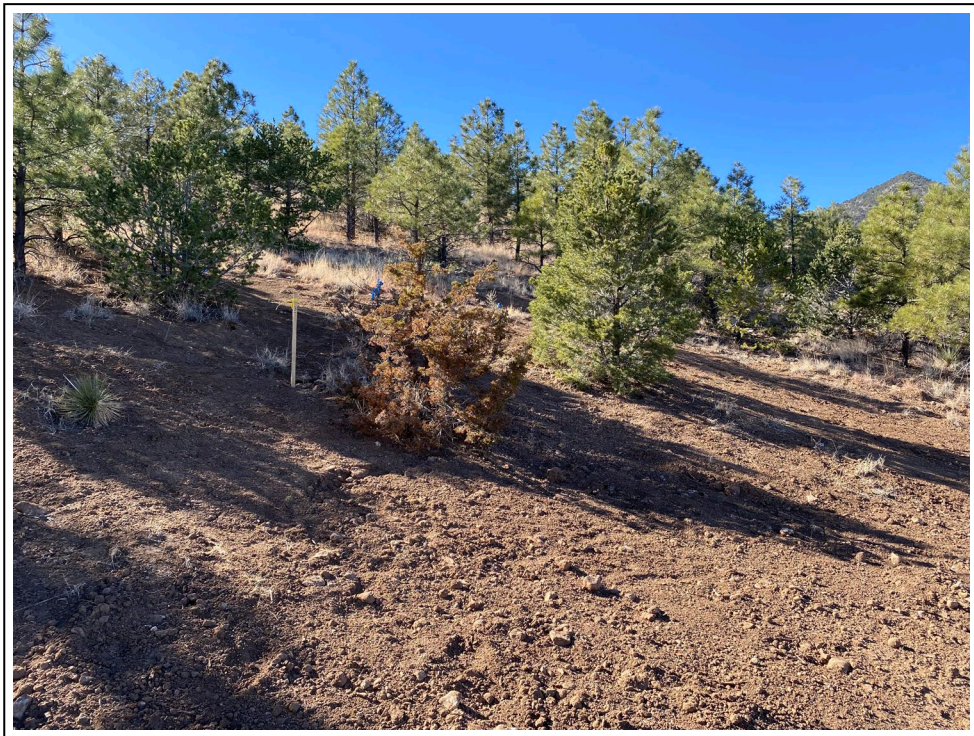
6. WRP location 3 after completion of repairs

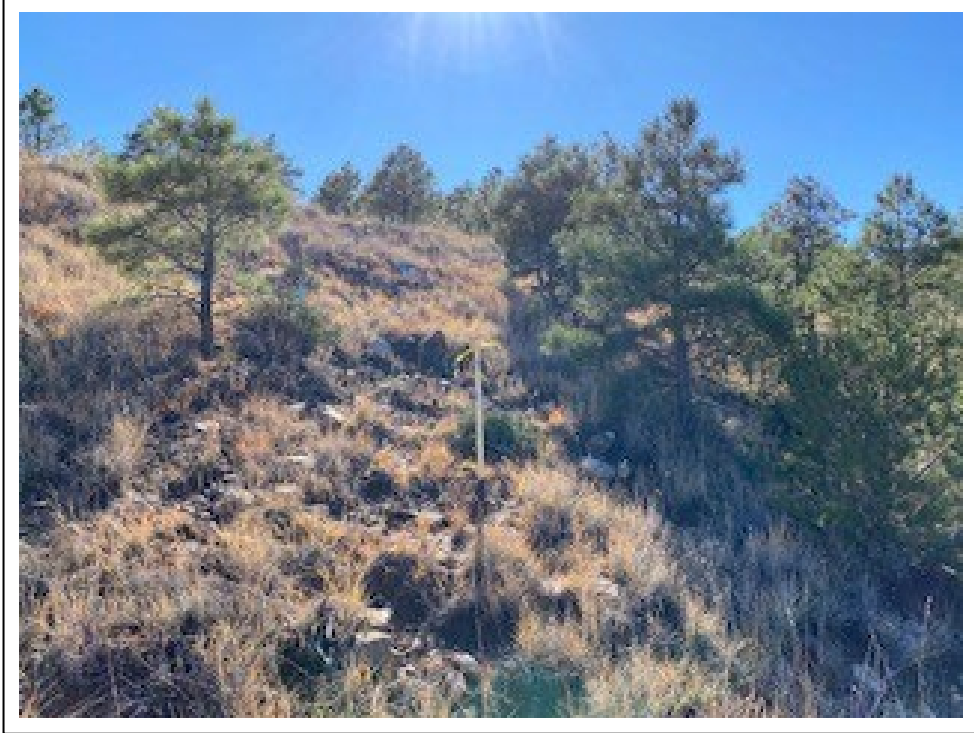
7. WRP location 4 prior to completion of repairs

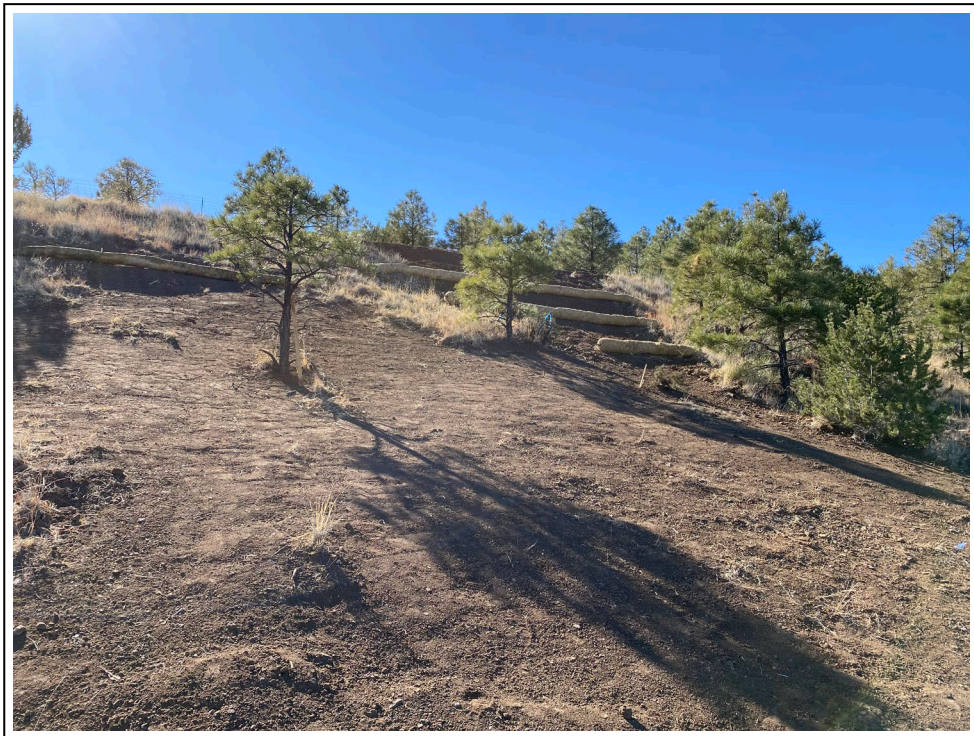
8. WRP location 4 after completion of repairs

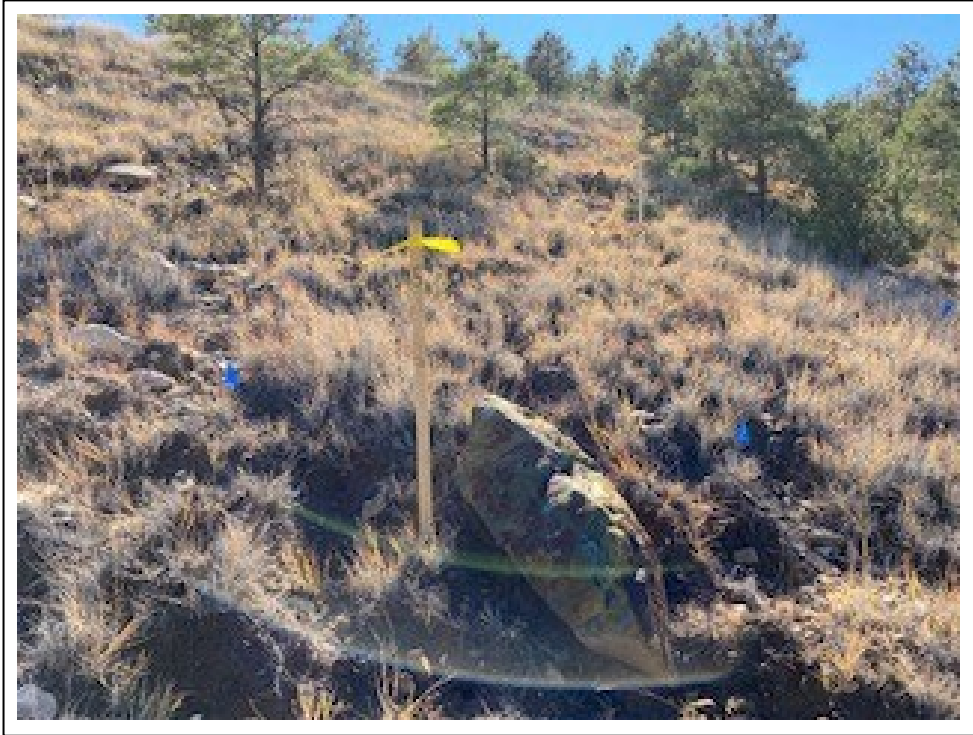
9. WRP location 5 prior to completion of repairs

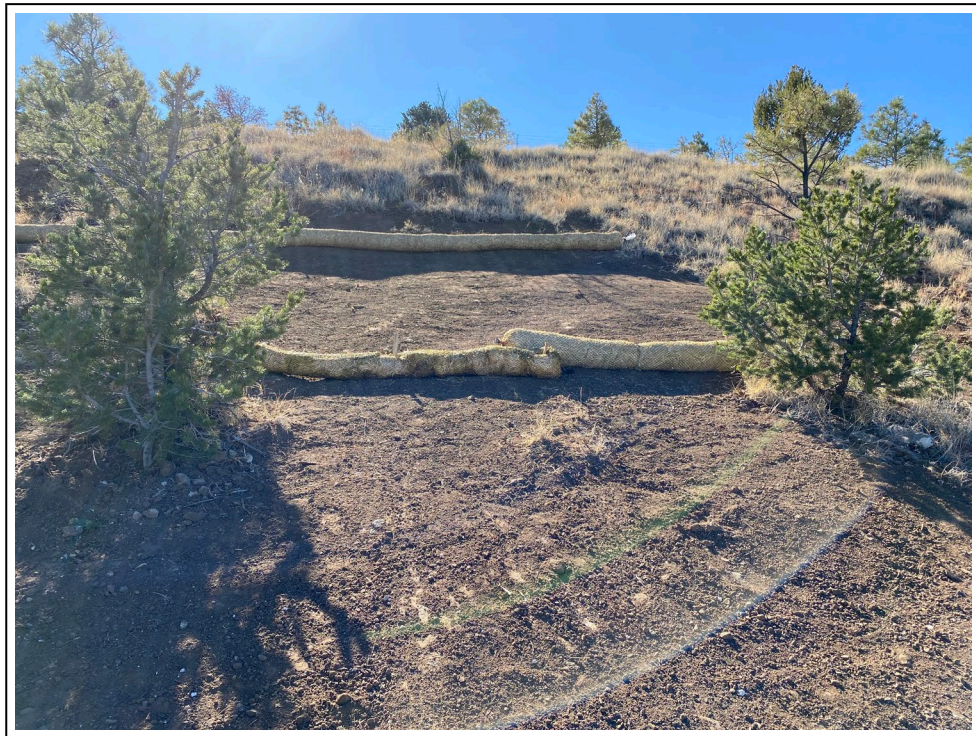
10. WRP location 5 after completion of repairs

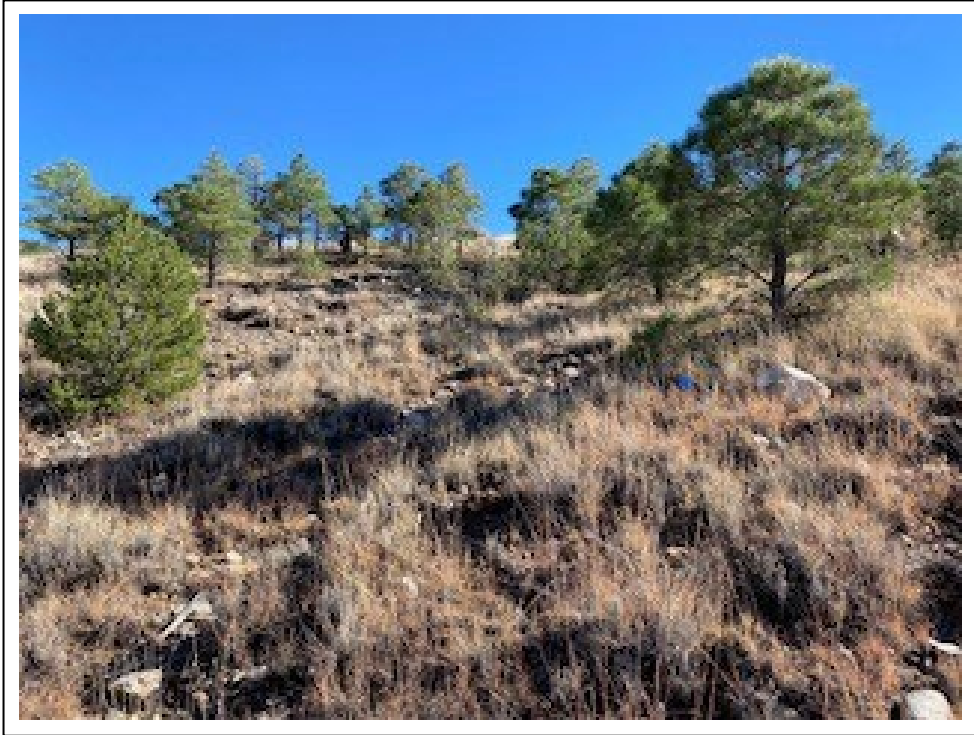
11. WRP location 6 prior to completion of repairs

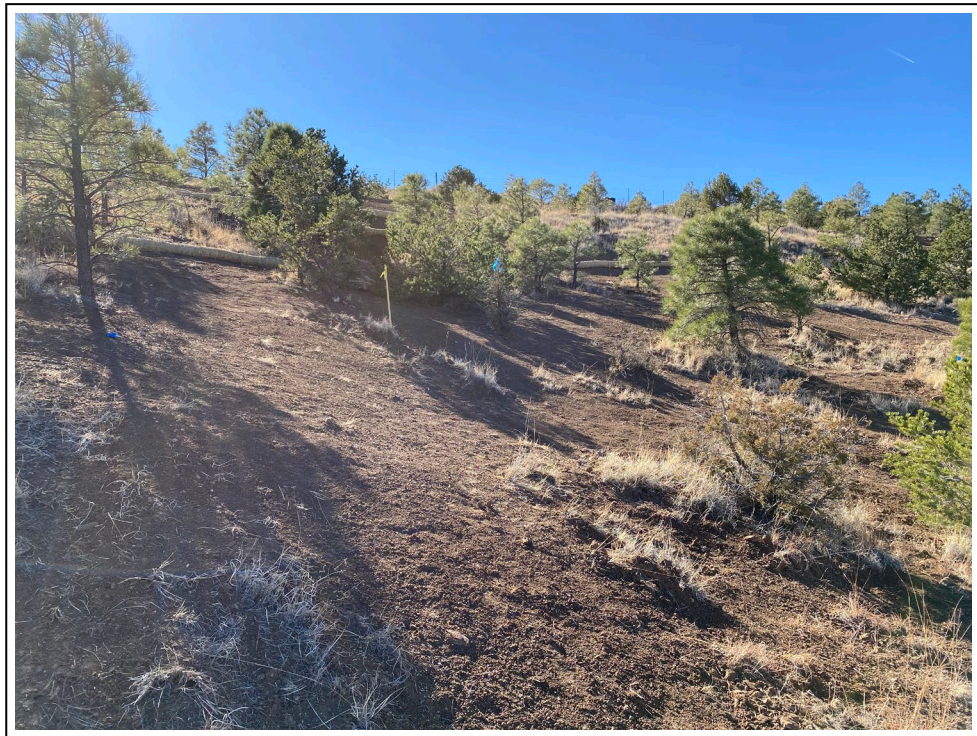
12. WRP location 6 after completion of repairs

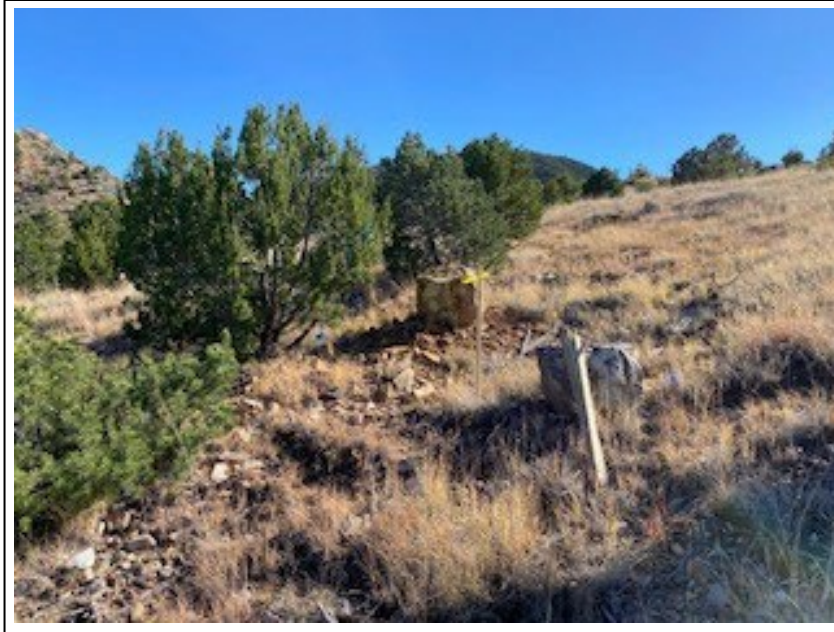
13. WRP location 7 prior to completion of repairs

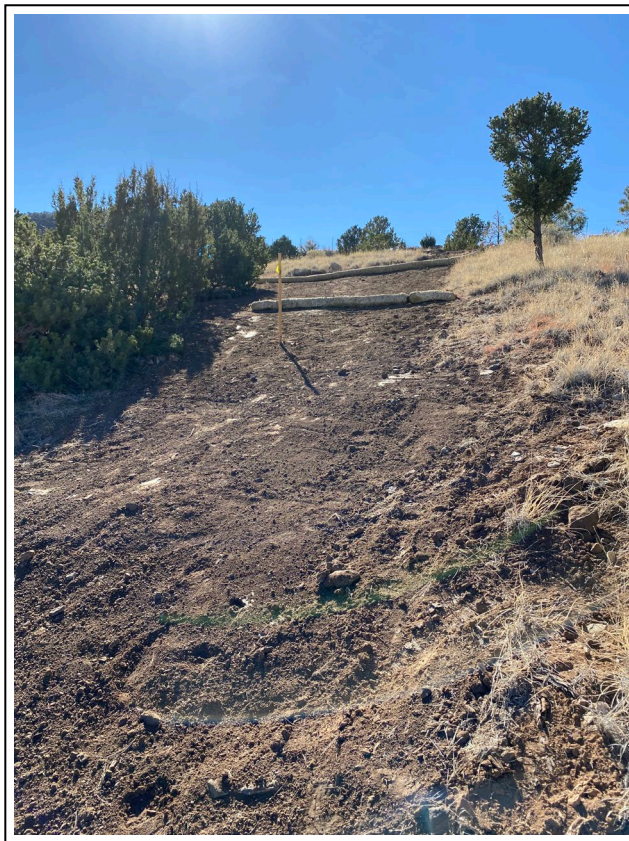
14. WRP location 7 after completion of repairs

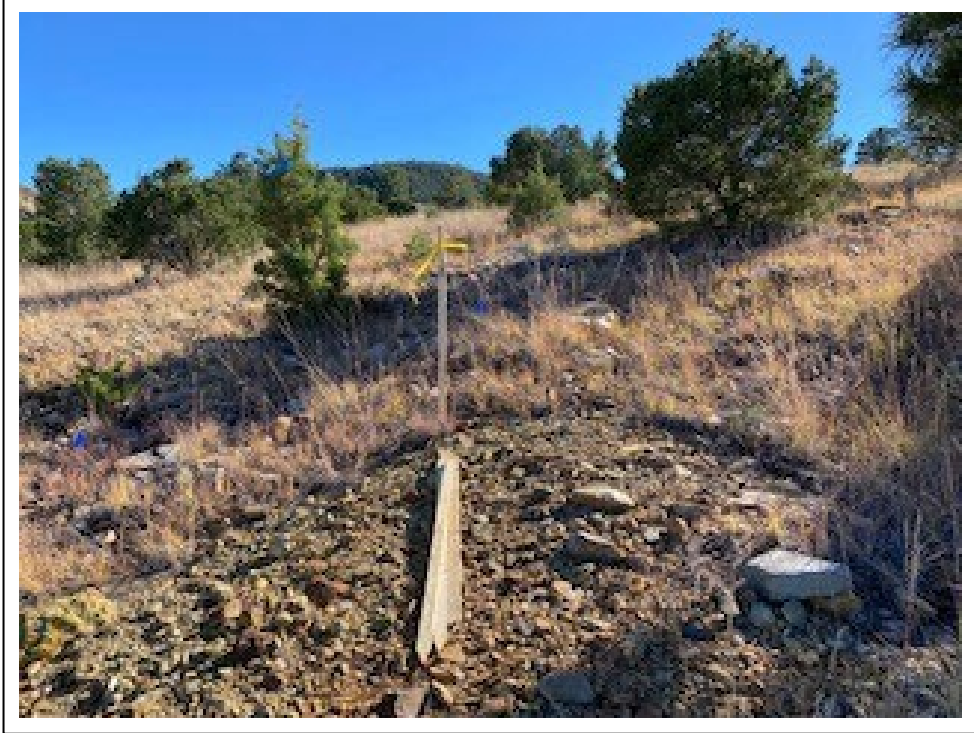
15. WRP location 8 prior to completion of repairs

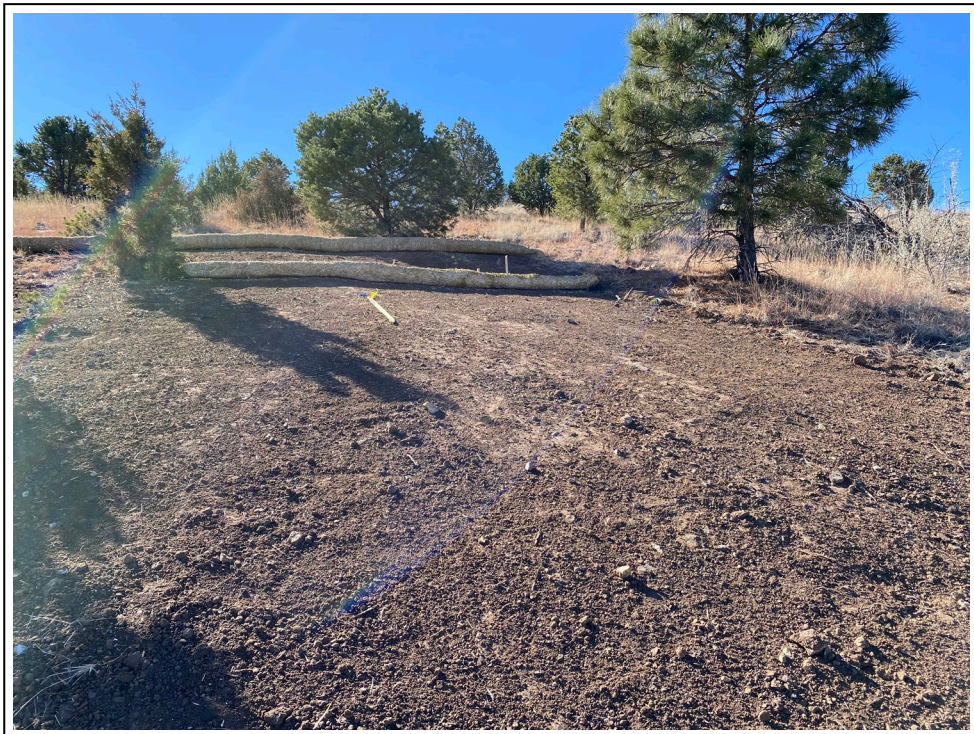
16. WRP location 8 after completion of repairs

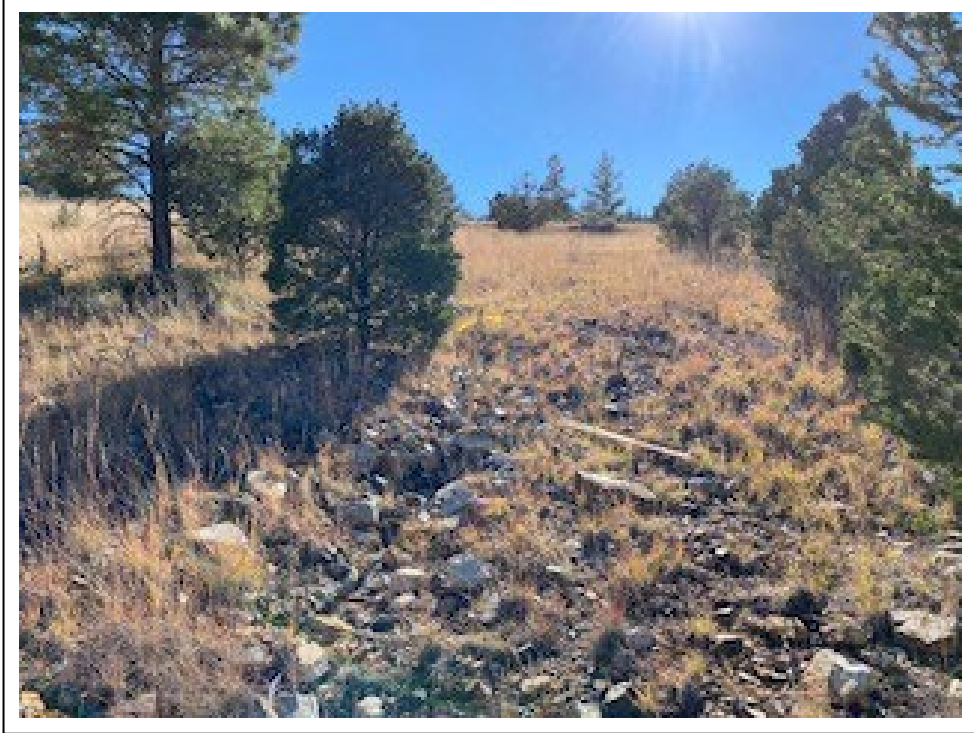
17. WRP location 9 prior to completion of repairs

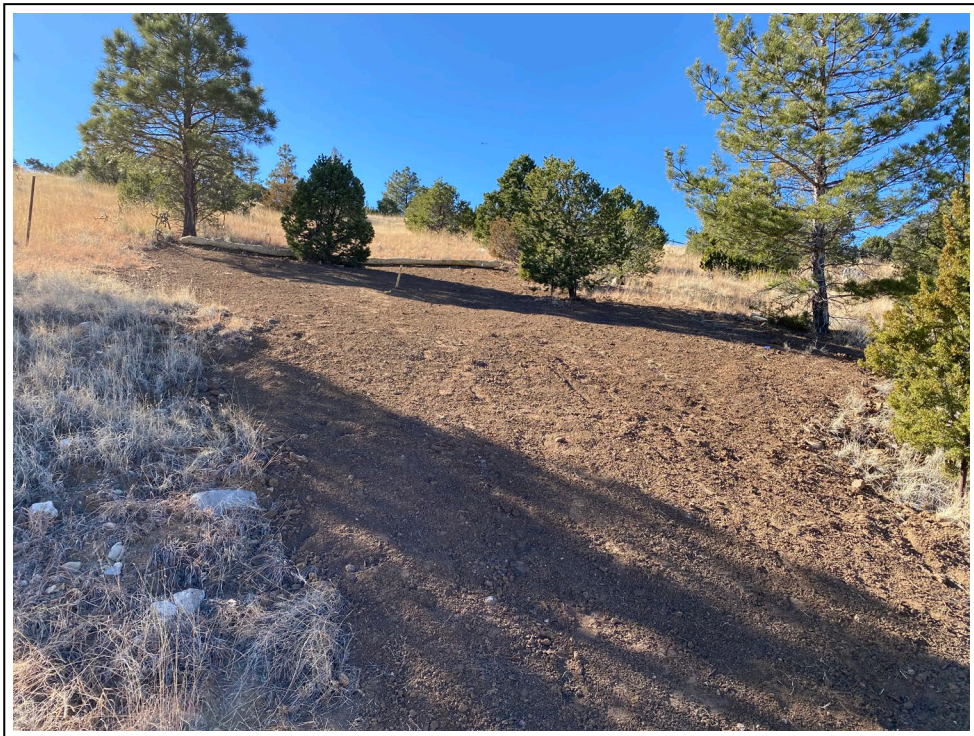
18. WRP location 9 after completion of repairs

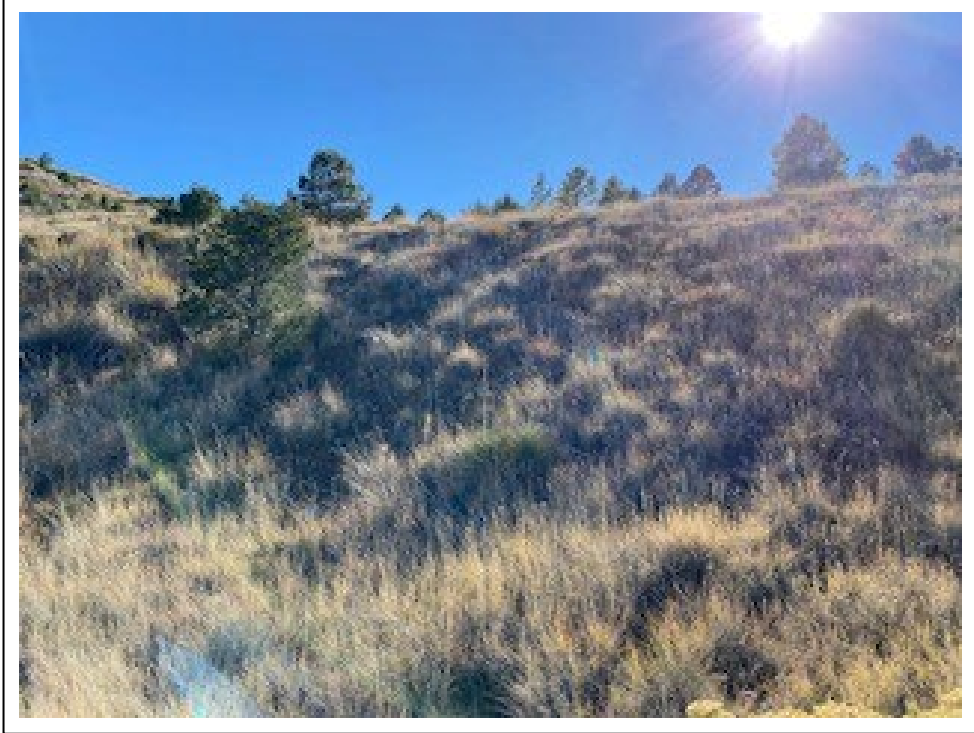
19. WRP location 10 prior to completion of repairs

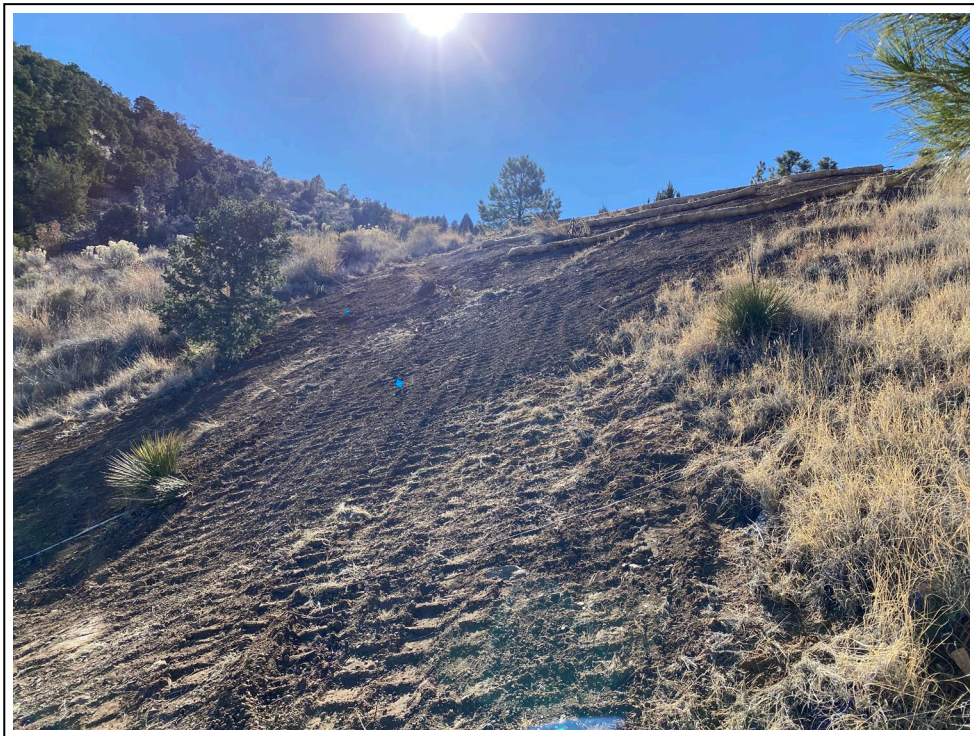
20. WRP location 10 after completion of repairs

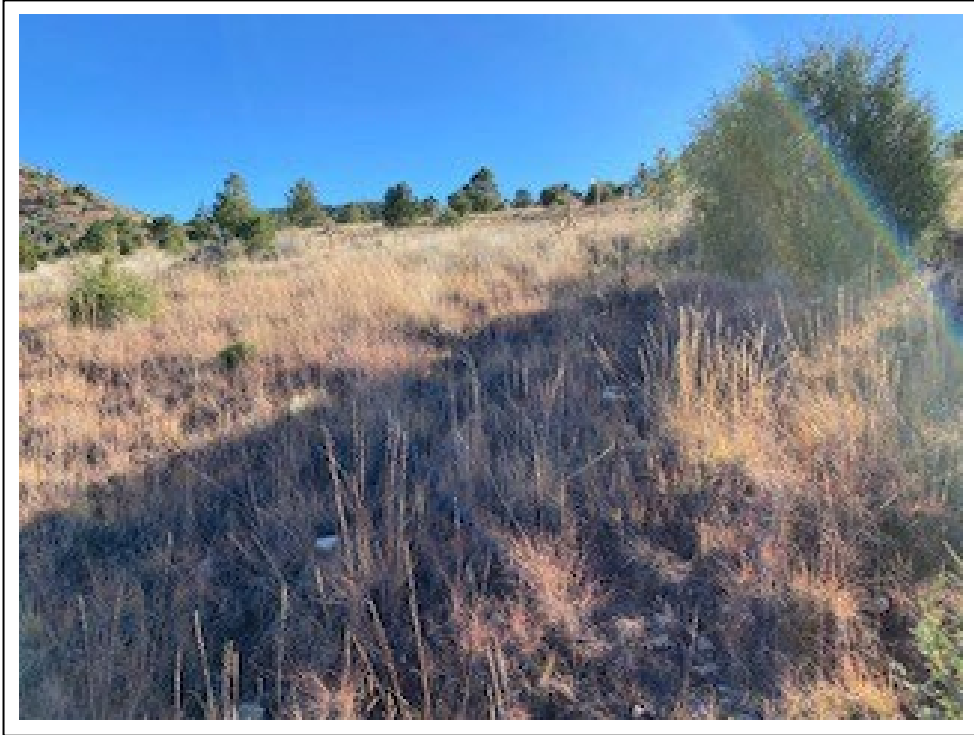
21. WRP location 11 prior to completion of repairs

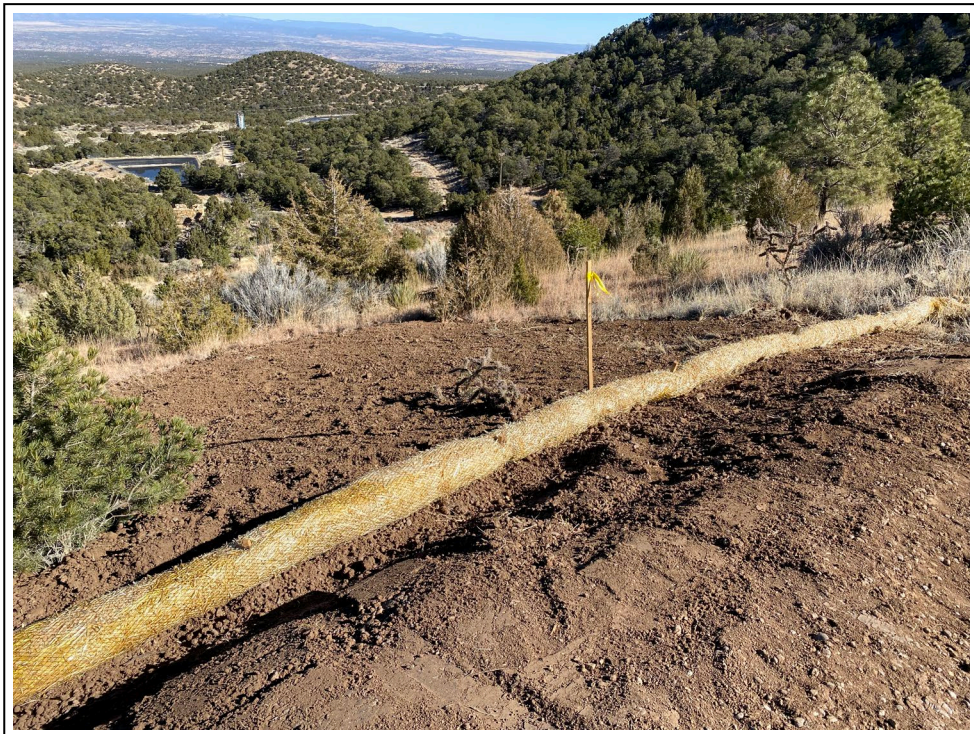
22. WRP location 11 after completion of repairs

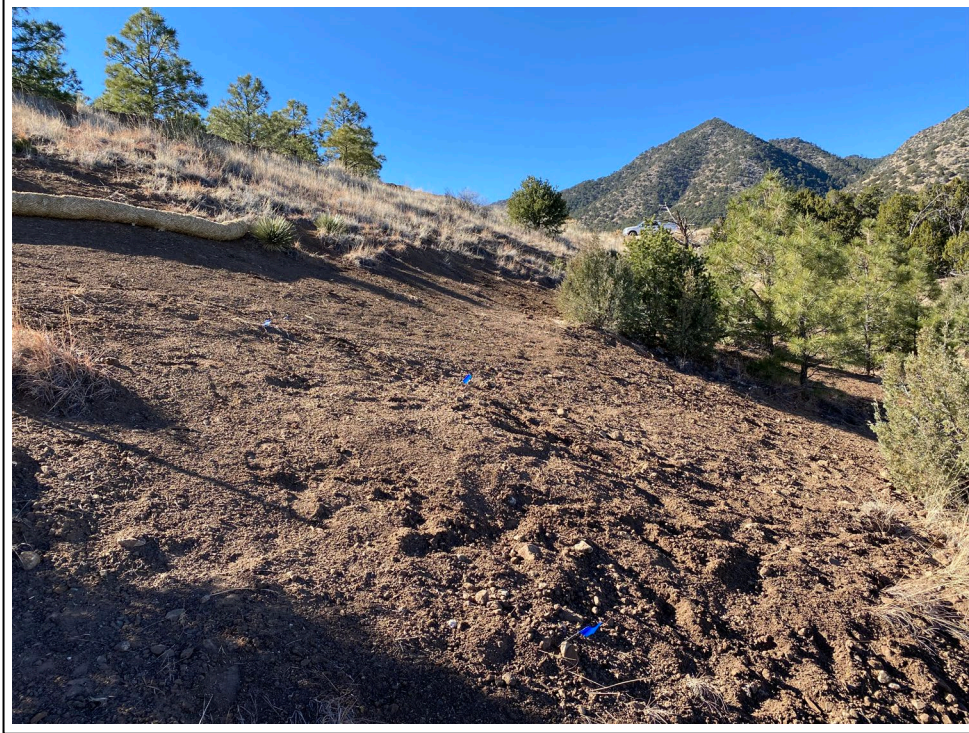
23. WRP location 12 after completion of repairs

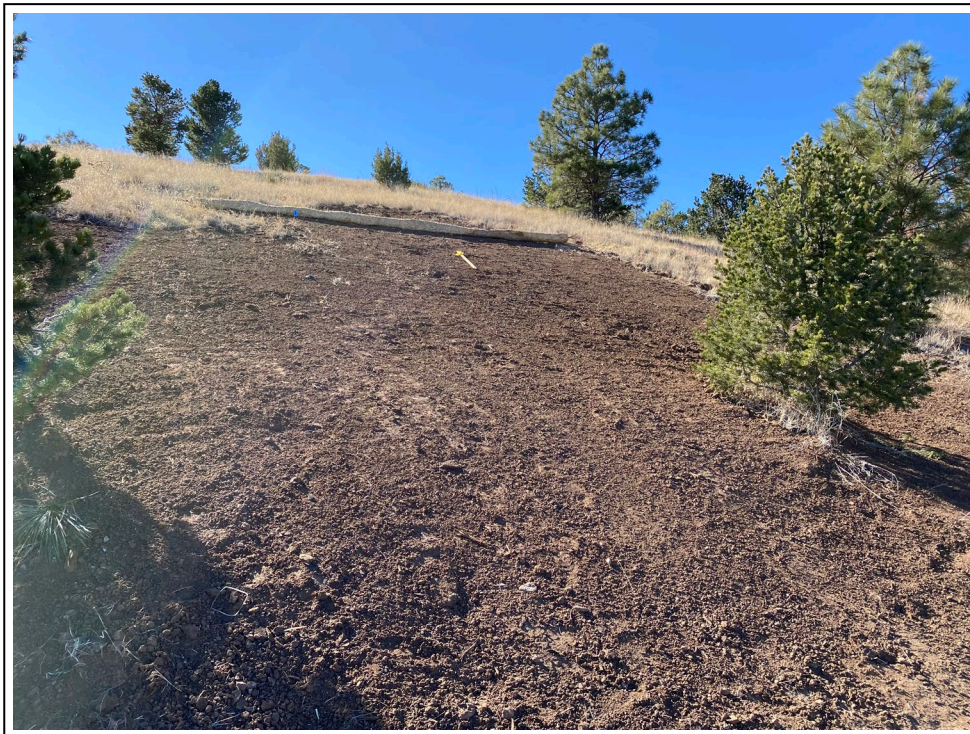
24. WRP location 13 after completion of repairs

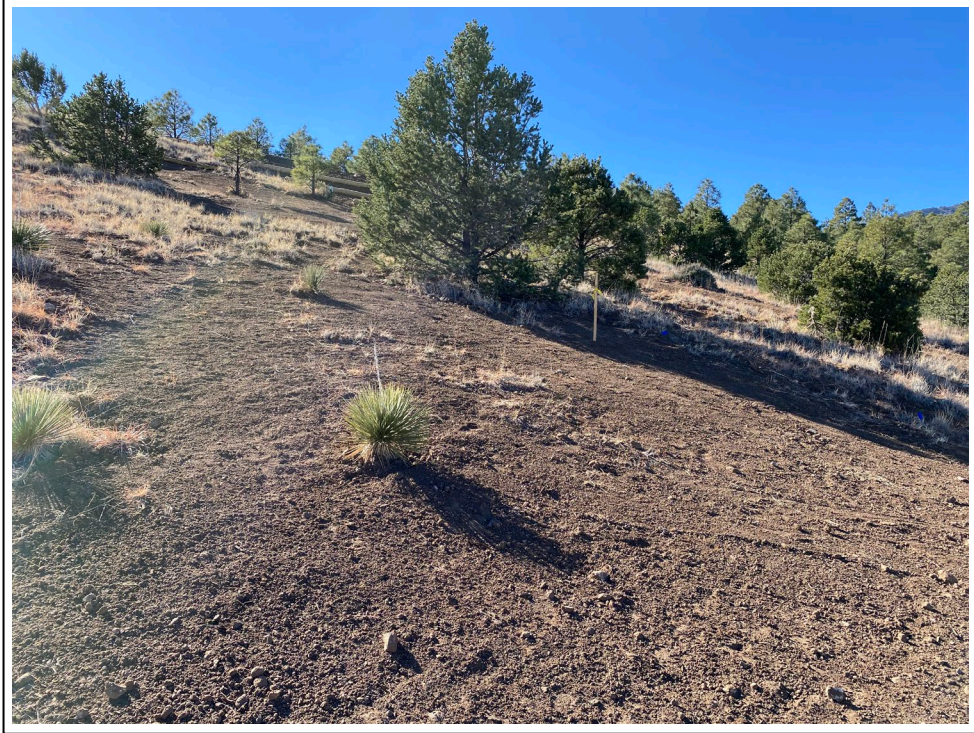
25. WRP location 14 after completion of repairs

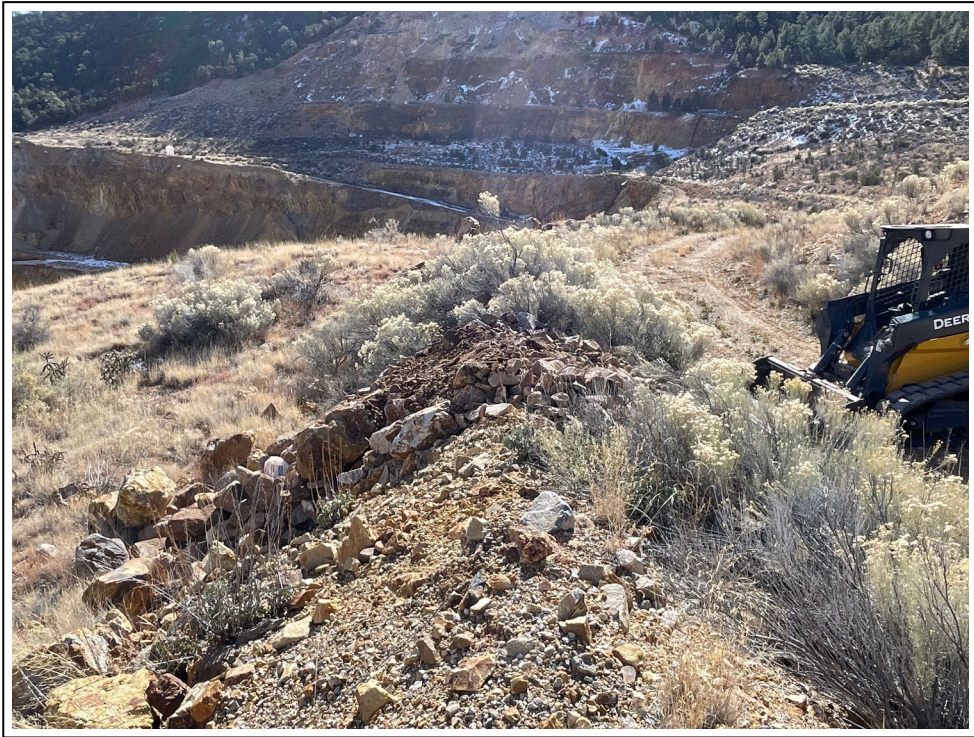
26. Pile of rocks (larger than 4 inches) removed

Before placement of the soil on the WRP cover repair areas, rocks larger than 4 inches in dimension were removed. These rocks were placed in a pile within the open pit drainage area. Rills were filled with the native soil, and the soil was then compacted with the vibratory plate compactor and/or hand compaction tools. The skid steer was used to level and grade the areas in preparation for the placement of more native soil to serve as a growth media soil. The growth media soil was placed directly on the areas and over any existing vegetation. Materials were placed in not larger than 6-inch lifts and compacted using the skid steer tracks. The final surfaces were lightly raked and broadcast seeded with the mix included in Attachment 2.
