MINING INSPECTION REPORT

Name of Operator:	Gulf Coast Mining Group, LLC
Name of Mine:	Iron Duke Mine
Address:	Sections 3 and 4, Township 22 S, Range 8 E
Permit Number:	OT006MN
Commodity:	Hematite & magnetite X_SURFACEUNDERGROUND
Date of Inspection:	May 17, 2023
Time of On-Site Inspection: 2:30 PM – 4 PM	
Weather Conditions:	Sunny, ~80°F
Purpose of Inspection	n: Annual
Lead Inspector:	Carmen Rose
Present During Inspe	ction: DJ Ennis & Carmen Rose (MMD)
ENFORCEMENT ACTION TAKEN: None NOTICE OF VIOLATION: # YES: NO:X CESSATION ORDER: YES: NO:X	
Time: On-Site: 1.5 Permit Review: 2 Travel: 10 Report Writing: 1 TOTAL INSPECTION TIME: 14.5 HOURS	
NOTE: Turn left onto a dirt road 3 miles north from Orogrande on US-54. Follow the dirt road west for almost 3 miles until you reach a gate. Go through the gate to get to the mine site.

Iron Duke Mine Site Inspection

May 17, 2023

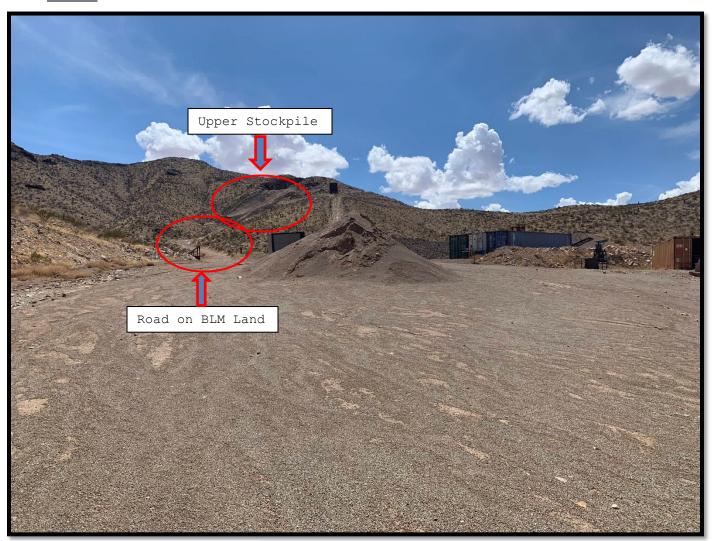
Figure 1. Main staging area

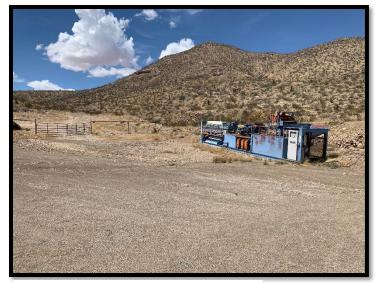
This inspection was done on the same day as the Orogrande Inspection, and the operator was not notified of our visit. The site had quite a bit of disbursed disturbance with multiple stockpiles of material stationed throughout the permit area. A screening plant, ten storage containers, two trailer office buildings (one was tipped over), and the ball mill were also present during the inspection. The new ball mill was relocated near the front gate, and appeared to have had some maintenance or possible vandalism.

Figure 2. Ball Mill

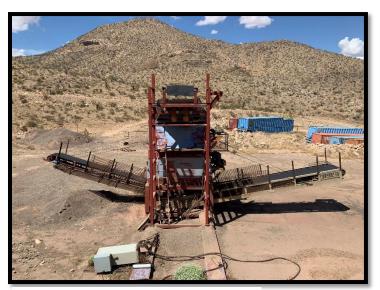
Figure 4. Screening plant

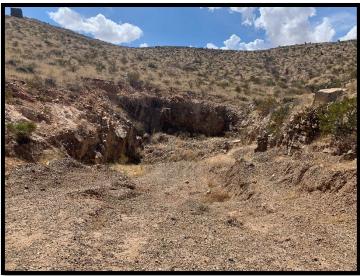
Figure 5. Lower disturbed exploration area

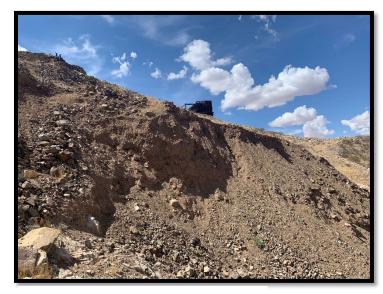
Figure 6. Upper Stockpile

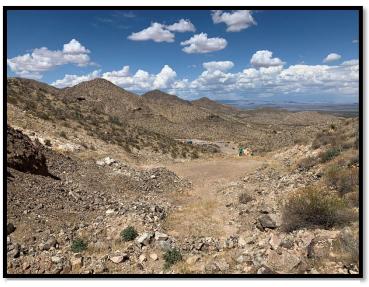
During the previous inspection in 2019, there was a berm at the base of the BLM road to prevent direct access to the upper stockpile. However, the berm was no longer there during this inspection, indicating that the operator has been using the road without BLM permission. This violates Section 10.B of the Permit (Mod 17-1):

Figure 7. Looking down from Upper Stockpile toward road on BLM land

• Consider a Notice of Noncompliance or NOV for road on BLM land (permit condition 10.B) as a means to have operator submit a modification application.

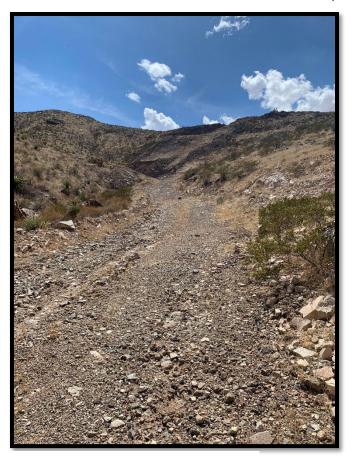
Figure 8. Road on BLM land, unreclaimed

The Permittee needs to submit a modification application to MMD to reassess the FA, provide a
reclamation plan for the road on BLM land, propose a reference area, and provide a mitigation plan
for the Golden Eagle nest in the permit area.

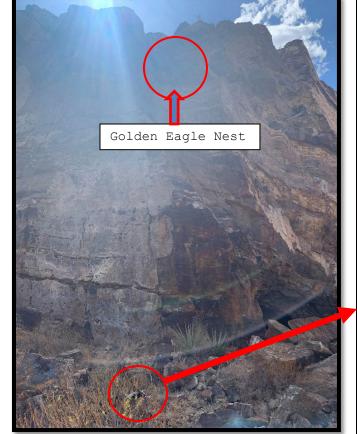
MMD walked up the road on BLM land to the upper stockpile, then continued up the hill to the highwall. It did not seem like any active mining was occurring in this area. A dead Golden Eagle chick was found at the base of the highwall. A large raptor nest could be seen directly above the dead chick, indicating that Golden Eagles do nest on site. The inspectors continued around the north side of the historic underground mining

Figure 10. Golden Eagle Nest

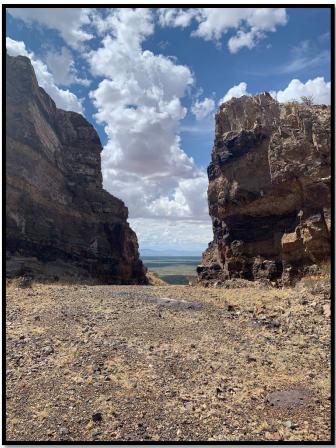
Figure 9. "Highwalls" at top of hill

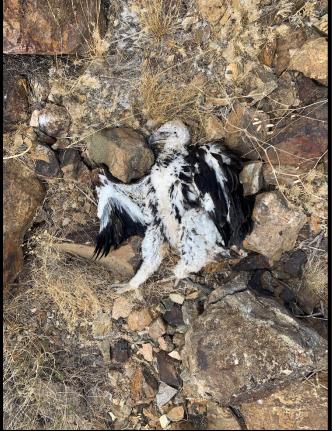
Figure 11. Dead Golden Eagle chick

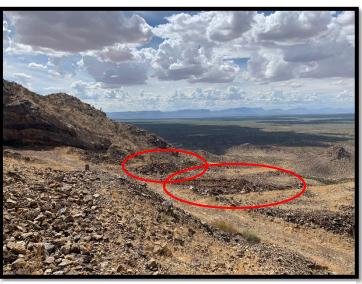
area, and observed what looked like some recent disturbance on the top of the waste piles that extend over the north slopes. The inspectors walked down the access road and left the site at 4pm.

Figure 13. Looking north towards old waste rock stockpiles. Areas of new disturbance circled in red
