**RE: Cunningham Hill Pit Slope Stability Analysis Revision 01, Cunningham Hill Mine,
Permit No. SF200RE**

MEMORANDUM

Subject: Cunningham Hill Pit Slope Stability Analysis – Revision 01

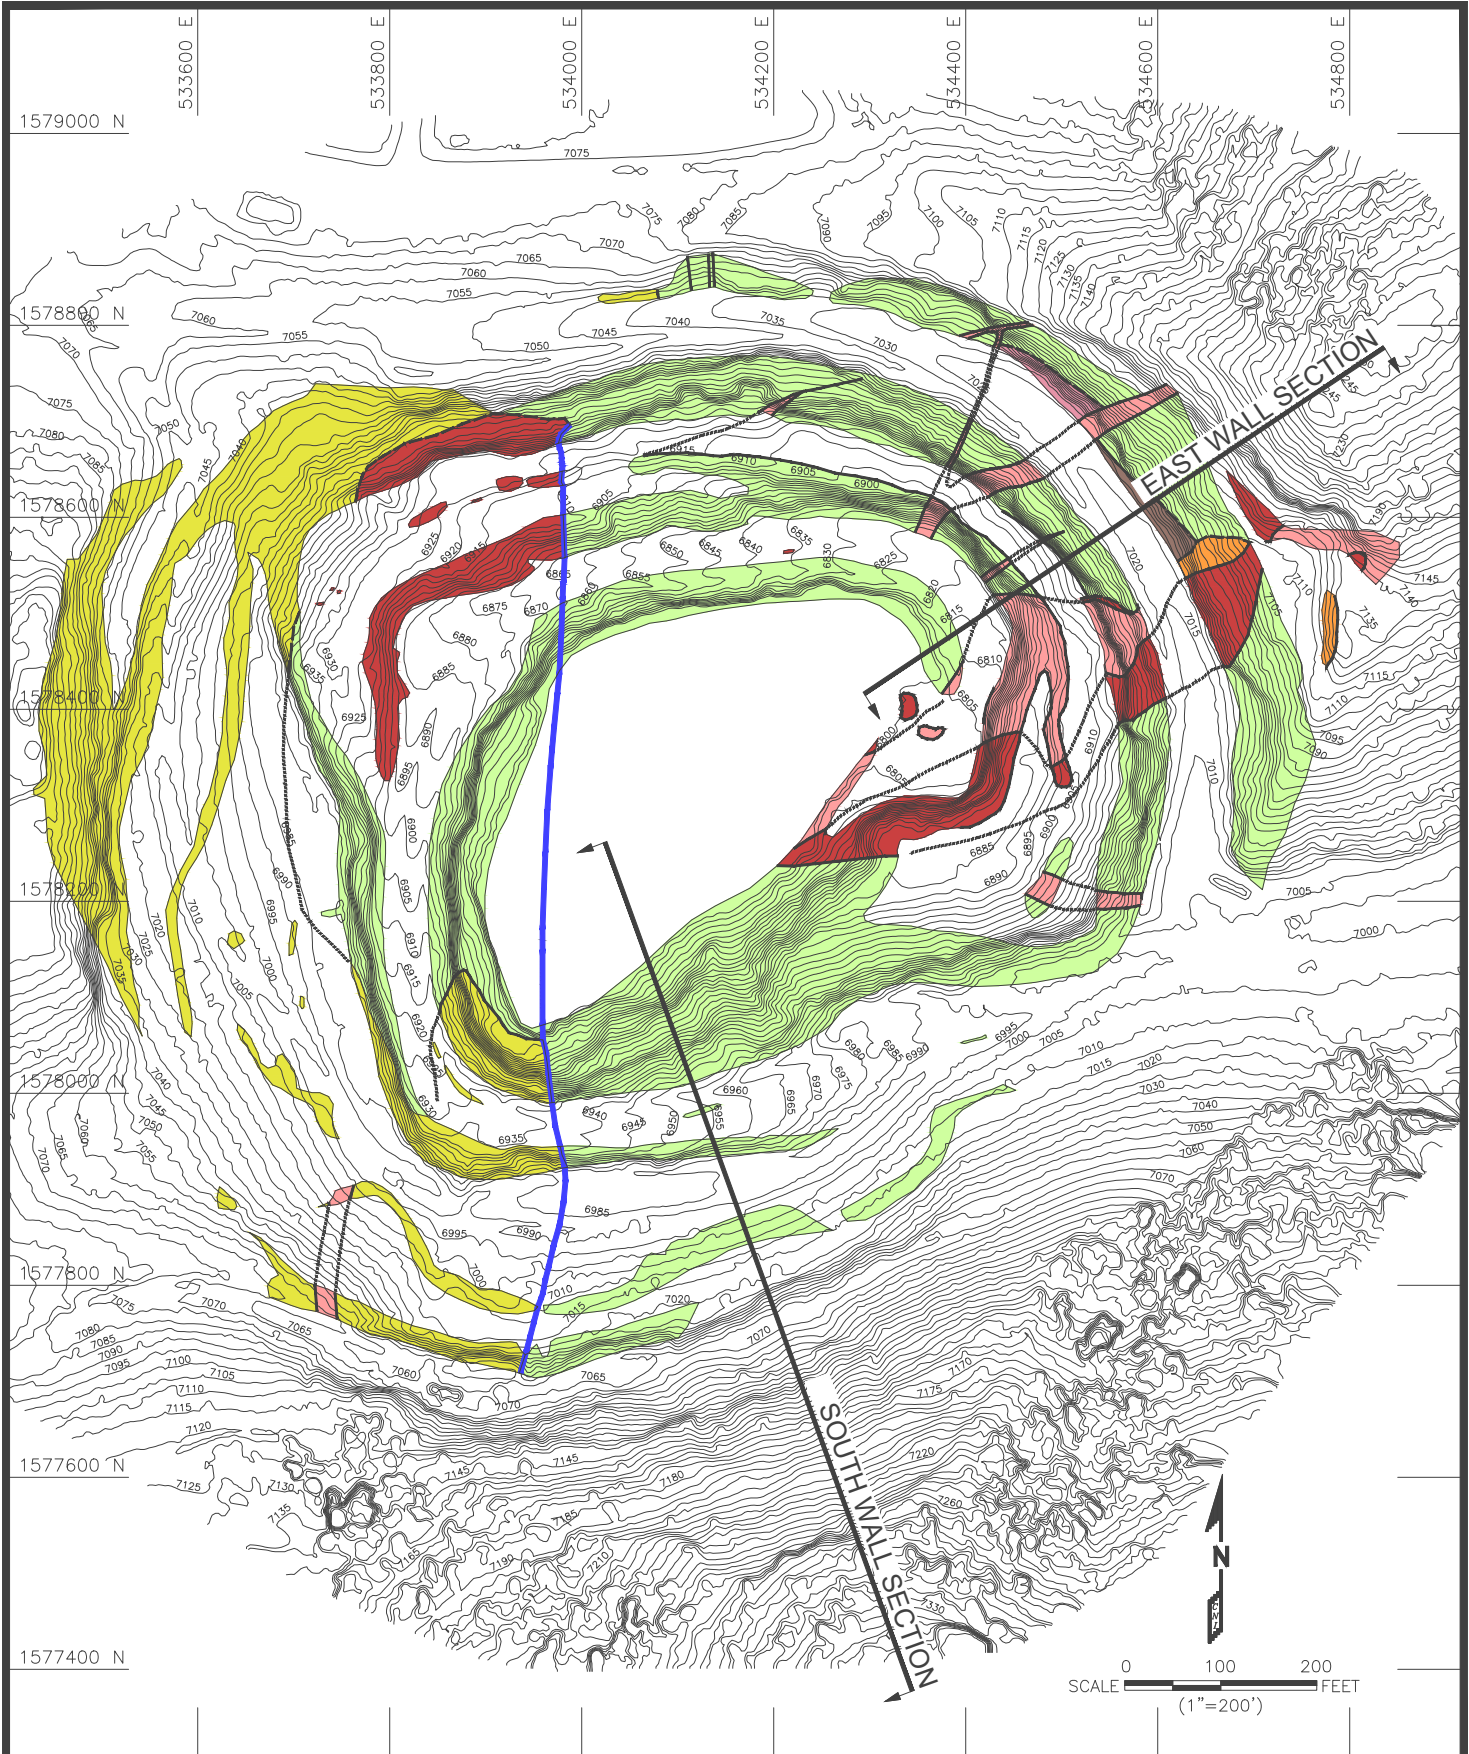
SCALE 1"=200' **FIGURE 1**

A one-day site visit to the CHMRP property was conducted on 27 June 2023. The property is located approximately 25 miles south of Santa Fe, on the eastern side of the Ortiz mountains. Pit geology is primarily metamorphosed Paleocene sediments, volcanic vent breccia, and latite porphyry. Brecciation in the sediments, caused by the latite intrusion, is the primary ore host. Major structure consists of a nearly vertical fault striking north-south that crosses the pit, movement along which has caused contact between vent breccia to the west and quartzite to the east. Current topography, with outlines of mapped geology from Stephen R. Maynard's 1995 work, is shown in Figure 1. Accompanying geologic descriptions, adapted from Maynard (1995), are shown in Table 1. Large scale figures will follow the full text of the memo.

Table 1. CHMRP Pit Geology Descriptions for Figure 1

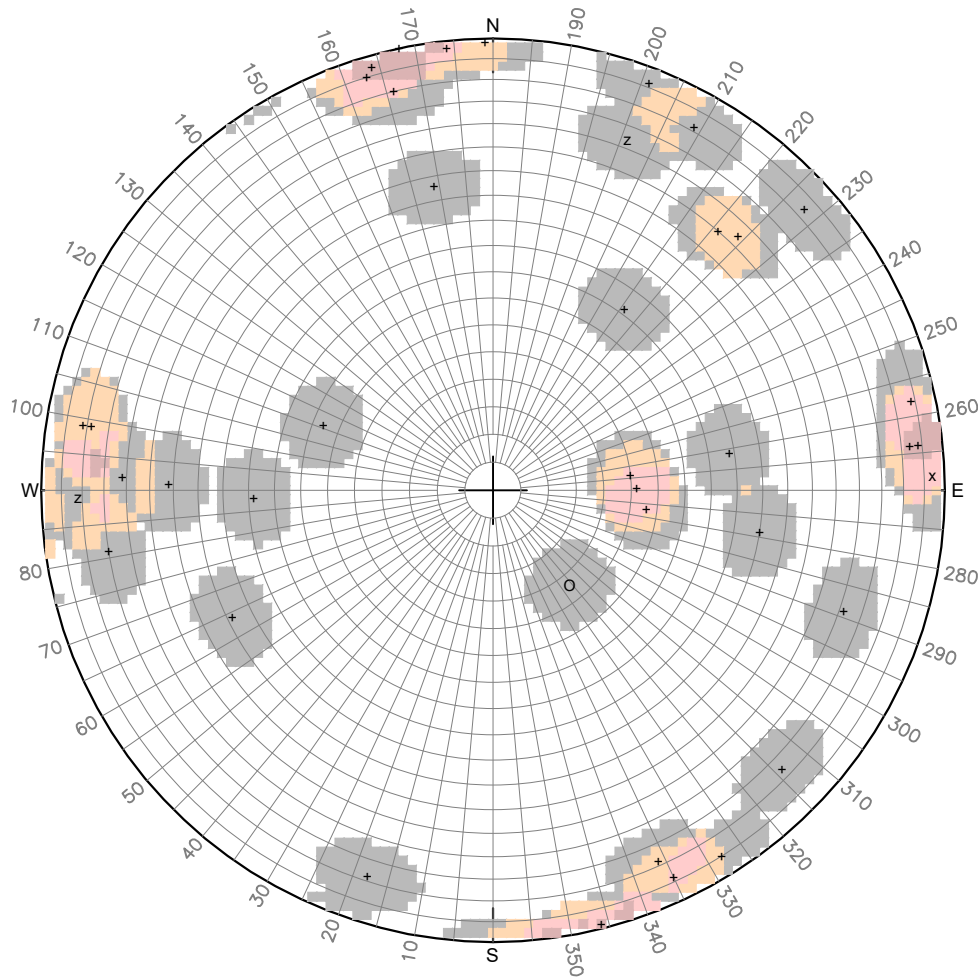
FIGURE 2

Stereonet plots of structure sets for the most prominent rock types in the pit wall (the Diamond Tail Sandstone and the Volcanic Breccia) are shown in Figures 2 and 3. Pervasive Diamond Tail Sandstone structure east of the pit-scale fault generally includes a low angle bedding set, of variable dip direction, and long perpendicular high-angle cross joints resulting in blocky pit wall outcrops. West of the fault the Diamond Tail is massive with only sporadic, irregular joints.

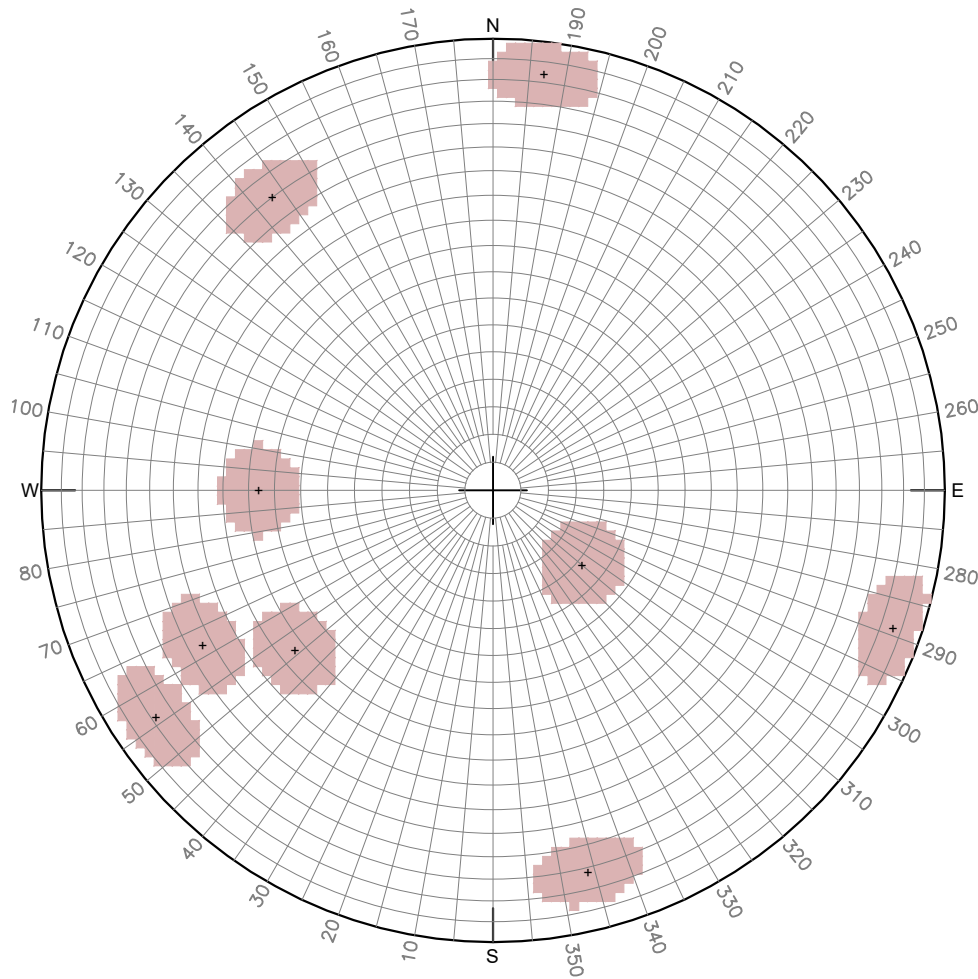
FIGURE 3

The Volcanic Breccia shows two prominent high angle joint sets in the upper west wall. The first set dips into the pit at an oblique, near-parallel angle relative to the pit wall with an average spacing of 12 feet. The bottom of this structure is not daylighted in the pit wall as the structure dip exceeds the wall dip. The second structure occurs nearly perpendicular to the wall, dips away from the pit, and has an average spacing of 8 feet.

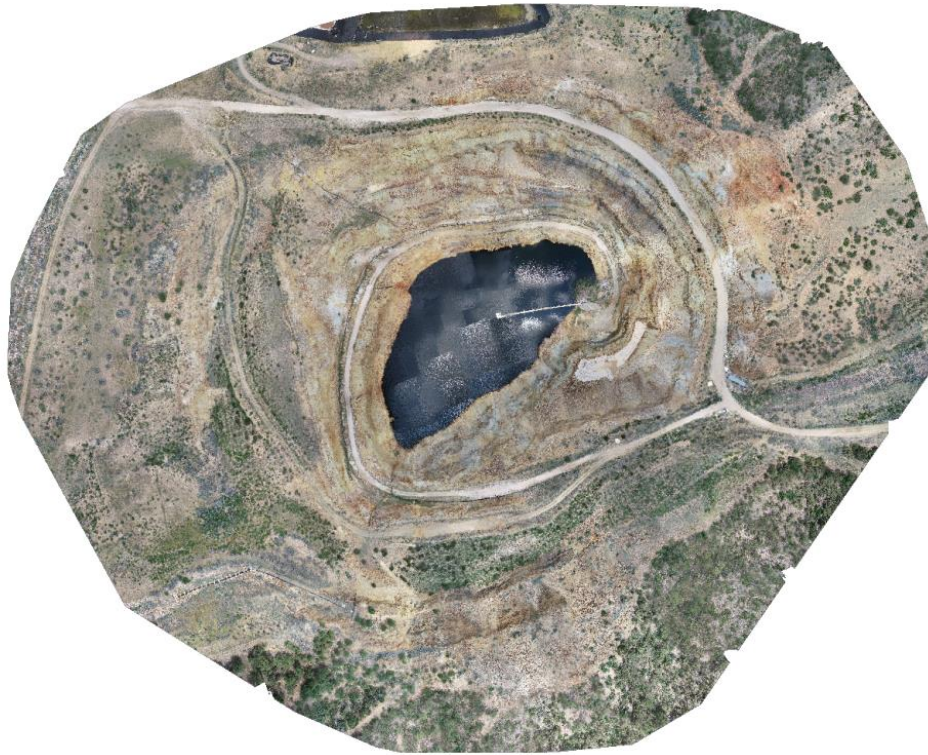
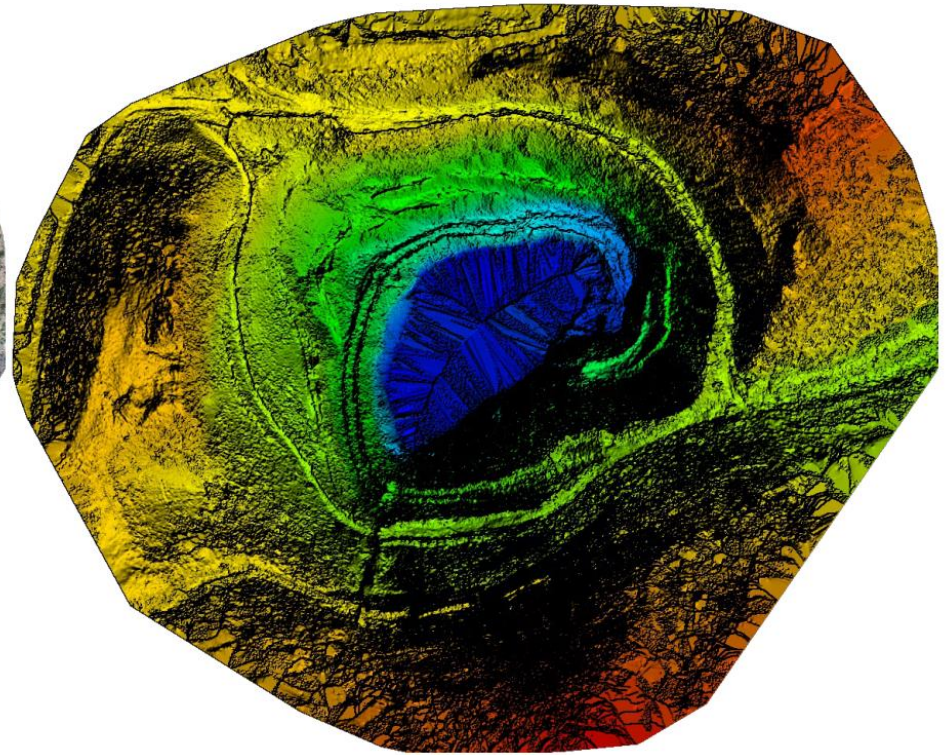
FIGURE 4

CNI processed the drone survey photos using Pix4D to achieve a high-density point cloud. Figure 4 shows the drone photo orthomosaic and the corresponding sparse Digital Surface Model (DSM). The drone survey and processed point cloud specifications are presented in Table 3. A full suite of GPS survey points was not available during photogrammetric processing. These will be delivered at a later date when a surveyor is on site. The locational accuracy with the existing pit control points is sufficient for the 2D analysis. For future use in a comparative point cloud analysis with a future drone flight, the drone data will be reprocessed when the survey points are available.

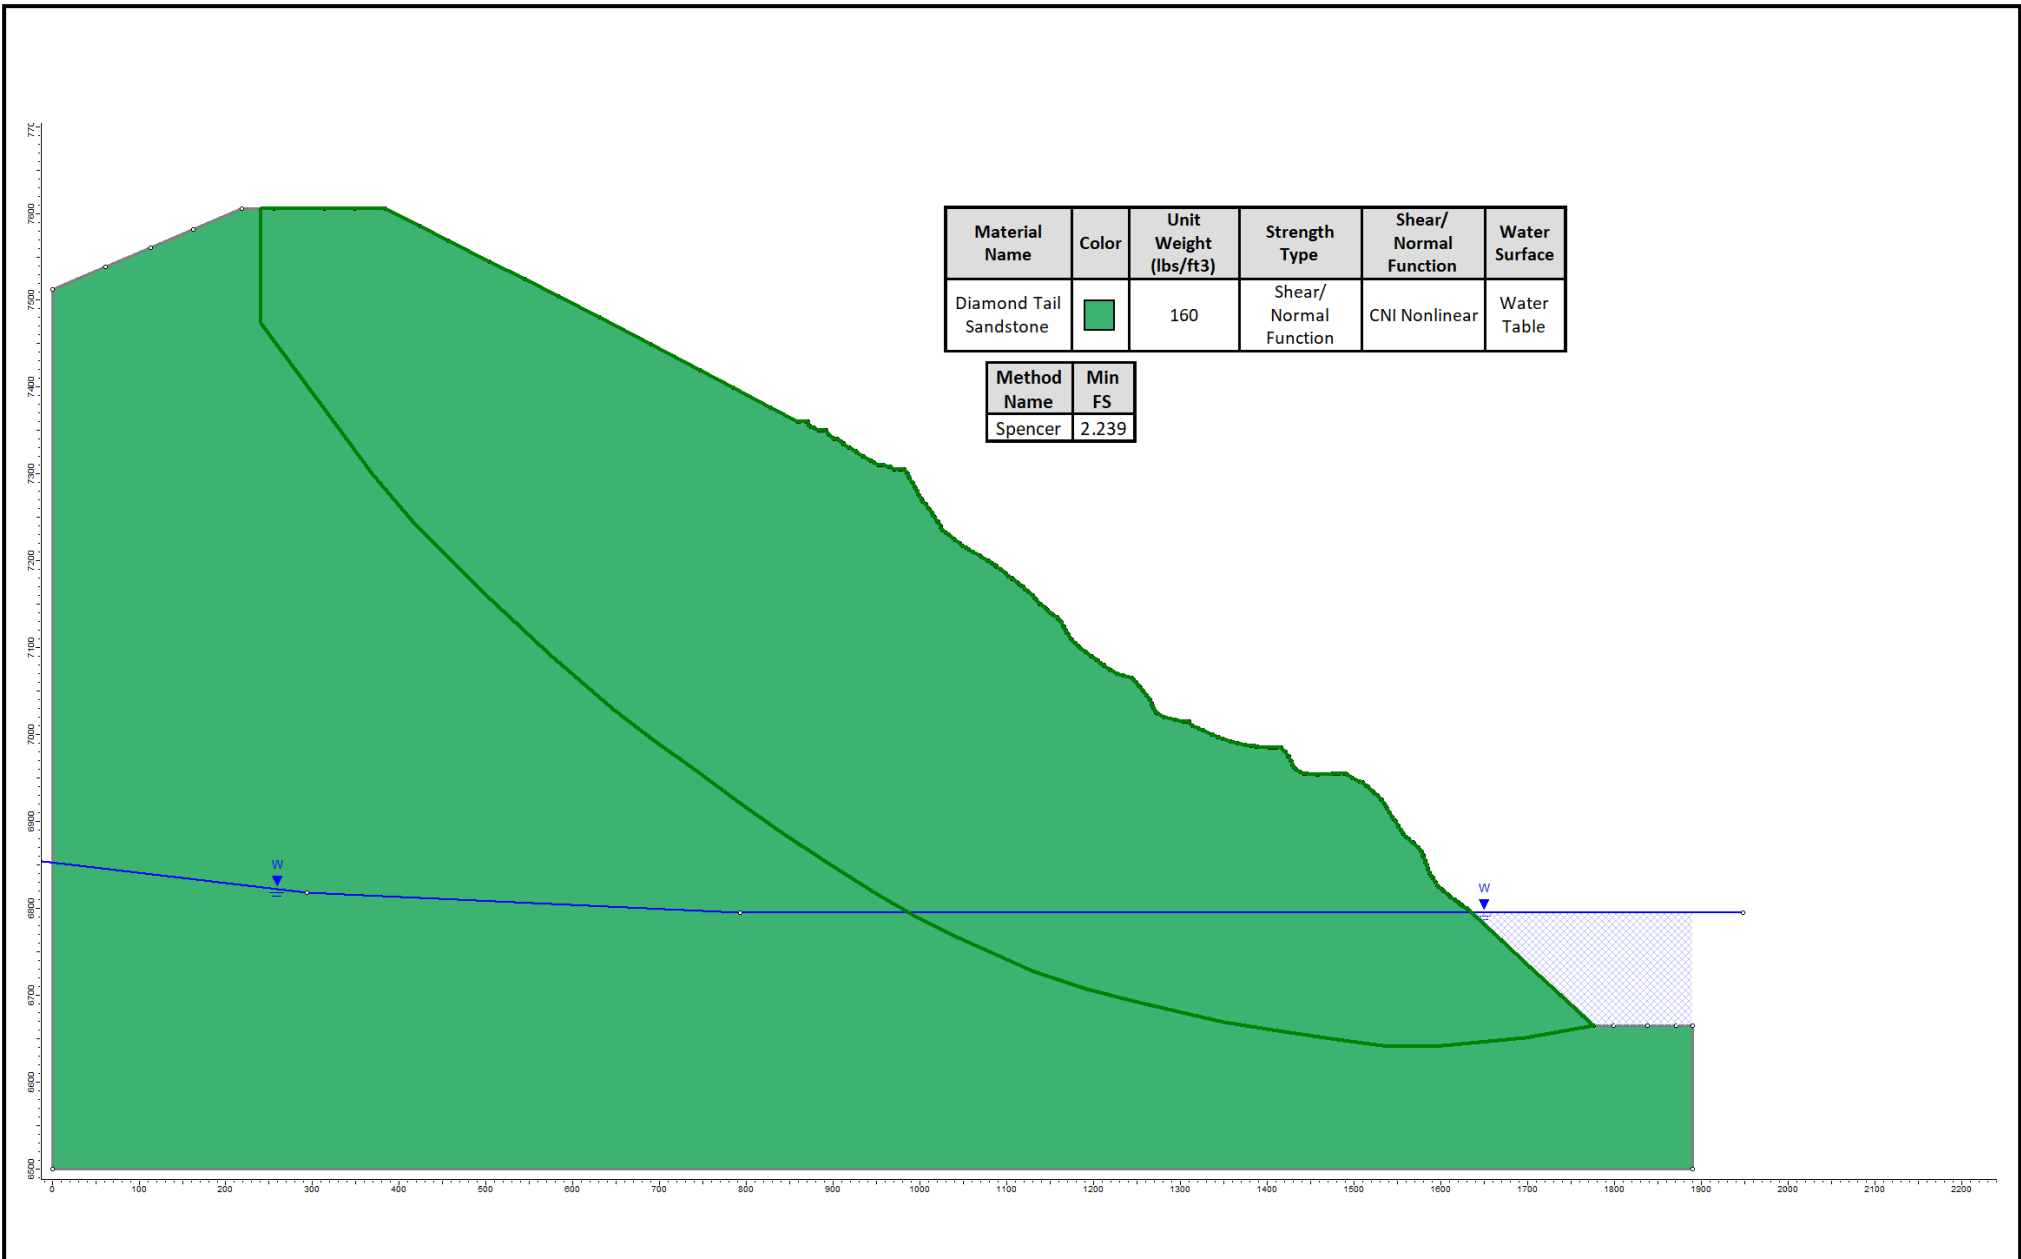
| SCALE | N.T.S | FIGURE 5 |

The limit equilibrium analysis results for cross sections CHMRP – South Wall and CHMRP – East Wall are shown in Table 5. Sections for the South wall are shown in Figures 5 and 6. Figures 7 and 8 show the East wall cases. For both cross sections, in both the static case and the case with a seismic load, the factor of safety (FOS) is shown to be 2.0 or greater. Based on the factor of safety values, no slope instability is expected. The results are consistent with the expectations for this site given the strong rock, lack of unfavorable structure sets, and low hydrologic surface elevation. The observed long-term performance of the pit walls is also

| Cross Section Title | Water Surface | Static FOS | Seismic Hz Load 0.065g |
|---|---|---|---|
| CHMRP – South Wall | Water Table | 2.2 (Fig. 5) | 2.0 (Fig. 6) |

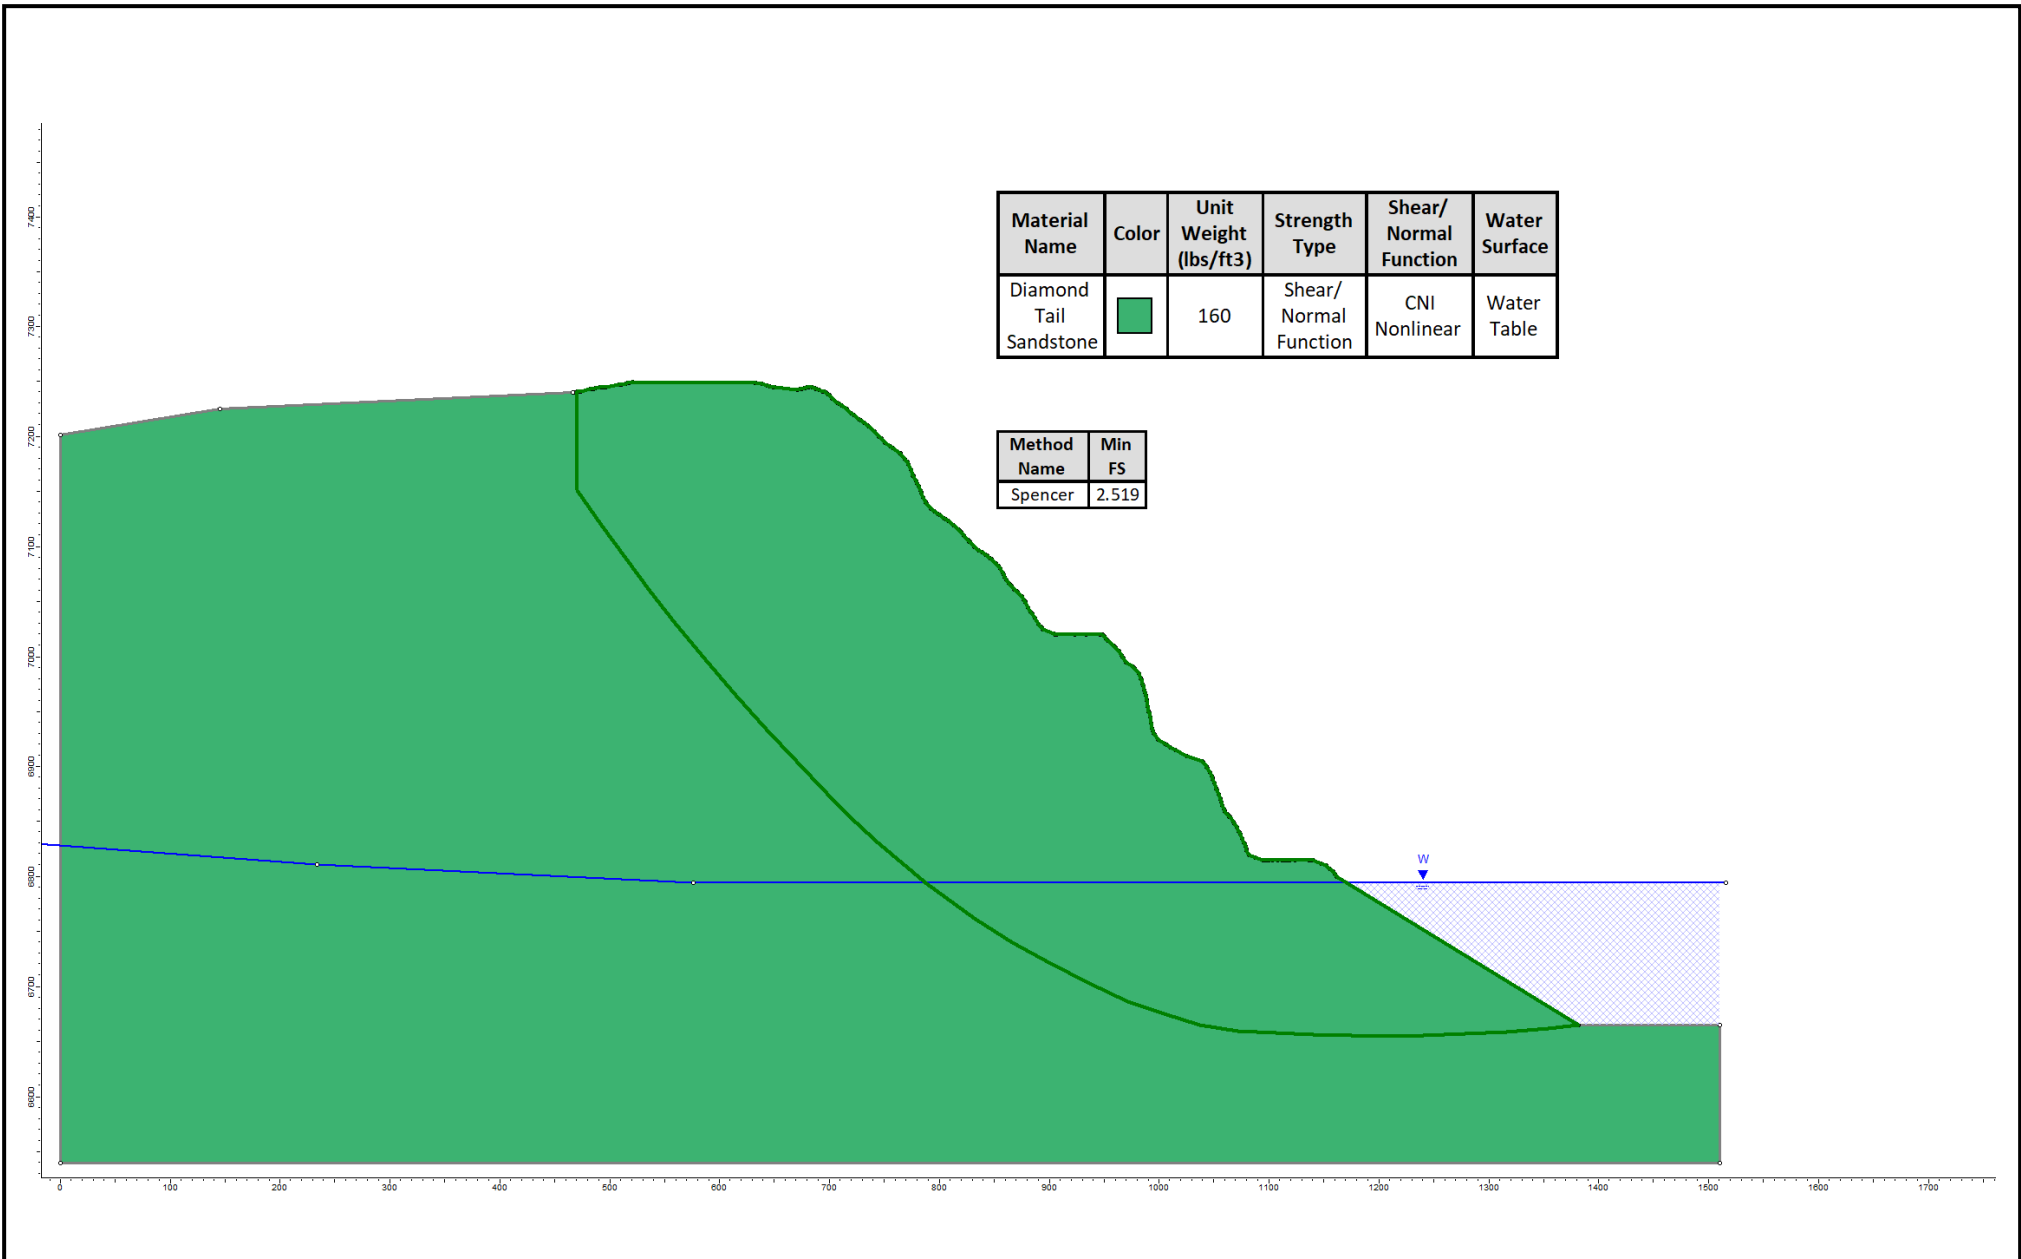
FIGURE 7

| Cross Section Title | Water Surface | Static FOS | Seismic Hz Load 0.065g |
|---|---|---|---|
| CHMRP – East Wall | Water Table | 2.5 (Fig. 7) | 2.3 (Fig. 8) |
