PERMIT UPDATE:

**Emma Pit Pre-permitting Inspection
Tyrone Mine (GR010RE) Revision 21-1**

November 20, 2023

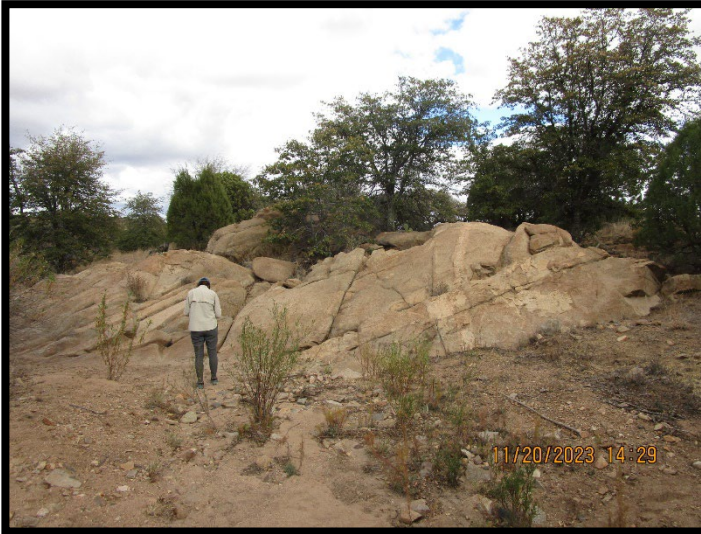
Figure 1. Igneous bedrock outcrop (photo by Kevin Myers ("KM"))

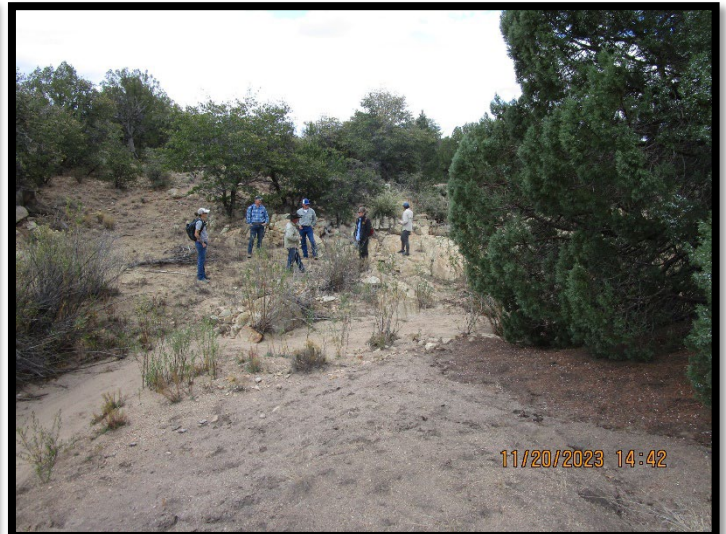
Figure 2. Area of first mapped spring (photo by KM)

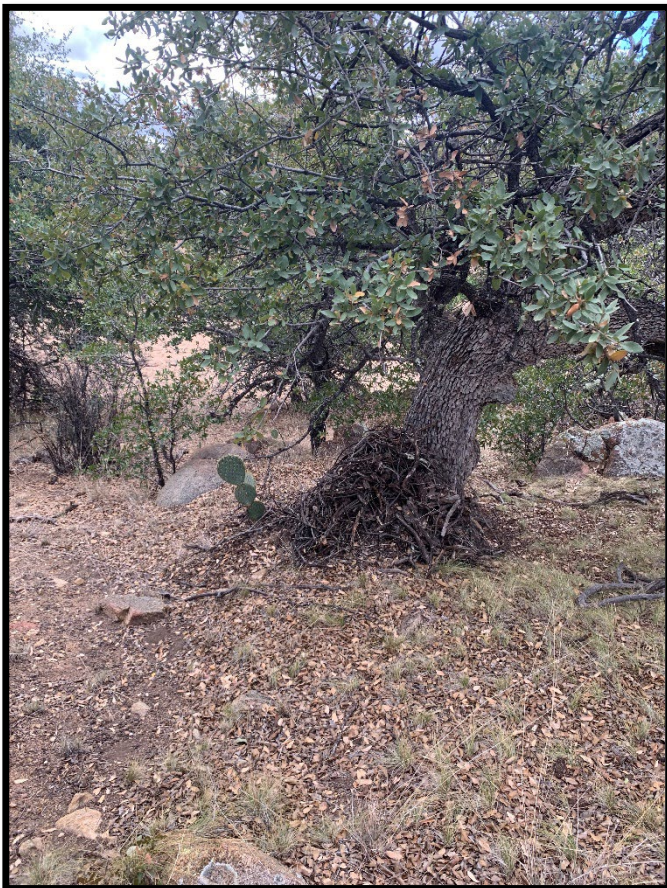
Figure 3. Debris against oak from flow during storm events

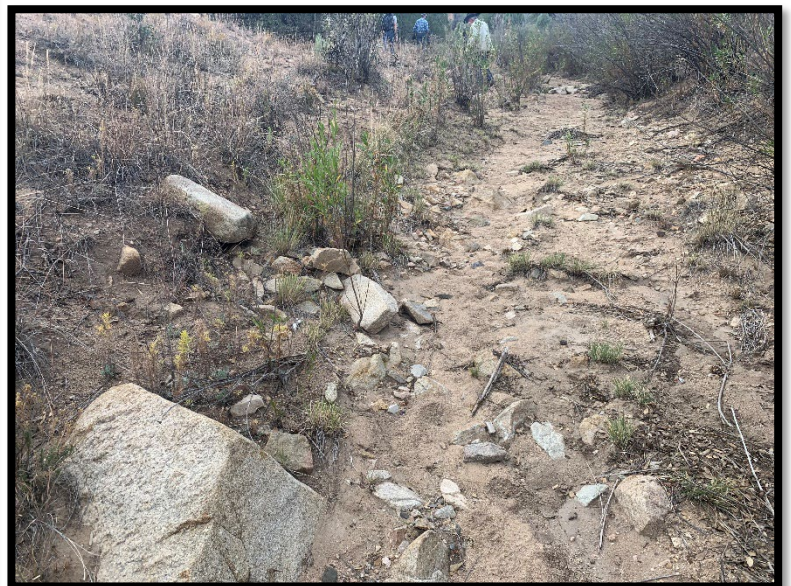
Figure 4. mulefat and browsed vegetation along Cherry Creek

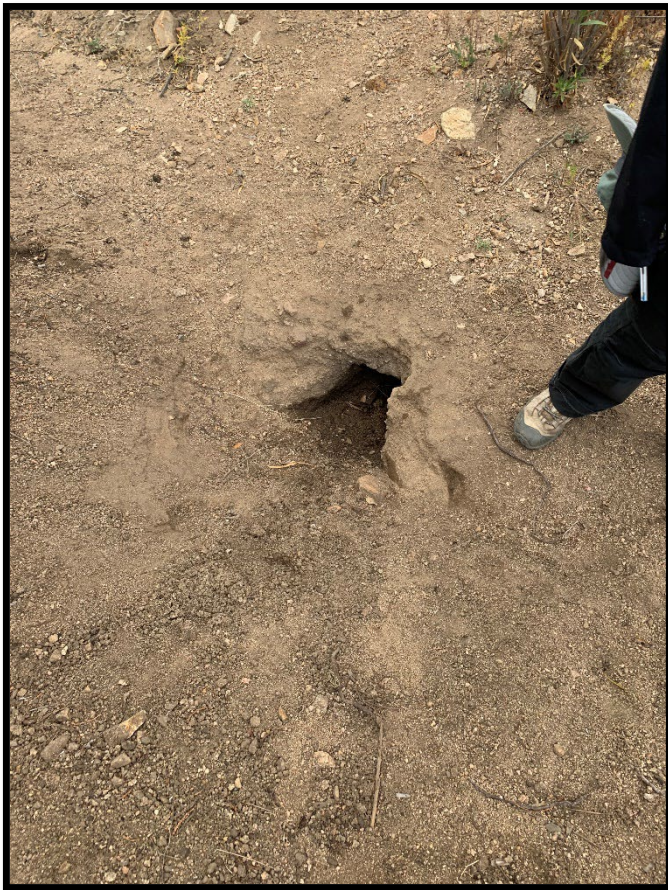
Southwest of the western spring (labeled *Exposed Ground Water* on the attached map) MMD discovered an approximately six (6) inch deep hole that appeared to have been created by a burrowing animal, exposing ground water (Figure 5). The soil was not wet on the surface in this location. As the inspectors walked west from this location, MMD found cottonwood trees and an increased number of green herbaceous plant species growing along the bottom of Cherry Creek where finer grained soil was deposited (Figure 6). Figure 6 was taken at the point identified as *Wet Soil* on the attached map. Farther to the west, MMD found a longer stretch of Cherry Creek with wet soils at the surface, and, upon digging down approximately four (4) to six (6) inches in a couple of locations, found ground water (identified as *Shallow Ground Water* on map; see Figures 8 & 9). Along the base of the stream bank at this location, MMD observed moist soils (Figure 7). Mosses were also found growing on the surface in this general area (Figures 10 & 11).

Figure 5. Exposed ground water

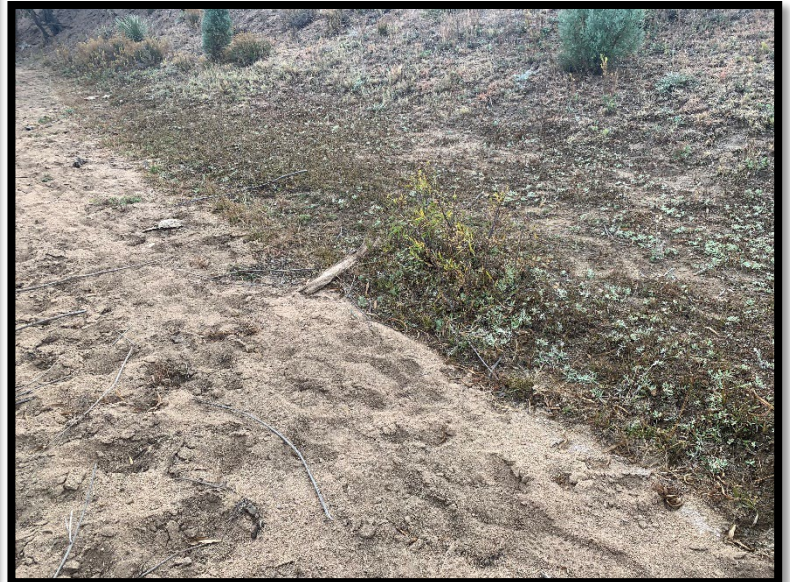
Figure 6. Increased vegetation on finer grained soils that were wet at the surface along Cherry Creek as you travel west

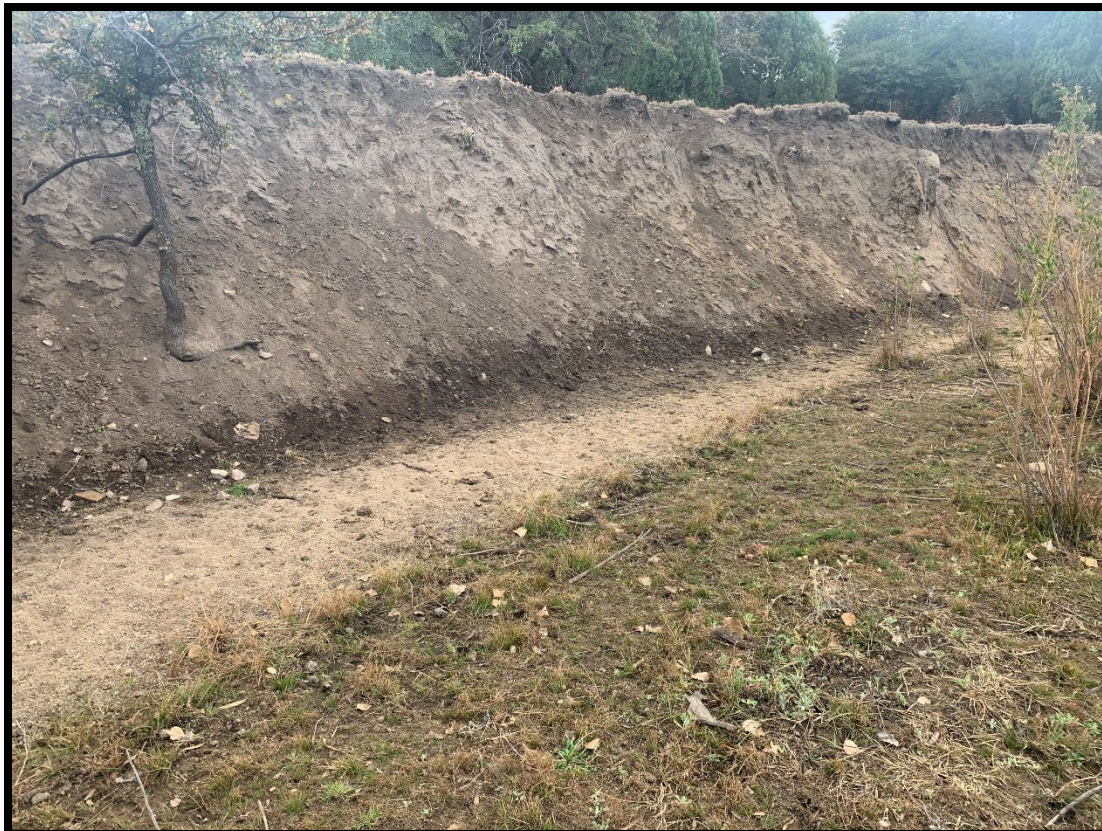
Figure 7. Wet soil along base of bank of Cherry Creek at western mapped spring

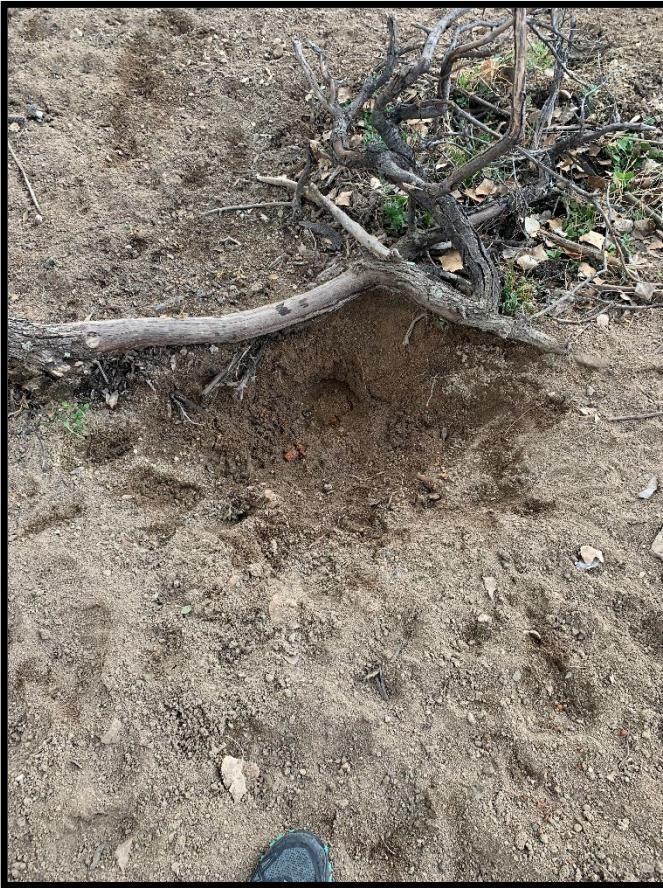
Figure 8. Ground water at *Shallow Ground Water* location

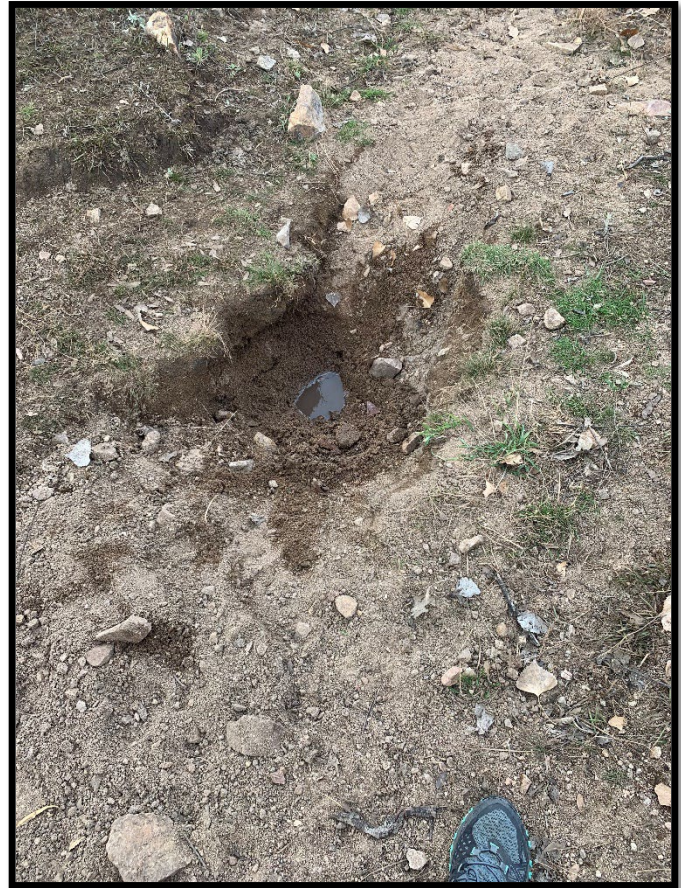
Figure 9. Ground water at *Shallow Ground Water* location

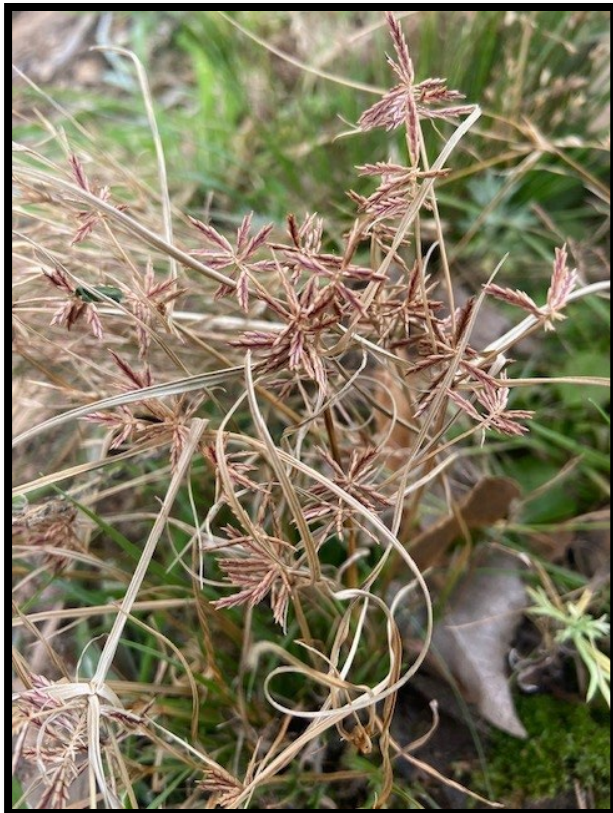
Figure 10. Moss growing at *Shallow Ground Water* (photo by Alaina Osimowicz (AO))

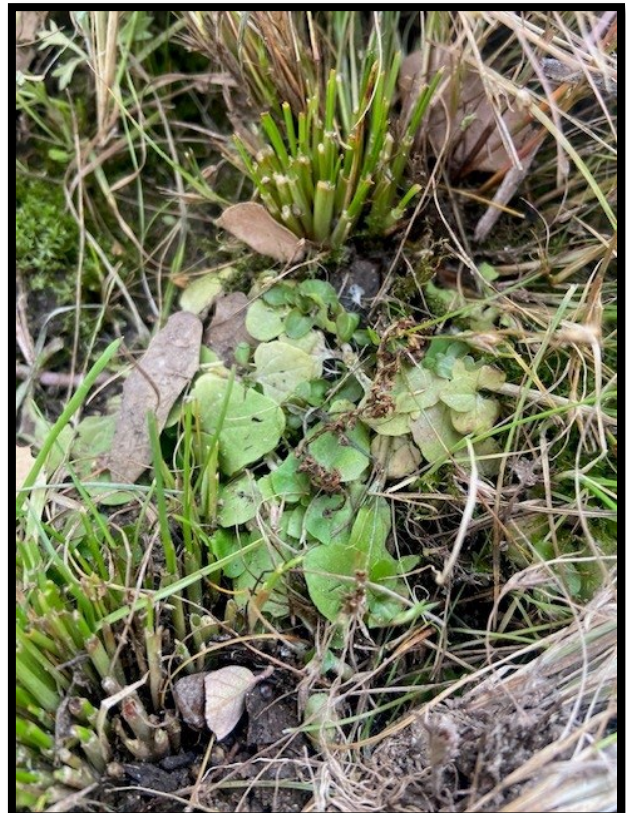
Figure 11. Browsed grass and moss growing at *Shallow Ground Water* (photo by AO)

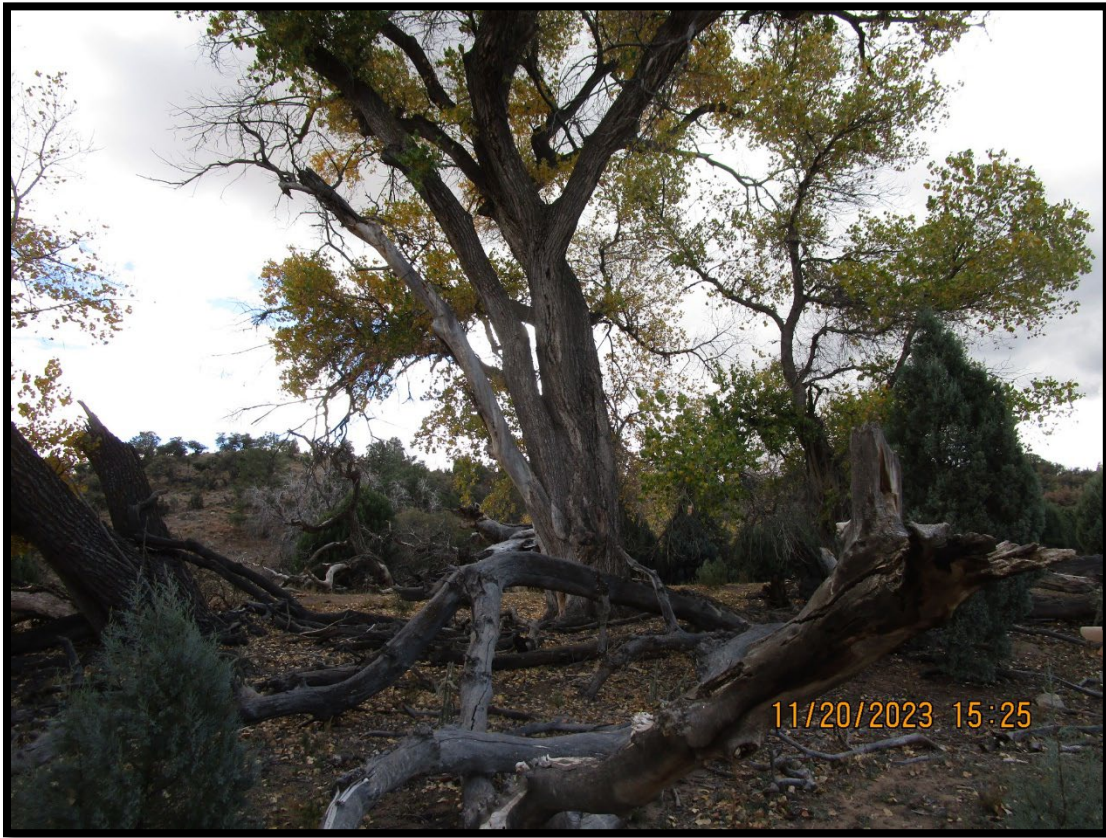
The final stop on this inspection was to walk to a large cottonwood tree west of the western spring (Figure 12). MMD did not dig down or observe moist surface soils at this location. MMD walked back east along Cherry Creek and left the site at approximately 3:45pm.

Figure 12. One of the cottonwoods along Cherry Creek, west of the western mapped spring (photo by KM)
