## **MINING INSPECTION REPORT**

Name of Operator: Frank Bain				
Name of Mine: Lordsburg Playa Exploration Project - Bain				
Address: 2425 Chof Trail				
Flagstaff, AZ 86005				
Permit Number: Lordsburg Playa Exploration: HI018EM				
Commodity: Lithium X SURFACE UNDERGROUND				
Date of Inspection: November 29, 2023				
Time of On-Site Inspection: approximately 1:00 PM to 3:00 PM				
Weather Conditions: Sunny 60's				
Purpose of Inspection: See 2 drill sites in response to operator's request for an inspection				
Lead Inspector: Kevin Myers, MMD				
<b>Present During Inspection:</b> Ron Kellermueller, <i>NMGF</i> ; David Mercer; <i>NMED-GWQB</i> ; Susan Styer, <i>NMED-SWQB</i> ; April Elliott, Josh Nemeth, <i>NMSLO</i> ; Martin Purdy, Ashley Taylor, <i>SFD-EMNRD;</i> Frank Bain, Operator.				
ENFORCEMENT ACTION TAKEN: None  NOTICE OF VIOLATION: # YES: NO:X  CESSATION ORDER: YES: NO:X				
Time: On-Site: 2 Permit Review: 1 Travel: 12 Report Writing: 3

TOTAL INSPECTION TIME: <u>18</u> HOURS				
NOTE: Inspection of two drilling sites and access roads at NW corner of the Lordsburg Playa

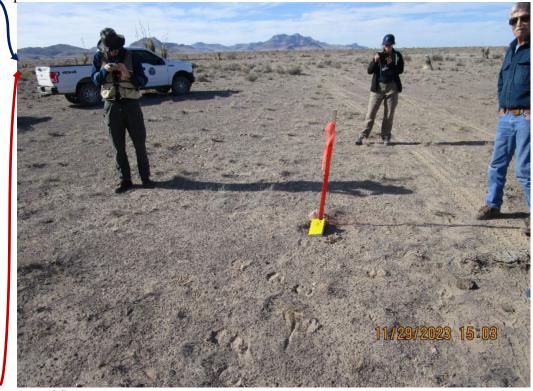
Top of First Terrace

Bottom of first terrace

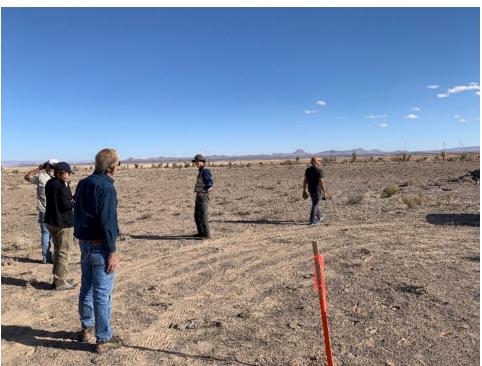
Proposed drilling location LB1 looking West on second terrace – paleo shoreline Lake Animas

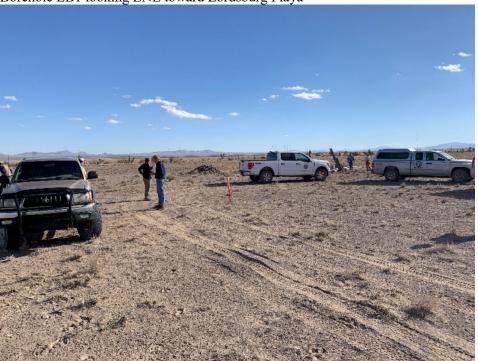
Borehole LB1 looking ENE toward Lordsburg Playa

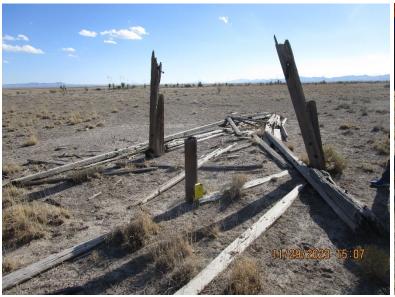
Borehole LB1 looking SE towards Lorsdburg Playa

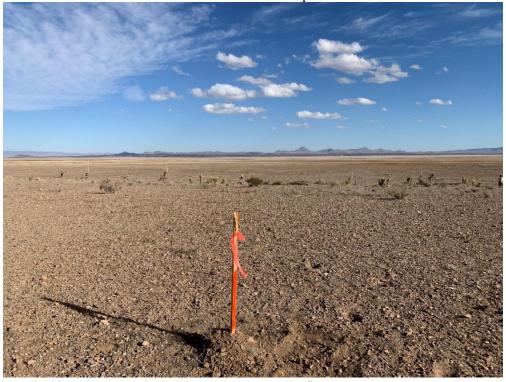
1402 at the LB1 first exploration borehole on second or third terrace. Drill sites proposed to be 300-500 feet deep. LB1 is nearest 6-inch steel well drilled in the 1950's to 150 feet (likely NMOSE No. A-675-POD1) and labeld as too salty for livestock. Frank said he had the steel plate cut off the top of well in 2017 by a rancher. Well is now open. Frank took the plate back to Arizona. Frank was unable to reach water because well has partially collapsed. He hoped to measure the water level and get a water sample. During 2023 inspection, light reflected down steel pipe shows well is not straight and white salts forming inside steel, likely evidence of corrosion. Around the well, wooden debris is possibly old windmill or livestock pen. Recent hoof marks show signs of livestock. Some grasses and shrubs such as creosote bush, tar bush, low woolly grass, broom snakeweed, soaptree yucca, cane cholla, fourwing saltbush, acacias and possibly alkali sacaton or other dropseed & grama grass. 1437 At second proposed borehole LB2, south of pipeline road. LB2 on first terrace higher (10-20 feet) than LB1. Drilling pad marked with orange rocks for 100 feet by 100 feet area. Drilling rig may be rubber tired or track mounted, likely from Stewart Brothers Drilling Company. Activity west of LB2 to reduce erosion (downcuttng) of arroyos that feed the playa. Rock dams & other BMPs used.

Near LB1 -Well A-675-POD1 as seen in 2023 after plate removed Well in 2017 before plate removal

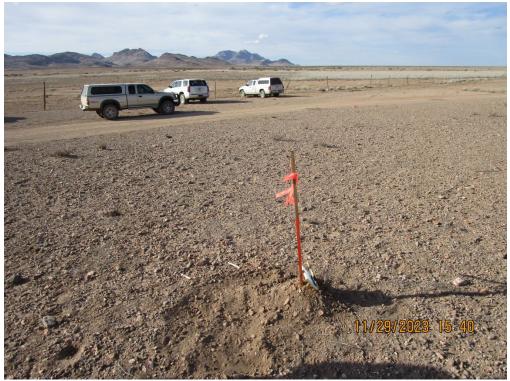
LB2 looking East toward Lordsburg Playa. LB2 on first terrace.
