**NEW MEXICO ABANDONED MINE LAND PROGRAM
COUNTY ROAD A-25 SUBSIDENCE
COLFAX COUNTY, NEW MEXICO
SITE CHARACTERIZATION AND MITIGATION RECOMMENDATIONS REPORT**

January 10, 2023

Project #: 01A-003-002

SUBMITTED BY: Trihydro Corporation

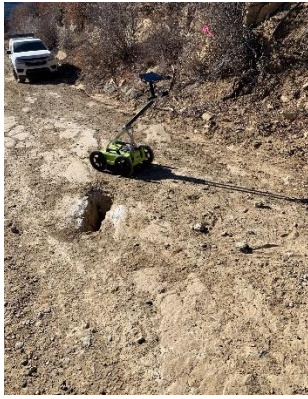
Site photo of the crack in the rocky area being scanned.

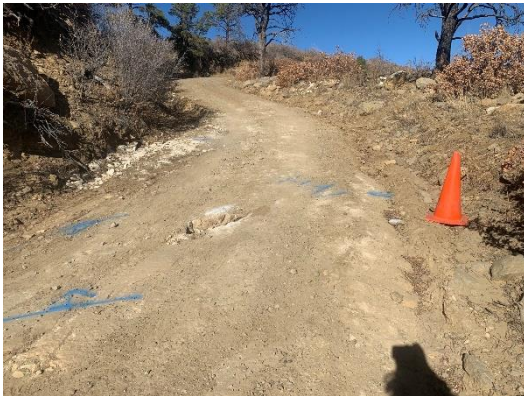
Closer photo of the crack and area of concern, in this photo you can see the blue lines indicating a similar reaction of right over the crack, possibly where the crack is continuing.

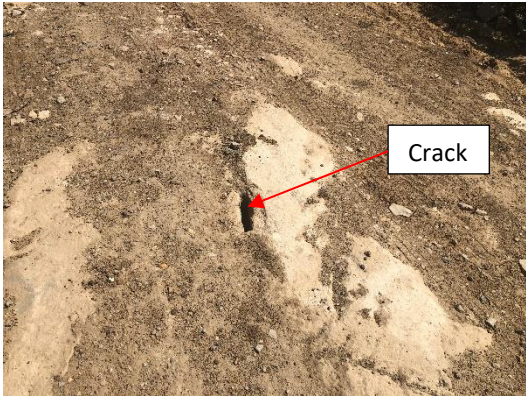
Photo of scan area. Photo displays crack discovered by client.

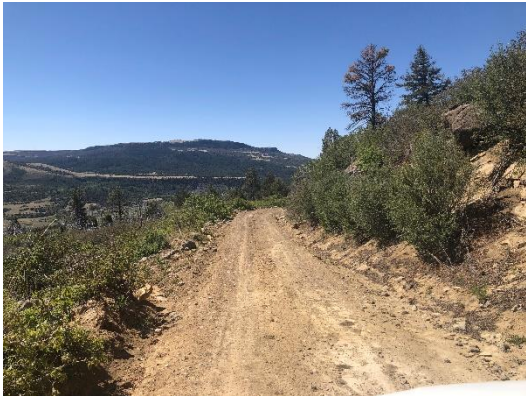
Photo of scan area. Section of road following second bend and containing crack discovered by client.

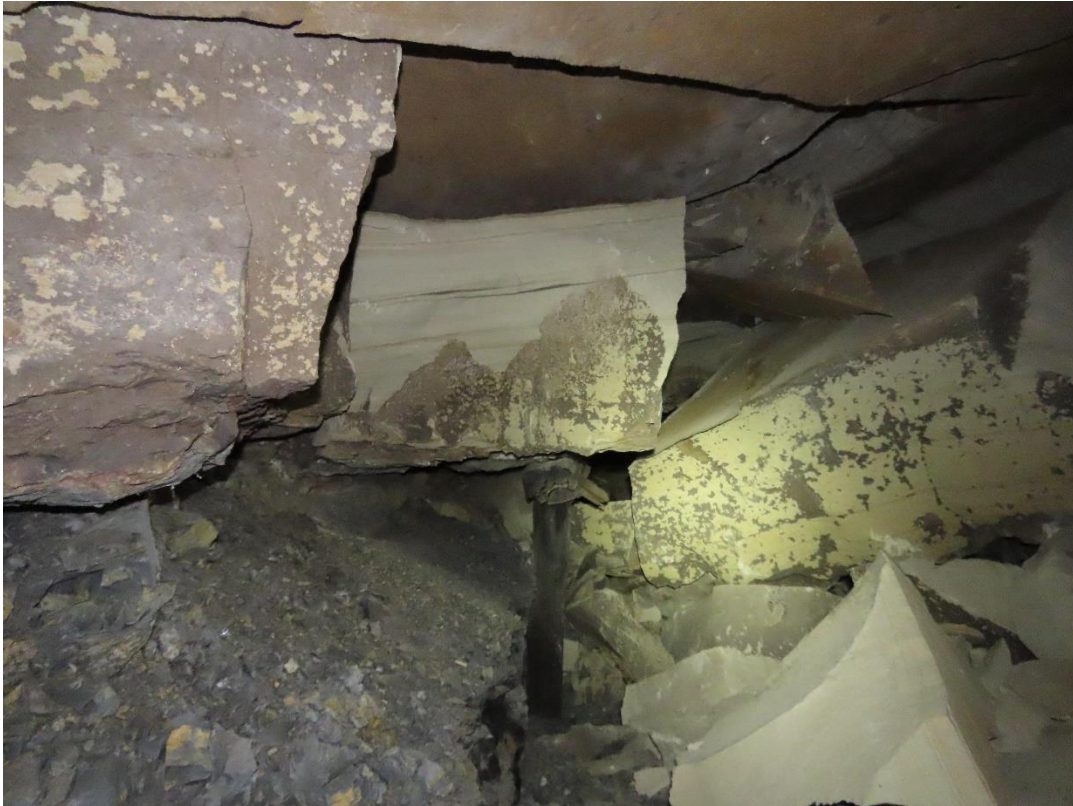
Yankee Adit 02: The dangerous section that prohibited passage. Note the large, rectangular white block balanced on a single old timber stull.

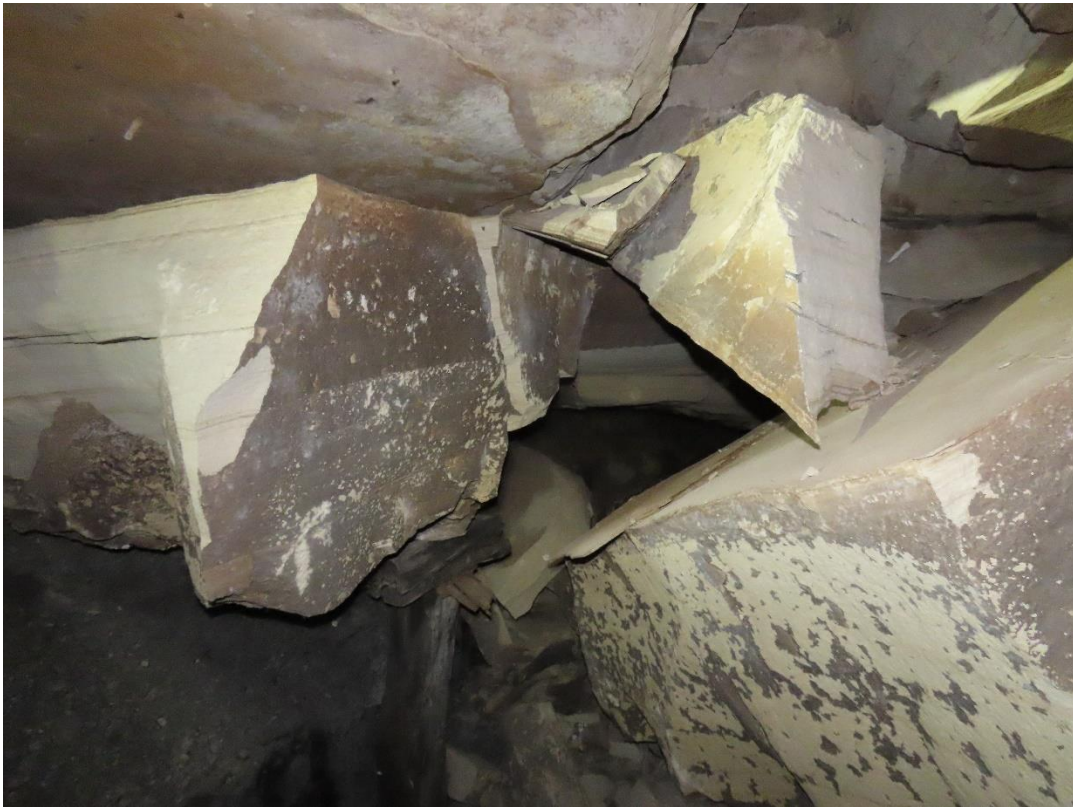
Yankee Adit 02: Another view of the dangerous blockage.

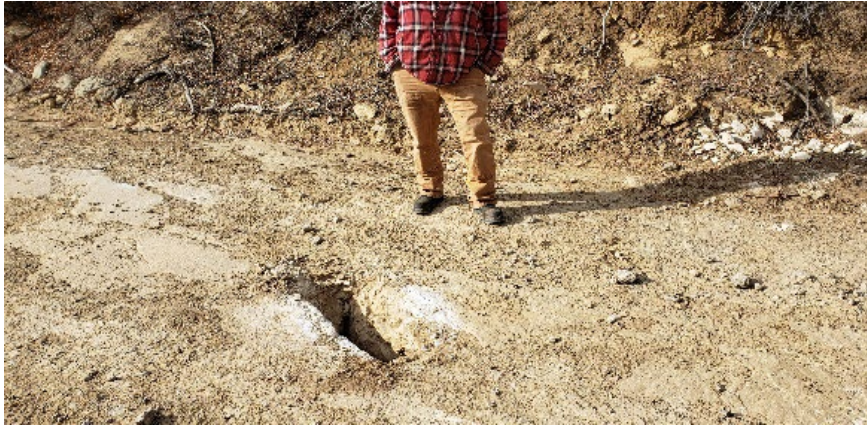
Photo 1. Subsidence feature found by Colfax County Road Department

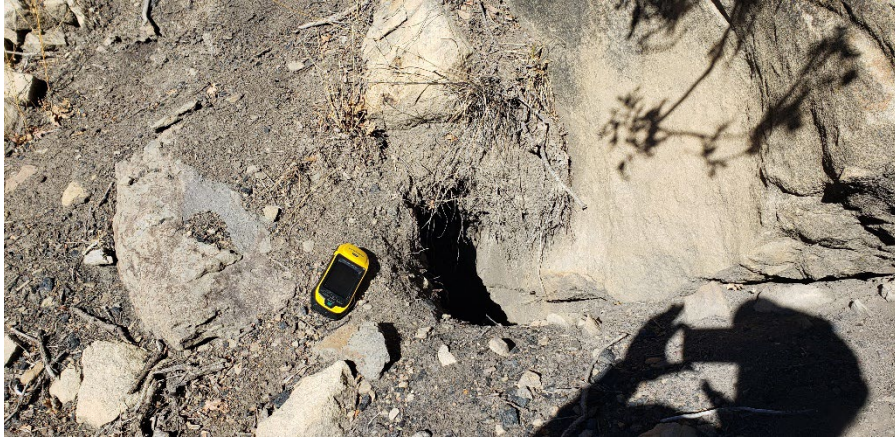
Photo 21. Adit A-2.

A second open adit was discovered approximately 1,200 ft further west of adit A-1. Adit A-2 measures approximately 1 ft by 2 ft and appears to be open to the mine workings. Several gob piles were noted along the access. Adit A-2 can be accessed from A-25 in the same manner as adit A-1. Much of the access to Adit A-2 is passable with moderate improvement except for a short section immediately west of adit A-1. Steep gob piles through that area may prove difficult to traverse with equipment without extensive improvement. Adits A-1 and A-2 can be found on Figures 2 and 3.

Trihydro recommends a bat-compatible culvert with a bat gate closure at the Turner-Urtado mine adits A-1 and A-2, and the Denton Mine adit A-3. This closure will provide an entrance for bats to continue to use the Turner-Urtado and Denton Mines as well as provide a landmark noting the existence of nearby underground mine workings. The proposed culvert with the bat closure consists of a 24 in. corrugated metal pipe (CMP) culvert and bate gate with a removable crossbar for further investigation and monitoring of the bat habitat. The vertical opening (VO-1) will be included in the over-excavation of the adit A-1 (Figure 3) opening. A separate closure is not proposed for VO-1.

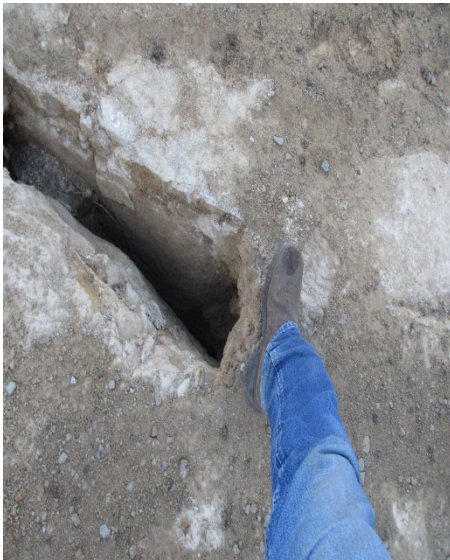
The subsidence features were measured once again on December 3rd, 2021, as part of the surface and subsurface site investigation. This measurement determined that the two smaller features had grown only slightly in size. A fourth feature was also noted during the investigation and was similar in size to the two smaller features already mapped. The largest feature had grown significantly, most likely from the freeze-thaw cycle as there had been only minimal precipitation at the site. The largest feature measured approximately 28 in. by 11 in. with a measured depth of 15 ft.

Photo 23. Largest subsidence feature in County Road A-25; February 16, 2022.

Trihydro recommends the drilling and grouting option. This option involves drilling the area immediately adjacent to the A-25 subsidence features and areas where related mine workings may impact the road, and injecting grout into the voids beneath and adjacent to the A-25 alignment. The grouting work may take place concurrently with the drilling investigation. The goal of drilling and grouting the A-25 subsidence features is to map the voids under and near the road alignment and to fill those voids with grout to stop additional subsidence in the area and stabilize the road. The drill holes will be spaced every 30 ft along the A-25 alignment with an increased drilling density of every 20 ft around the existing subsidence features (Figure 6). Based on room and pillar findings in the field, some adjustments to the hole locations may be made to encounter more voids. The proposed drilling program includes 31 holes. Based on projections of the mined coal seam, the proposed drilling program includes drilling up to expected mine floor depths of 100 ft. This drilling plan includes approximately 1,938 ft of drilling. The mined coal seam outcrops very close to the southern edge of the surface investigation area and holes drilled on this end will encounter the mined coal seam at very shallow depths.

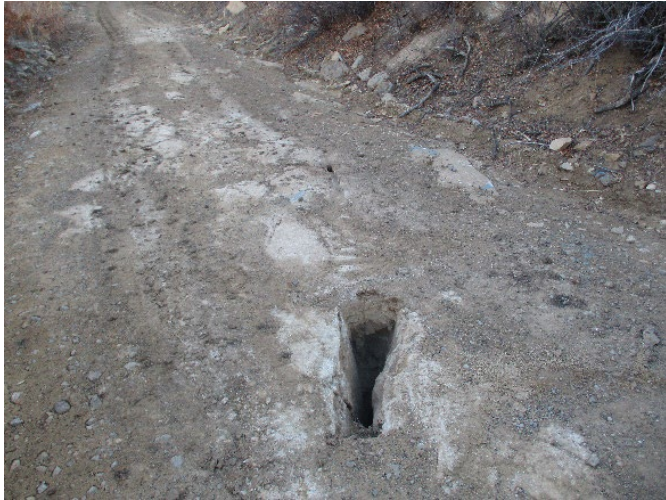
Photo 25. Subsidence features in County Road A-25; February 16, 2022.
