# **MINING INSPECTION REPORT**

**Iron Duke Mine**

**Permit #: OT006MN**

**Date of Inspection: March 21, 2024**

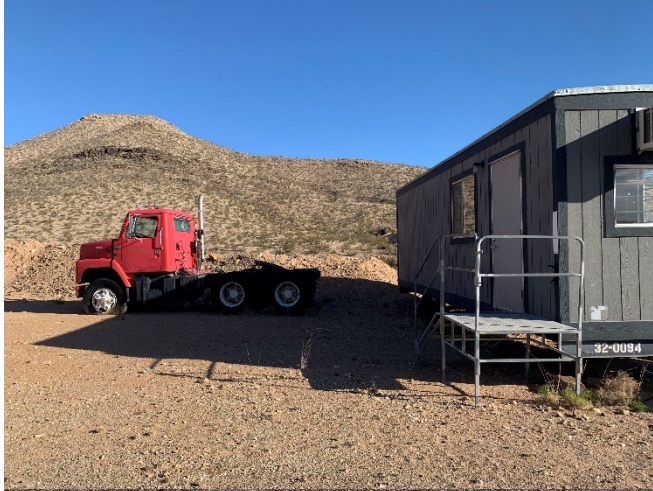
The front gate has a small trailer, which was vandalized as well as a truck in disrepair. Near the truck was what appeared to be fresh dirt on a stockpile.

**FIGURE 1 TRAILER AND TRUCK**

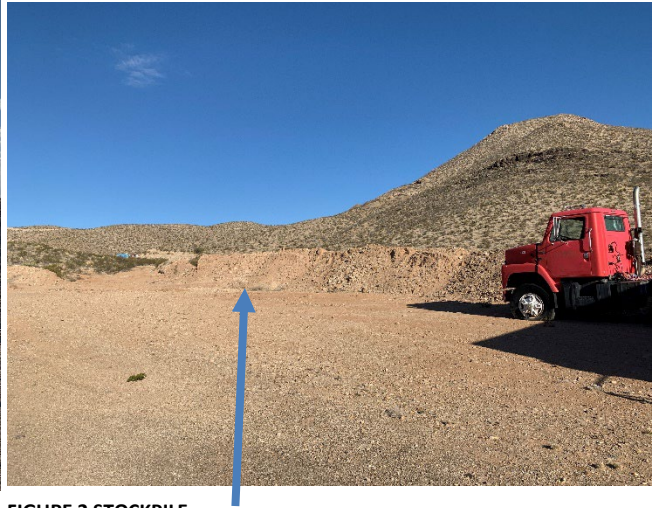
**FIGURE 2 STOCKPILE**

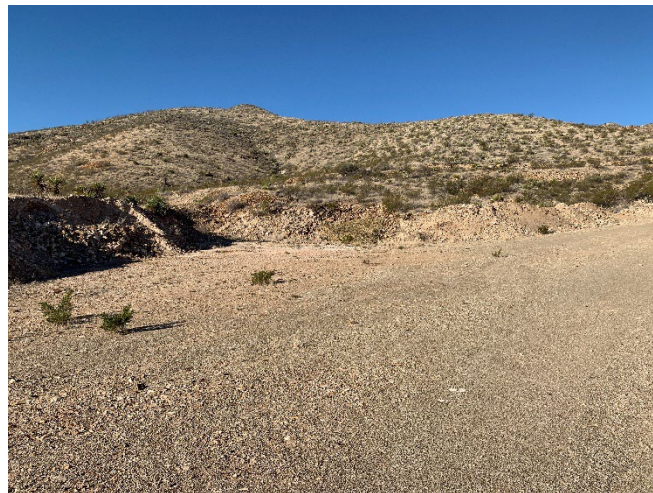
**FIGURE 3 STOCKPILE AT ENTRANCE ON THE LEFT/SOUTH SIDE**

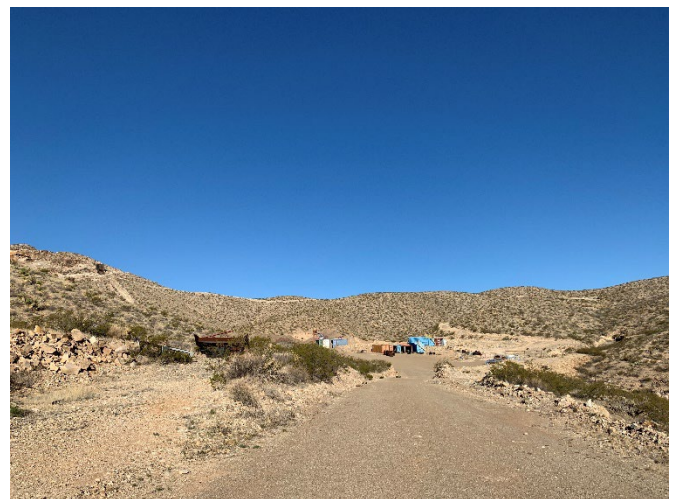
**FIGURE 4 LOOKING INTO PROCESSING AREA (WEST)**

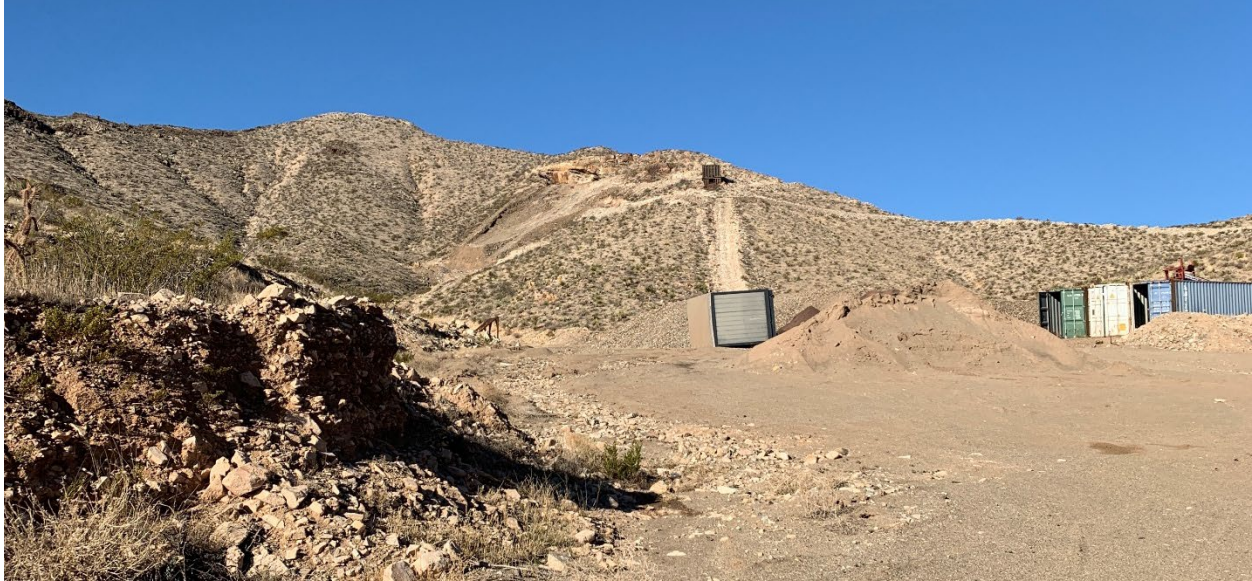
**FIGURE 1 LOOKING UP TO THE HIGHWALL/MINING AREA (WEST)**

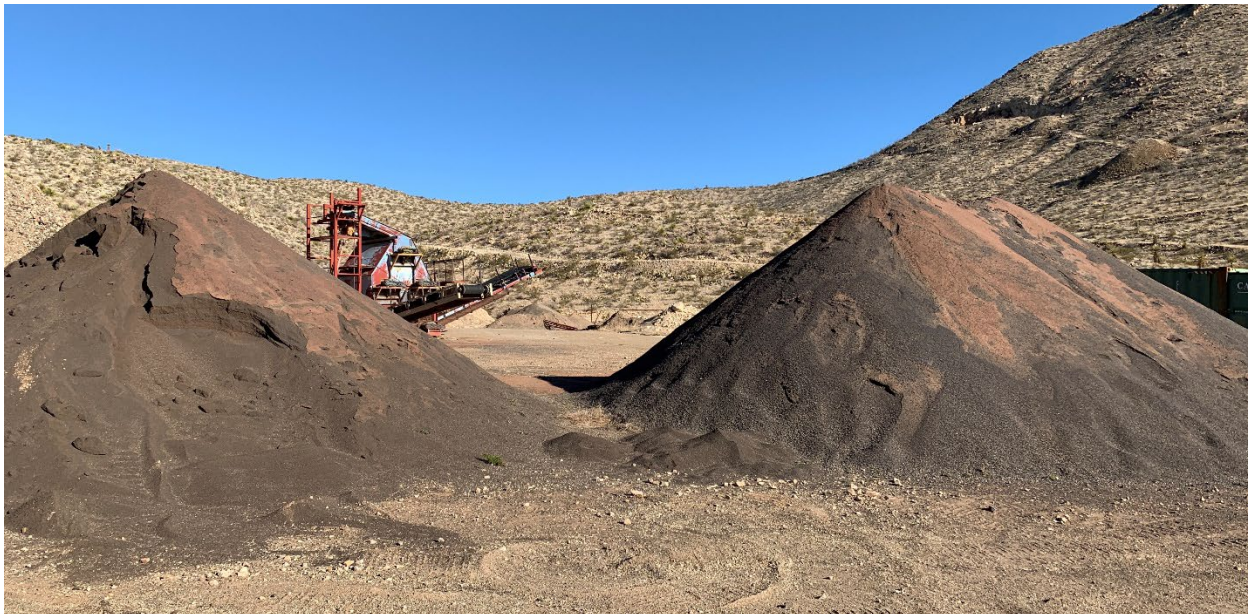
**FIGURE 2 STOCK PILES IN MINE PROCESSING AREA**

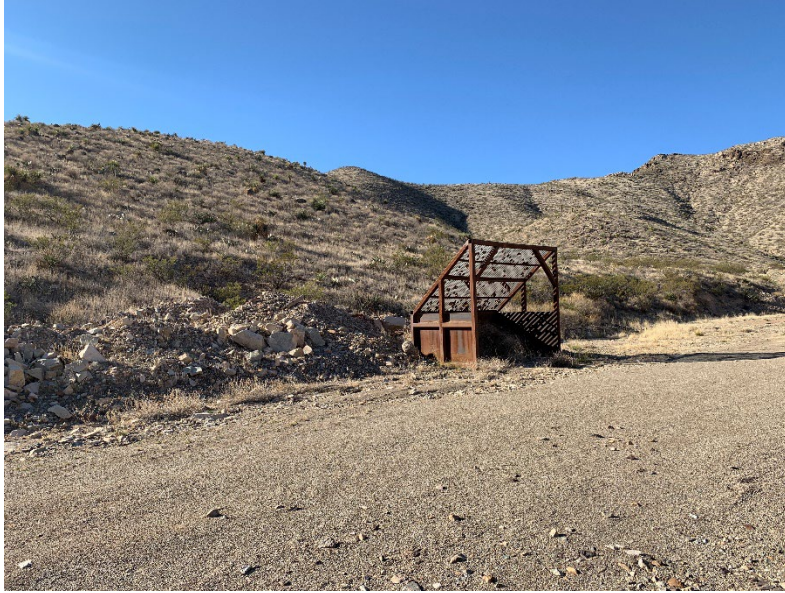
**FIGURE 3 SIEVE IN THE MINE PROCESSING AREA**

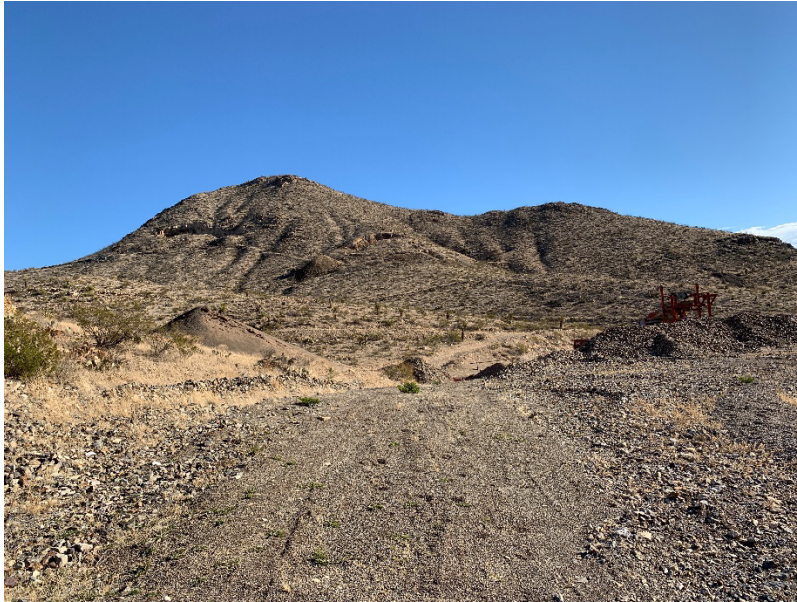
**FIGURE 4 LOOKING EAST DOWN THE ROAD**

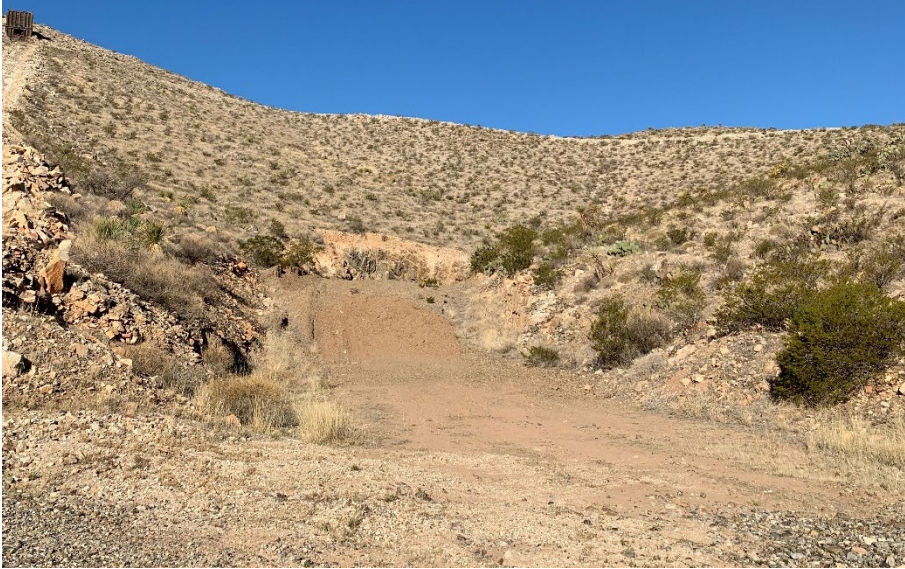
**FIGURE 5 LOWER DISTURBED EXPLORATION AREA**

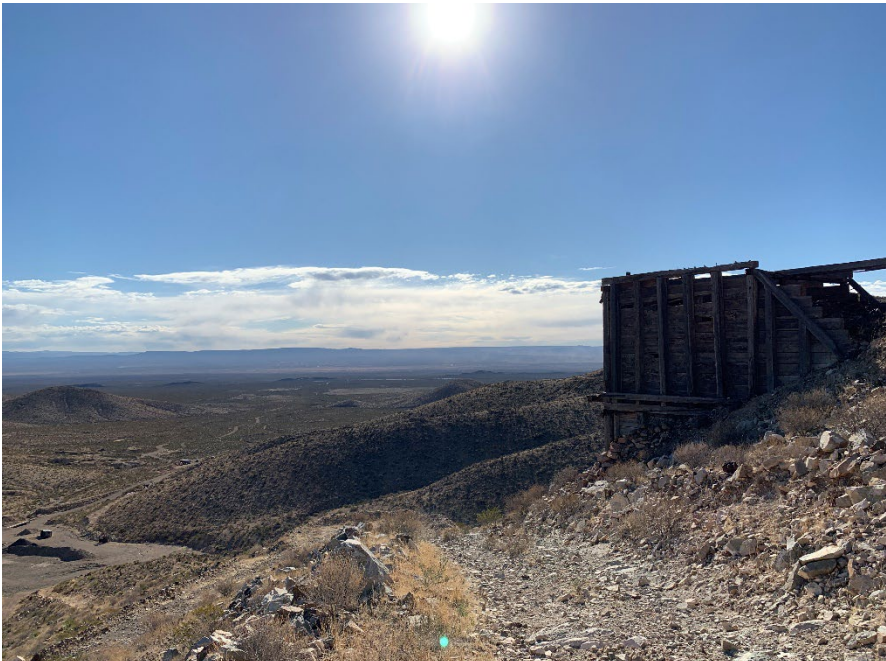
**FIGURE 6 LOOKING DOWN THE ROAD FROM HISTORIC MINING FEATURE (EAST)**

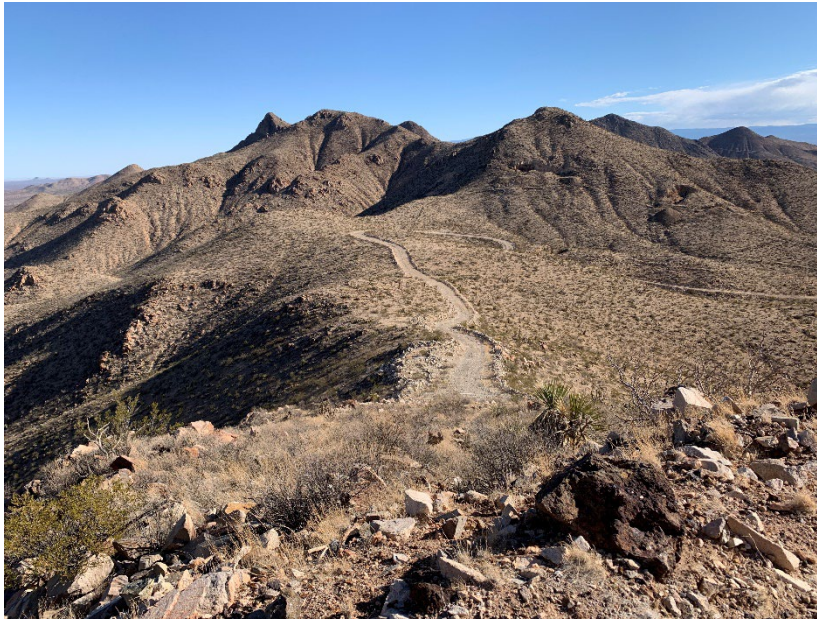
**FIGURE 7 LOOKING DOWN AT THE LONGER ROAD (NNE DIRECTION)**

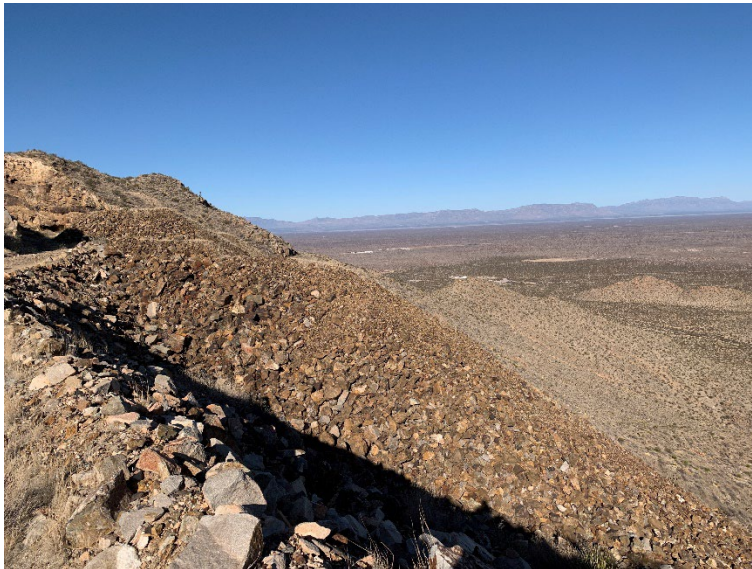
**FIGURE 8 LOOK NORTH WEST OFF THE ROAD**

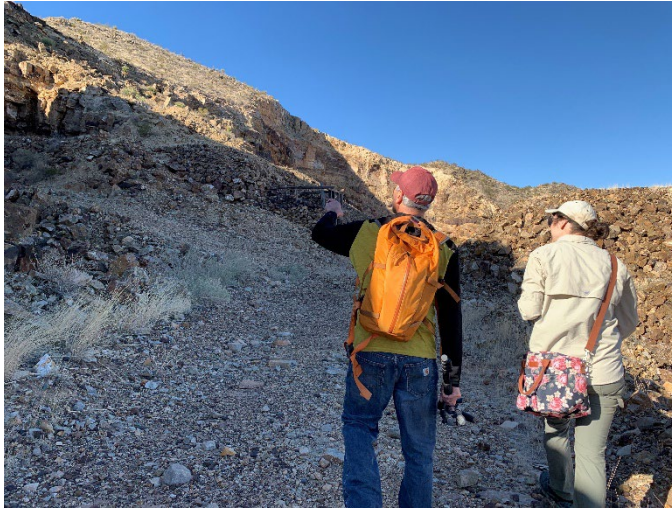
**FIGURE 9 LOOKING AT BACKSIDE OF HIGHWALL CUT**

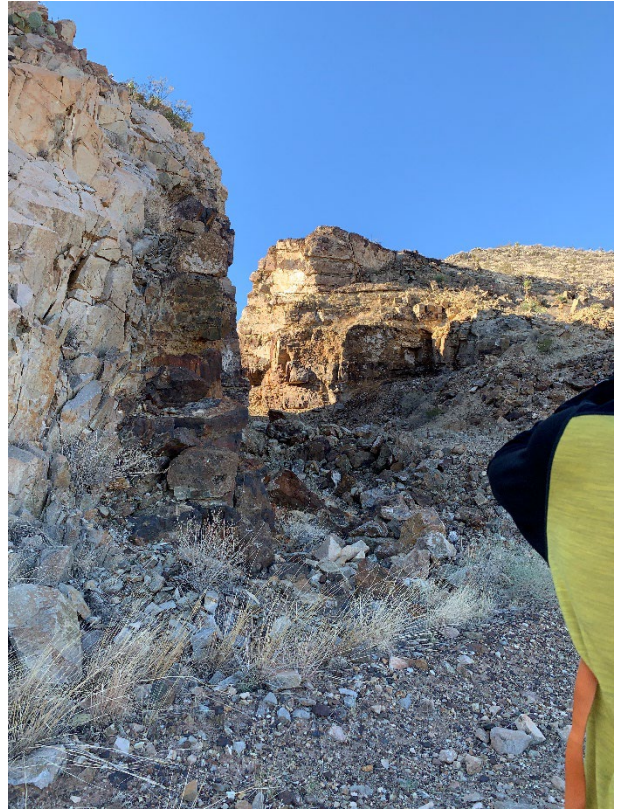
**FIGURE 10 LOOKING AT BACKSIDE OF HIGHWALL CUT**

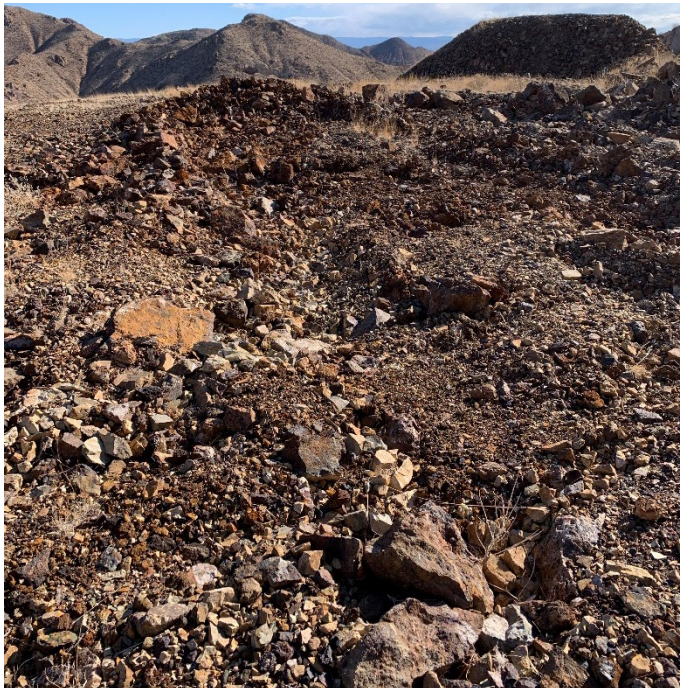
**FIGURE 11 ROCKS APPEARING TO HAVE BEEN MOVED WITH MACHINES**

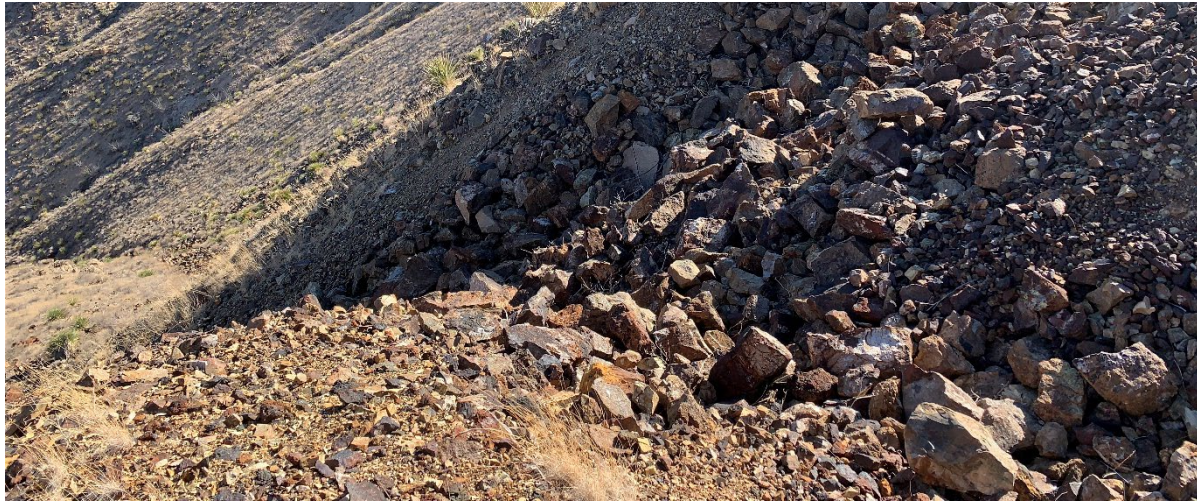
**FIGURE 12 DRAINAGE OFF THE ROAD**

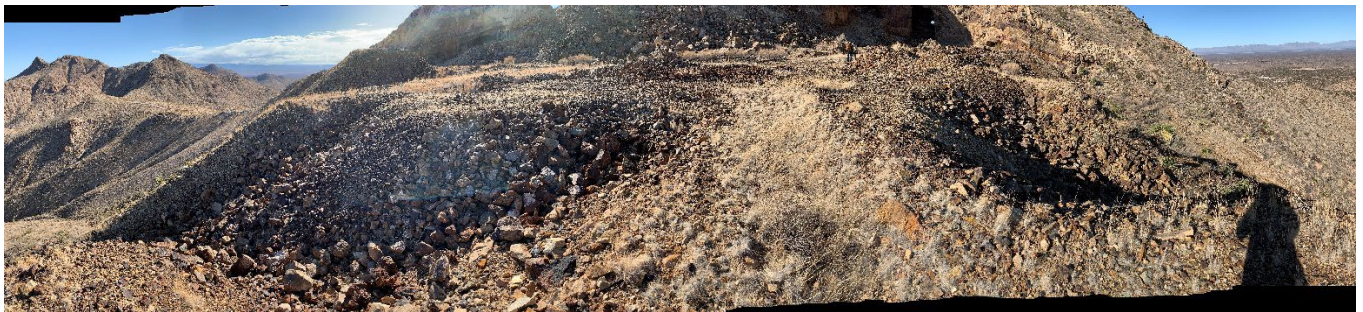
**FIGURE 13 PANORAMA OF DISTURBANCE LOOKING SOUTH**

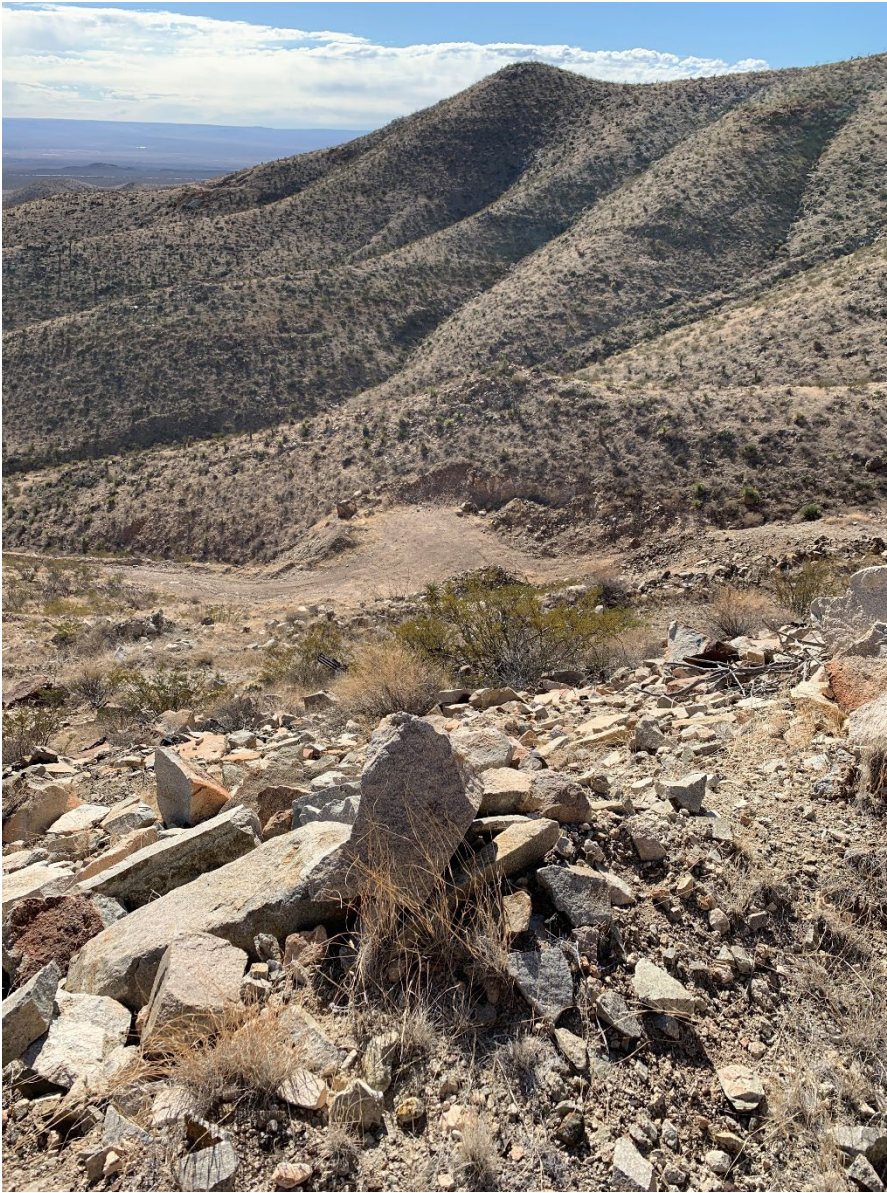
This area addresses un-reclaimed road and eagles nest areas. While there was some vegetation growing in the upper stock pile, some areas appear more recently disturbed. There was slight berming visible on the northern side of the upper stock pile on one side but not related to the berming that should be closing the road at the bottom to prevent access.

**FIGURE 14 LOOKNG DUE EAST TO THE ROAD**

Re-assess NOV/road issue. Request updated Permit to address FA/Disturbance.

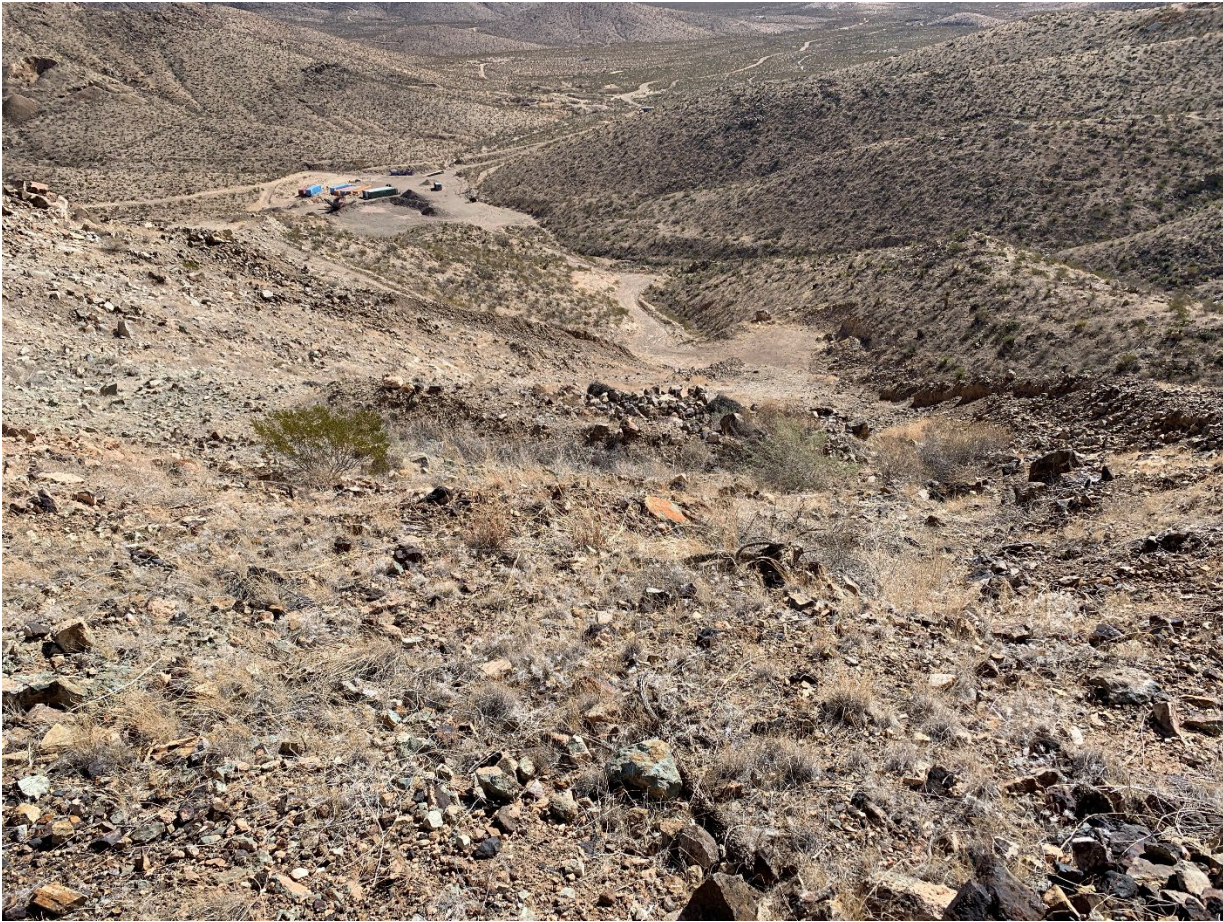
**FIGURE 15 LOOKING EAST DOWN THE ROAD.**

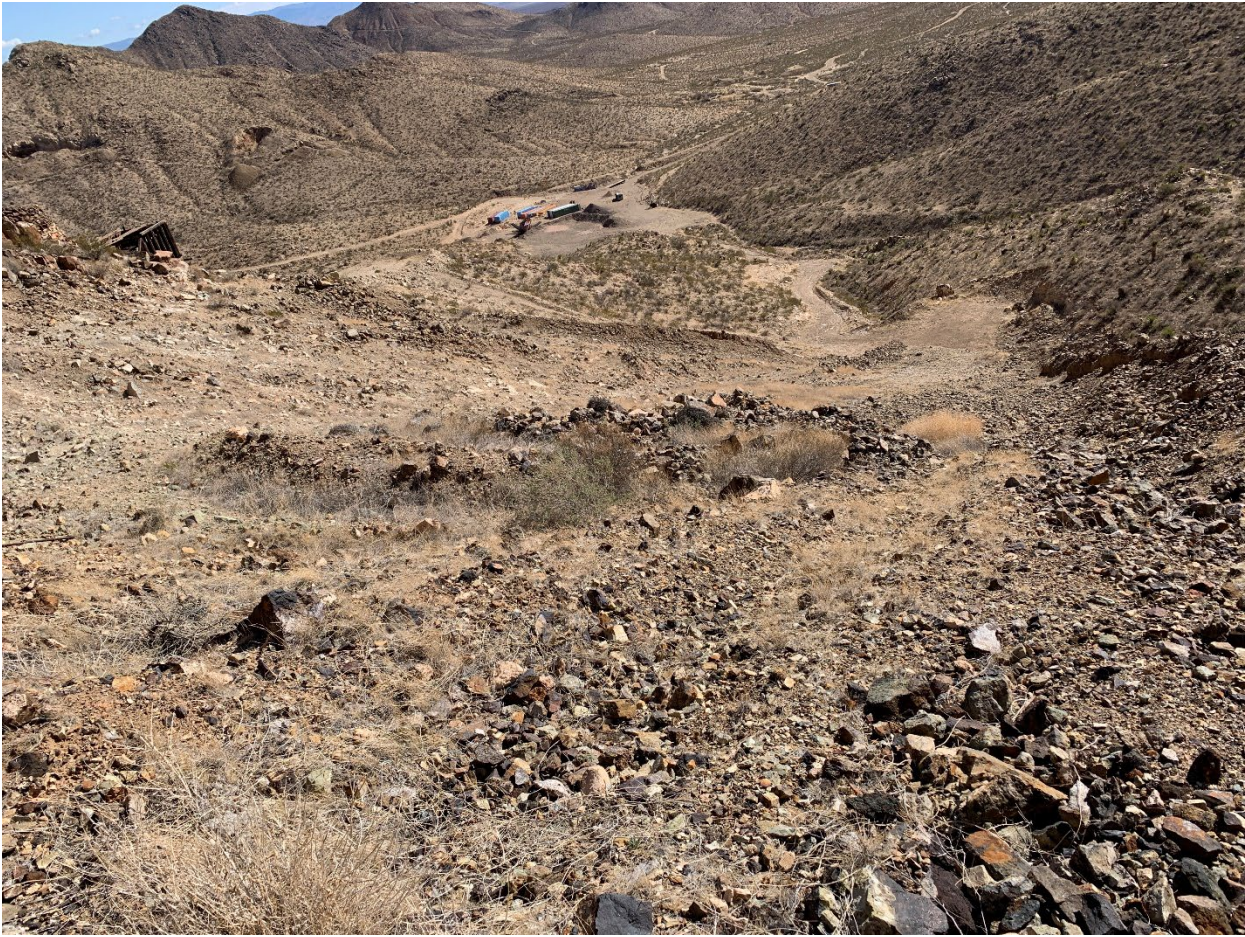
**FIGURE 16 ROAD LOOKING NE**

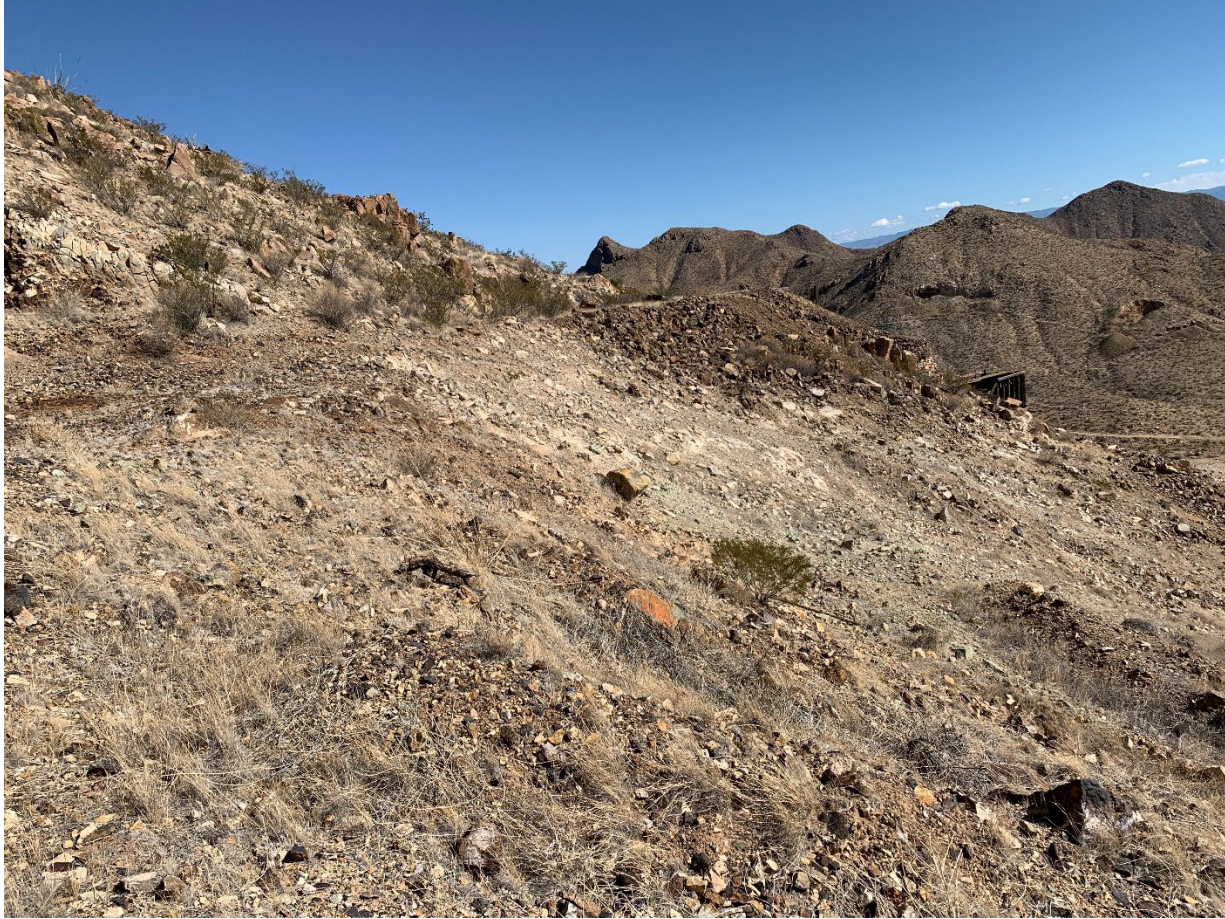
**FIGURE 17 LOOKING ACROSS STOCKPILE; NEWER DISTURBANCE**

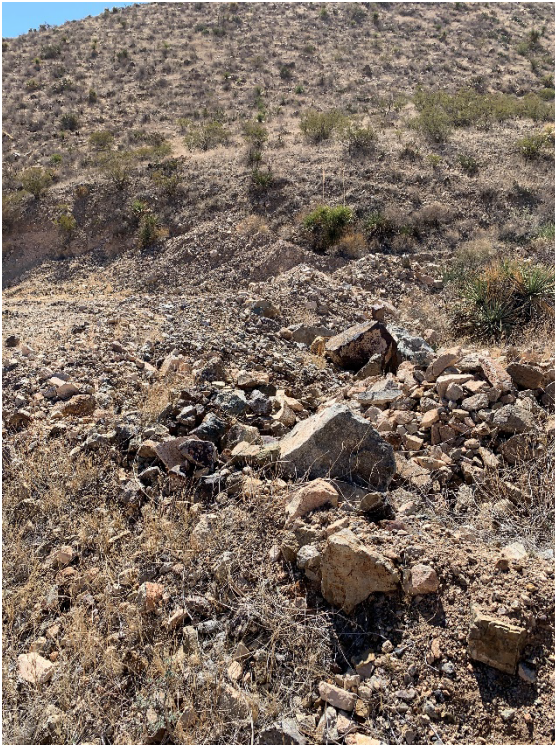
**FIGURE 19 TOP OF THE STOCKPILE**

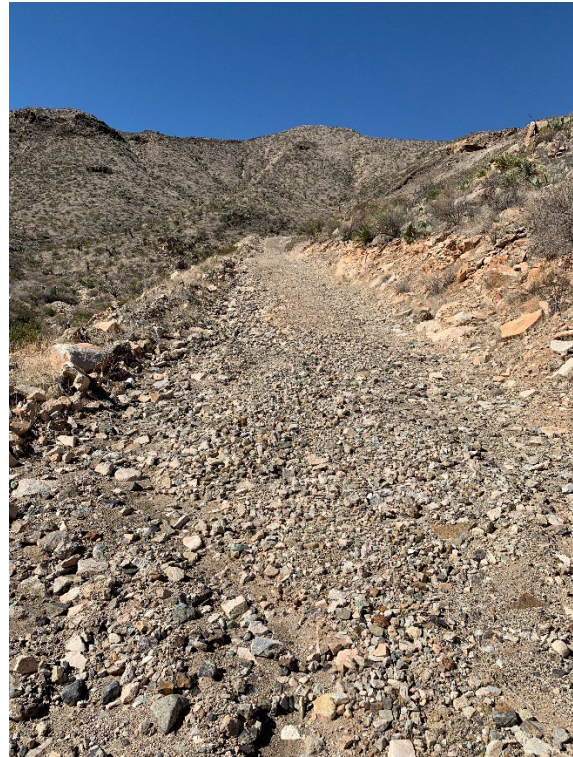
**FIGURE 18 LOOKING UP THE UN-RECLAIMED ROAD**

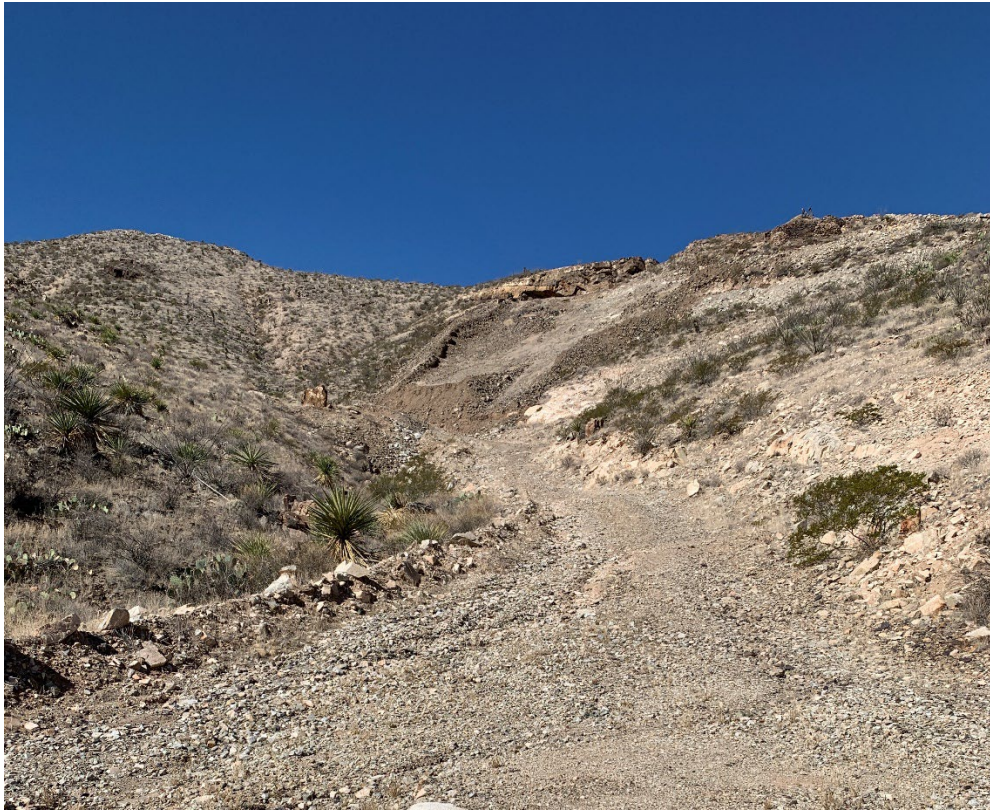
**FIGURE 20 LOOKING UP UNRECLAIMED ROAD AT THE STOCKPILE**
