**RE: Notice of Violation N24-4 Failure to contain fluids within Permit Area, Cebolleta Uranium Exploration, Permit No. CI018EM Operated by Cibola Resources, LLC.**

NOTICE OF VIOLATION NO.: N24-4

March 22, 2024 Cebolleta Uranium Exploration Inspection Report

**MINING INSPECTION REPORT**  
**Cebolleta Uranium Mine Exploration**  
**Permit #: CI018EM**  
**Date of Inspection: March 22, 2024**

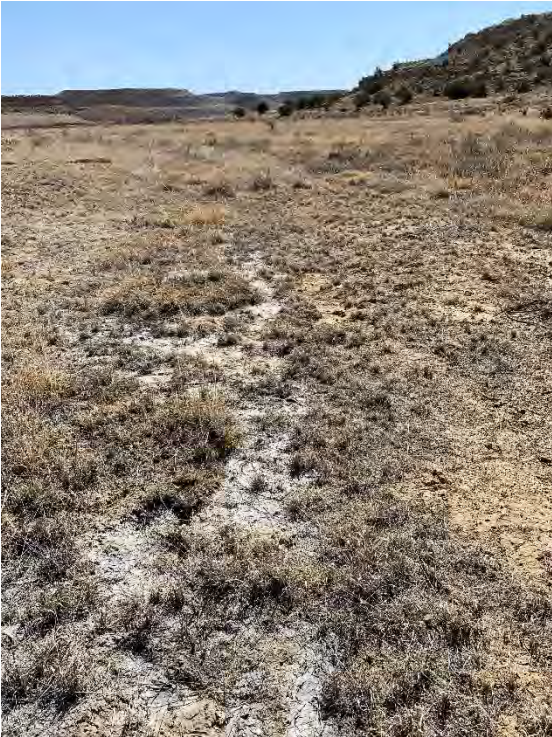
LJ31: While at this first drill pad, inspectors noticed grey run-off coming from the drill pad. Run off drained south off the pad for ~ 100ft. See photos below. Additionally, there was an extra overland road from LJ31 to LJ29 which was not approved. However, it appeared that the root masses were still intact, indicating that this road was used as an overland travel route and had been reseeded as part of reclamation (Fig 7 & 8). Desktop review – this sheet flow extended approx. 187 feet from the drill pad.

**FIGURE 2 LOOKING SOUTHEAST OFF THE DRILL PAD, AS THE MUD FLOWED**

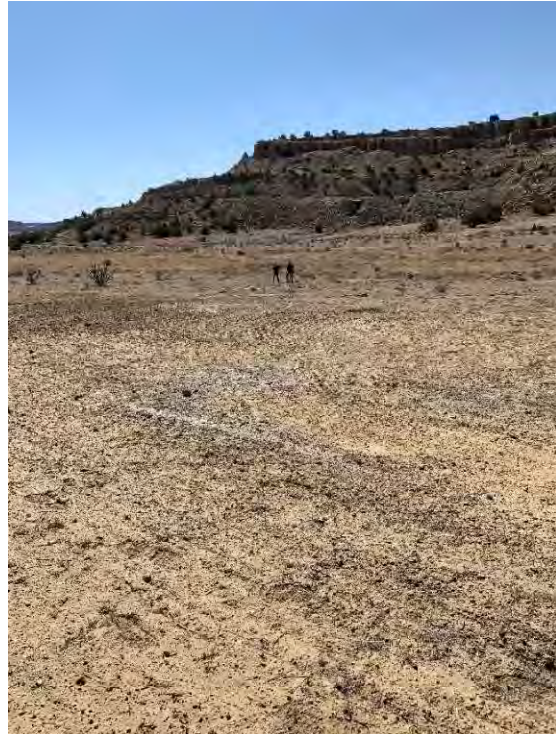
**FIGURE 3 CARMEN AND RON STANDING IN THE MUD AREA OFF THE DRILL PAD, LOOKING SOUTHEAST**

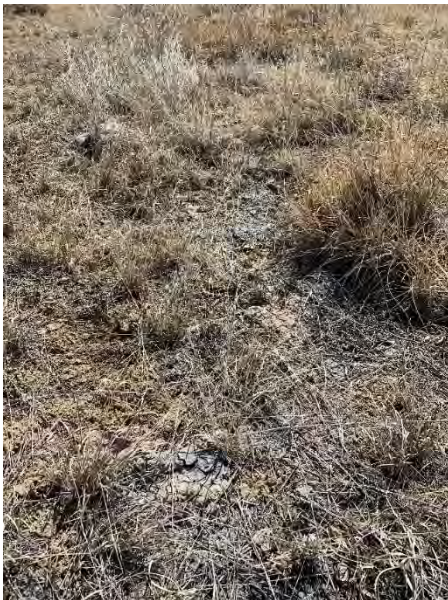
**FIGURE 4 MUD IN GRASS**

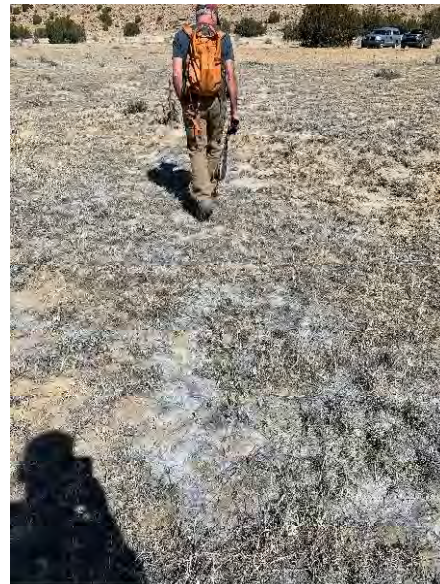
**FIGURE 5 RON WALKING BACK TO THE DRILL PAD, MUD VISIBLE**

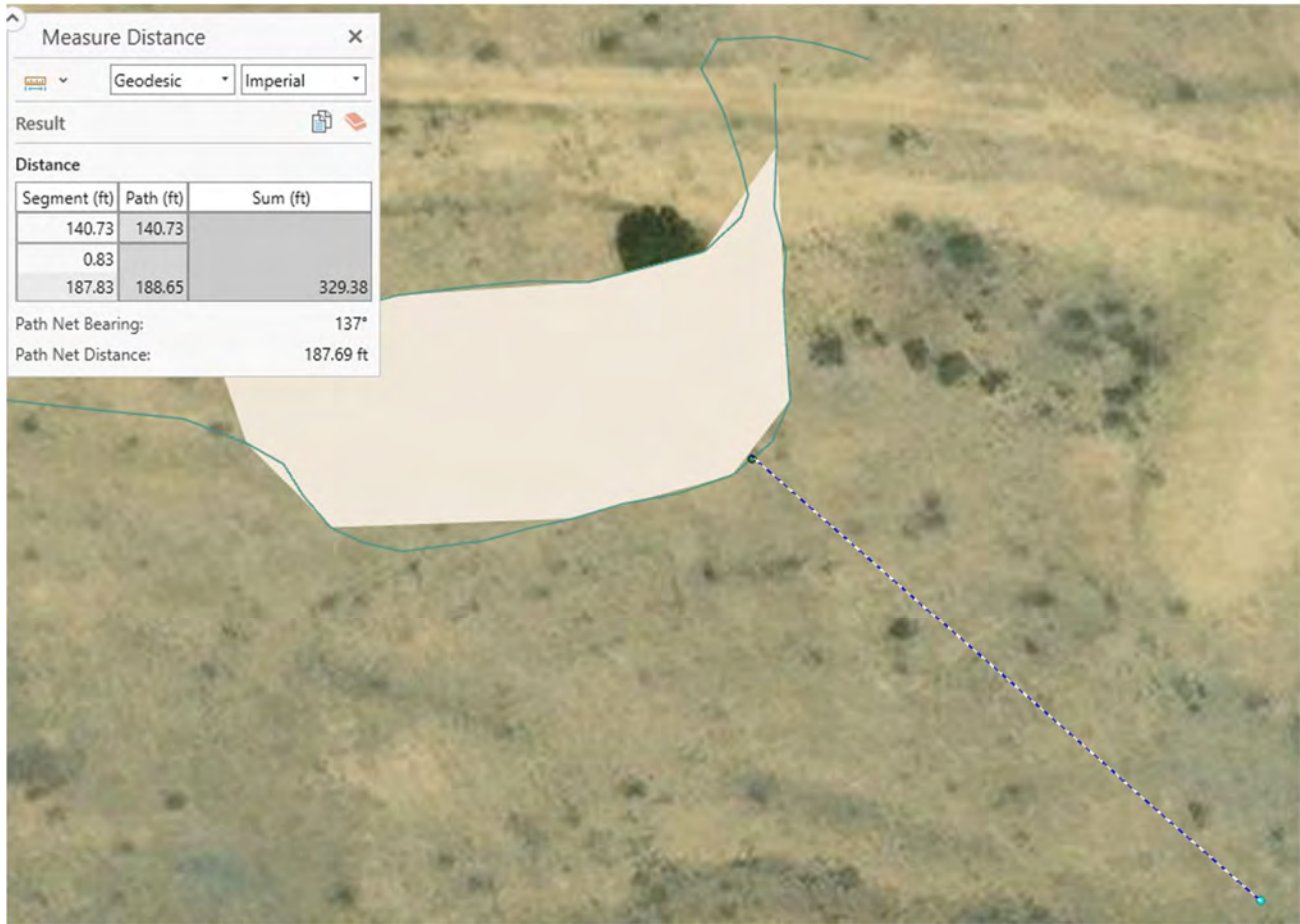
**FIGURE 6 POINT TO POINT MEASUREMENT OF MUD FLOW OBSERVED**

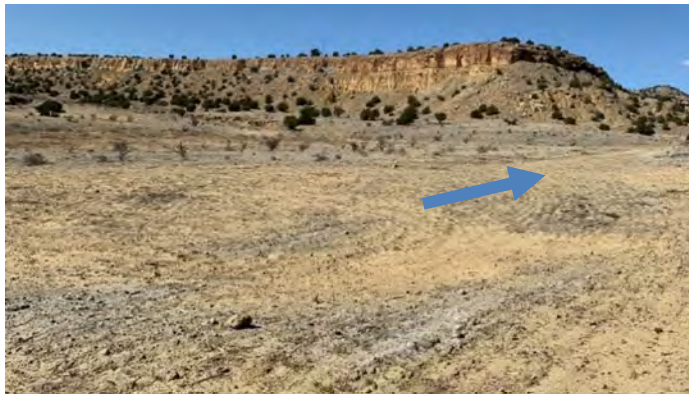
**FIGURE 7 BLUE ARROW POINTS TO OVERLAND SEEDING, FROM LJ31**

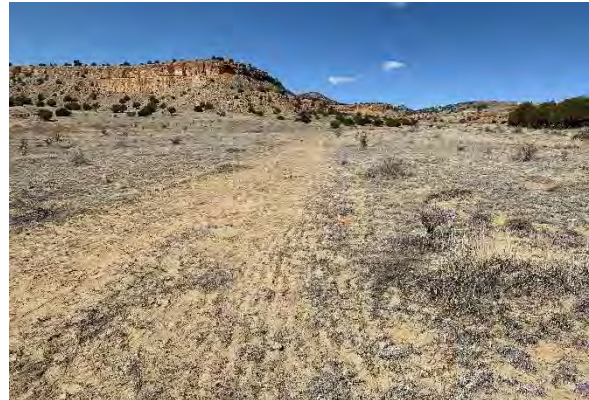
**FIGURE 8 ROAD LOOKING TO LJ297**

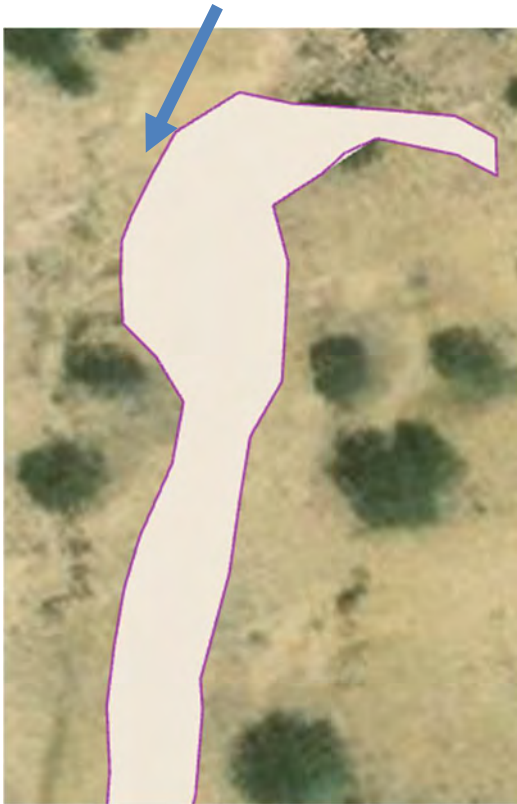
LJ126: This drill pad, it was noted, had a significant amount of what appeared to be drilling fluid flow down into a deep drainage that flows to the south from the west side of the pit. A video was taken showing the extent of the spill and is located in the electronic file. Desktop review - flow went approx. 40ft.

FIGURE 9 LOCATION OF DRAINAGE

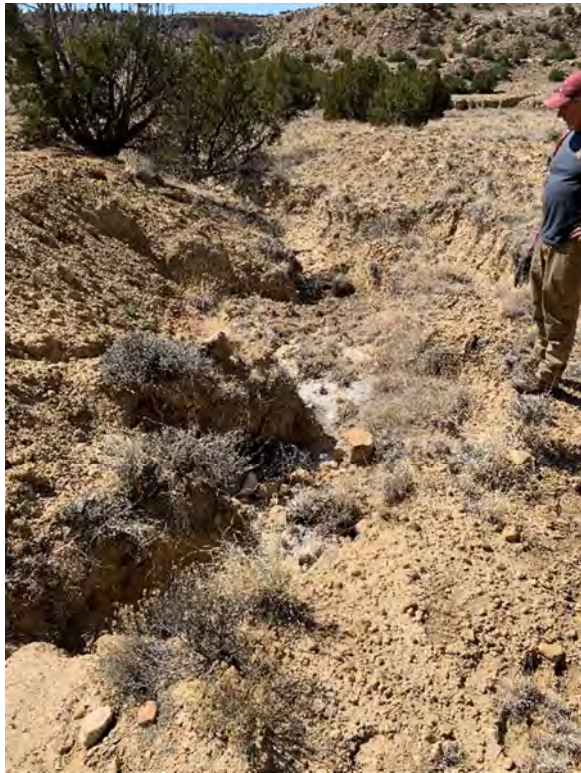
FIGURE 10 LOOKING DOWN DRAINAGE TO THE SOUTH

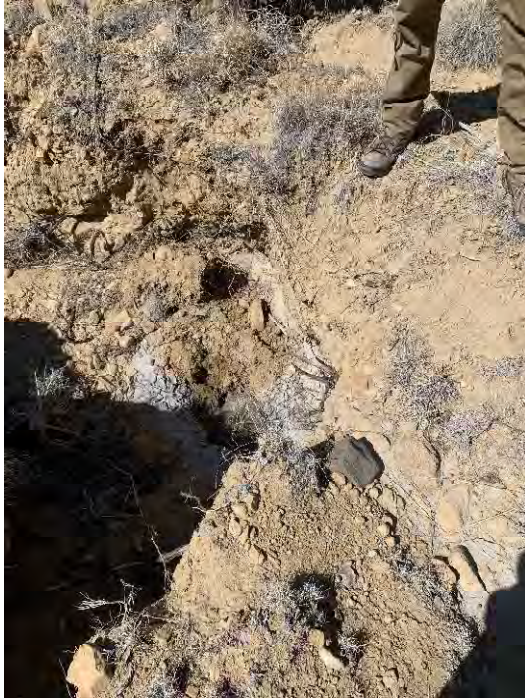
**FIGURE 11 MUD IN ARROYO**

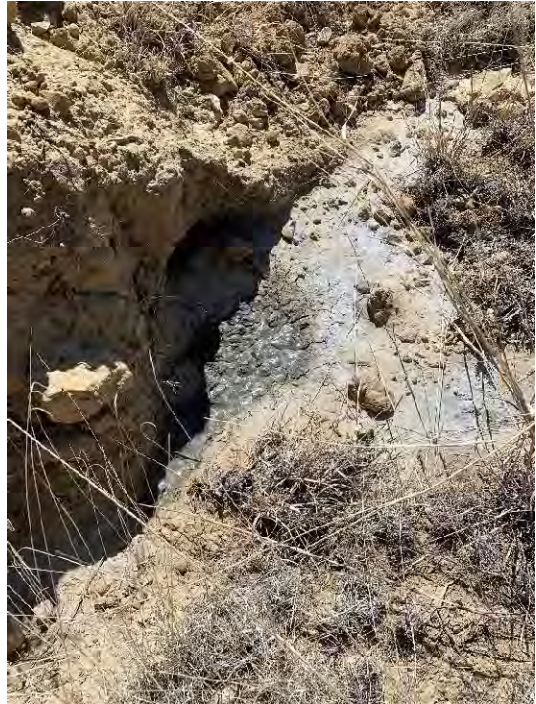
**FIGURE 12 MUD IN ARROYO**

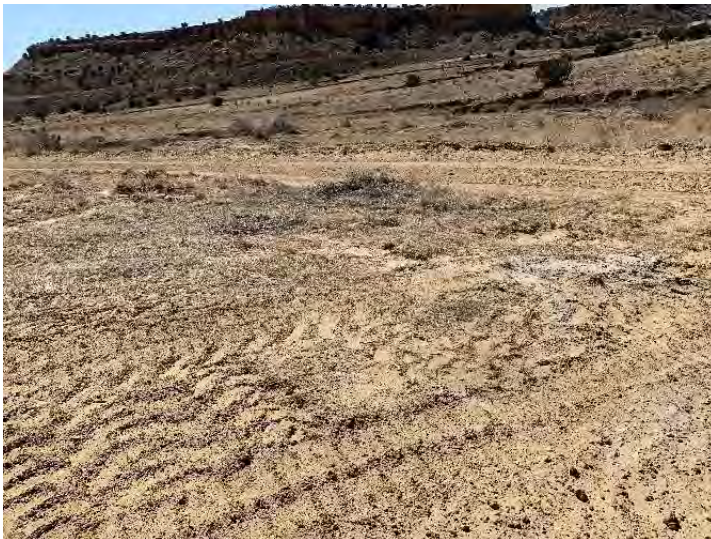
A27: Mud was observed as having flowed from drill pad area on to and then down the road.

**FIGURE 13 LOOKING SOUTH FROM DRILL PAD A27**

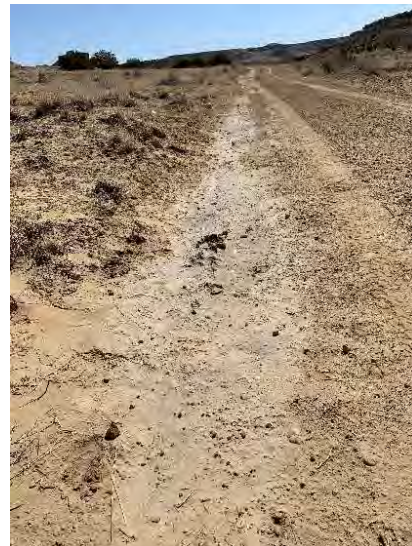
**FIGURE 14 LOOKING EAST FOLLOWING FLOW**

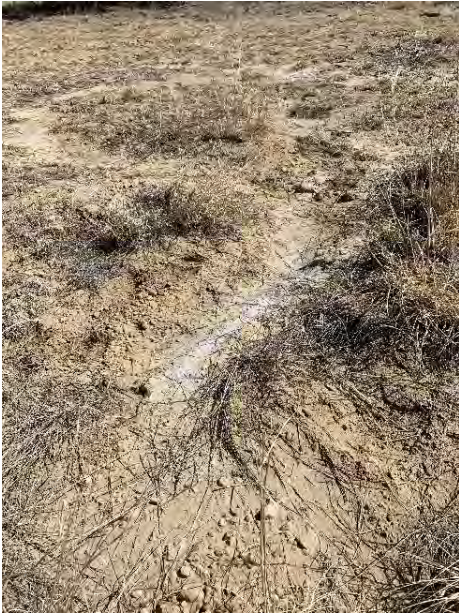
**FIGURE 15 MUD DRAINING DOWN AWAY FROM DRILLPAD TO THE ROAD (A27)**

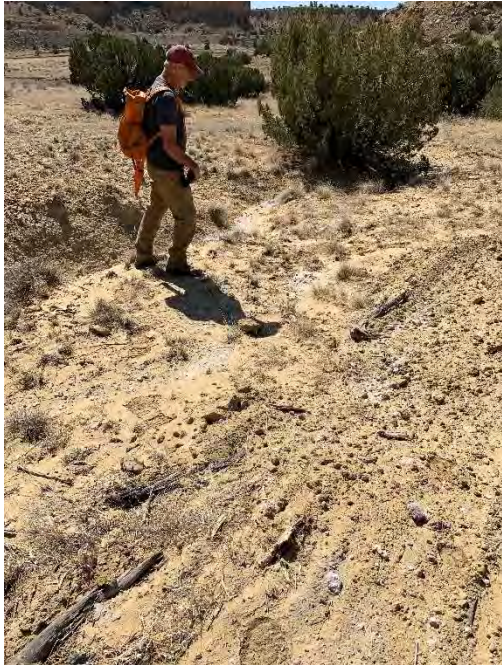
A8: Site had drilling fluid leaving the drill pad into a smaller drainage, ~30feet down.

**FIGURE 16 ENTRY OF FLOW INTO THE DRAINAGE OFF DRILL PAD A8**

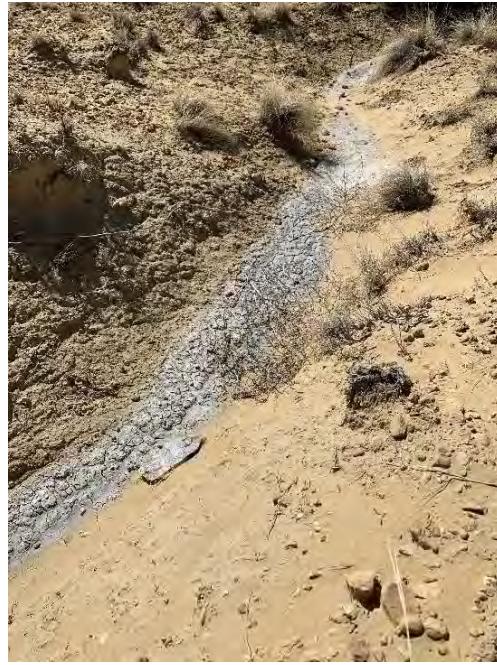
**FIGURE 17 MUD IN THE ARROYO**

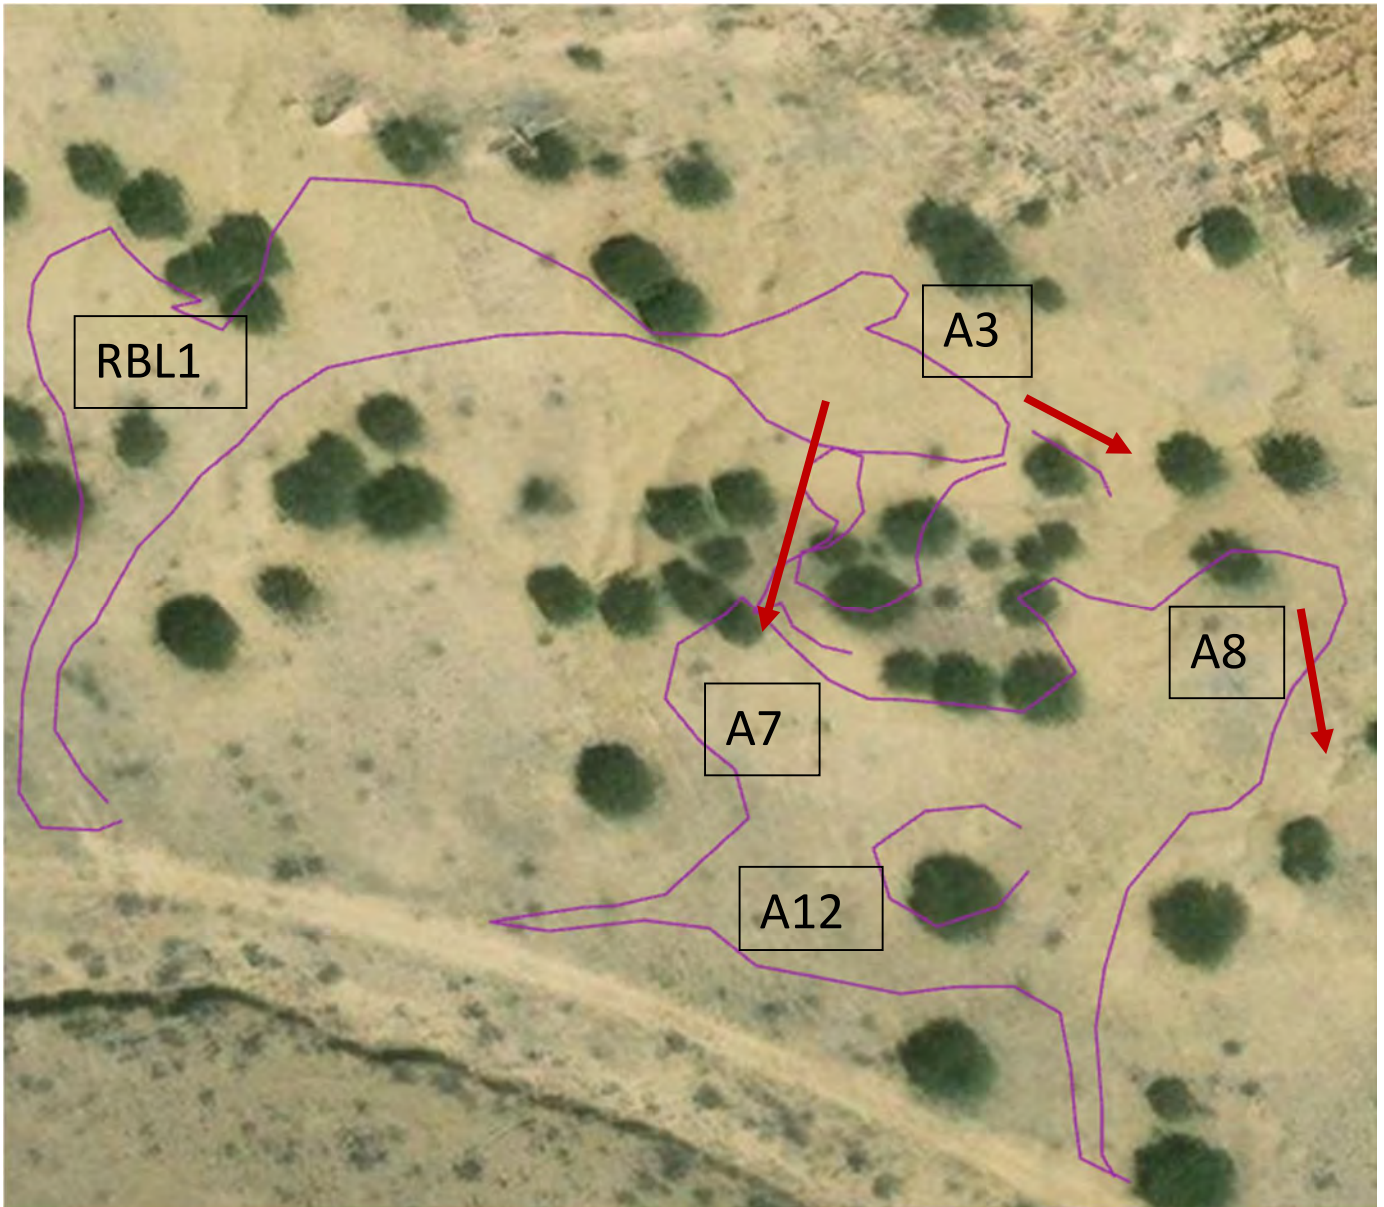
**FIGURE 18 RED ARROWS SHOW OBSERVED DRILLING FLUID FLOW DIRECTION OFF DRILL PADS**

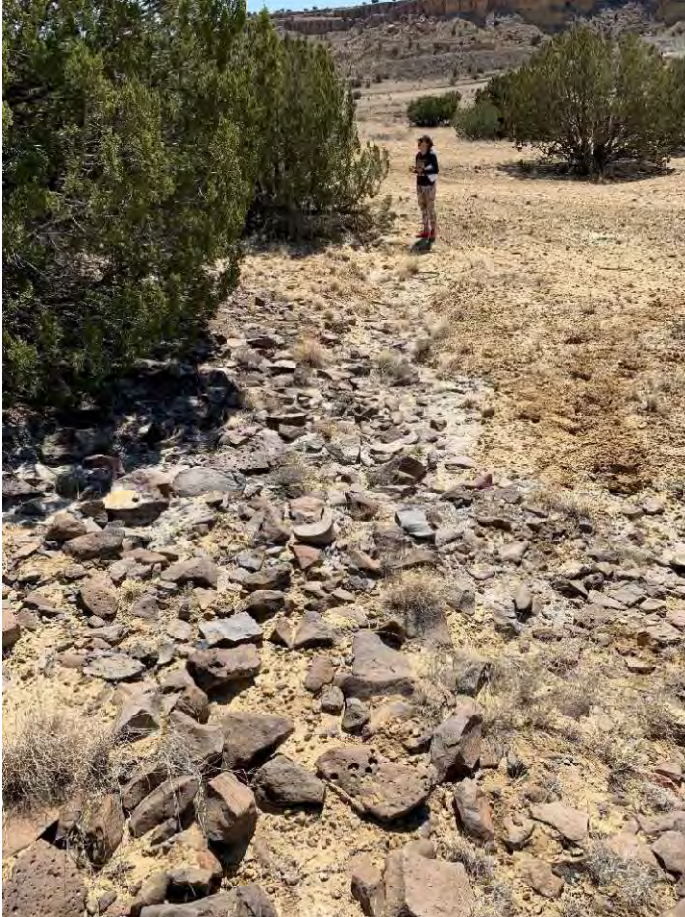
A3: Large quantities of crusted drilling fluid present on the south side of the drill pad. The mud flowed through the rocks and extended all the way to the drill pad below (A7).

FIGURE 19 MUD VISIBLE IN ROCKS, LOOKING INTO A7 DRILL PAD TO THE EAST

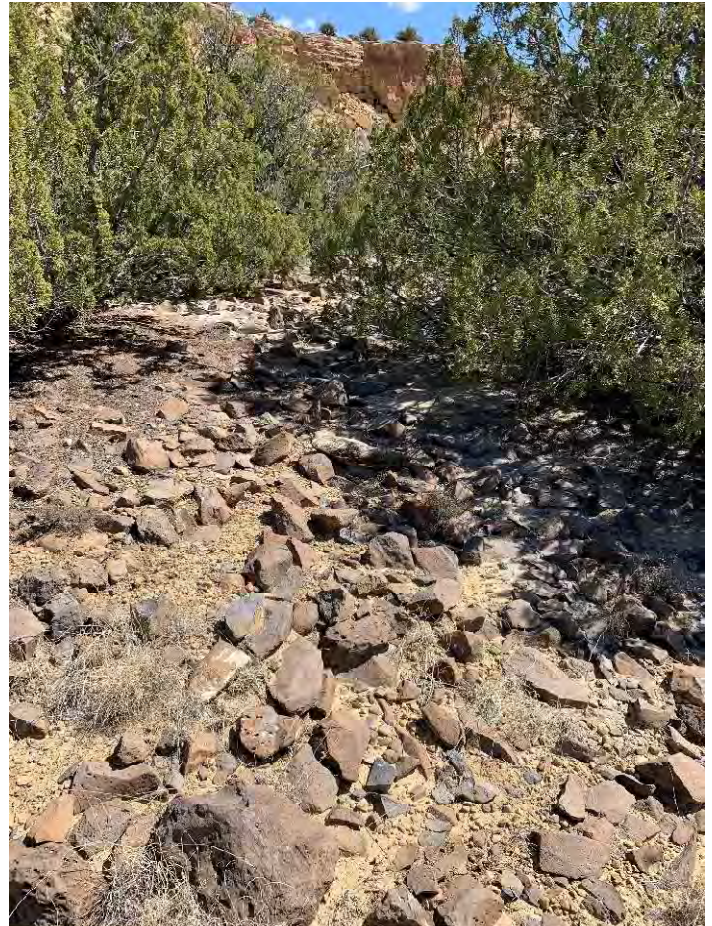
FIGURE 20 LOOKING UP/NORTH FROM A7 TO A3, MUD IN ROCKS

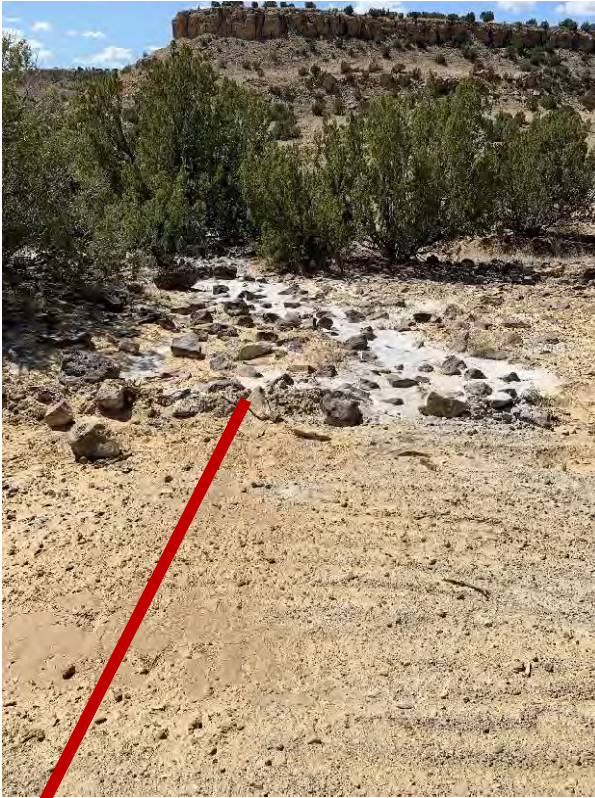
**FIGURE 21** LOOKING DOWN THE ROCKS FROM A3

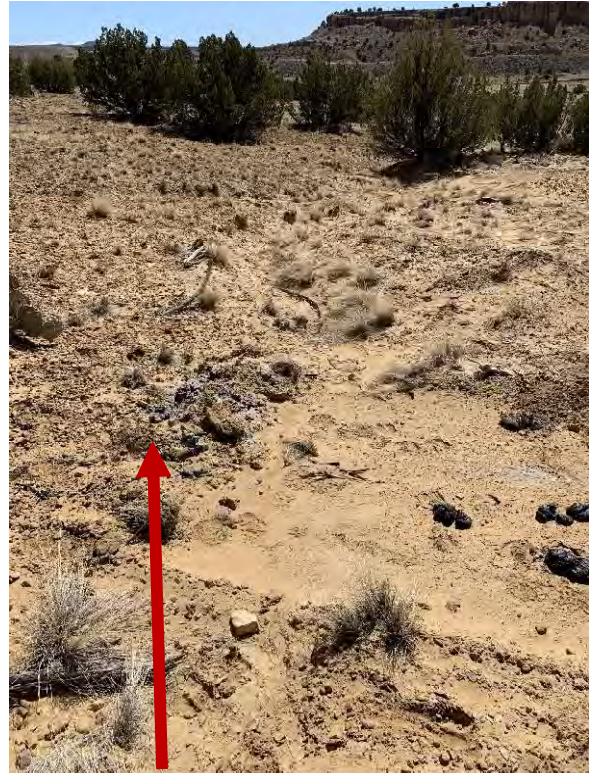
**FIGURE 22** POSSIBLE CUTTINGS PILE ABOVE ARROYO

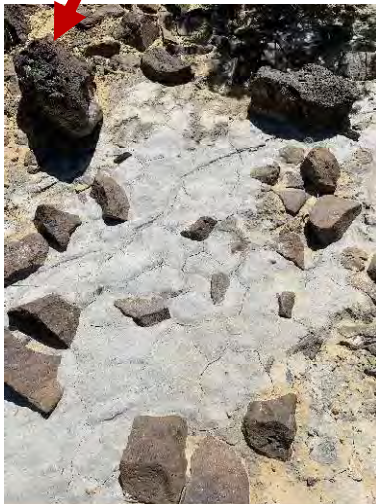
**FIGURE 21B** CLOSE UP OF FLUID IN THE DRAINAGE.

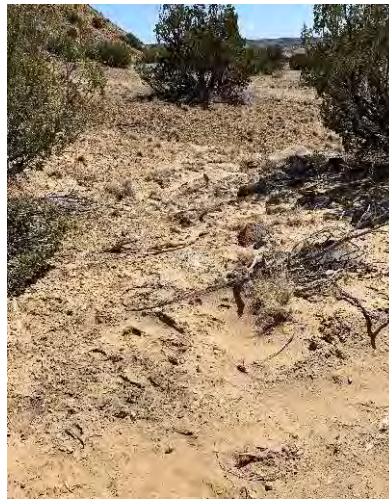
**FIGURE 23** LOOKING OFF A3, VISIBLE GREY COLOR DROPPING INTO ARROYO

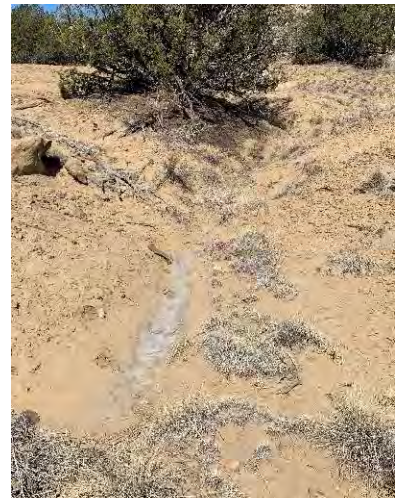
**FIGURE 24** DOWN IN THE ARROYO, LOOKING UP, GREY MATERIAL VISIBLE IN DRAINAGE, OFF DRILL PAD A3

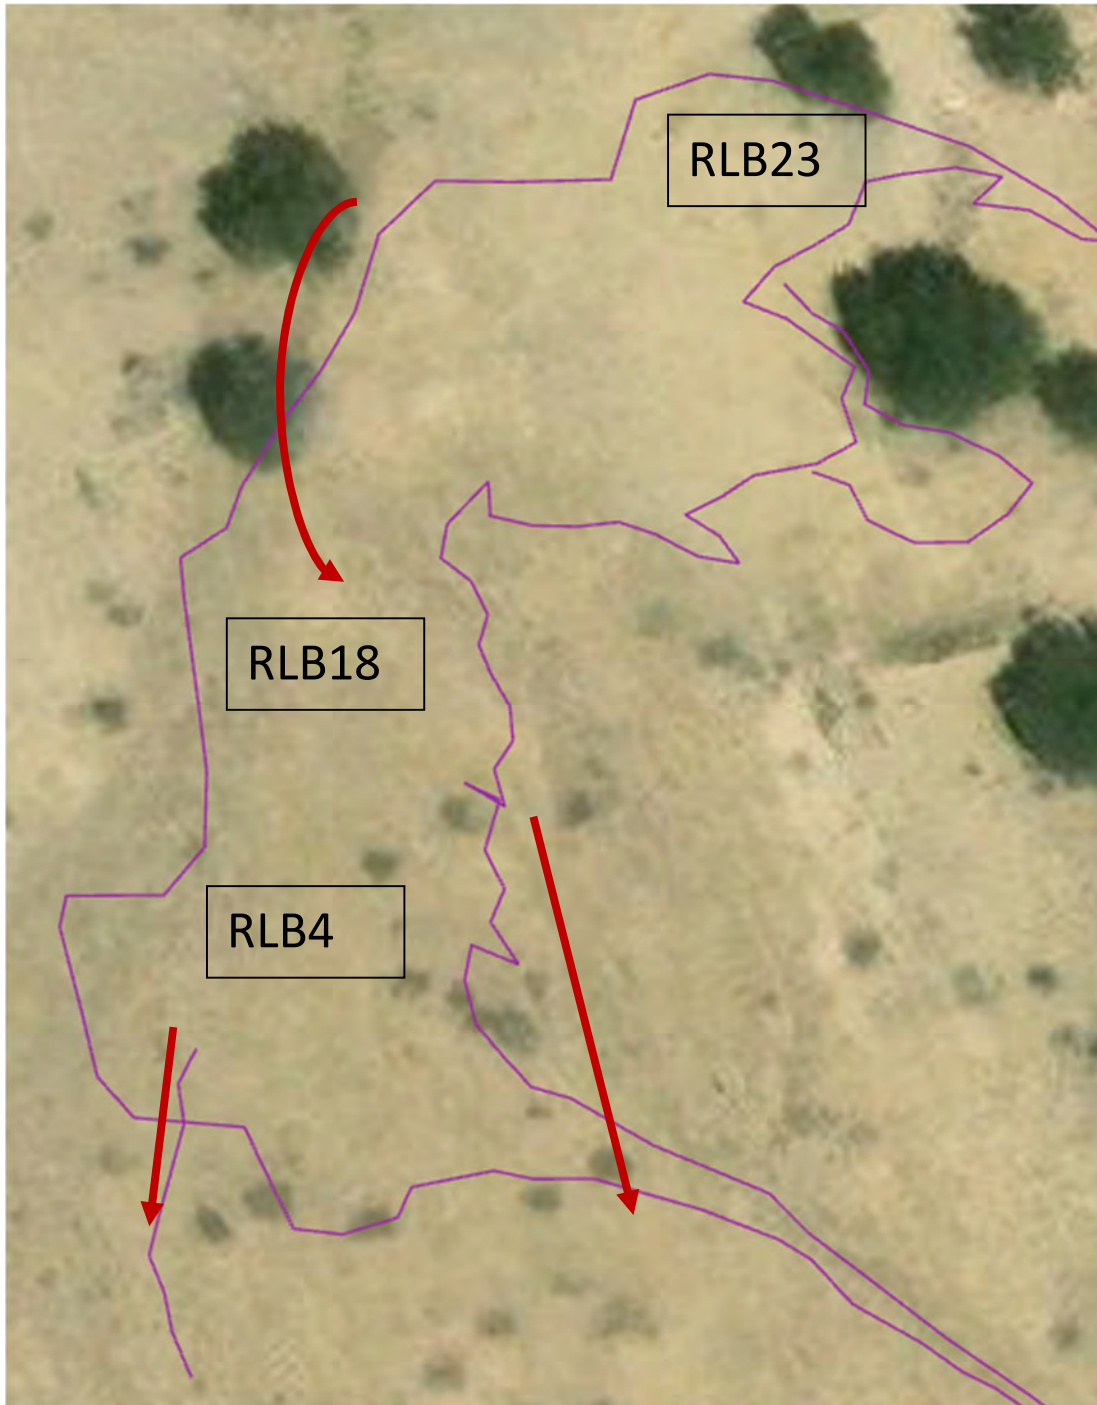
FIGURE 25 RED ARROWS SHOW FLOW DIRECTIONS.

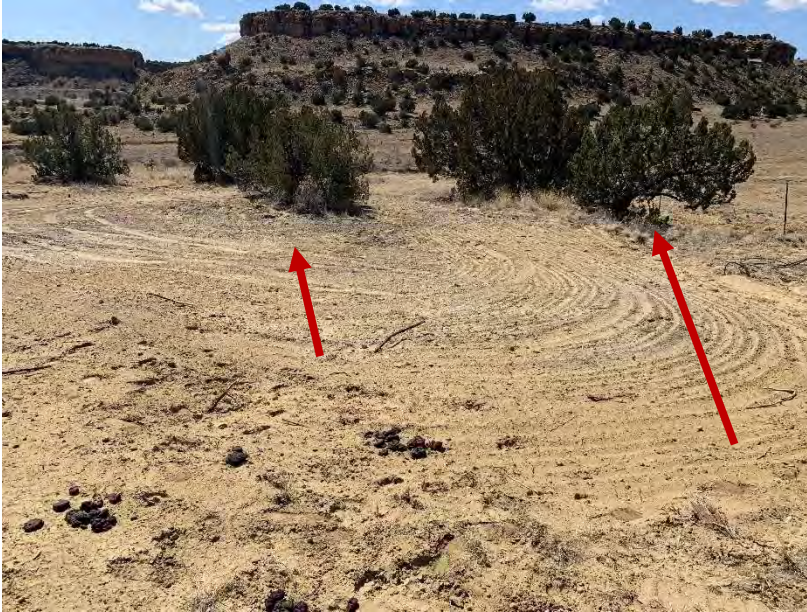
**FIGURE 26 MUD FLOW VISIBLE AROUND THE BASES OF BOTH GROUPS OF TREES, LOOKING SOUTH, (3) PHOTOS BELOW ARE CLOSE UPS OF THE SAME AREA.**

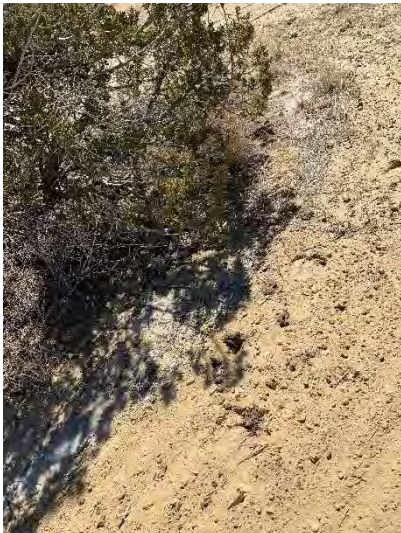
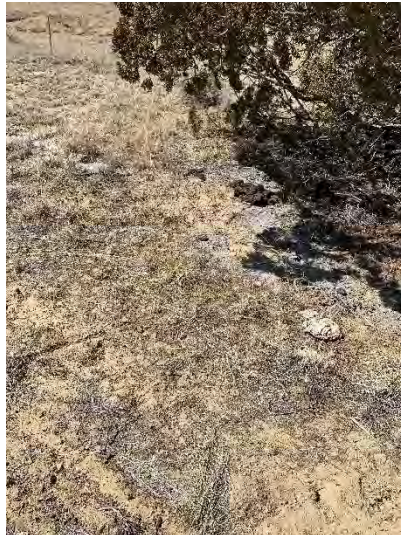
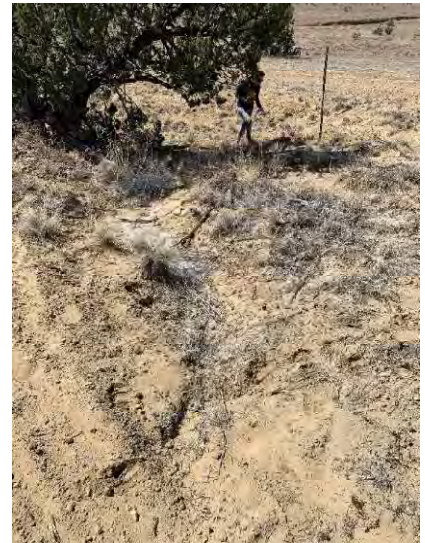
**FIGURES 26A/B/C; MUD FLOWS AROUND TREES**

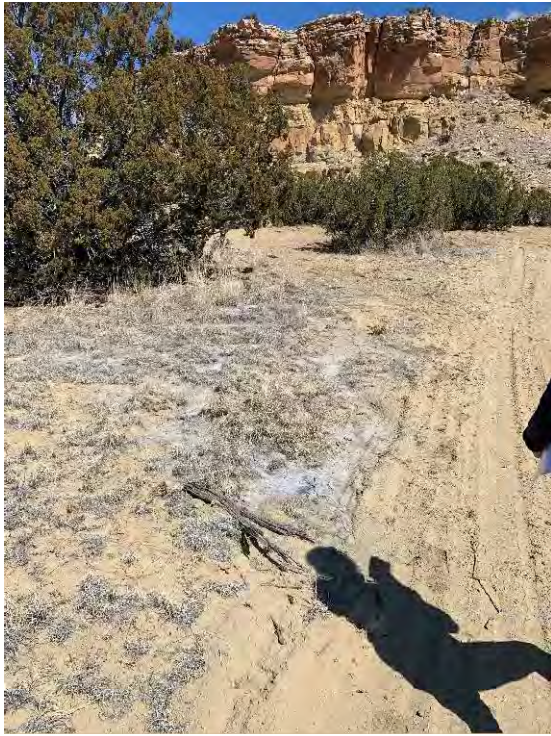
**FIGURE 27 LOOKING UP FLOW TO THE NORTH**

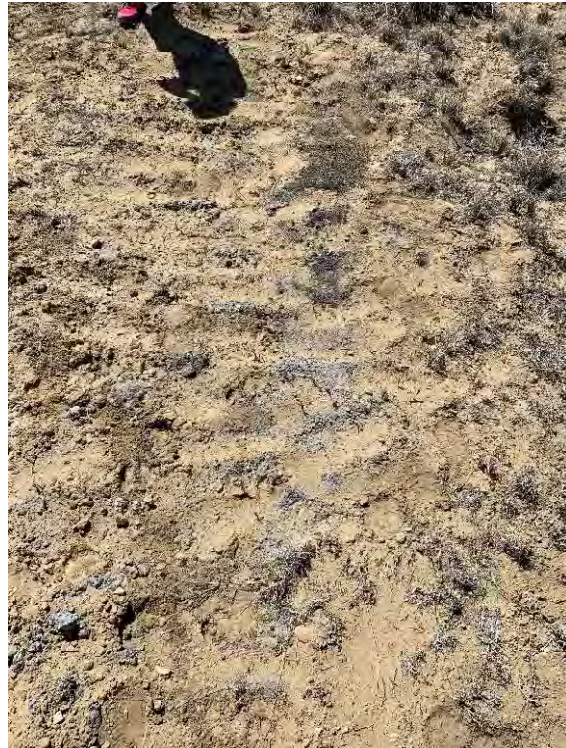
**FIGURE 28 POSSIBLE CORE LAY DOWN AREA, VISIBLE BANDING NEAR RLB18**

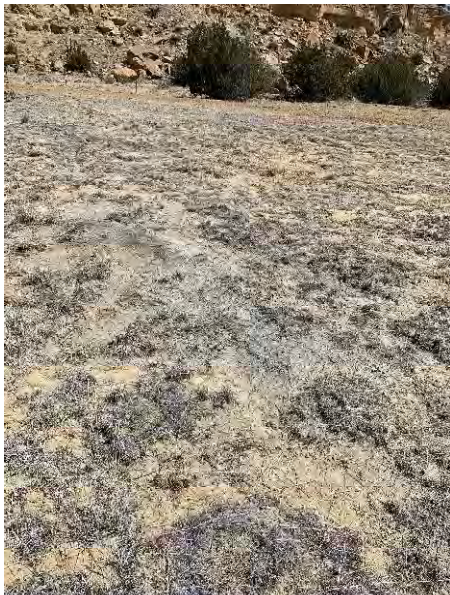
**FIGURE 29 BOTTOM OF FLOW COMING OFF OVERLAND FROM RLB4, LOOKING SOUTH**

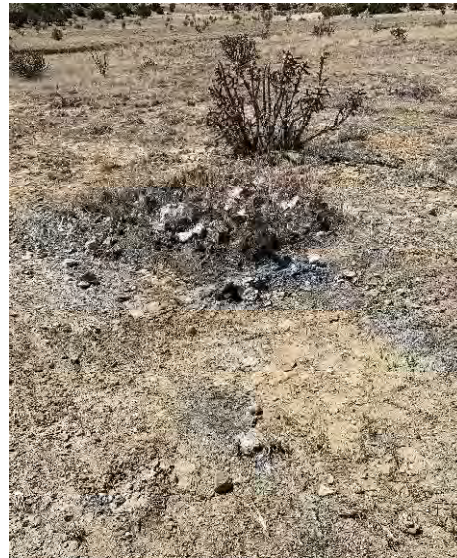
**FIGURE 30 MUD MIXED INTO CACTUS BASE**

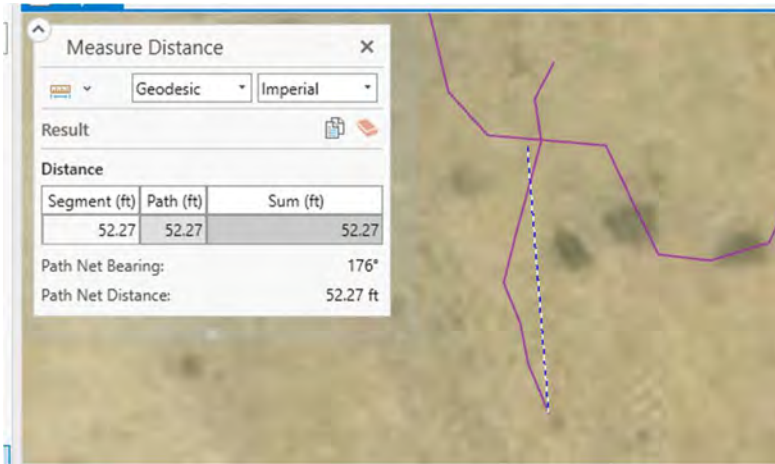
FIGURE 31 DISTANCE MUD FLOWED FROM THE DRILL PAD FOR RLB4

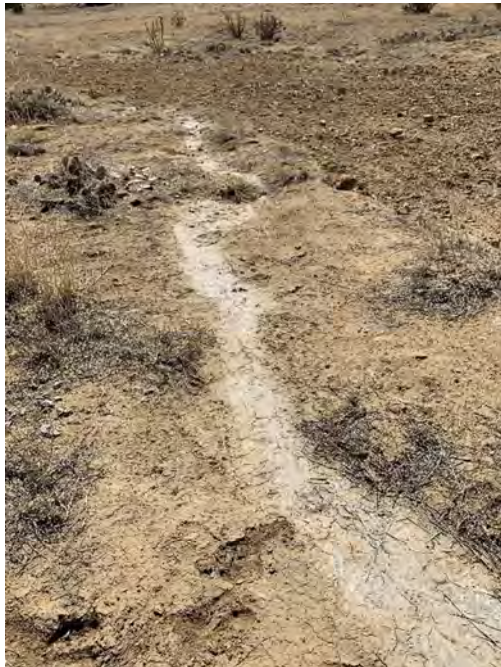
FIGURE 32 FLOW COMING DOWN OFF RLB4 AREA

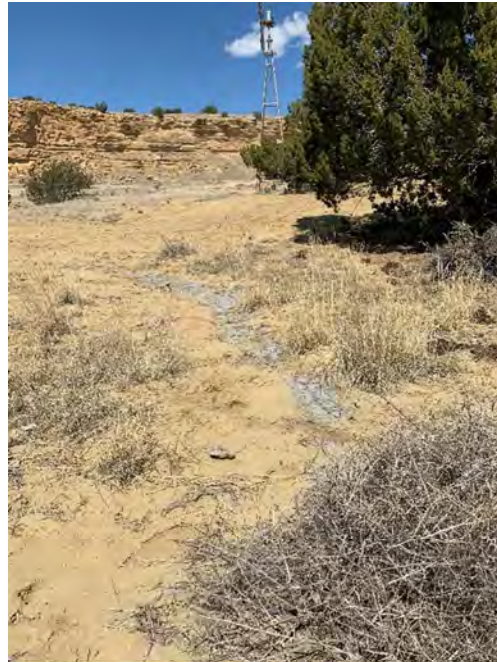
FIGURE 33 FLOW COMING DOWN NEAR RLB18

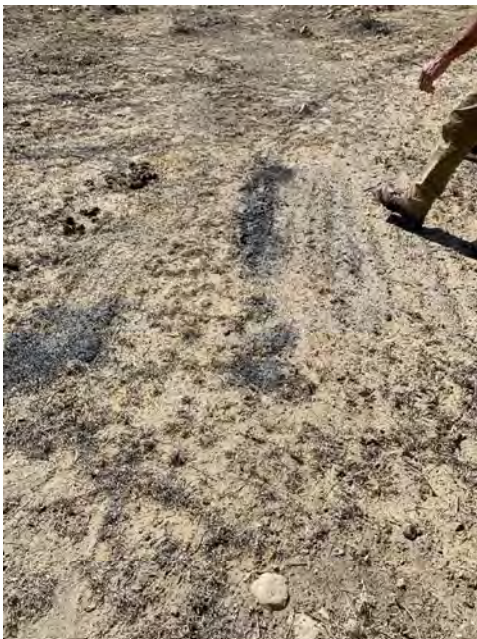
LJ5/LJ25: Observed possible area where core was laid out. Appeared to have the same gradient of soil to shale layering visible

FIGURE 34 POSSIBLE CORE LAY DOWN AREA

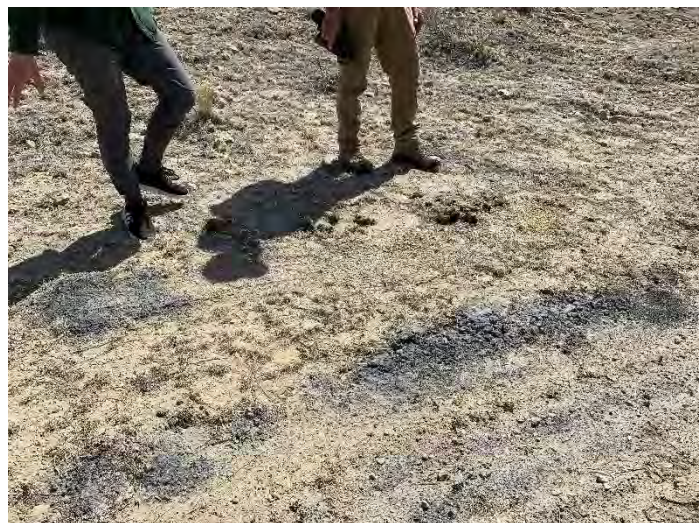
FIGURE 35 POSSIBLE CORE LAYDOWN AREA

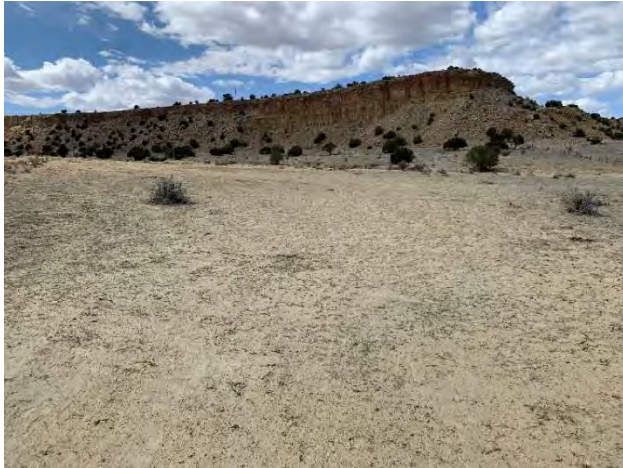
**FIGURE 36 RLB83 DRILL PAD**

RLB83: Walked the area of disturbance, which was large for one drill pad.
