MINING INSPECTION REPORT

Capitan Iron Mine

Permit #: LI005ME

Date of Inspection: March 4, 2025

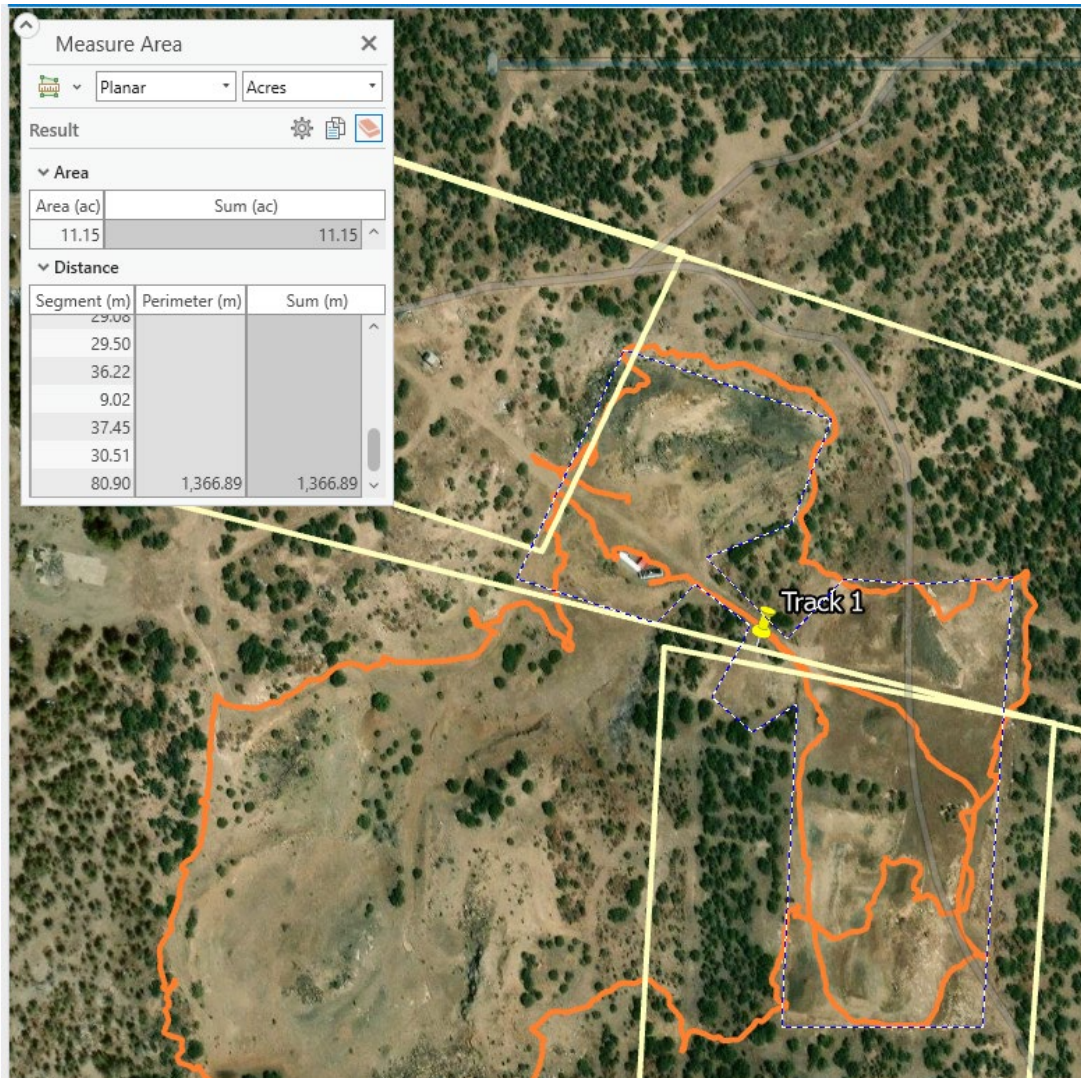
FIGURE 2 DISTURBANCE AREA

On desktop review general disturbance is 11.15 acres (see figure 2). This doesn't include the residence or the cement pad area. Additional items of note following a detailed file review on the site:

Small clearing below yellow marker for Track 1, on google earth review this appears to be part of the mining activities.

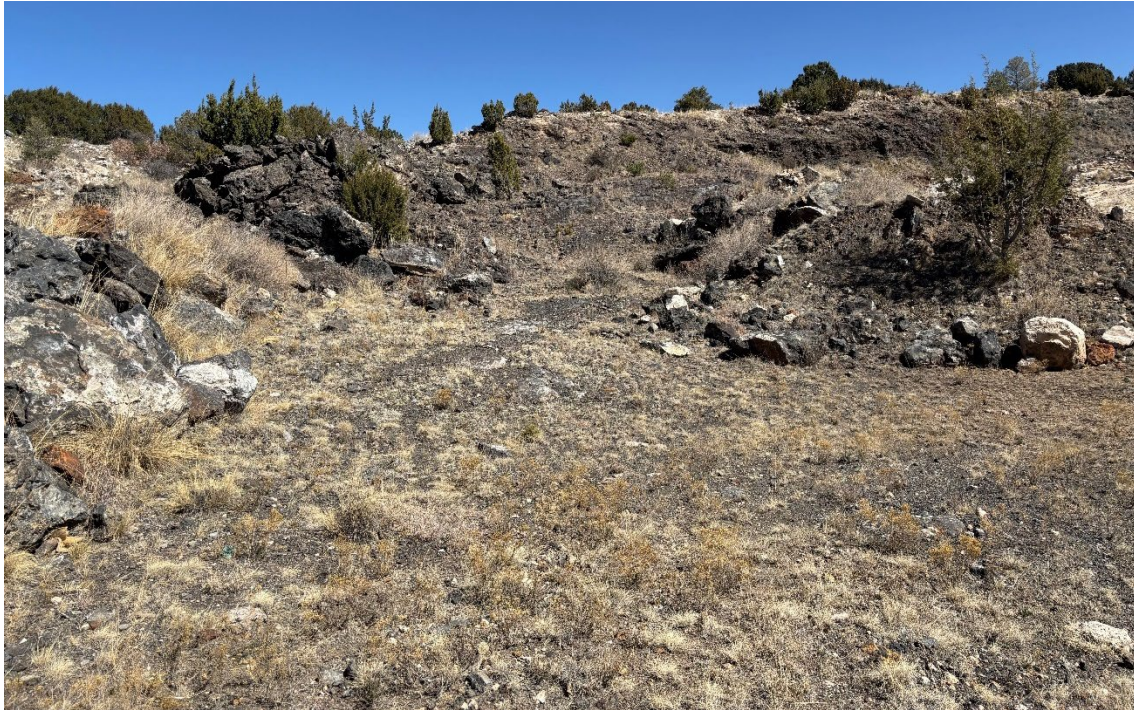
FIGURE 4 LOOKING TOWARDS PIT AREA FROM THE ROAD

Large rocks piled in the upper left, on the midground right is a pile of unknown material left un-reclaimed/not graded with vegetation now growing.

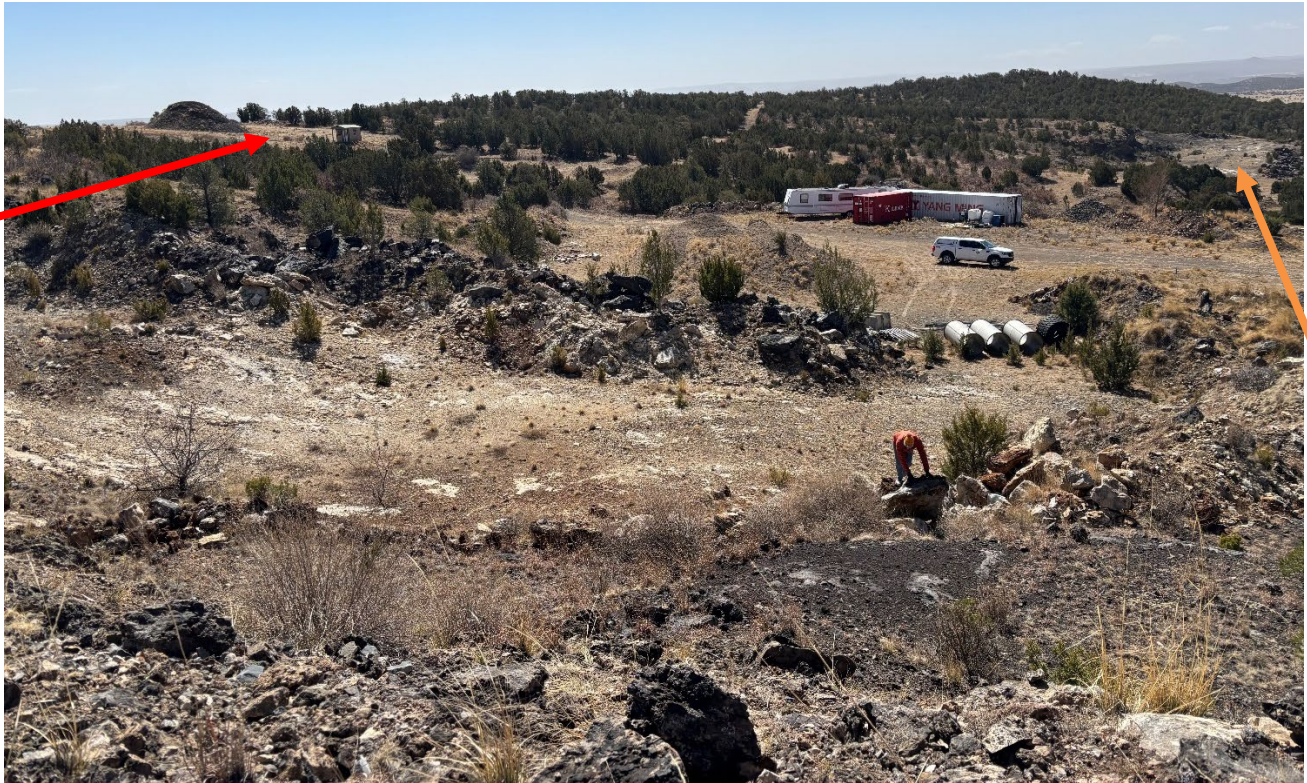
FIGURE 5 LOOKING BACK DOWN TOWARDS THE ROAD FROM "TOP" OF THE PIT

- Orange Arrow showing the historic pit – LI002ME – Smokey Mine
- RV and containers visible near road.
- Red arrow is the area of Pit 2/3 of disturbance visible in the background. The small office is also visible.

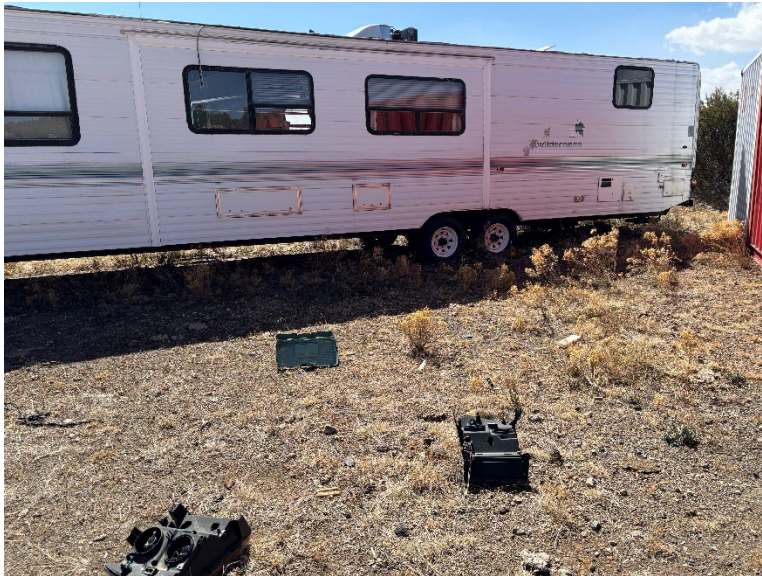
FIGURE 10 RV

Storage containers were not closed or locked. RV appeared to possibly have some door damage. Unsure of if any materials have been vandalized or damaged.

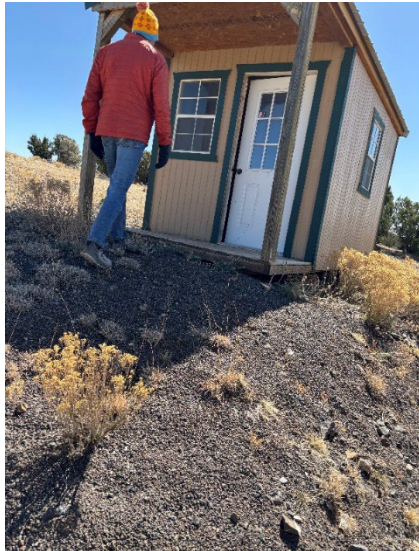
FIGURE 18 WALKING UP TO OFFICE - DOOR VISIBLY OPEN

There is also a Small office building on the site that was open.

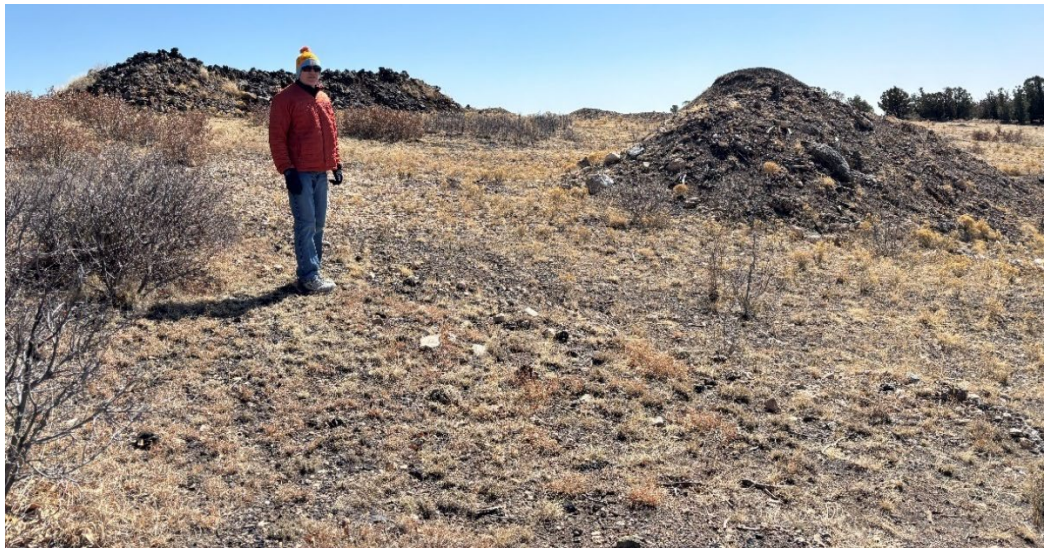
FIGURE 21 UNRECLAIMED PILES

Pits 2/3 are not very defined, the entire north-south disturbance is composed mostly of large disordered piles. There are various fences but they are mostly fallen down.

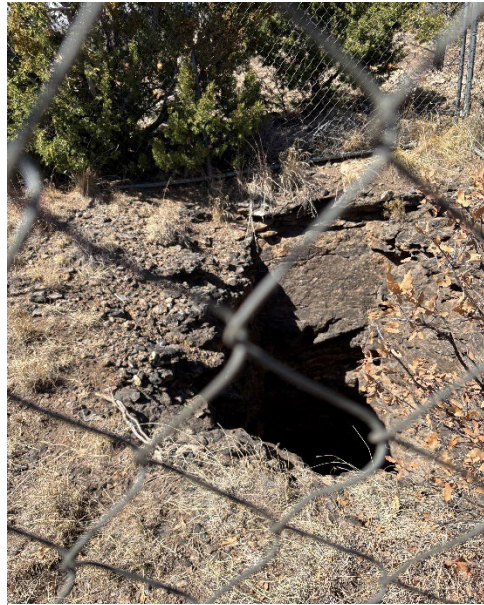
FIGURE 24 SHAFT

There is a Shaft on this area which is fenced/protected.

Shaft is ~2-3 feet wide.

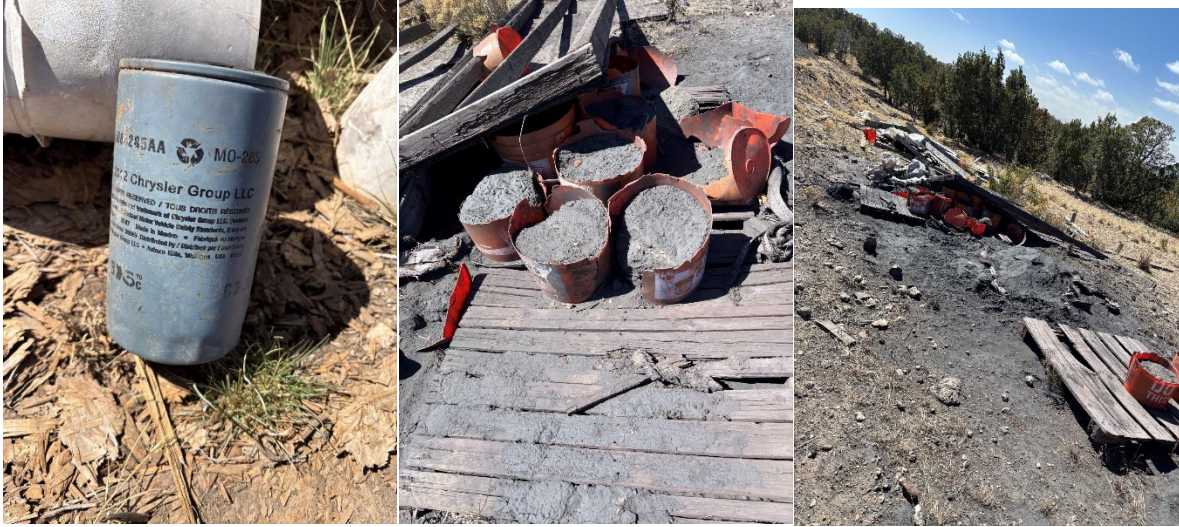
Trash and Materials left on site along the South east border.

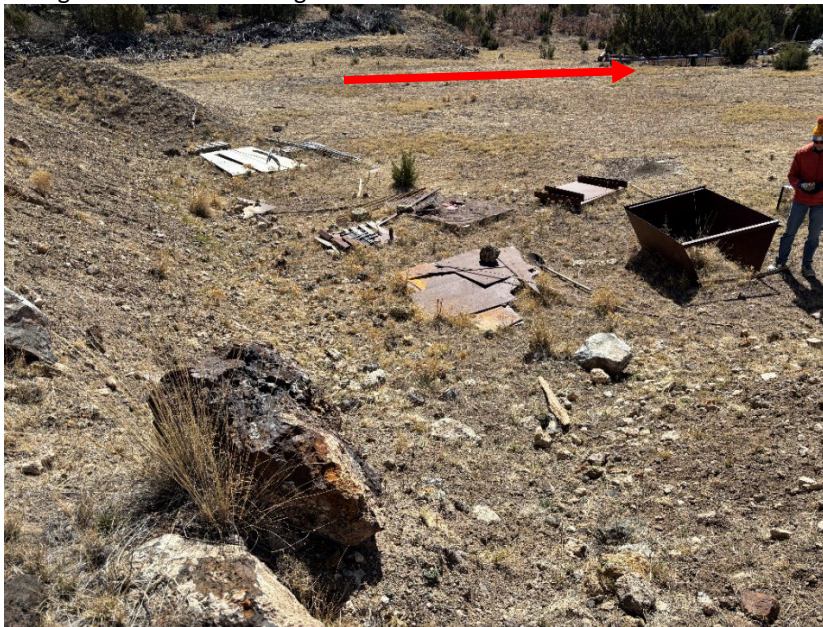
FIGURE 43 VARIOUS EQUIPMENT AND MATERIALS LEFT BEHIND

- 2016 0325 Inspection: details the road changes as well as exceeding the 5 acre permit boundary for disturbance. This disturbance appears to be the same location as Figures 43-45 which is on USFS property as well as outside the permit boundary.
- 2019 1009 Inspection: Mentions the concrete pad with USFS and needing reclamation.

Notify USFS on road status and materials on USFS property. Confirm what Bonds, or NOI's/Permissions does Operator have for the site.

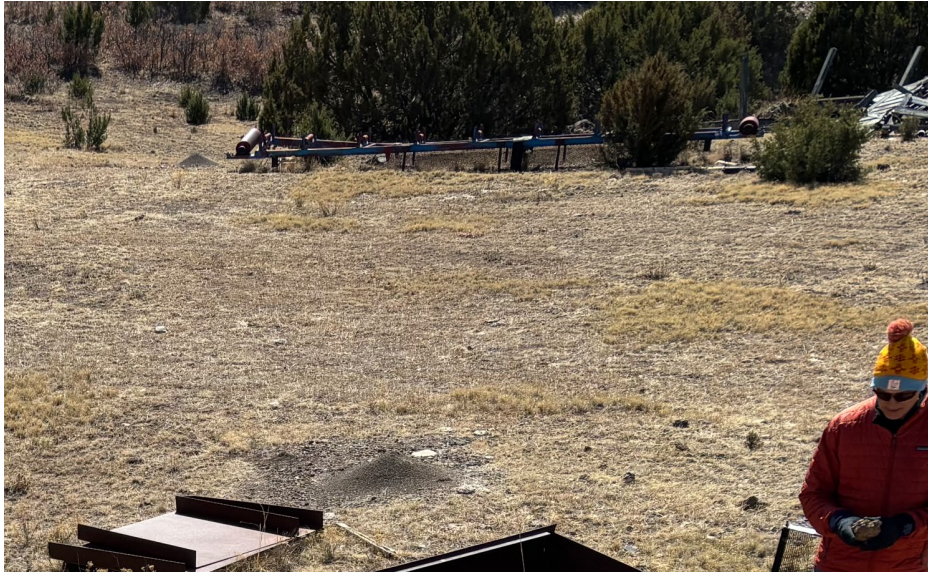
FIGURE 44 MATERIALS ON USFS PROPERTY

Larger Machinery Equipment with red rollers, red arrow marking items in the background. Zoom in below.

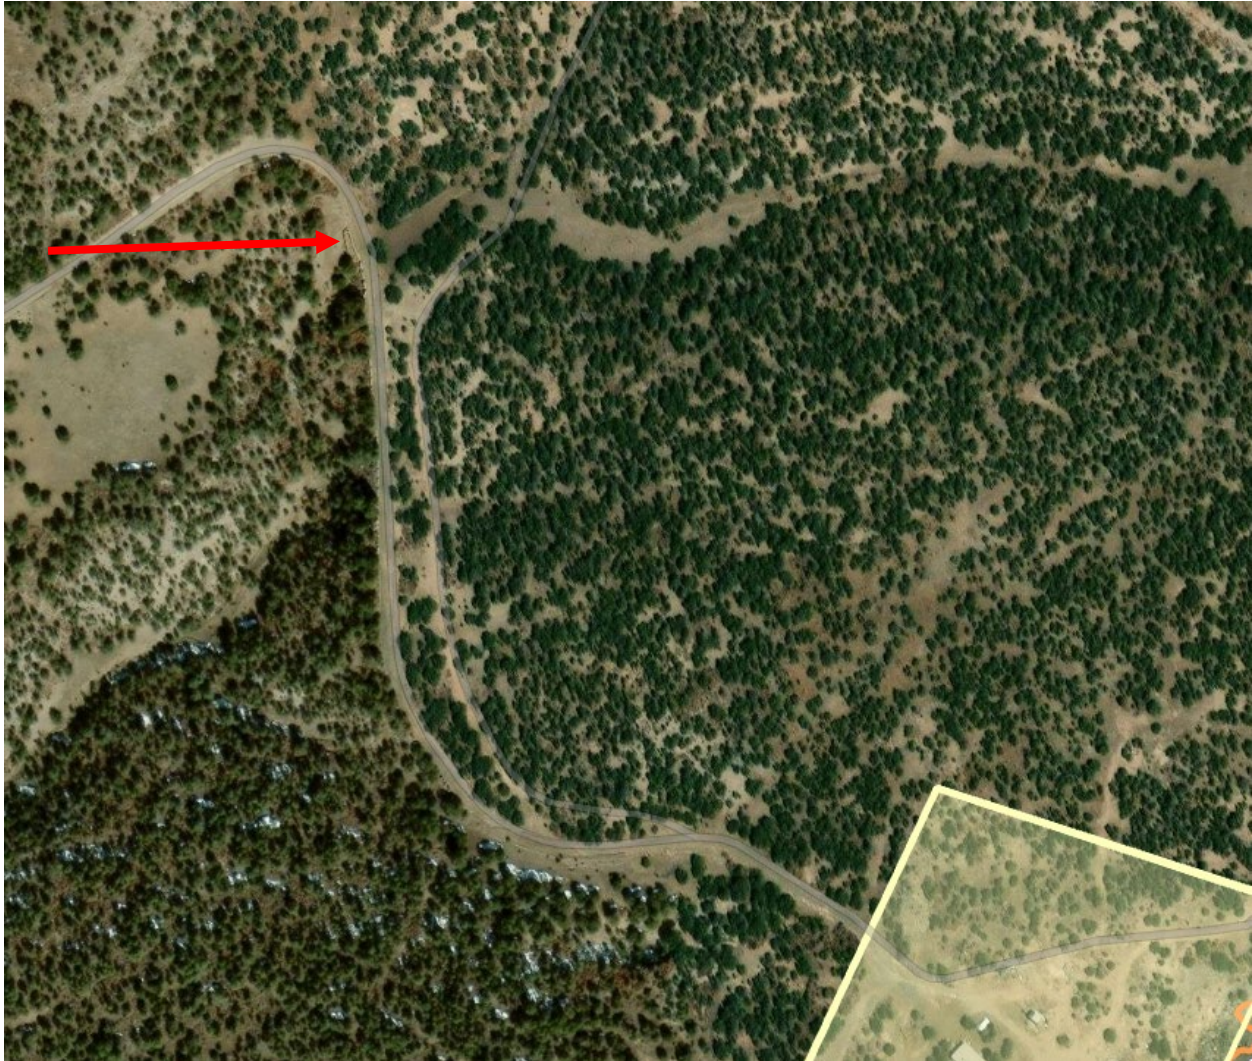
FIGURE 47 LOCATION OF ROAD CHANGES & DRAINAGE

As MMD staff drove off site the section of road that was ‘improved’ and filled with mine material was checked. There are no culverts and it appears that while some head cutting and erosion was present previously, however on inspection there is erosion and stability concerns that need to be reviewed.

1. Has any reclamation work been performed.
2. Updated FA/Mine Plan → Possible application for regular existing mine.
3. Likely need a remediation plan for the road in conjunction with USFS.
4. Confirm if Smokey Mine is now owned by ECPMI. And records of any reclamation work done.

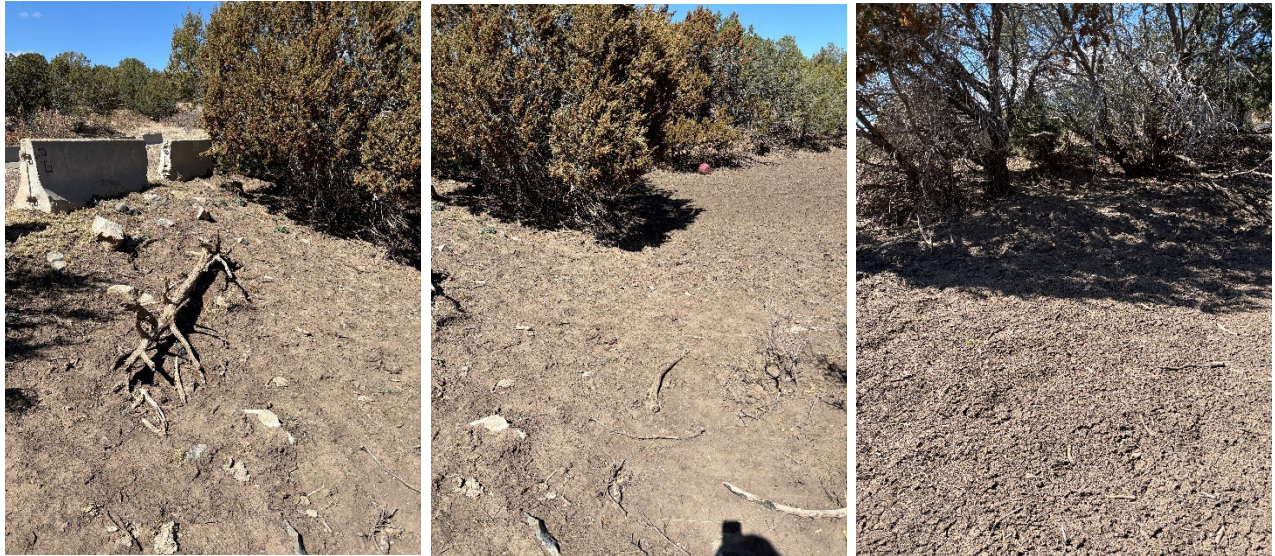
West side: Soil looks like it consistently holds water.

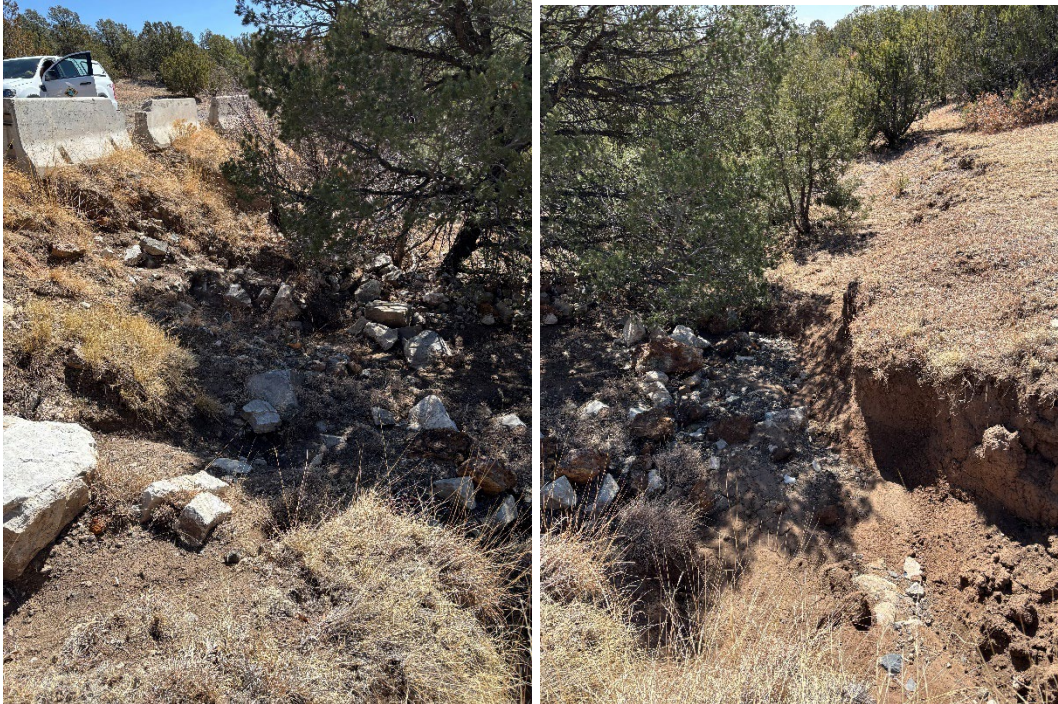
FIGURE 48 VIEW OF WHERE WATER FLOWS OFF ROAD

East Side: Significant erosion occurring as the water drops off the road.
