Subject: Minimal Impact Exploration Permit Termination Report for Tetra Tech Inc., Otero County, NM

Orogrande Garnet Project Termination Report

January 10, 2014

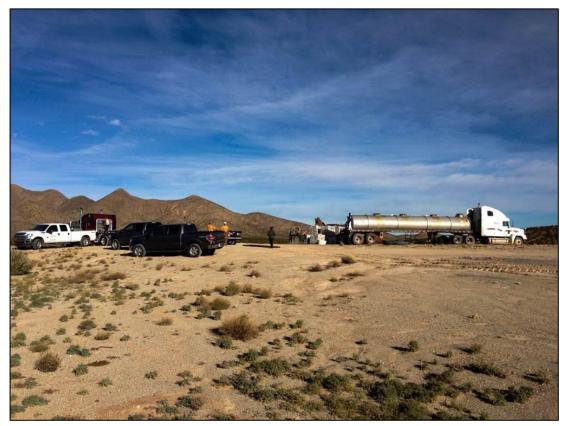
Figure 1: View of staging area during drilling operations

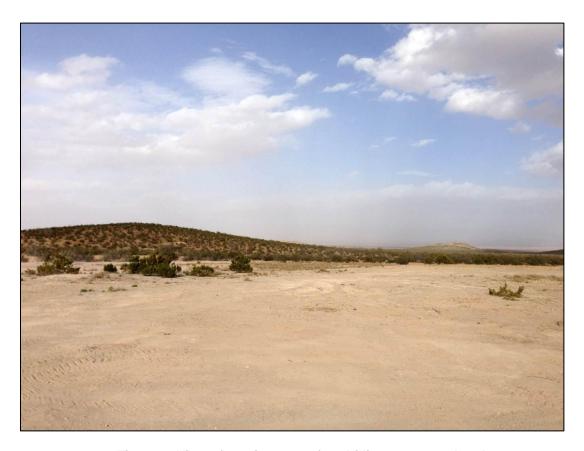
A section of previously disturbed public land at the entrance to the site was used to store equipment that did not have the clearance or four-wheel-drive capabilities to make it to the site. Efforts to have a minimal impact on the site were executed during project activity and all equipment was removed from this area at project completion and the area was returned to its original state. Figures 1 and 2 below shows an before and after image of the staging area.

Figure 2: View of staging area after drilling was completed

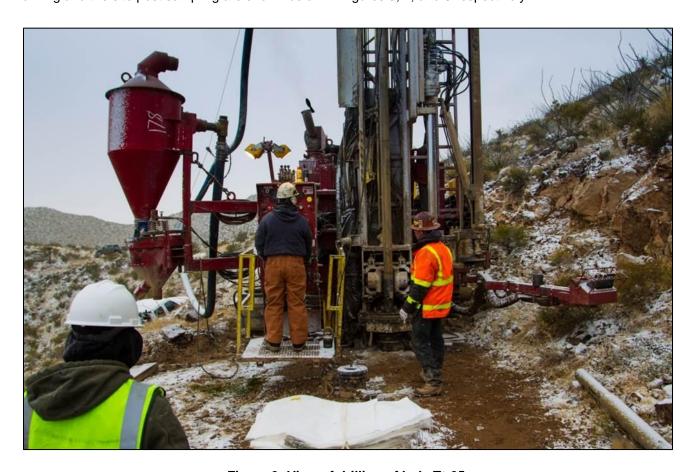
Figure 3: View of drilling of hole Tt-05

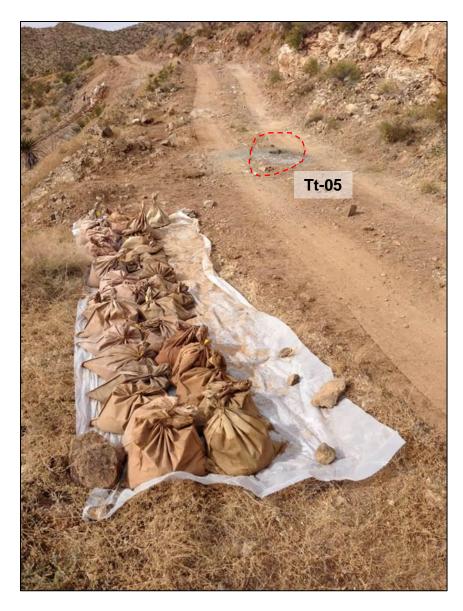
Ten drill sites were proposed for The Project: five exploratory drillholes and five twin drillholes. All ten holes were drilled using an T450GT Crawler drill rig with 5.25 inch diameter holes. Each of the holes were backfilled from total depth to within two feet of ground surface with bentonite chips, and then capped with two feet of cement. Drillhole information is provided in the table and maps below.

Figure 4: View of hole Tt-05 post drilling

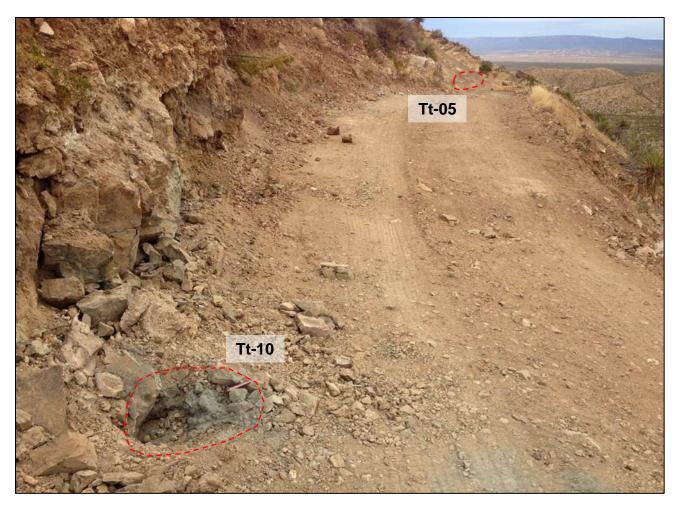
Drill sampling was done following the completion of drilling efforts. At the end of this process, all manmade material, excluding the material used to plug the drillholes, was removed from The Project and the site was returned as close as possible to its original conditions and appearance. Photos of the drilling, the site post drilling and the site post sampling are shown below in Figures 3, 4, and 5 respectively.

Figure 5: View of Tt-05 and Tt-10 post drilling and sampling
