F-33 MINE RECLAMATION REPORT

**ATLANTIC RICHFIELD COMPANY
HOMESTAKE MINING COMPANY**

AUGUST 1994

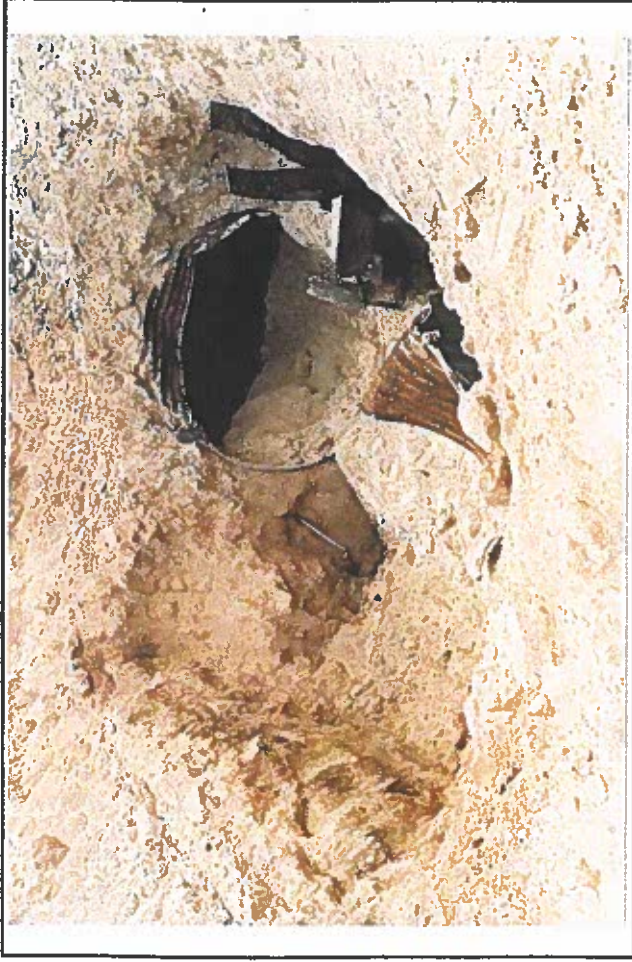
Figure 1 Portal No. 5 Prior to Permanent Closure

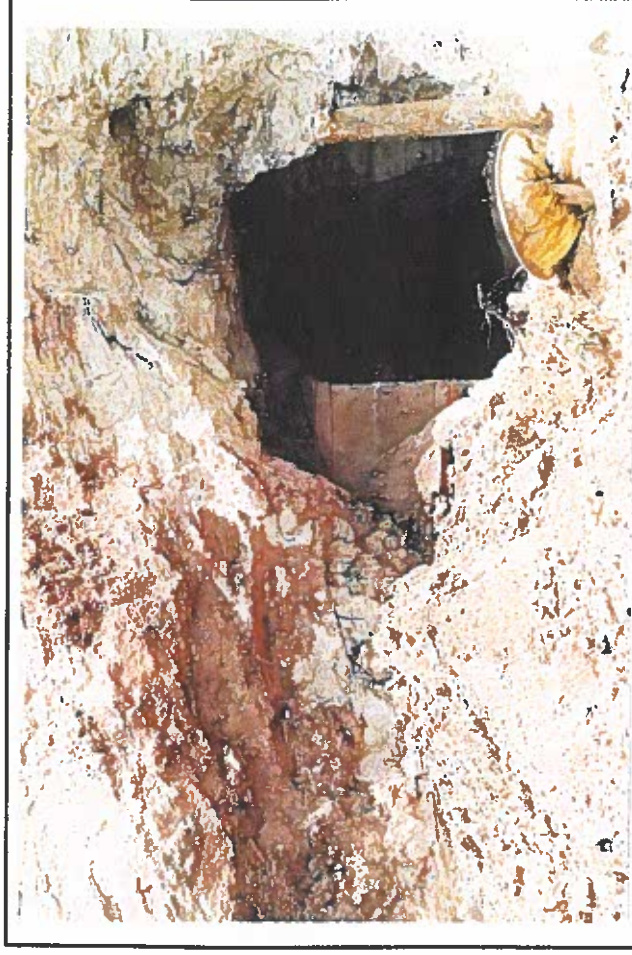
Figure 2 Portal No. 2 Prior to Permanent Closure

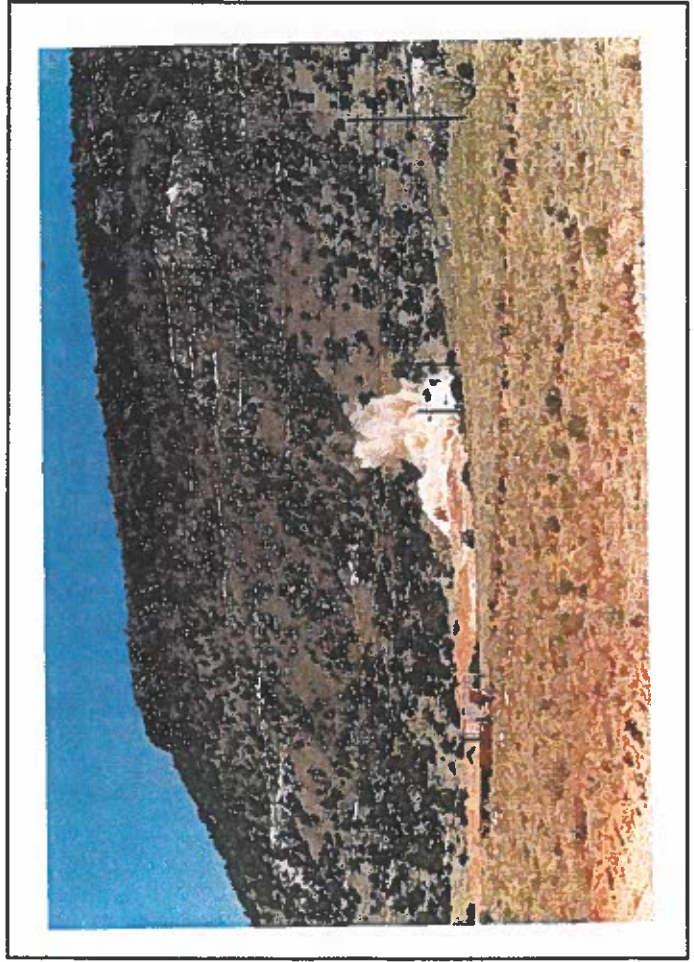
Figure 3 Closure of Portal No. 5

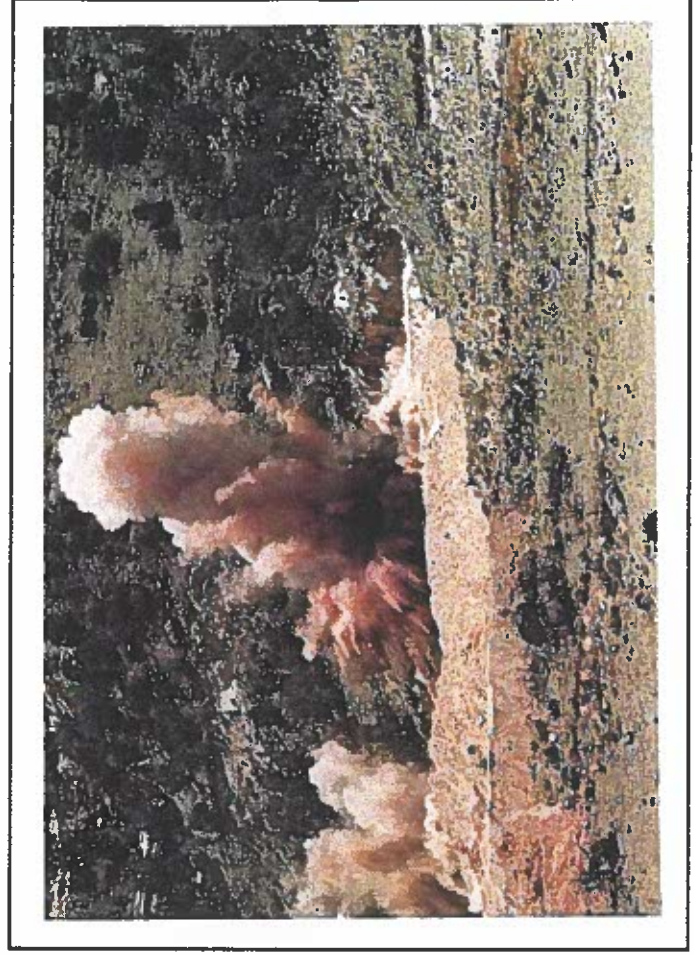
Figure 4 Closure of Portals No. 1 and 2

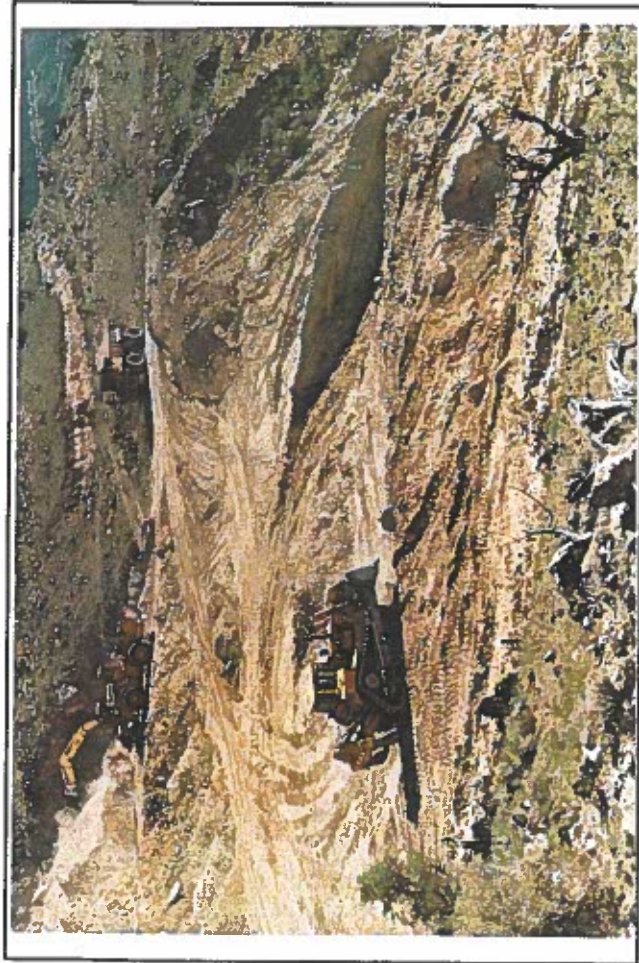
Figure 5 Excavation of Mining Waste Portal No. 4 Area

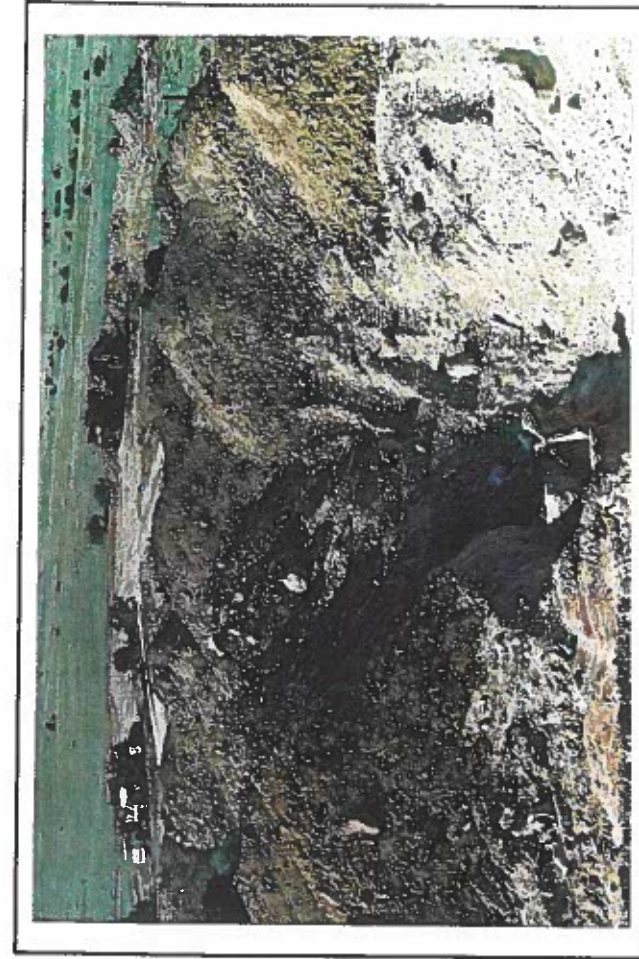
Figure 6 Backfill of Portal No. 5 Cut Area

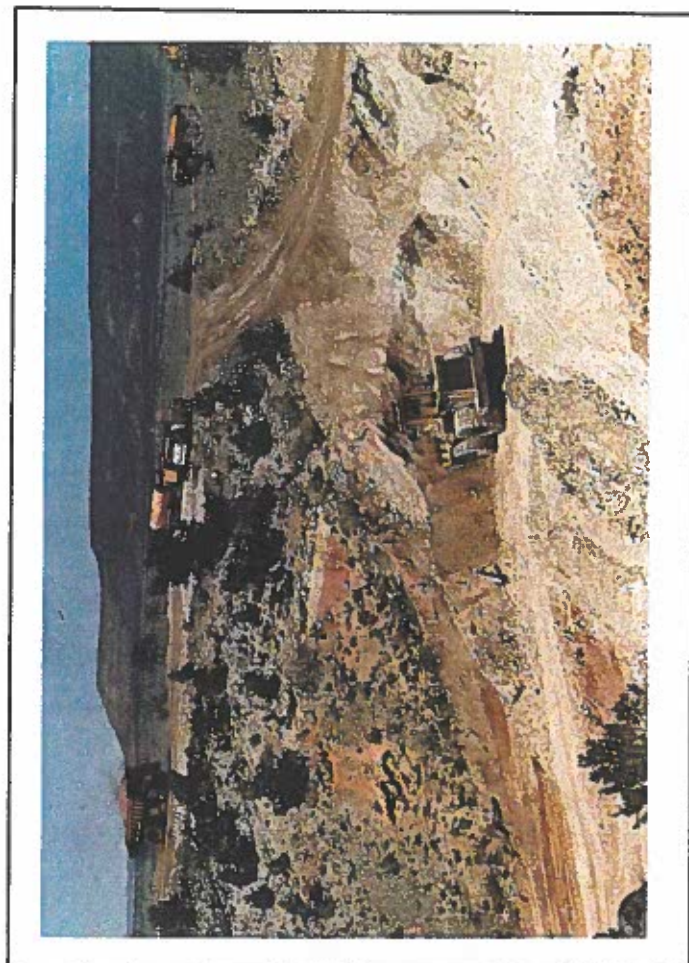
Figure 7 Upper Topsoiling of Ore Stockpile Area; Lower Removal of Mining Waste Portal No. 4 Area

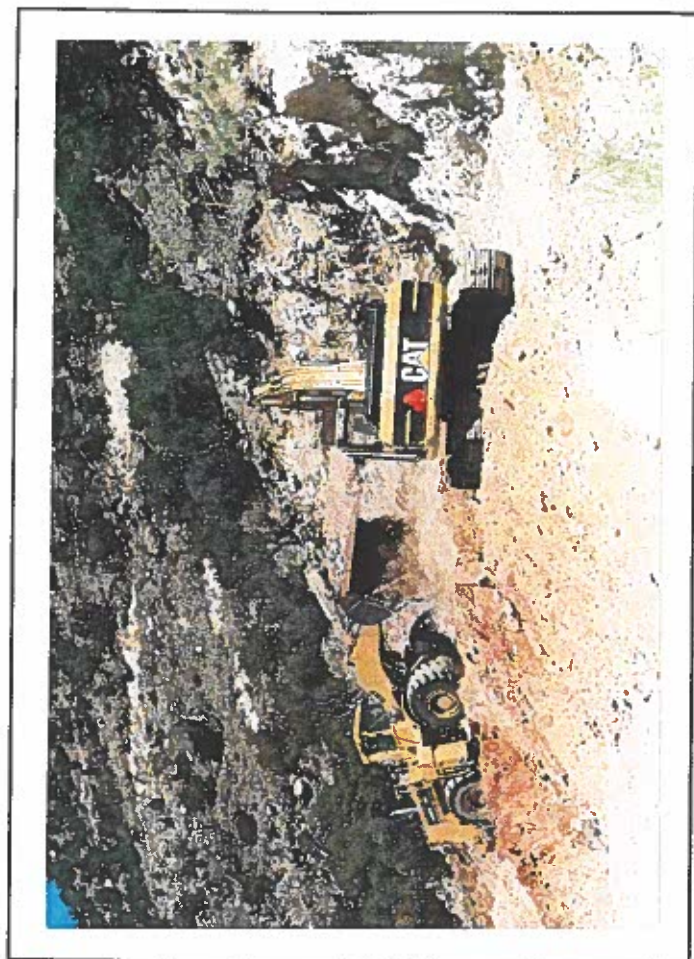
Figure 8 Backfilling of Mining Waste Against Cut Face

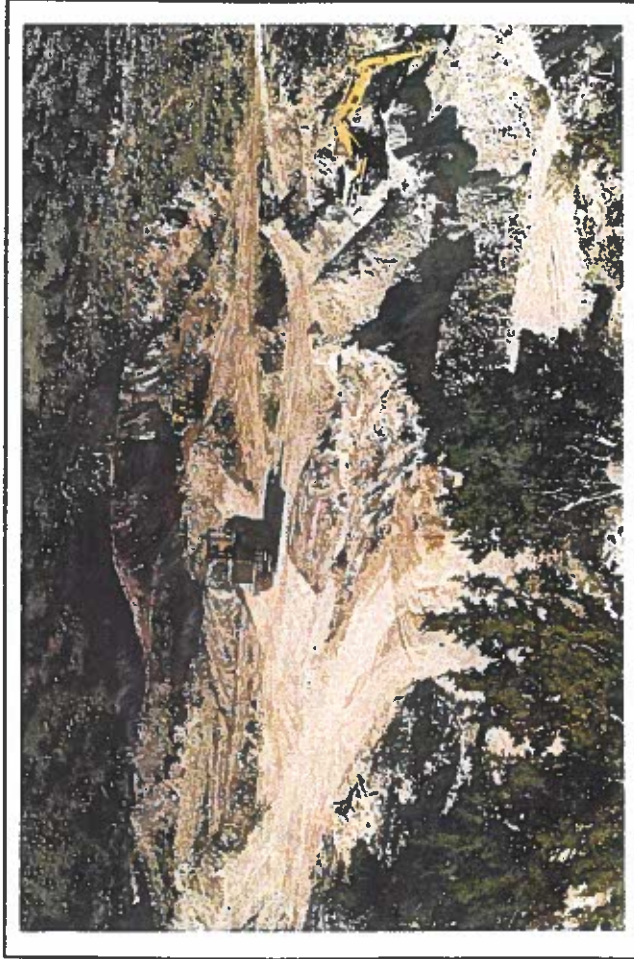
Figure 9 Removal of Mining Waste Portal No. 4 Area

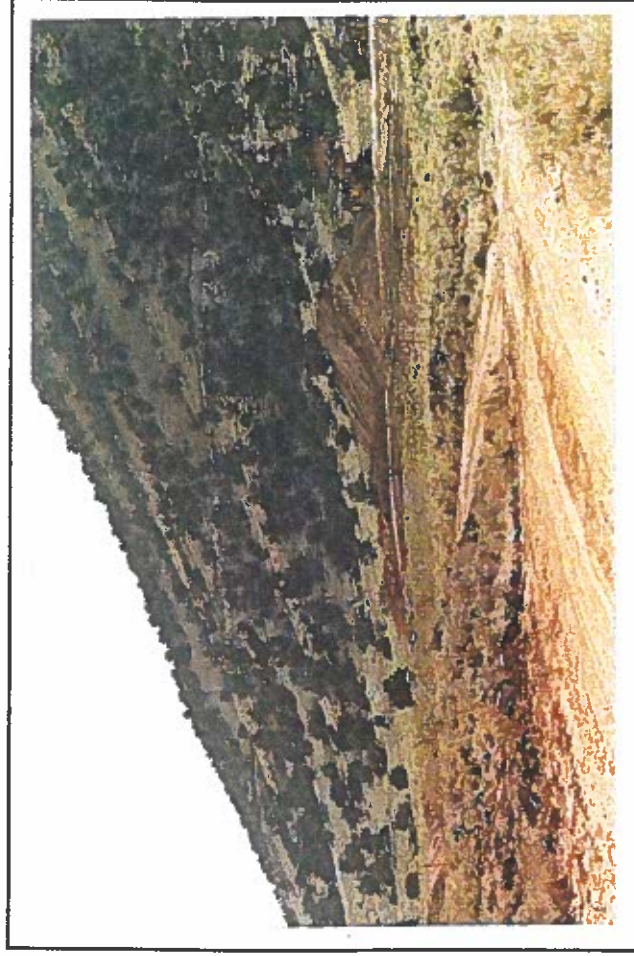
Figure 10 Dozing and Loading of Mining Waste Portal No. 5 Area

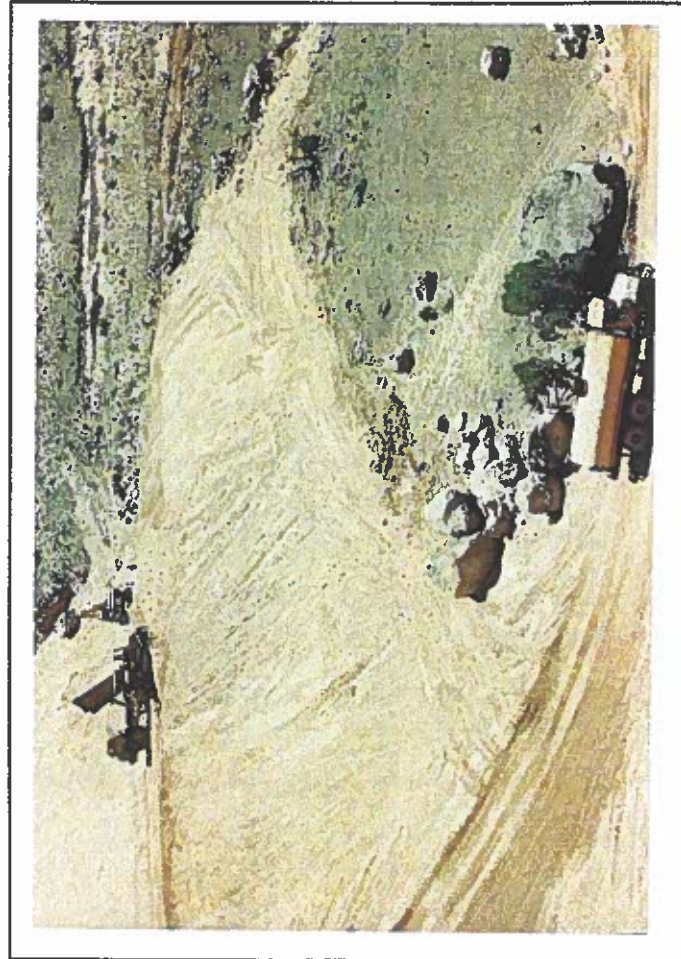
Figure 11 Land Shaping Portal No. 4

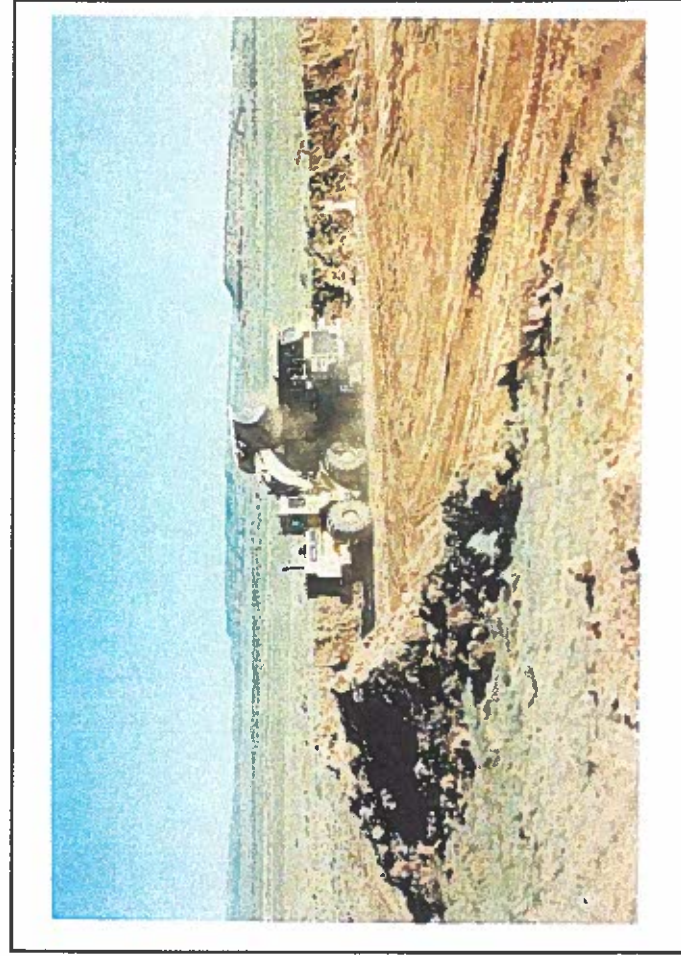
Figure 12 Loading Topsoil at Borrow Area

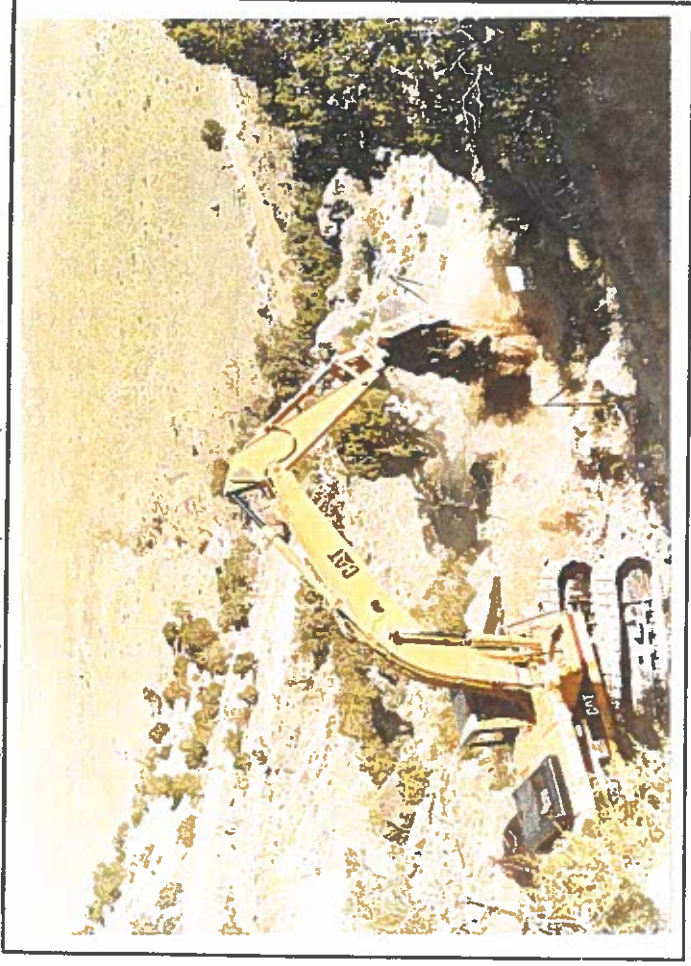
Figure 13 Backfilling Vent Raise

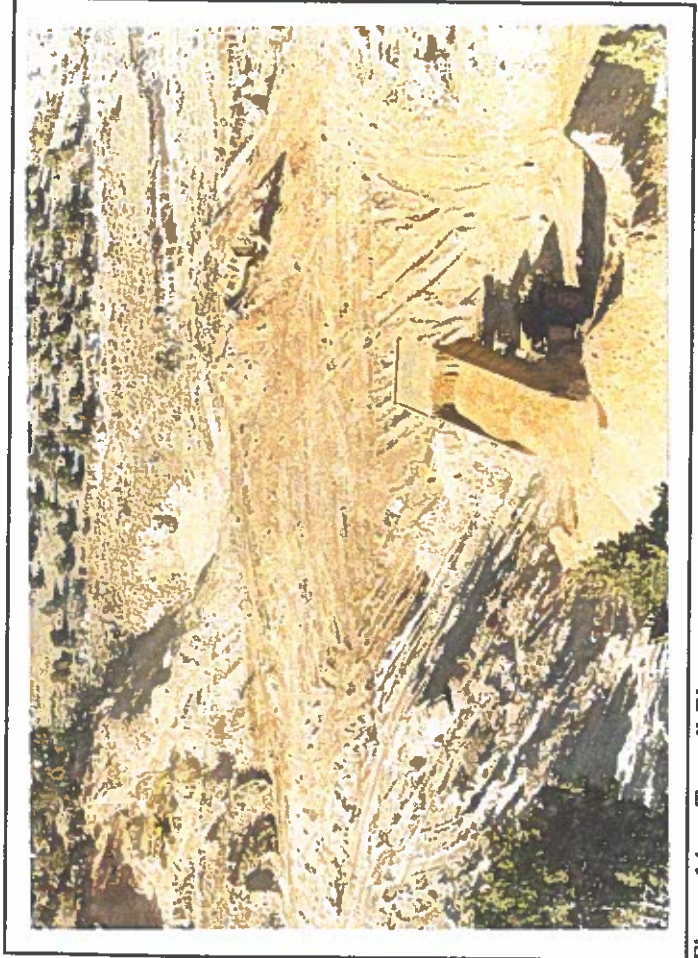
Figure 14 Topsoil Placement

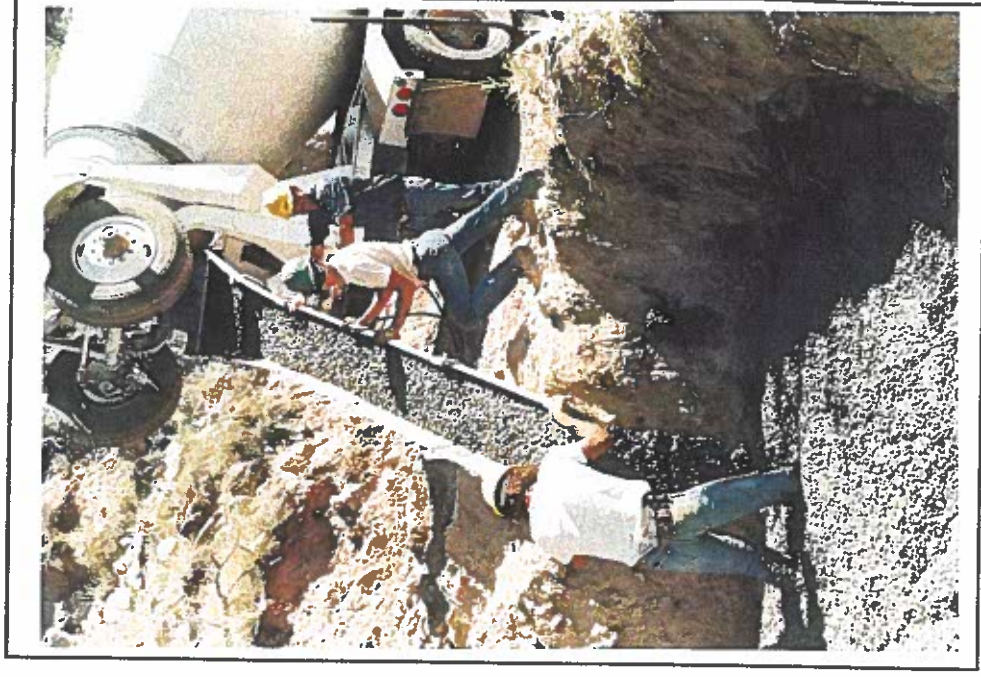
Figure 15 Cement Cap at Vent Raise

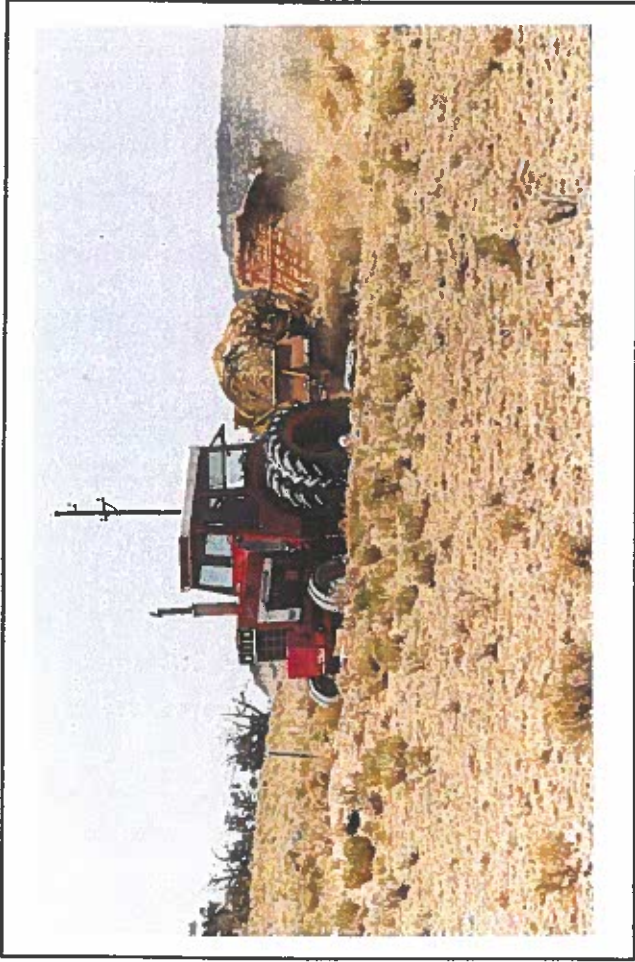
Figure 16 Revegetation Activities

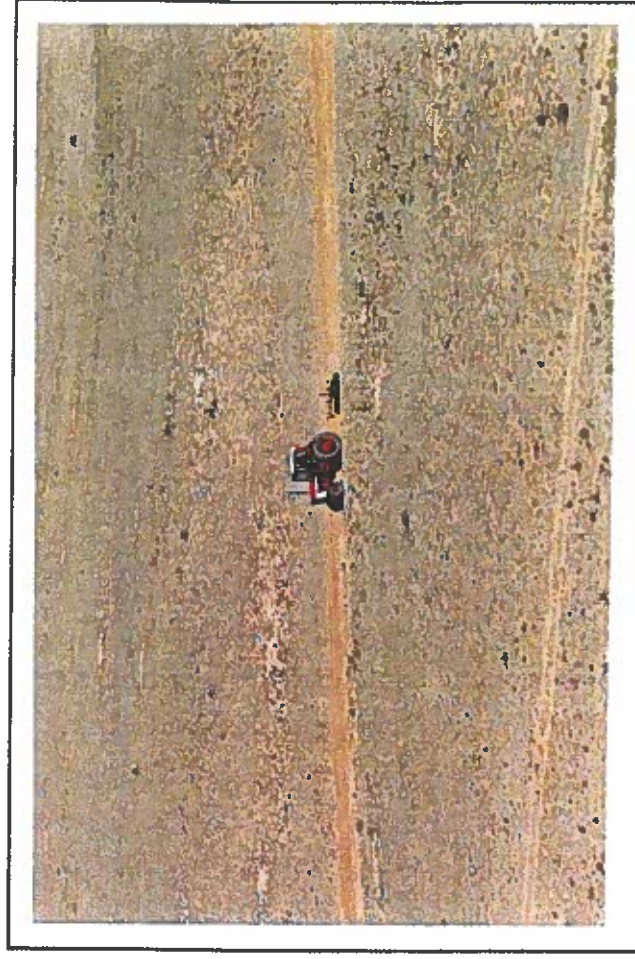
Figure 17 Road Revegetation

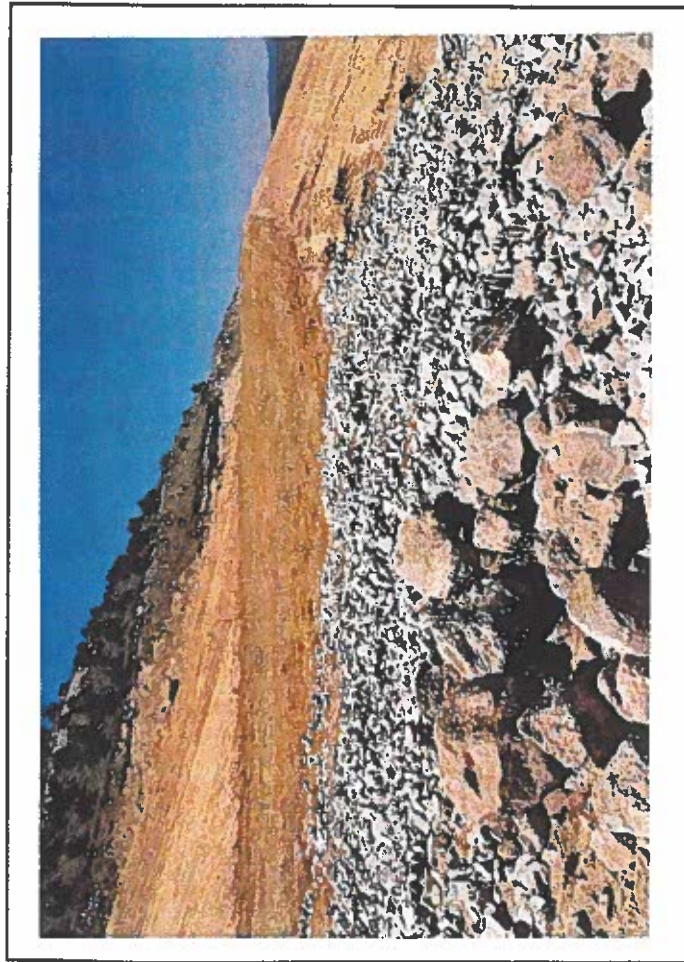
Figure 18 Placed Rip Rap

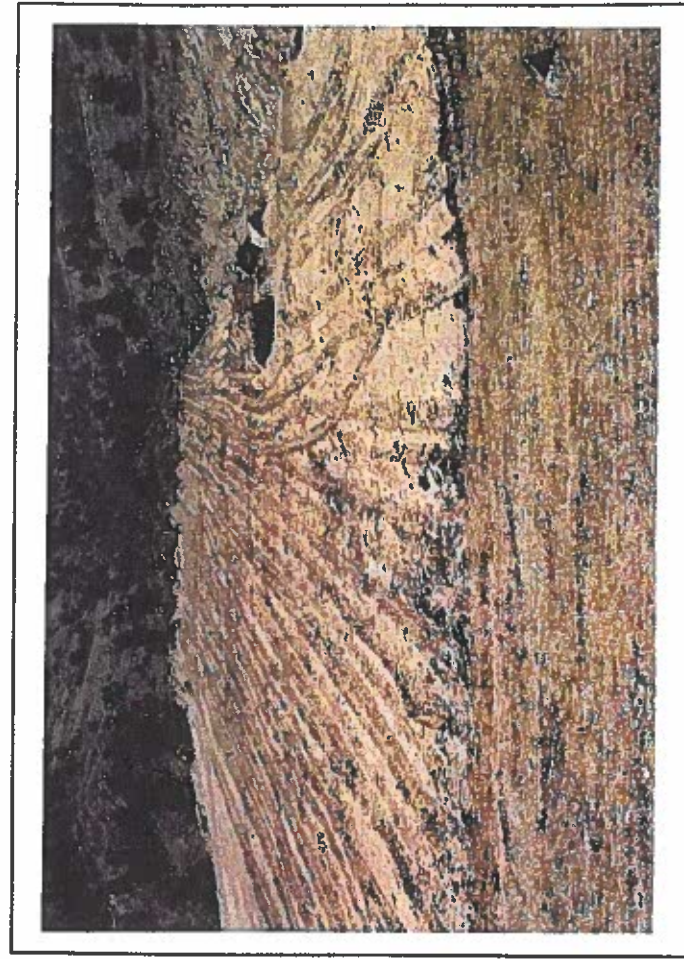
Figure 19 Track Walking of Slopes - Erosion Control

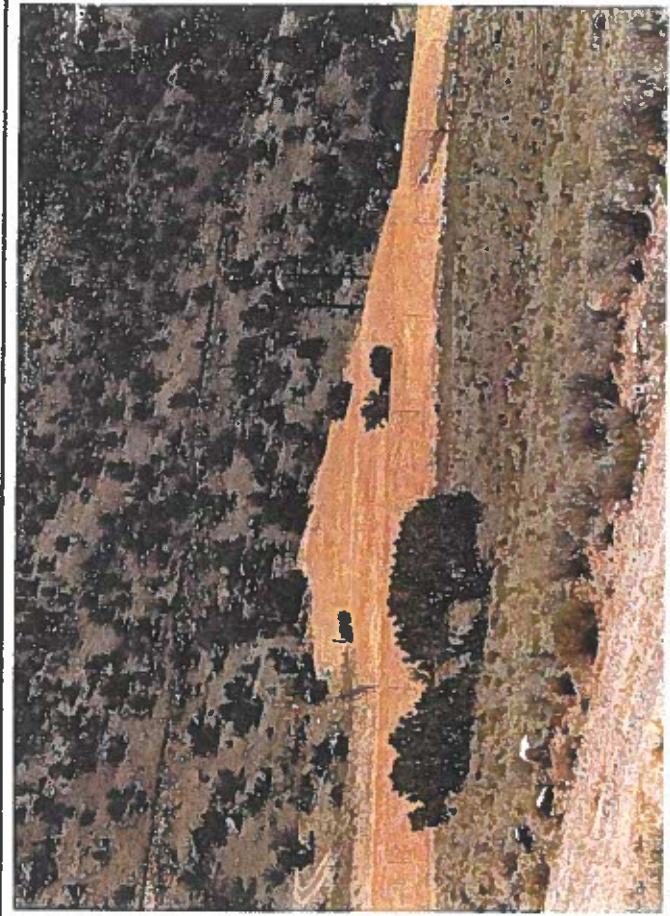
Figure 20 Completed Work Portal No. 5 Area

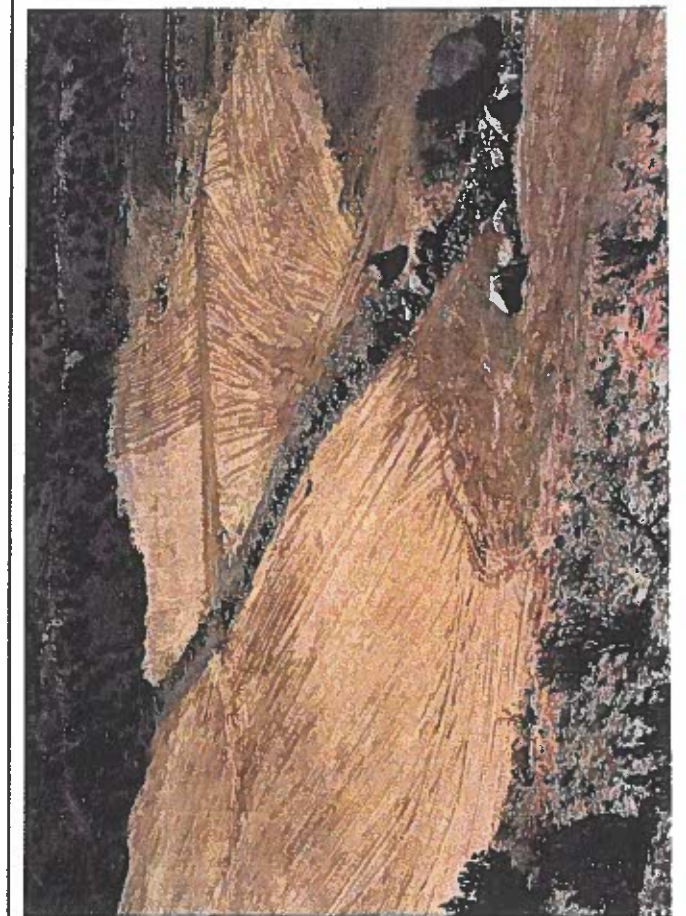
Figure 21 Completed Rip Rap and Gravel Mulch in Drainage Area

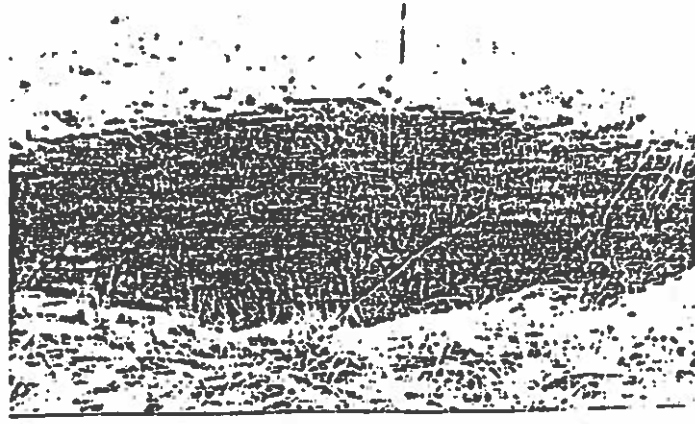
FIGURE 7.2.3: EXAMPLE OF AN OPEN SINKHOLE BEFORE BLASTING
