Construction Quality Assurance Report Lake One Reclamation Chino Mines Company – Hurley, New Mexico

September 19, 2014

**CONSTRUCTION QUALITY ASSURANCE REPORT
LAKE ONE RECLAMATION
CHINO MINES COMPANY – HURLEY, NEW MEXICO**

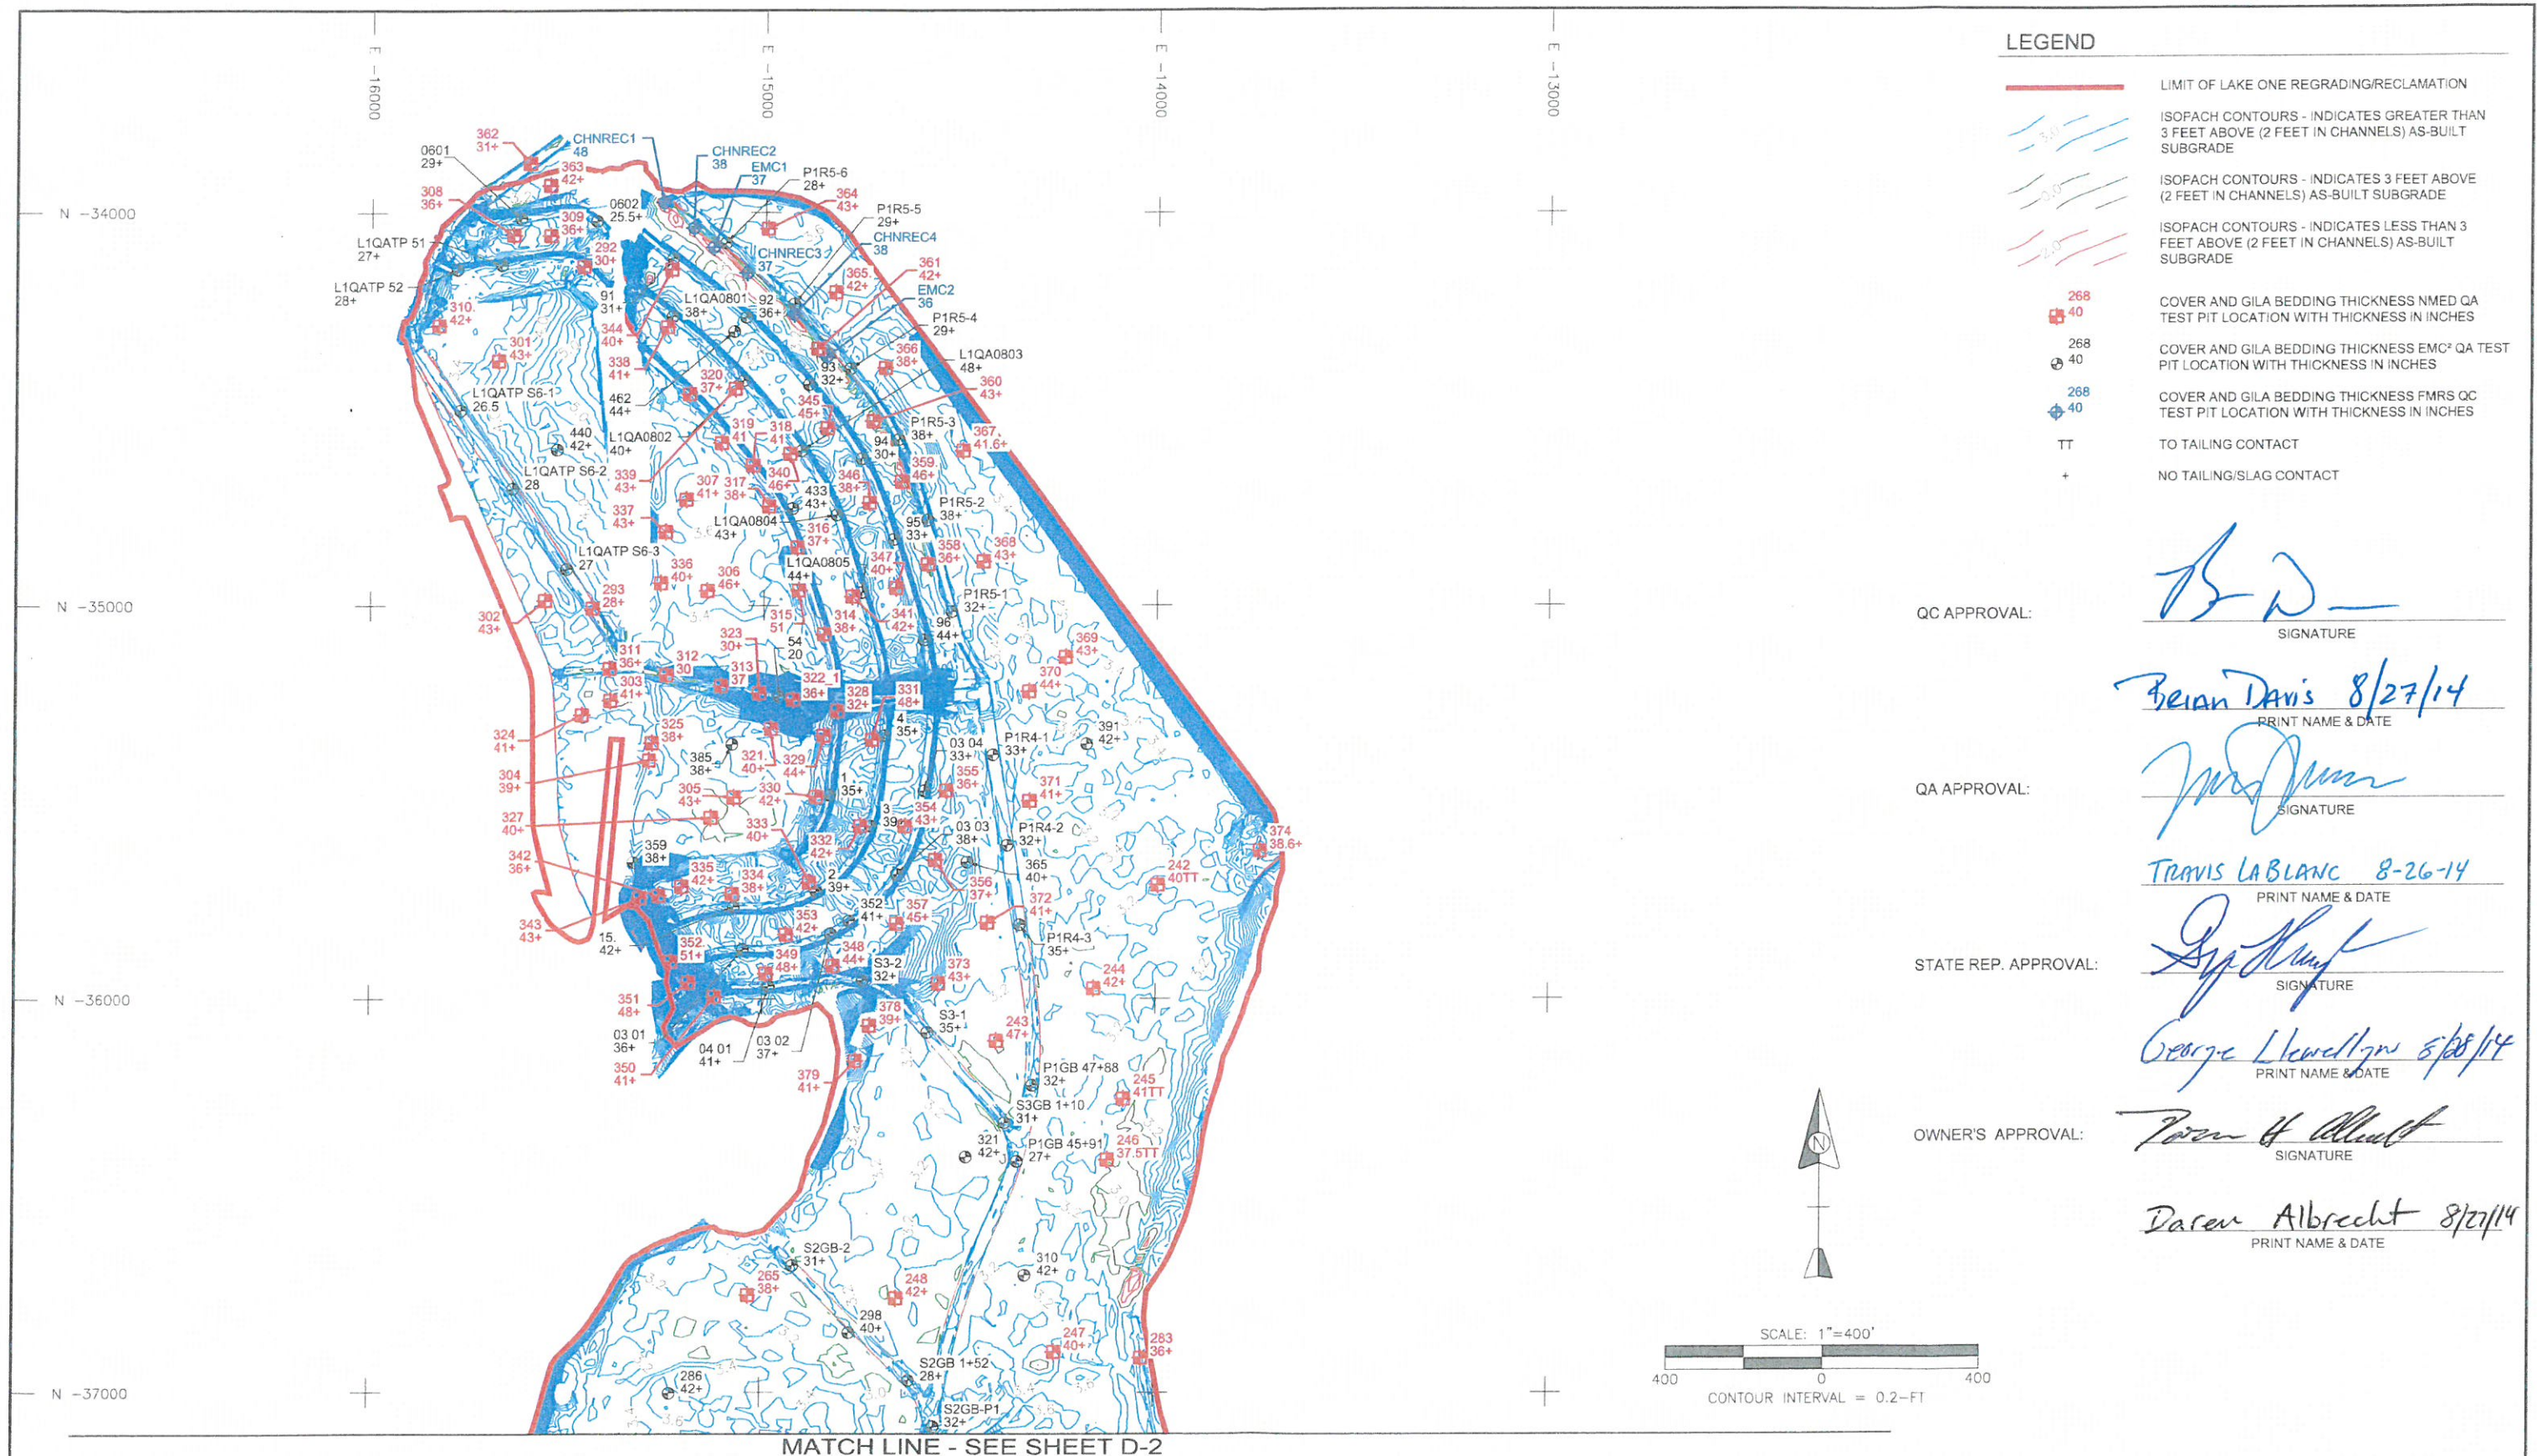
- (1) Since Test Pit 54 indicated a thickness less than 24 inches, additional test pits (322_1 and 323) were performed on either side, which verified that the 24-inch thickness was met.

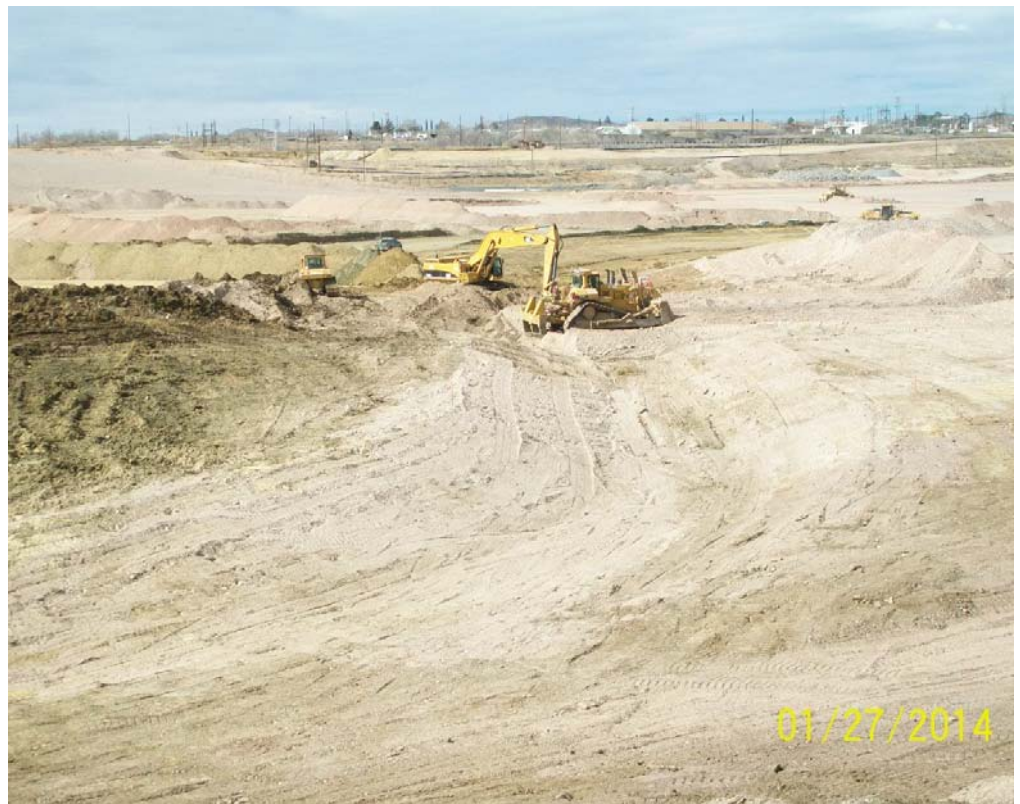
PHOTO 14

January 25 - January 31, 2014
Removal of soft, saturated
tailing material in
Channel P1, Reach 1.

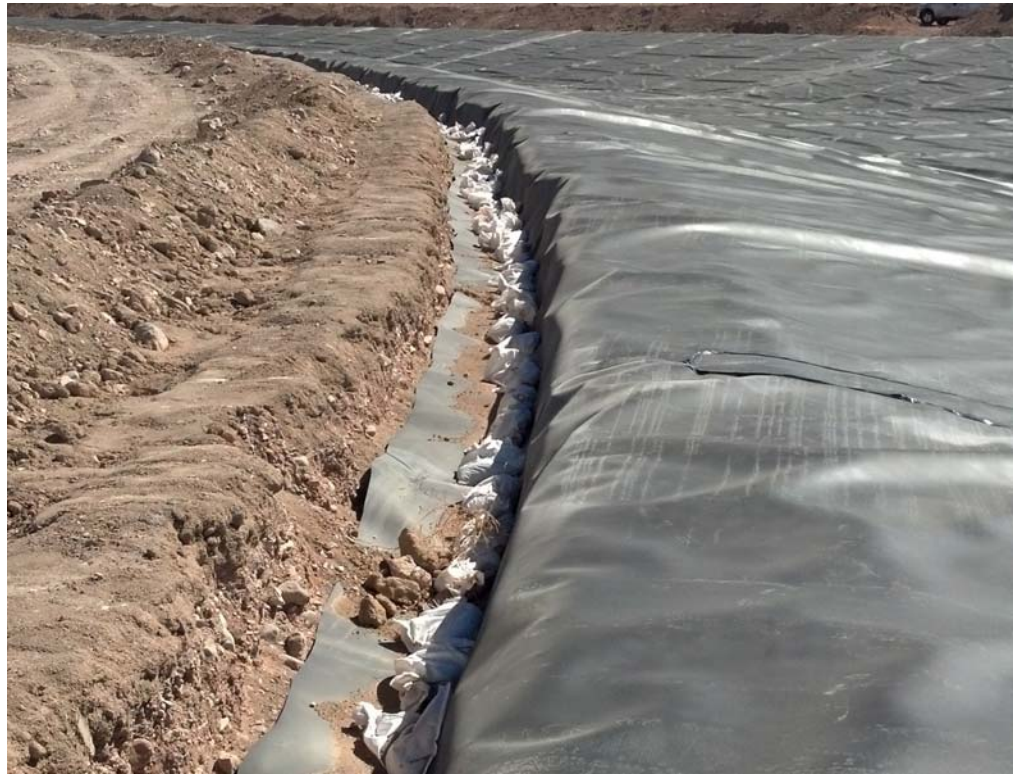
PHOTO 20

February 22 -
February 28, 2014
Placement of
additional sandbags
in the anchor trench
to resist wind gusts.

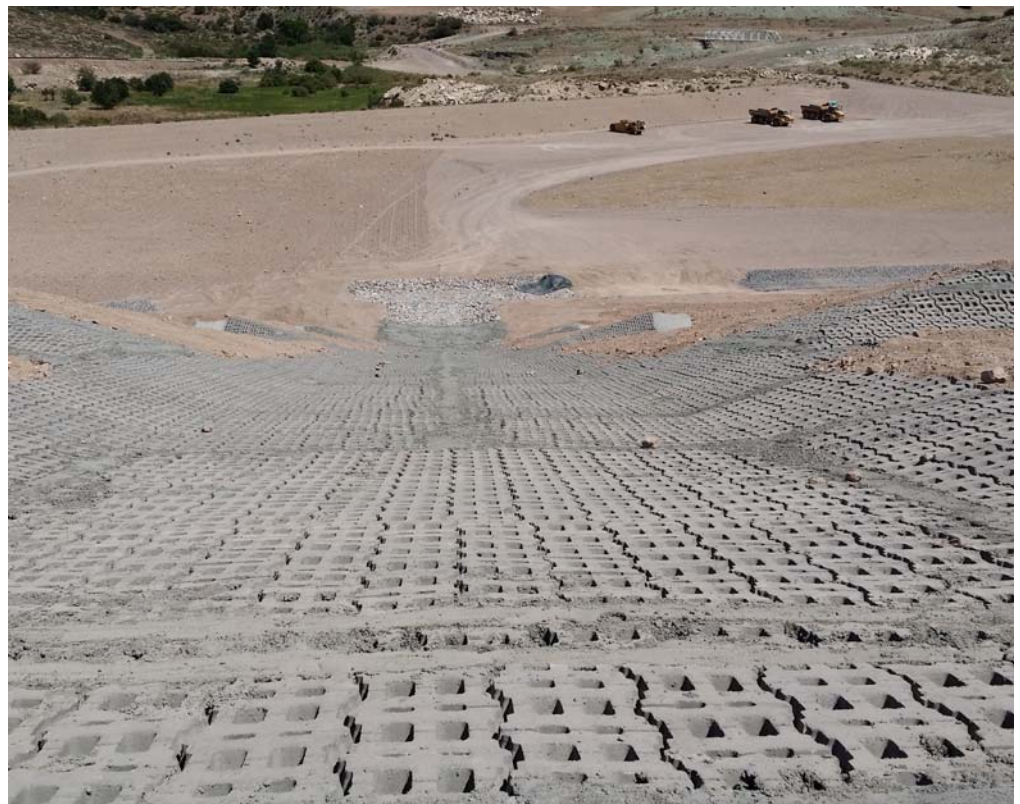
September 2, 2014
Down Drain 2 prior to
filling voids with crusher fines.
