**RE: 2022 Erosion Mitigation Plan for JJ No. 1 Mine, Permit No. CI007RE, Cibola County, New Mexico**

This Plan summarizes the Year 11 inspection summary associated with the erosion monitoring requirements and the recent (August 2022) Site visit, as well as proposed recommendations to mitigate recent, increased erosion at the Site.

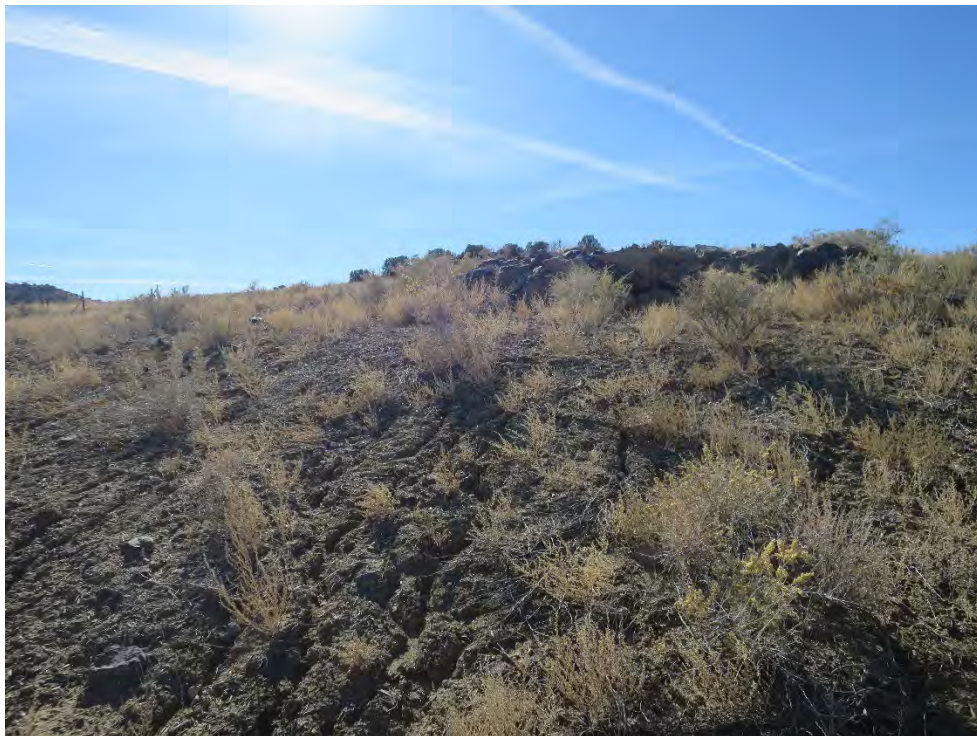
*Photograph 2 - (VS-3 Photo Area A, looking southwest): Rilling and gully formation within fenced area.*

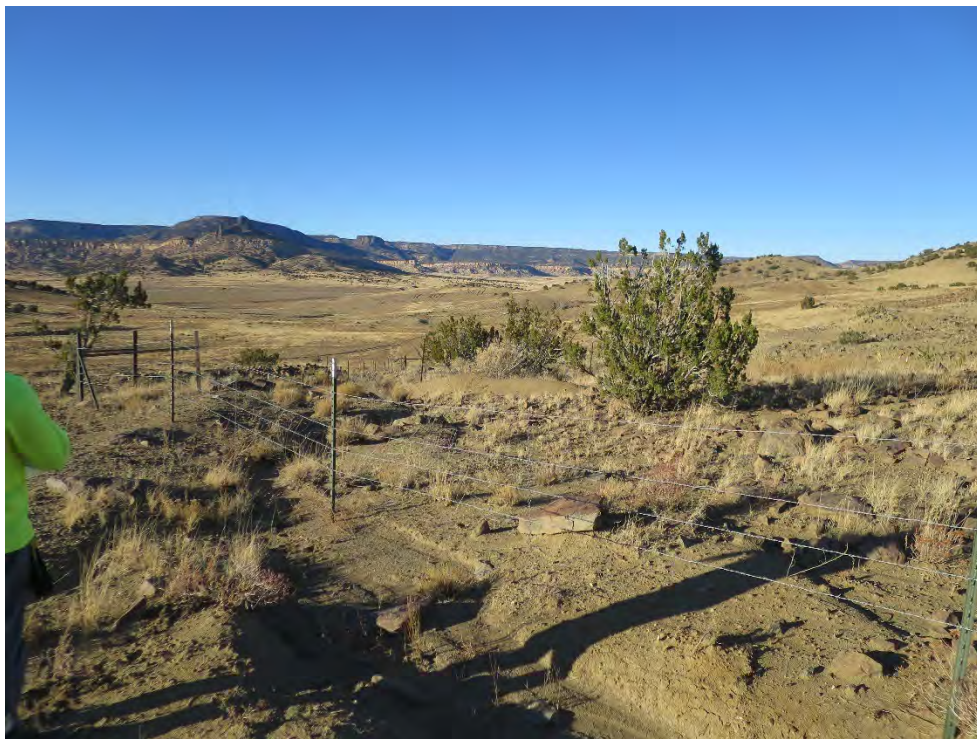
*Photograph 4 - (VS-4 Photo Area A, looking northwest): Shallow channeling within the Reference area, entering the VS-4 Reclamation fence line. The natural drainage channel runs along the western side VS-4.*

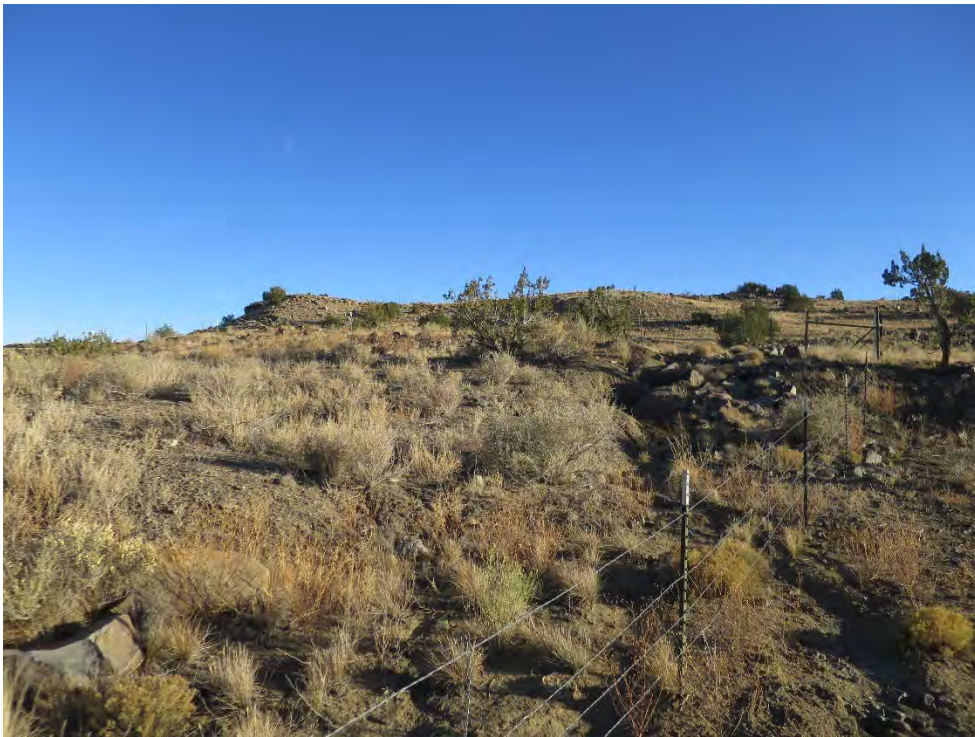
*Photograph 6 - (VS-4 Photo Area C, looking southeast): Pre-existing channeling within the Reference Area north of the Reclamation fence.*

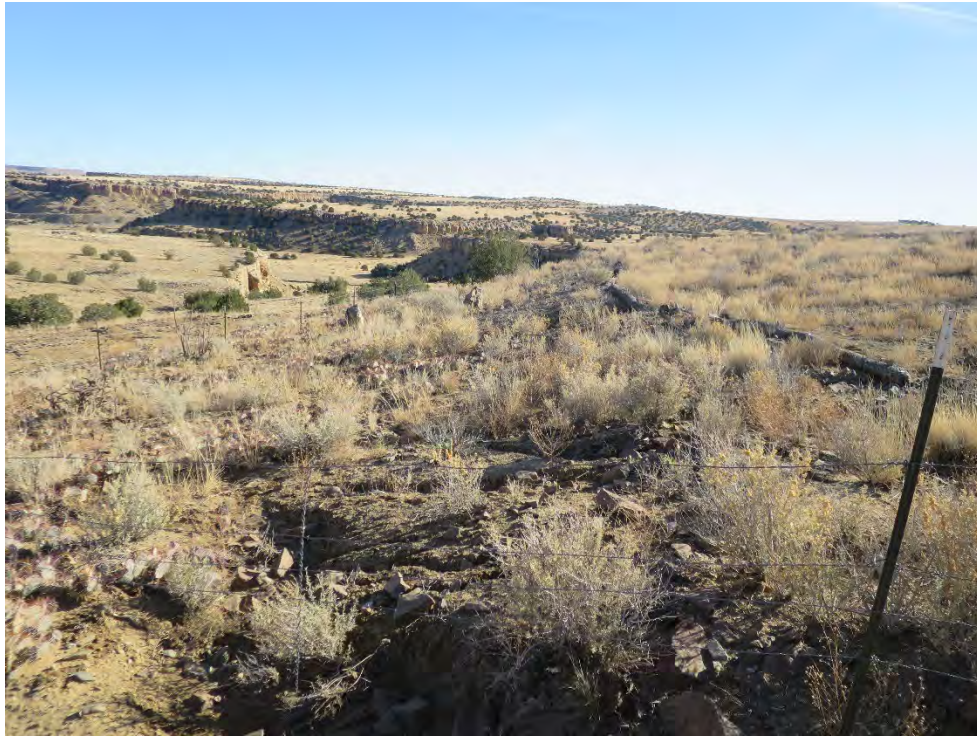
*Photograph 7 - (VS-5 Photo Area A, looking south): Sheet flow erosion visible within VS-5 fence line despite rock armor and vegetation.*

VS-5	Interrilling and rilling along western area of fenced area. Rilling and channeling noted, despite rock check dams. See Photo Nos. 7 - 10; Figures 3 and 4.	<ul style="list-style-type: none"> <li>• Add seed and matting to lightly to moderately rilled areas.</li> <li>• Add wattles above rock armor out fall area within fence line to try to mitigate.</li> </ul>		X	X	X			
VS-6	Gully erosion (Photograph Location A) within the revegetation fenced area despite existing rock check dams. Rills and channels forming below rock check dams. See Photo Nos. 11 - 12; Figure 3.	<ul style="list-style-type: none"> <li>• Add seeding in and wattles across the rills/channels forming below the existing rock check dam area.</li> <li>• Add matting to this area.</li> <li>• Place additional rock armoring in water conveyance pathways.</li> </ul>		X	X	X		X	X
VS-7	No major erosion Issues within fenced area. See Photo No. 13; Figure 4.	None at this time.

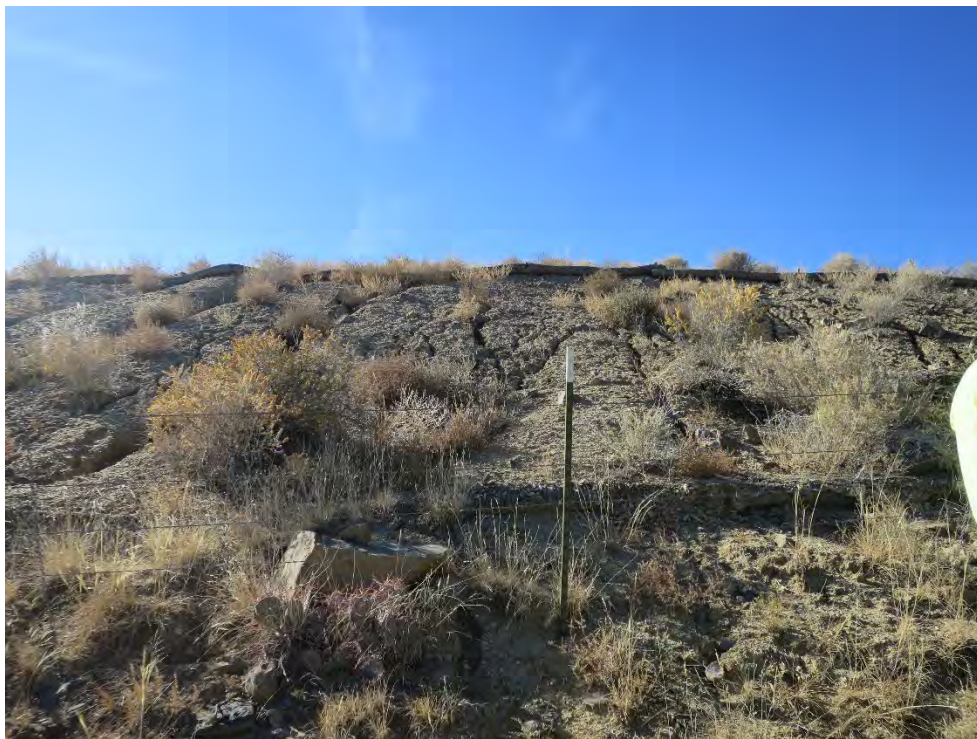
*Photograph 8 - (VS-5 Photo Area B, looking west): Interrill and gully formation on slope below wattles within the fence line.*

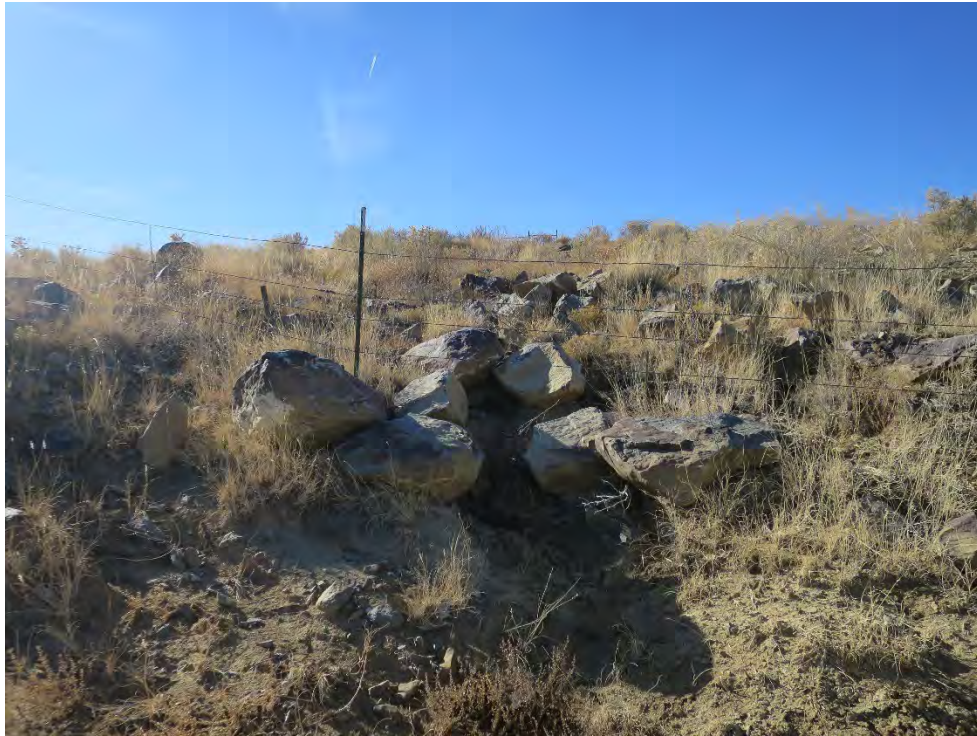
*Photograph 9 - (VS-5 Photo Area C, looking west): Moderate undercutting starting within armored zone within the fenced area.*

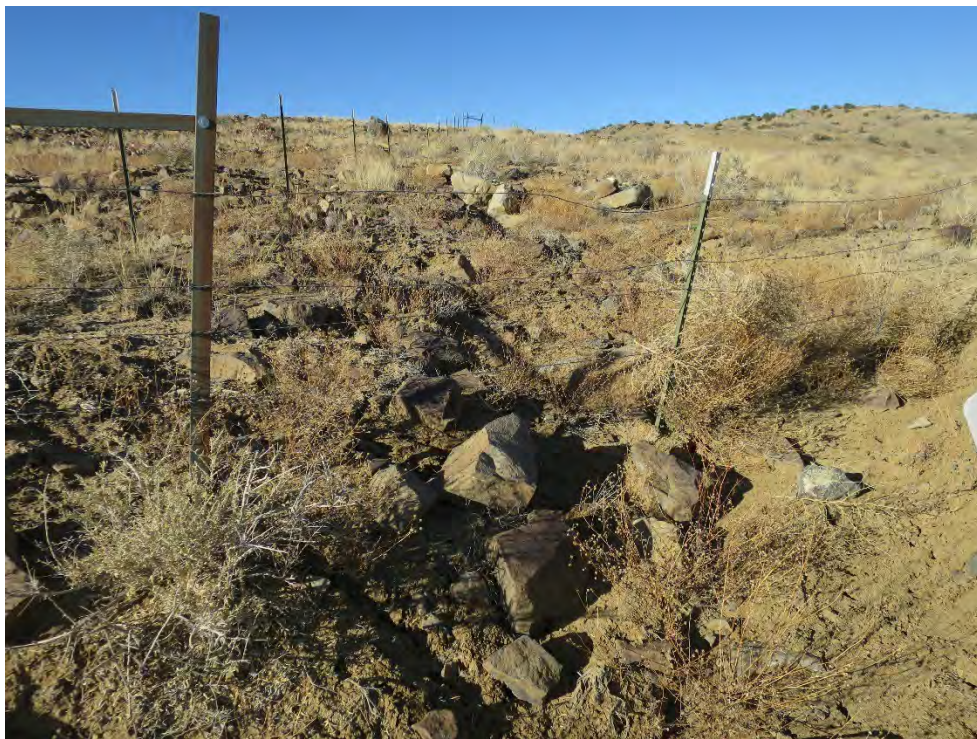
*Photograph 10 - (VS-5 Photo Area D, looking northwest): Rill and gully formation within the southern corner of the fenced area.*

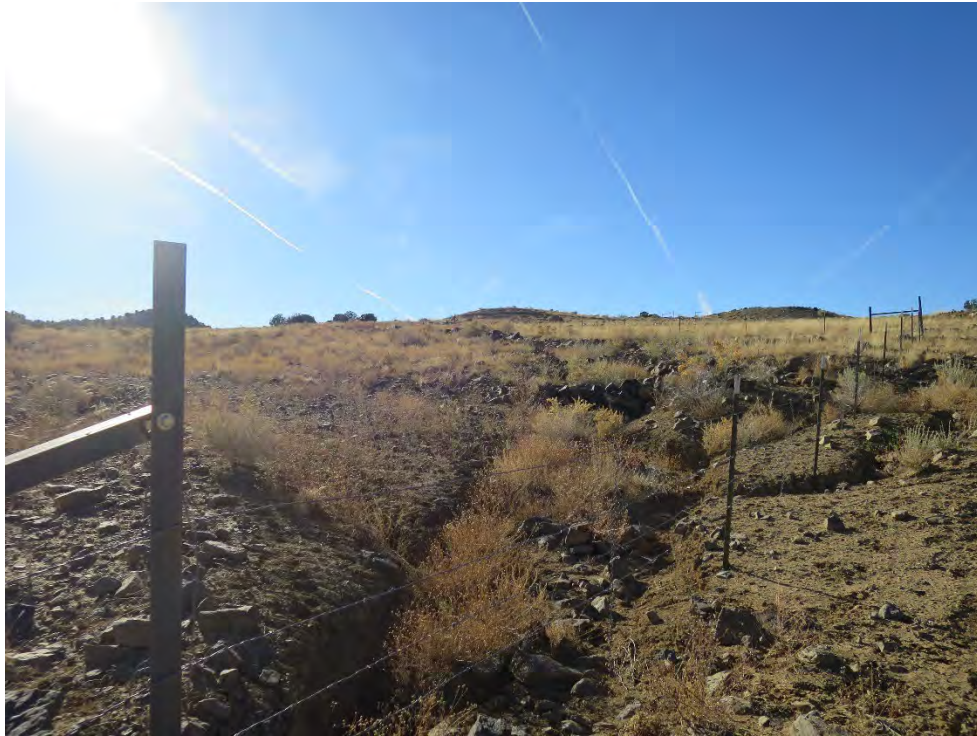
*Photograph 11 - (VS-6 Photo Area A, looking west): Gully erosion occurring despite three check dams within fenced area. Channels are part of the natural drainage along the northwestern and northern area of the fenced area.*

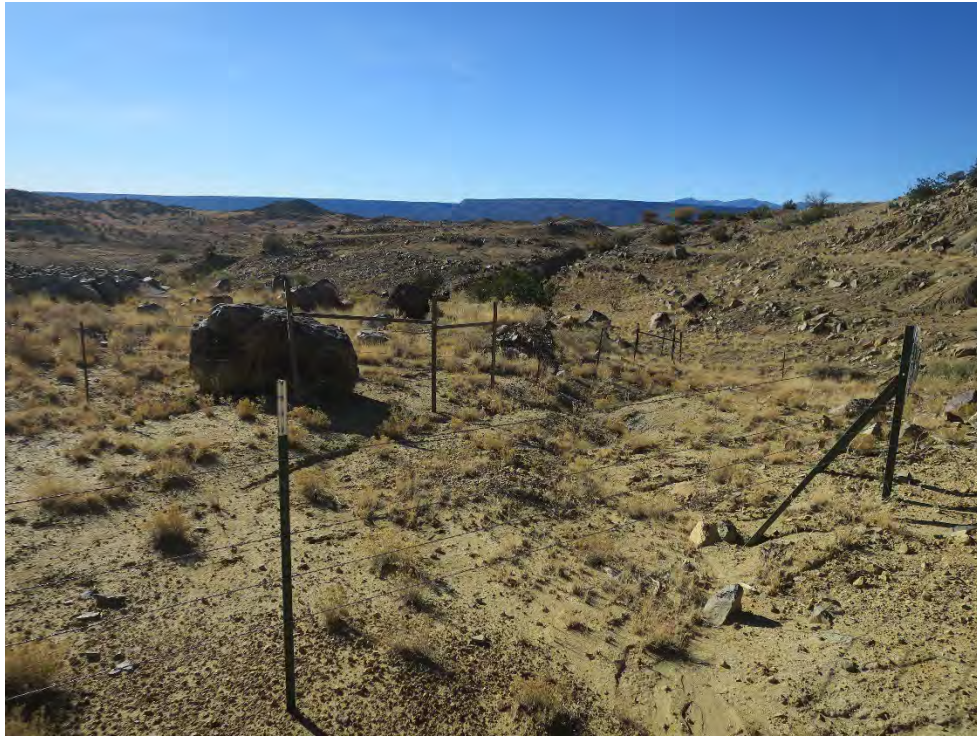
*Photograph 15 - (VS-9 Photo Area A, looking west): Interrill erosion within Reference Area fence line; erosional flow existed prior to fence installation.*

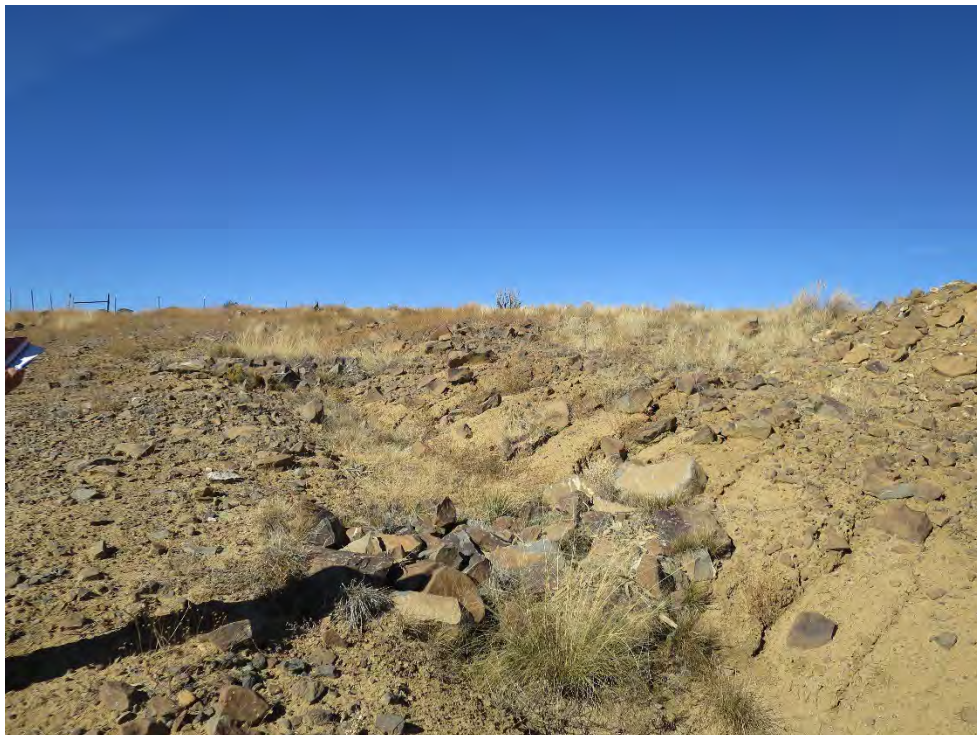
*Photograph 18 - (VS-10 Photo Area B, looking west): Series of small rock check dams, with interrill-rill formation. The rill severity decreases as the slope flattens.*

VS-8	No major erosion Issues within fenced area. See Photo No. 14; Figure 4.	None at this time.							
VS-9	No major erosion Issues within fenced area. See Photo Nos. 15 - 16; Figure 5.	None at this time.							
VS-10	Deep rilling and channels forming, especially along steep slopes. See Photo Nos. 17 - 27; Figures 7 and 8.	<ul style="list-style-type: none"> <li>• Add to bolster check dams.</li> <li>• Add bales, wattles, and seed to channels to slow erosion and furhtering channel severity.</li> <li>• May require equipment and berm repair.</li> <li>• Place additional rock armoring in water conveyance pathways.</li> </ul>	X	X	X	X	X	X	X
VS-11	Rilling erosion noted within fenced reference area and the east side of VS-11 (Photograph Location C). See Photo Nos. 28 - 30; Figure 7.	<ul style="list-style-type: none"> <li>• Repair wattles along the fenceline.</li> </ul>		X					
VS-12	Increased rilling erosion along steep slope. Deeper gully erosion on the east side. See Photo Nos. 32 - 39; Figure 8.	<ul style="list-style-type: none"> <li>• Add additional wattles parallel to crest of slope that has rilling.</li> <li>• Add seeds and matting to slope and seed the deeper channels that have formed.</li> <li>• Add additional haybales where erosion has bypassed the existing hay bale.</li> <li>• Add check dams or create water bars outside of and above the fenced area where a significant erosional channel enters VS-12. This may help to slow the energy of the water or help to divert water away from VS-12.</li> <li>• Focus on steep slopes with matting and seeding.</li> <li>• Place additional rock armoring in water conveyance pathways.</li> </ul>	X	X	X	X	X	X	X

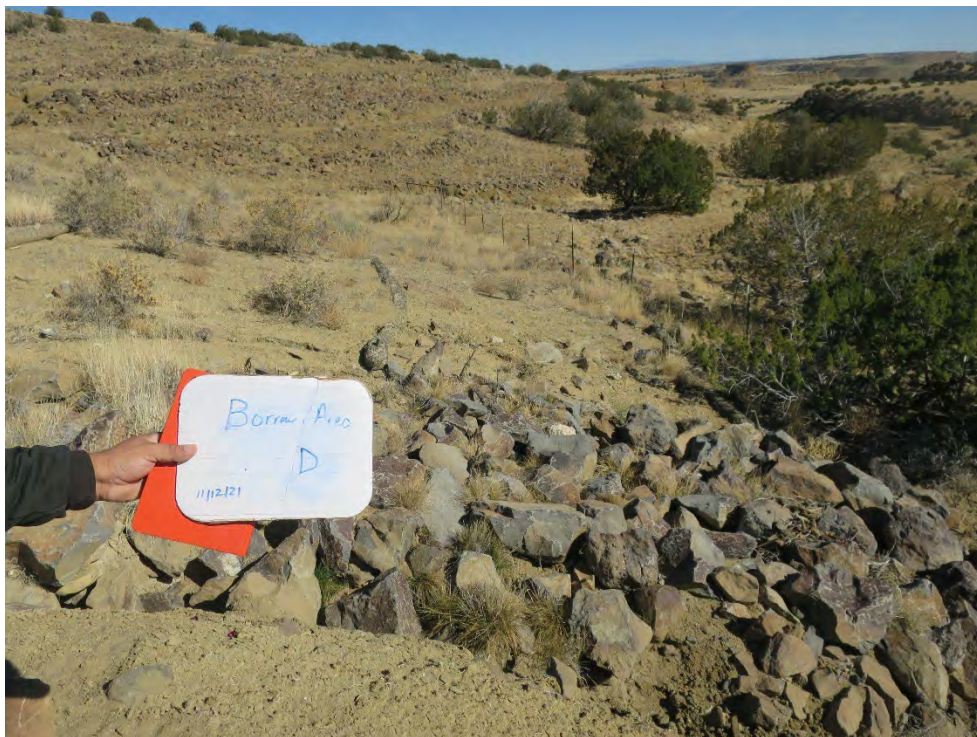
*Photograph 20 - (VS-10 Photo Area D, looking east): Undercut and rilling along edge of existing rock armor.*

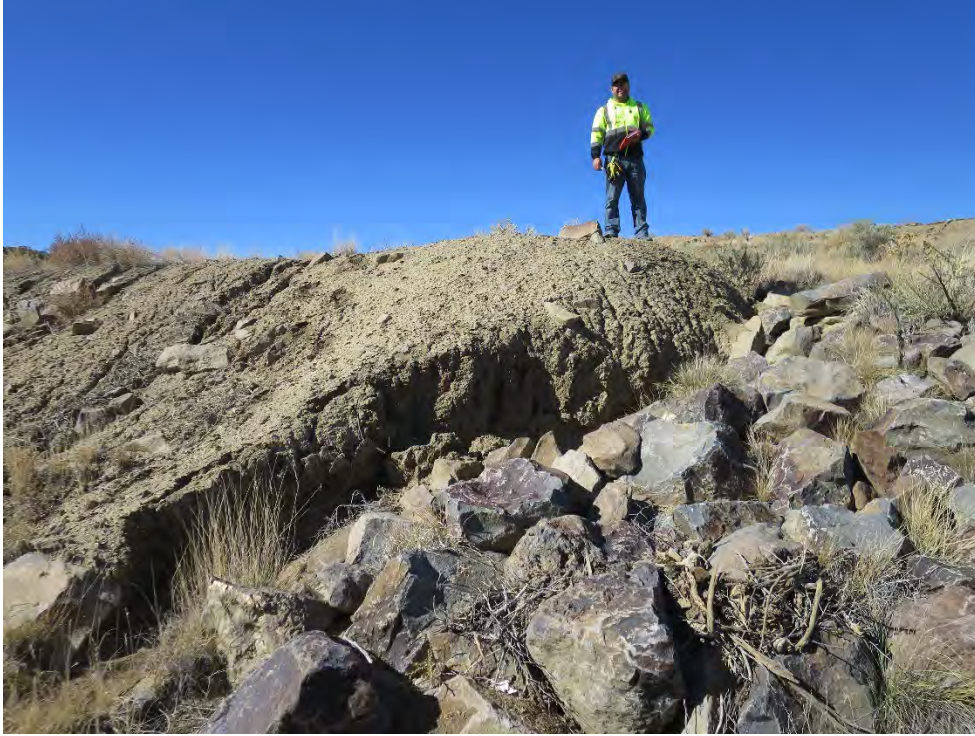
*Photograph 21 - (VS-10 Photo Area D, looking northwest): Gully erosion along edge of existing rock armor, forming channels into slope.*

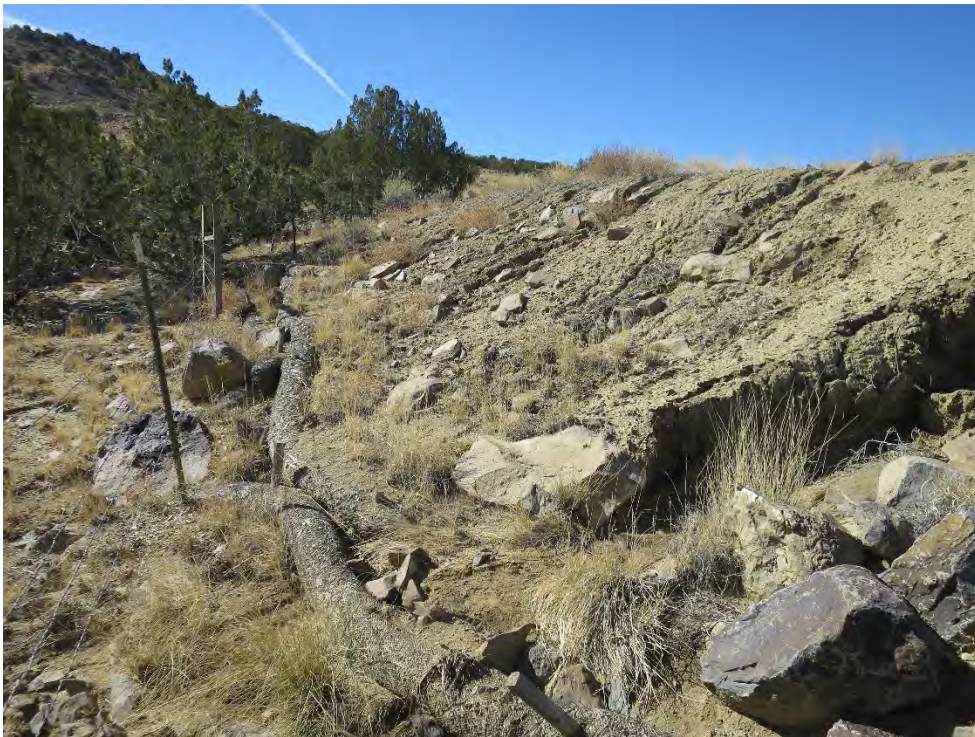
*Photograph 22 - (VS-10 Photo Area D, looking east): Toe of slope in which a 3' deep channel has formed near the southeast fence line.*

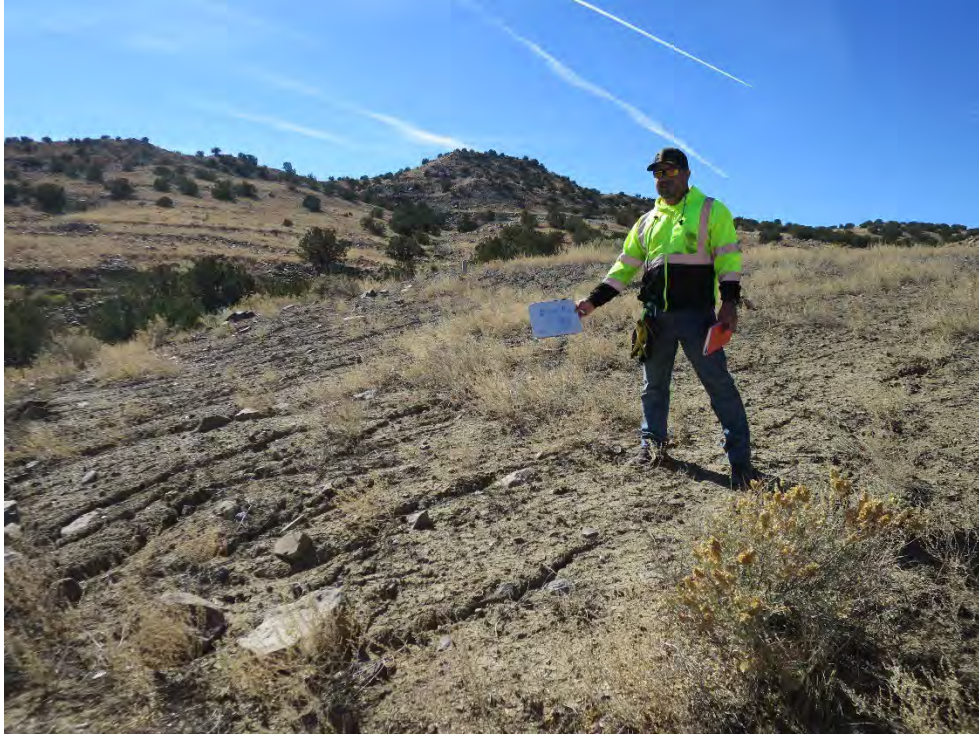
*Photograph 23 - (VS-10 Photo Area E, looking south): Interrilling along gentle sloped area.*

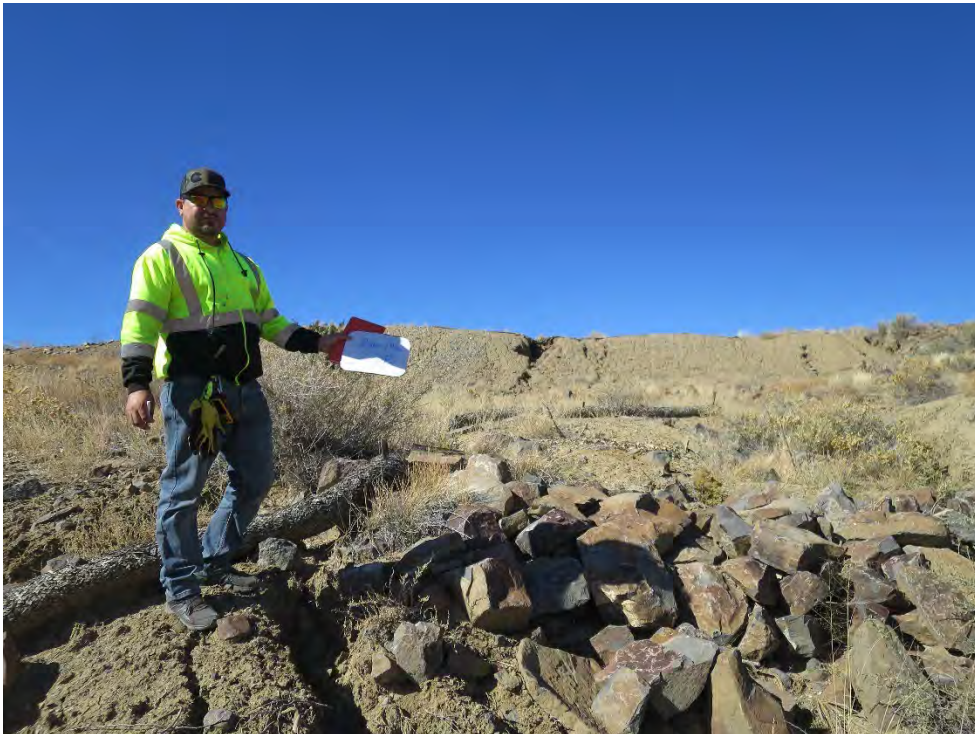
*Photograph 24 - (Borrow Area/VS-10 Photo Area F, looking northeast): Significant gully erosion, creating channels along steeper slopes.*

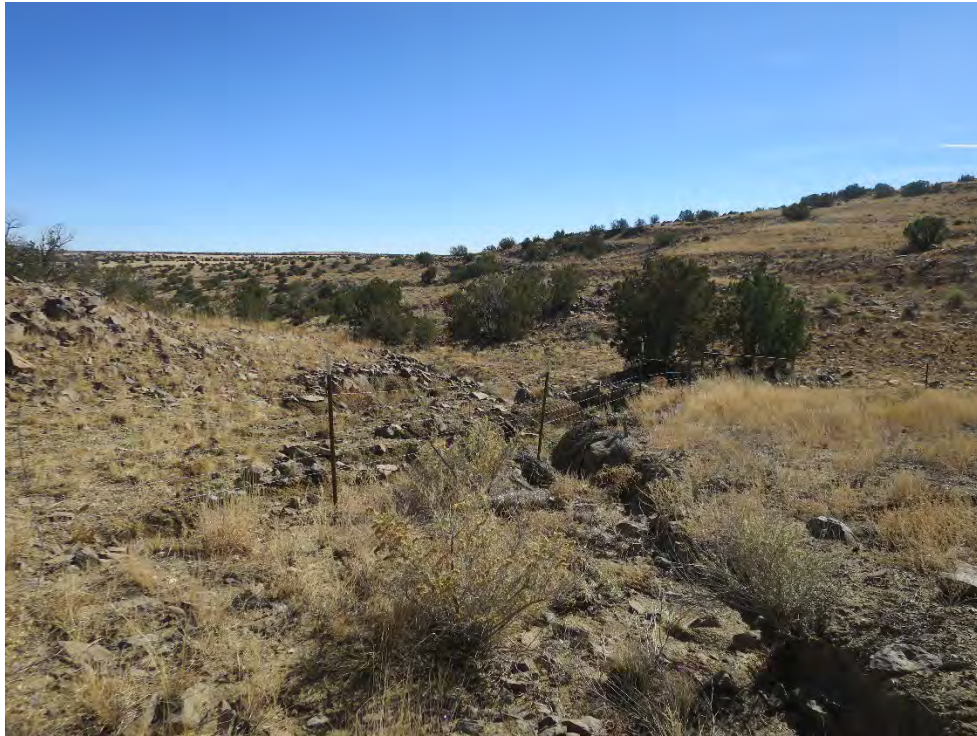
*Photograph 25 - (VS-10 Photo Area F, looking south): Erosion channel exiting VS-10 under the southeast fence line.*

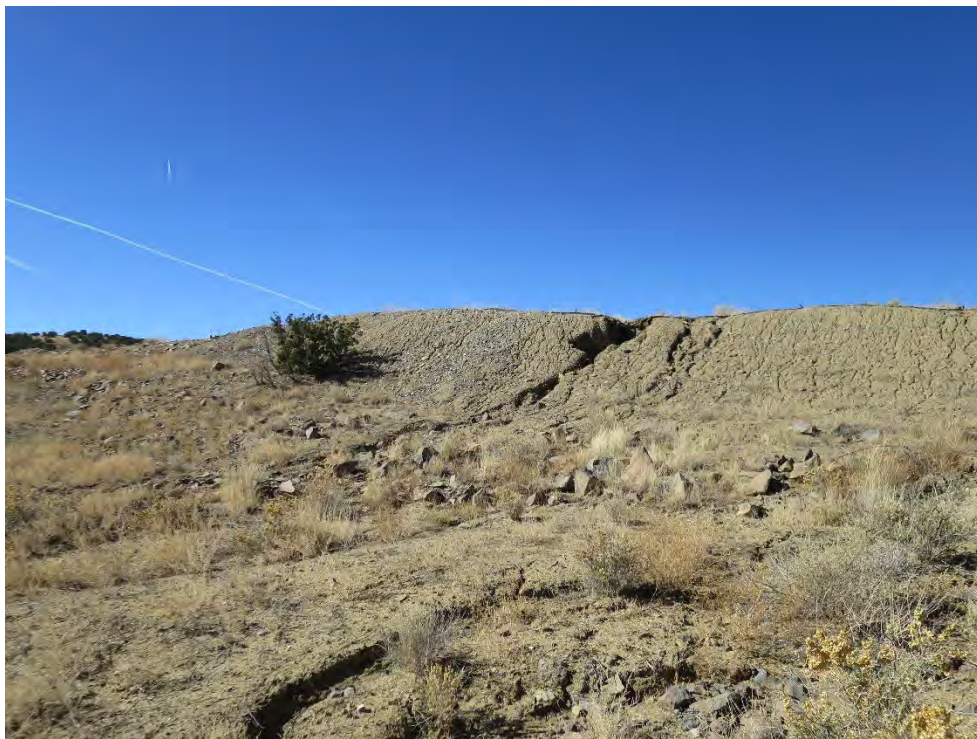
*Photograph 26 - (Borrow Area/VS-10 Photo Area F, looking east): Erosion along steep slope between VS-10 and Borrow Area. Channel is about 5' to 7' wide and 5' deep near crest of the hill.*

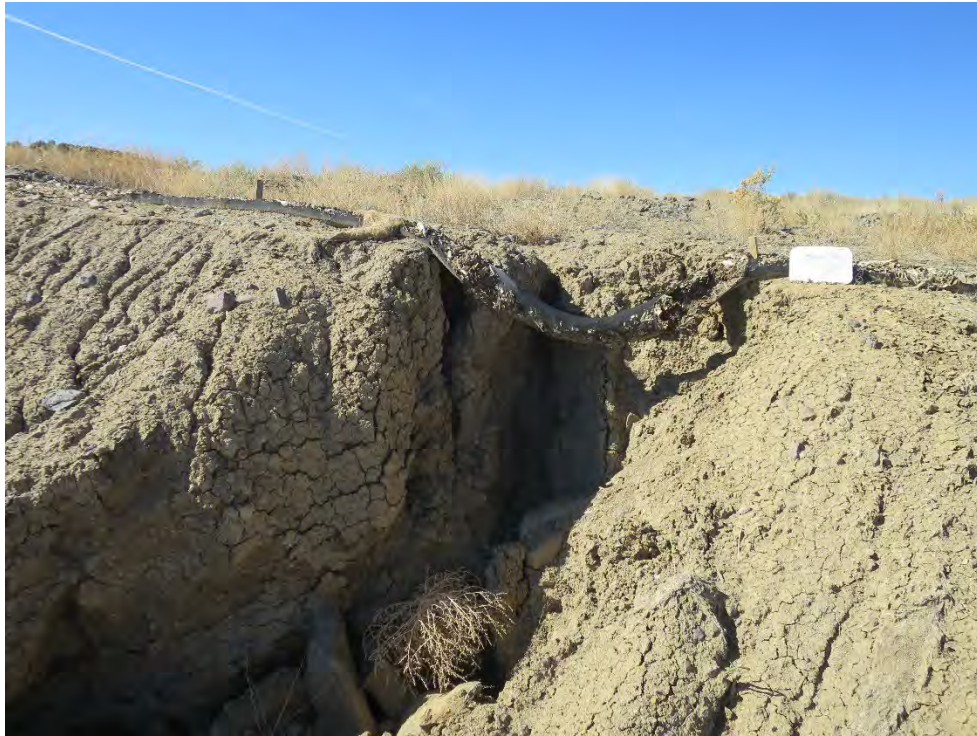
*Photograph 27 - (Borrow Area/VS-10, looking northwest): Closeup of deep erosional channel at the crest of the hill between the Borrow Area and VS-10.*

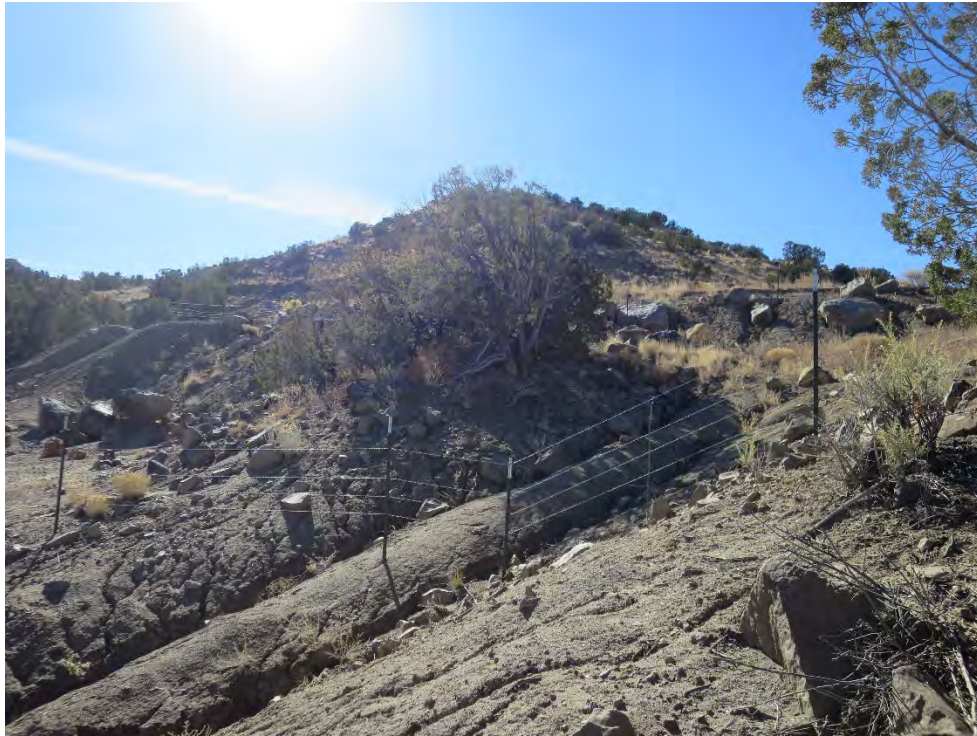
*Photograph 29 - (VS-11 Photo Area B, looking southwest): Reference Area along northeast side of VS-11 and adjacent to pre-existing drainage. Rilling erosion does not extend to within the reclamation fenced area.*

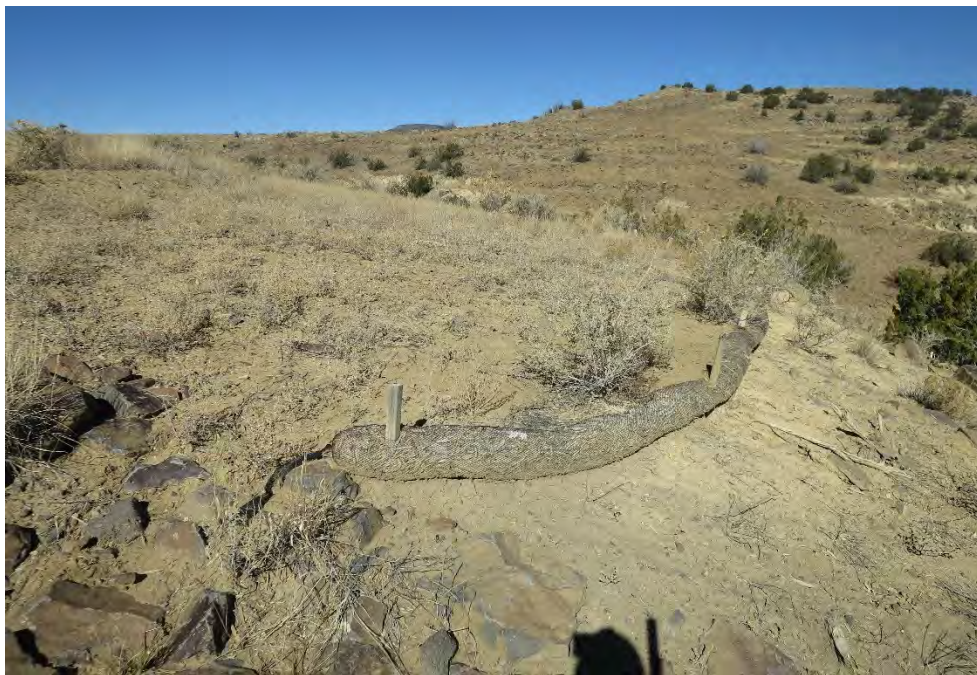
*Photograph 33 - (VS-12 Photo Area B, looking northwest): Wood chip wattles providing erosion protection. Interrilling present below wattles.*

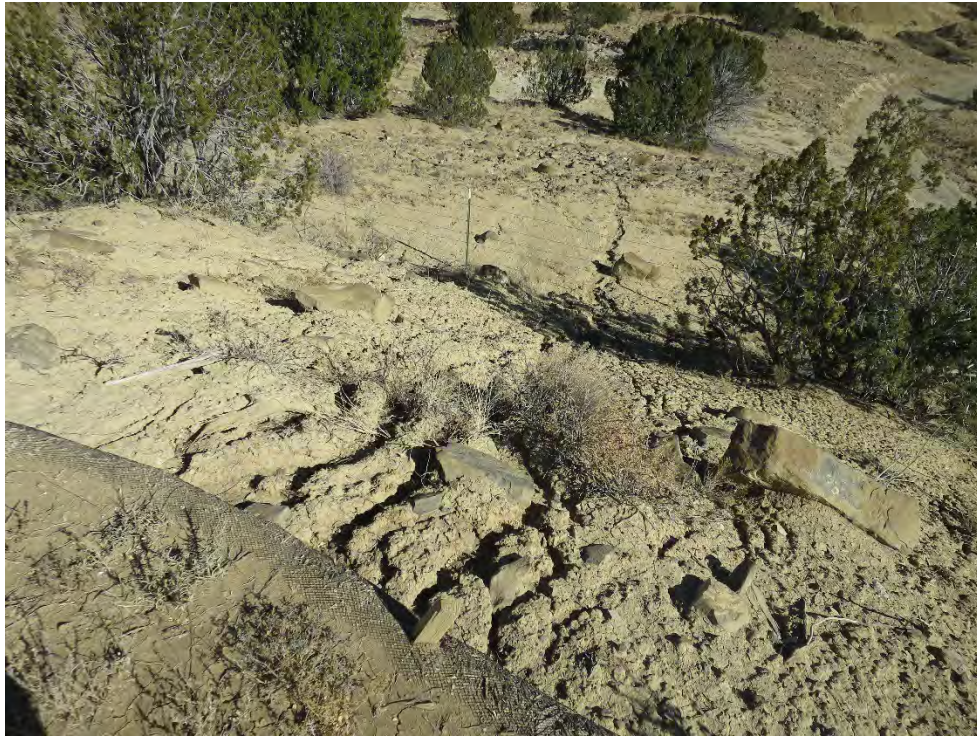
*Photograph 34 - (VS-12 Photo Area B, looking northeast): Looking downhill from wood chip wattles. Wattles have provided some erosion protection. Rilling present on steeper downhill slope.*

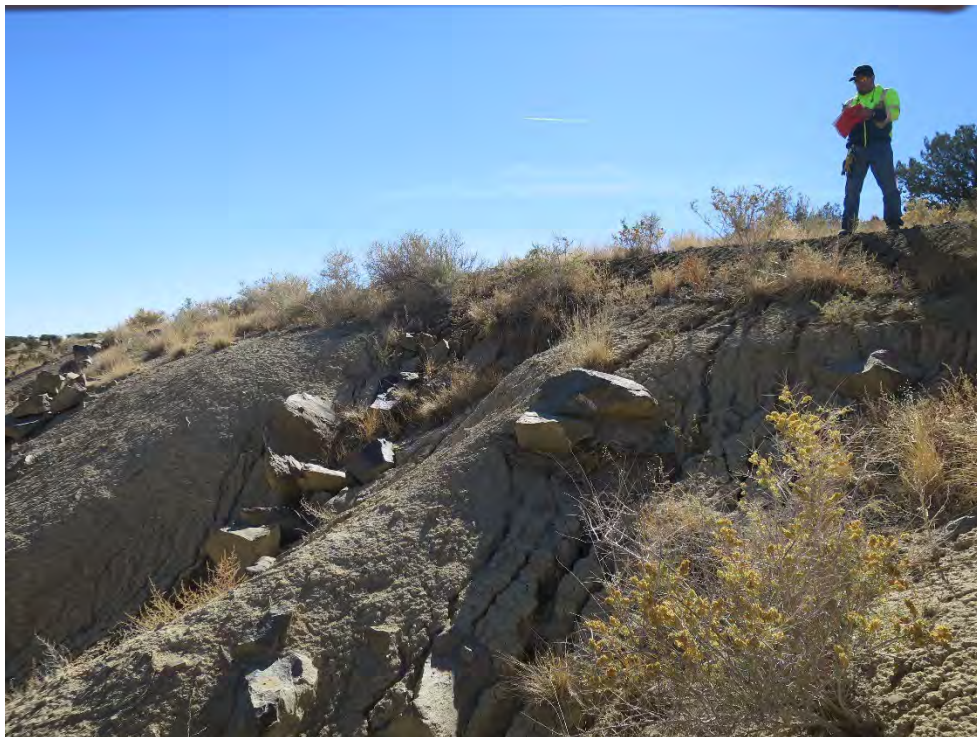
*Photograph 35 -(VS-12 Photo Area C, looking south): Two parallel gullies developing along northwest side of VS-12. Gullies are 1-2' deep in spots.*

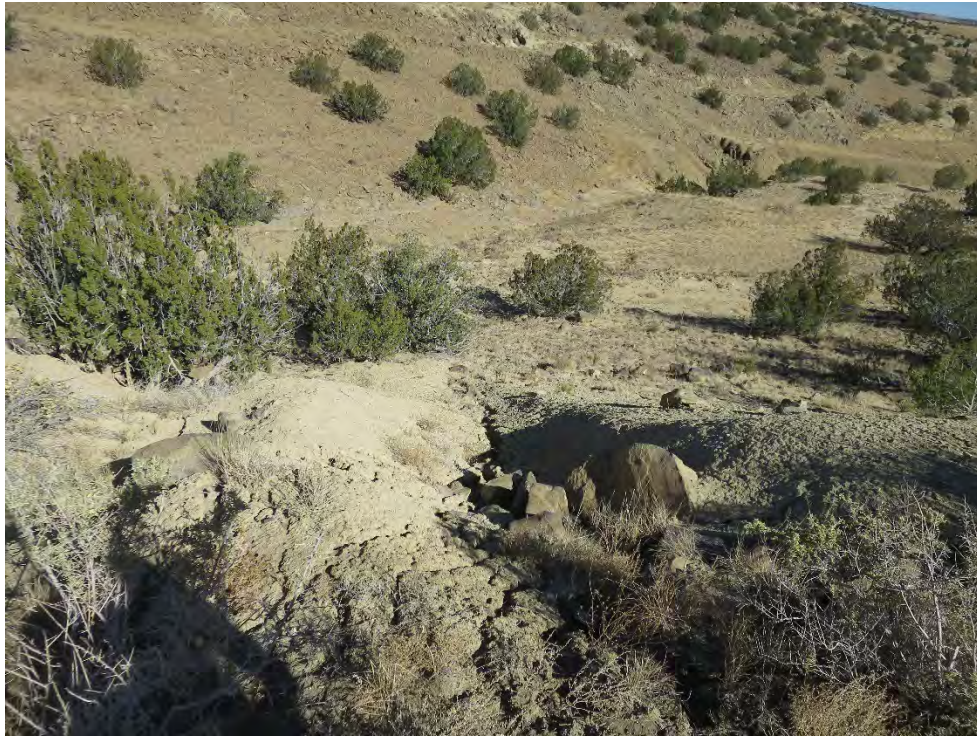
*Photograph 36 - (VS-12 Photo Area D, looking northeast): Two parallel gullies, 1-2' developing along the northeast side of VS-12.*

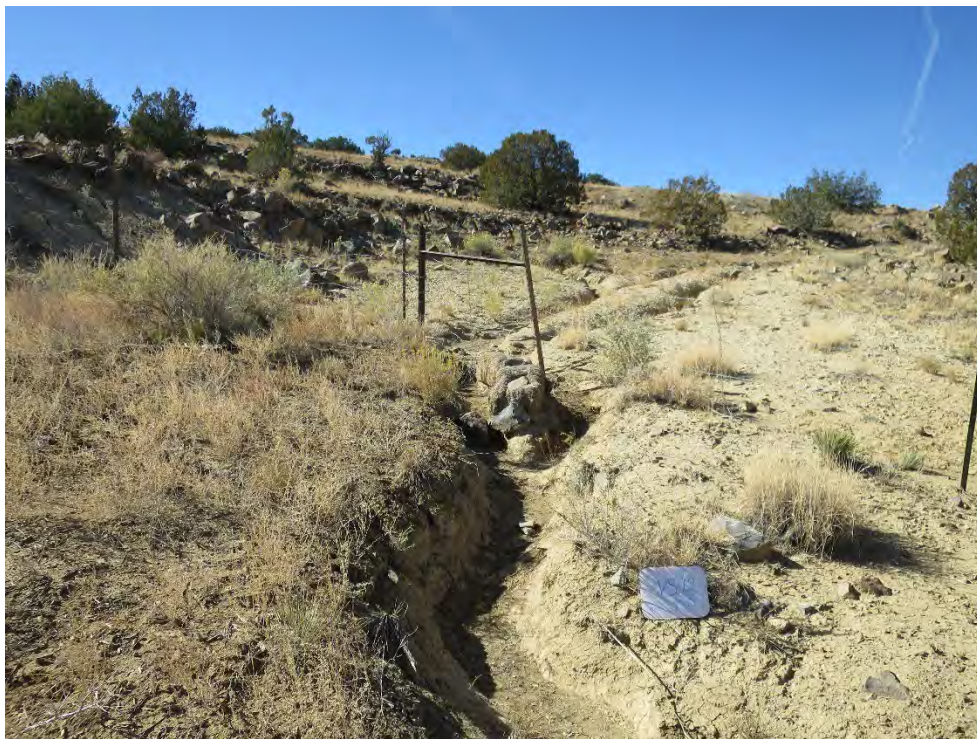
*Photograph 37 - (VS-12 Photo Area D, looking west): Hay bales placed at VS-12 fence line. Note channel developing upstream near roadway and entering fence line, along the northwest side of VS-12.*

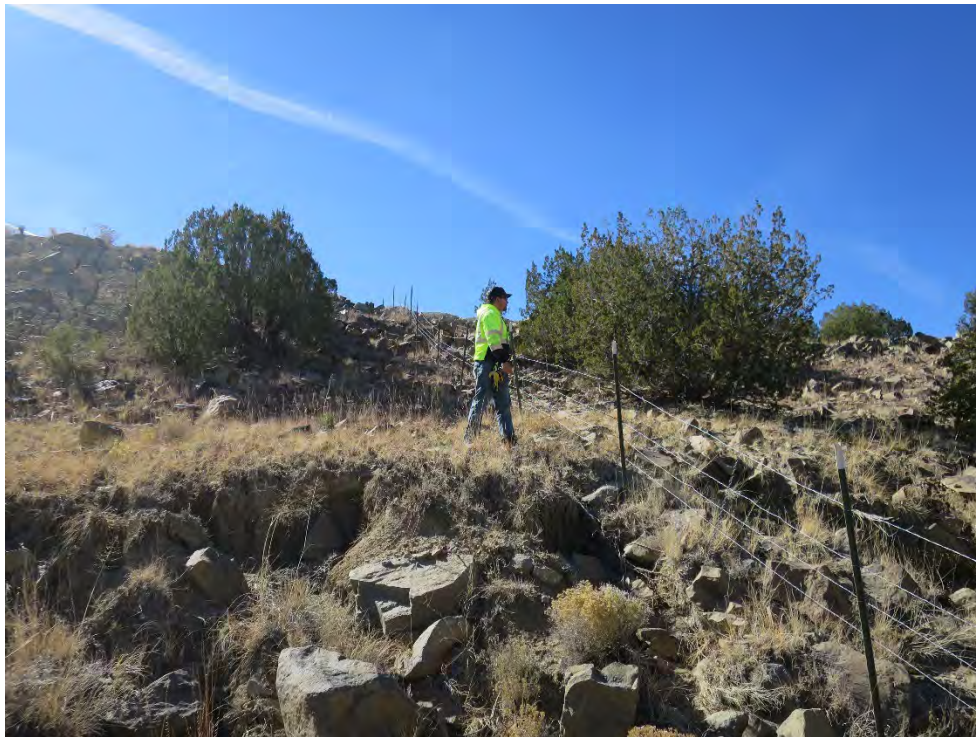
*Photograph 39 - (VS-12 Photo Area F, looking southwest): Rilling present at the toe of hill at base of rock armoring.*

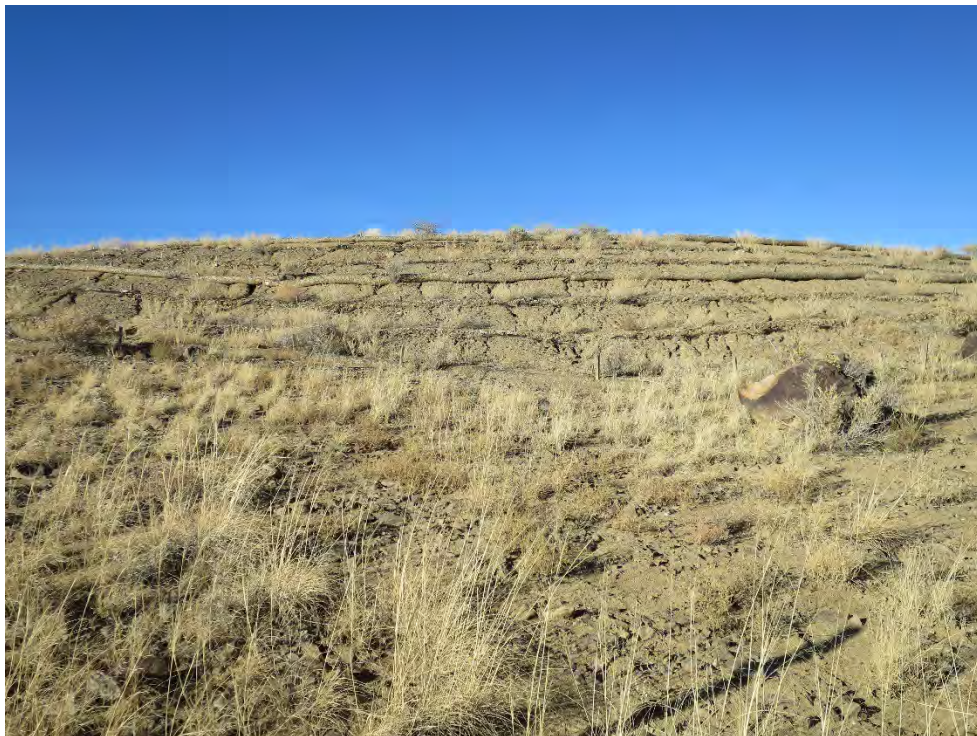
*Photograph 41 - (Stockpile Photo Area B, looking north): Interrilling and rilling on all sides (south, east, and west) of the Stockpile hill despite wattles.*

Stockpile	Widespread interrilling and rilling on all slopes of the hill near southern edge of fenced area. See Photo Nos. 40 - 42; Figure 6.	<ul style="list-style-type: none"> <li>• Add seed and matting over rilled areas to prevent rills from getting worse or developing deep channels.</li> </ul>			X	X			
Borrow Area	Significant gully erosion starts near crest of slopes, between the borrow area and VS-10, and contributes to channel formation downslope on VS-10. Erosion channels are about 5 – 7' wide and 5' deep near crest of hill and about 3-5' deep near outfall at the lower fence line along the southern end of VS-10. See Photo Nos. 43 - 45; Figures 7 and 8.	<ul style="list-style-type: none"> <li>• Add wattles to outfall channel near bottom fence line and place perpendicular to channel to slow the flow.</li> <li>• Add additional wattles at the crest of the upper and middle slope crest to slow energy and promote better sheet flow in an effort to avoid surface flow concentrating at wash out zones.</li> <li>• Add seed and haybales to deeper gullies to keep channels from washing out further.</li> <li>• It might be worthwhile trying to fix the berm (by hand?) above the slope because water ponds on the borrow area and then breaks through to create the channels on the slope.</li> <li>• In addition, water from the ponded area could be redirected to the east and away from the steep slope to the south.</li> <li>• Place additional rock armoring in water conveyance pathways.</li> </ul>	X	X		X			X

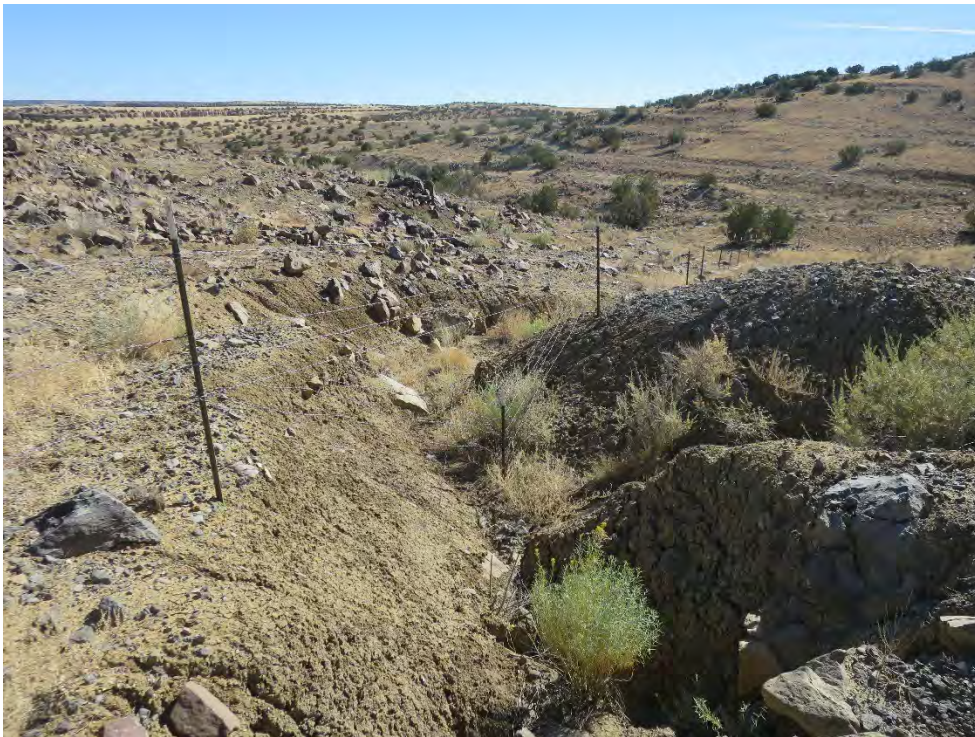
*Photograph 43 - (Borrow Area Photo Area H, looking west): Erosion channel near eastern fence line.*

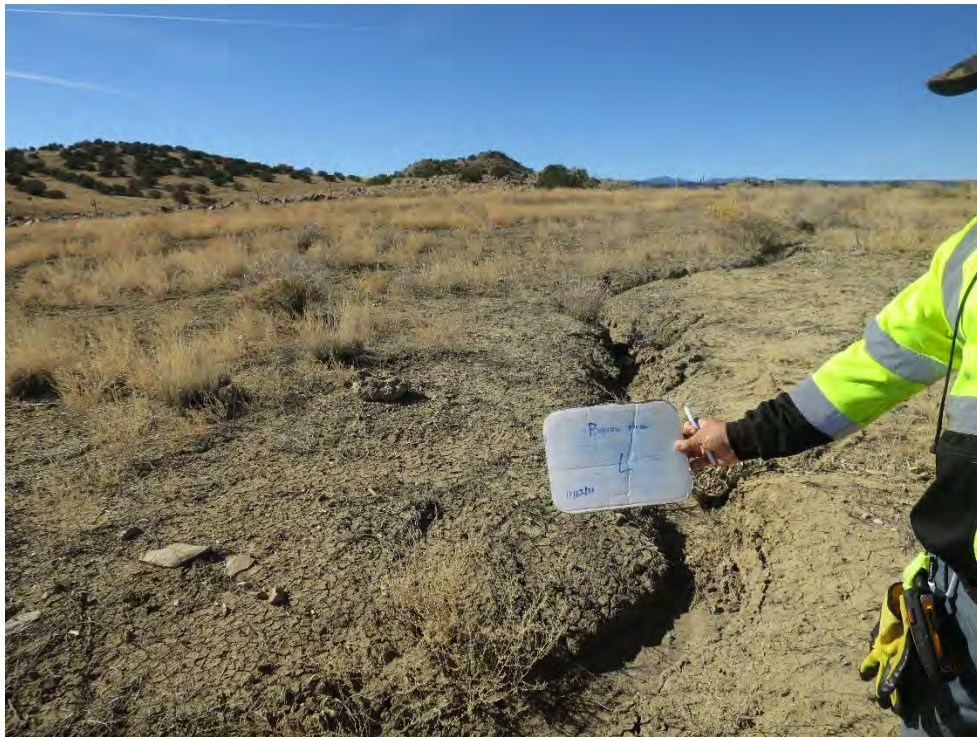
*Photograph 45 - (Borrow Area Photo Area L, looking west): Deep gully/shallow channel forming on the western side of the Borrow Area.*
