**PRIOR RECLAMATION INSPECTION REPORT  
AND  
RECOMMENDATION FOR RELEASE OR PERMIT  
REQUIREMENT**

**Homestake Mining Company of California - Section 32 Mine**

**New Mexico Energy, Minerals and Natural Resources Department  
Mining and Minerals Division  
Mining Act Reclamation Bureau**

**August 15, 1995**

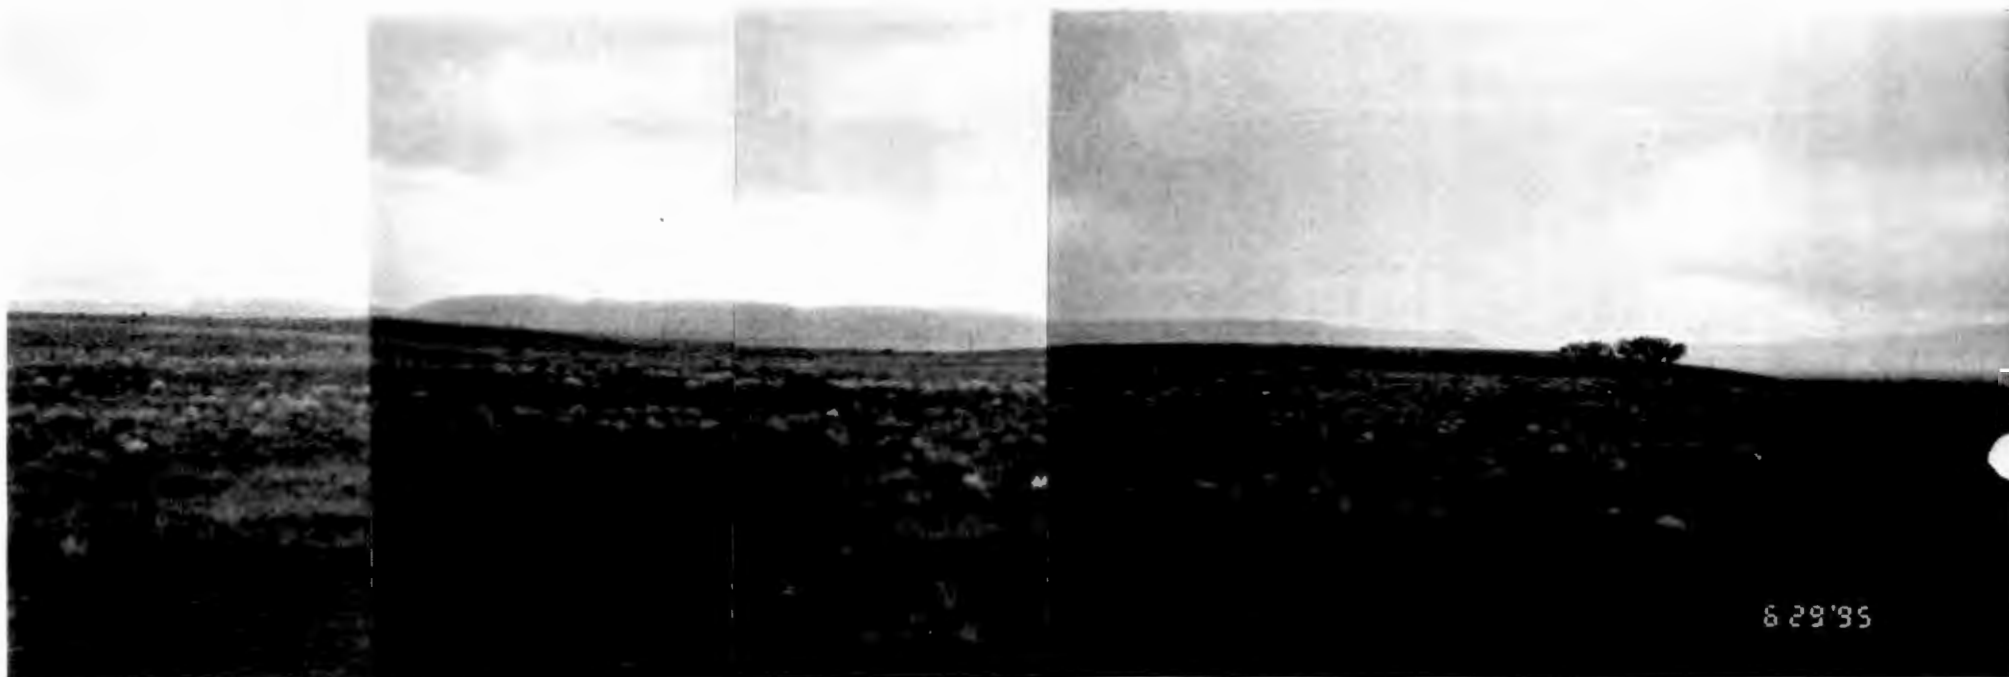
Based on the outcome of these inspections, staff does not recommend the release of the Section 23 site. The vegetation at this site was too sparse to provide adequate information needed in making the determination that the site has been reclaimed to a condition that allows for a self-sustaining ecosystem. Staff recommends waiting to make this determination until the plant community onsite has become better established.

*Homestake Section 23 Mine (T14N, R10W)*  
*From east side of site looking west*

Homestake's Section 23 Mine (T 14N, R 10W).  
Panoramic view. June 28, 1995.  
Joe DeAguero Photographer

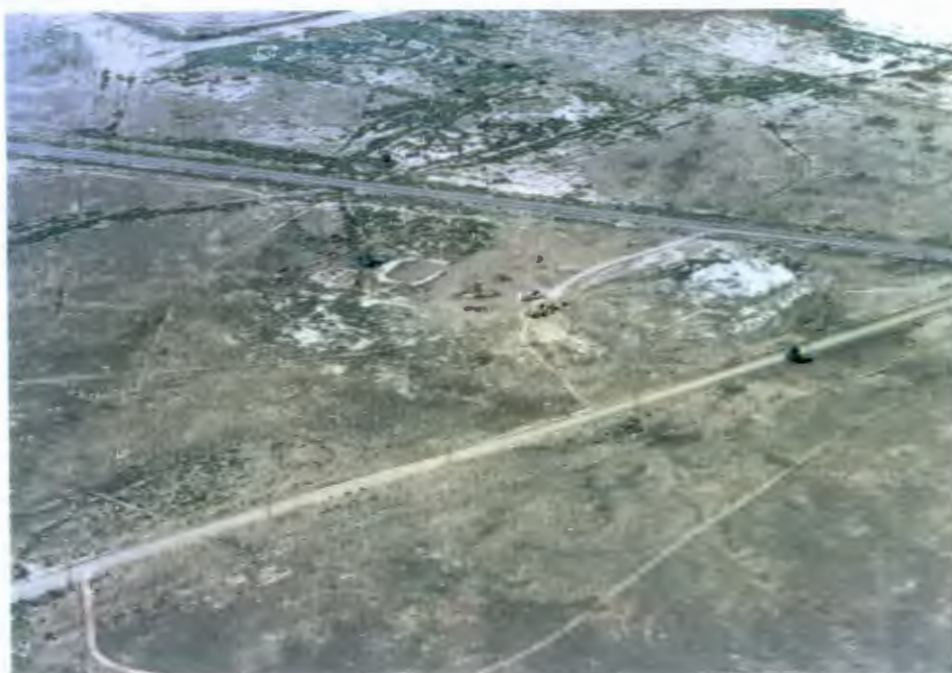
PHOTO 32A

- 32A: Aerial view of the mine site during early stages of reclamation.
- 32B: Vent borehole with mine waste backfill.
- 32C: View across mine site during placement of soil cover prior to reseeding.
- 32D: Reseeding operations viewed north across mine site.
- 32E: View of reclaimed mine site looking north toward old Phillips mill.
- 32F: View of reclaimed mine site looking south.
- 32G: View looking west across mine site and stockpile area after reclamation.
- 32H: View looking north across mine site and ore pads two years after reclamation.
