**PRIOR RECLAMATION INSPECTION REPORT
AND
RECOMMENDATION FOR RELEASE OR PERMIT
REQUIREMENT**

Santa Fe Pacific Gold Corporation

**New Mexico Energy, Minerals and Natural Resources Department
Mining and Minerals Division
Mining Act Reclamation Bureau**

September 29, 1995

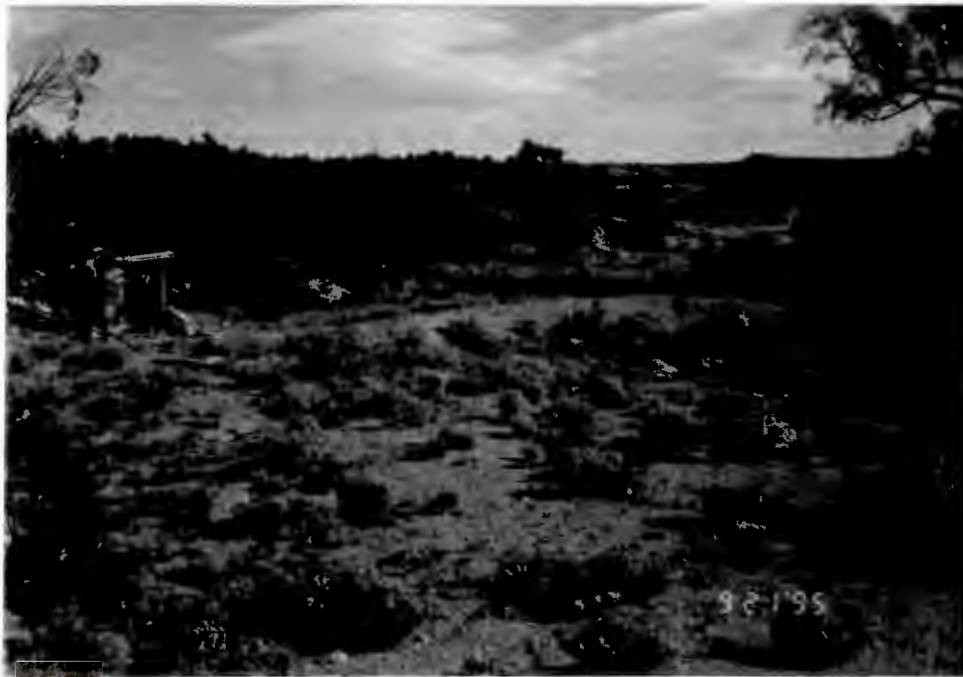
Section 13 T1N R6W, Powder Magazine, September 21, 1995

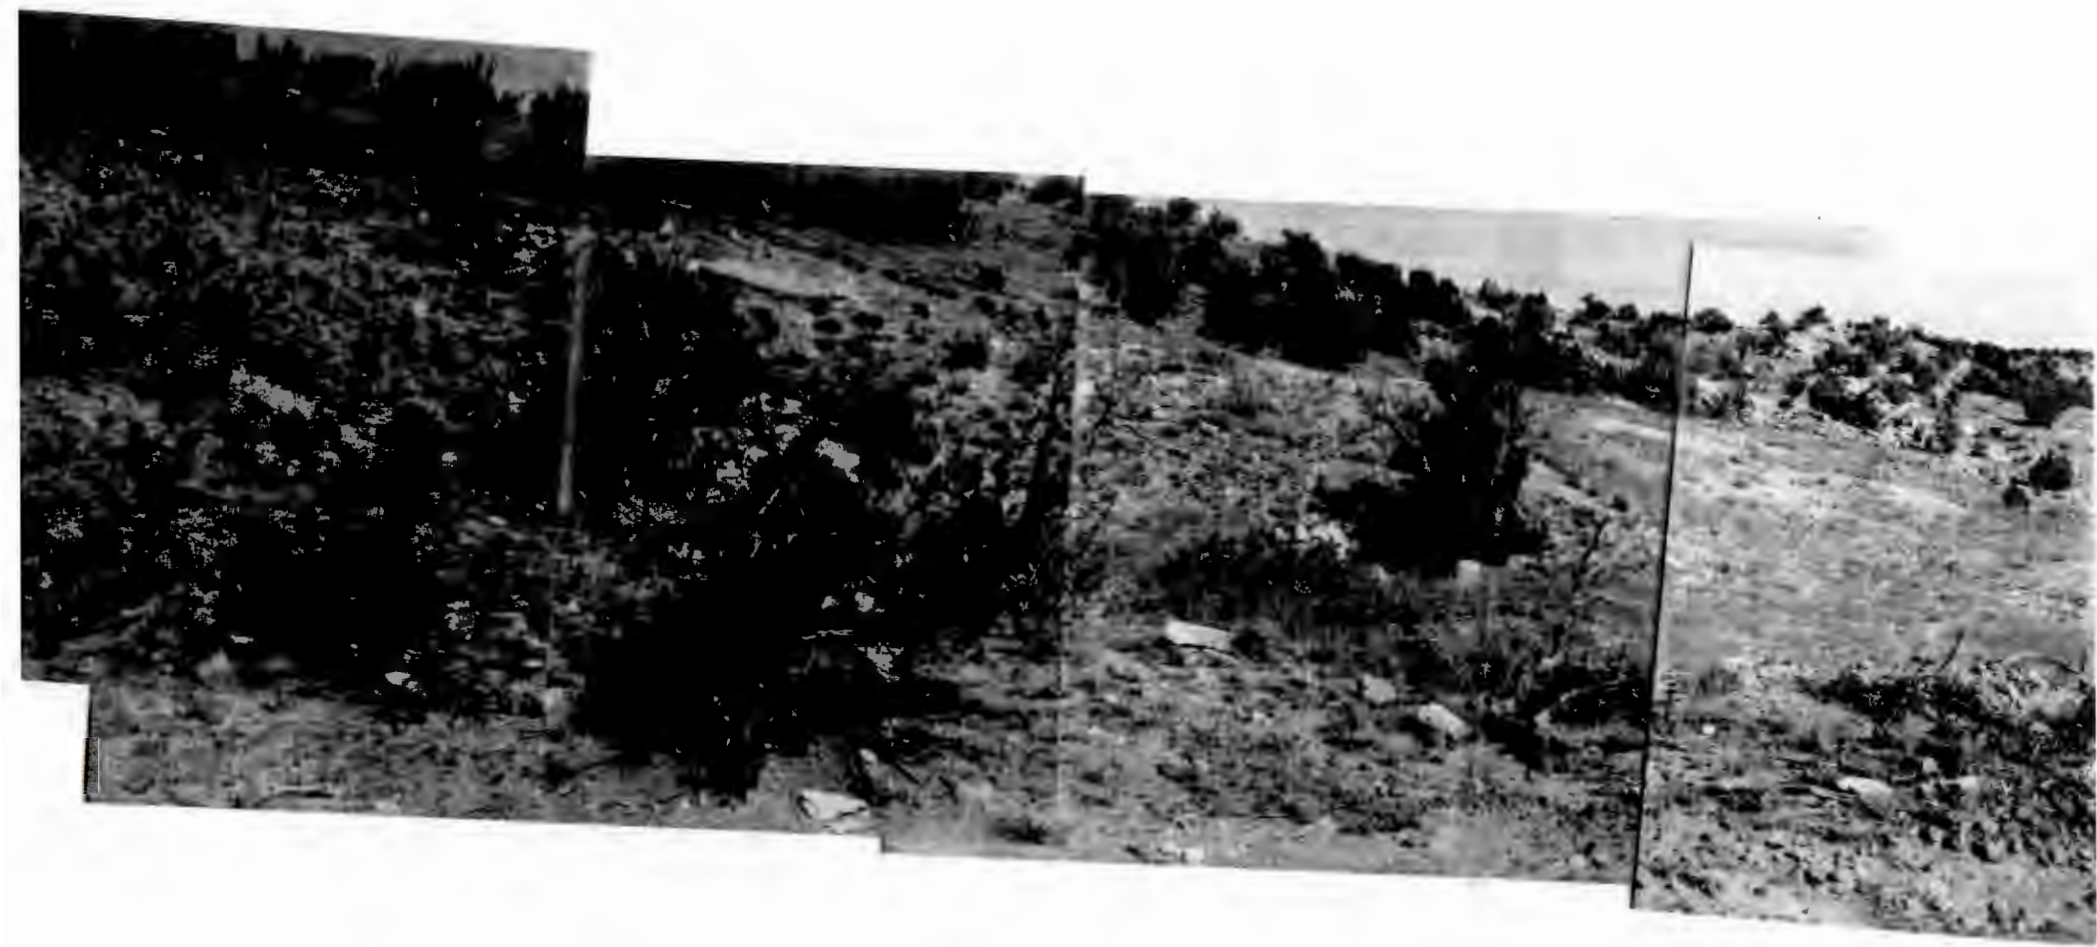
Section 13 T1N R6W, Mine Site From South

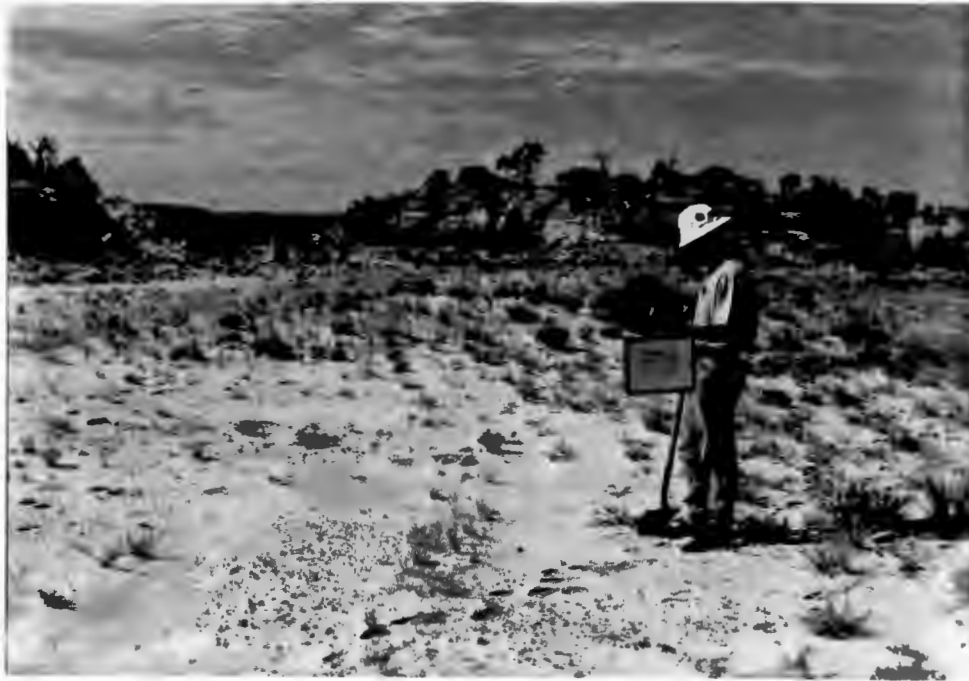
Section 1 T13N R9W, Shaft Site looking South, 9/13/95

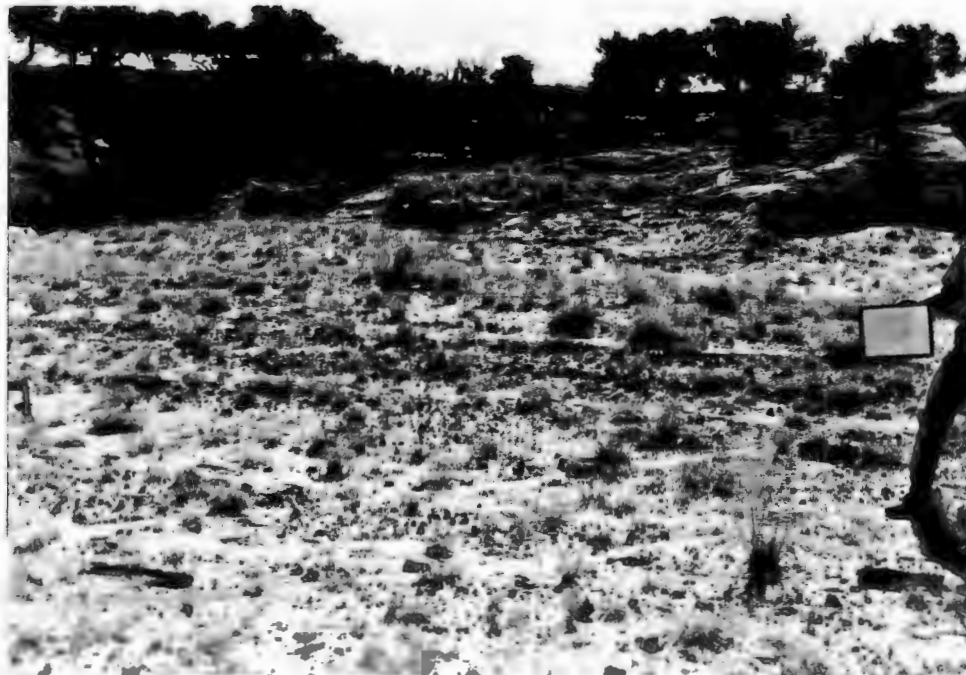
Section 1 T13N R9W, Shaft Site Looking West, 9/13/95

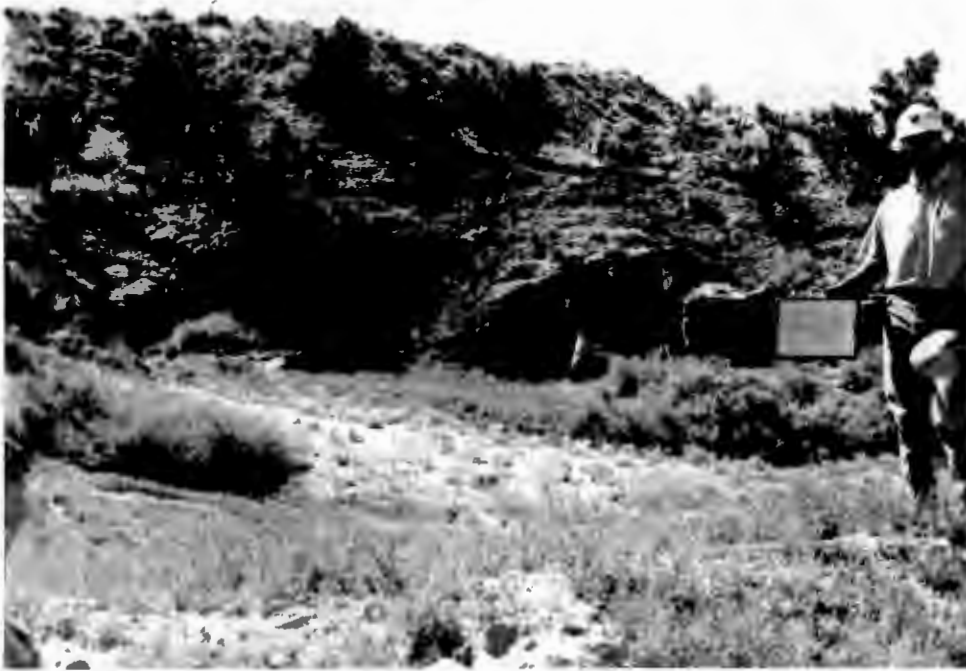
Section 1 T13N R9W, Sediment Pond, 9/13/95

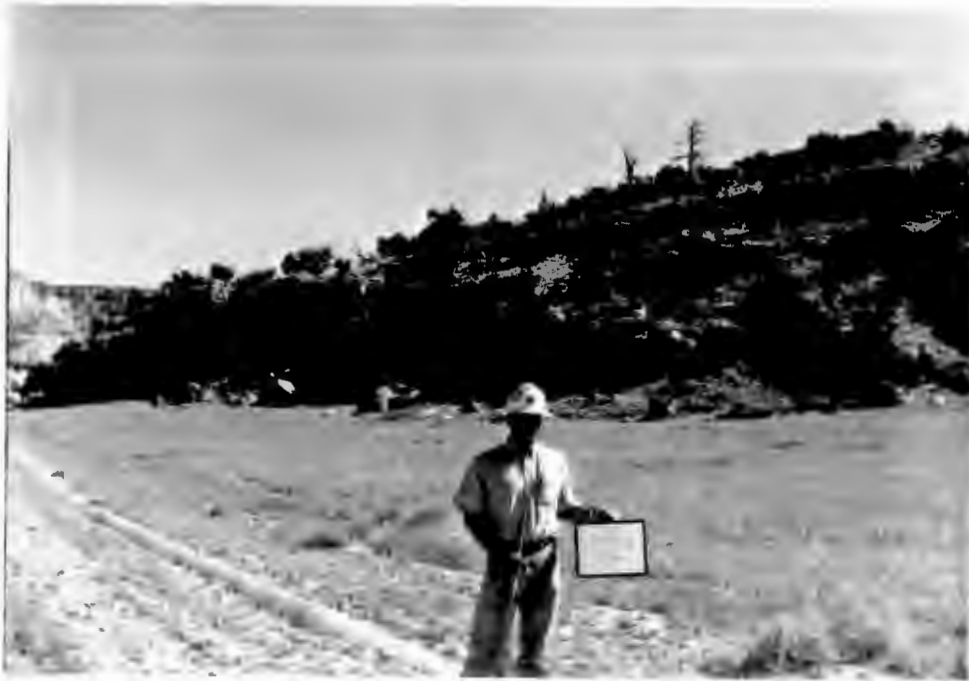
Section 1 T13N R9W, Looking Up at Mine Site, 9/13/95

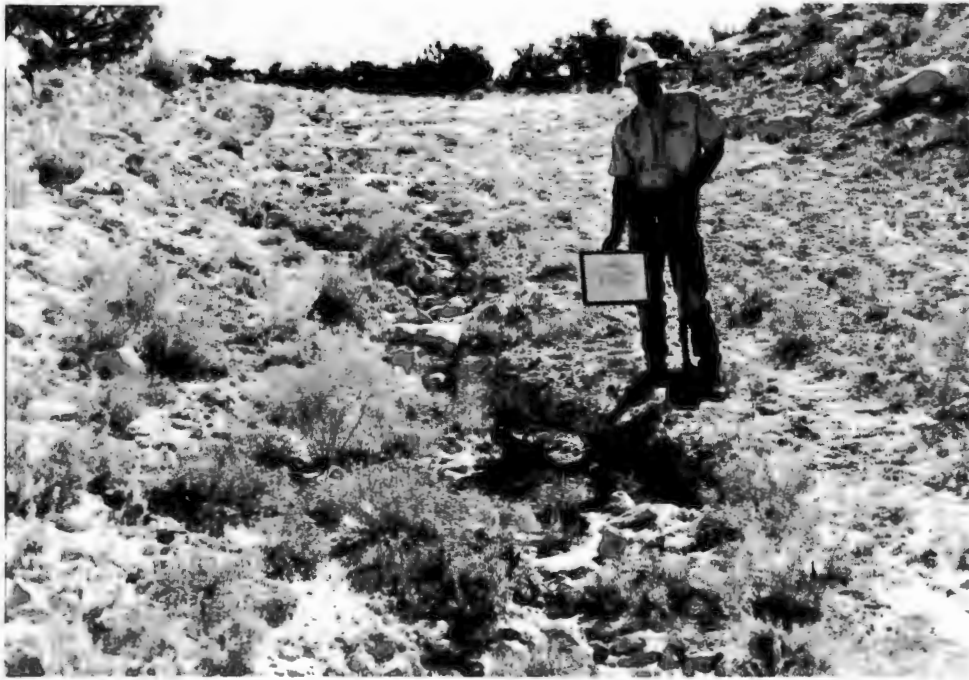
Section 1 T13N R9W, Access Road, 9/13/95

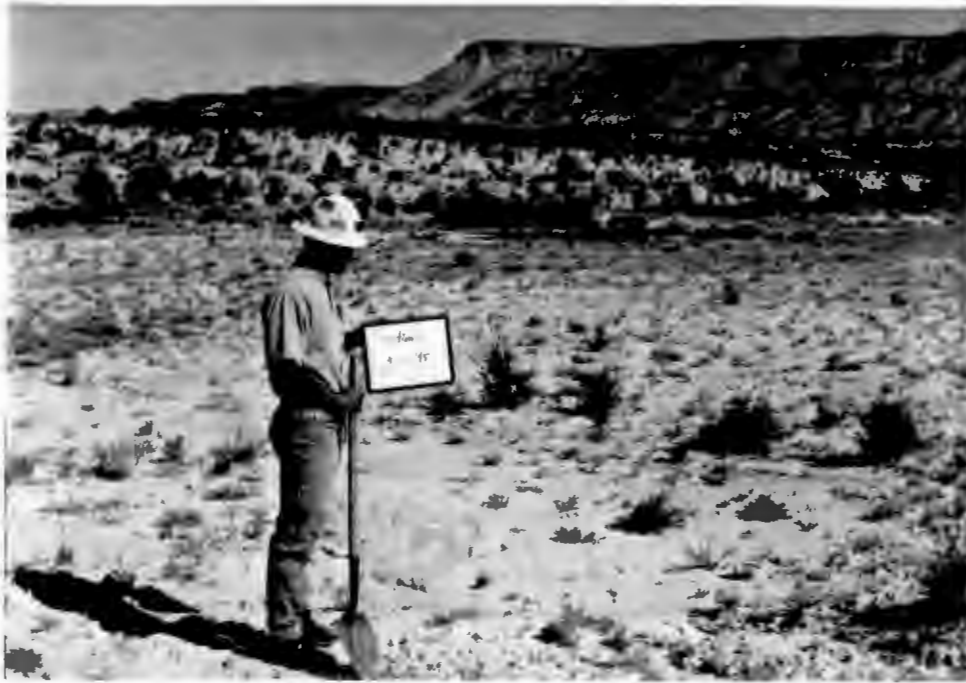
Section 1 T13N R9W, South Side Looking North, 9/13/95

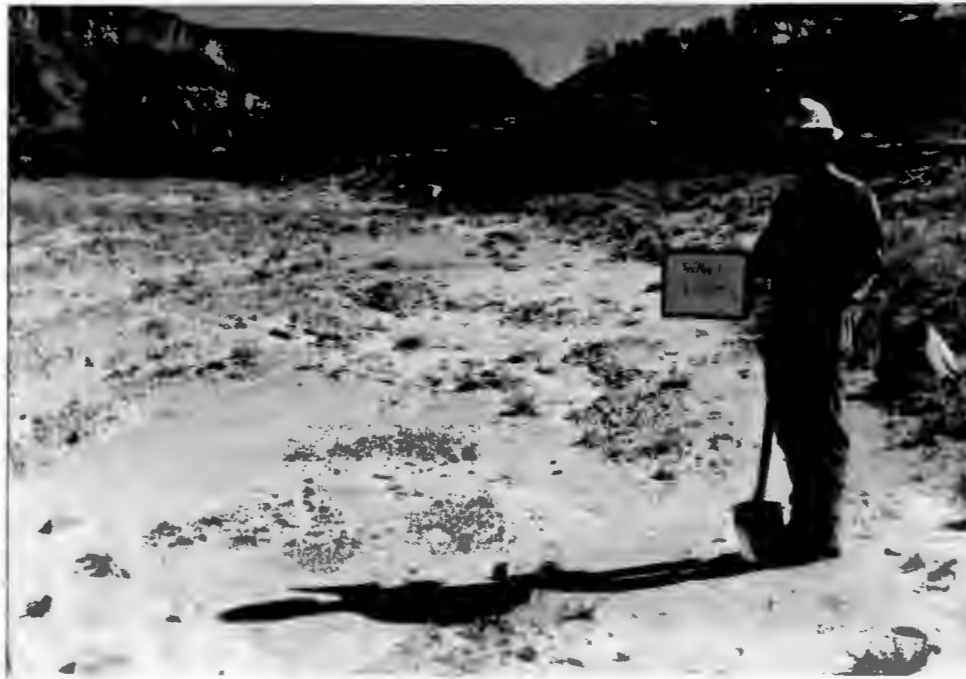
Section 1 T13N R9W, North Side Looking South, 9/13/95

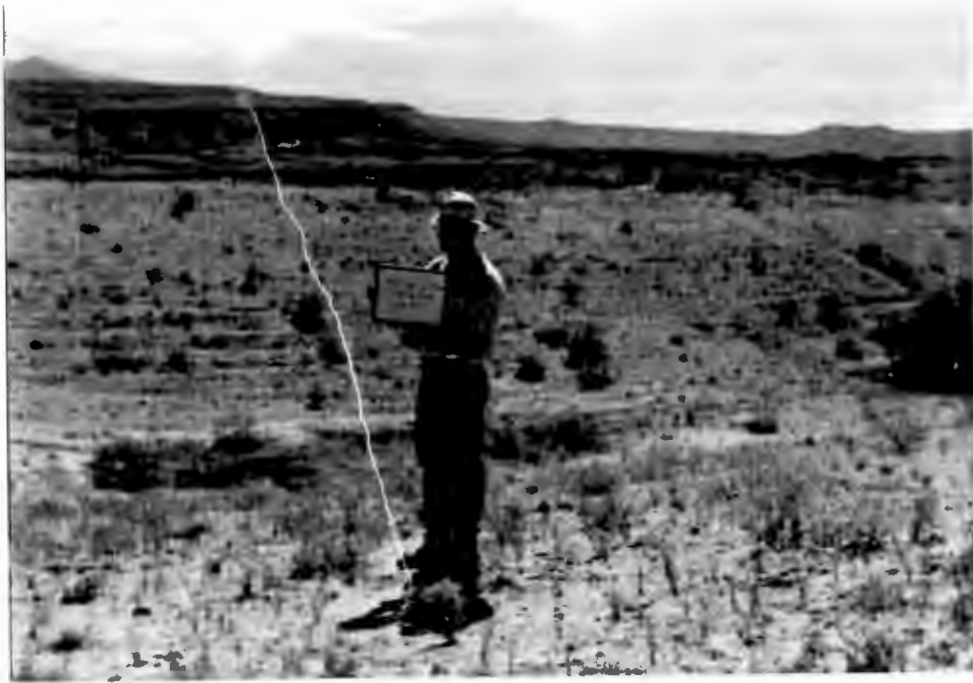
Section 25 Mine, West Side Looking West, 9/12/95

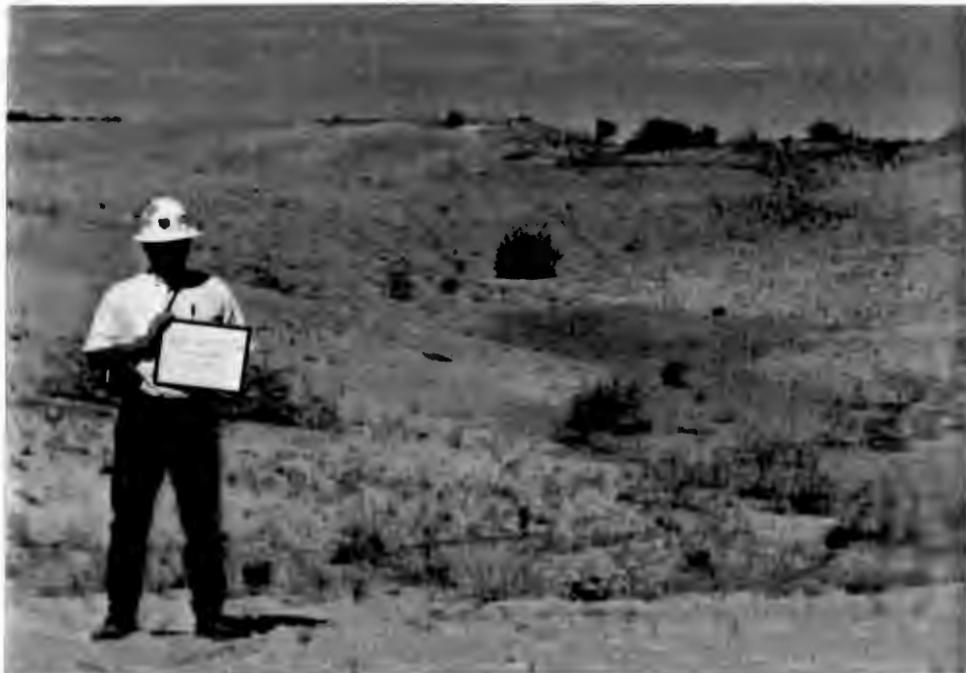
Section 25 Mine, Middle Looking East, 9/12/95

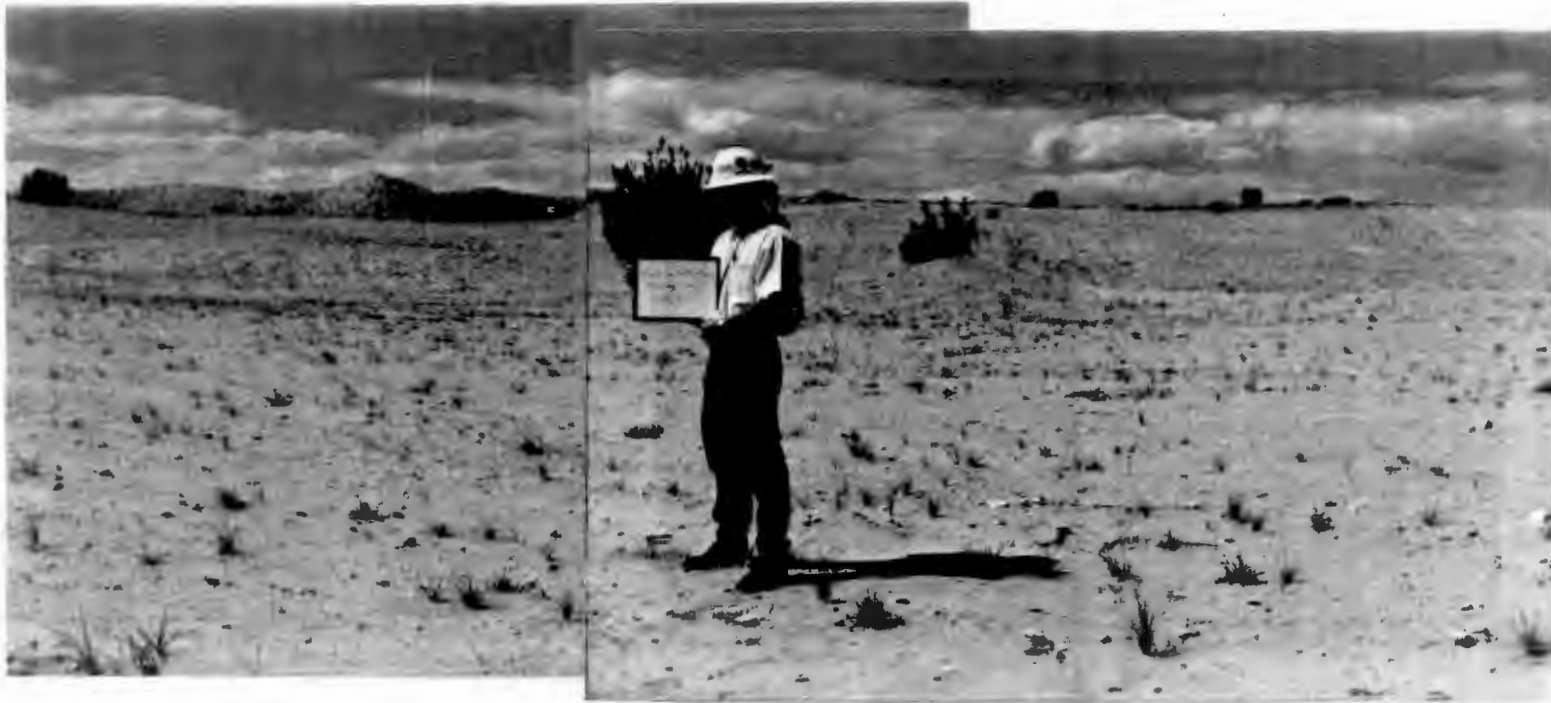
Section 25 Mine, East Side Looking Southwest, 9/12/95

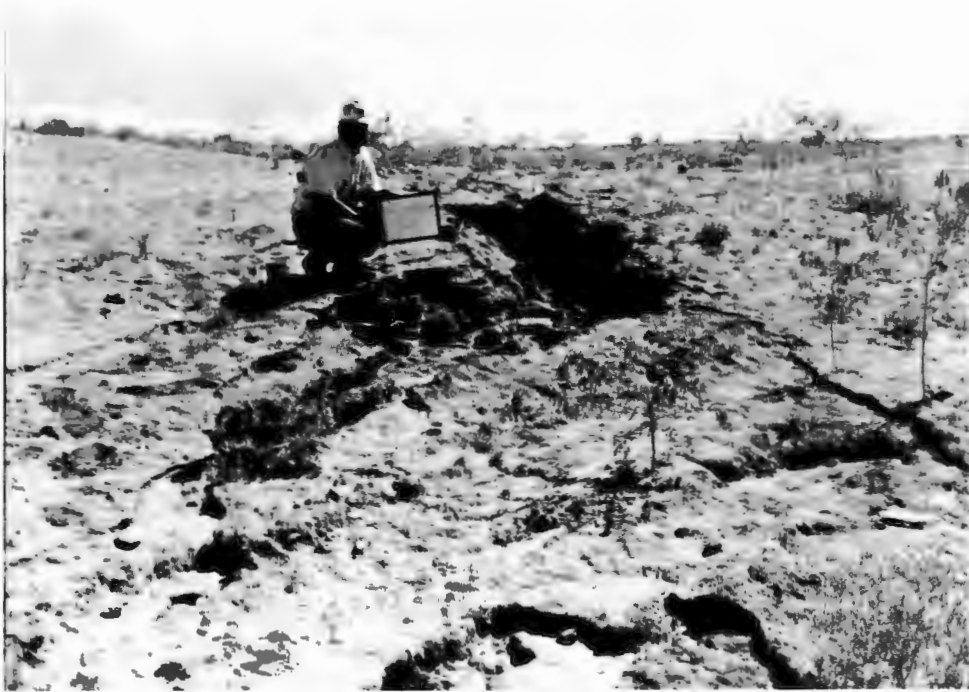
Section 25 Mine, Erosion Feature, 9/12/95

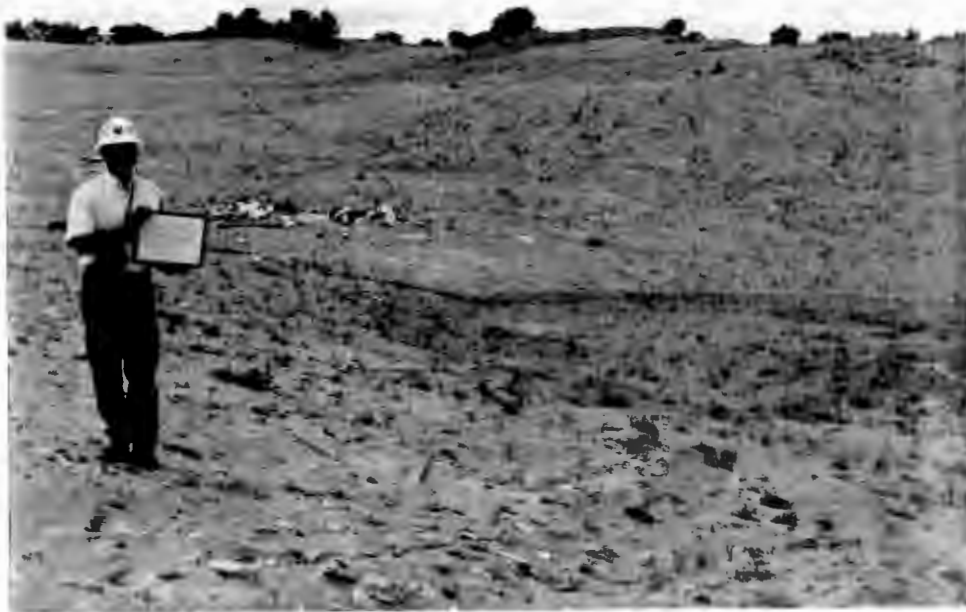
Section 31 T13N R9W, North End Looking South, 9/12/95

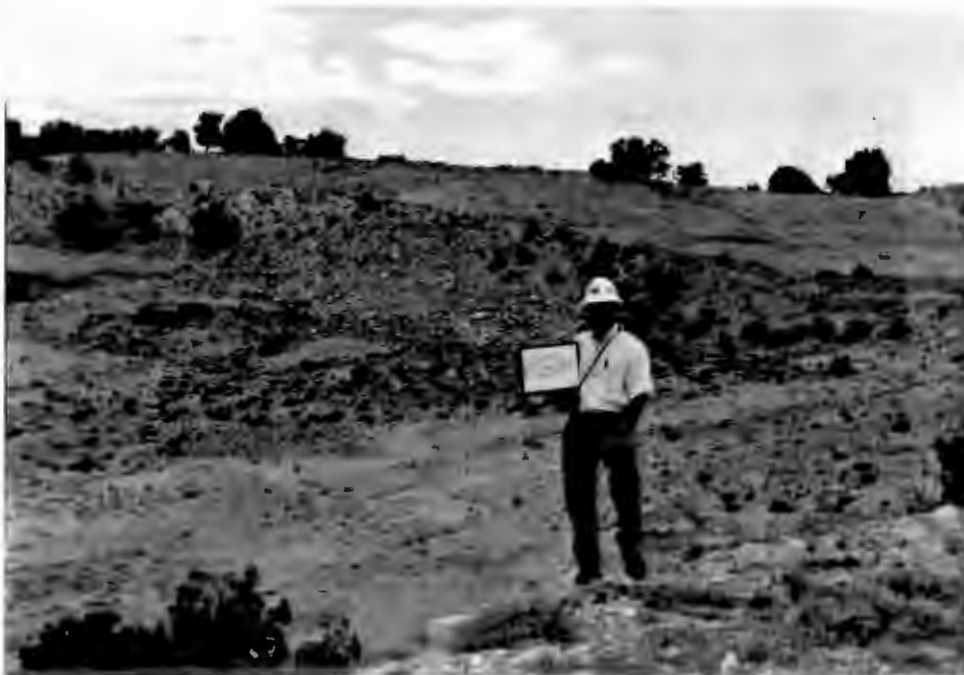
Section 31 T13N R9W, Northeast Side Looking West, 9/12/95

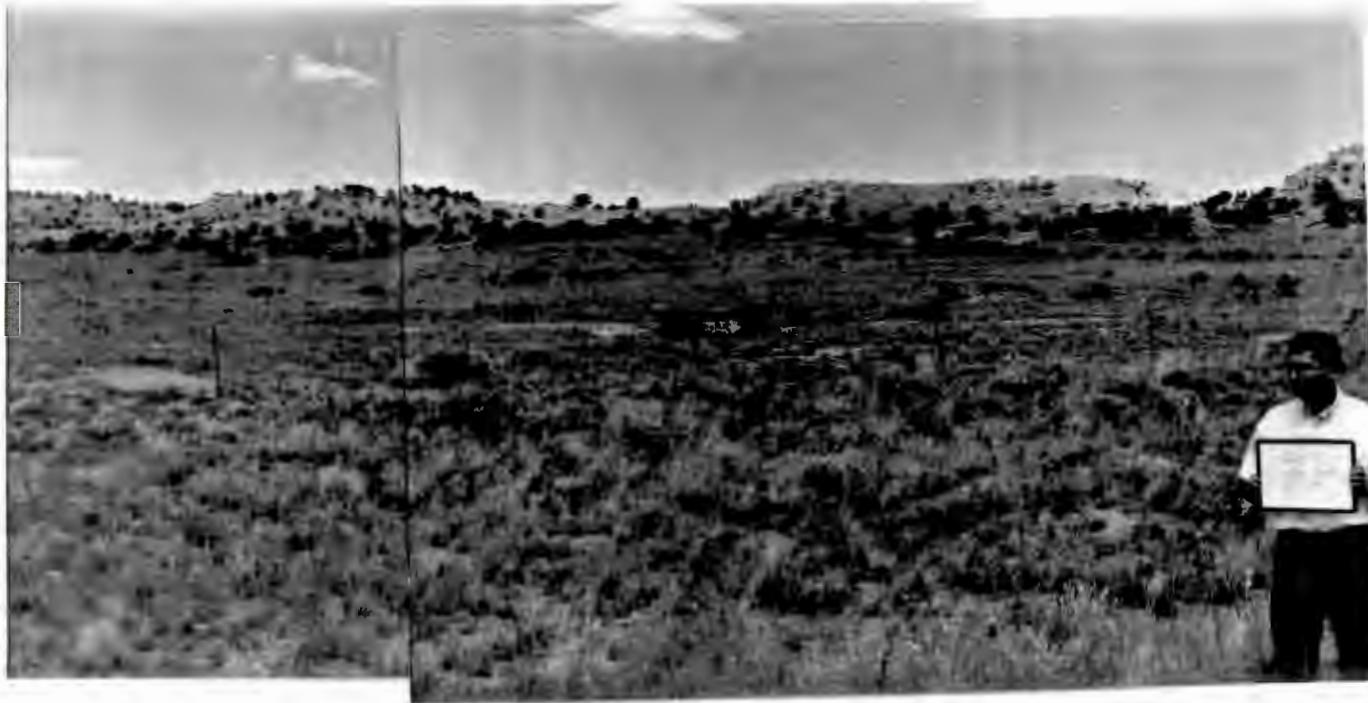
Section 31 T13N R9W, Reconstructed Limestone Bluffs, 9/12/95

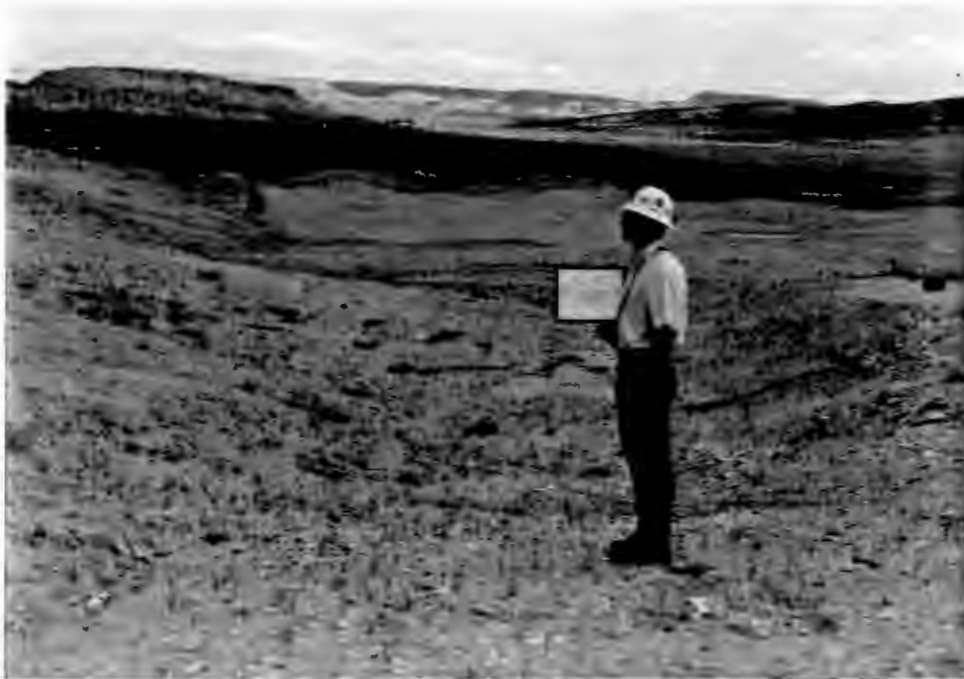
Section 31 T13N R9W, Southeast Side looking North

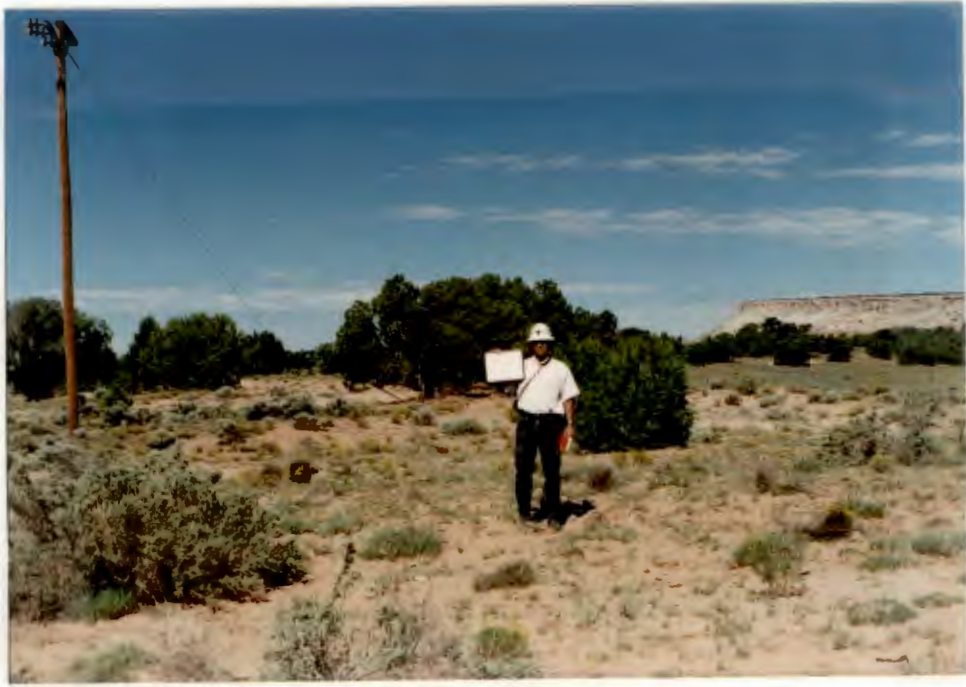
Faith Mine Shaft Site, Looking West, 9/12/95

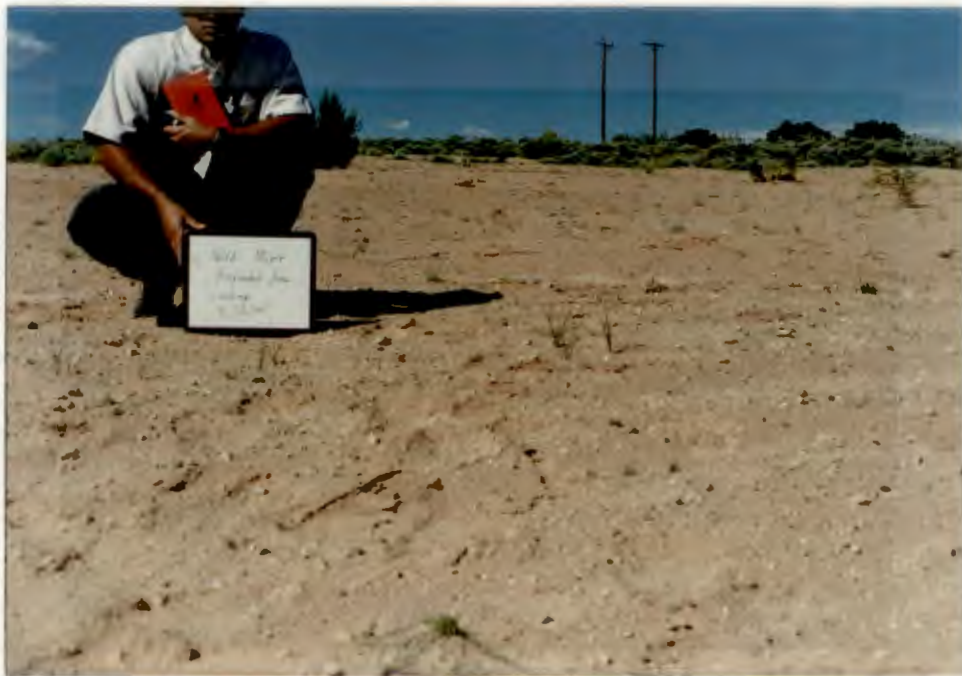
Faith Mine Regraded Area, 9/12/95

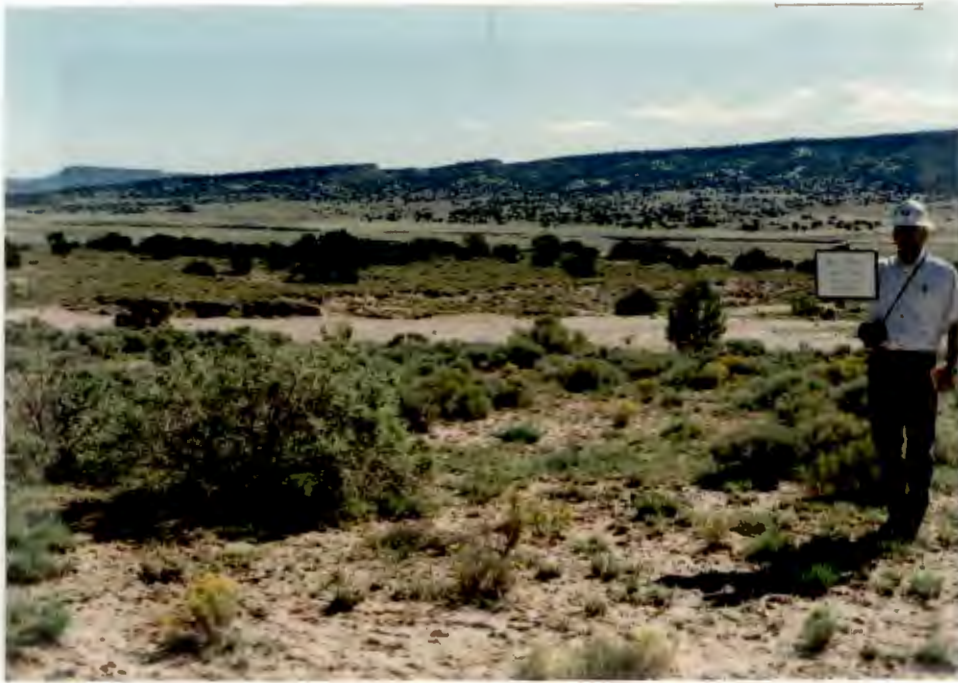
Faith Mine Shaft Site, Looking East, 9/12/95
Regraded Area in Background

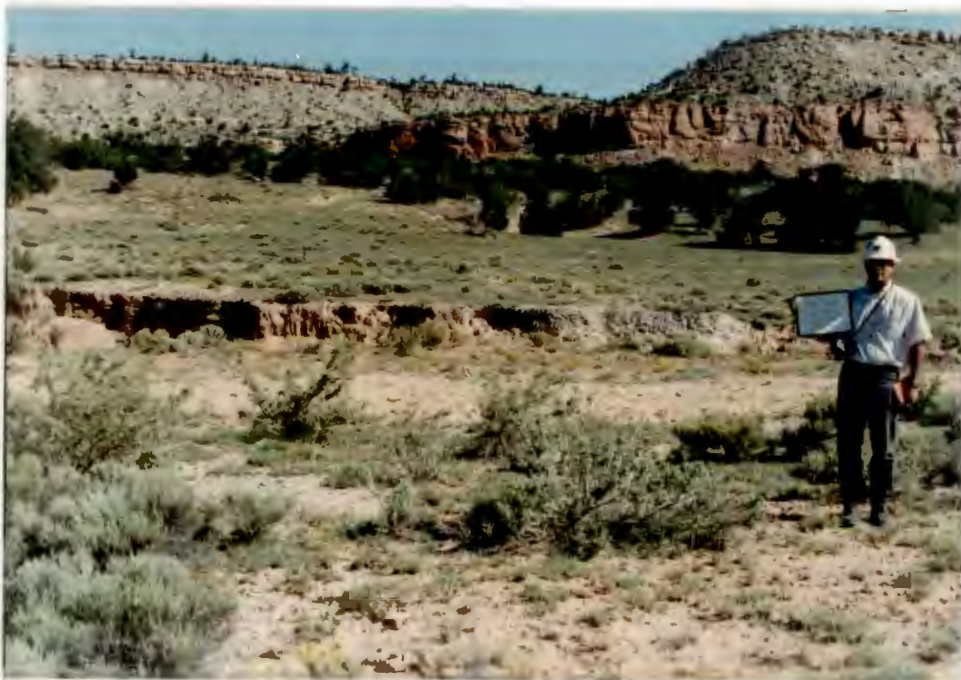
Faith Mine Shaft Site, Looking North, 9/12/95

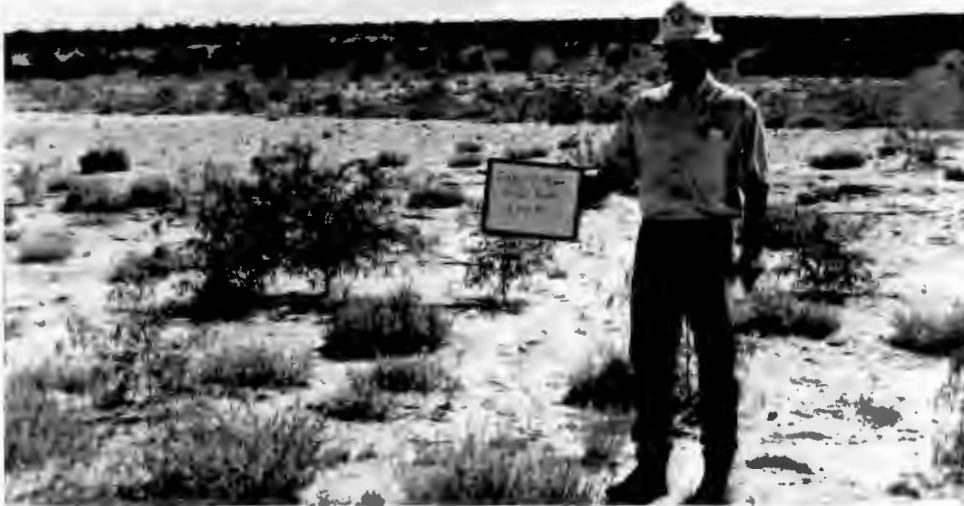
Isabella Mine, From North, 9/12/95

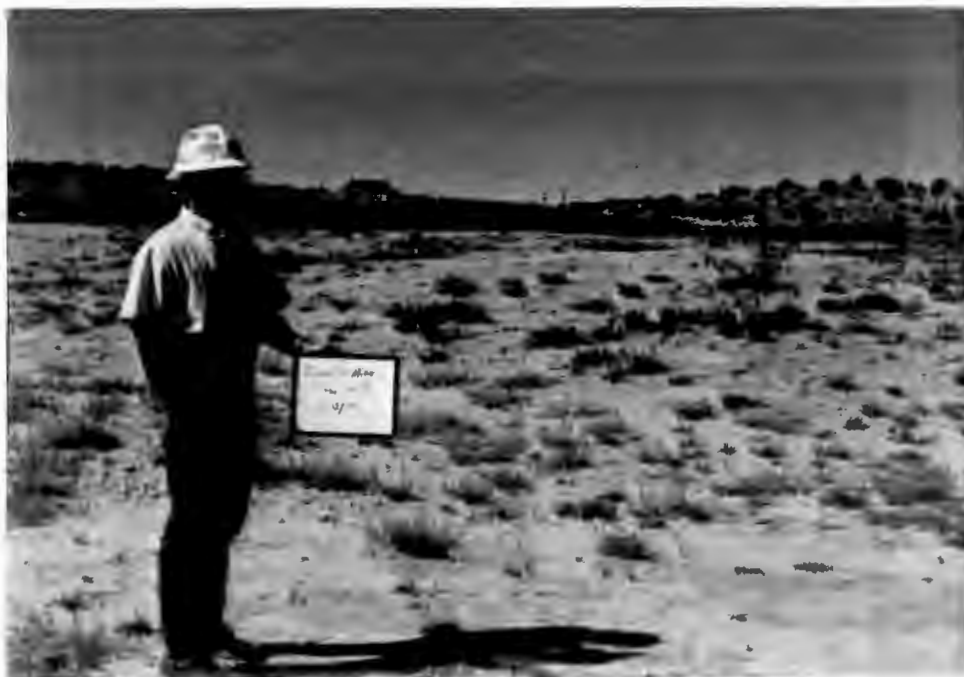
Isabella Mine, From South, 9/12/95

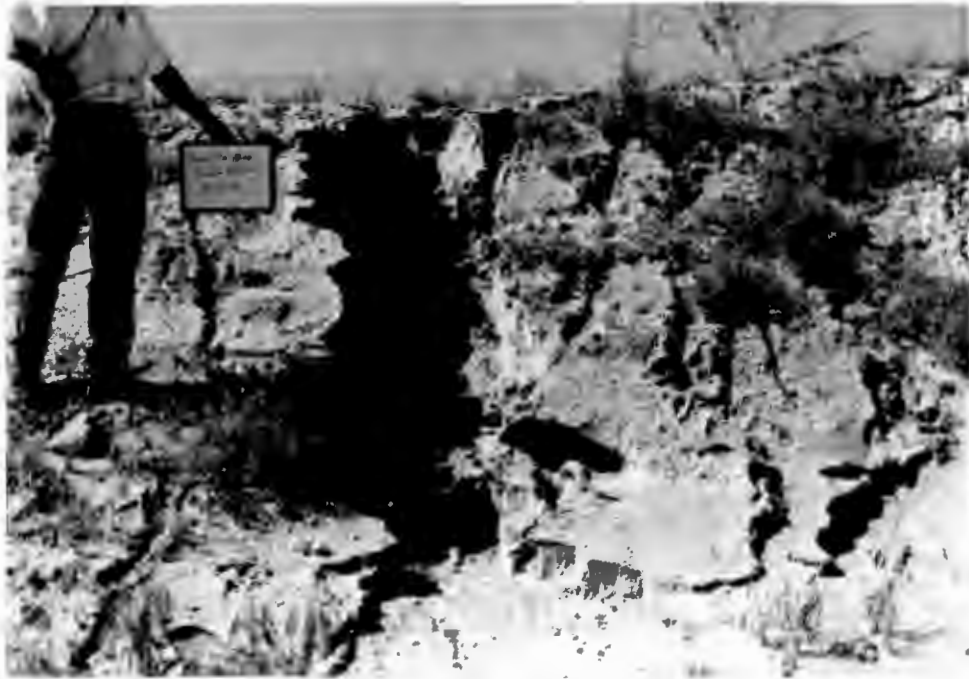
Isabella Mine, Erosion Feature, 9/12/95

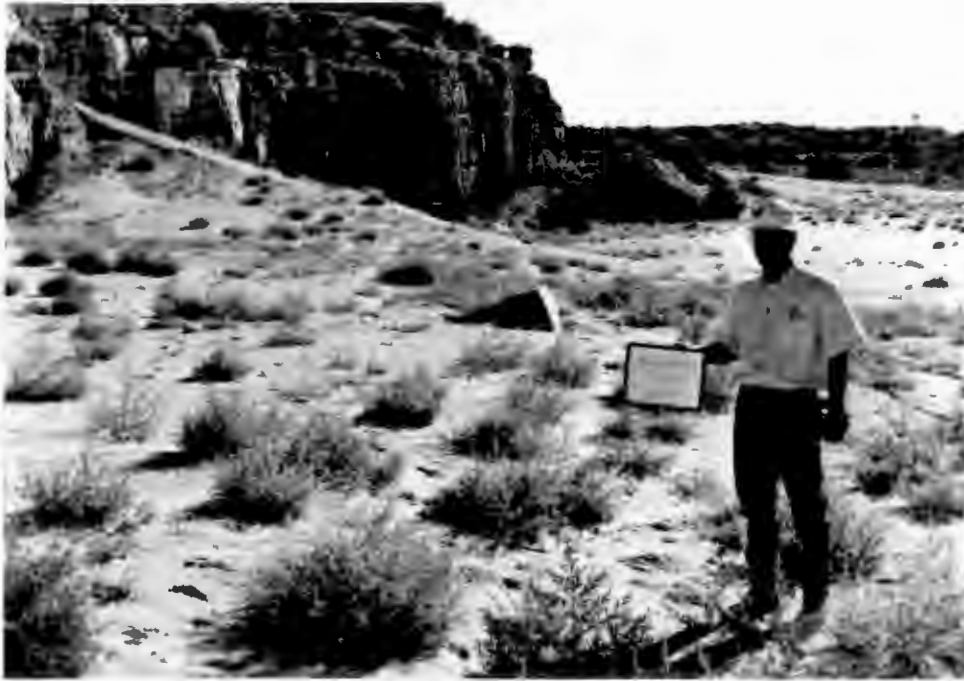
Marquez Mine, Reclaimed Declined Shaft, 9/12/95

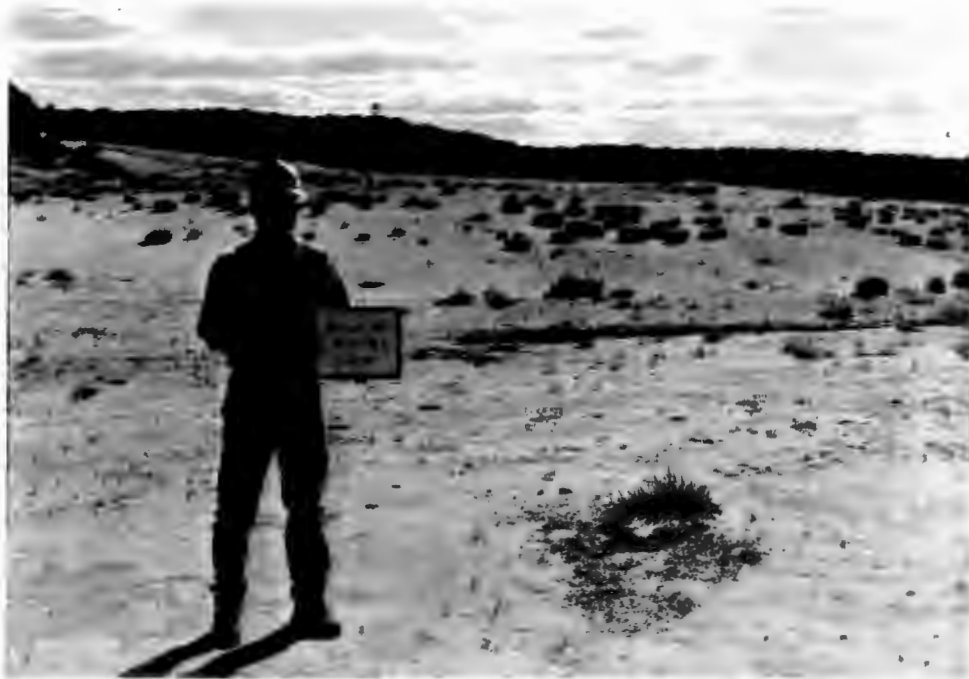
Marquez Mine, Waste Pile, 9/12/95

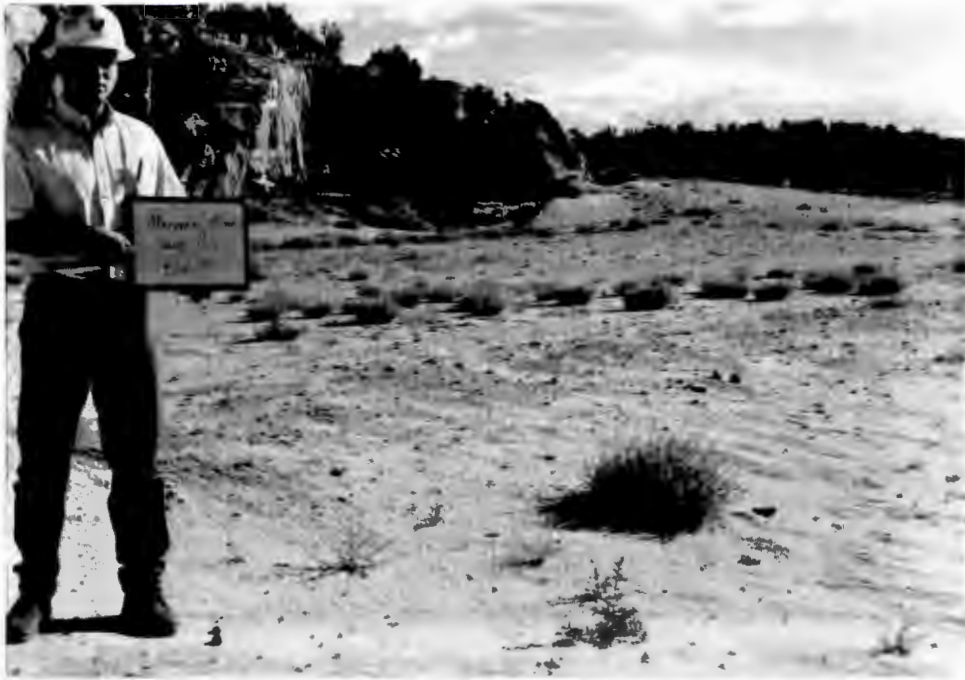
Marquez Mine Waste Pile, 9/12/95

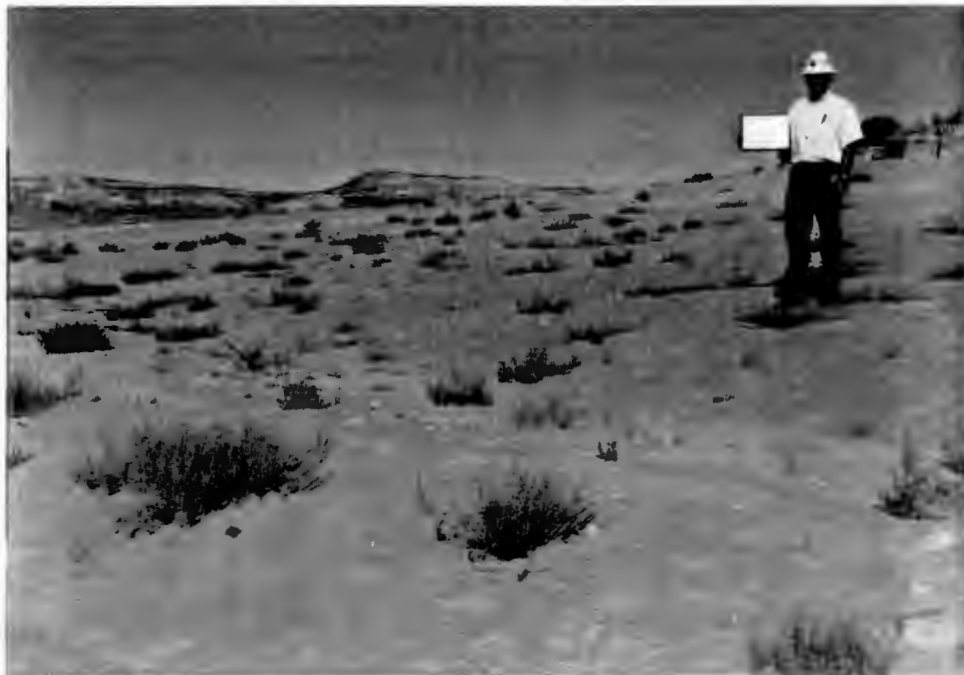
Marquez Mine, Waste Pile, 9/12/95

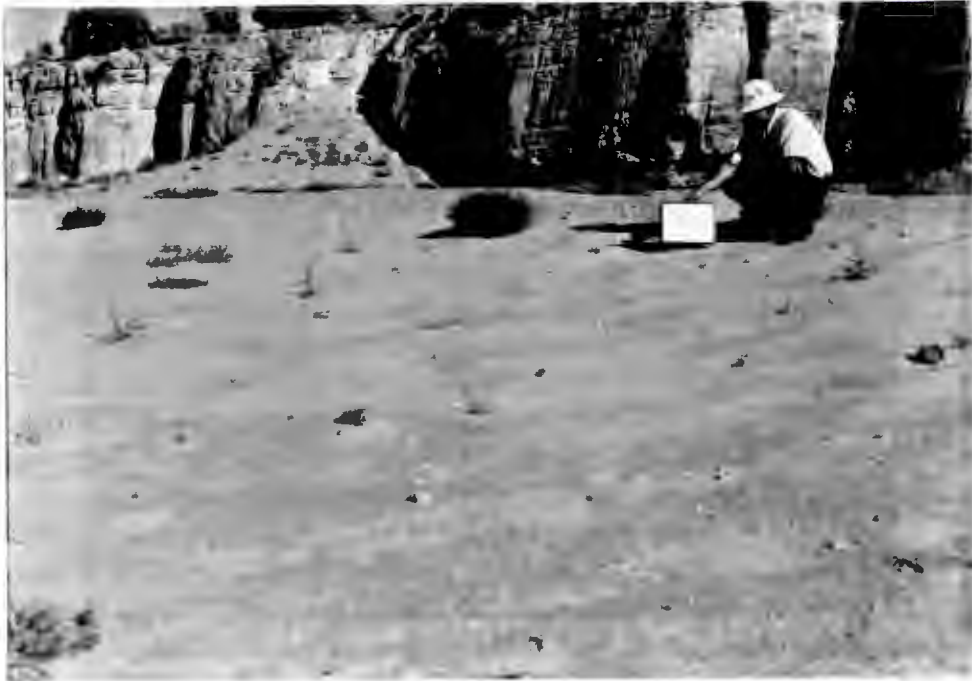
Marquez Mine, Waste Pile, 9/12/95

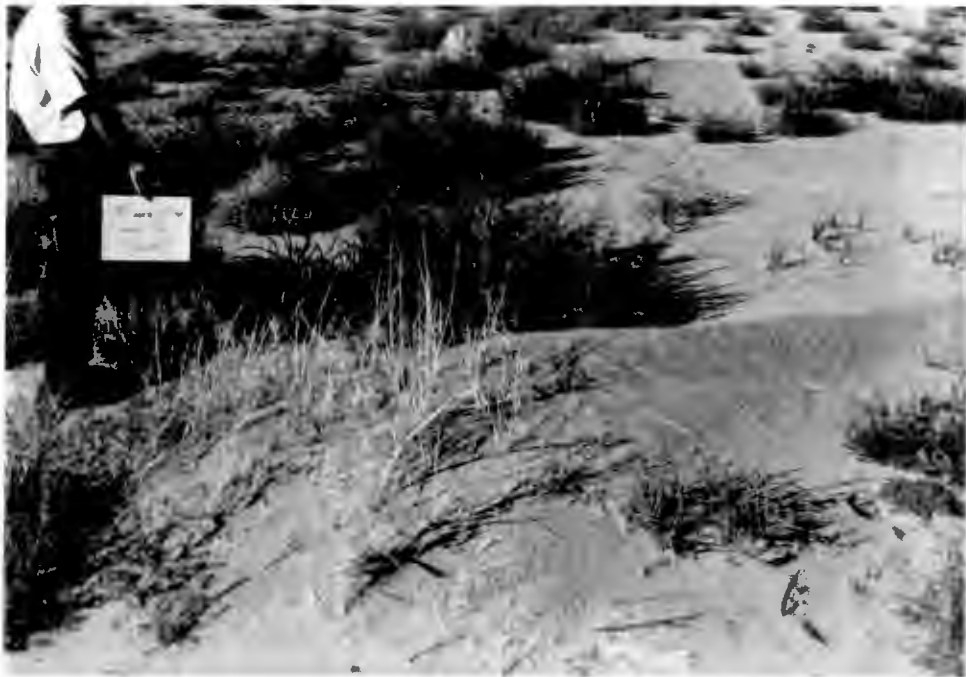
Marquez Mine, Sand Dune, 9/12/95

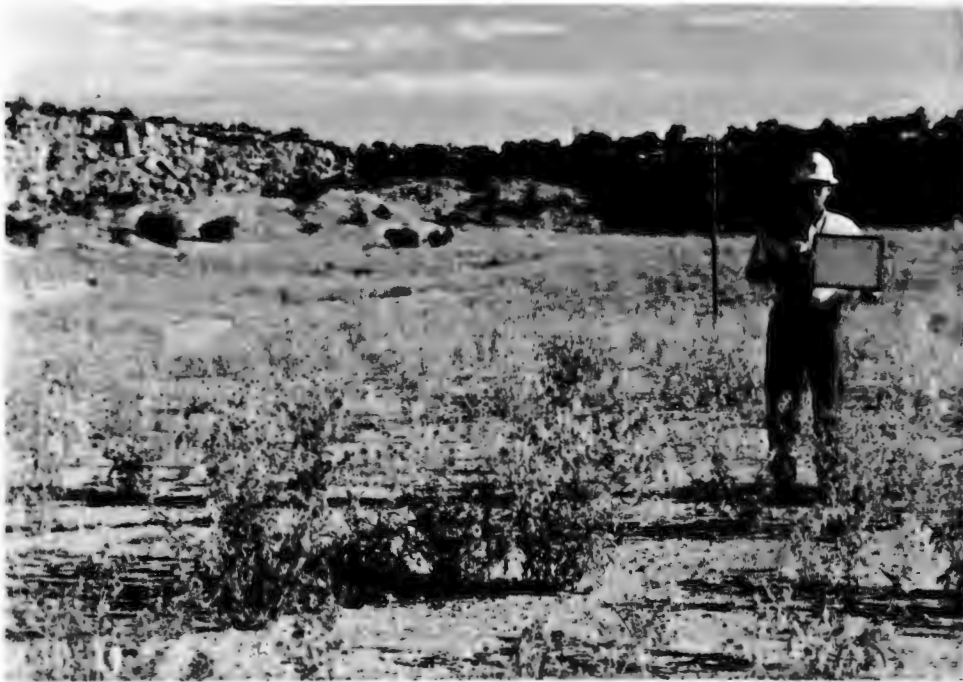
Poison Canyon Mine, Middle Looking North, 9/12/95

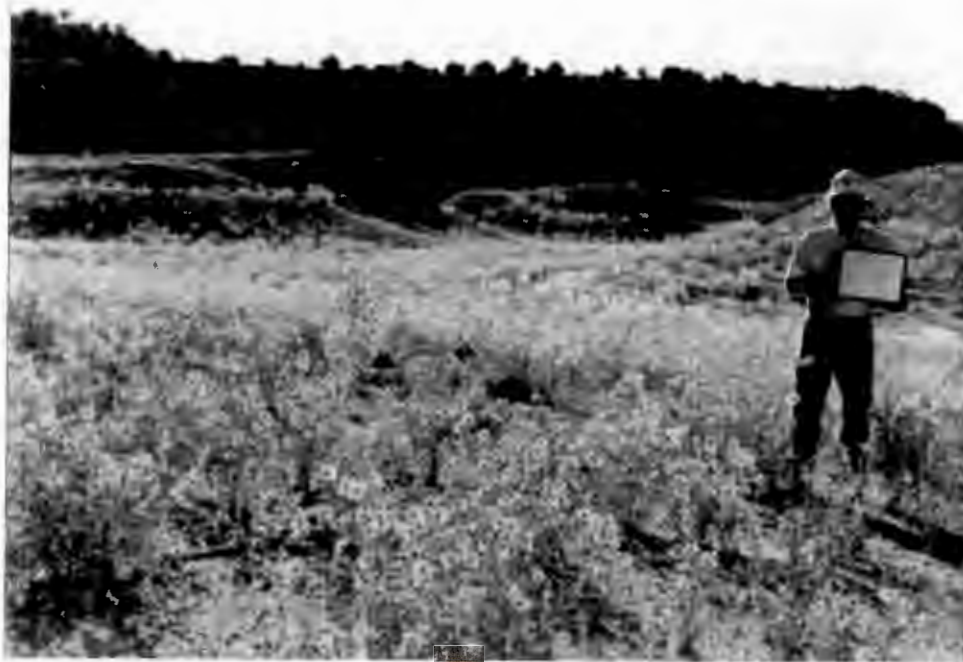
Poison Canyon Mine, Middle Looking East, 9/12/95
