**PRIOR RECLAMATION INSPECTION REPORT
AND
RECOMMENDATION FOR RELEASE OR PERMIT
REQUIREMENT**

Santa Fe Pacific Gold Corporation

**New Mexico Energy, Minerals and Natural Resources Department
Mining and Minerals Division
Mining Act Reclamation Bureau**

September 29, 1995

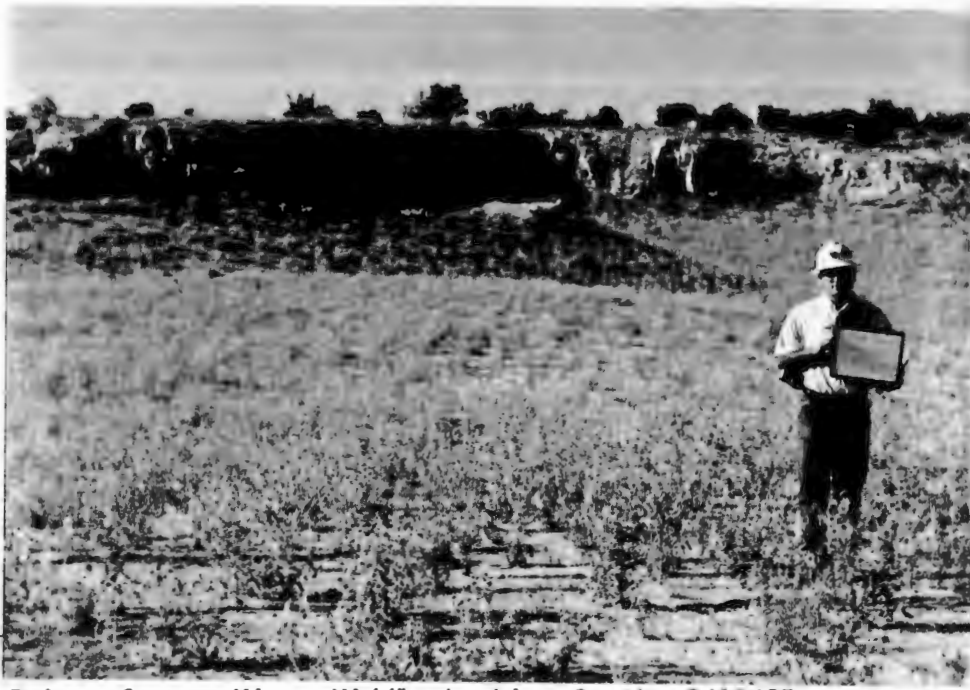
Poison Canyon Mine, Middle Looking South, 9/12/95

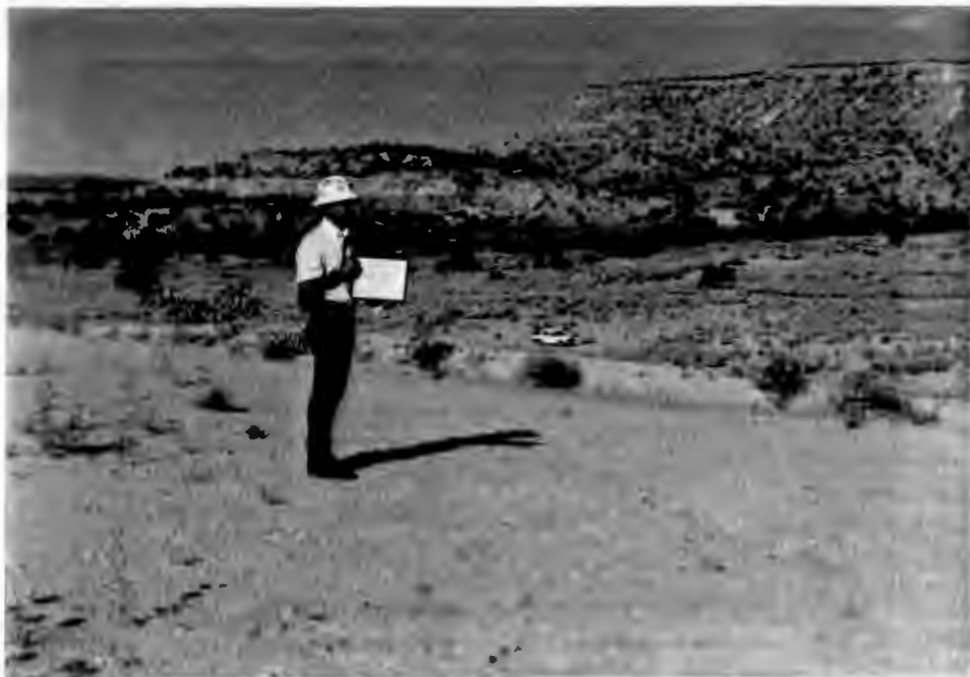
Poison Canyon Mine, Middle Looking West, 9/12/95

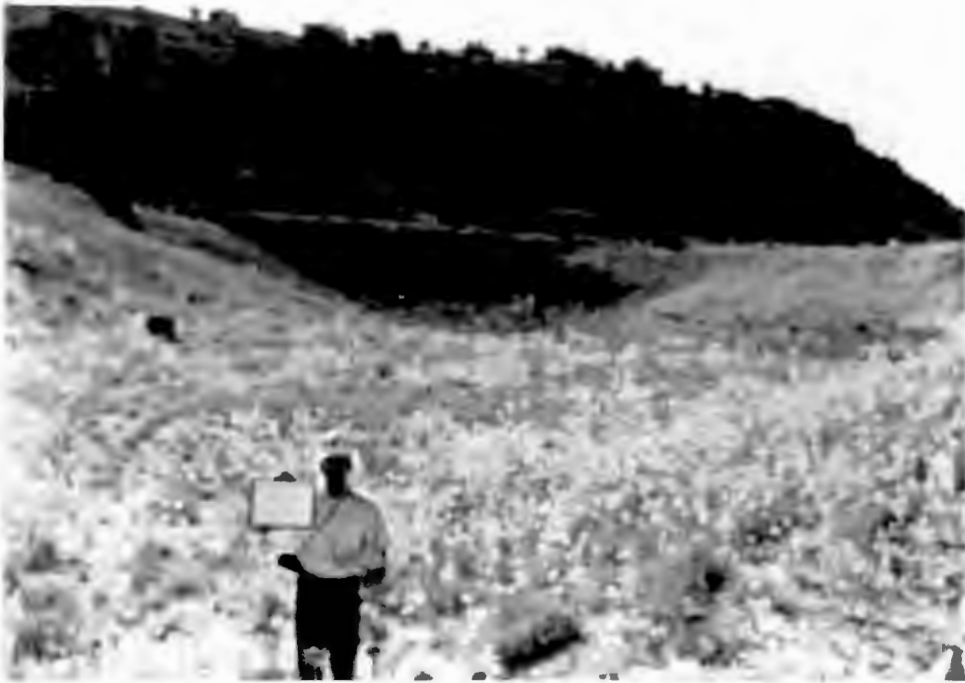
Poison Canyon Mine, Reclaimed Declined Shaft, 9/12/95

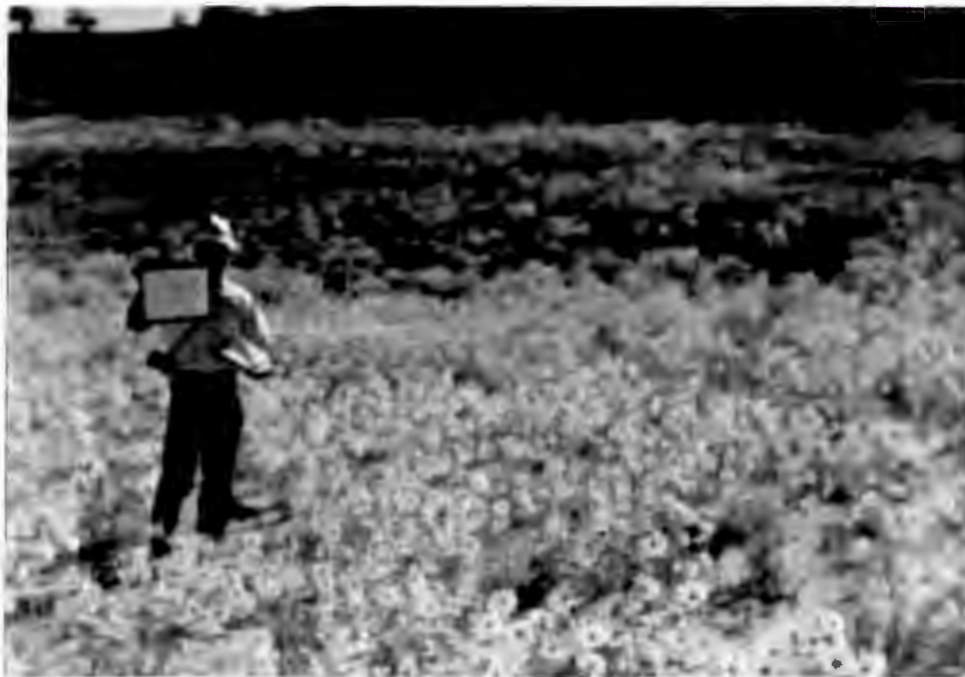
Poison Canyon Mine, Small Depression, 9/12/95

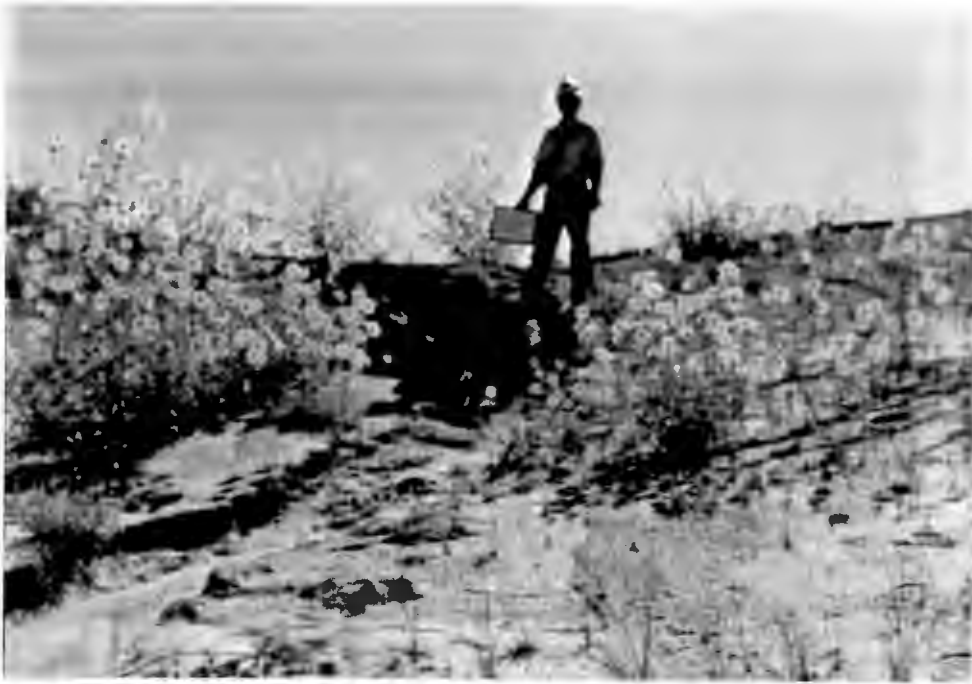
Poison Canyon Mine, Erosion Feature, 9/12/95
