HAYSTACK MINE

**PRIOR RECLAMATION INSPECTION REPORT
AND
RECOMMENDATION FOR RELEASE OR PERMIT
REQUIREMENT**

Santa Fe Pacific Gold Corporation

September 29, 1995

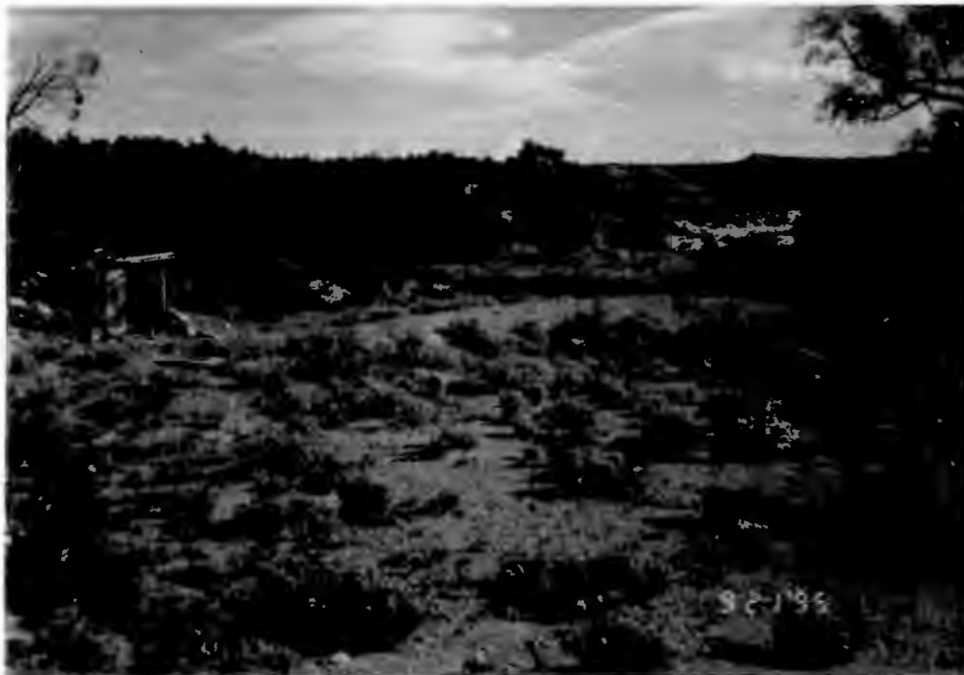
Section 13 T1N R6W, Powder Magazine, September 21, 1995

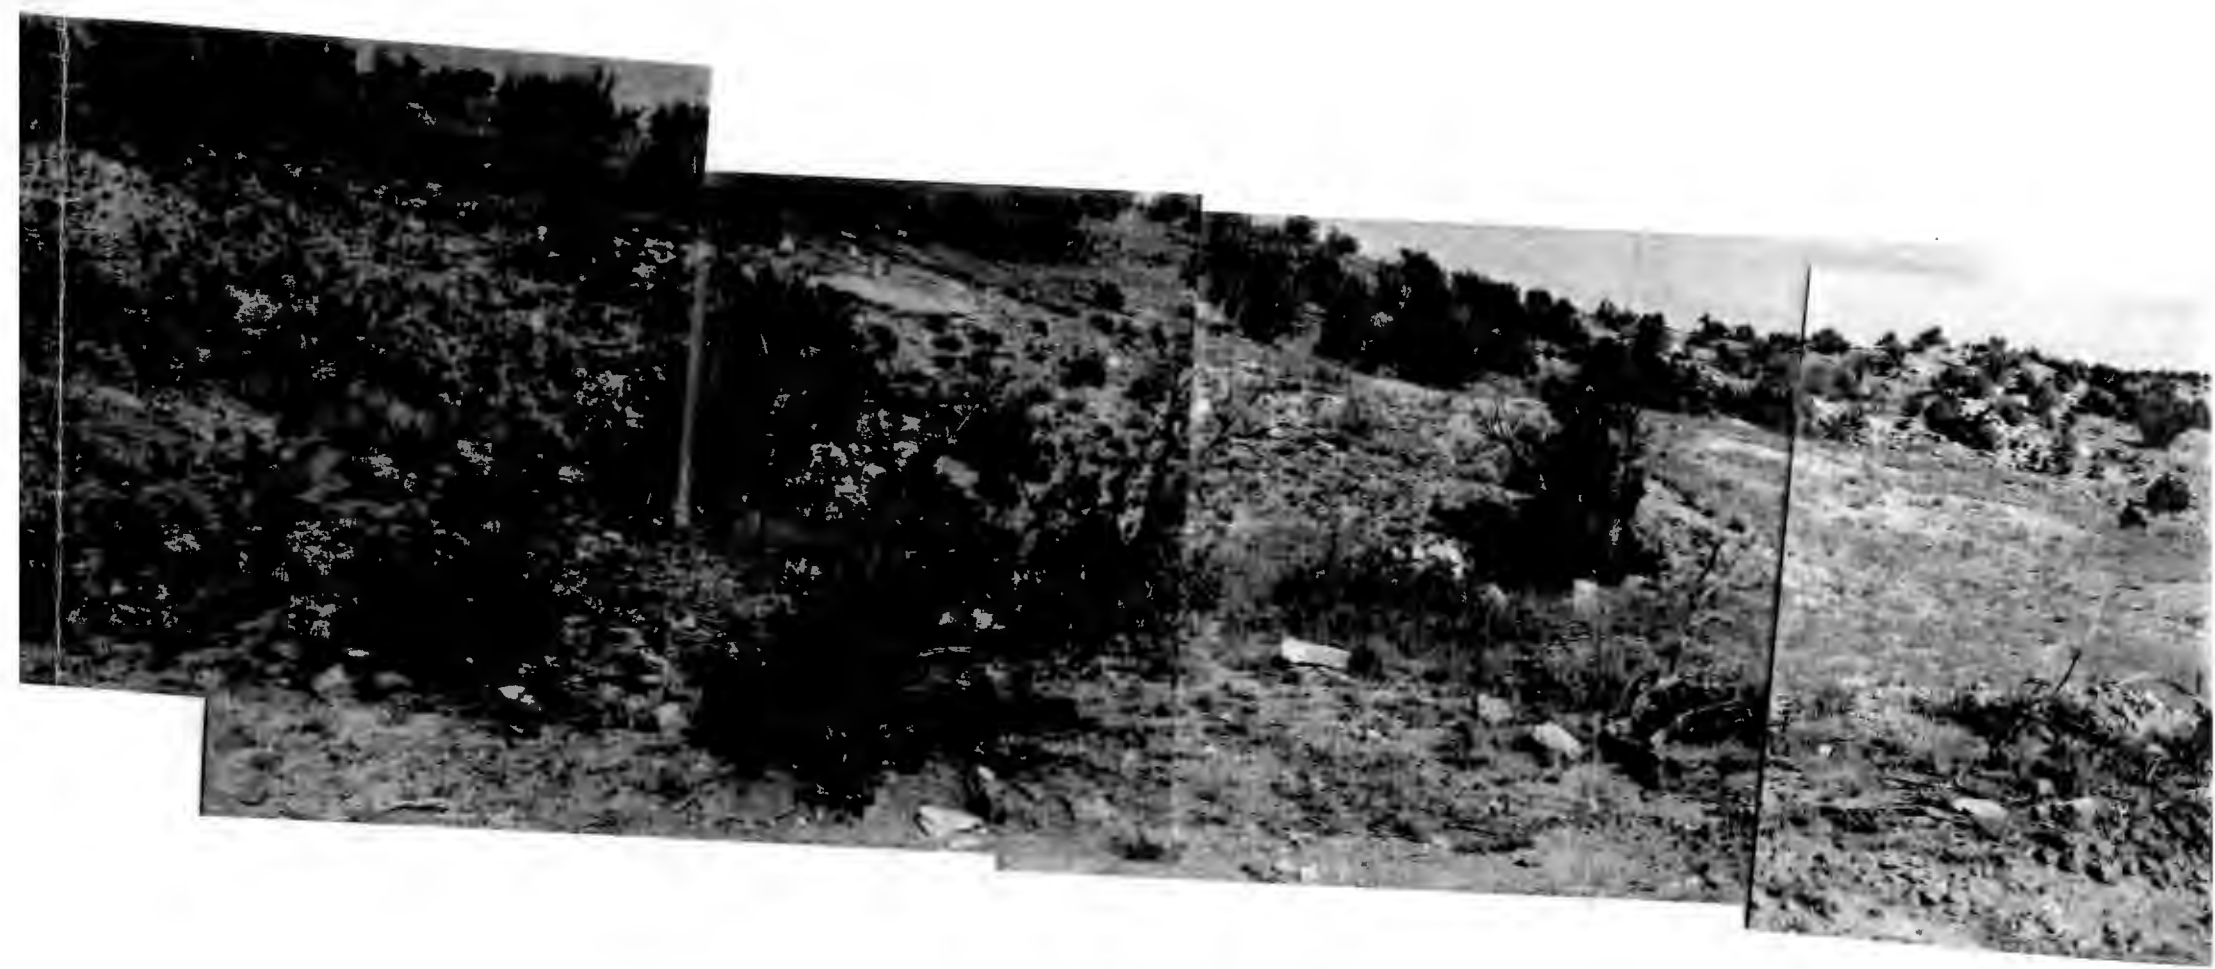
Section 13 T1N R6W, Mine Site From South

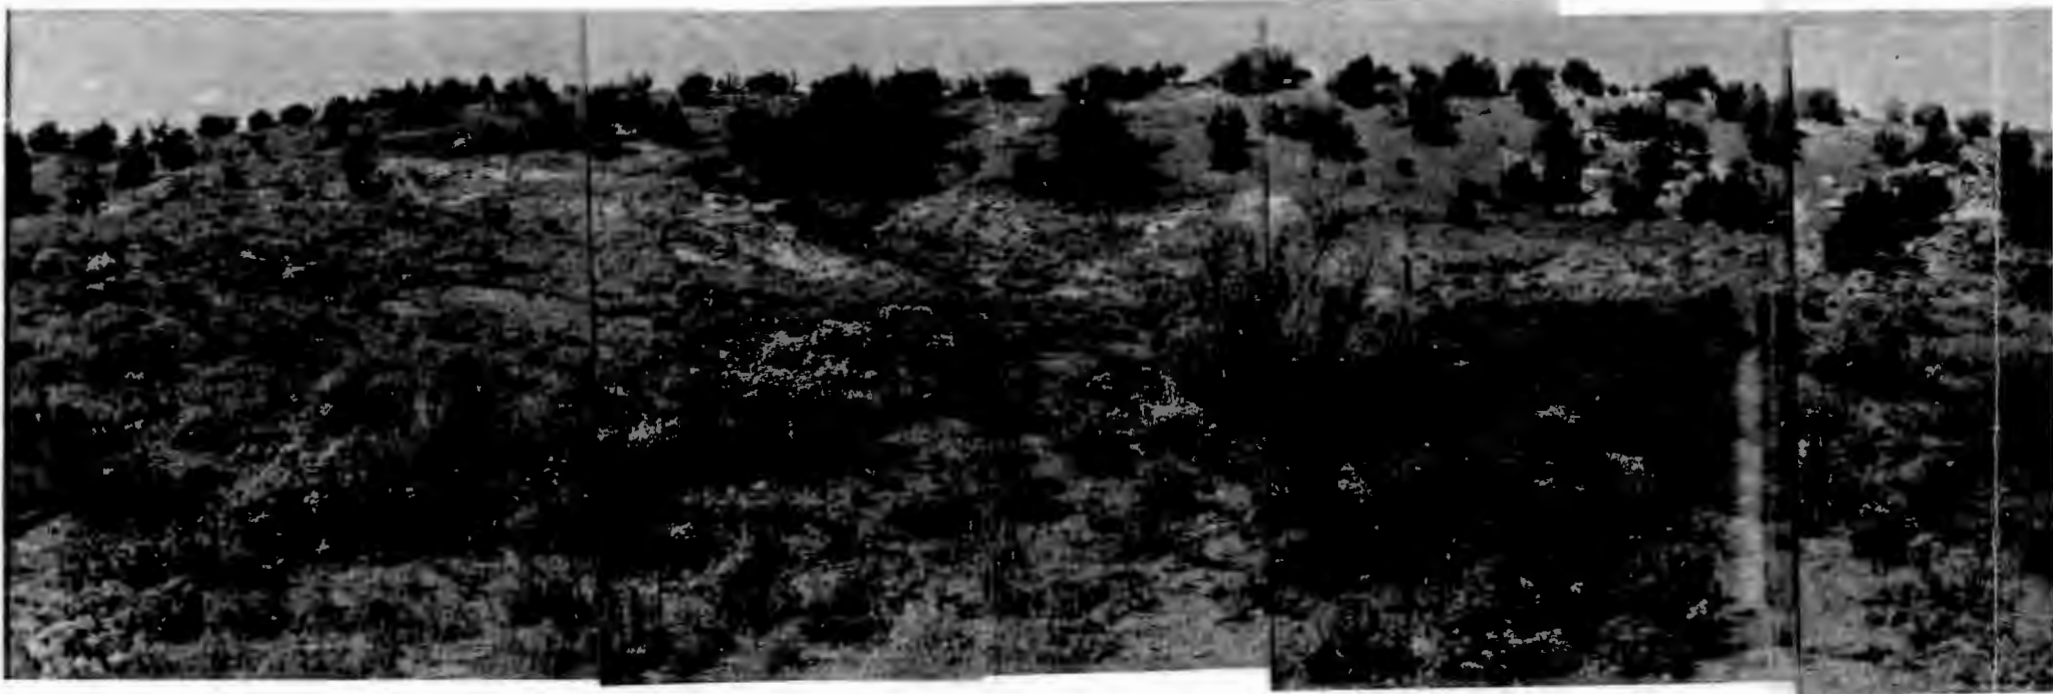
Section 13 T1N R6W, Mine Site From East

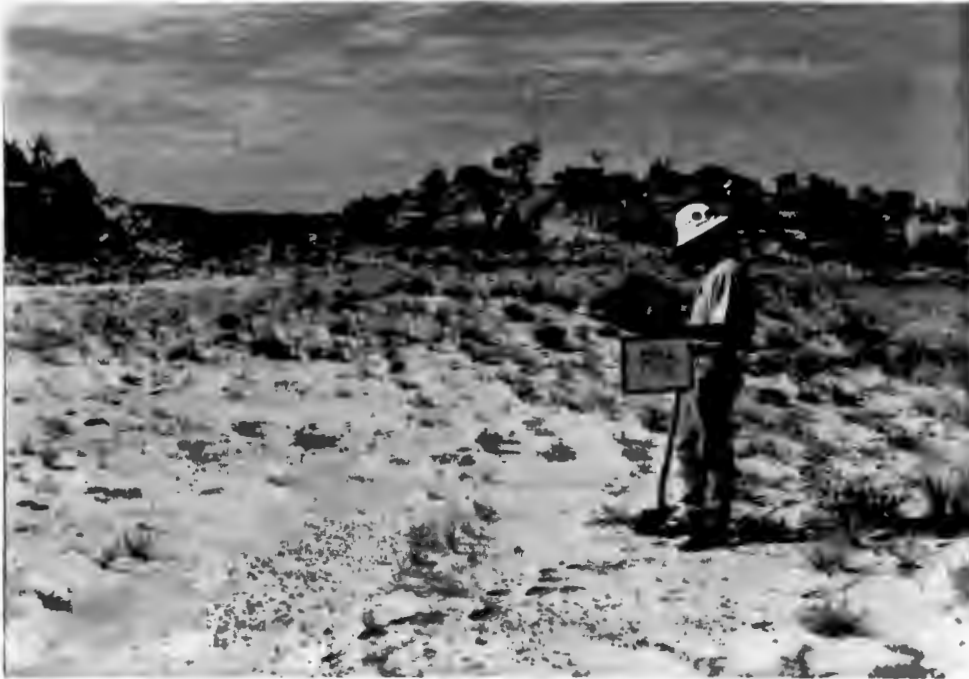
Essentially, the site had been safeguarded but not topsoiled or reseeded. The site is characterized by white fine grained sandstone covered by a few inches of fine white sand. The sand is subsequently being eroded away by wind and water. A mine access road had significant erosion. An impoundment had been constructed to impound sediment from the mine site, however, erosion from the access road was bypassing the impoundment and was entering the mine site. Photographs documenting vegetation and the general condition of the site are presented in Appendix C.

Section 1 T13N R9W, Shaft Site Looking South, 9/13/95

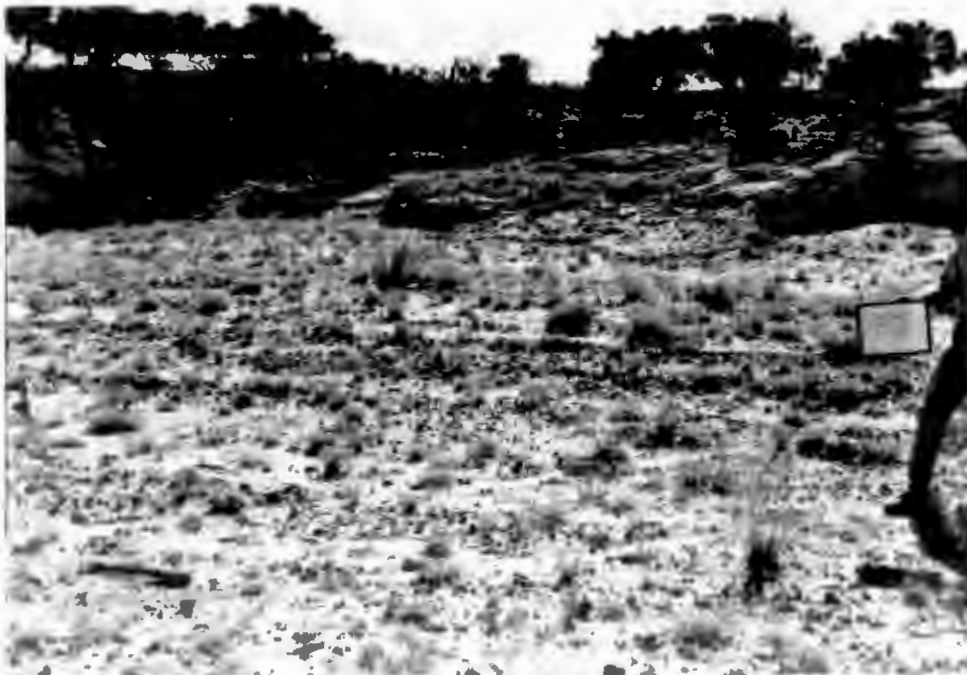
Section 1 T13N R9W, Shaft Site Looking West, 9/13/95

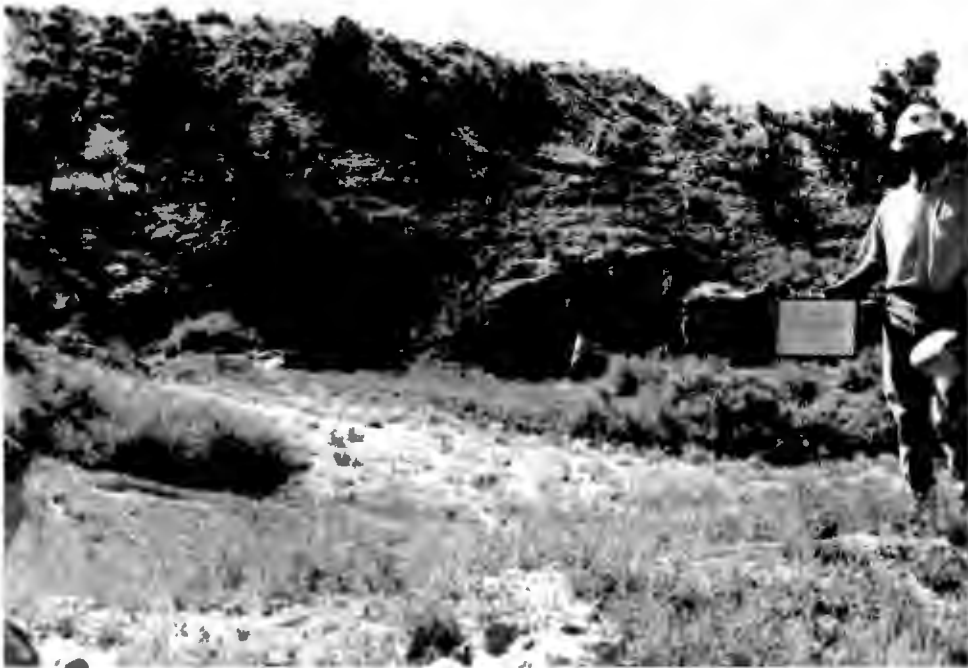
Section 1 T13N R9W, Sediment Pond, 9/13/95

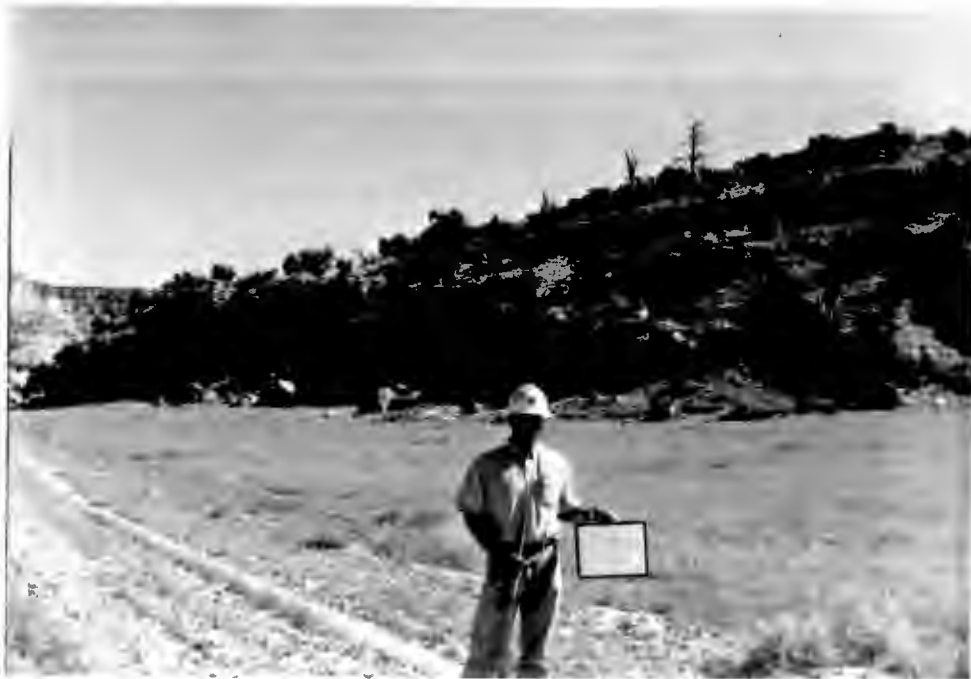
Section 1 T13N R9W, Looking Up at Mine Site, 9/13/95

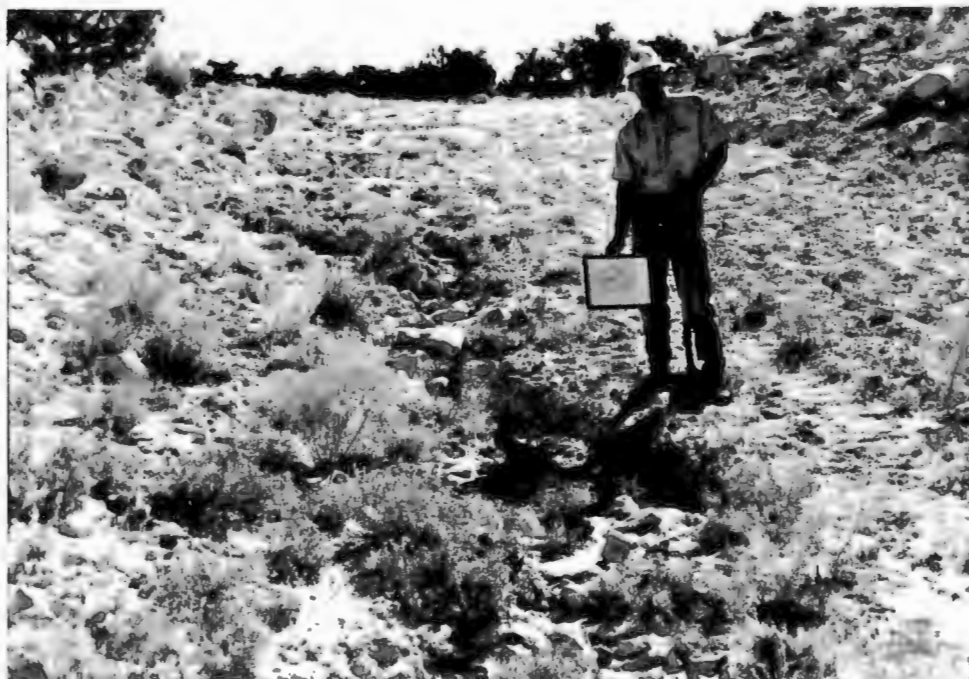
Section 1 T13N R9W, Access Road, 9/13/95

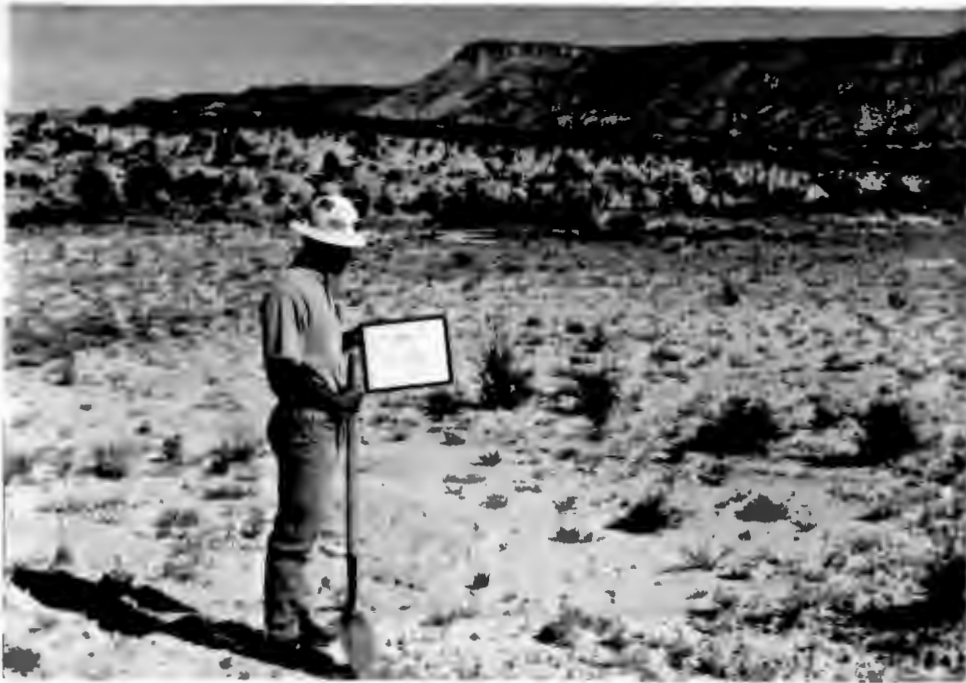
Section 1 T13N R9W, South Side Looking North, 9/13/95

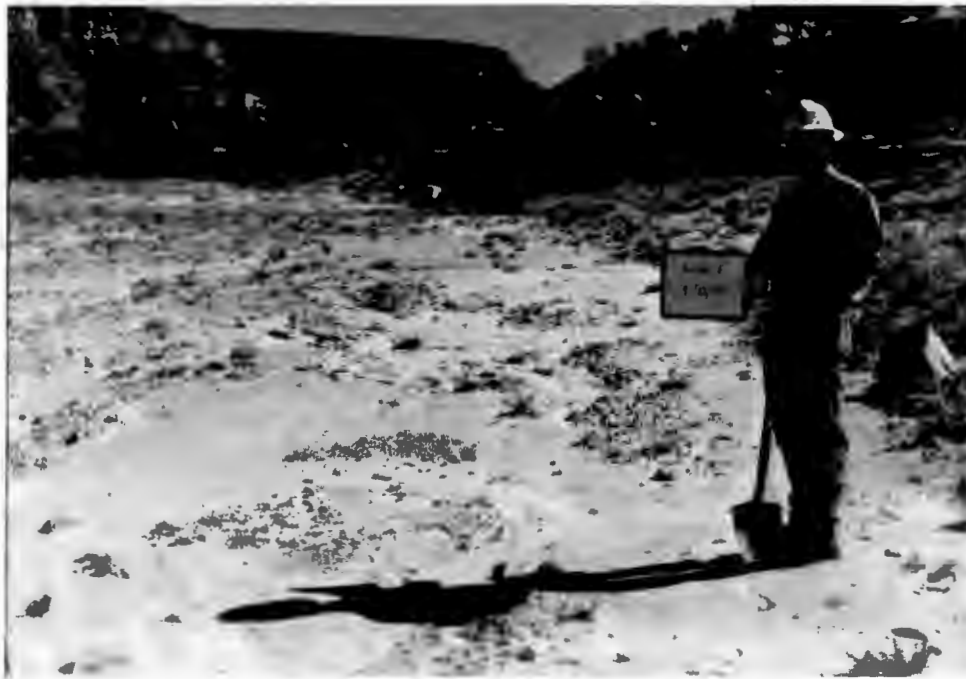
Section 1 T13N R9W, North Side Looking South, 9/13/95

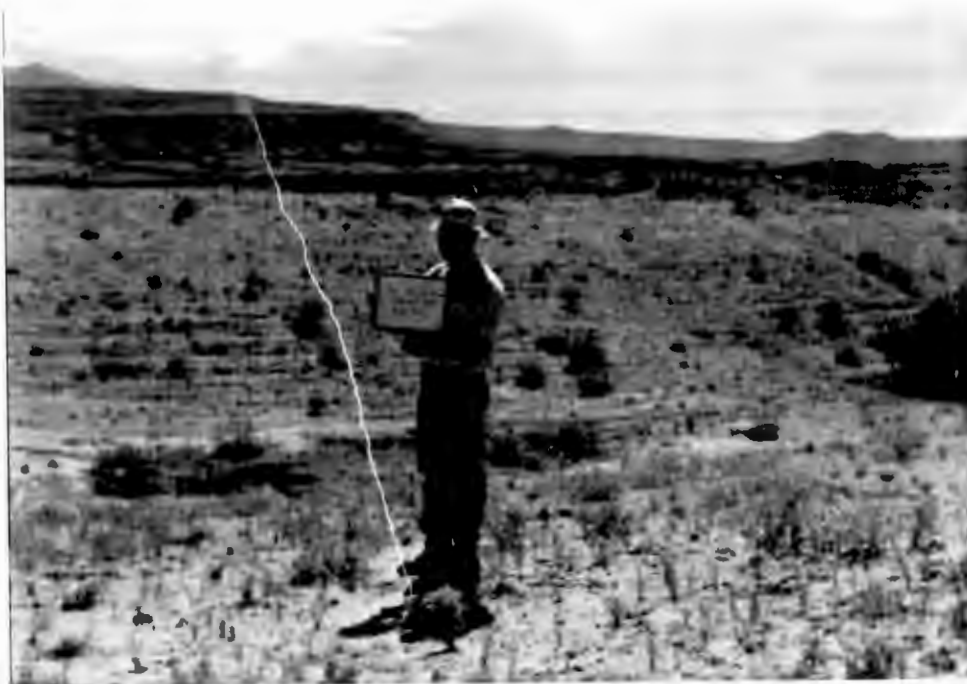
Section 25 Mine, West Side Looking West, 9/12/95

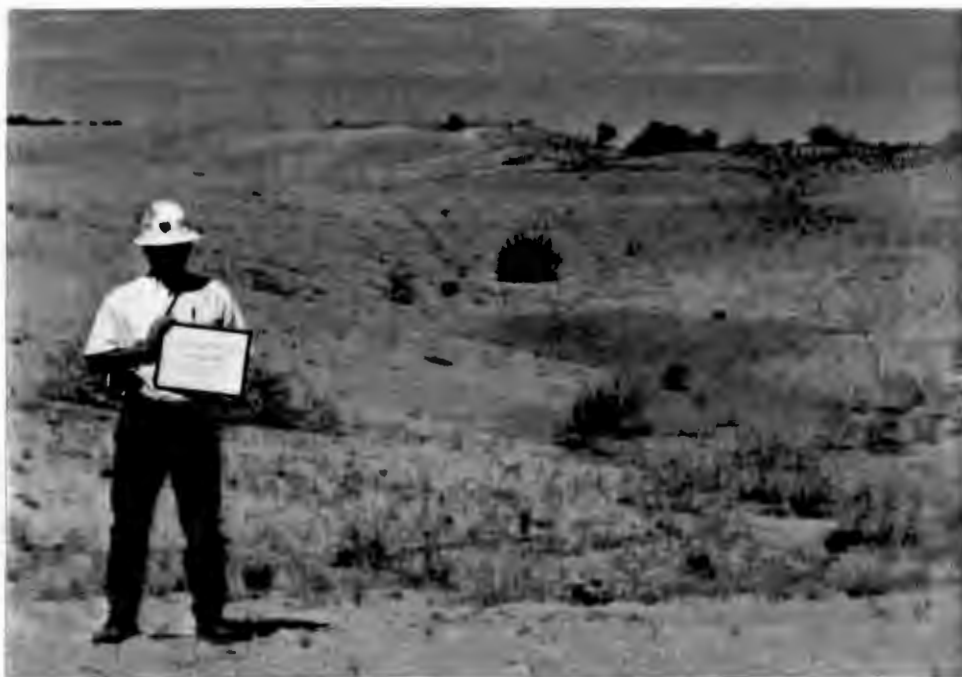
Section 25 Mine, Middle Looking East, 9/12/95

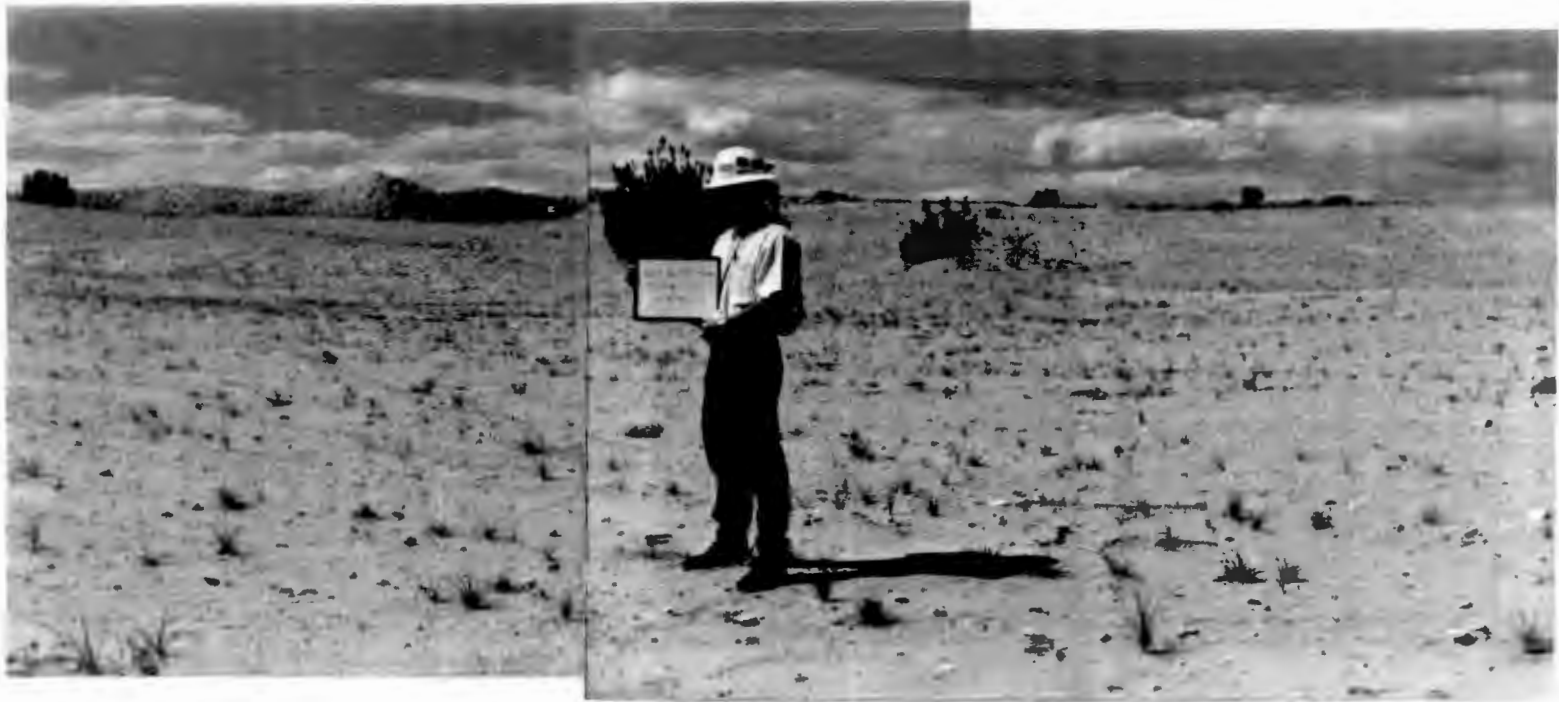
Section 25 Mine, East Side Looking Southwest, 9/12/95

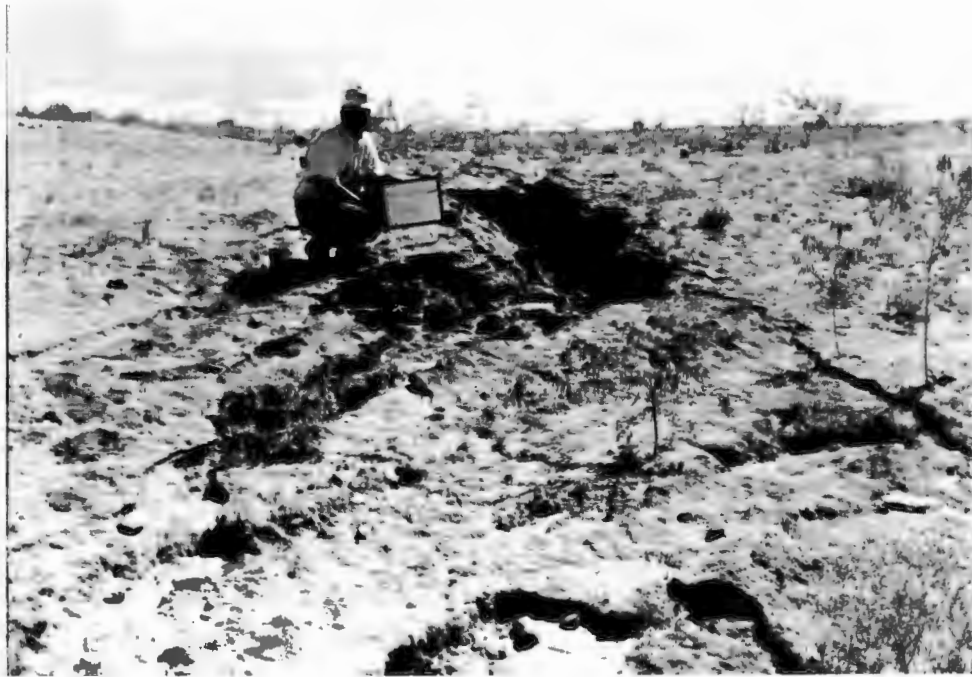
Section 25 Mine, Erosion Feature, 9/12/95

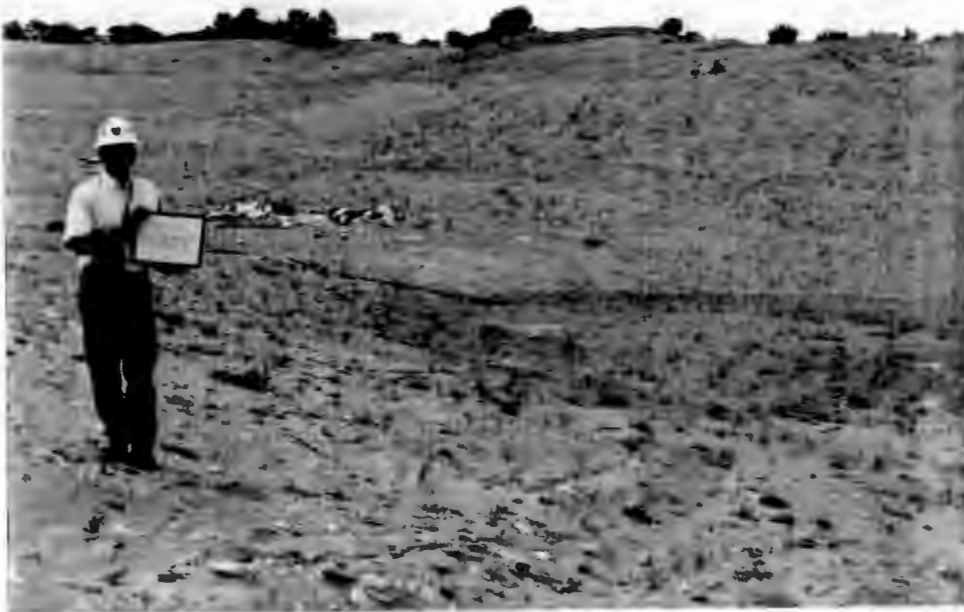
This was a surface mine located 14 miles northwest of the Grants, New Mexico. The mine was operated by United Nuclear Corporation until termination of the lease in 1975. Open adits and shafts were backfilled and otherwise safeguarded in 1987. The site was reclaimed and reseeded by Santa Fe the fall of 1994 (Santa Fe, 1994). All structures, trash or junk had been removed from the site however, trespass dumping has since taken place. There were no piles or accumulations of toxic or waste material on the site. There were no apparent hazards that could effect public health or safety. There were minor erosion features where water had flowed into depressions. Twenty foot slopes of limestone cobble were left on the south side of the reclaimed area to blend in with a natural limestone outcropping. Several 6 foot high, 50 foot long topsoil stockpiles were left because small animals were burrowing into them and were using them for habitat. Photographs documenting vegetation and general condition of the site are presented in Appendix G.

Section 31 T13N R9W, North End Looking South, 9/12/95

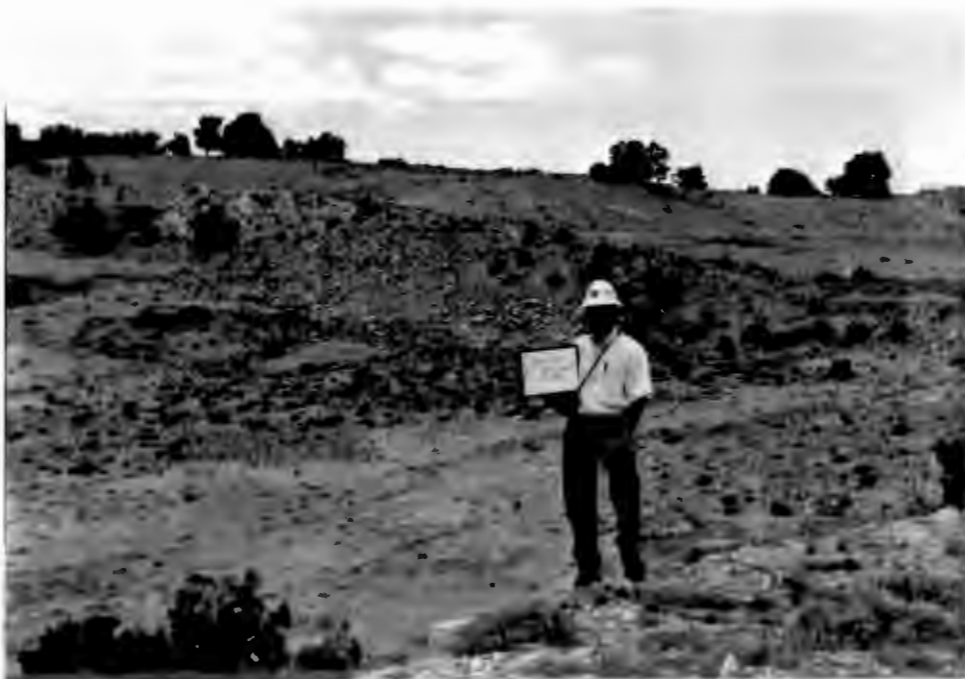
Section 31 T13N R9W, Northeast Side Looking West, 9/12/95

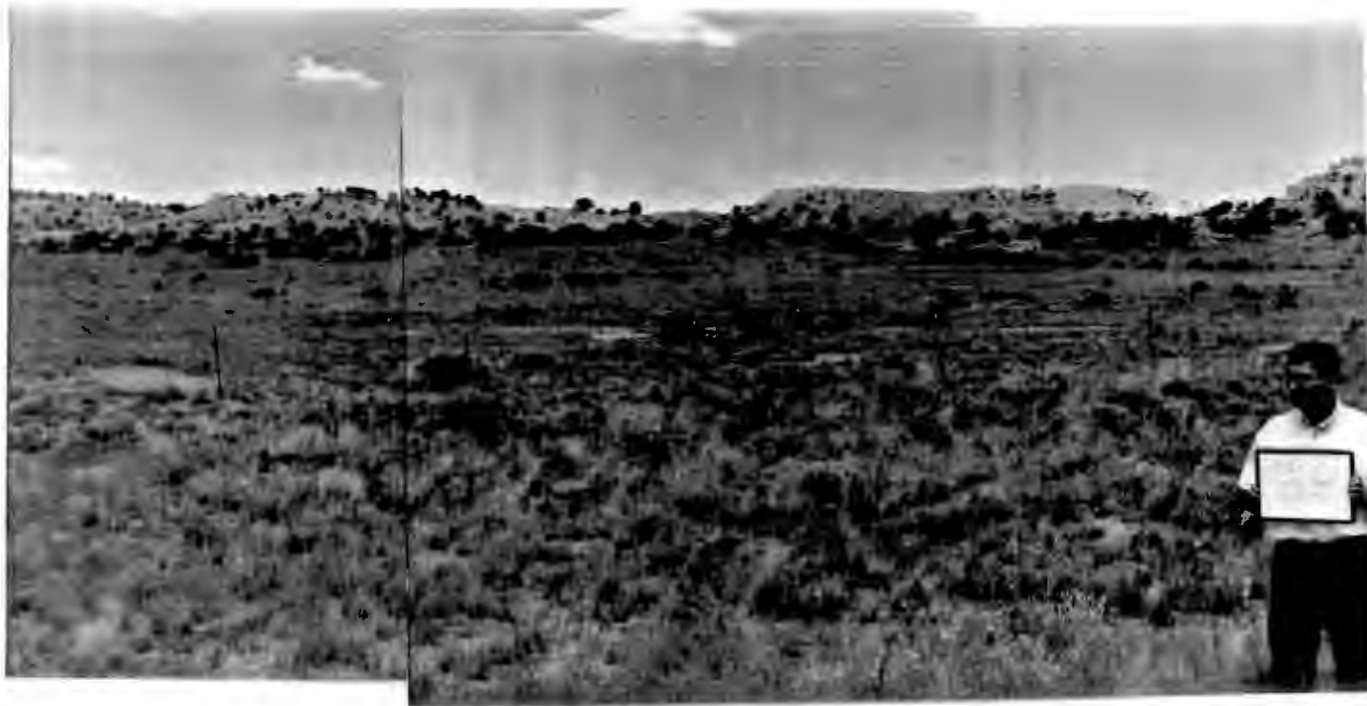
Section 31 T13N R9W, Reconstructed Limestone Bluffs, 9/12/95

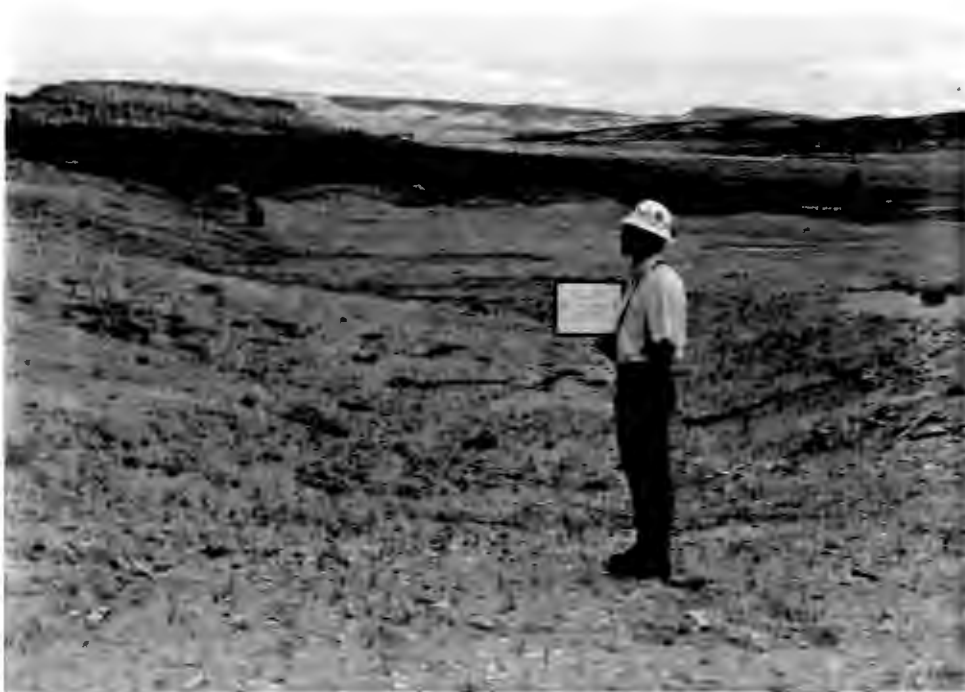
Section 31 T13N R9W, Southeast Side looking North

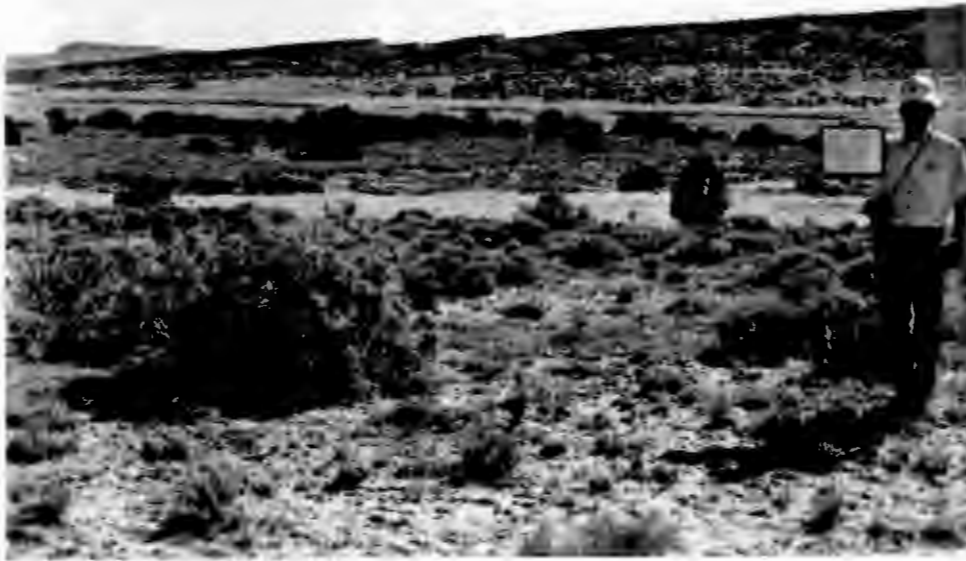
Faith Mine Shaft Site, Looking East, 9/12/95
Regraded Area in Background

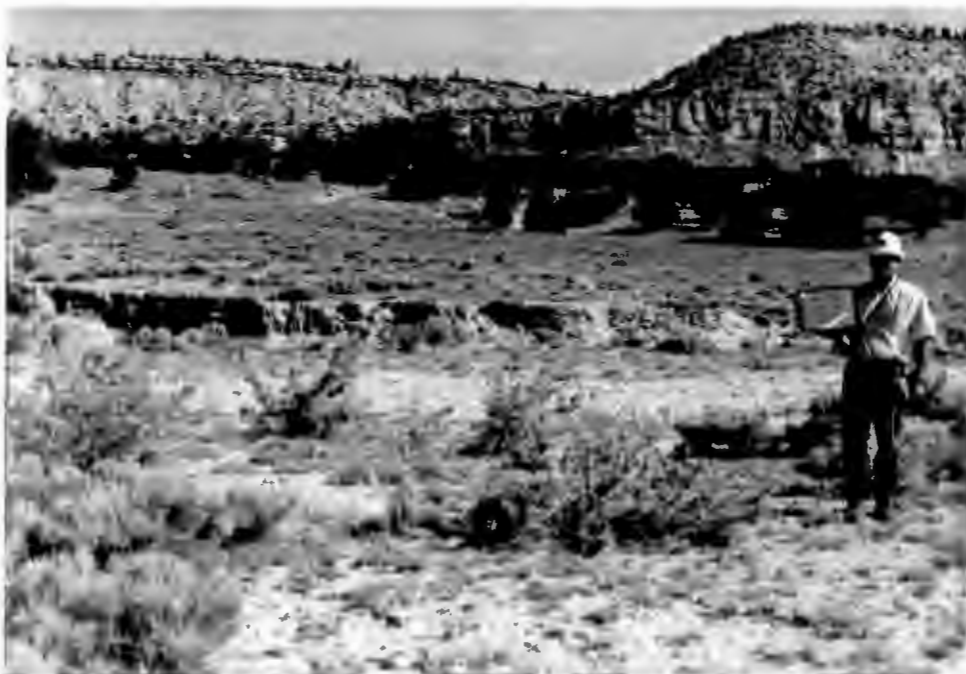
Faith Mine Shaft Site, Looking North, 9/12/95

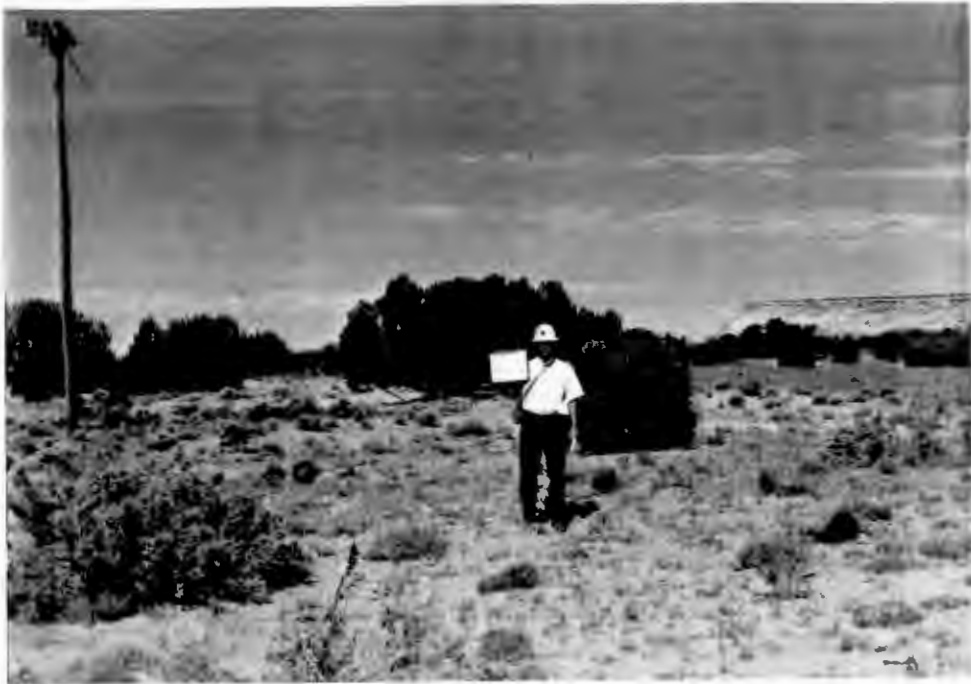
Faith Mine Shaft Site, Looking West, 9/12/95

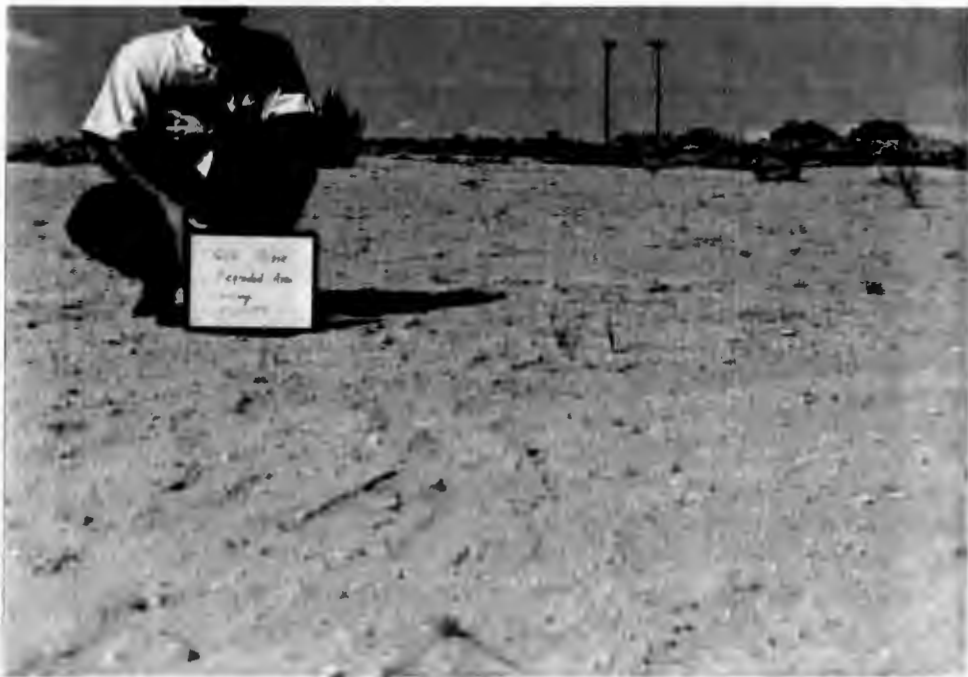
Faith Mine Regraded Area, 9/12/95

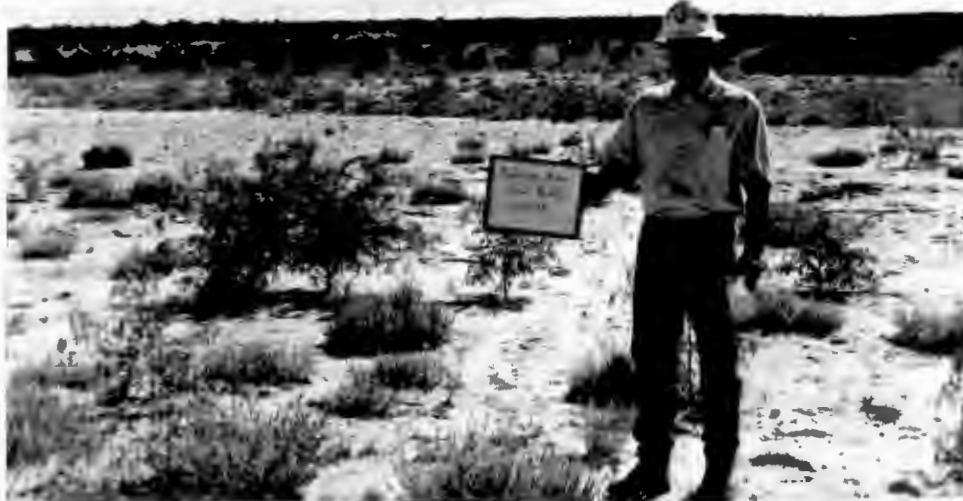
Isabella Mine, From North, 9/12/95

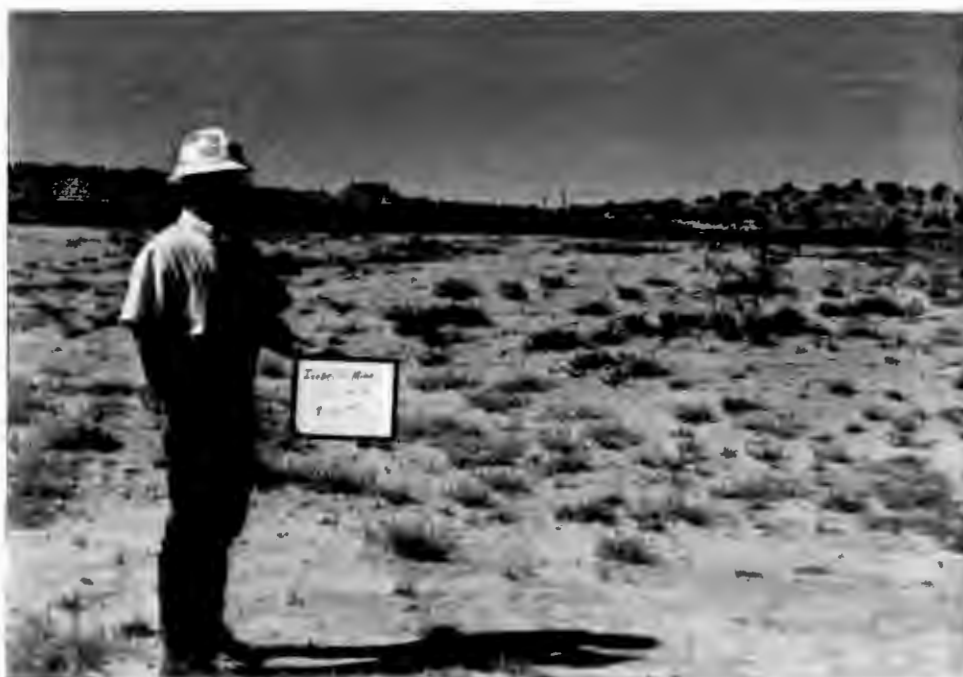
Isabella Mine, From South, 9/12/95

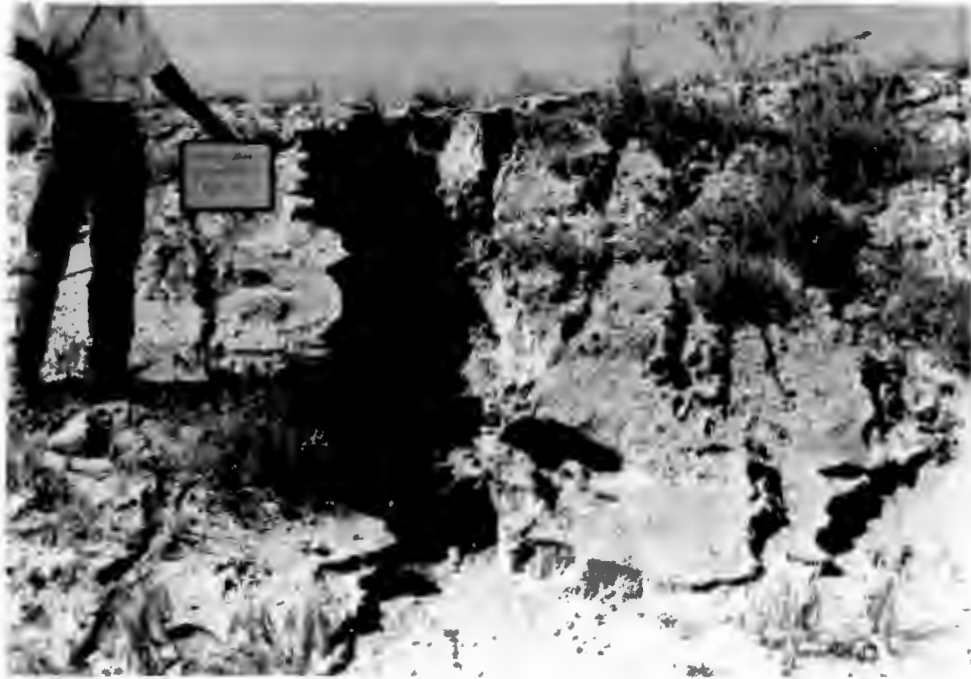
Isabella Mine, Erosion Feature, 9/12/95

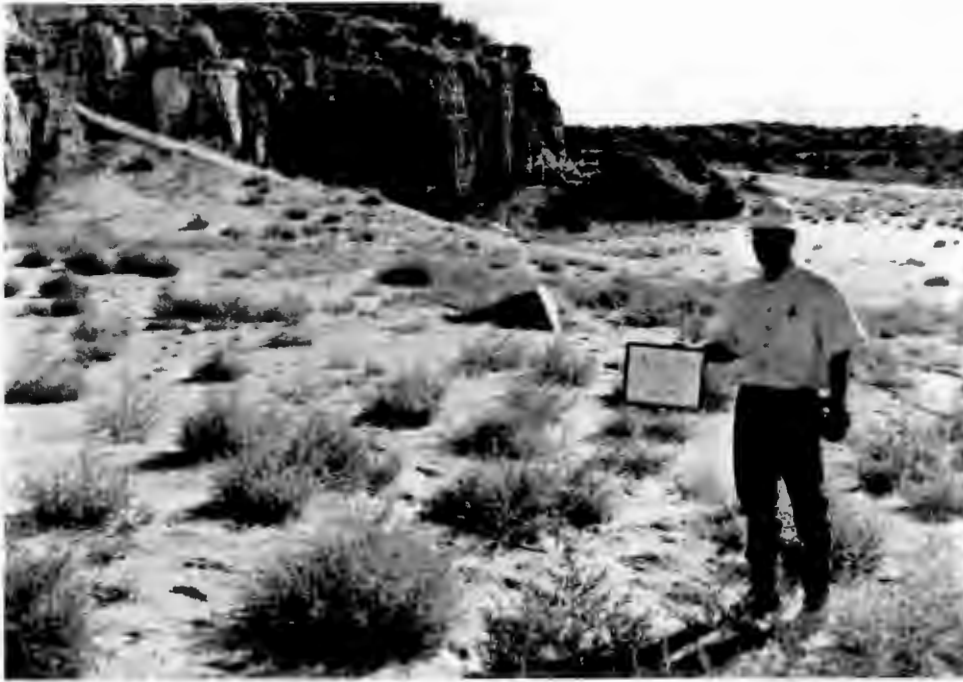
Marquez Mine, Reclaimed Declined Shaft, 9/12/95

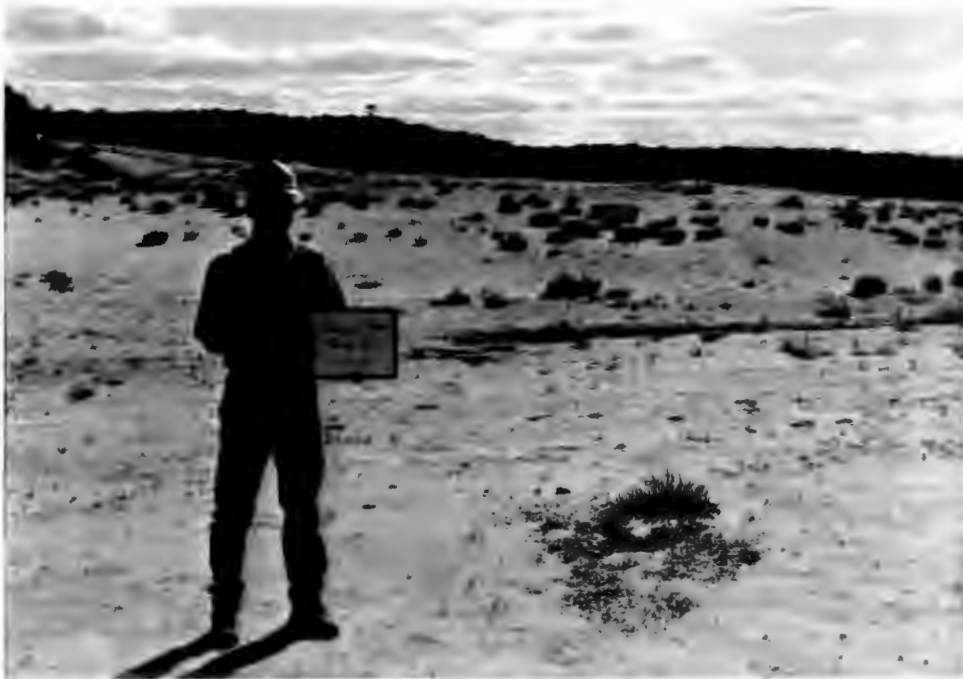
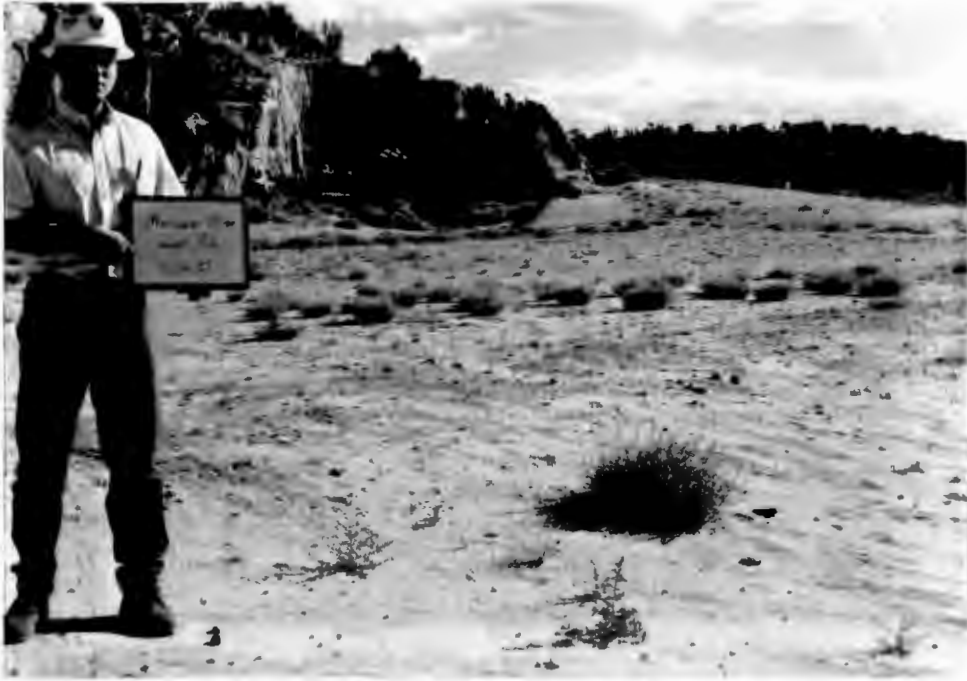
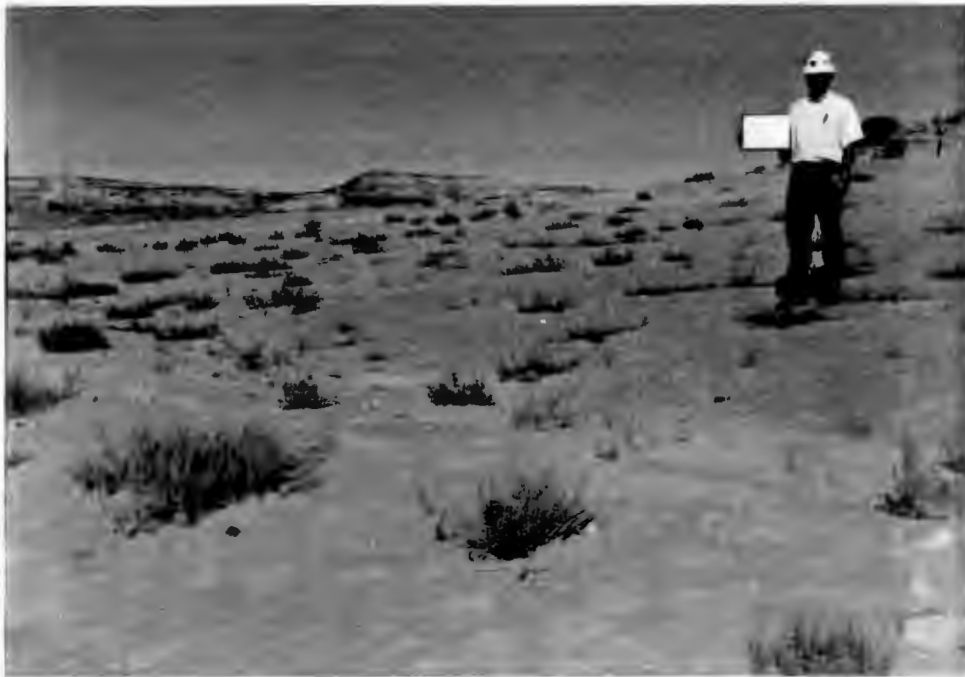
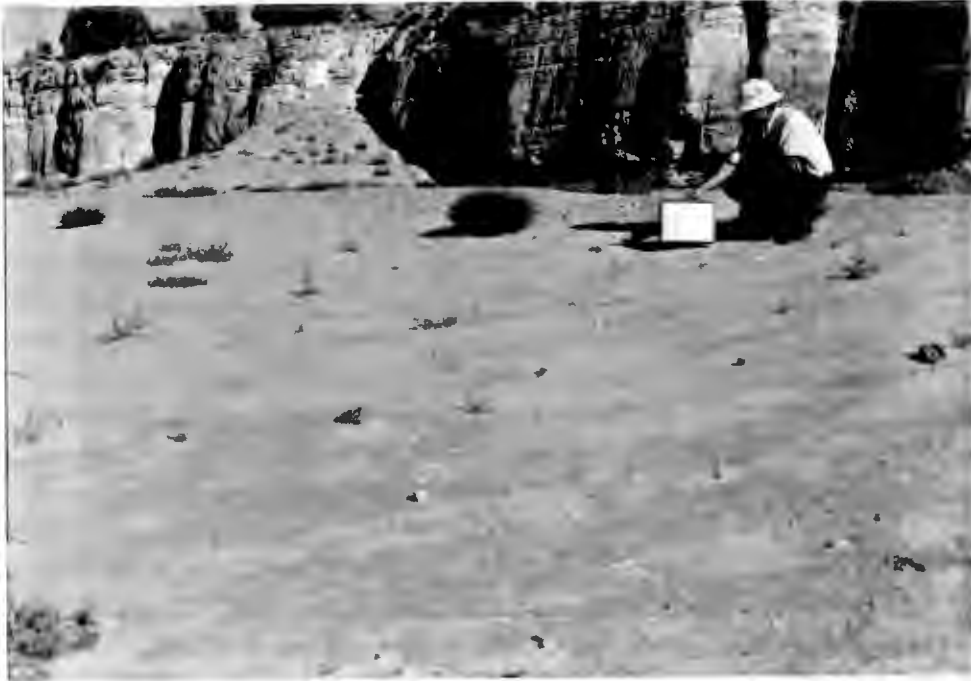
Marquez Mine, Waste Pile, 9/12/95

Marquez Mine Waste Pile, 9/12/95
