HAYSTACK MINE

**PRIOR RECLAMATION INSPECTION REPORT
AND
RECOMMENDATION FOR RELEASE OR PERMIT
REQUIREMENT**

Santa Fe Pacific Gold Corporation

September 29, 1995

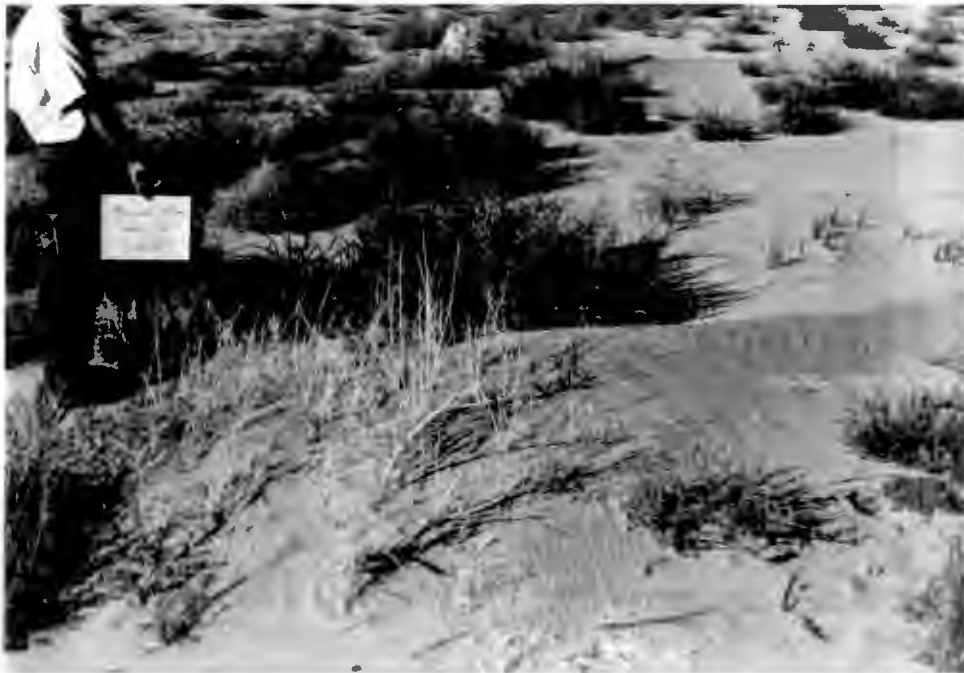
Topsoil depths across the site were greater than 12 inches, but consisted entirely of windblown sand. This area was essentially barren with most of the seed and mulch blown away before vegetation could be established. Native species such as Indian ricegrass (*Oryzopsis hymenoides*), from adjoining areas were starting to invade the disturbance area (Young, 1995). Because of the obvious lack of plant cover at the site no transects were attempted. Staff does not recommend release of this site.

Marquez Mine, Sand Dune, 9/12/95

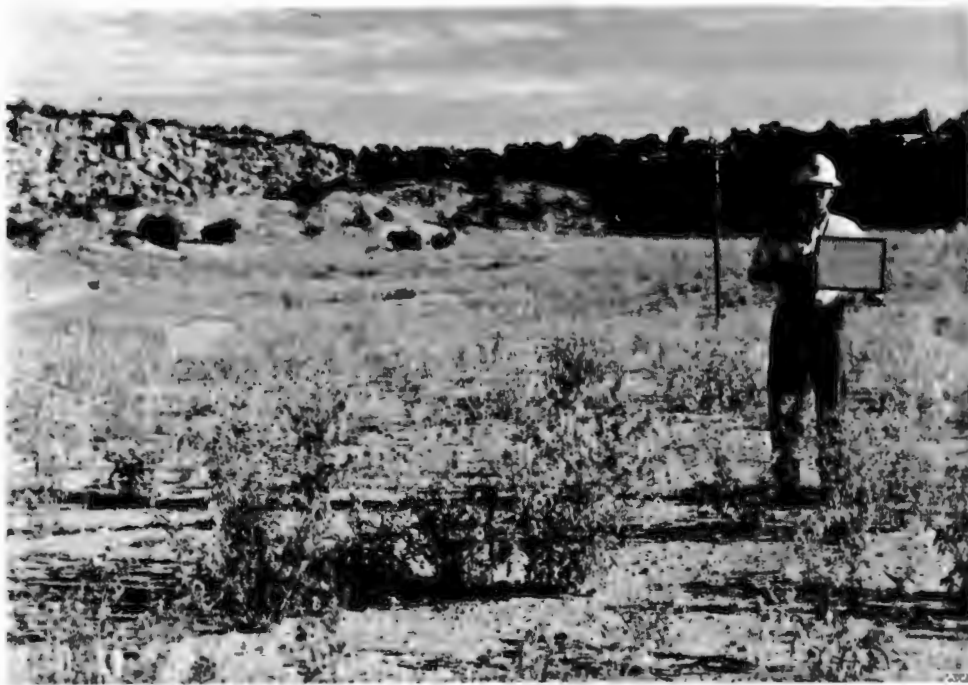
Poison Canyon Mine, Middle Looking North, 9/12/95

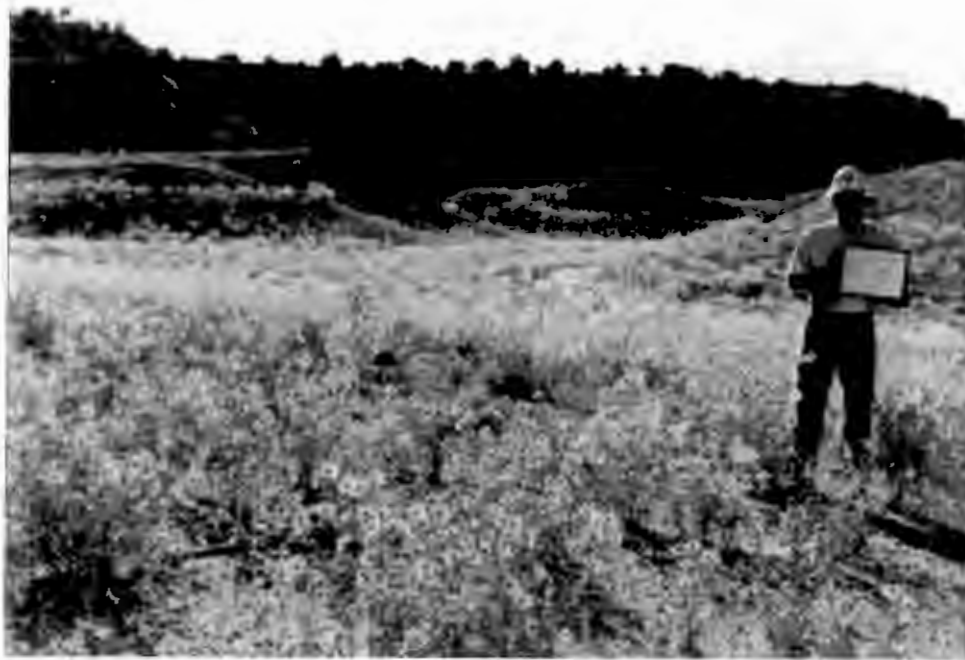
Poison Canyon Mine, Middle Looking East, 9/12/95

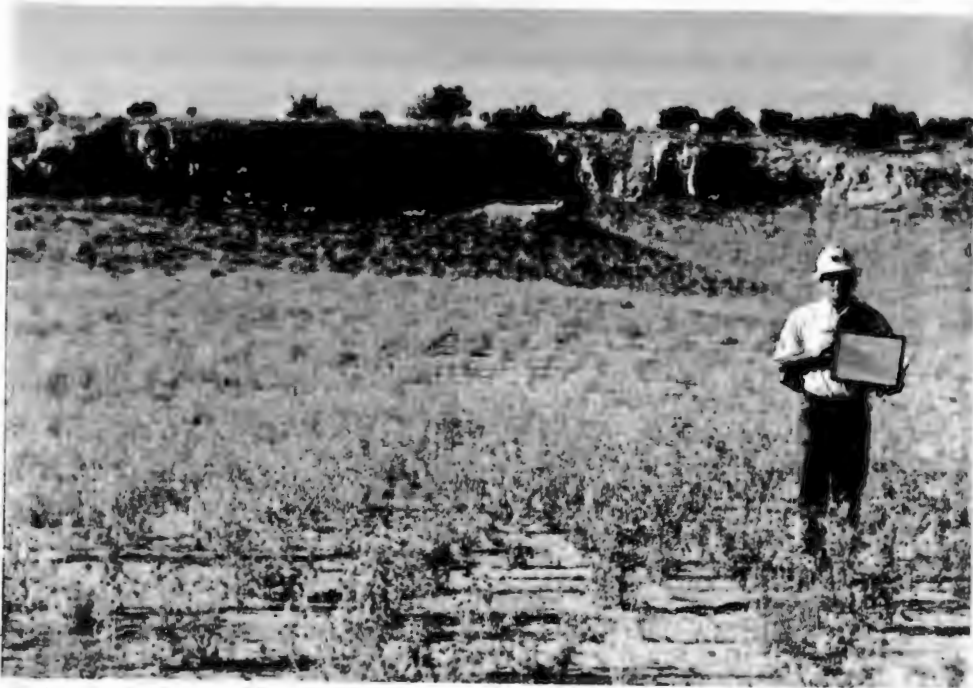
Poison Canyon Mine, Middle Looking South, 9/12/95

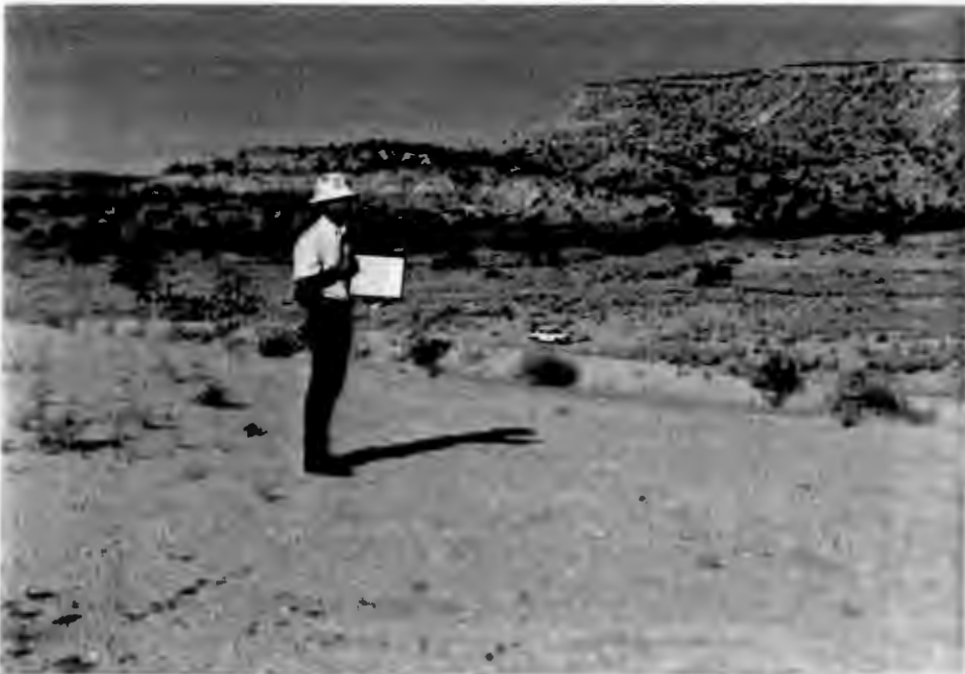
Poison Canyon Mine, Middle Looking West, 9/12/95

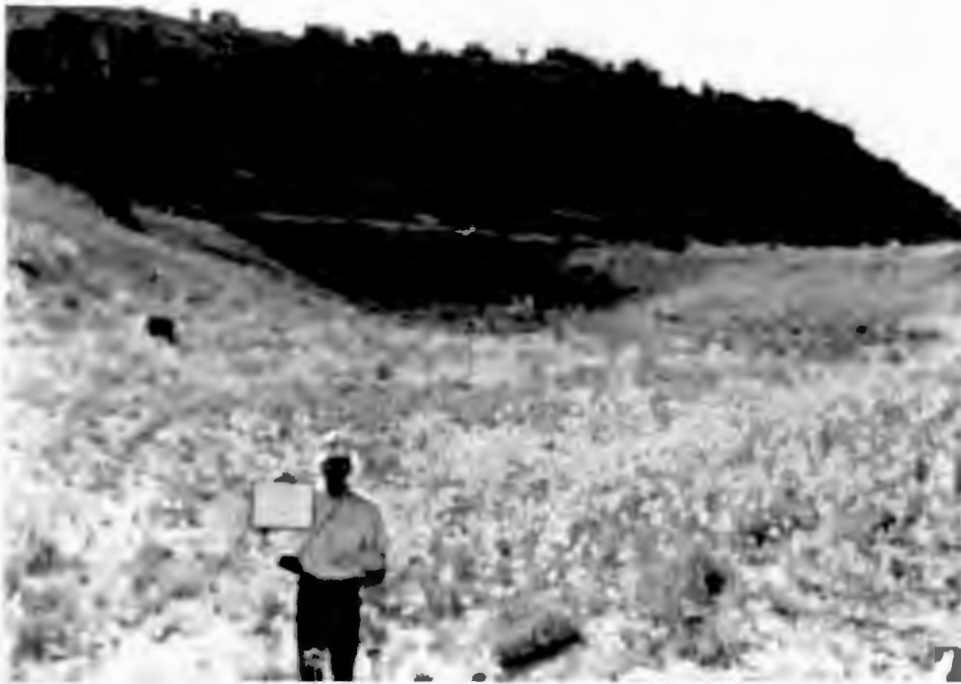
Poison Canyon Mine, Reclaimed Declined Shaft, 9/12/95

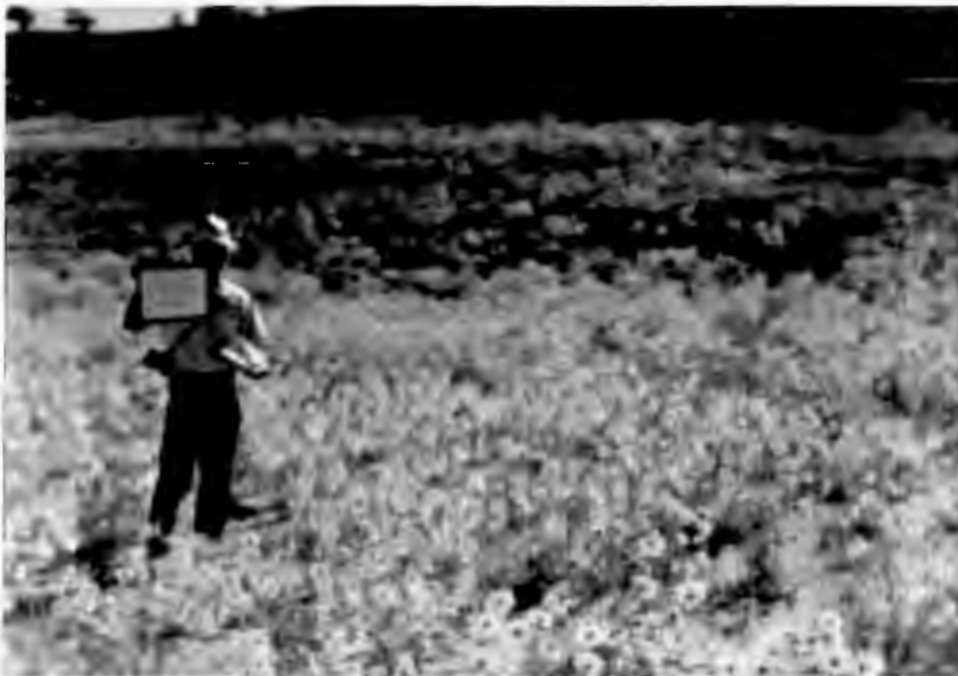
Poison Canyon Mine, Small Depression, 9/12/95

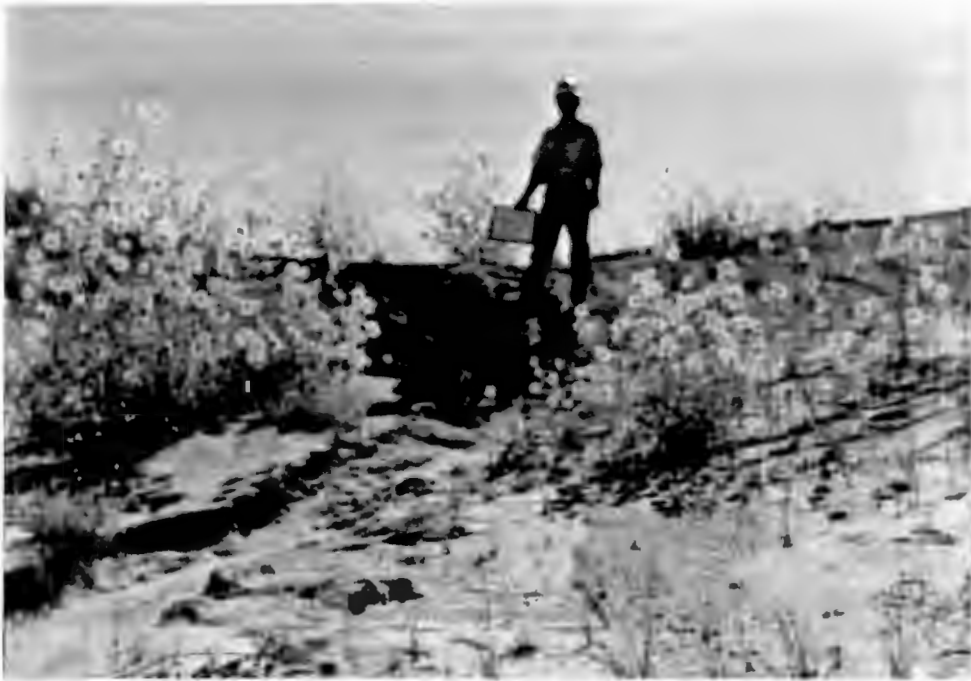
Poison Canyon Mine, Erosion Feature, 9/12/95
