ISABELLA

**RE:
Prior Reclamation Inspections**

PRIOR RECLAMATION INSPECTION

**PRIOR RECLAMATION INSPECTION REPORT
AND
RECOMMENDATION FOR RELEASE OR PERMIT
REQUIREMENT**

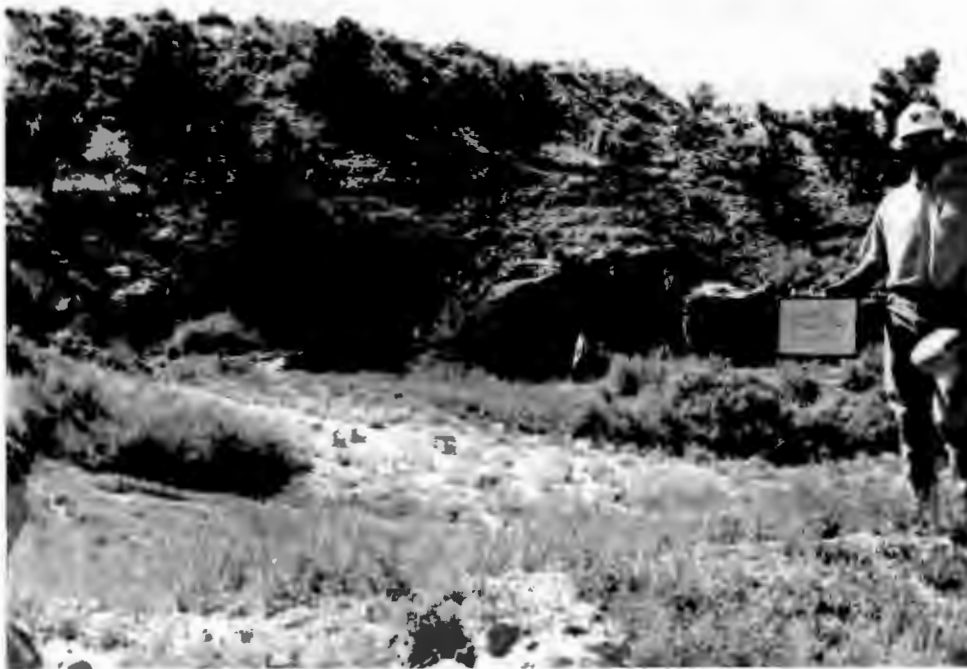
Section 1 T13N R9W, Sediment Pond, 9/13/95

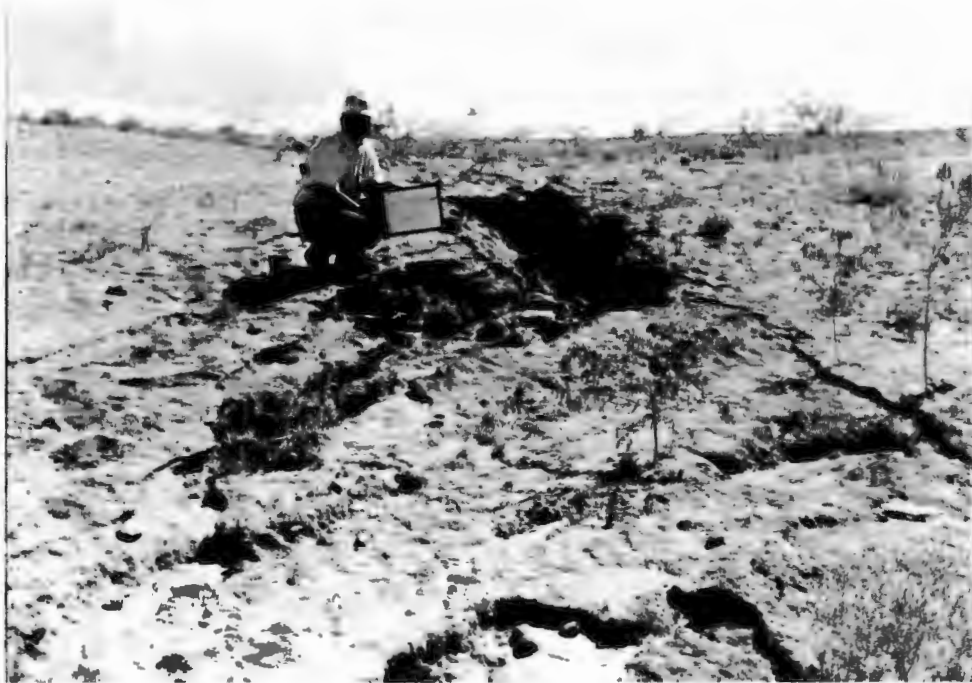
Section 25 Mine, Erosion Feature, 9/12/95

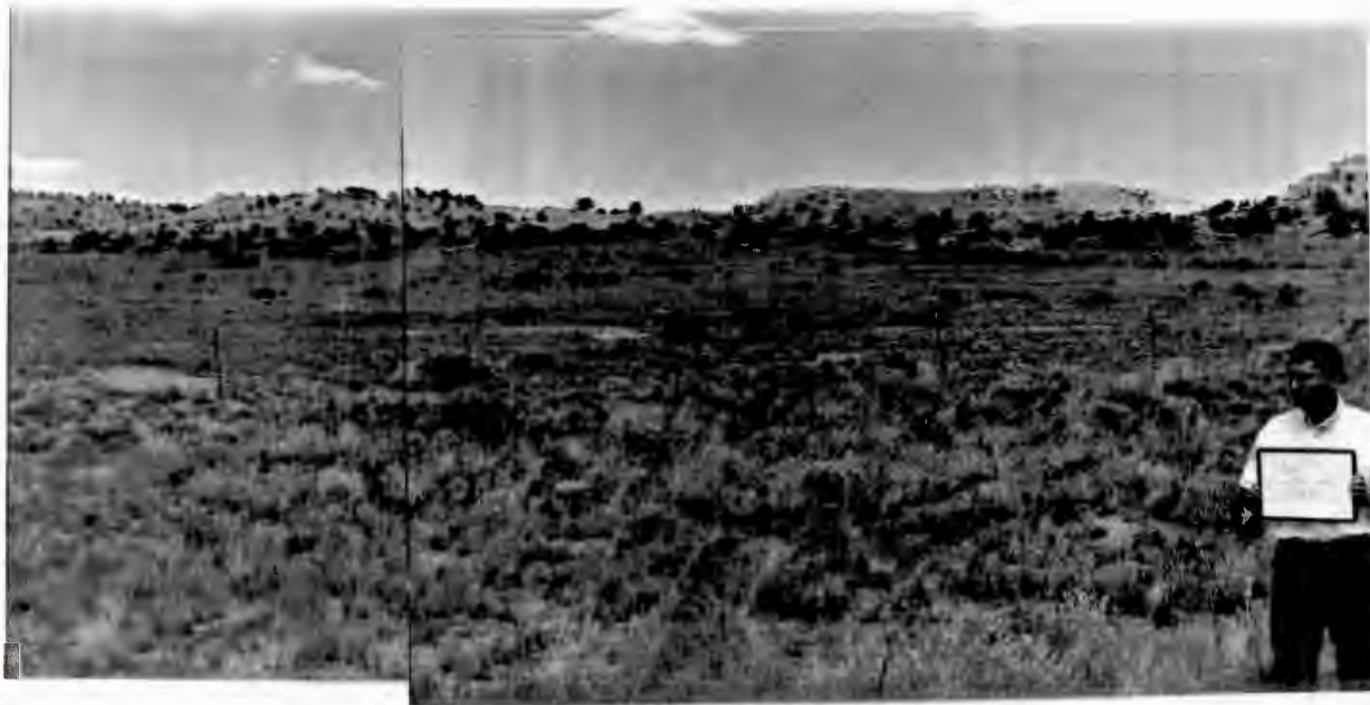
Section 31 T13N R9W, Reconstructed Limestone Bluffs, 9/12/95

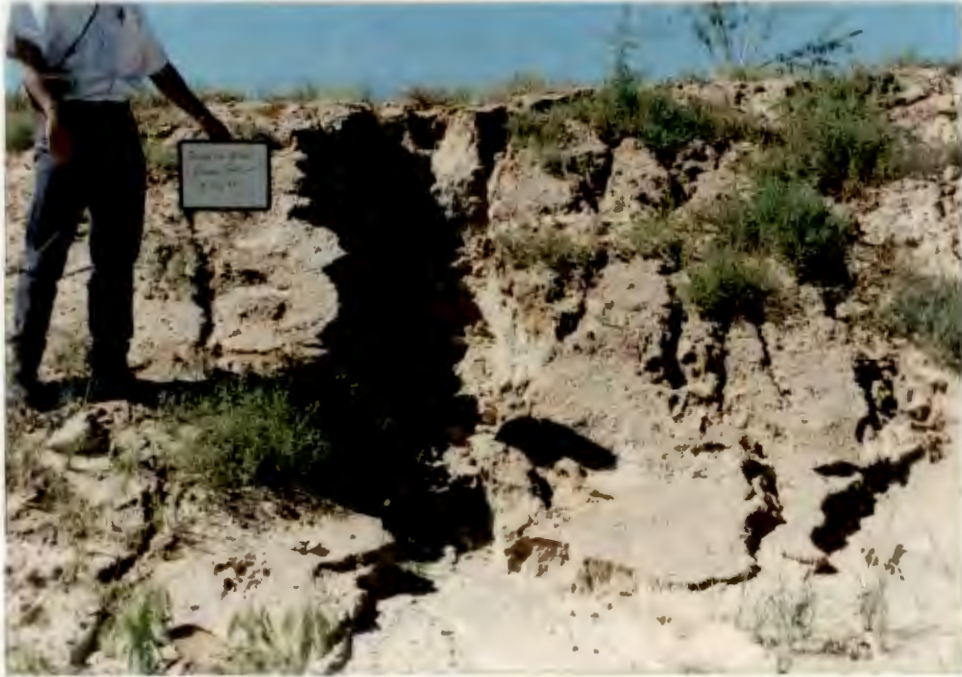
CONDITIONS → erosion feature, headcutting from natural array ~ 200' s. of filled shaft - sheet flow erosion from last stems - could cause further backcutting to shaft! Extremely sandy, vegetation on perimeter (Begr) looks good, but area (2-3 acres) around shaft is bare. Berm is needed to reduce sheetflow from around shaft to arrays. move

Isabella Mine, Erosion Feature, 9/12/95

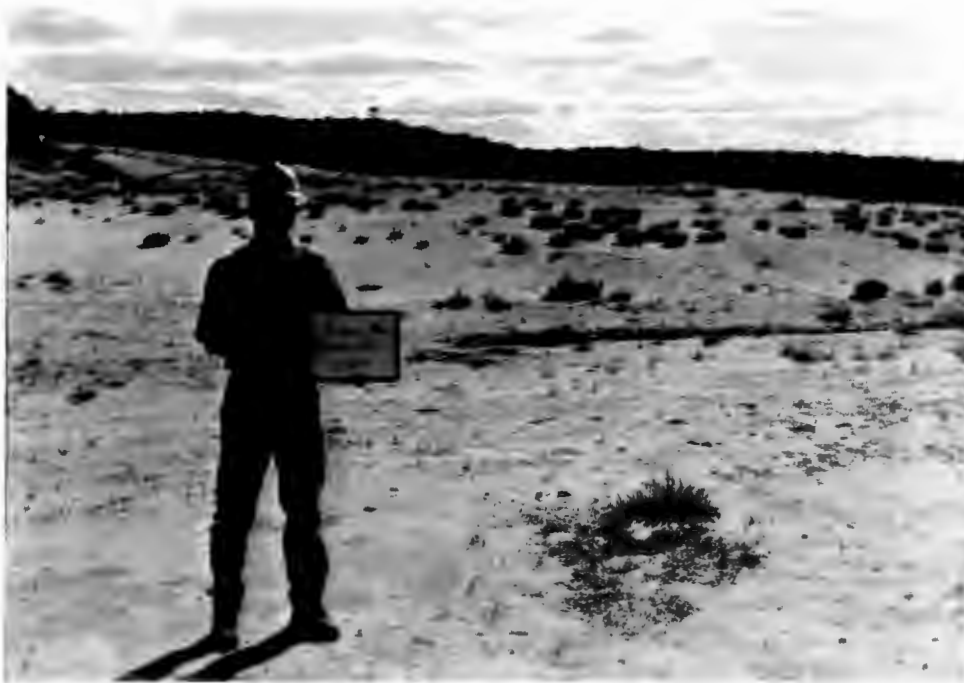
Marquez Mine, Waste Pile, 9/12/95

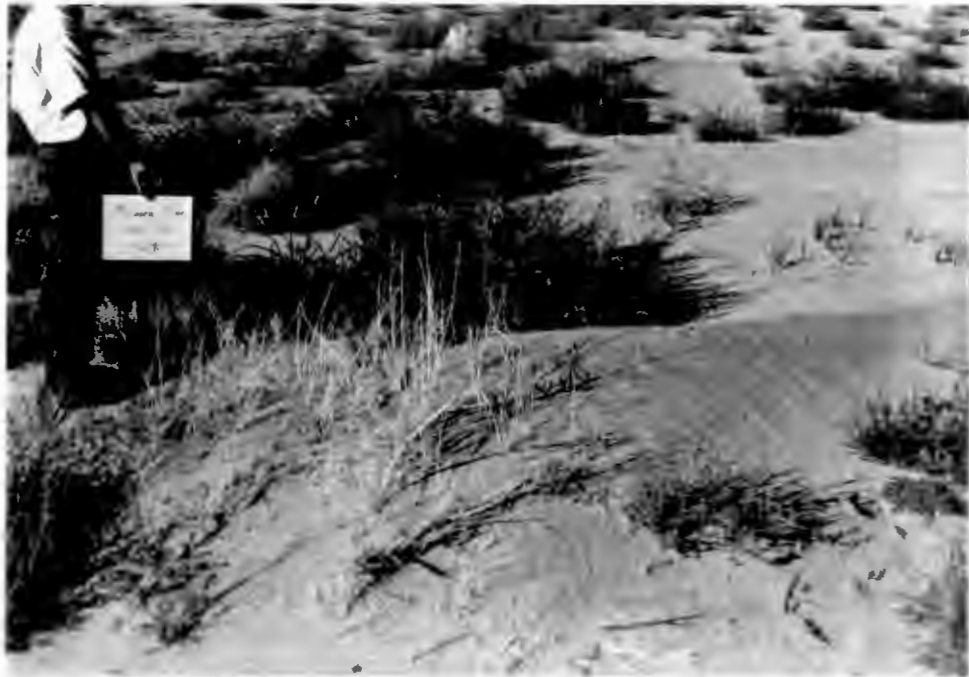
Marquez Mine, Sand Dune, 9/12/95

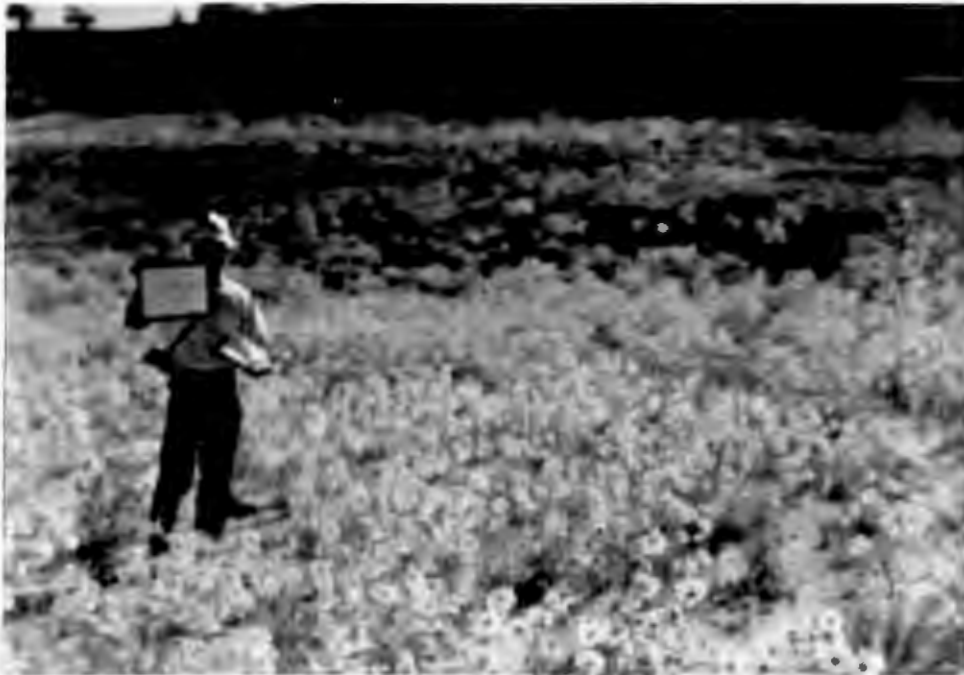
Poison Canyon Mine, Small Depression, 9/12/95

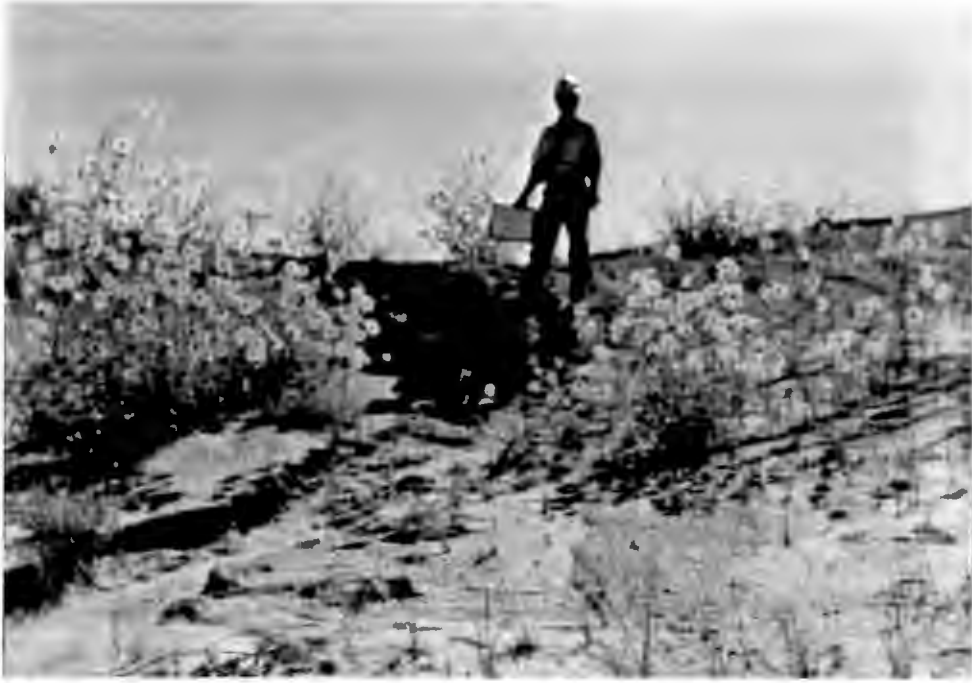
Poison Canyon Mine, Erosion Feature, 9/12/95
