**PRIOR RECLAMATION INSPECTION REPORT  
AND  
RECOMMENDATION FOR RELEASE OR PERMIT  
REQUIREMENT**

**Santa Fe Pacific Gold Corporation**

**New Mexico Energy, Minerals and Natural Resources Department  
Mining and Minerals Division  
Mining Act Reclamation Bureau**

**September 29, 1995**

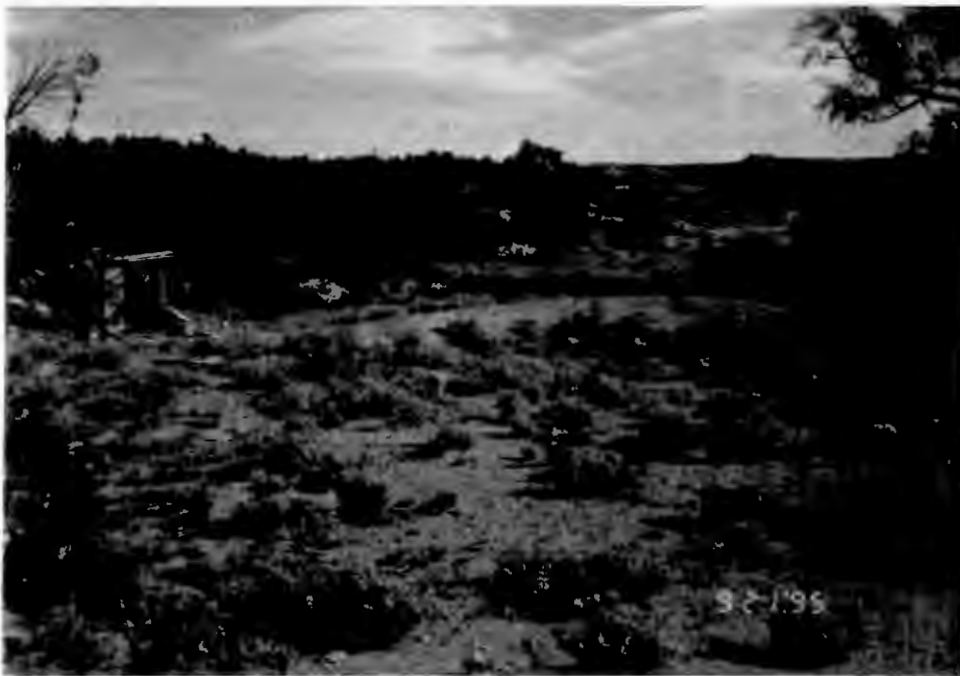
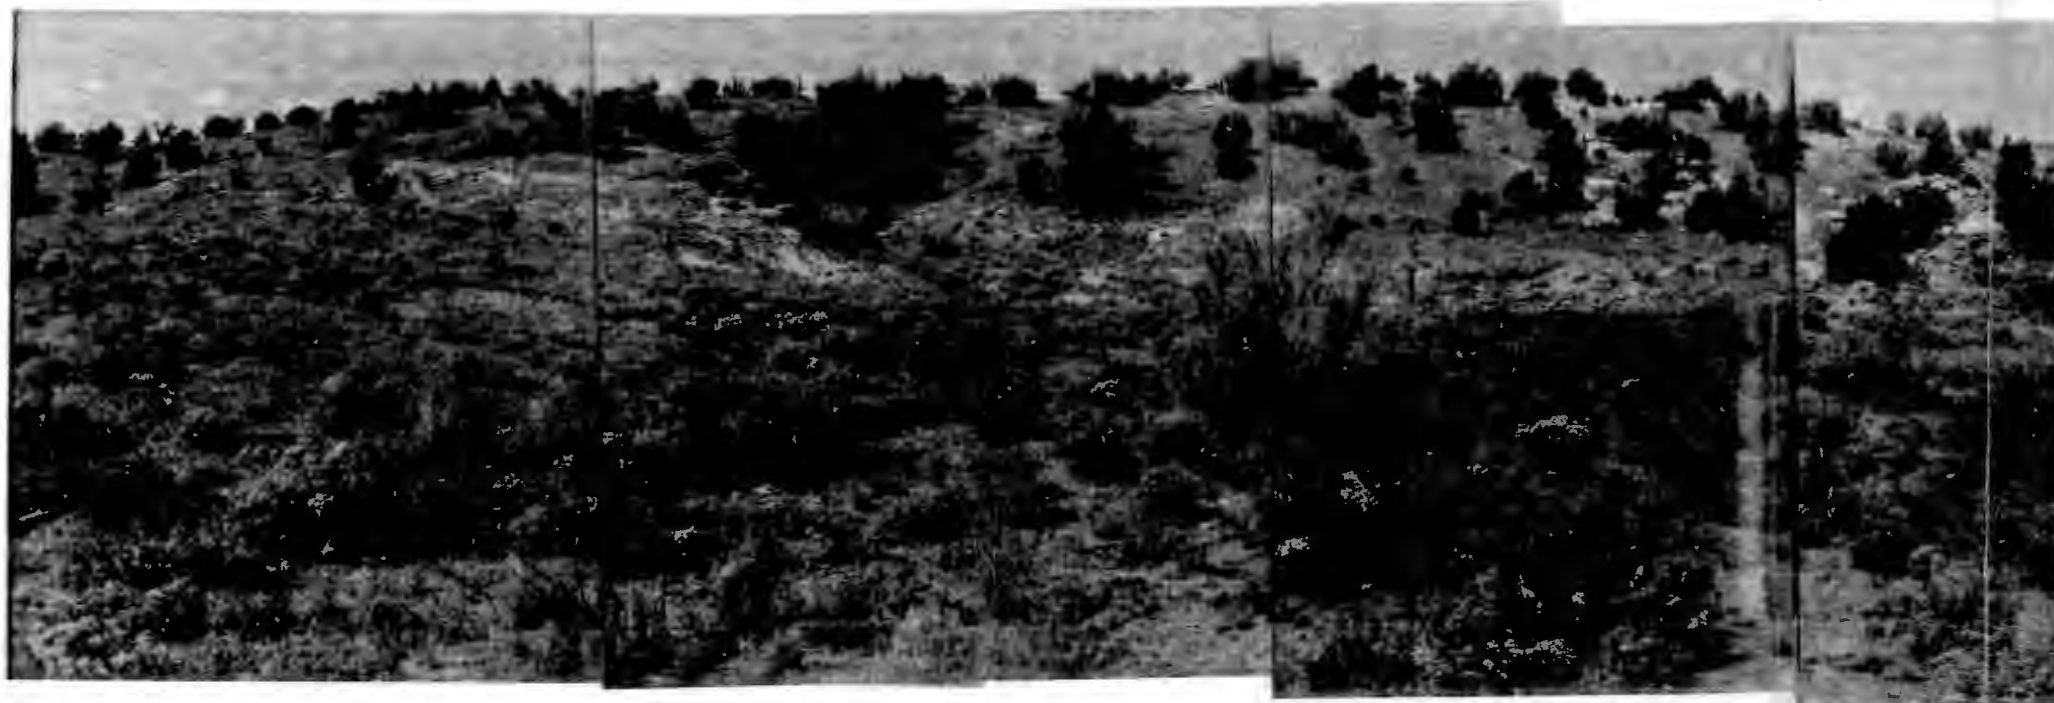
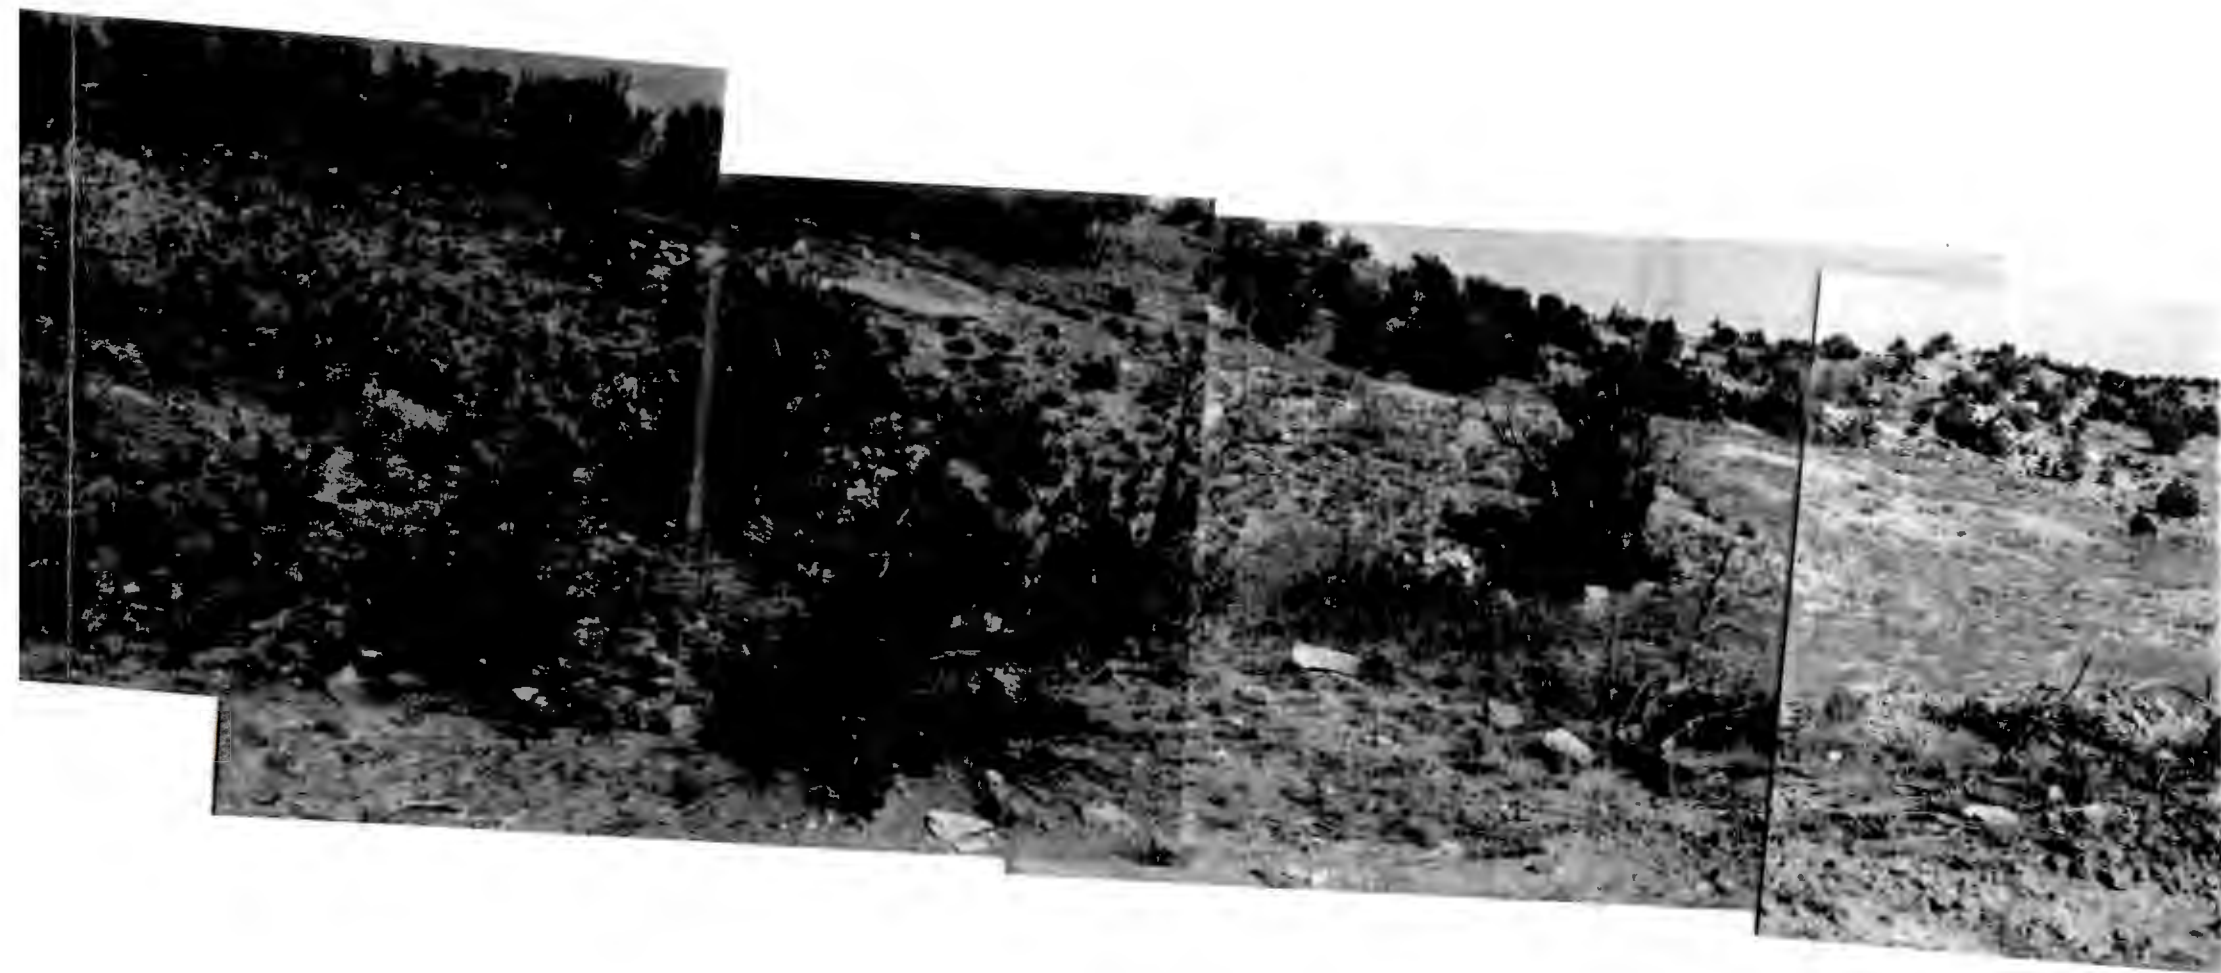
While it was difficult to locate the mine site, there were several small waste piles. Natural vegetation had successfully reestablished itself such that the waste piles were nearly indistinguishable from the natural mounds and ridges along the canyon. The location of the mine was located by a red clay that had been uncovered in one pit and was out of place. There was moderate erosion, but the erosion was consistent with that of the surrounding area. A powder magazine, circa 1970's, was left as a mining relic. All other structures, trash and junk had been removed. There were no piles or accumulations of toxic or waste material. There were no apparent hazards that could effect public health or safety.

The site and surrounding area showed signs of grazing impacts. Plant diversity, however, was good with more than 21 native plant species identified on the site. It was very difficult to distinguish this site from the adjacent undisturbed areas, so no transect evaluation was deemed necessary. Photographs documenting vegetation and the general condition of the site are presented in Appendix B. Because of the quality of cover and diversity of plants found on the site, it qualifies for release.

Section 13 T1N R6W, Mine Site from East, September 21, 1995

Section 13 T1N R6W, Powder Magazine, September 21, 1995

Section 13 T1N R6W, Mine Site From East

Section 13 T1N R6W, Mine Site From South

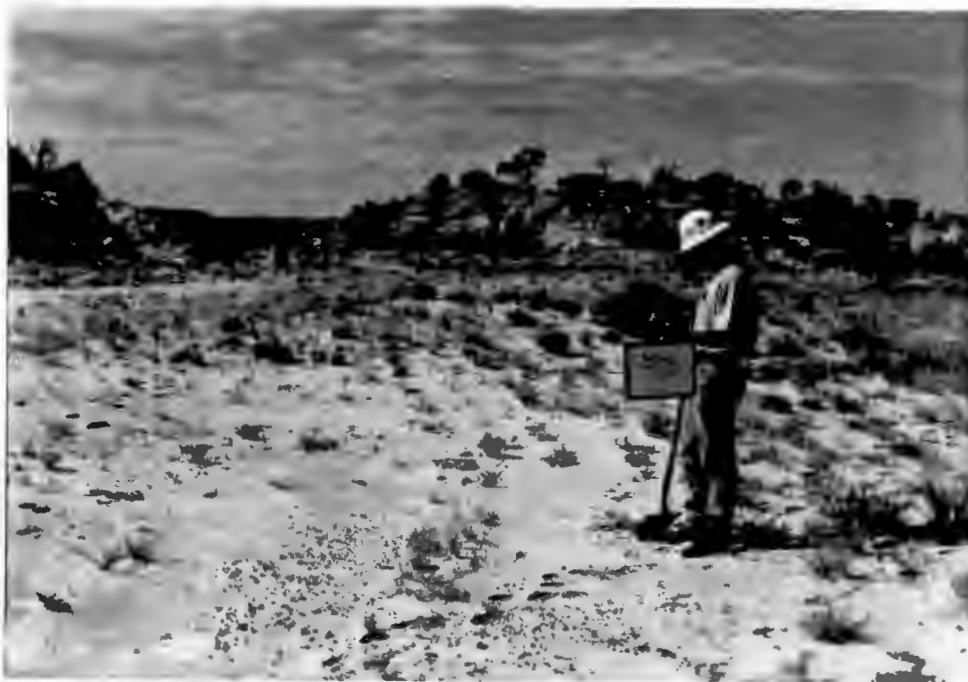
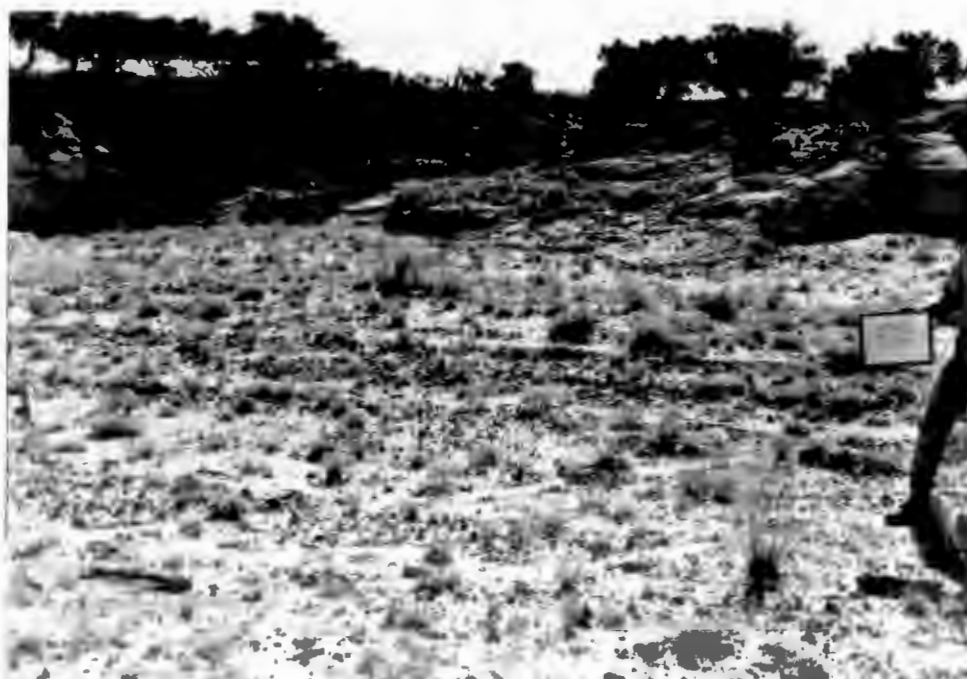
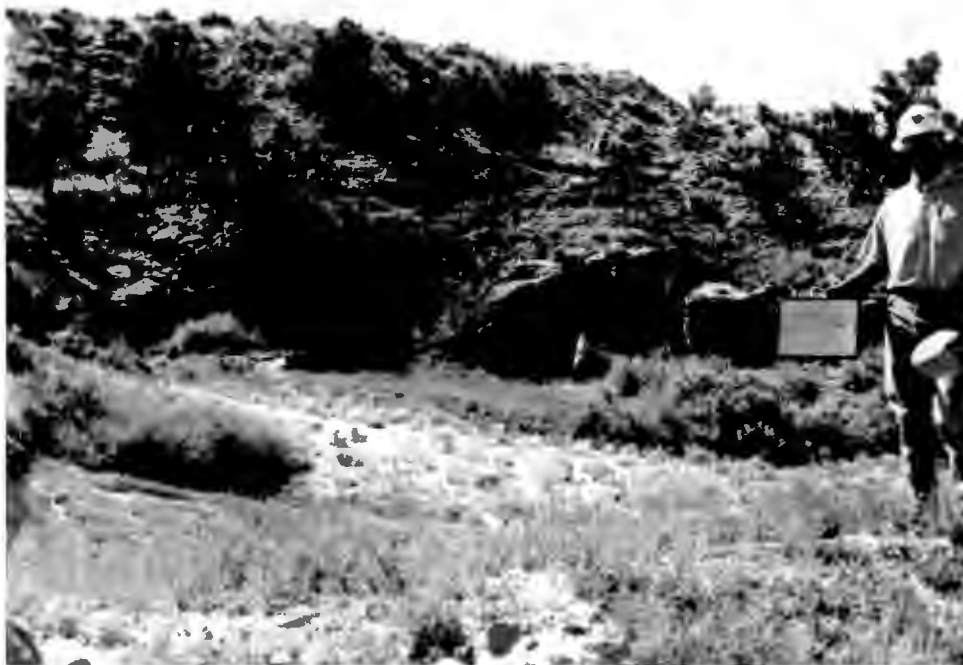
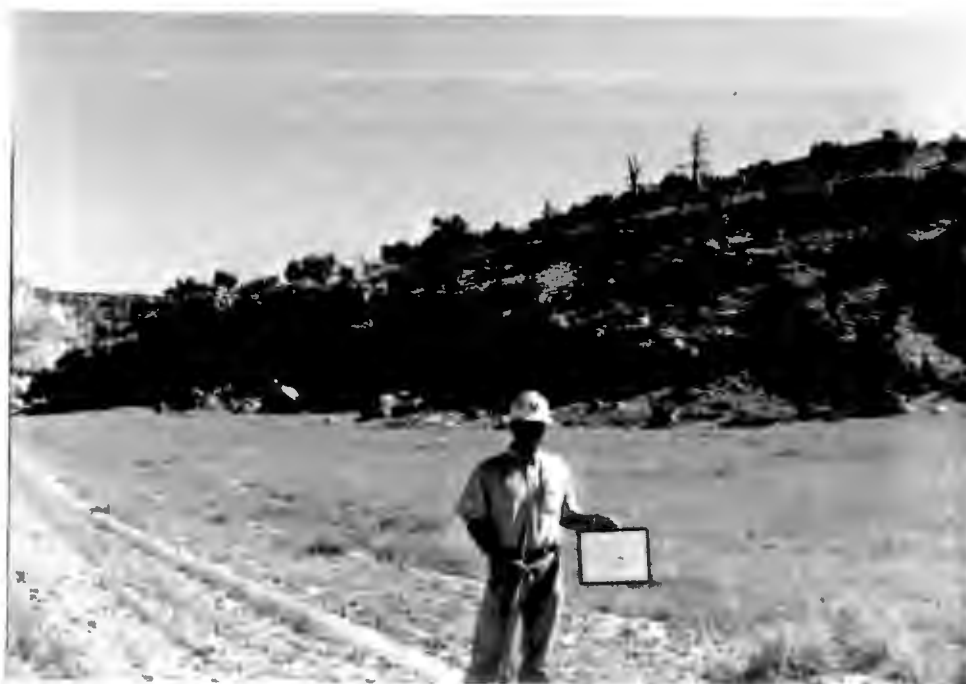
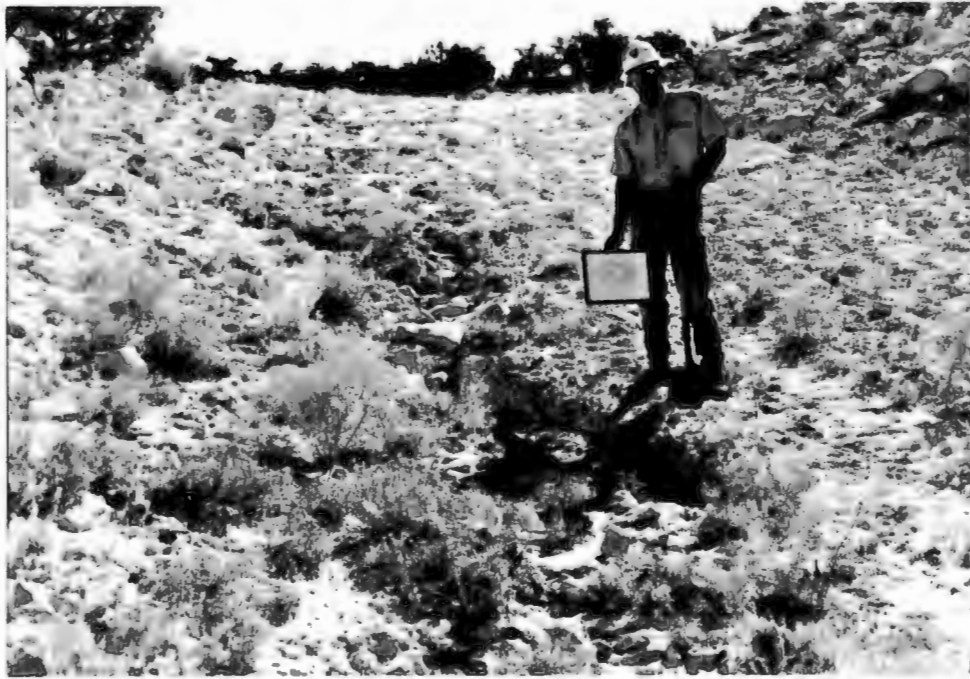
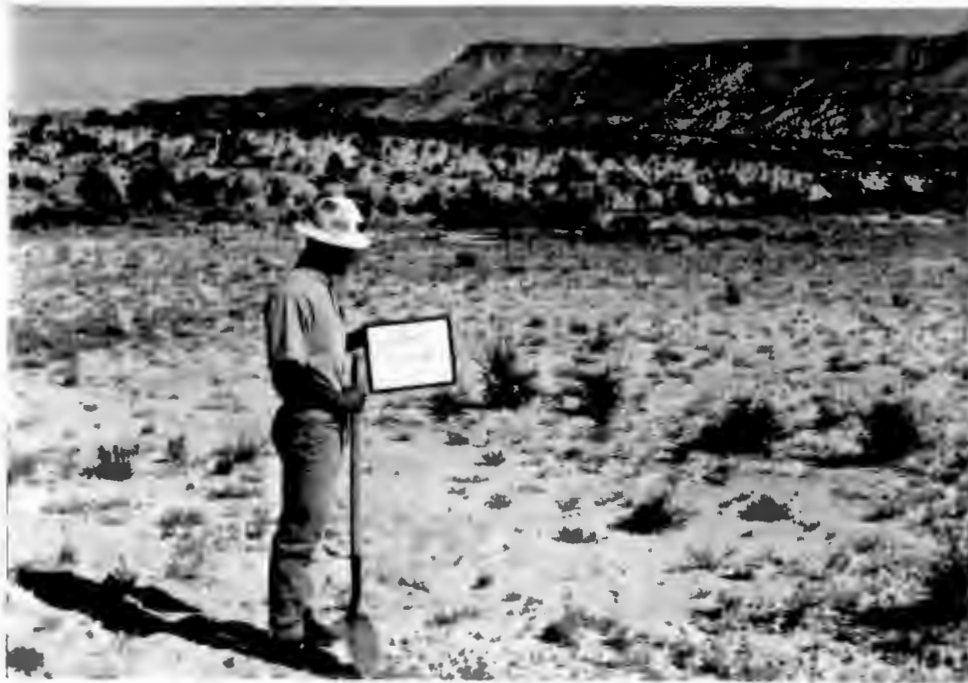
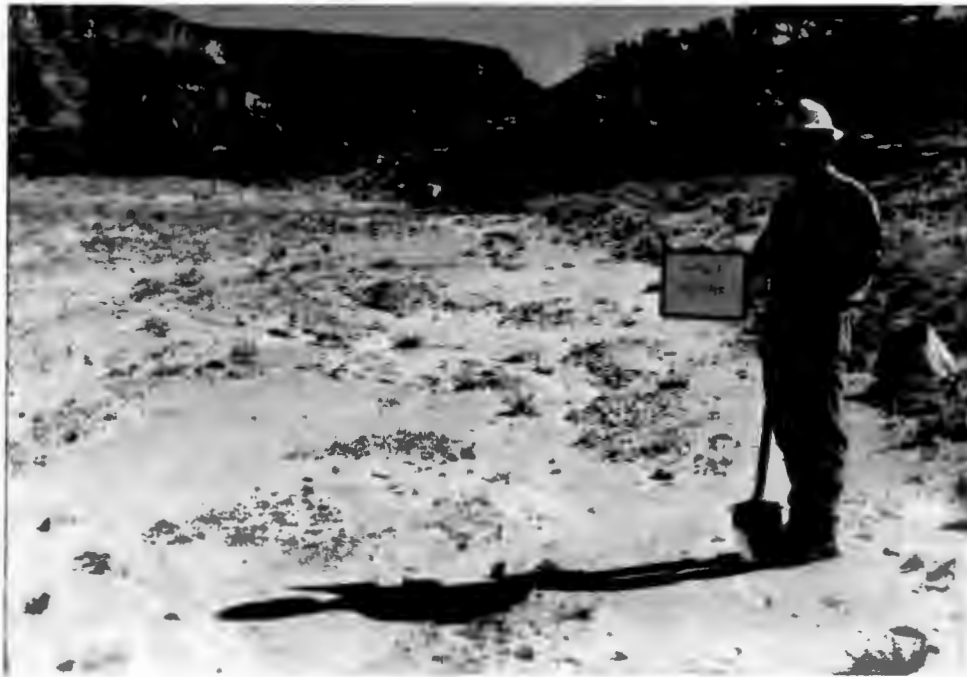
Essentially, the site had been safeguarded but not topsoiled or reseeded. The site is characterized by white fine grained sandstone covered by a few inches of fine white sand. The sand is subsequently being eroded away by wind and water. A mine access road had significant erosion. An impoundment had been constructed to impound sediment from the mine site, however, erosion from the access road was bypassing the impoundment and was entering the mine site. Photographs documenting vegetation and the general condition of the site are presented in Appendix C.

Some native plant species from adjoining areas were invading the disturbance area. Line-intercept transects indicated vegetation cover to be approximately 29 percent (Young, 1995). Vegetation measurements are presented in Table III. Vegetation on this site is dominated by hairy goldenaster (*Heterotheca villosa*), an unpalatable increaser. Indian ricegrass (*Oryzopsis hymenoides*), was also found growing sparsely on the site. Given the sandy nature of these soils, stands of Indian ricegrass and sand dropseed (*Sporobolus cryptandrus*) should be more prevalent here. Because of the overall lack of diversity and the poor establishment of perennial grasses and forbs, this site does not qualify for release.

Section 1 T13N R9W, Shaft Site looking South, 9/13/95

Section 1 T13N R9W, Shaft Site Looking West, 9/13/95

Section 1 T13N R9W, Sediment Pond, 9/13/95

Section 1 T13N R9W, Looking Up at Mine Site, 9/13/95

Section 1 T13N R9W, Access Road, 9/13/95

Section 1 T13N R9W, South Side Looking North, 9/13/95

Section 1 T13N R9W, North Side Looking South, 9/13/95

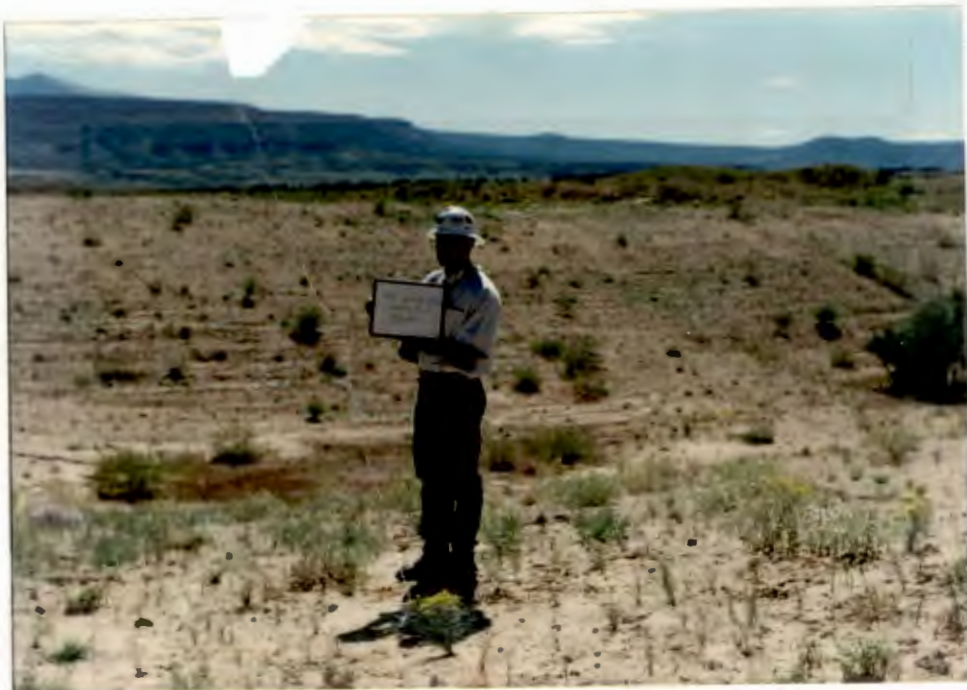
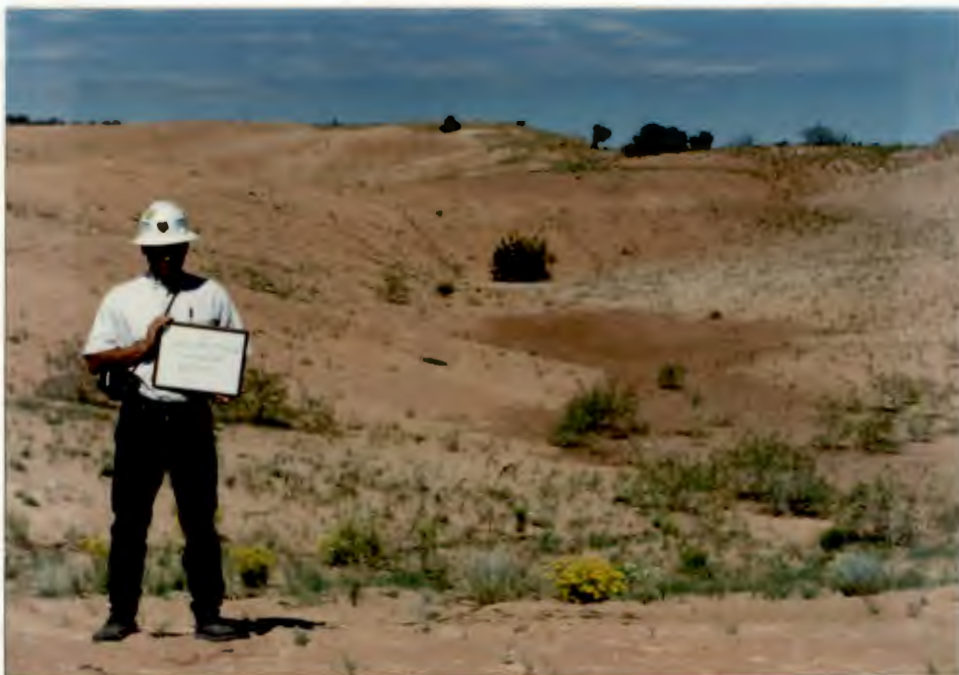
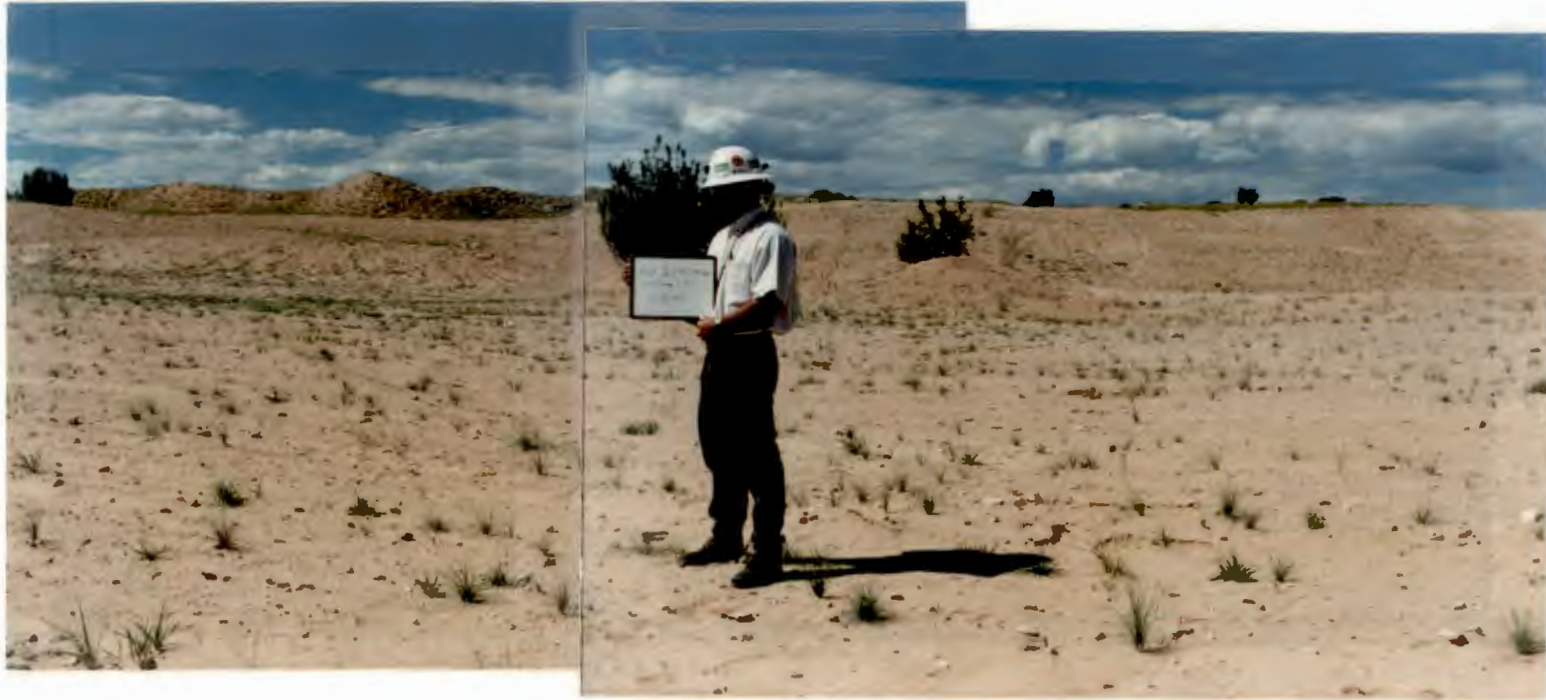
Portions of the reclaimed vegetation have heavily grazed by wildlife and domestic livestock. However, native plant species were invading the area. Twenty-six native species of plants were identified. Line-intercept transects showed average perennial vegetation cover to be approximately 22 percent (Young, 1995). Vegetation measurements are presented in Table V. Despite the slight increase in the number of perennial species invading this site from adjacent areas, there was poor establishment of the perennial grasses, forbs, and shrubs on the slopes of the depressions and topsoil mounds. Because of the lack of adequate cover, this site does not qualify for release at this time.

Section 25 Mine, West Side Looking West, 9/12/95

Section 25 Mine, Middle Looking East, 9/12/95

Section 25 Mine, East Side Looking Southwest, 9/12/95

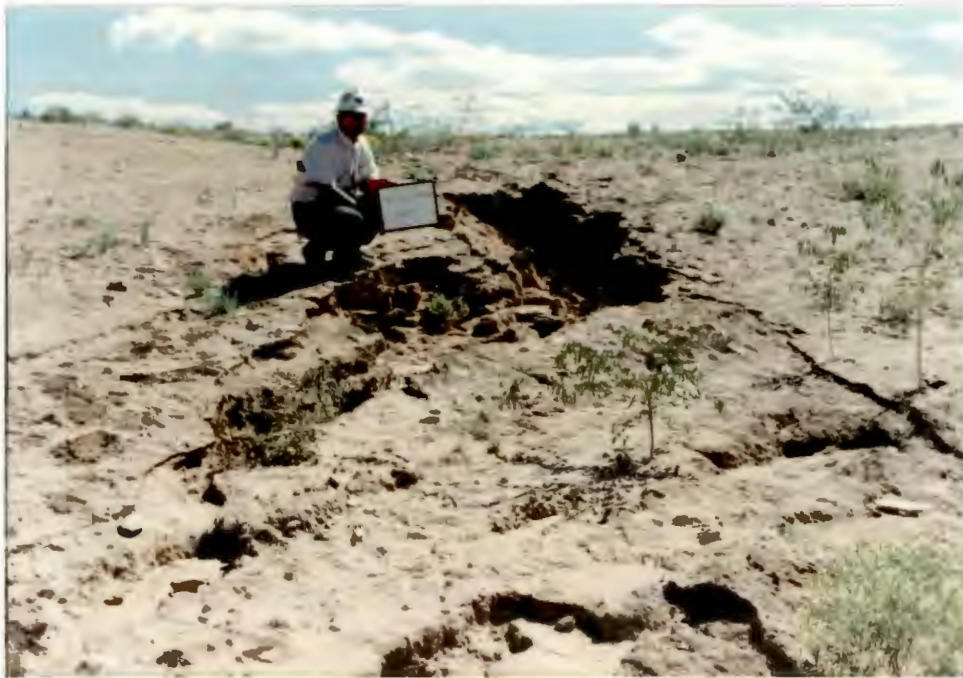
Section 25 Mine, Erosion Feature, 9/12/95

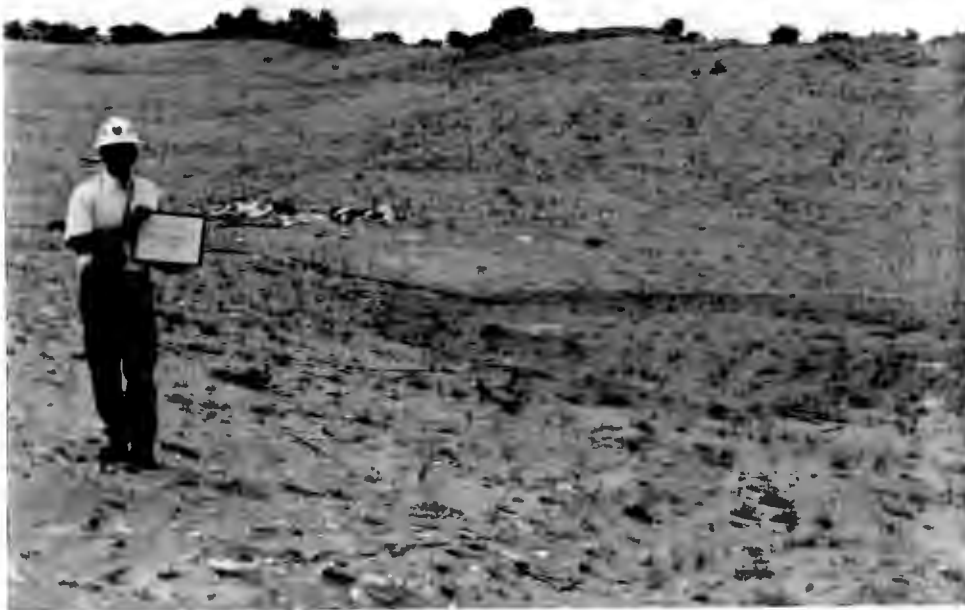
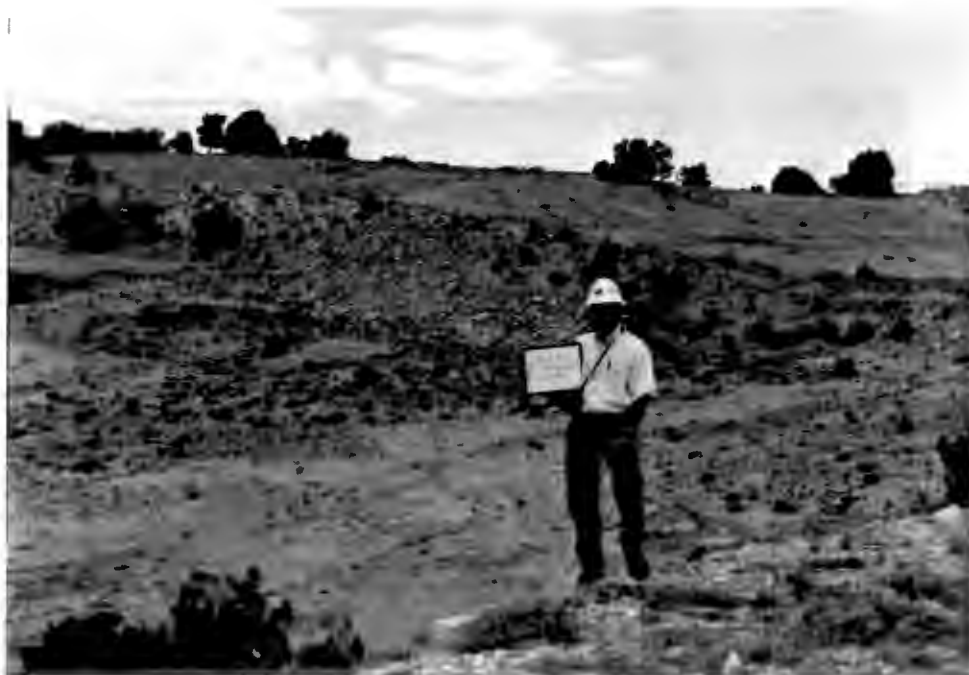
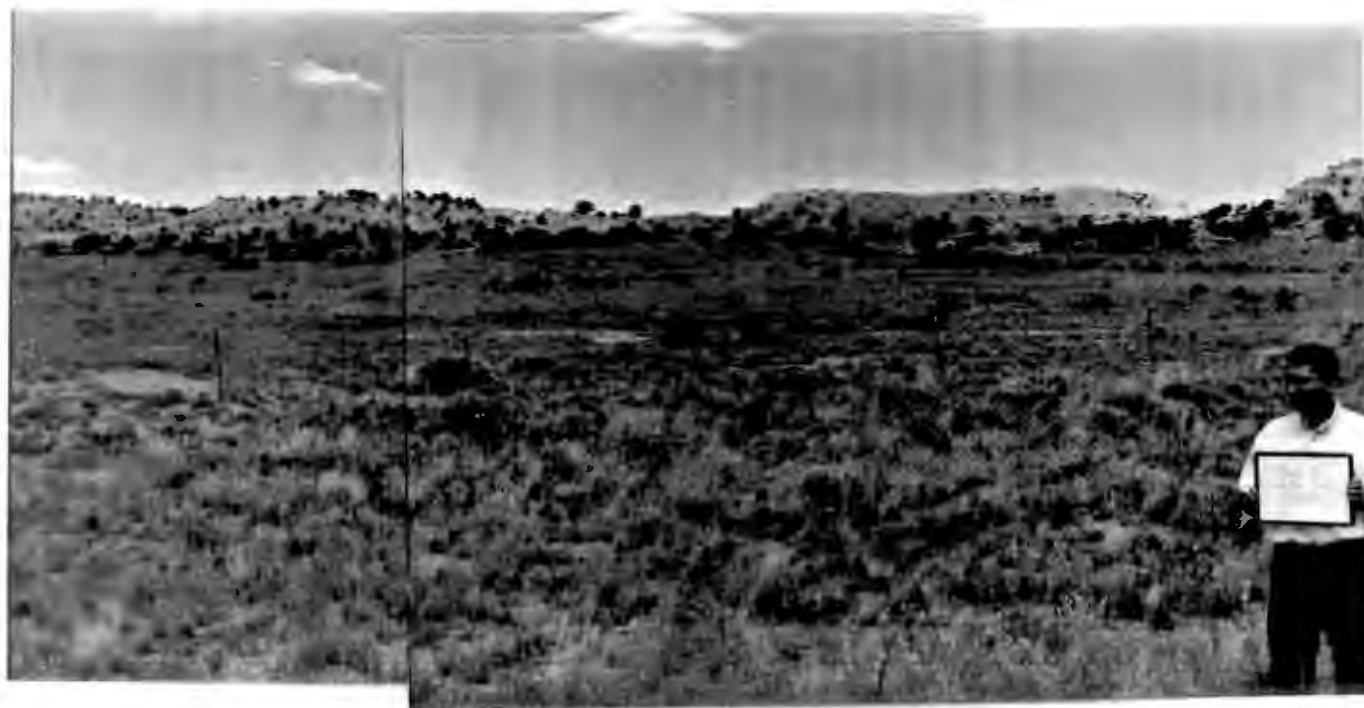
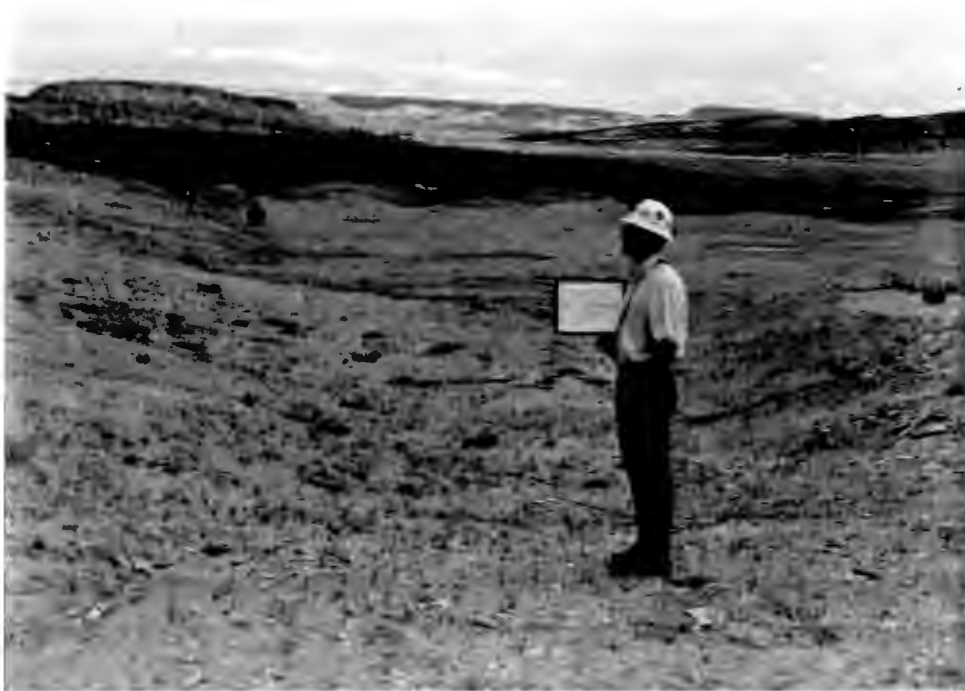
There was evidence of grazing by livestock and wildlife on this site. Vegetation also showed signs of drought stress. Line-intercept transects showed vegetation cover to be approximately 12 percent (Young, 1995). The results of these vegetation measurements are presented in Table VI. Because of the lack of cover and diversity, staff does not recommend this site for release.

Section 31 T13N R9W, North End Looking South, 9/12/95

Section 31 T13N R9W, Northeast Side Looking West, 9/12/95

Section 31 T13N R9W, Reconstructed Limestone Bluffs, 9/12/95

Section 31 T13N R9W, Southeast Side looking North

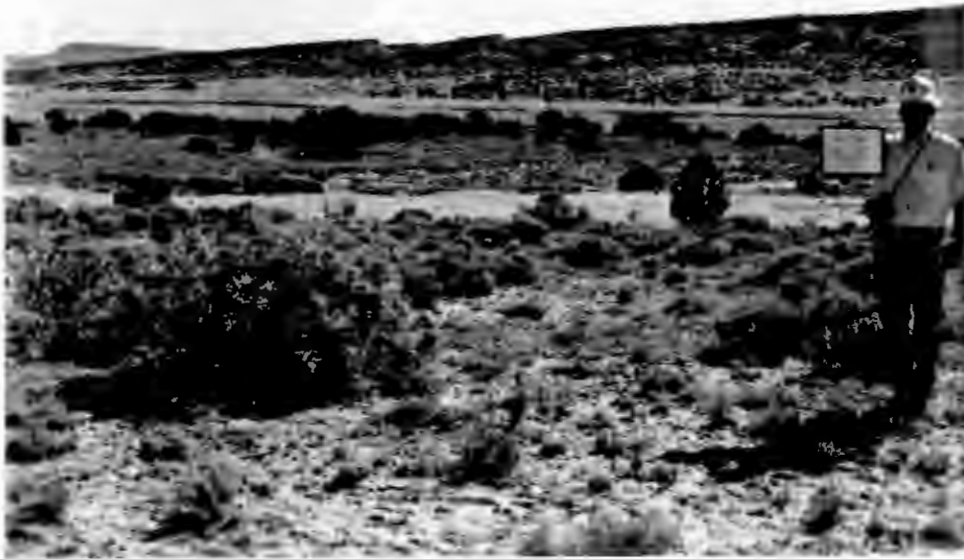
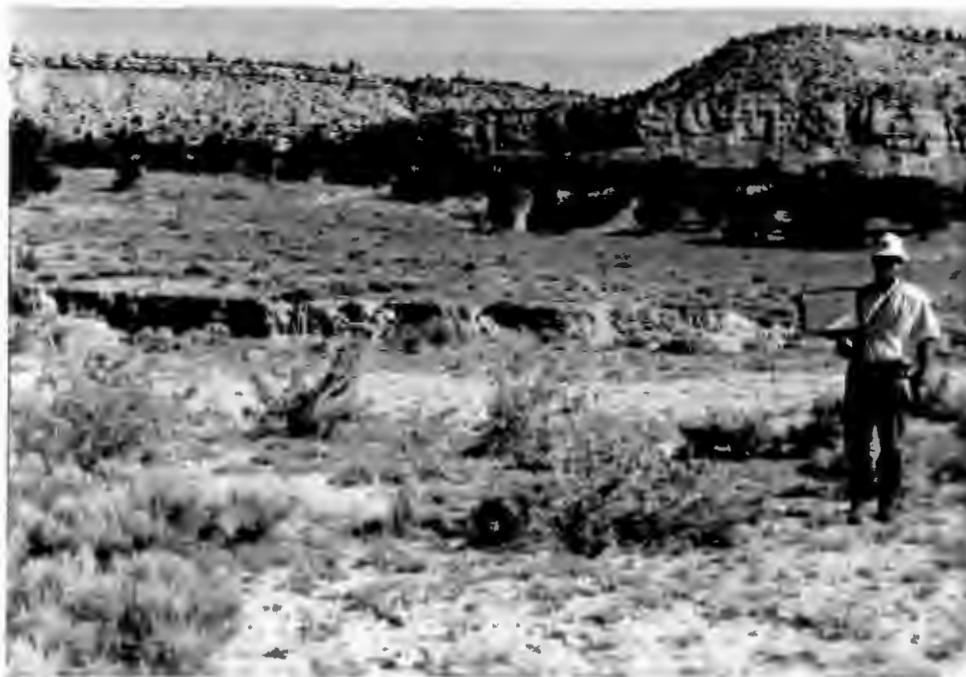
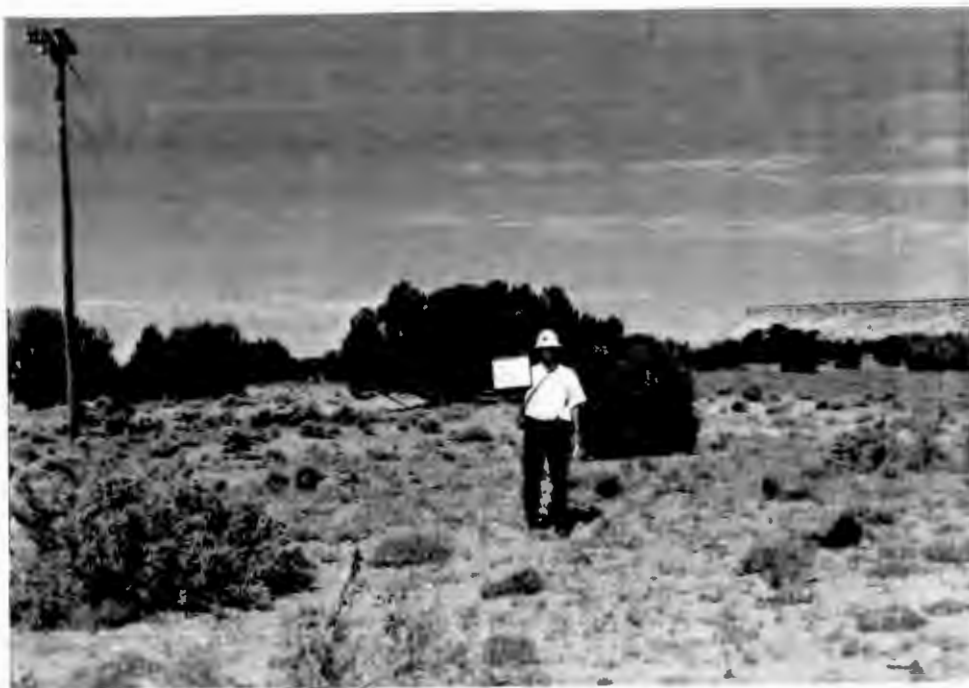
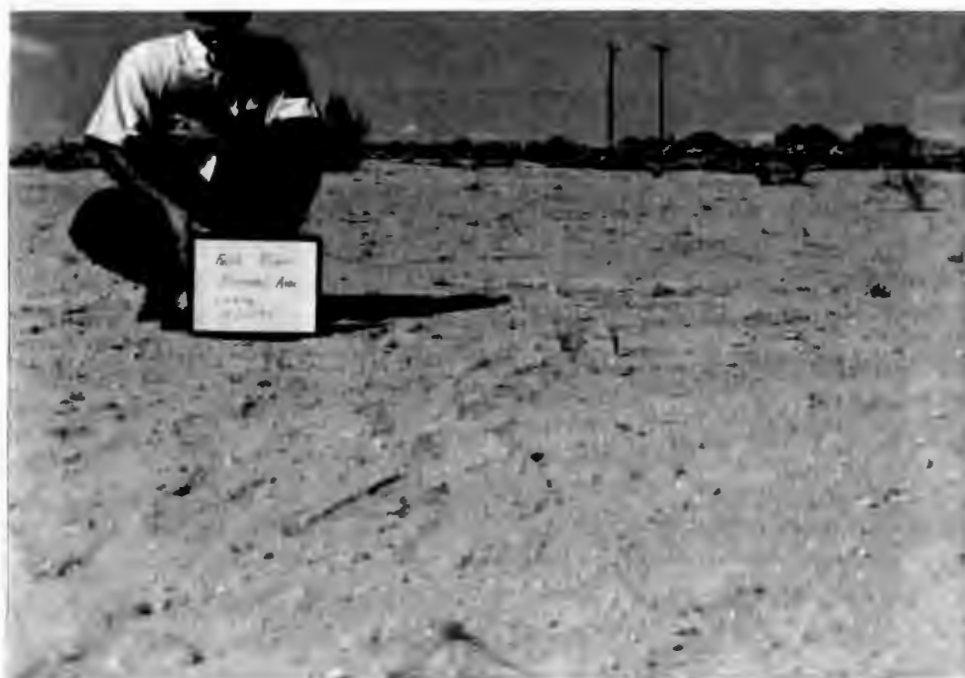
As with the other mines, the vegetation had been grazed by wildlife and domestic livestock. The vegetation also showed signs of drought stress. However, the adequate plant cover and diversity deemed it unnecessary to perform transect evaluations of the plant community. Staff recommends this site of release. The plant

Faith Mine Shaft Site, Looking East, 9/12/95  
Regraded Area in Background

Faith Mine Shaft Site, Looking North, 9/12/95

Faith Mine Shaft Site, Looking West, 9/12/95

Faith Mine Regraded Area, 9/12/95

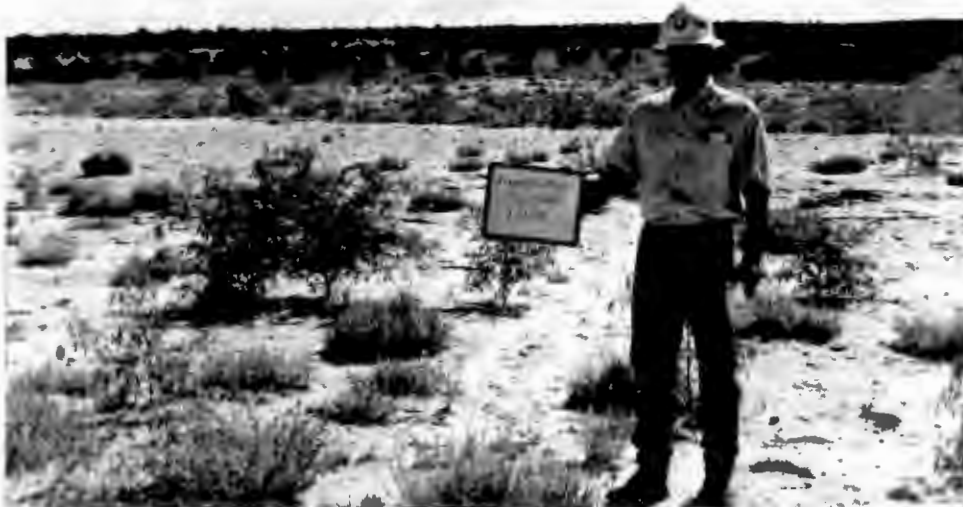
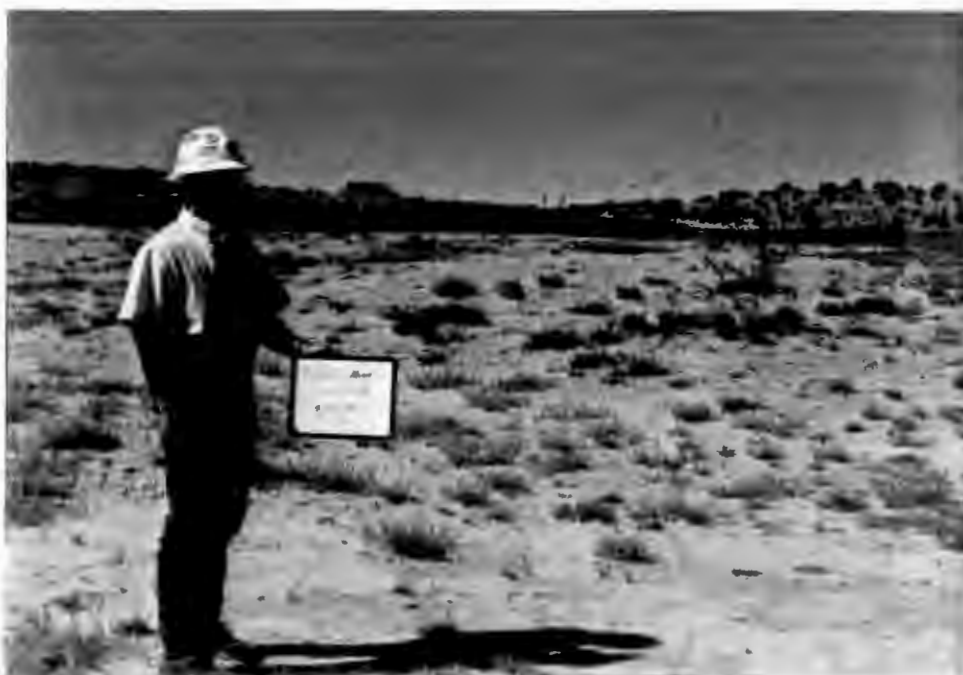
Again, the mine site had been grazed by livestock and wildlife. Similarly, vegetation showed signs of drought stress. Line-intercept transects indicated that vegetation cover was approximately 15 percent (Young, 1995). Results of vegetation measurements are presented in Table VII. Because of the lack of plant cover, this site is not recommended for release.

Isabella Mine, From North, 9/12/95

Isabella Mine, From South, 9/12/95

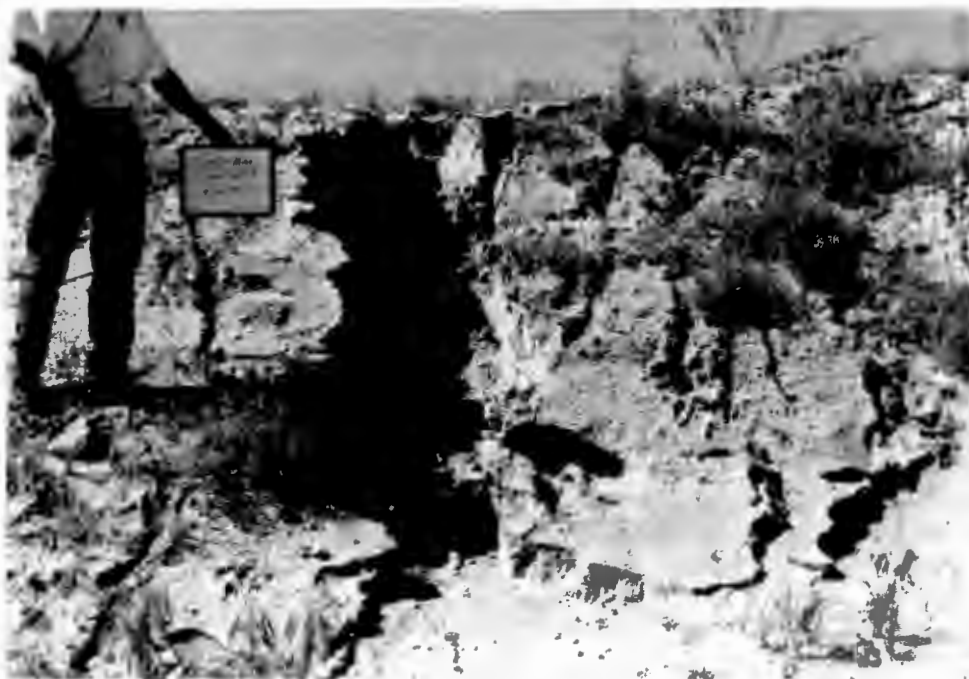
Isabella Mine, Erosion Feature, 9/12/95
