**PRIOR RECLAMATION INSPECTION REPORT  
AND  
RECOMMENDATION FOR RELEASE OR PERMIT  
REQUIREMENT**

**Santa Fe Pacific Gold Corporation**

**New Mexico Energy, Minerals and Natural Resources Department  
Mining and Minerals Division  
Mining Act Reclamation Bureau**

**September 29, 1995**

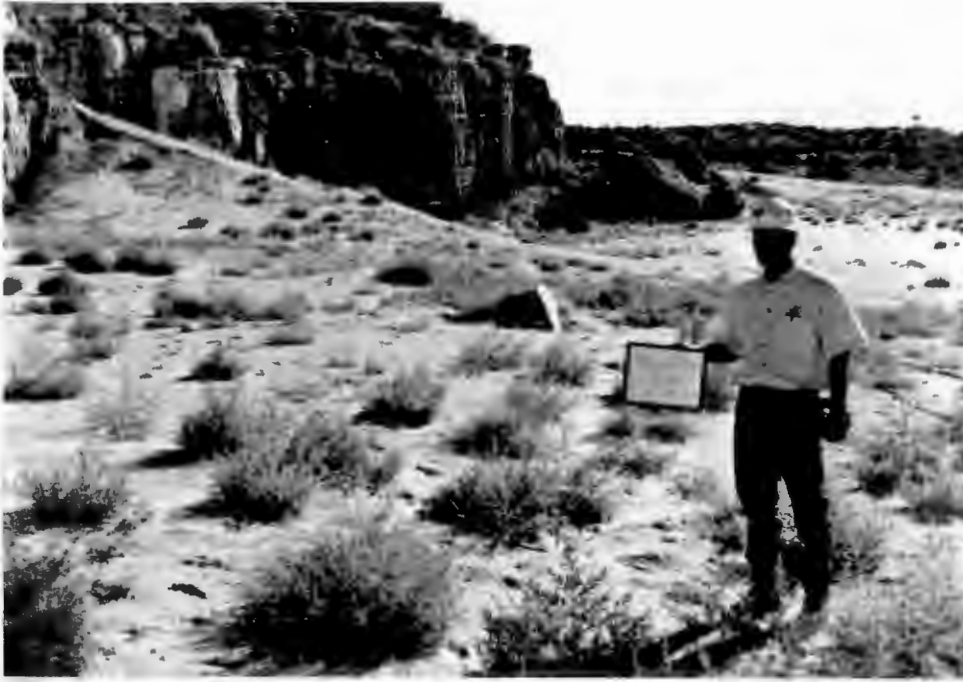
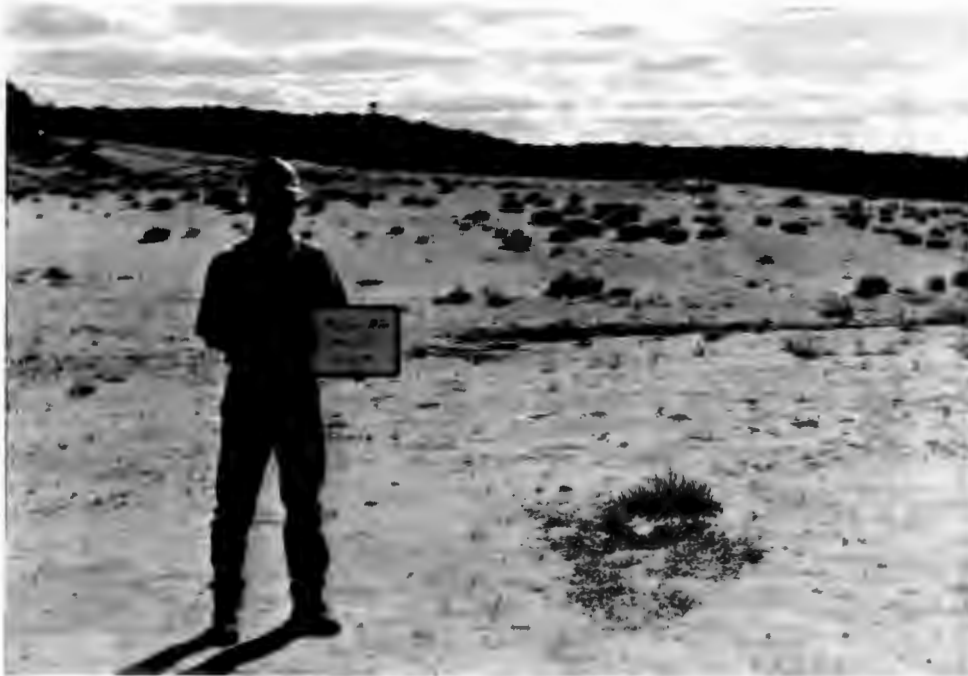
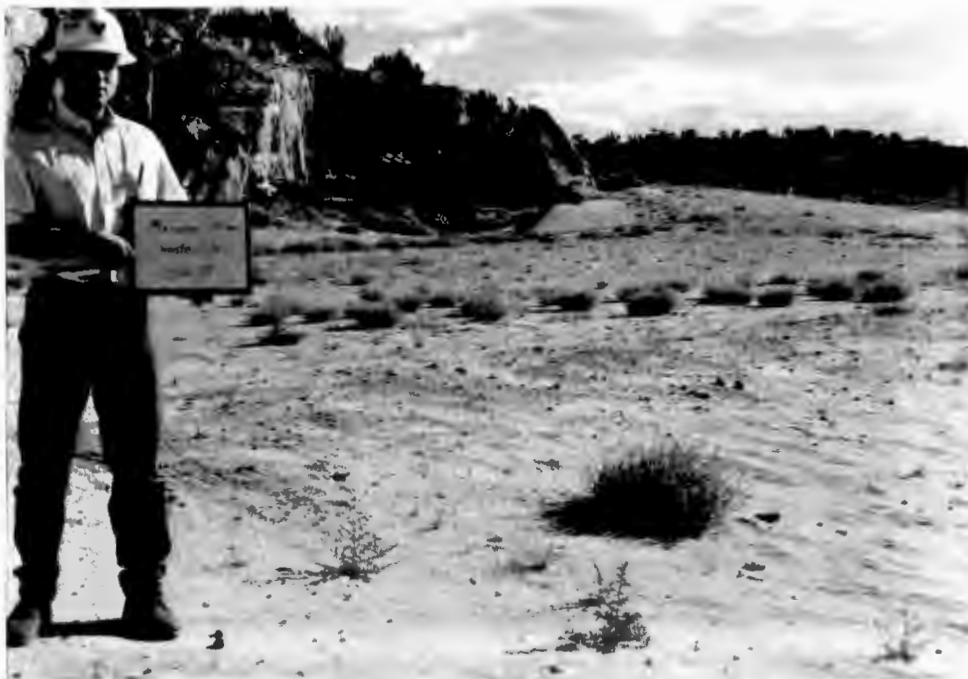
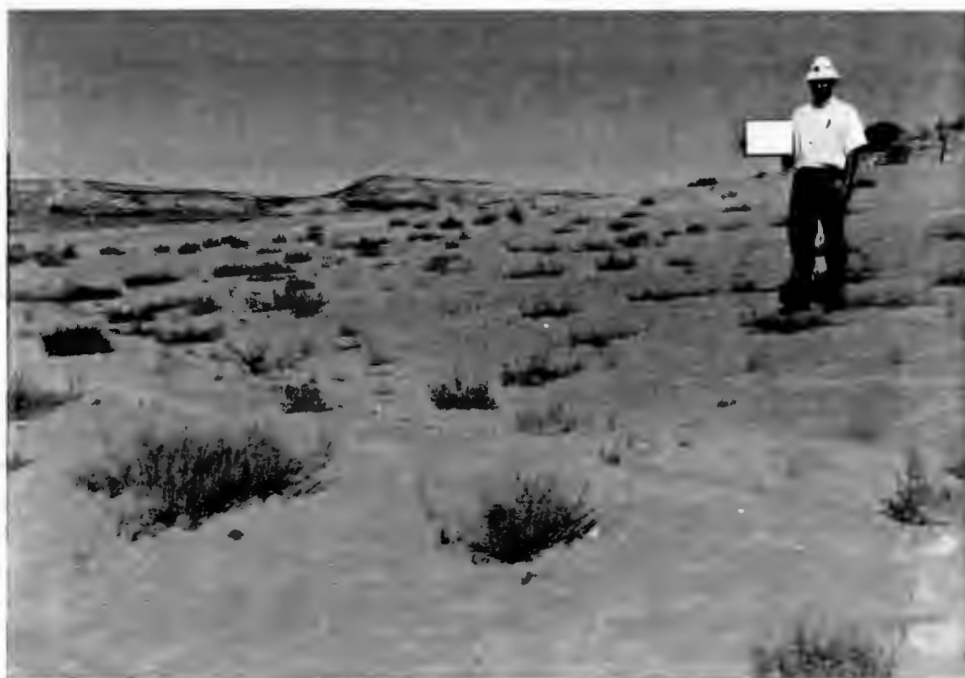
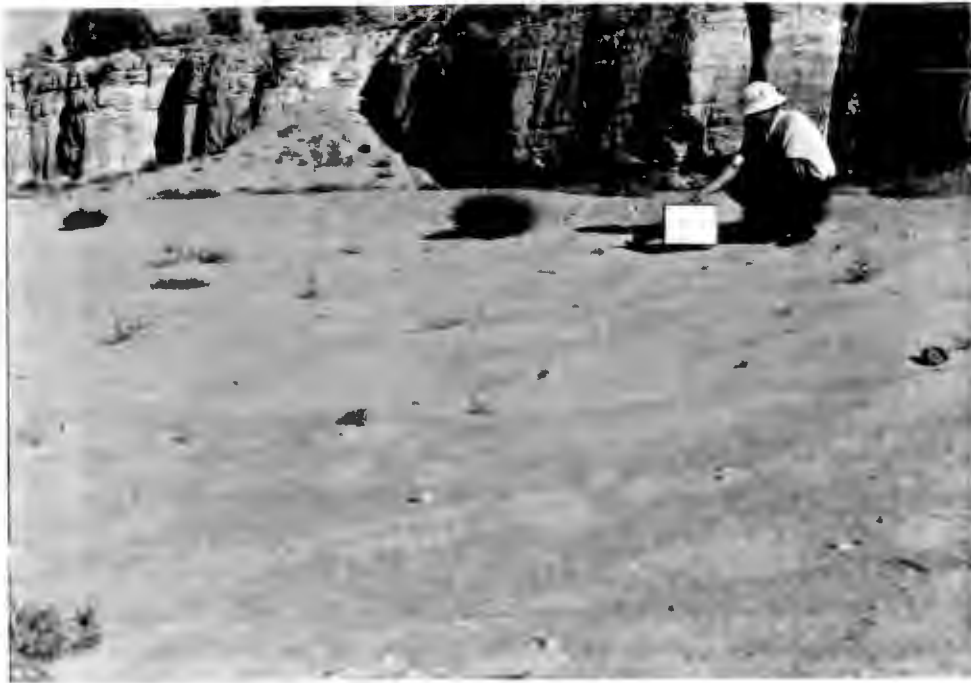
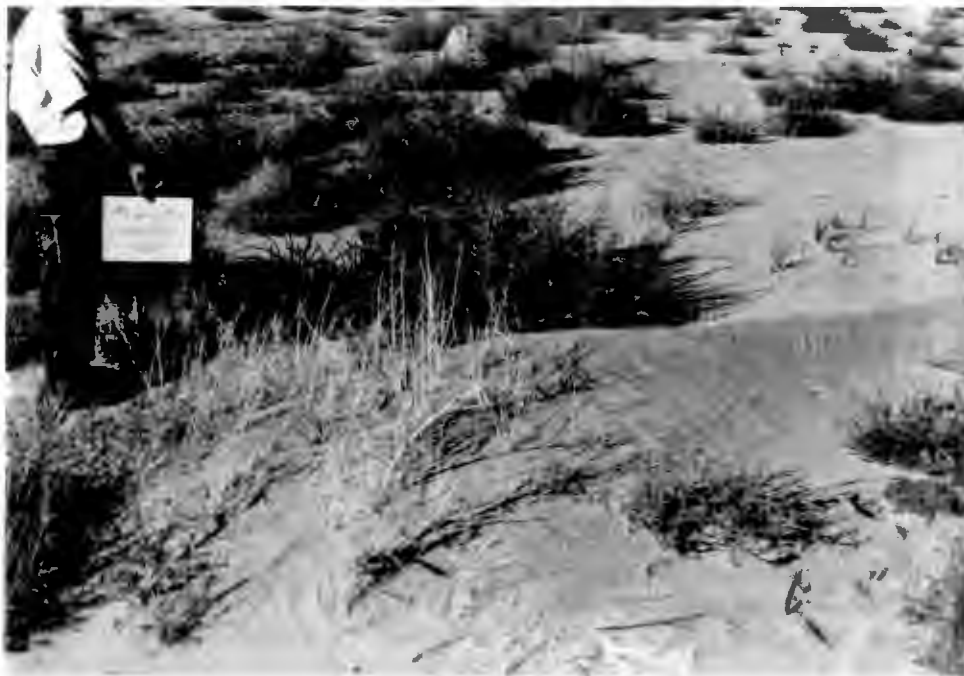
Topsoil depths across the site were greater than 12 inches, but consisted entirely of windblown sand. This area was essentially barren with most of the seed and mulch blown away before vegetation could be established. Native species such as Indian ricegrass (*Oryzopsis hymenoides*), from adjoining areas were starting to invade the disturbance area (Young, 1995). Because of the obvious lack of plant cover at the site no transects were attempted. Staff does not recommend release of this site.

Marquez Mine, Reclaimed Declined Shaft, 9/12/95

Marquez Mine, Waste Pile, 9/12/95

Marquez Mine Waste Pile, 9/12/95

Marquez Mine, Sand Dune, 9/12/95

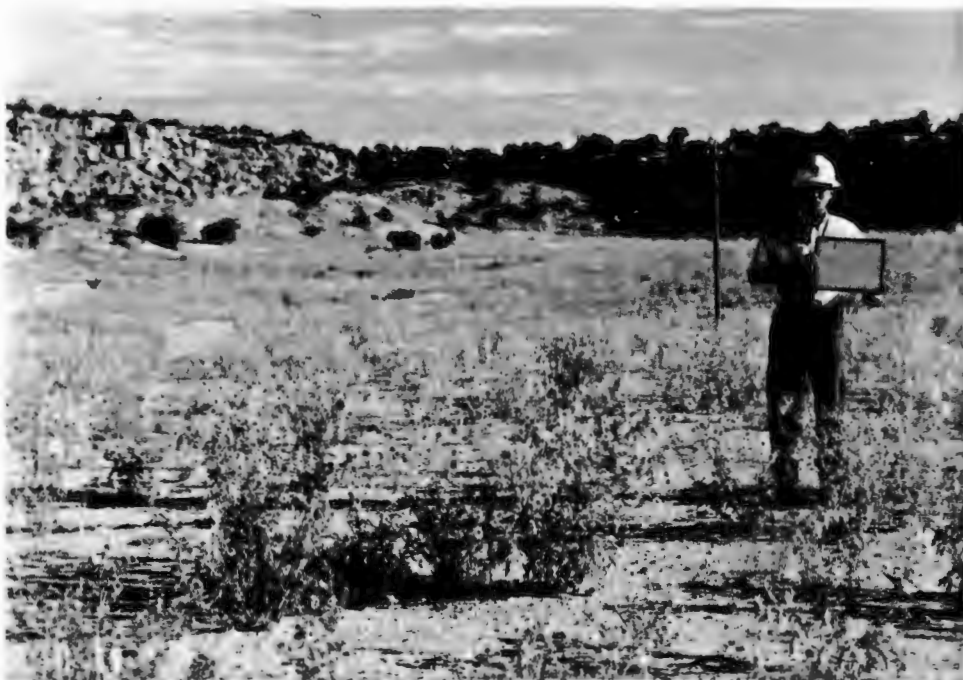
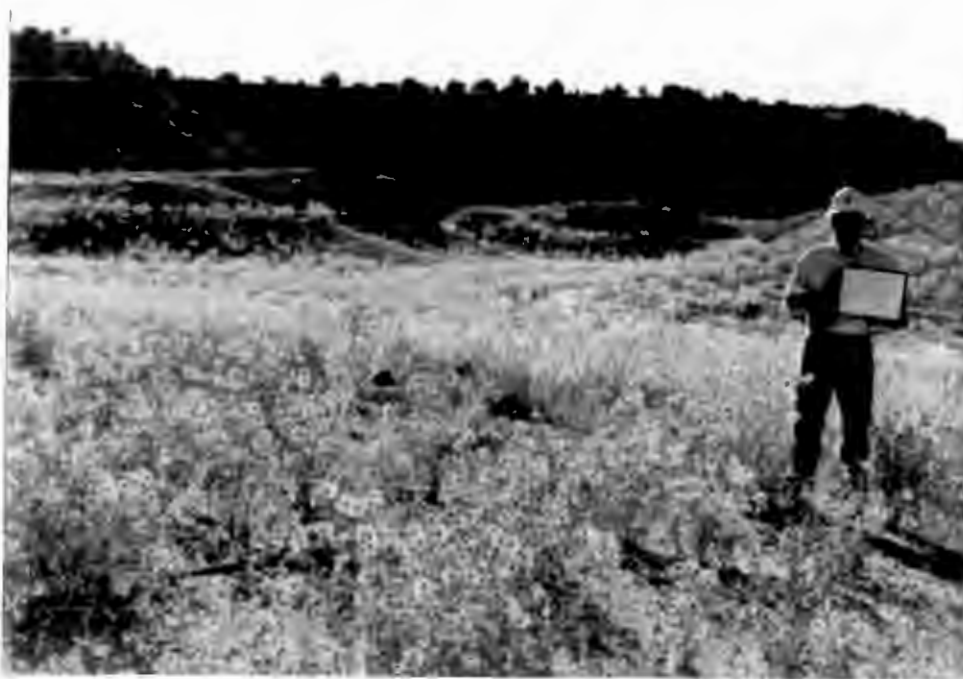
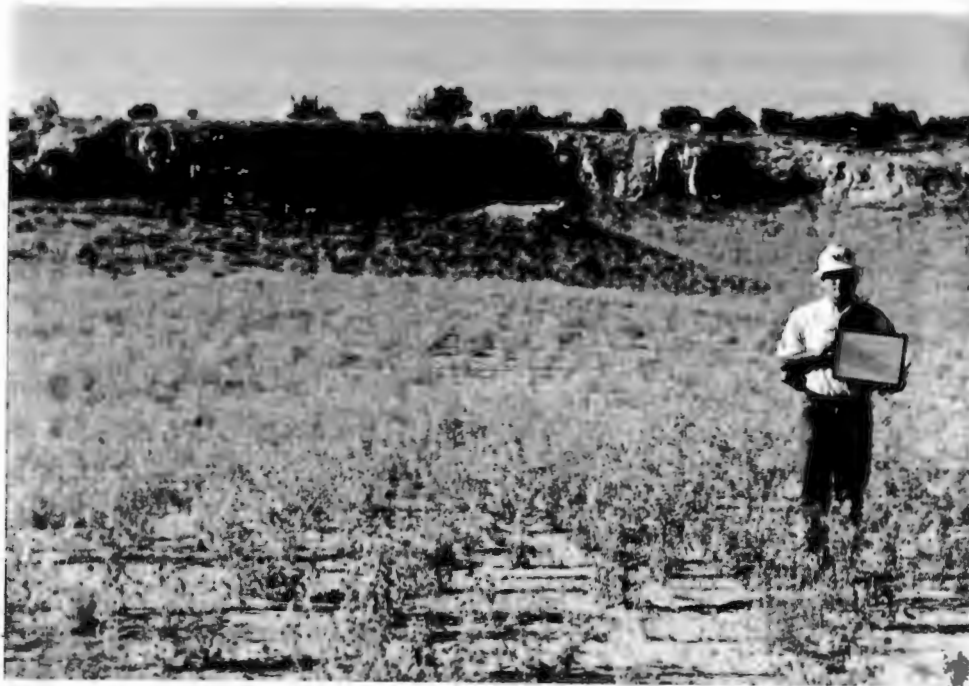
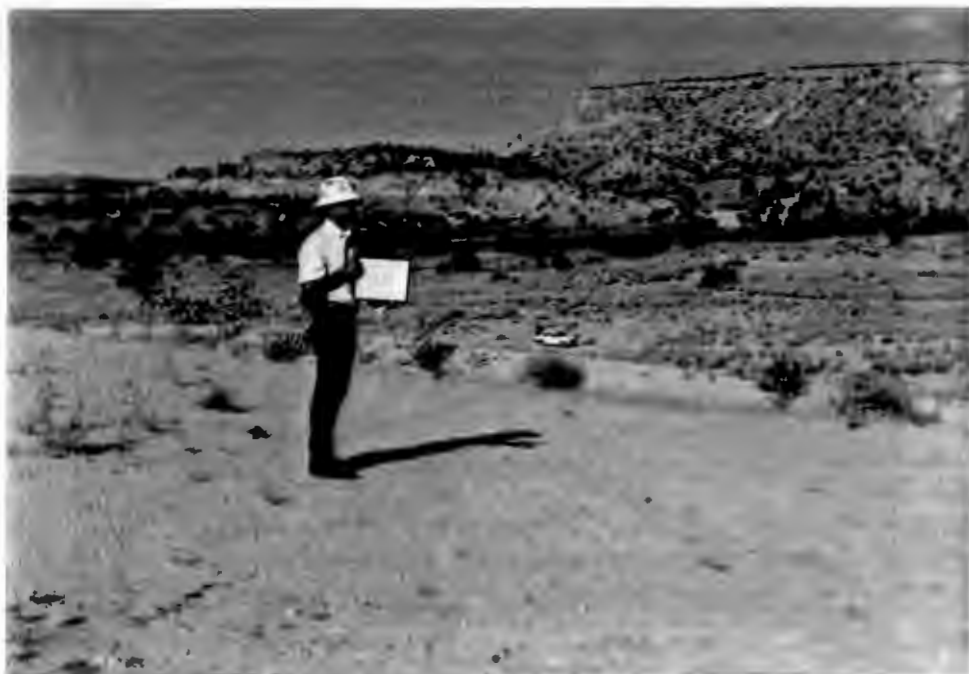
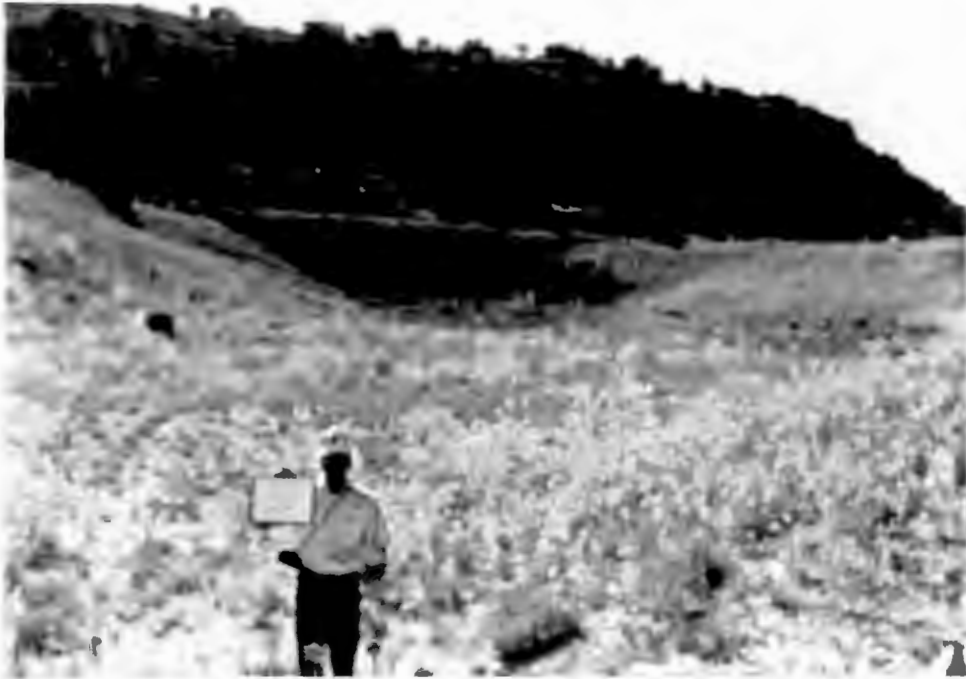
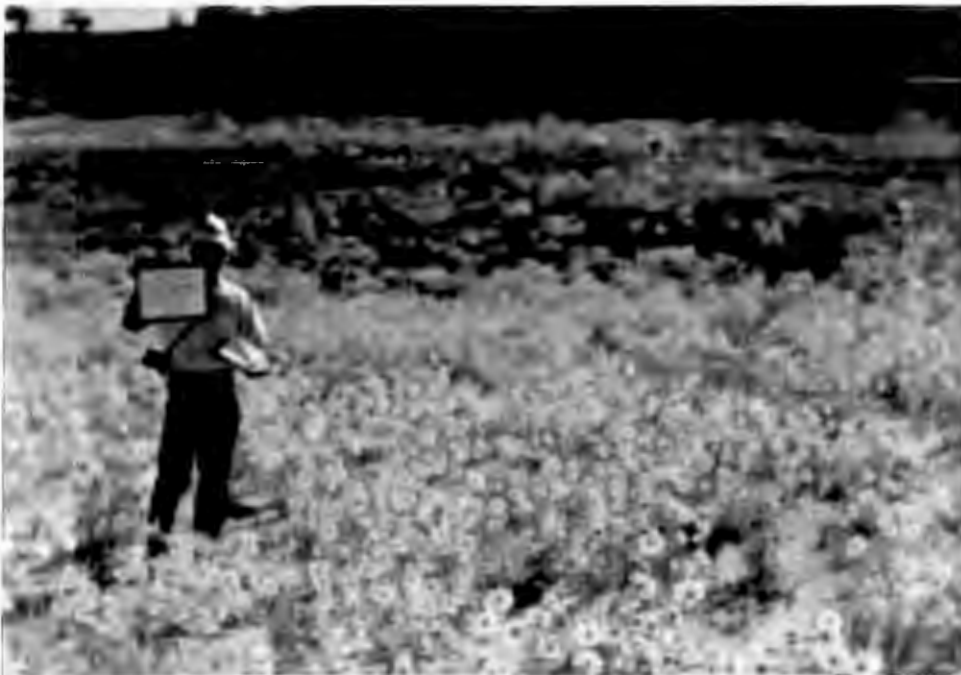
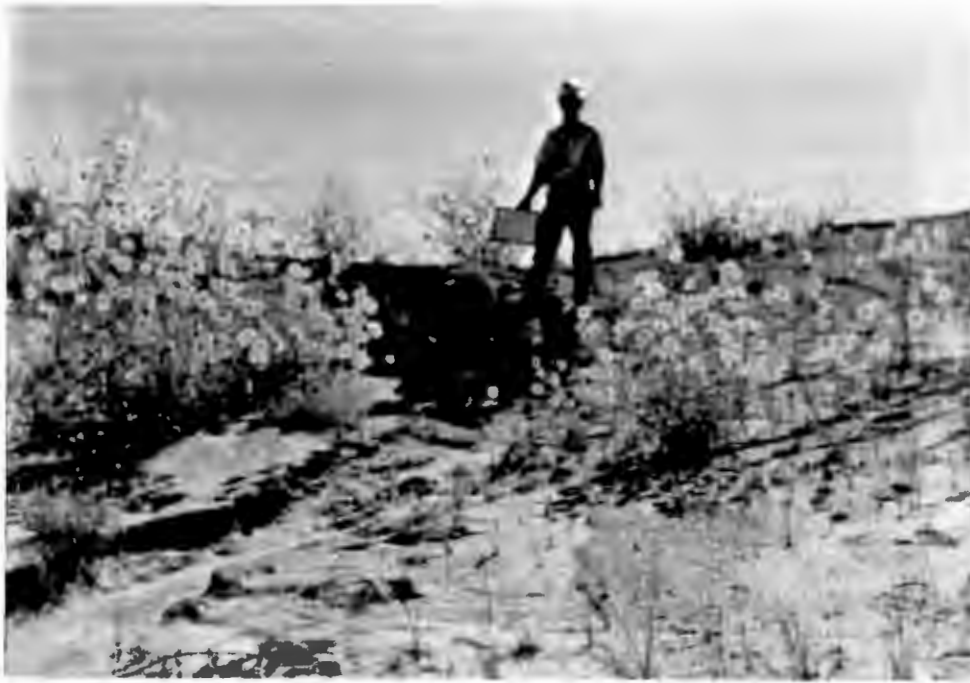
This site is characterized by an abundance of sunflowers and locoweed. The locoweed is probably a selenium accumulator for which the canyon (also known as 'Sheep Kill Canyon') was named. Reserve Oil and Minerals operated the mine under a lease from Santa Fe Pacific Minerals Corporation. Open mine features were backfilled and the mine reclaimed in 1987 upon termination of the lease. Additional reclamation of the site was conducted in 1993 and 1994 (Santa Fe, 1994). A barbed wire fence surrounded the site. All structures, trash or junk had been removed from the site. There were no piles or accumulations of toxic or waste material on the site. There were a few erosion features including one that was significant. Photographs documenting vegetation and general condition of the site are presented in Appendix K. An inclined shaft portal had been backfilled with nontoxic mine waste material (Santa Fe, 1994). The regrading of this site included construction of mounds, berms, terraces and depressions that impounded rainwater for livestock.

Poison Canyon Mine, Middle Looking North, 9/12/95

Poison Canyon Mine, Middle Looking East, 9/12/95

Poison Canyon Mine, Middle Looking South, 9/12/95

Poison Canyon Mine, Middle Looking West, 9/12/95

Poison Canyon Mine, Reclaimed Declined Shaft, 9/12/95

Poison Canyon Mine, Small Depression, 9/12/95

Poison Canyon Mine, Erosion Feature, 9/12/95
