**BI-ANNUAL INSPECTION****April 5, 2018****Mount Taylor Mine****PERMIT UPDATE:**

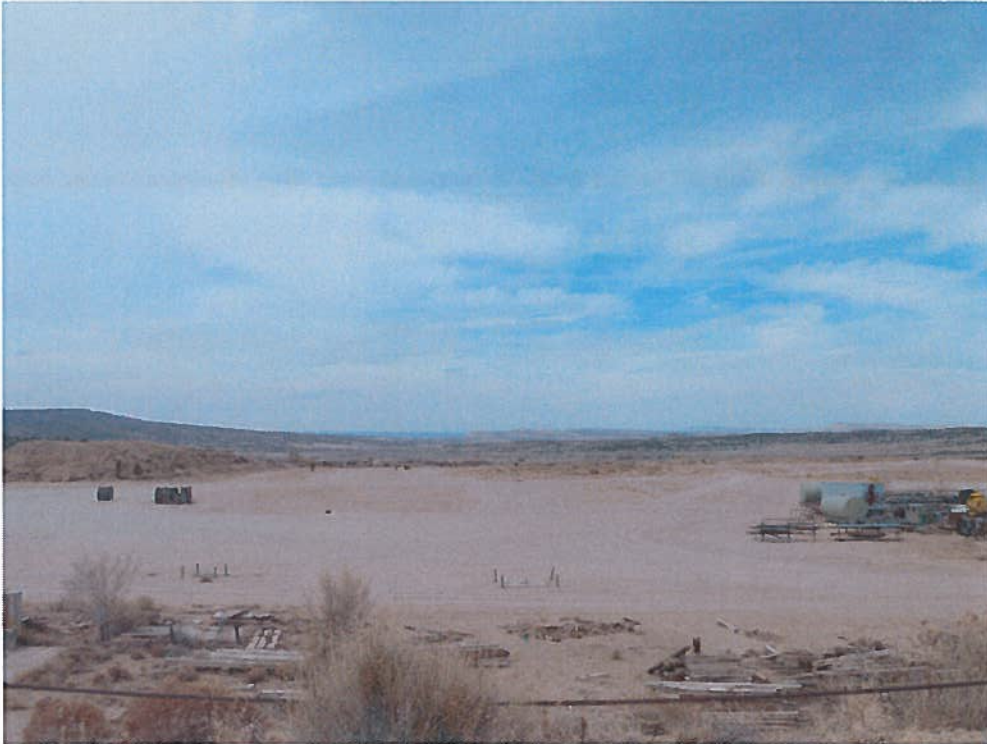
Joe reported that the top surface of the waste rock pile had been cleared of the pipe, spools of cable and wire, and various metal parts for the underground mine (see photos). This equipment was moved to accommodate the construction of the lined-disposal cell within the waste rock pile that will receive the sediments from the treatment ponds when they are rehabilitated.

North Top Surface of Waste Rock Pile formerly used as an equipment laydown area in preparation for excavation for the lined-disposal cell for contaminated materials

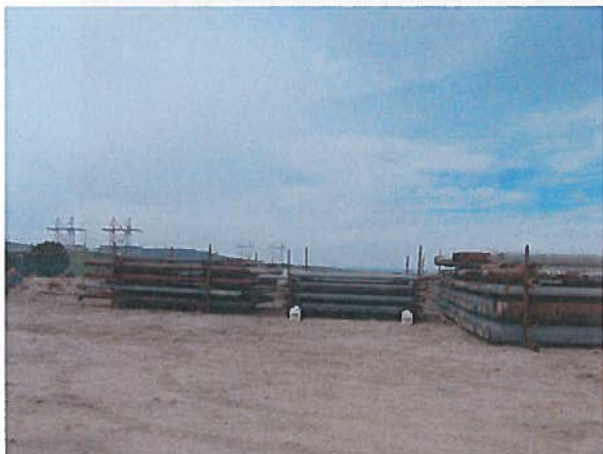
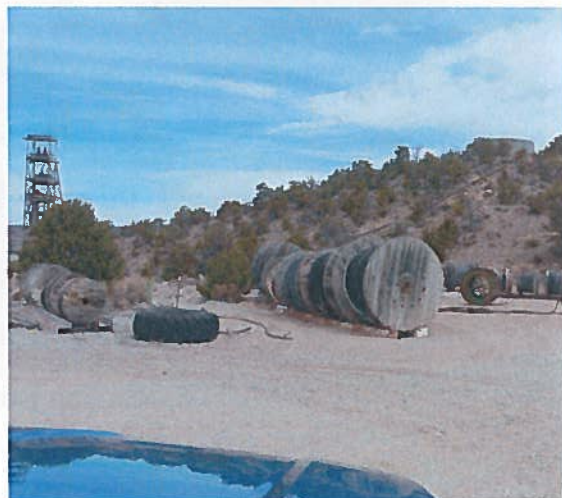
Pipe and Spools of Cable relocated to staging areas from the Waste Rock Pile Top Surface

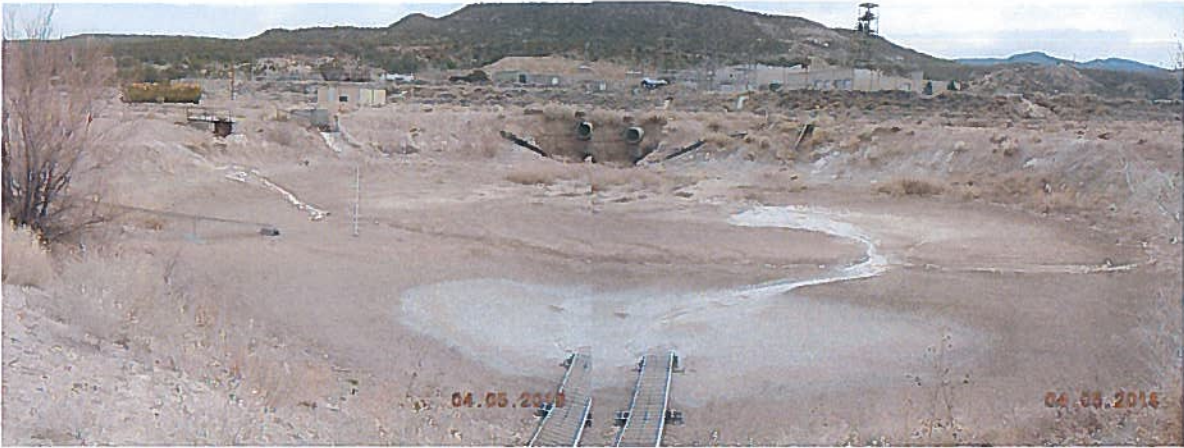
Ponds 2 and 3 were inspected (see photos). These ponds will be among the first to be excavated and re-built including synthetic-liners. Stormwater will be directed to the re-built and synthetically-lined south stormwater pond that will also receive effluent from the stage 2 abatement groundwater system. This water may also report to the renovated Pond 2 in the mine water treatment system. Joe showed where the pipelines interconnecting the surface treatment ponds were being excavated in order to upgrade them for the new mine water treatment system (see photos).

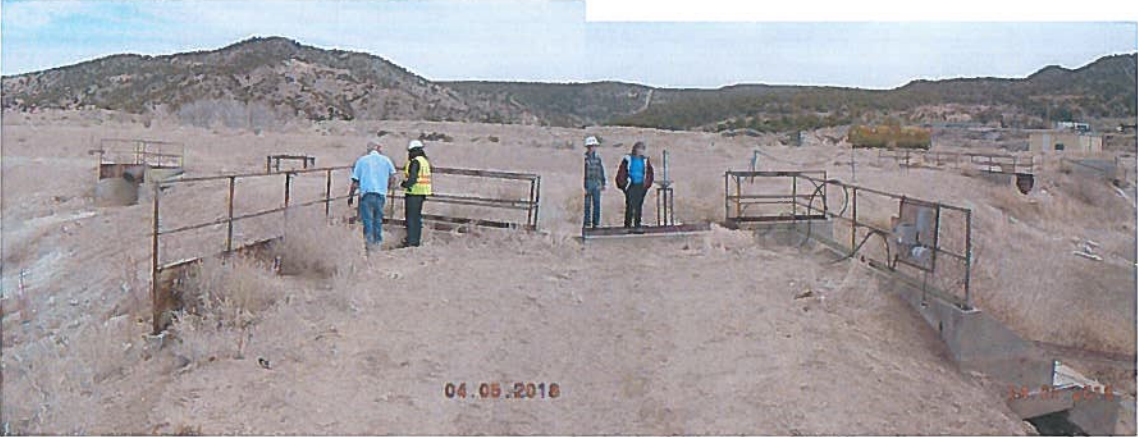
Concrete Connection Culvert between Pond 2 and 3

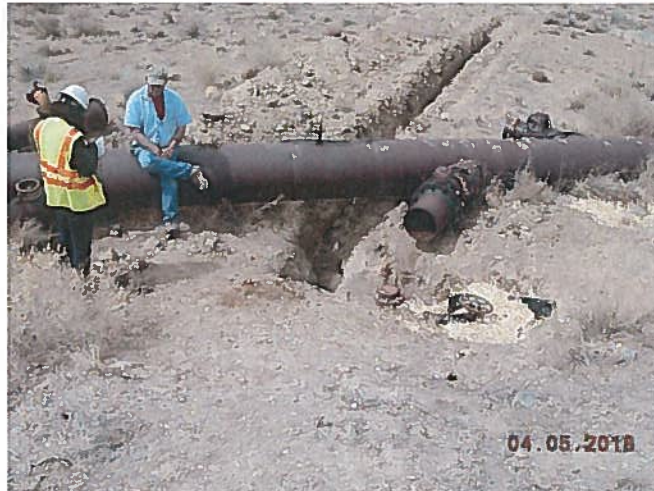
Pipelines and Excavated Interconnection to Ponds

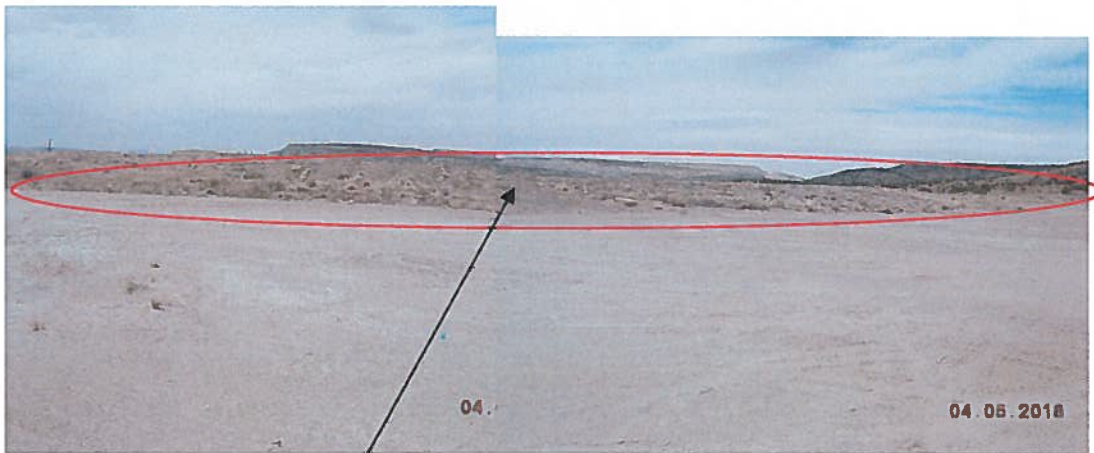
The ore pile that is covered with cover material and vegetation was observed (see photos).

Covered Ore Stockpile (in background)
