**Subject: Section 12 Mine Drum Resin Remediation
Section 12 Mine
Ambrosia Lake, New Mexico**

Section 12 Mine Drum Resin Remediation

DCN:444322-1095000.00-ABQ22RPT01_REV.0

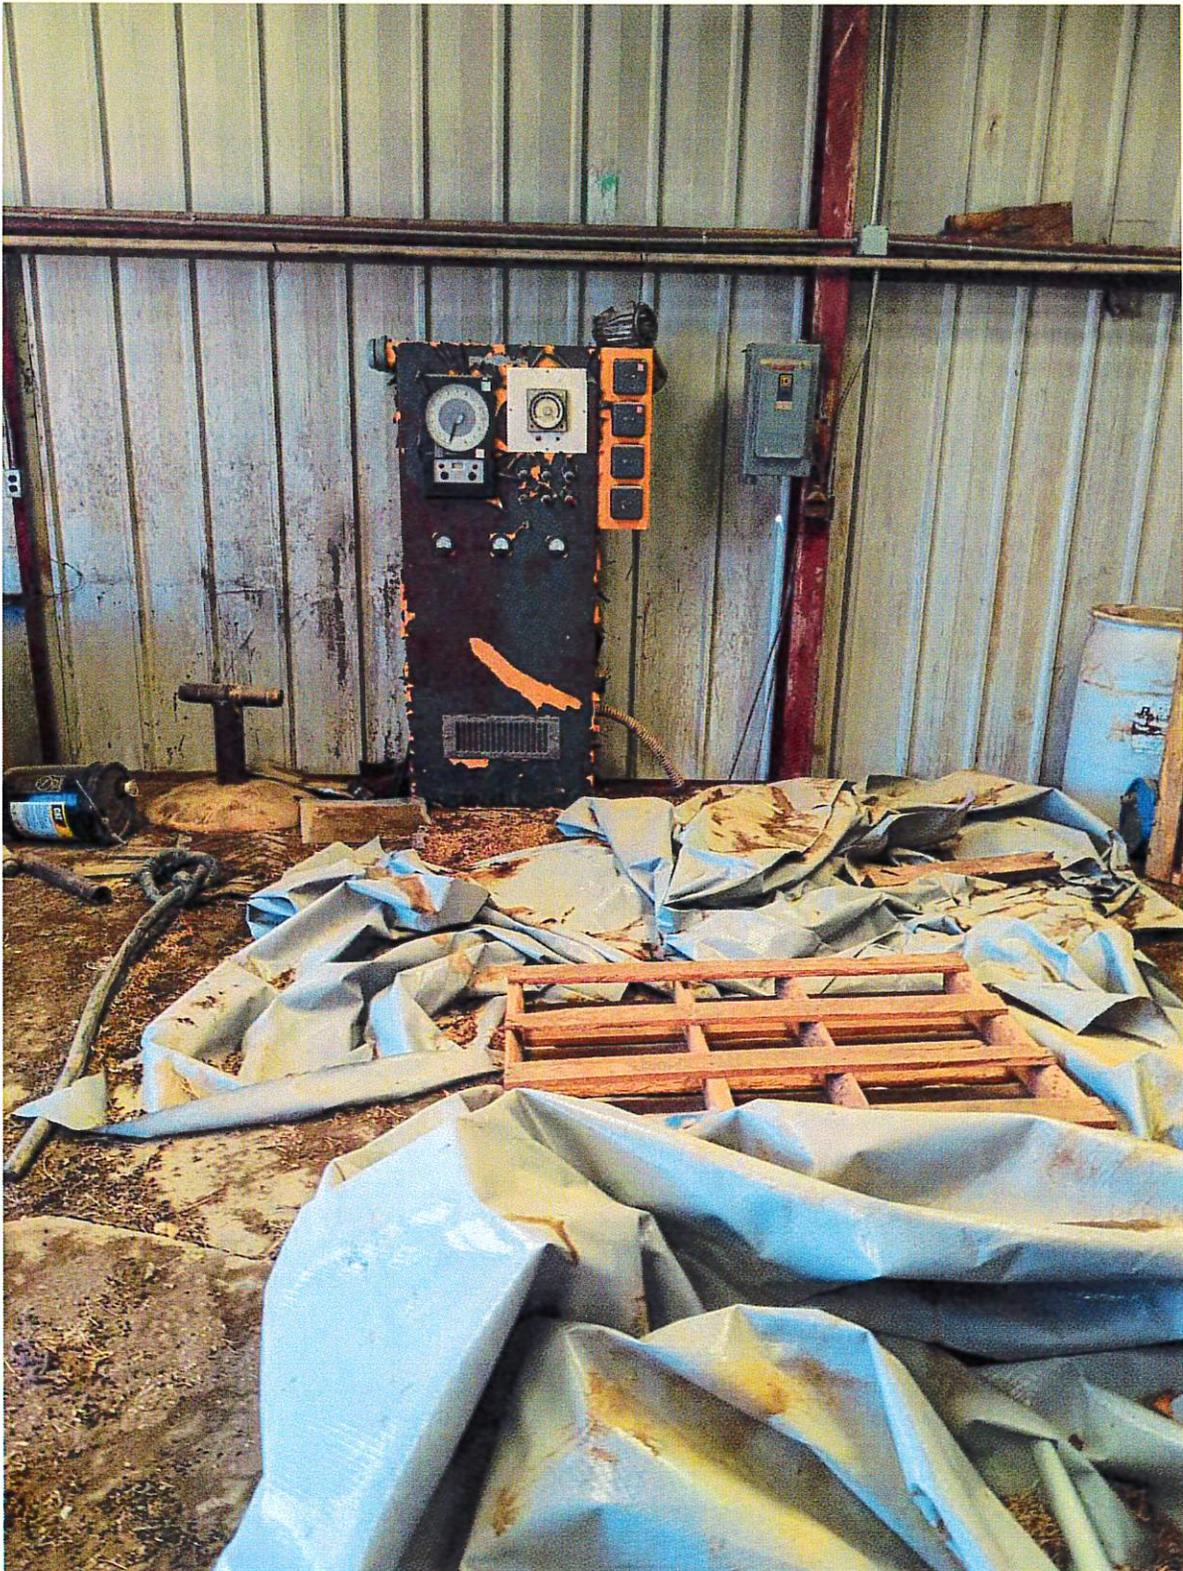
Figure 4

Hoist House front room.jpg

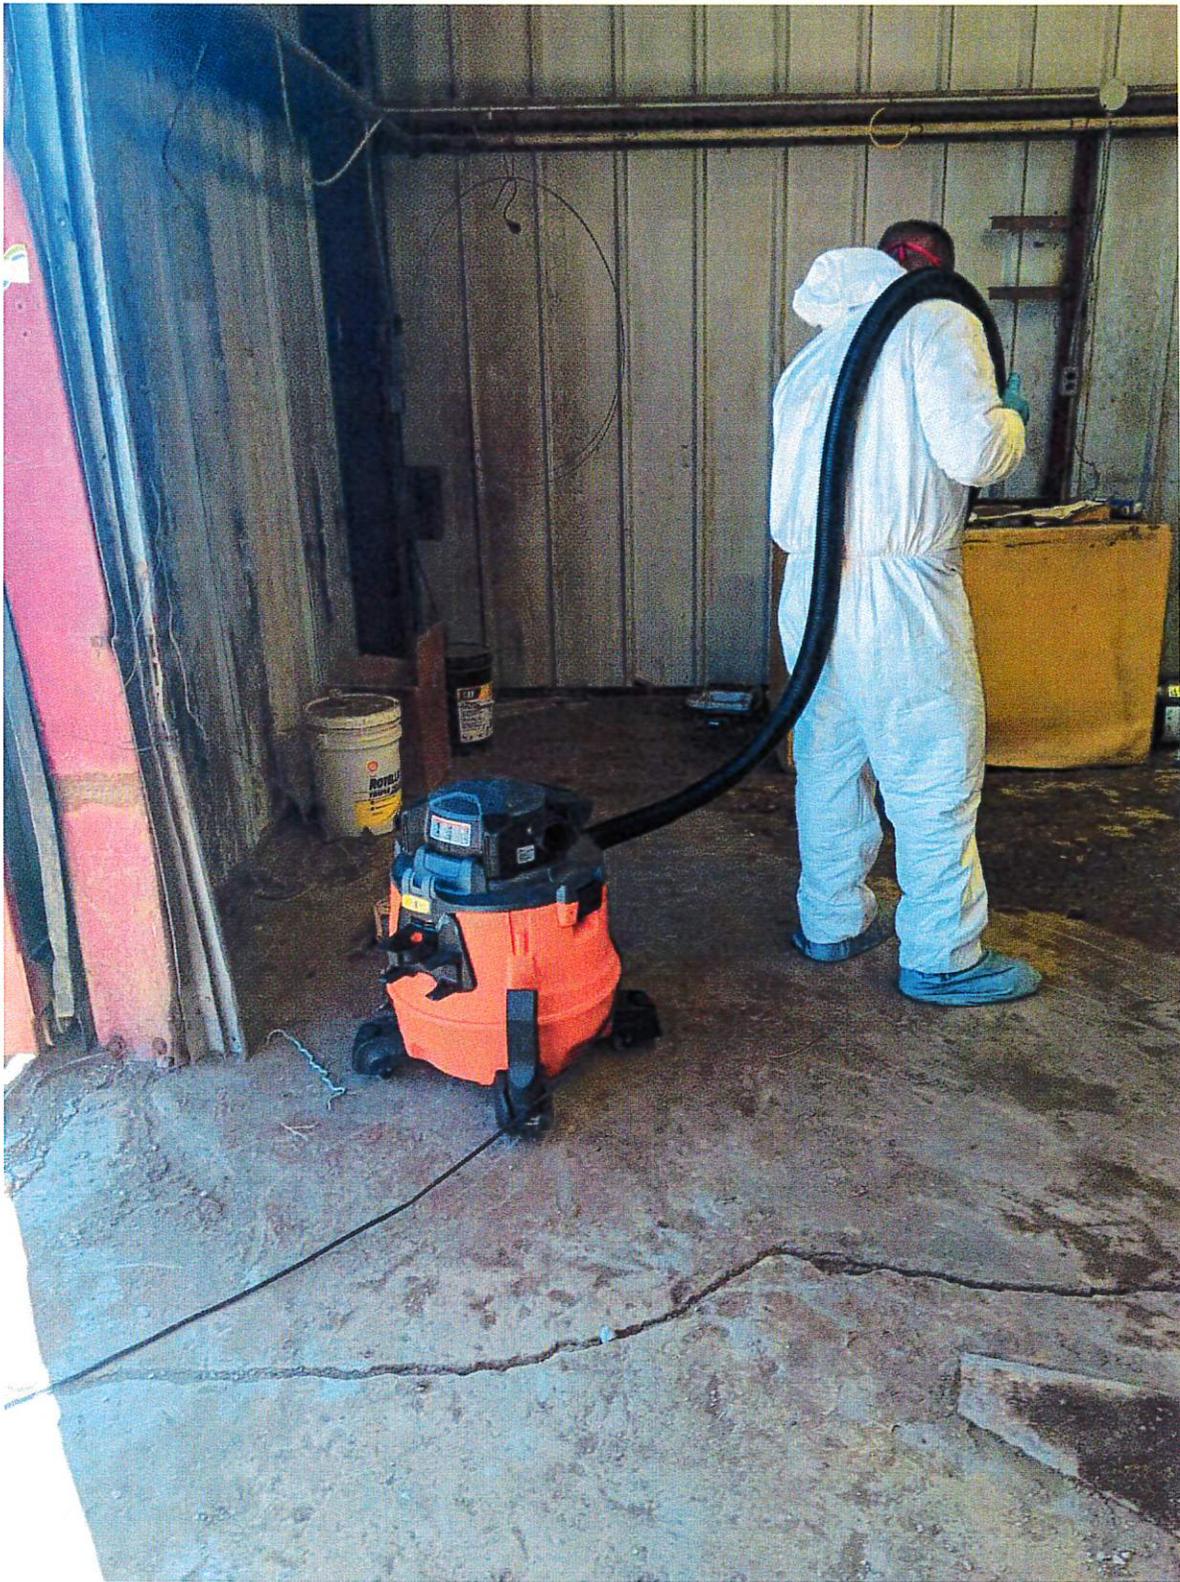
Figure 6

Vacuuming resin.jpg

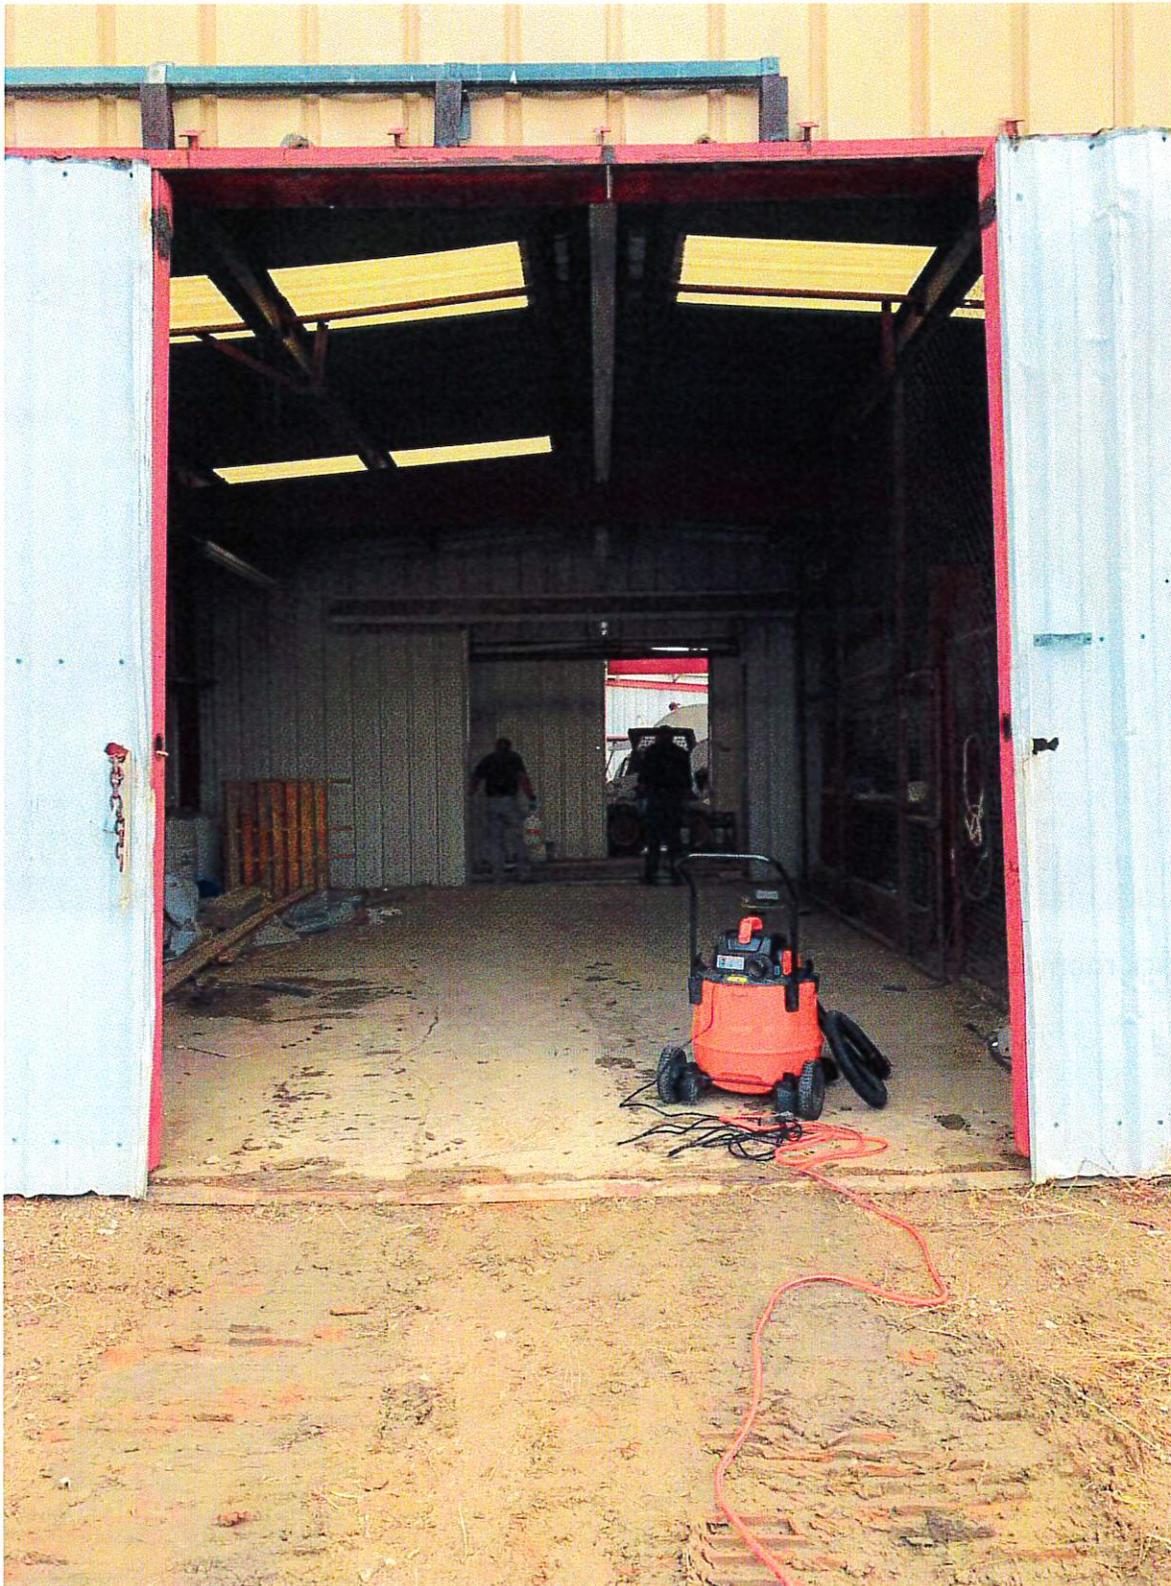
Figure 27

Cash team spraying Clorox and vacuuming resin.jpg

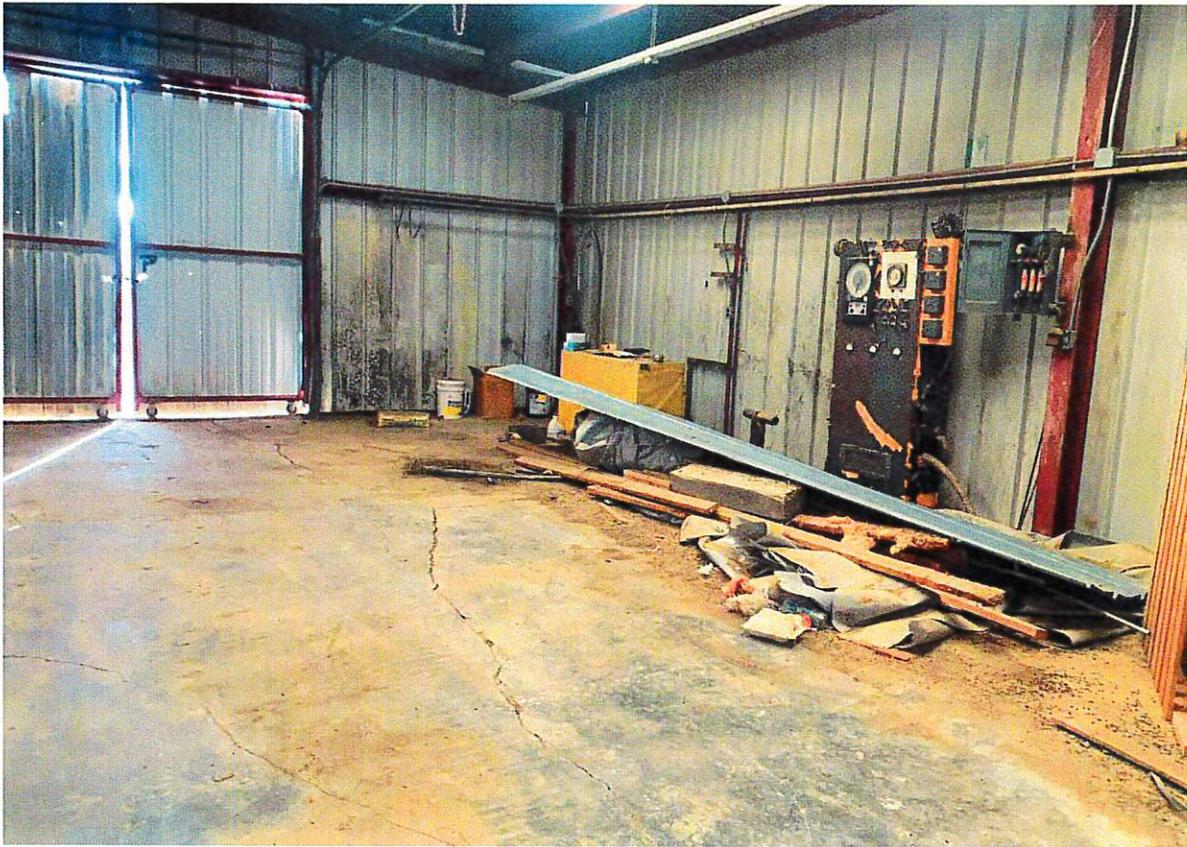
Debris in front room of HH after drum removal.jpg

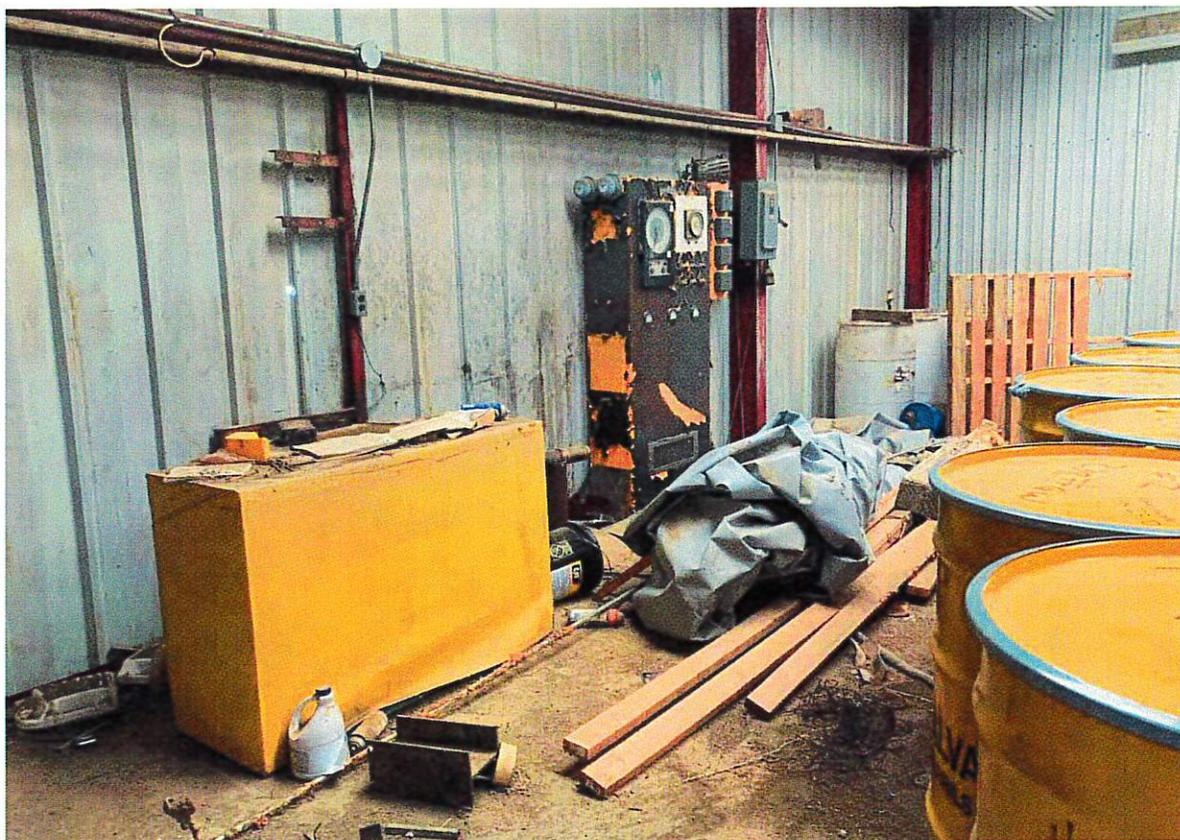
Debris in front room of HH before drum removal.jpg
