# Navajo North Site Assessment and Recommendations Report

McKinley County, New Mexico

AML Project SHARE No. 19-521-0620-0191 Task Order 7

January 17, 2022

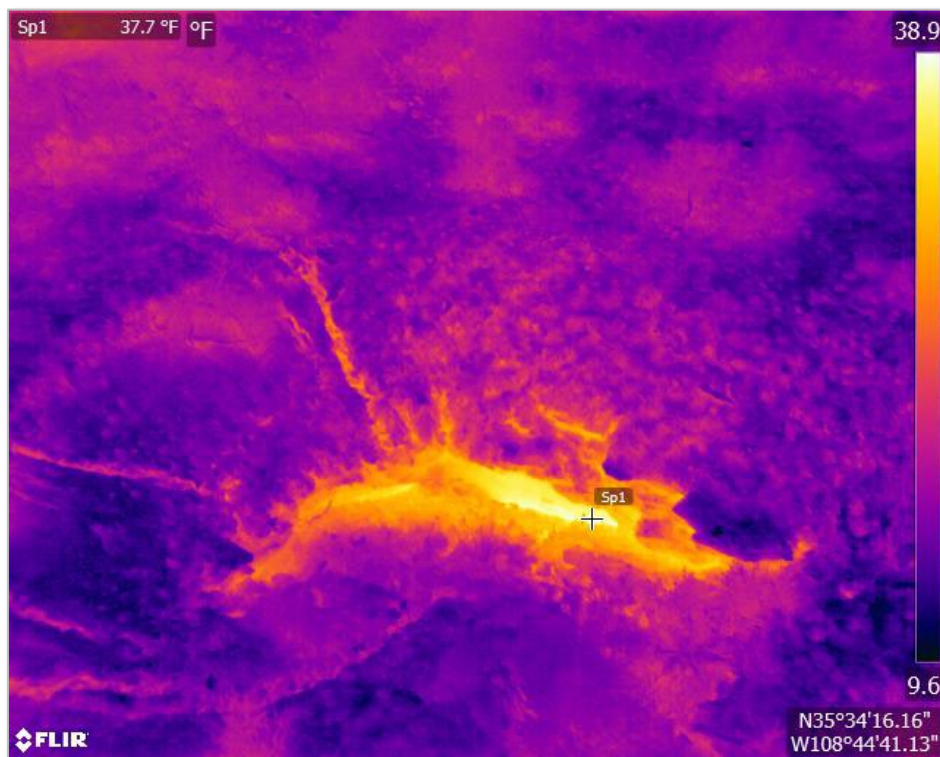
*Image 1: UAS-Thermal Image of Navajo North Subsidence Feature SF3.*

3. **SF3** (Navajo North Decline 3) This sinkhole subsidence feature is approximately 30 feet in diameter with an opening in the fractured sandstone at the base of the southern wall (Photo 4). Image 1, above is the thermal image of the opening showing a high temp of 37° F with background temperatures in the 20's° F.

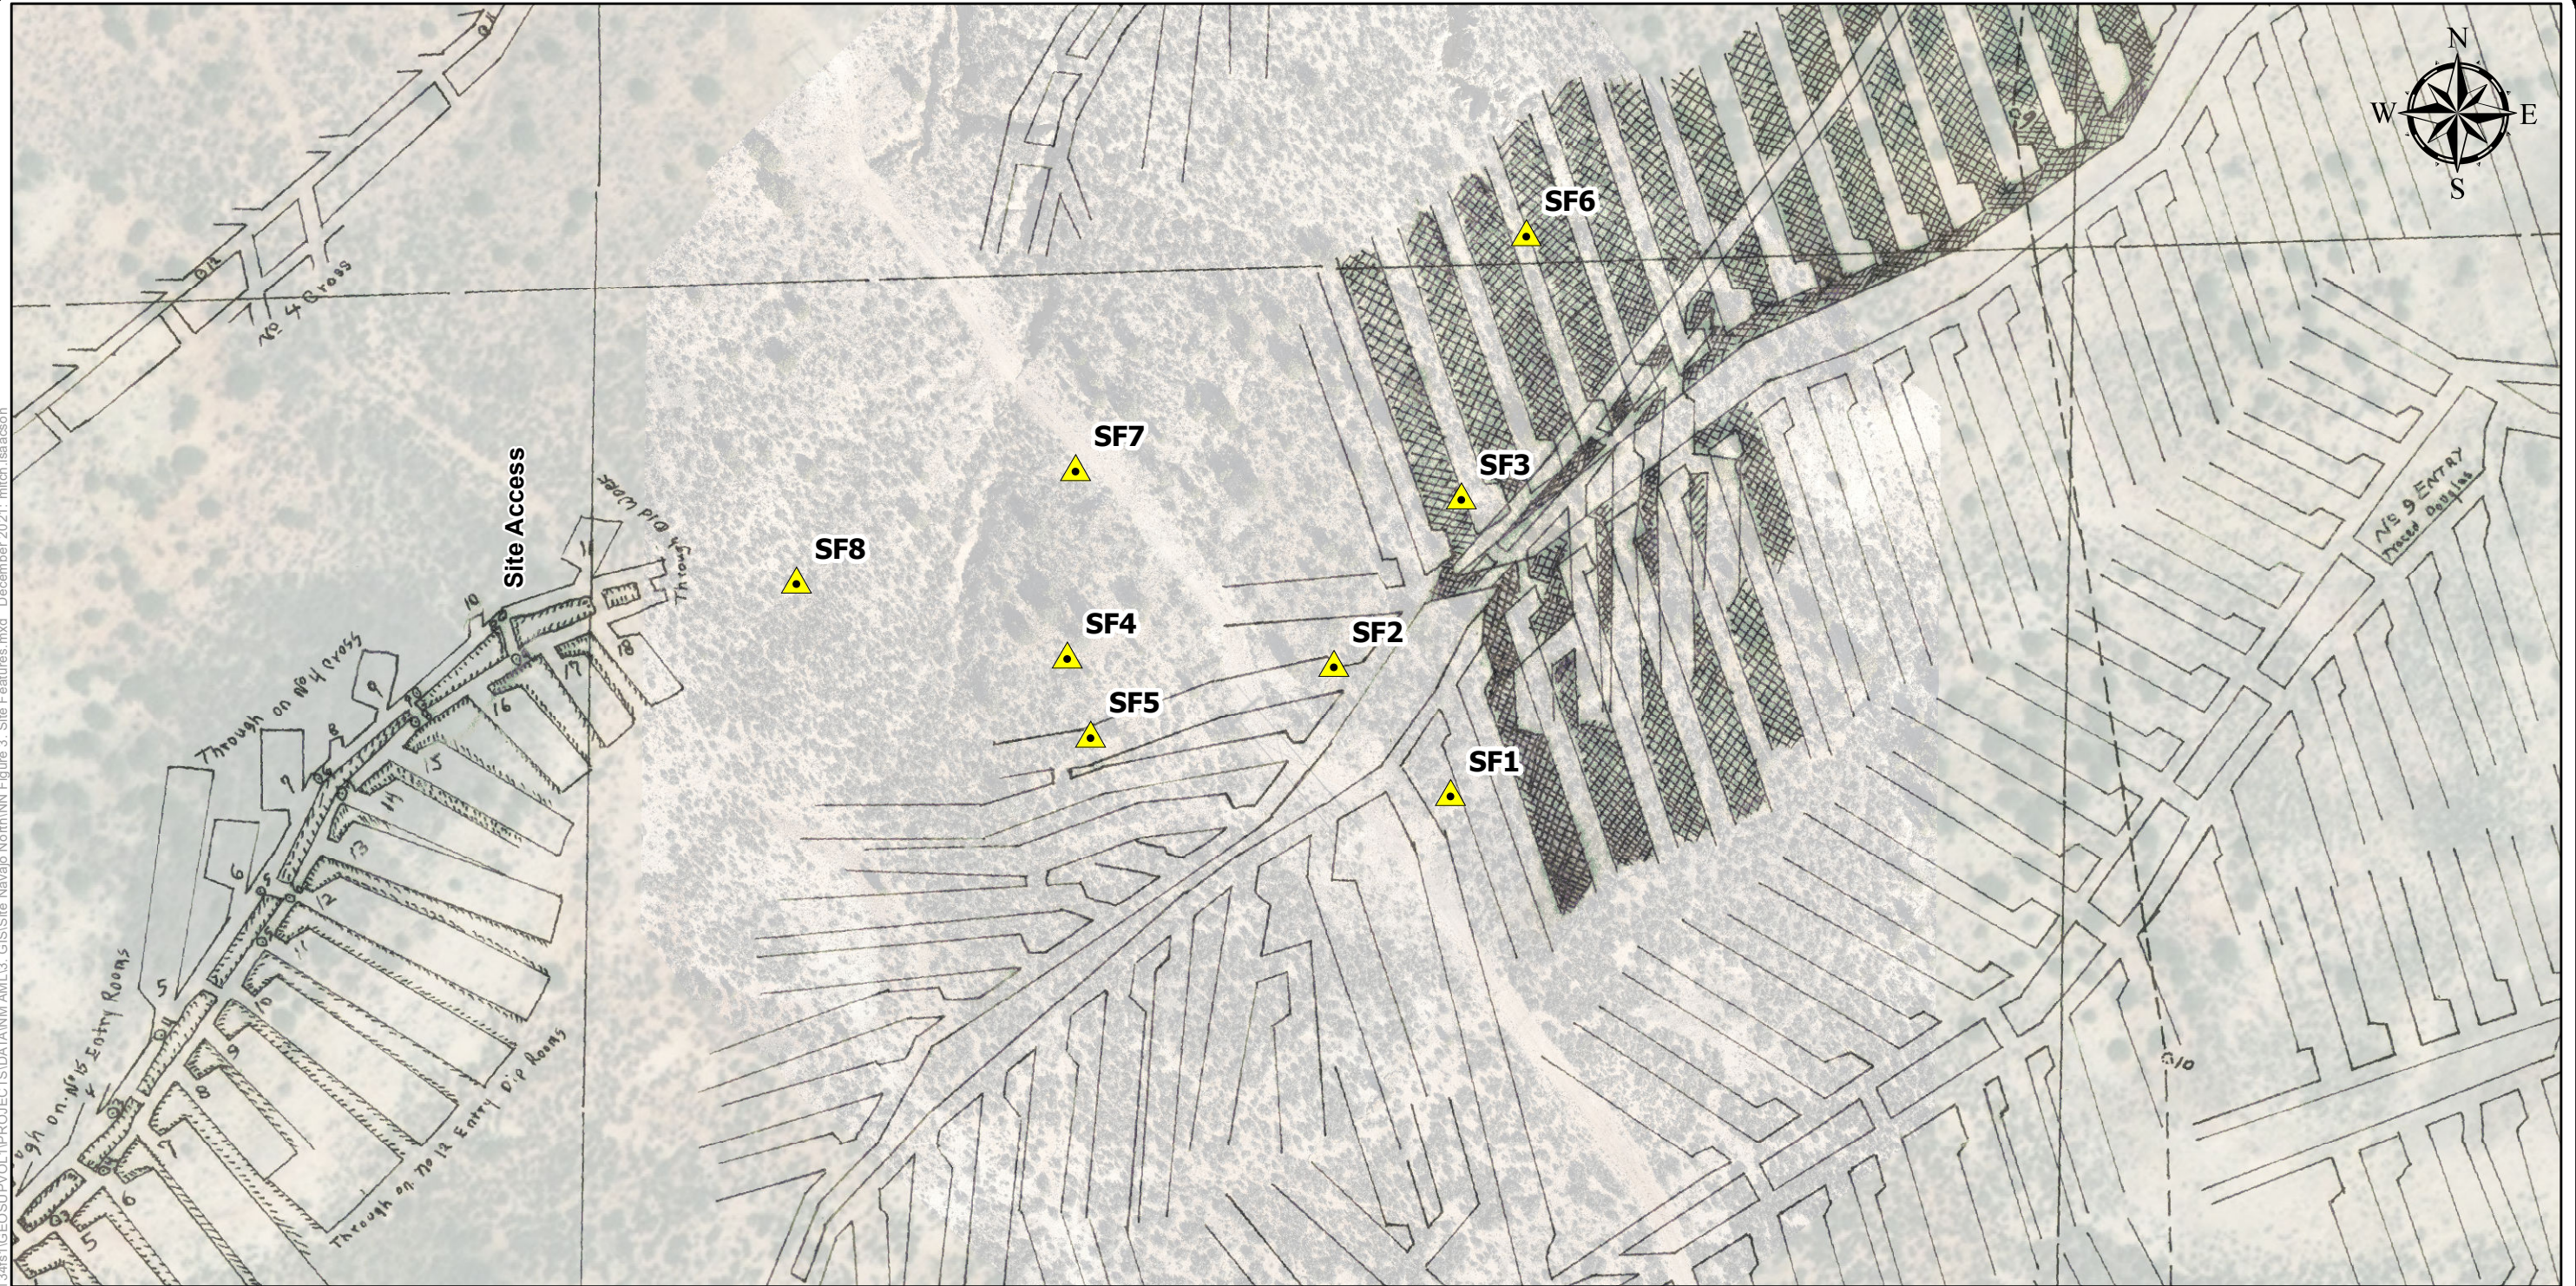
TITLE: Site Features and Mine Map Navajo North Area			
LOCATION: Gallup, Mckinley County, New Mexico

features and the corrected geotiffs are supplied with this report. The locations of the surface features over the mine maps for the area are shown on **Figure 3**.

The Navajo North features do not appear to be venting mine fire exhaust. Gas concentration, temperature analysis, and observed air moisture indicate that the features are venting mine atmosphere from a considerable volume of mine workings. Review of mine maps for the Gallup-Gibson mine show workings in the shallowest mined coal seam (No. 3 seam) beneath the Navajo North features. The mine map shows no adits or shafts located in the immediate vicinity of the features and there is no evidence on the surface that there was an entrance in the area. It is believed that the Navajo North features are subsidence features related to the roof collapse in a room or haulage and not related to a shaft or adit.

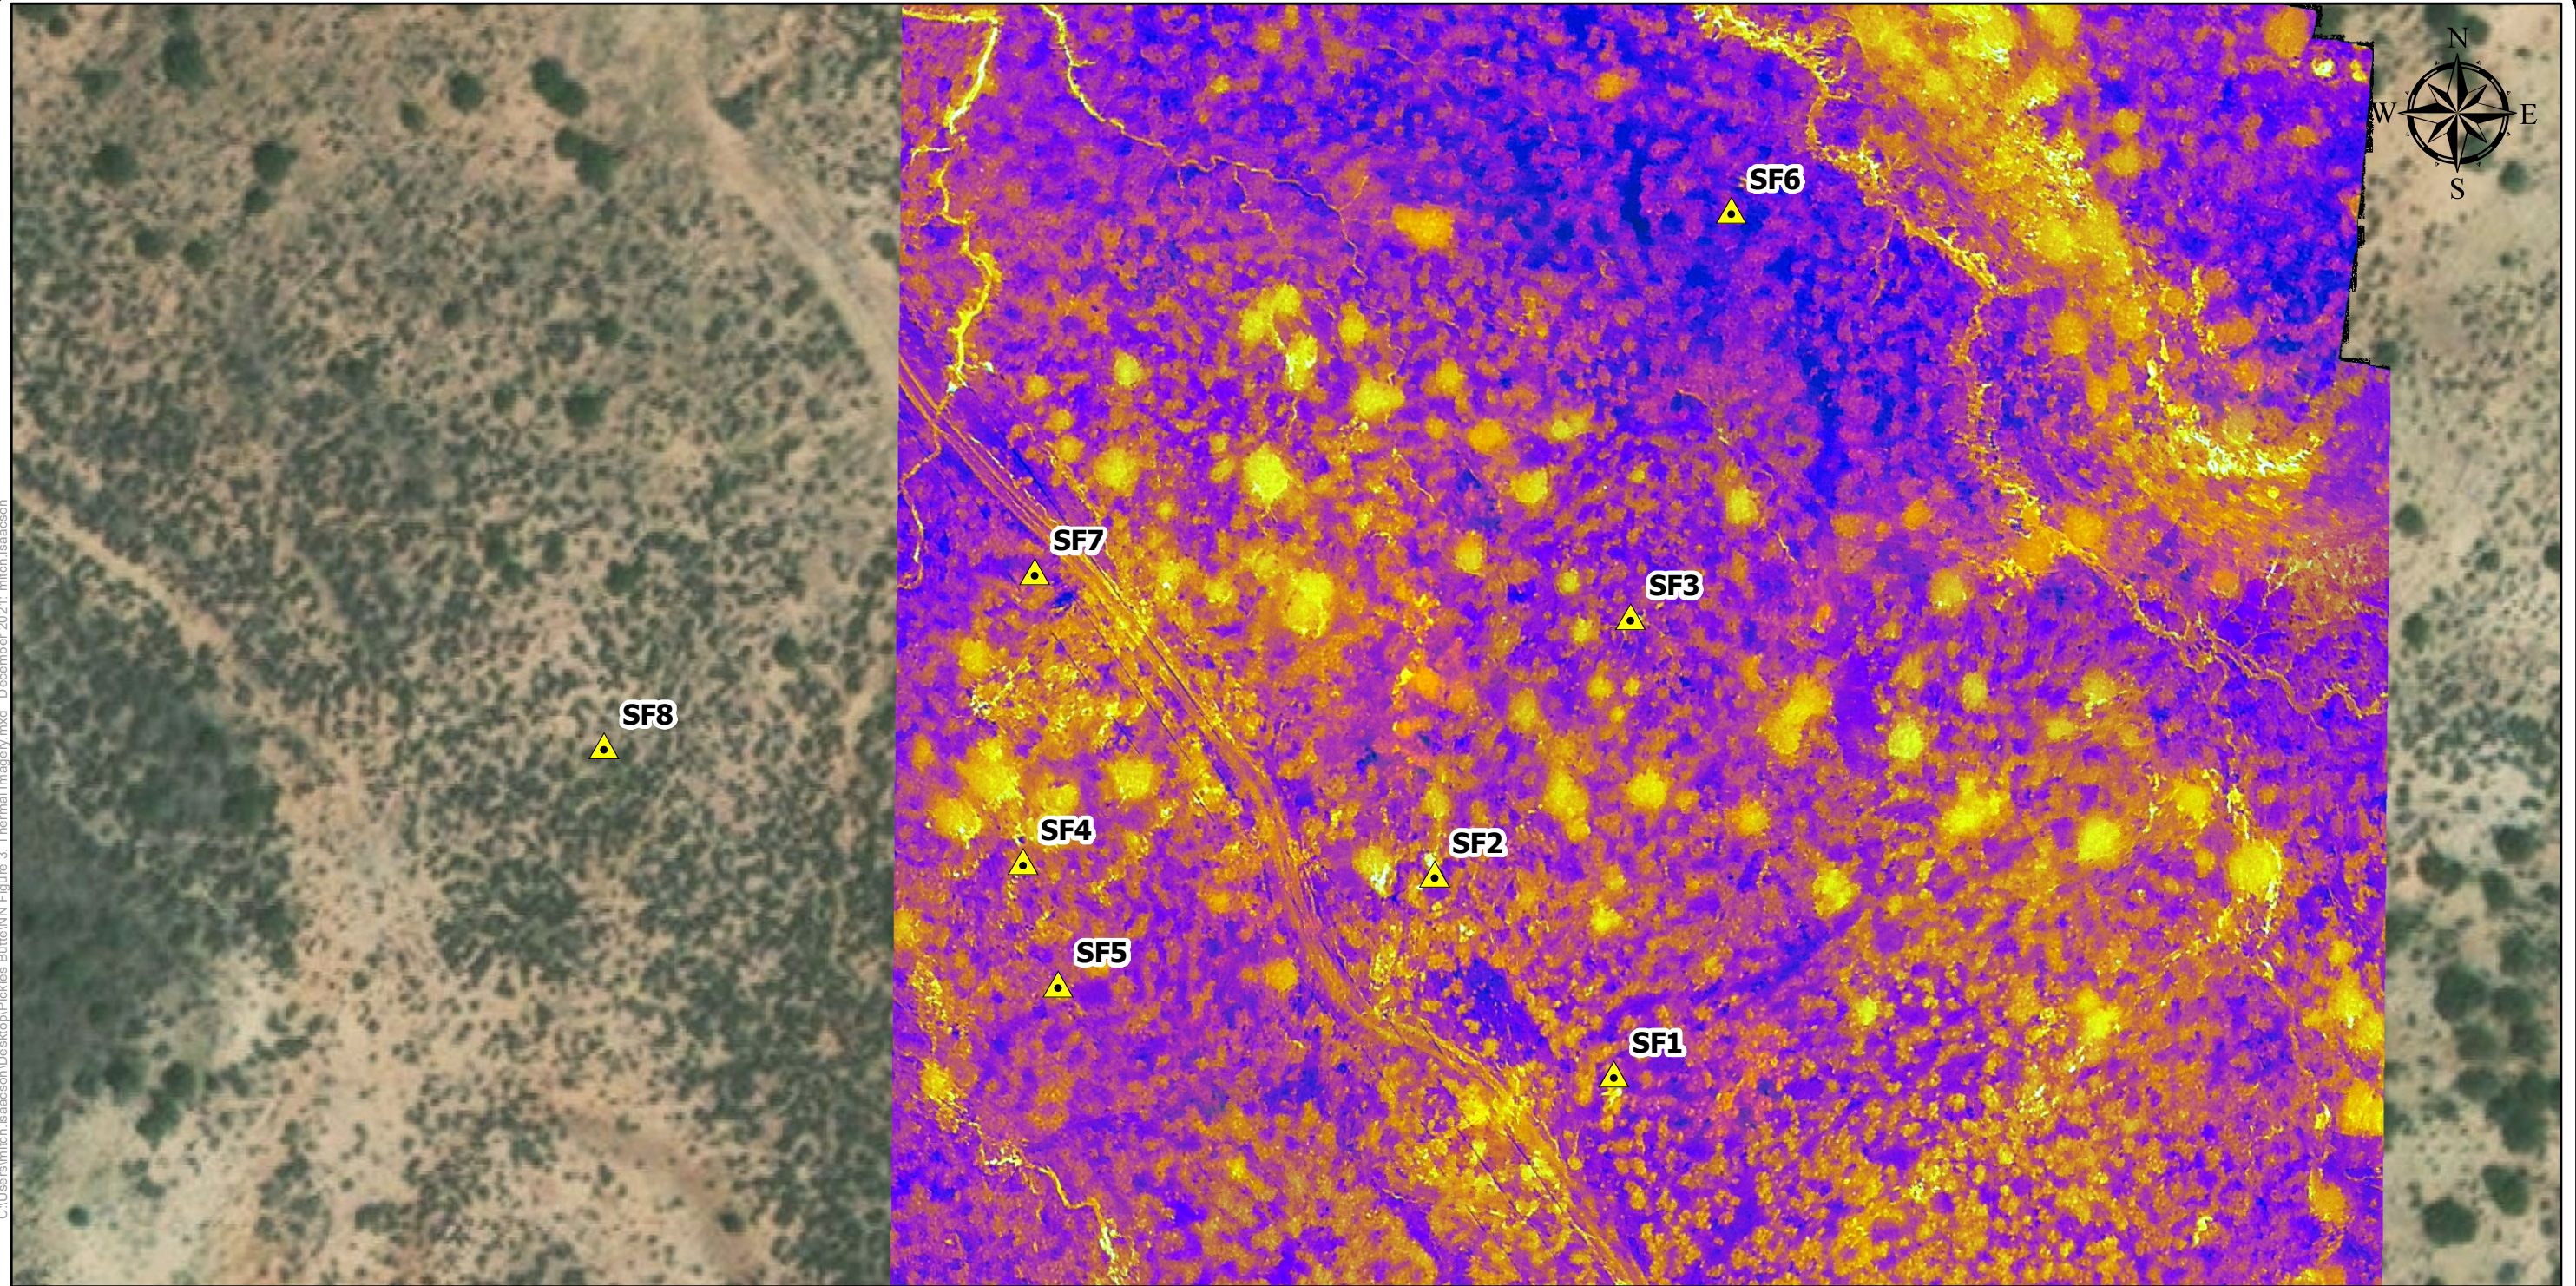
TITLE:		Thermal Imagery Navajo North Area	
LOCATION:		Gallup, Mckinley County, New Mexico

Additionally, a 1.5 square mile area surrounding the Navajo North area was flown at a high level searching for thermal anomalies that would indicate mine, refuse pile, or outcrop fires. No thermal anomalies were identified besides the Navajo North subsidence features and the Navajo Fire. This data is provided electronically.

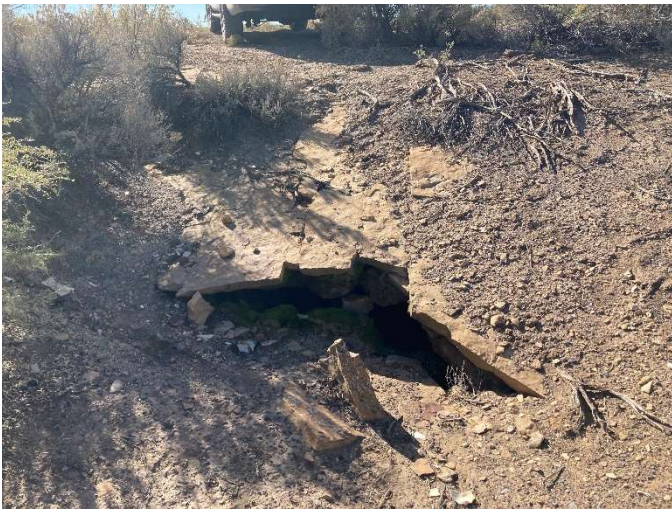
1. **SF1** (Navajo North Decline 1) A sinkhole subsidence feature, approximately 15 feet in diameter with a fracture in the bedrock at the base surrounded by green moss (Photo 1). There's a steady flow of musty air venting from the fracture. Temperatures in the subsidence features were found to be between 40° F and 50° F. No hazardous gases or combustion indicators detected.

**PHOTOGRAPH 1** Subsidence feature No. 1

This option would involve backfilling the open subsidence features to mitigate the low potential fall hazard as well as help reduce the amount of air flow through the old mine workings to slow oxidation within the mine. **Figure 5** shows the disturbance extents for each backfill area.

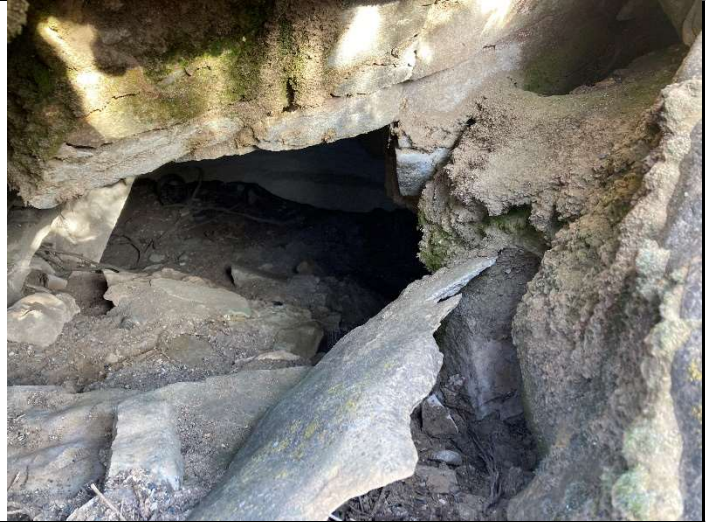
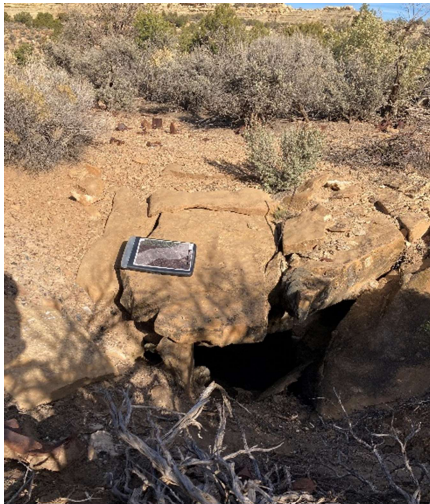
2. **SF2** (Navajo North Decline 2) A discrete fracture in the bedrock wall of a small sinkhole (Photos 2 and 3). Appears quite deep with a musty odor and slight flow of air. Temperatures were close to ambient and no hazardous gases or combustion indicators were detected.

**PHOTOGRAPH 2** Subsidence feature No. 2

**PHOTOGRAPH 3** Subsidence feature No. 2

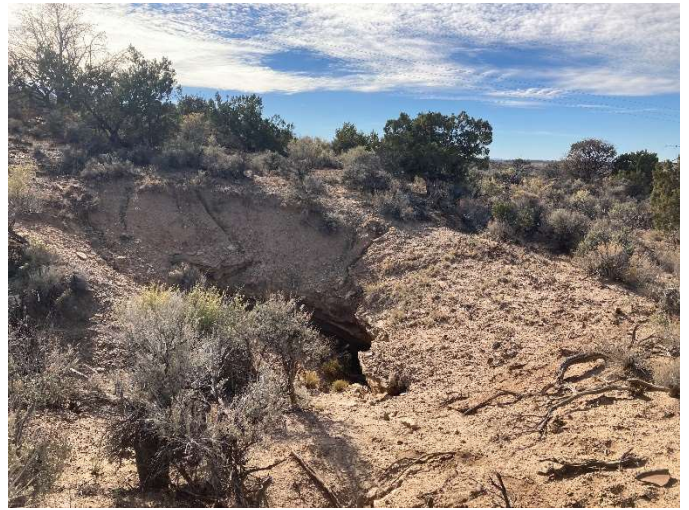
**PHOTOGRAPH 4** Subsidence feature No. 3

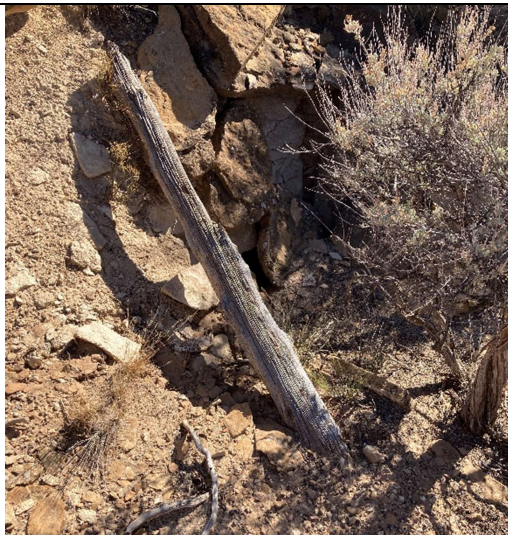
4. **SF4** This subsidence feature previously identified as Navajo North Vent 2 is shown in Photo 5.
5. **SF5** (Navajo North Vent 1) Photo 6 shows the measurement of gas concentrations from the low flow from this small subsidence feature. Temperatures were slightly above ambient, and no hazardous gases or combustion indicators were observed.

**PHOTOGRAPH 5** Subsidence No. 4.

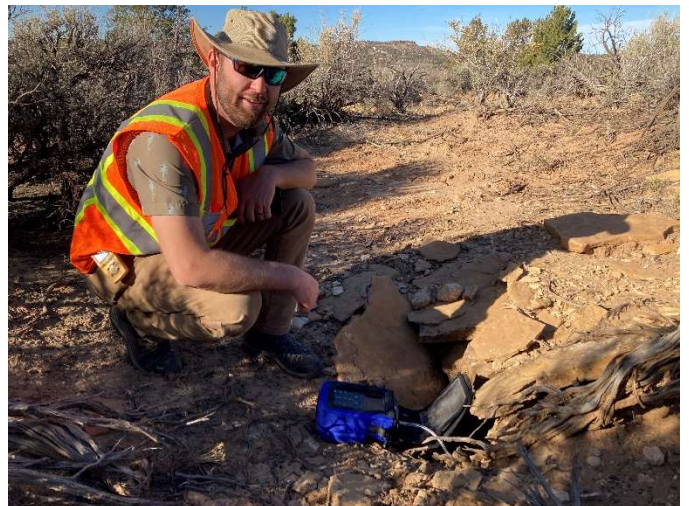
**PHOTOGRAPH 6** Gas readings in Subsidence No. 5

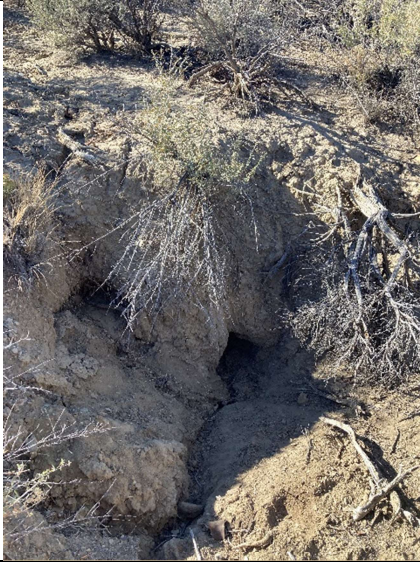
6. **SF6** One additional 8-inch diameter subsidence feature (Photo 7) was located near the wash 200 feet to the northeast of the previously identified features. This feature's temperature was 46°F. No odors or gases were observed or detected.

**PHOTOGRAPH 7** Subsidence No. 6

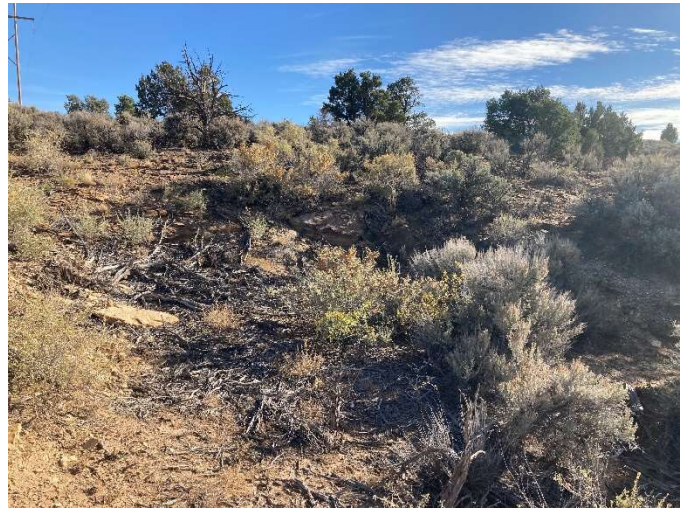
7. **SF7** Photo 8 shows a broader depression south of the overhead powerline maintenance road that is possibly related to mine subsidence. It is approximately 30 feet in diameter and there are no open fractures, recent signs of movement, or venting.

**PHOTOGRAPH 8** Subsidence No.7

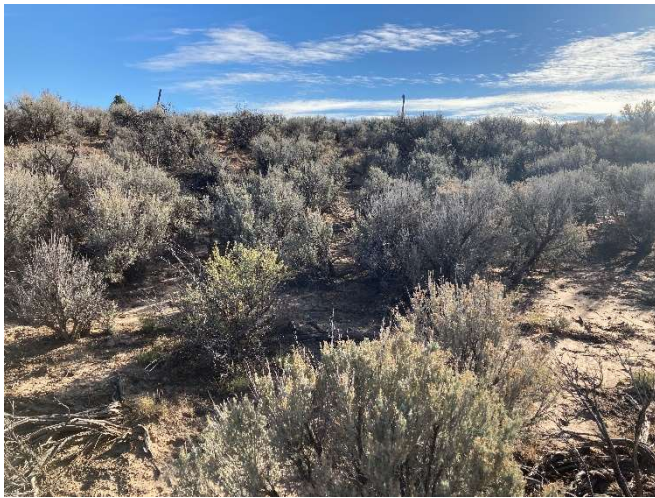
8. **SF8** This is a broad, shallow depression that is very similar in size to SF3 and possibly the initial expression of a subsidence feature.

**PHOTOGRAPH 9** Subsidence No. 8

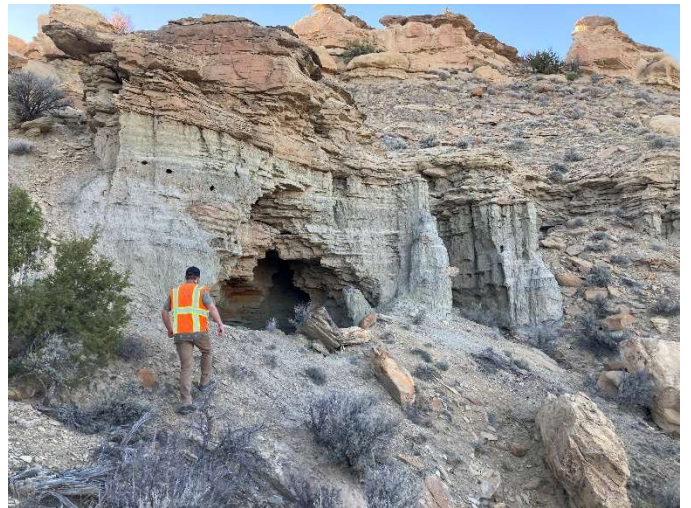
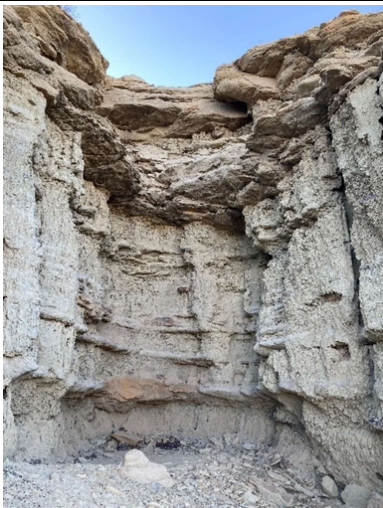
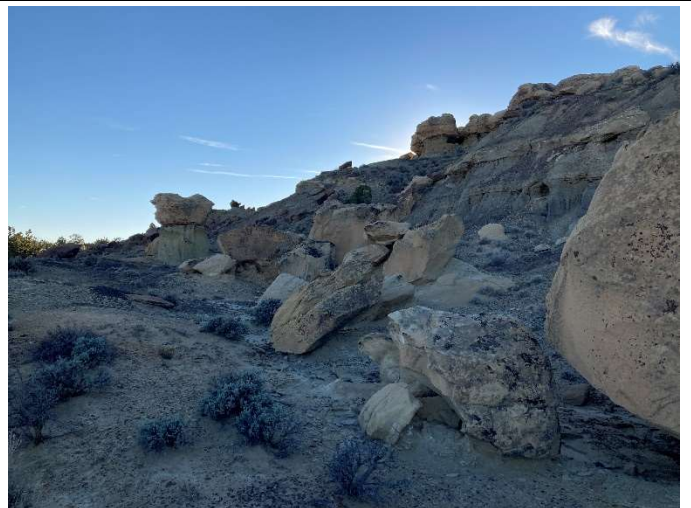
The O'Malley feature was visited and inspected in the afternoon of November 3, 2021. No thermal anomalies, odors, or gases were observed or detected, and the evidence suggests that it is a natural erosional feature. Photos 10, 11, and 12 in **Appendix A** show the highly erodible layer beneath a more competent sandstone layer. Natural contours funnel water through fractures in the overlying sandstone above and behind the main feature. With water entering the formation behind the face of the cliff, the resulting erosion has formed a cave like feature.

**PHOTOGRAPH 10** O'Malley feature

**PHOTOGRAPH 11** O'Malley feature

**PHOTOGRAPH 12** Erodible layer with sandstone cap
