# Photo Tour of the Gallup Mine Fires Mitigation Project

GALLUP, NEW MEXICO

# Enterprise Brown Mine Fire

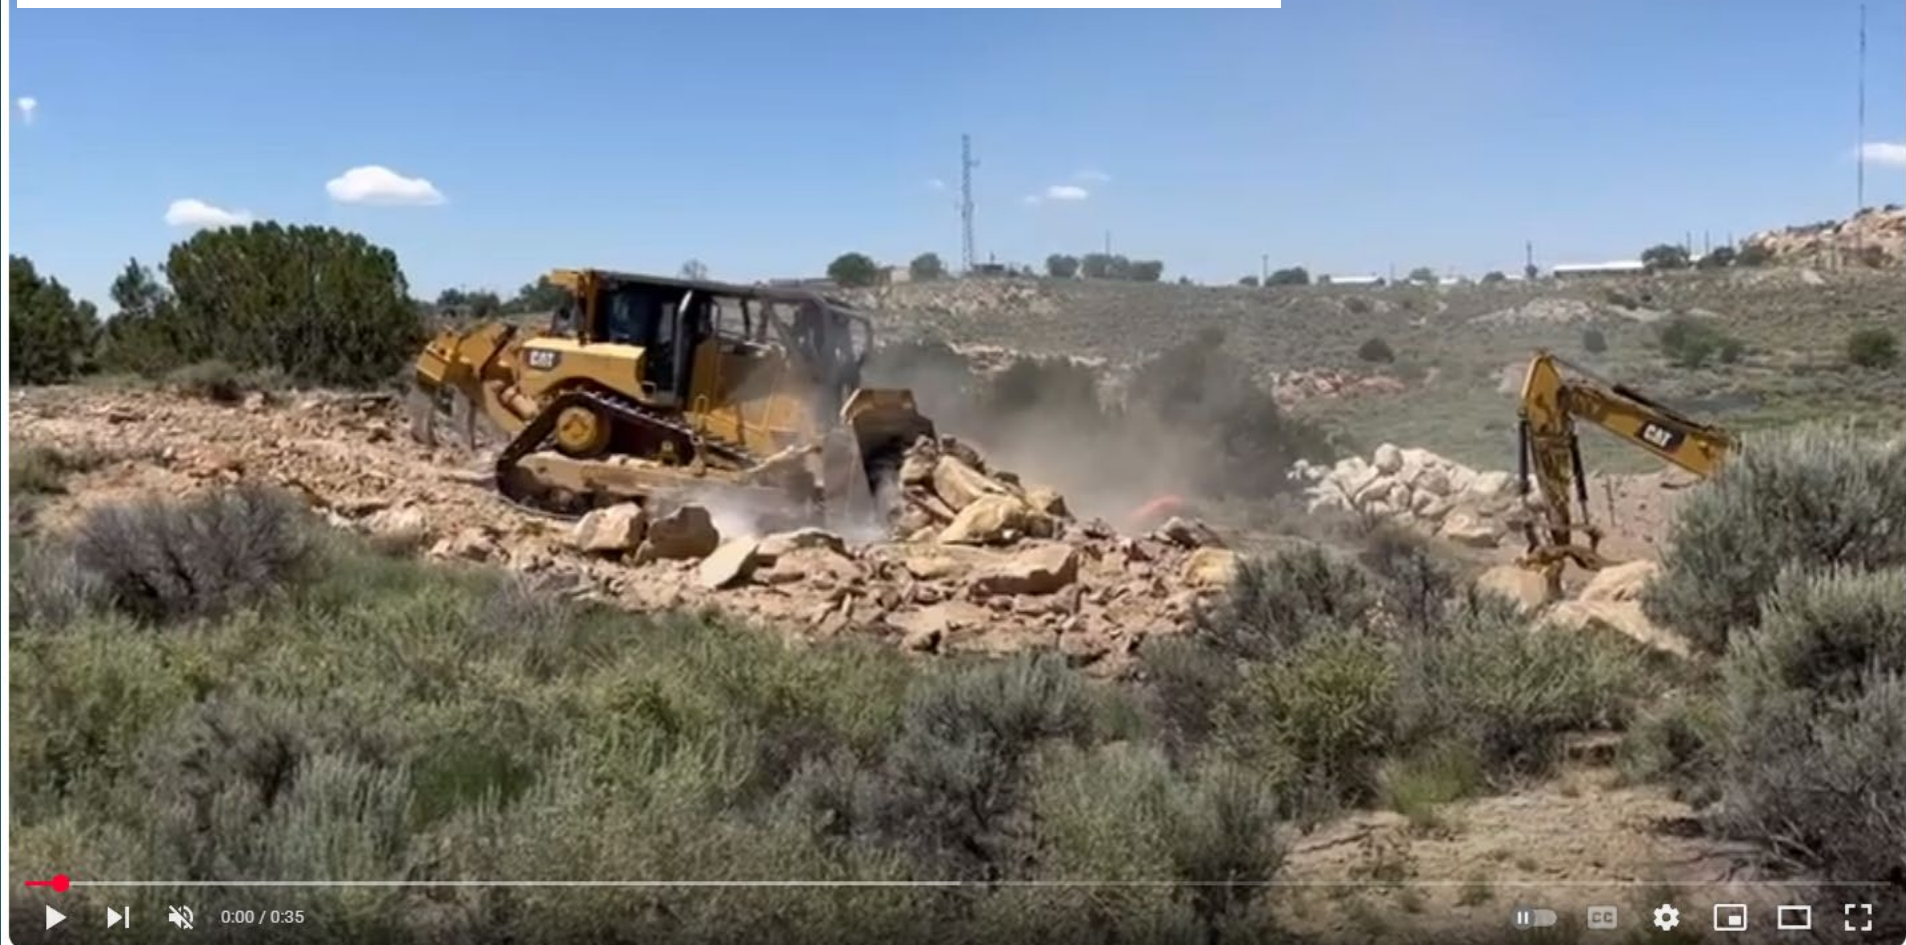
Due to the large sandstone cap above the fire, a D8 dozer was brought on site to assist in rock removal and expedite construction.

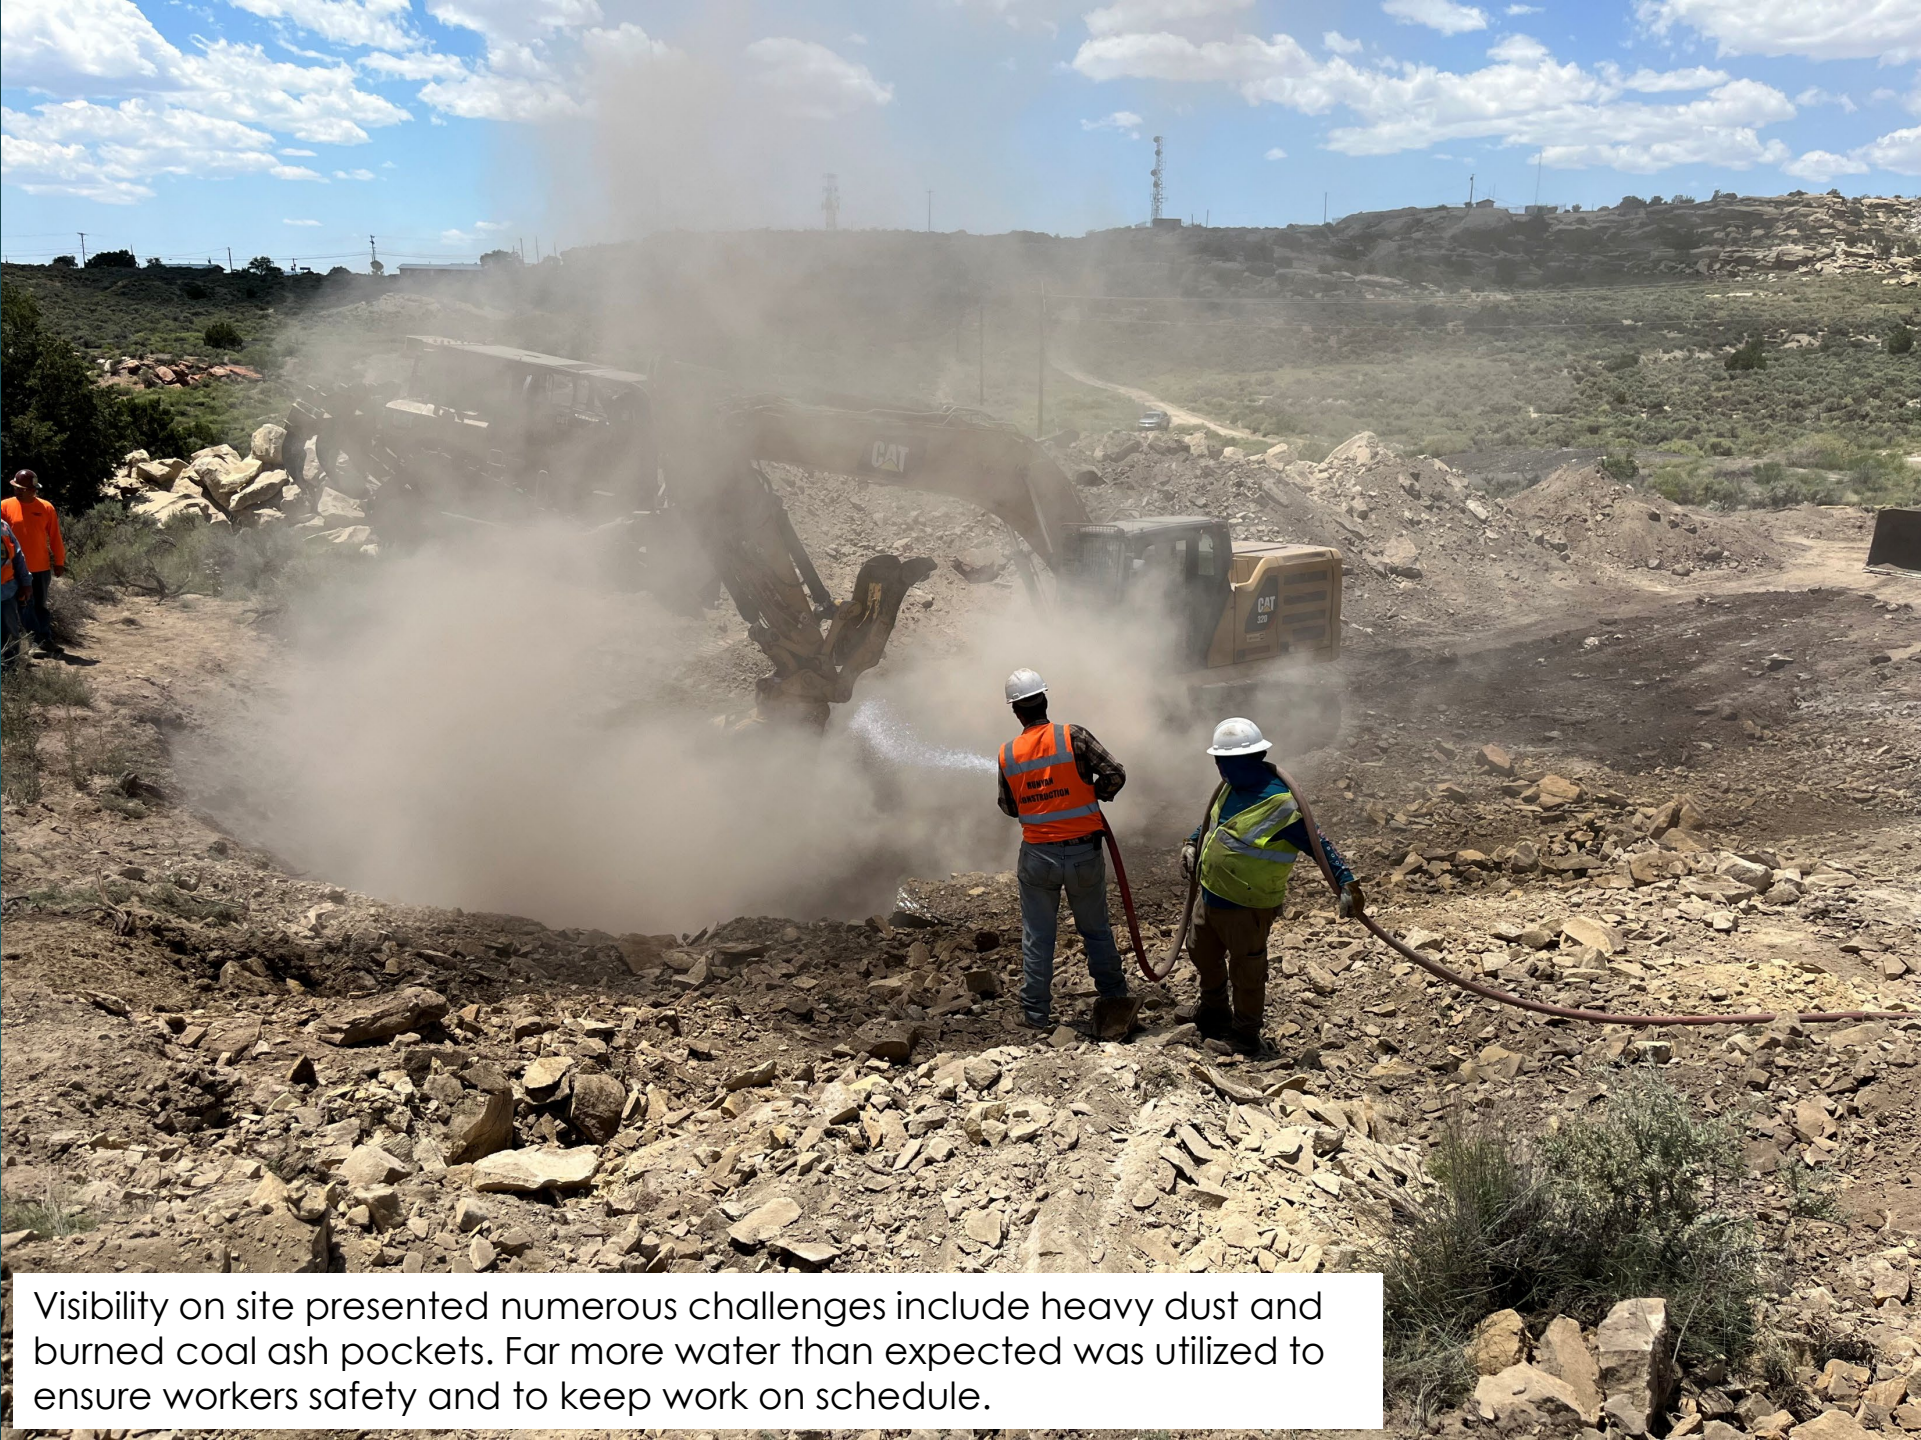
Visibility on site presented numerous challenges include heavy dust and burned coal ash pockets. Far more water than expected was utilized to ensure workers safety and to keep work on schedule.

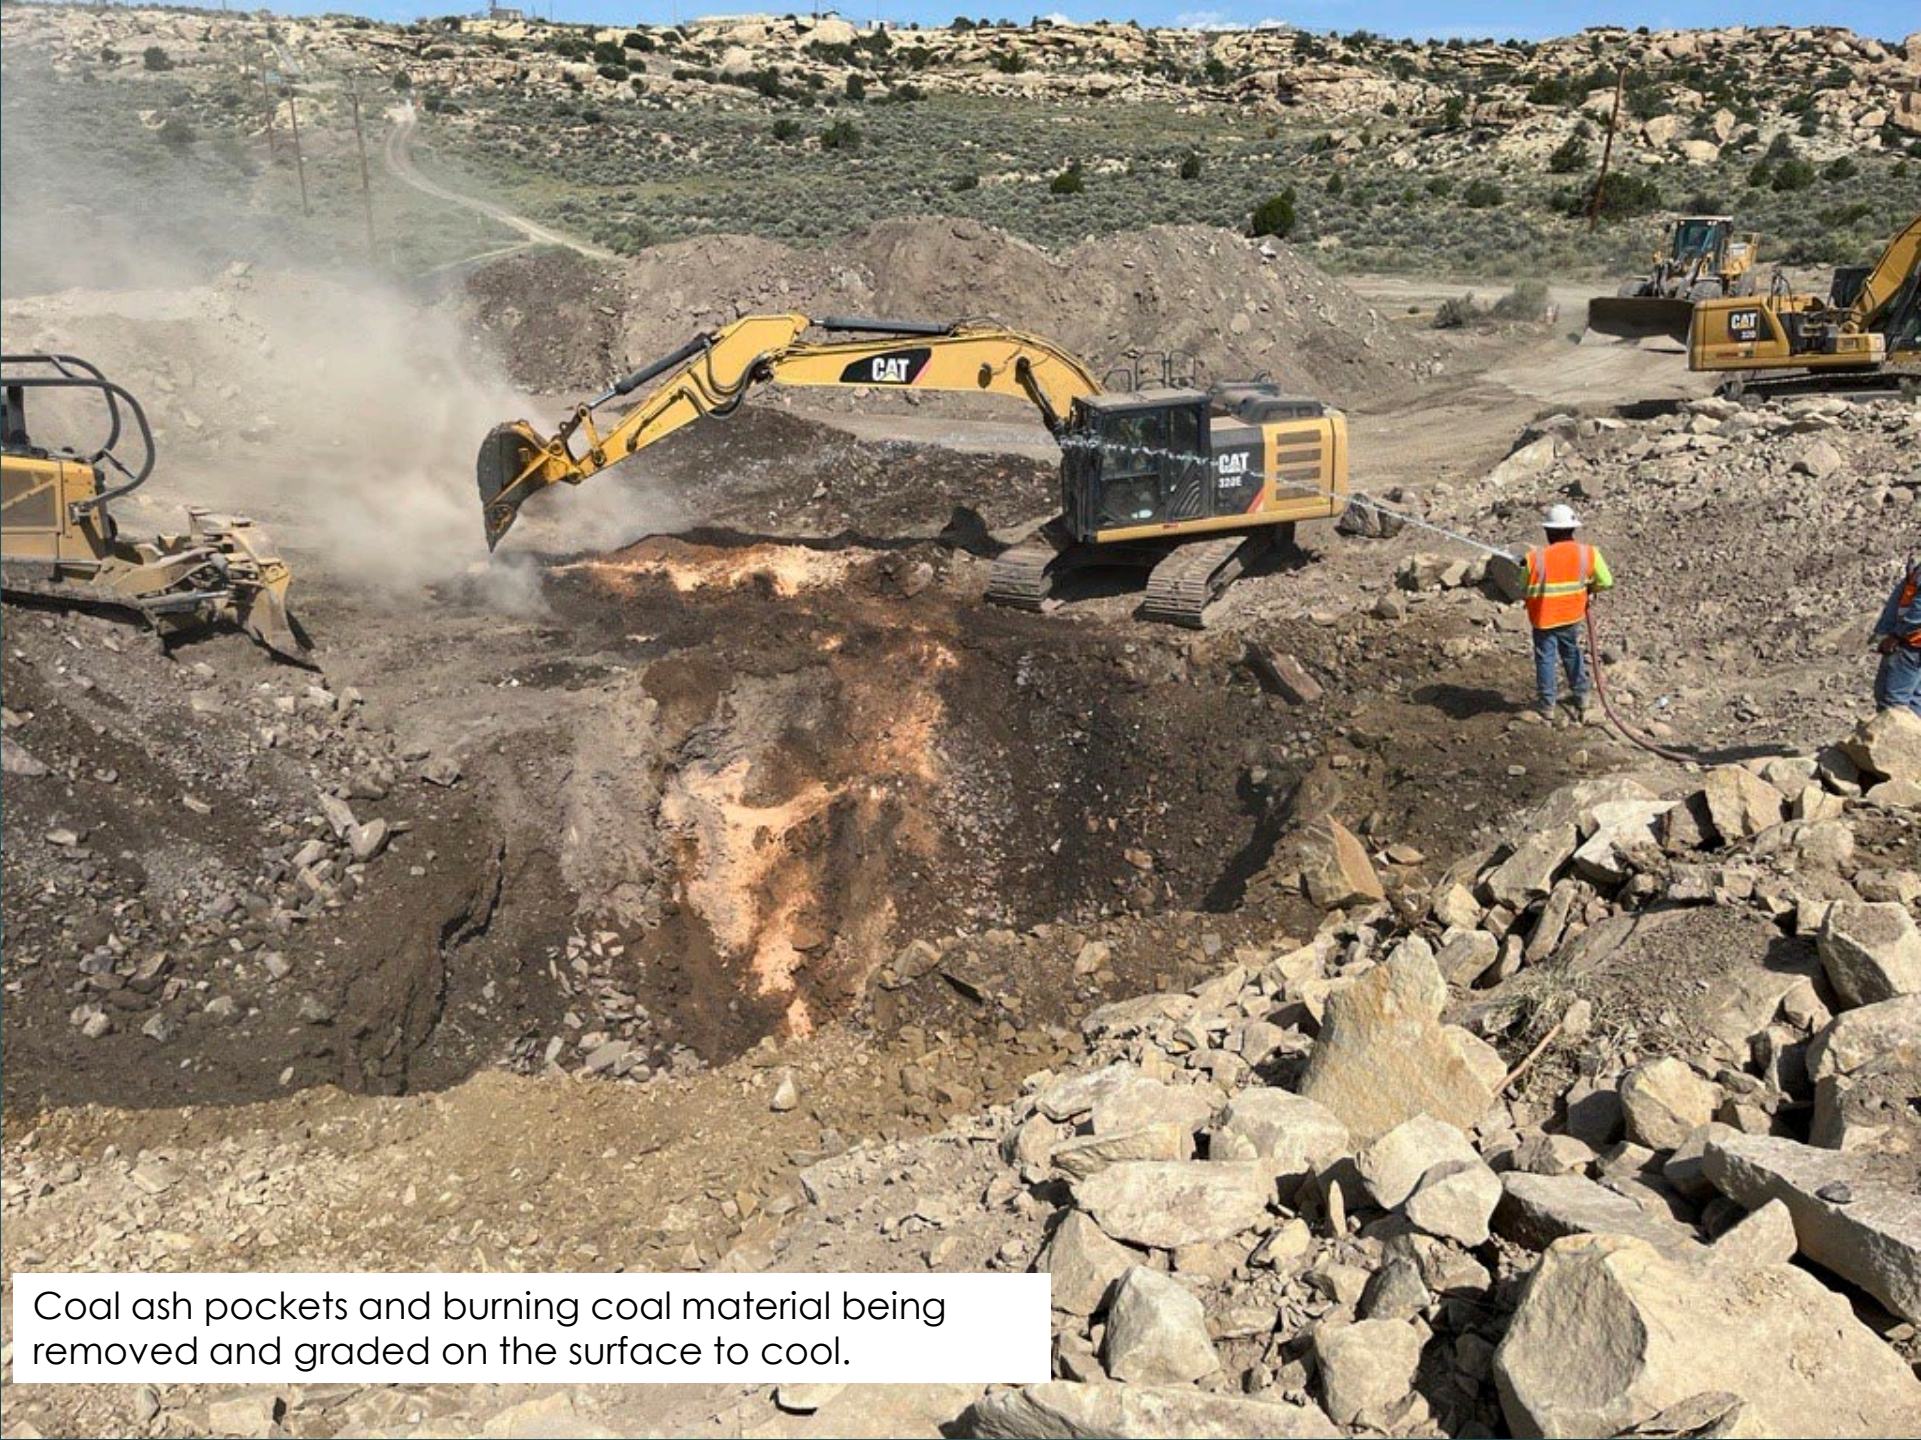
Coal ash pockets and burning coal material being removed and graded on the surface to cool.

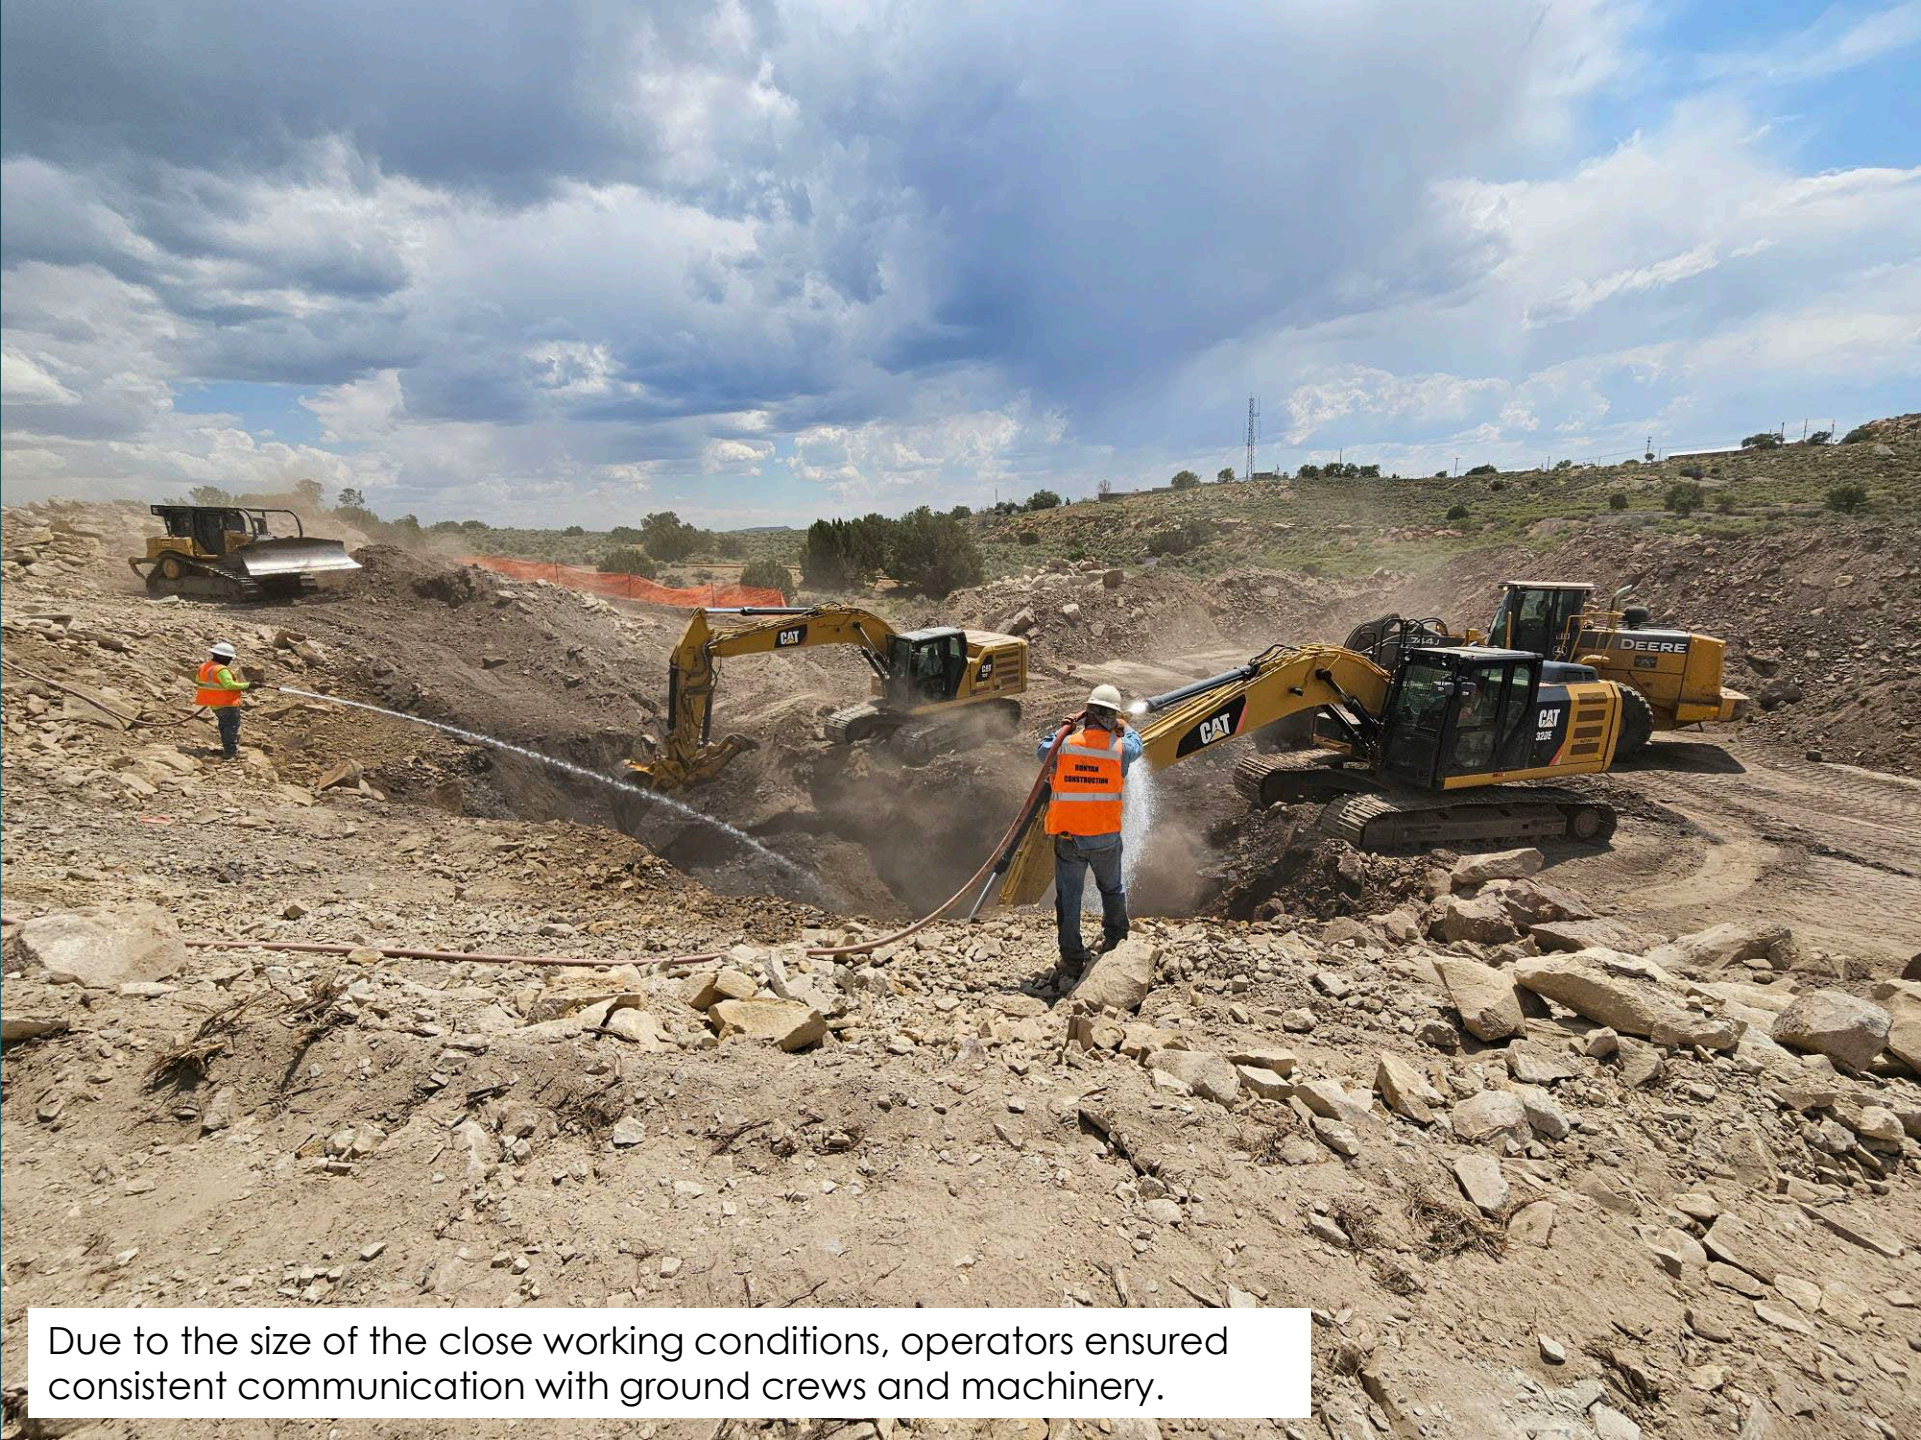
Due to the size of the close working conditions, operators ensured consistent communication with ground crews and machinery.

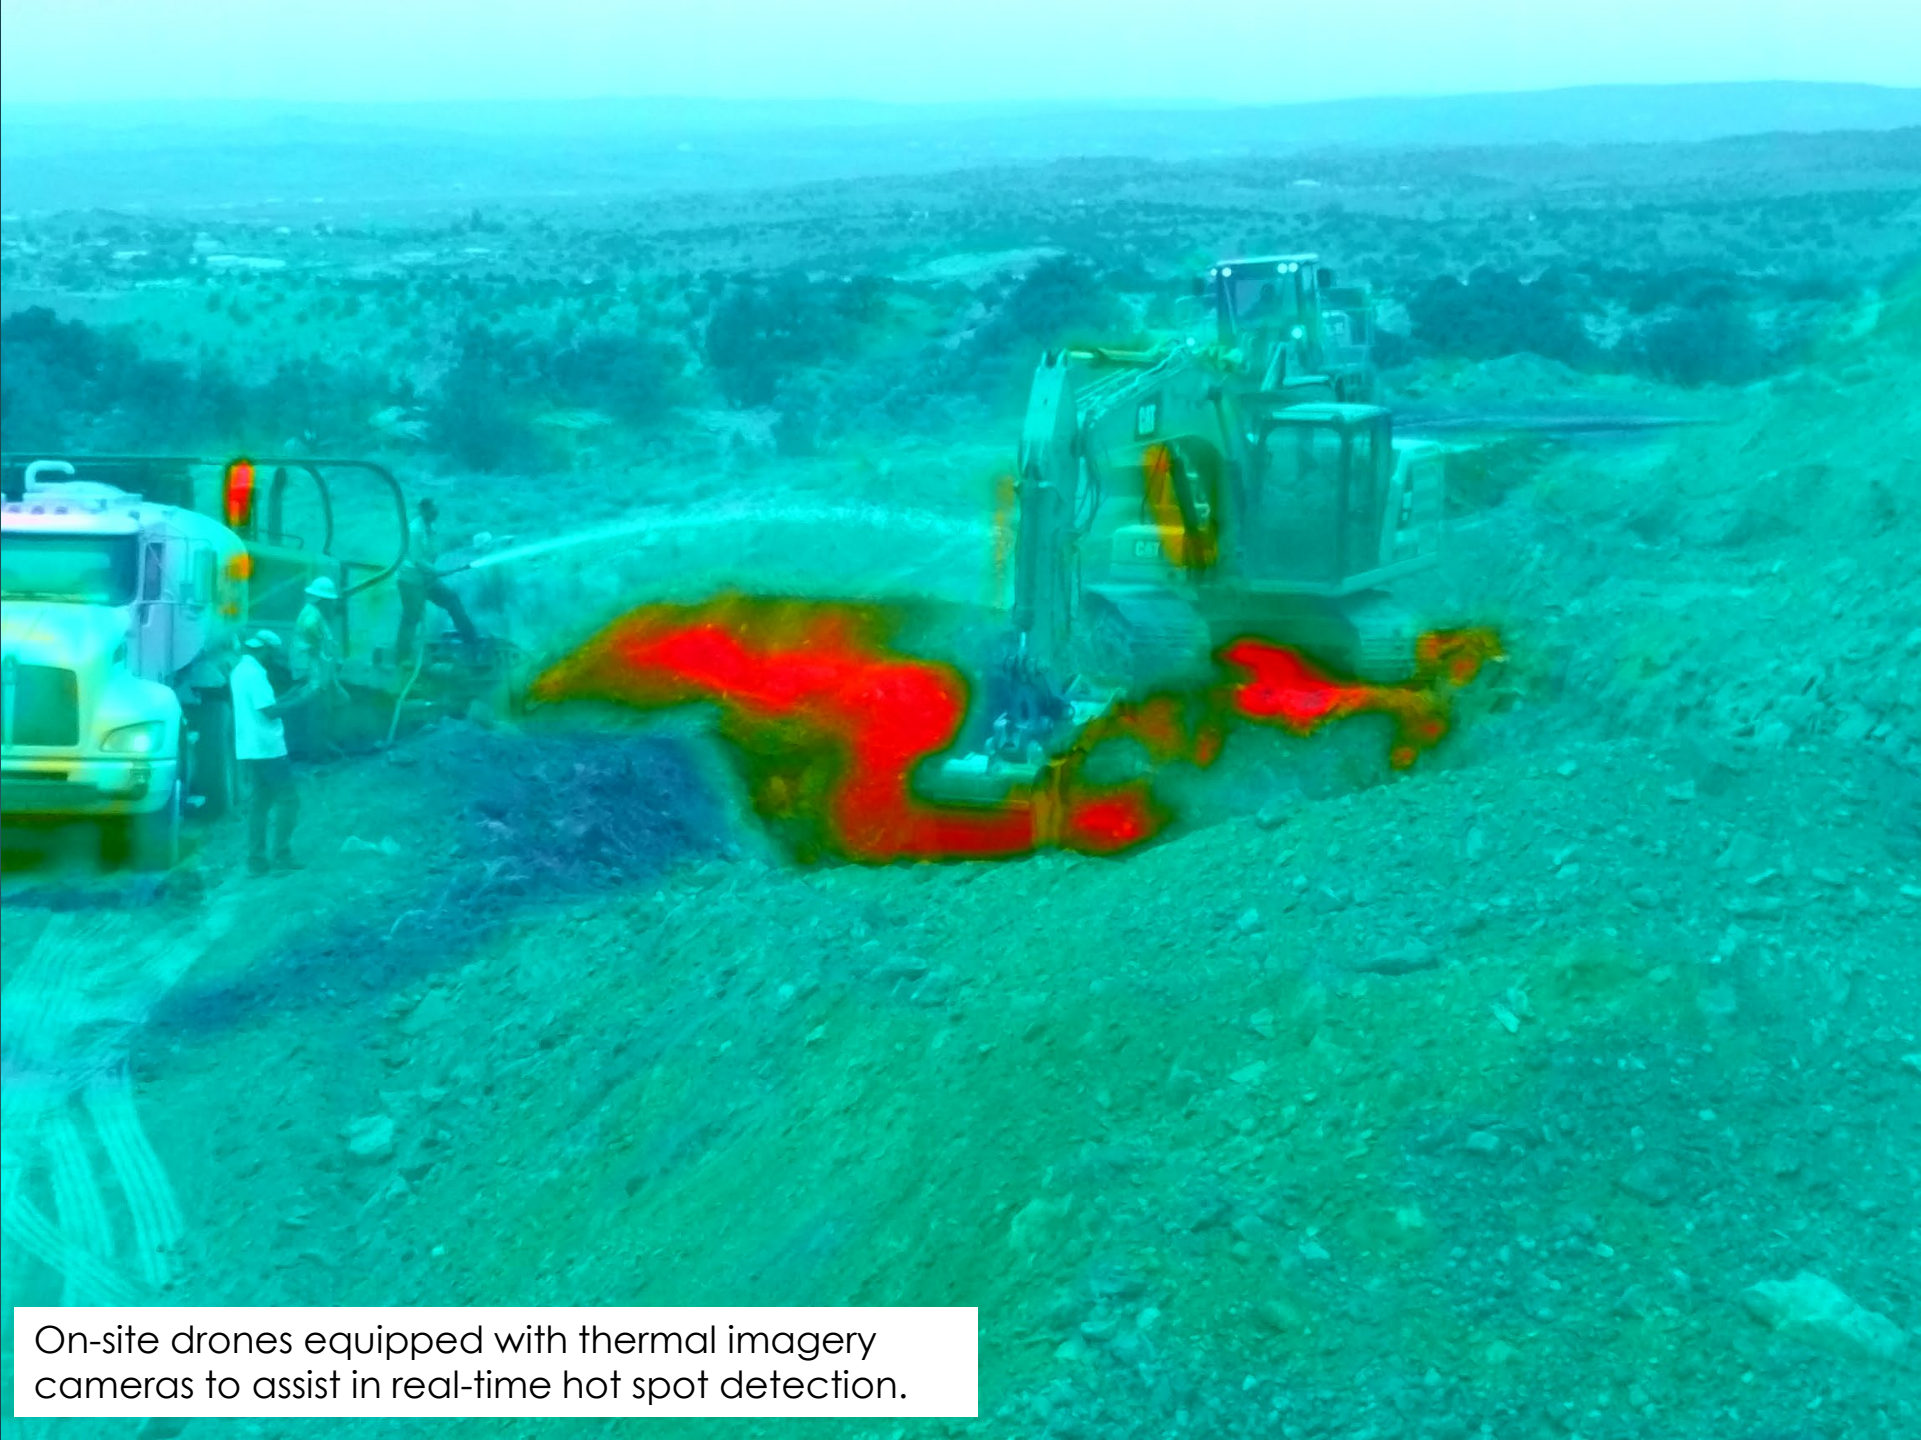
On-site drones equipped with thermal imagery cameras to assist in real-time hot spot detection.

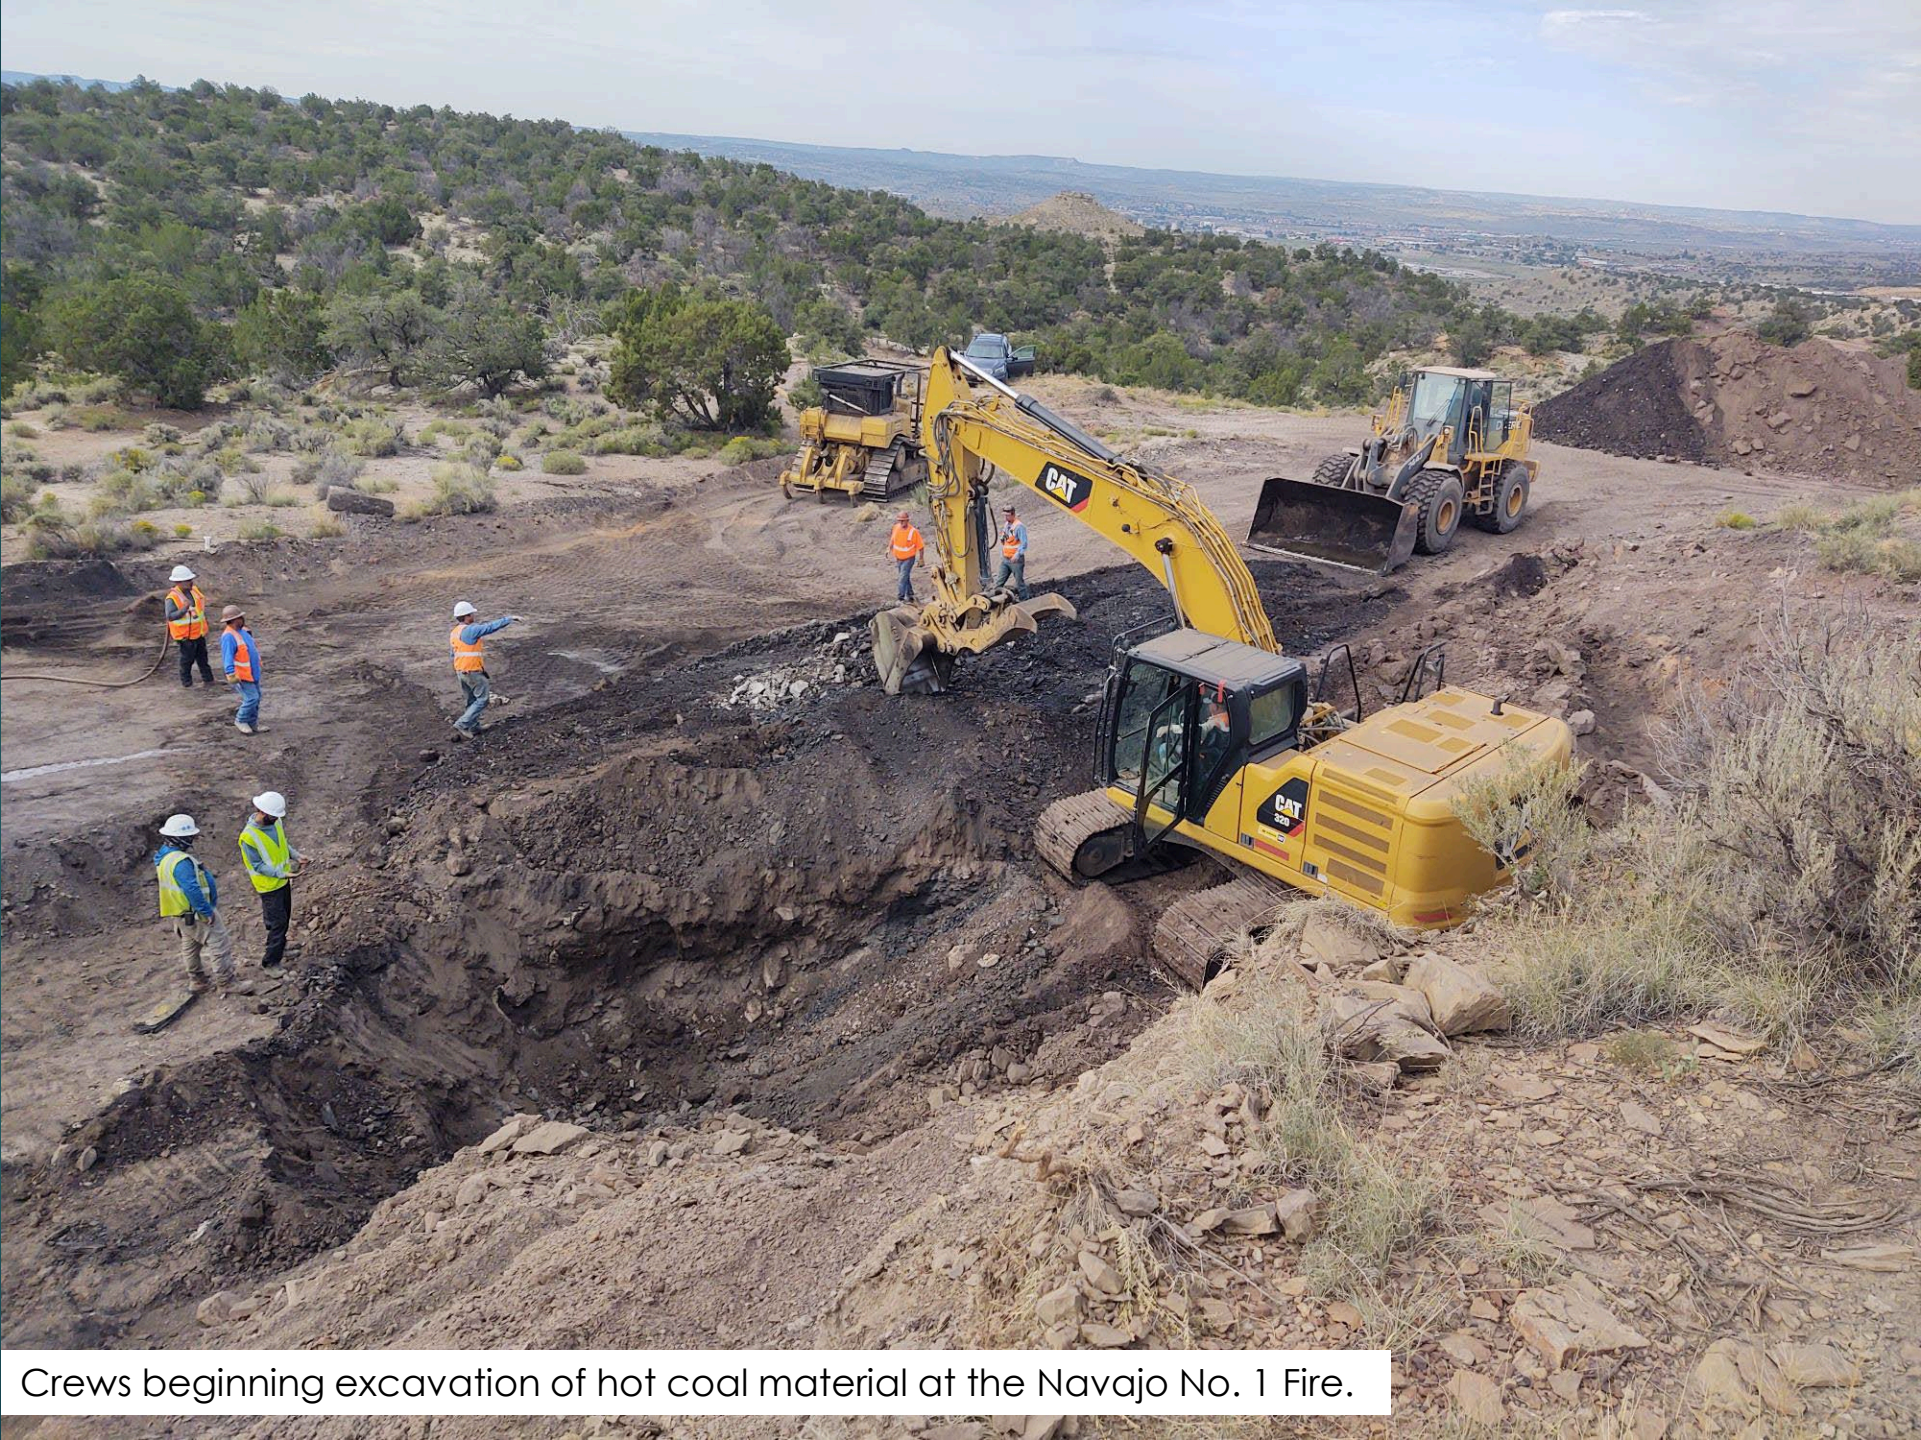
Crews beginning excavation of hot coal material at the Navajo No. 1 Fire.

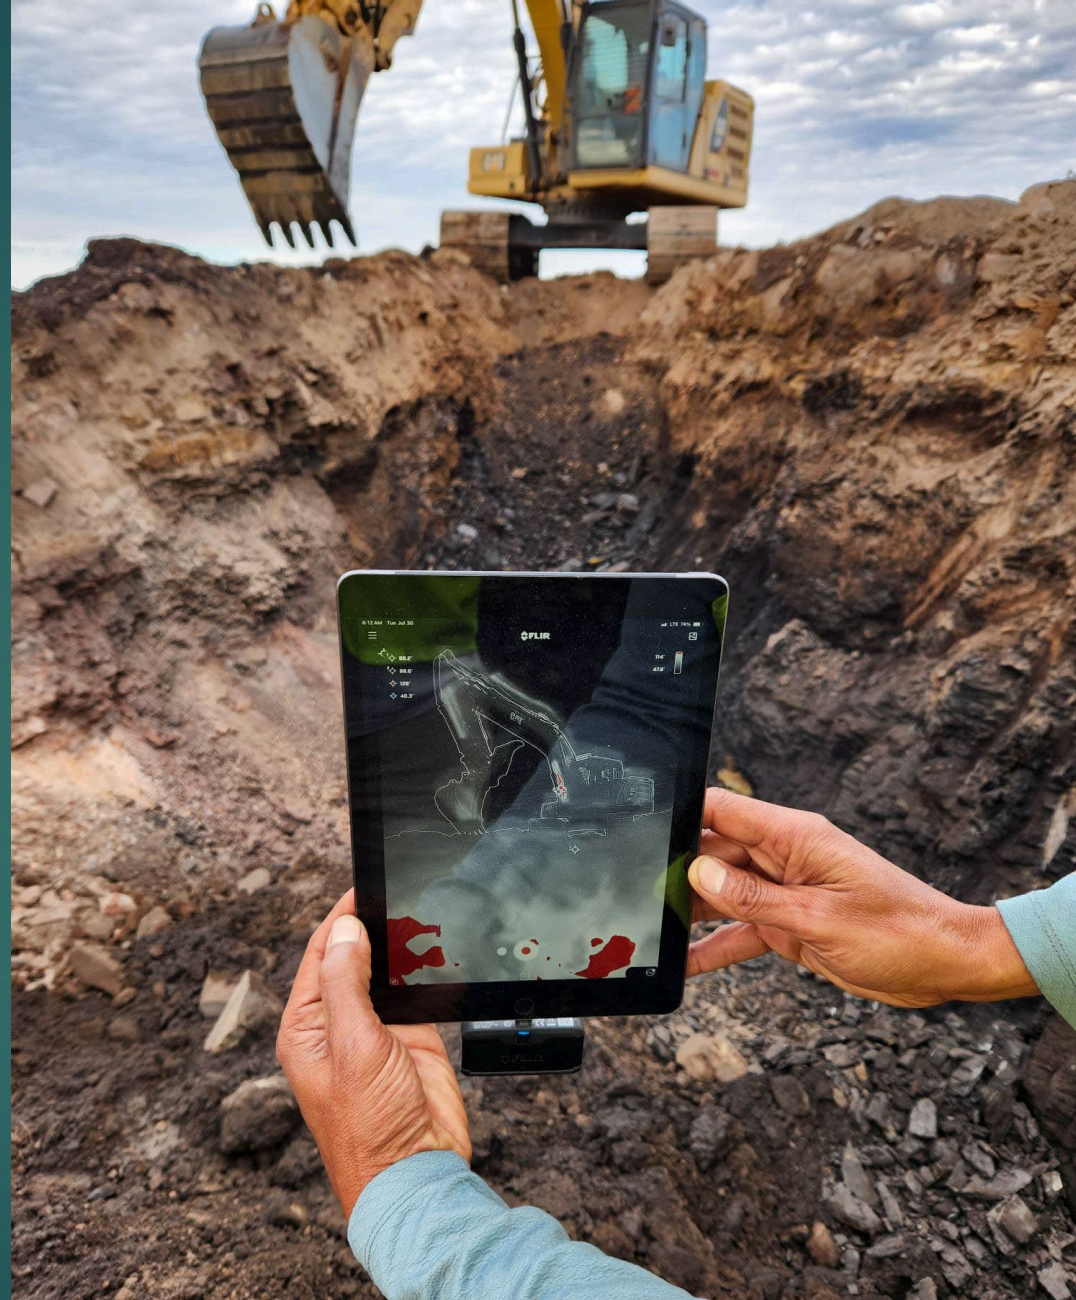
The NM AML Program utilized iPad thermal camera adapters and drones to identify hot spots while excavating.

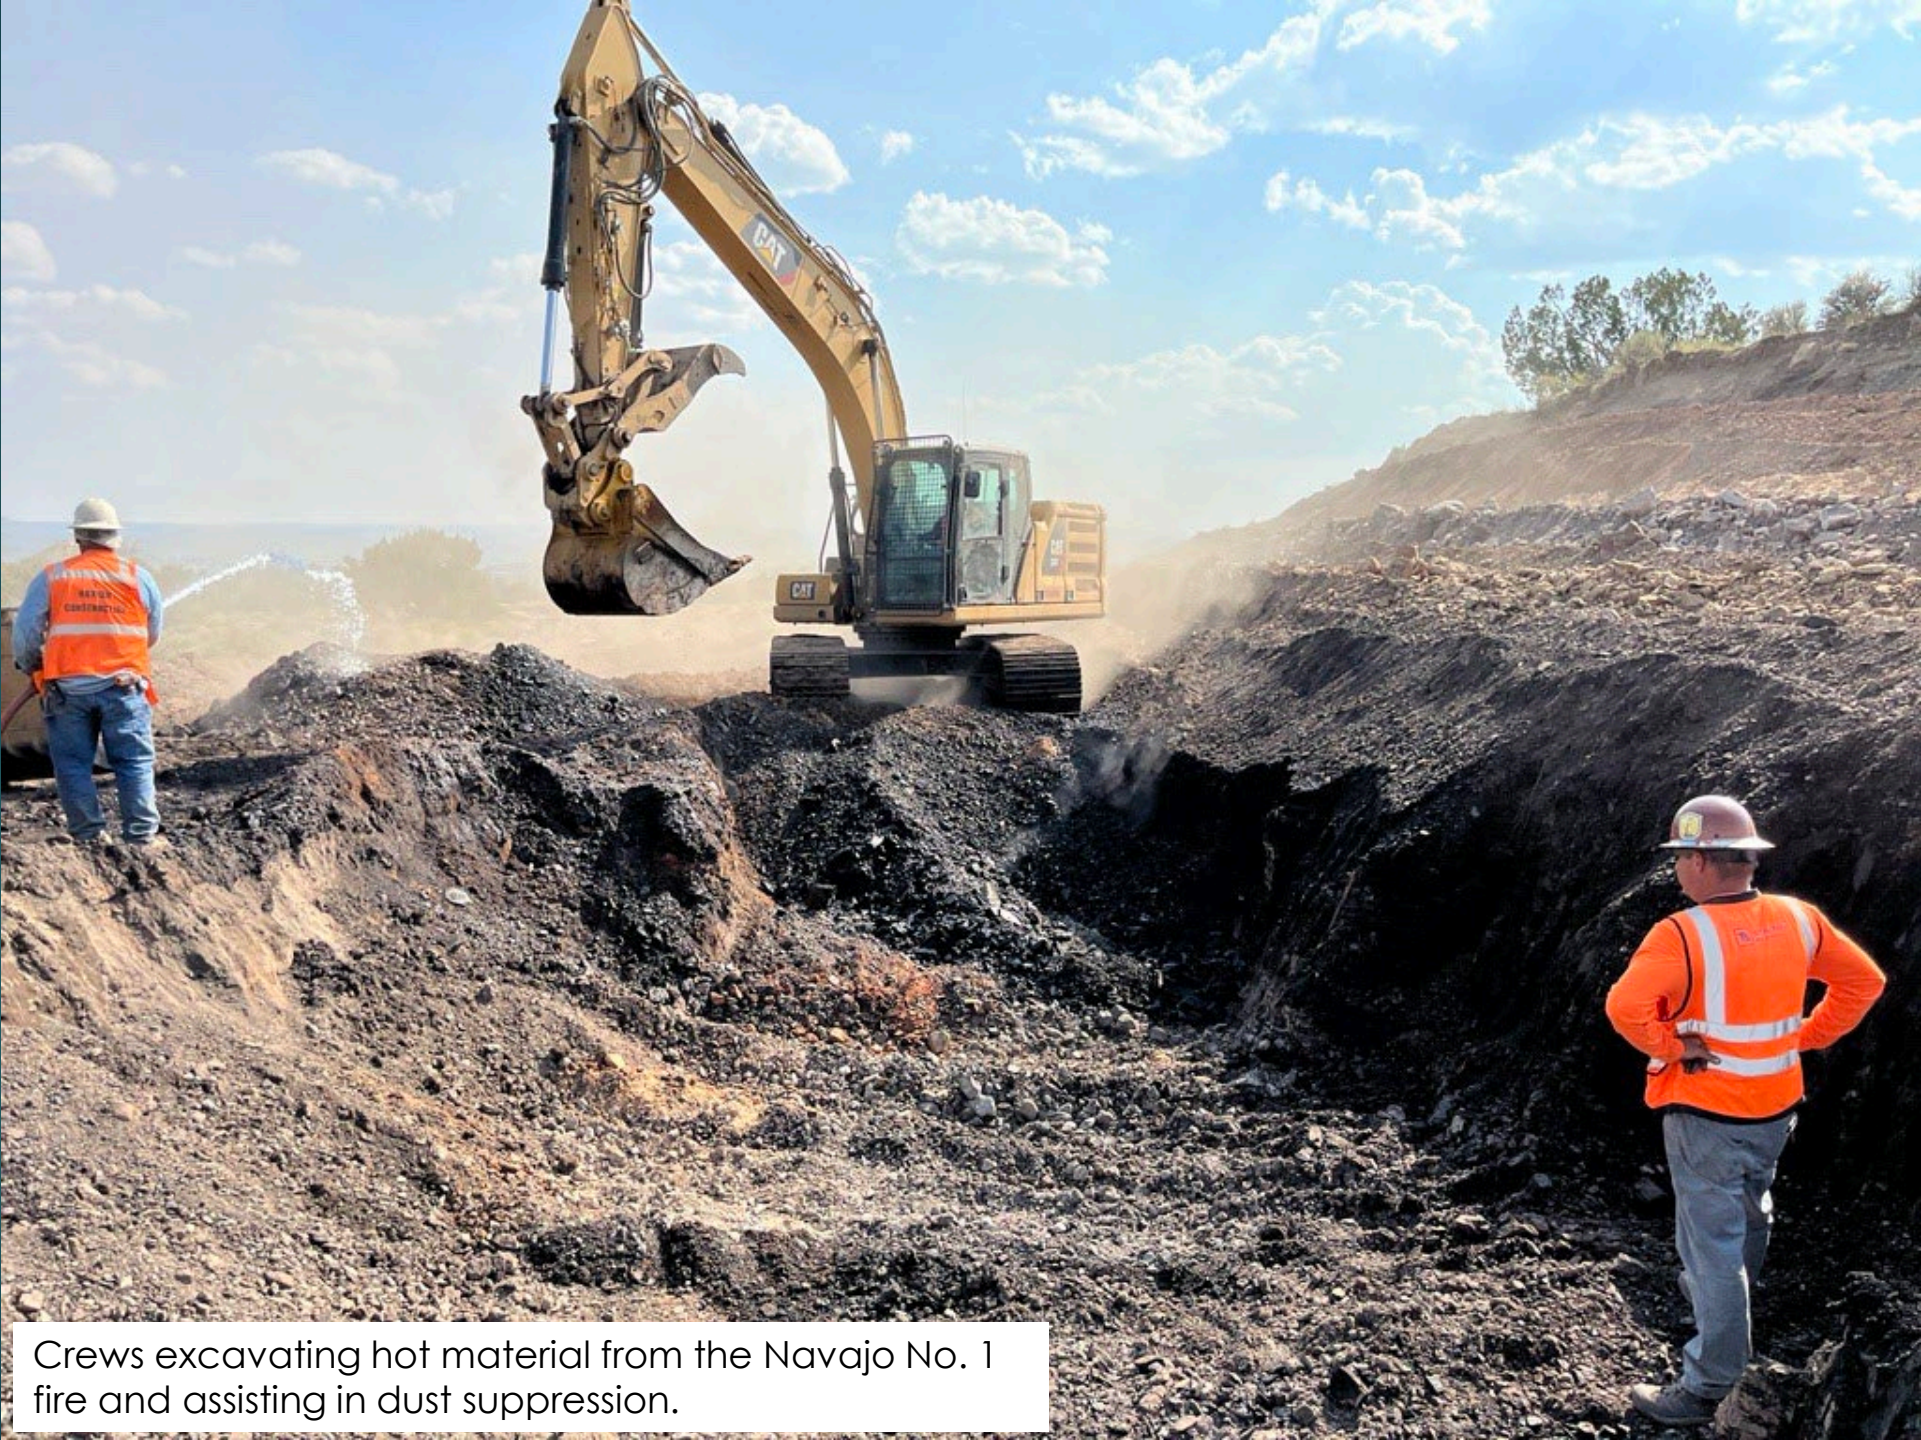
Crews excavating hot material from the Navajo No. 1 fire and assisting in dust suppression.

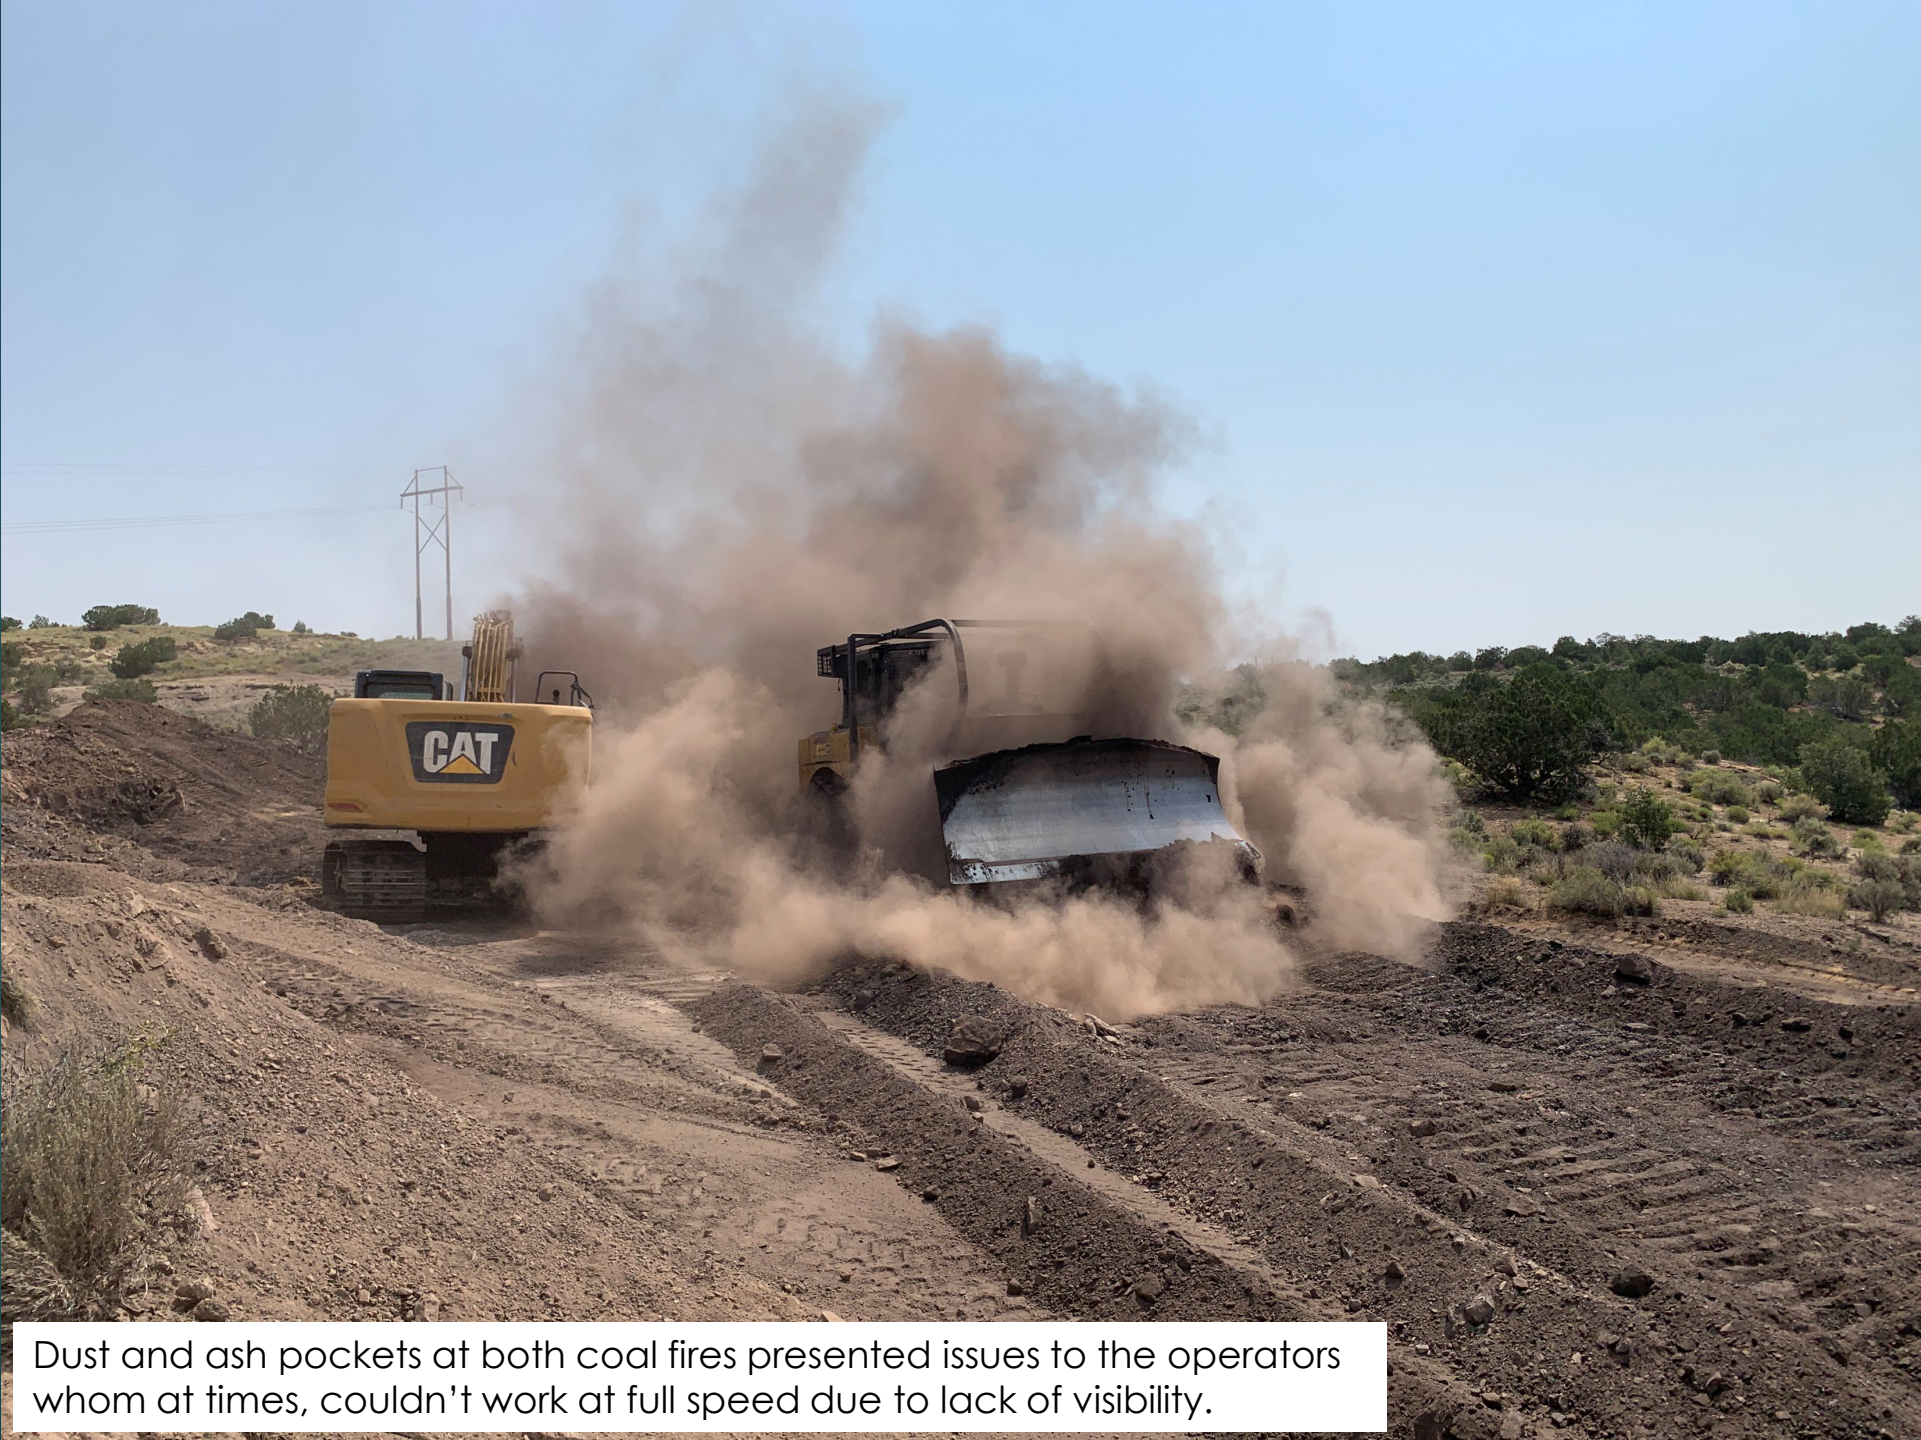
Dust and ash pockets at both coal fires presented issues to the operators whom at times, couldn't work at full speed due to lack of visibility.
