July 17, 2026

Clint Chisler  
Senior Reclamation Specialist  
NM EMNRD Mining and Minerals Division  
Mining Act Reclamation Program  
Wendell Chino Building  
1220 S. St. Francis Dr.  
Santa Fe, New Mexico 87505

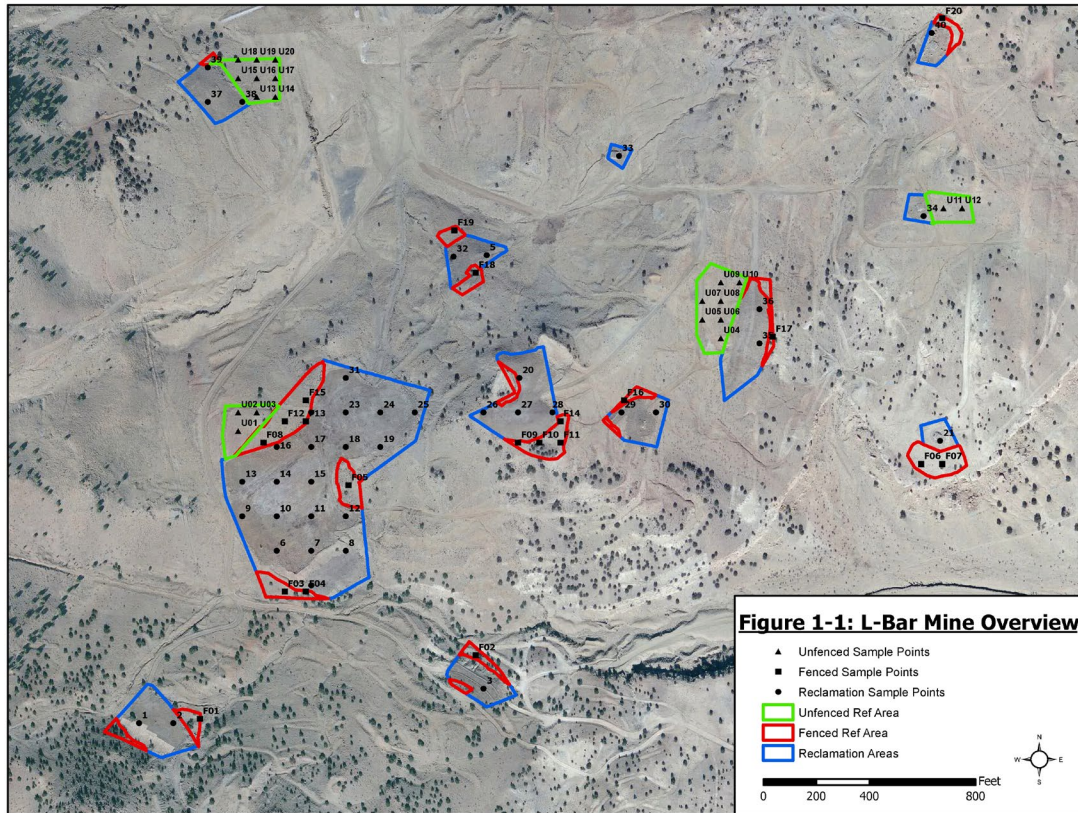
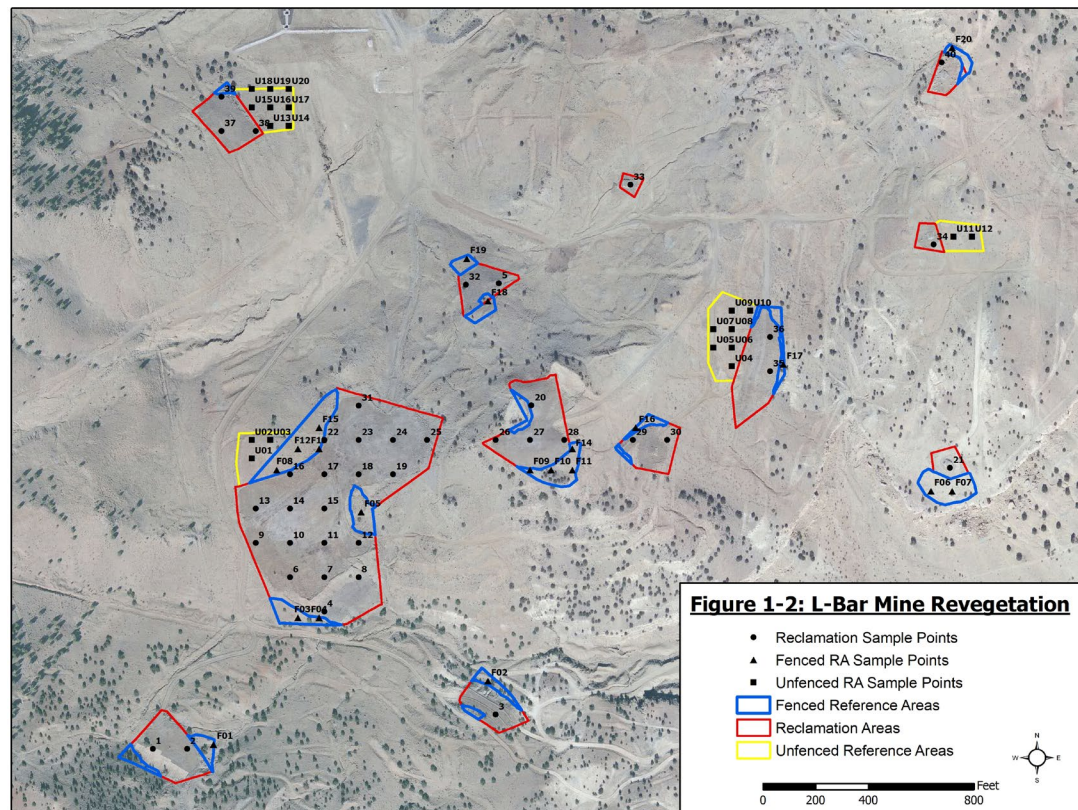
**Figure 1-1 and Figure 1-2** display the extent of the reclamation areas and the Year 14 and 15 sample point locations, as well as the fenced and unfenced reference areas on the Site. All raw data supplementing the information in this report can be found in **Appendix A**.

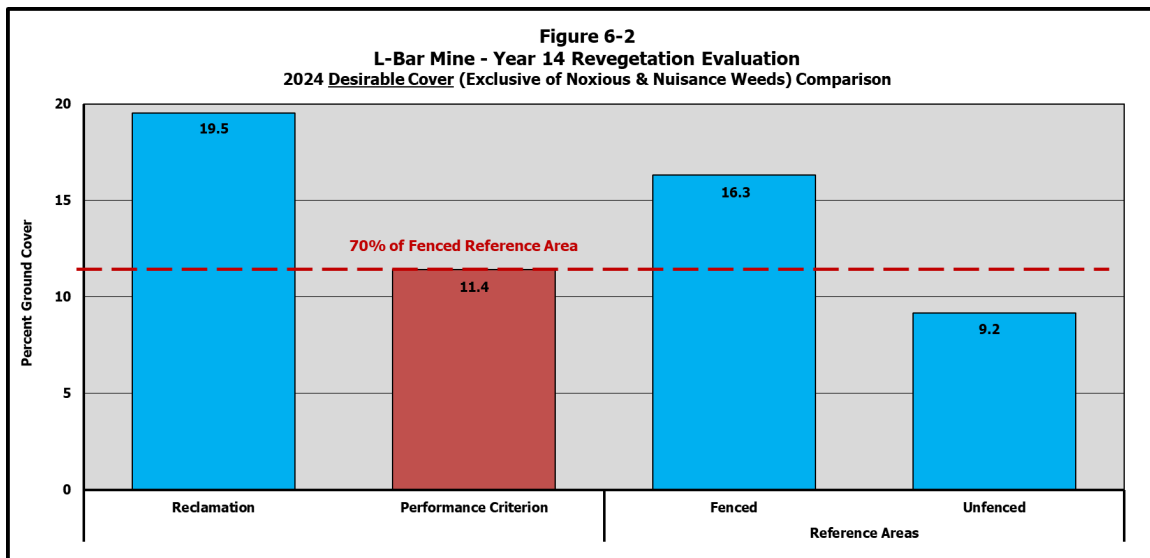
The woody plant density from the reclamation unit compared with the fenced and unfenced reference areas is shown on **Figure 6-3**, excluding non-qualifying sub-shrubs and succulents that do not contribute to the success standard. The qualifying woody plant density on the reclamation (1053 full shrubs and trees per acre) well exceeds the success criterion for 2024 of 115 full shrubs and trees per acre (60% of the 192 full shrubs and trees per acre found on the fenced reference area). A mathematical comparison is suitable to demonstrate success.

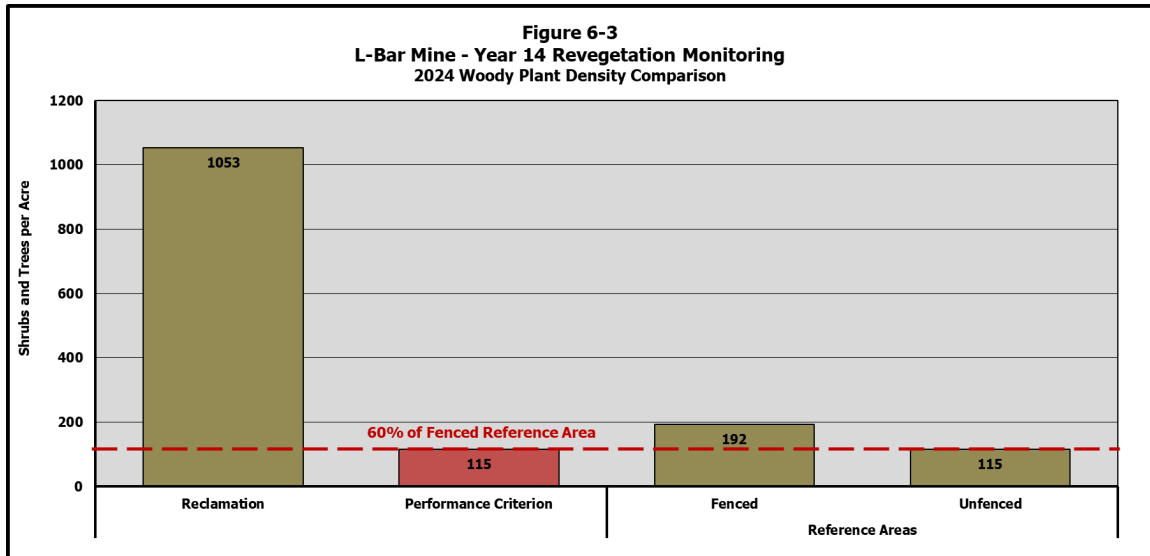
**Figure 6-4** displays the species diversity results from the reclamation compared with the fenced and unfenced reference areas. The number of important species ( $\geq 1\%$  average cover) on the reclamation was three, comprised of two grasses and one shrub. Year 14 results from the reclamation exceed the required one important species, based on 50% of the two important species from the fenced reference area. A mathematical comparison is suitable to demonstrate success.

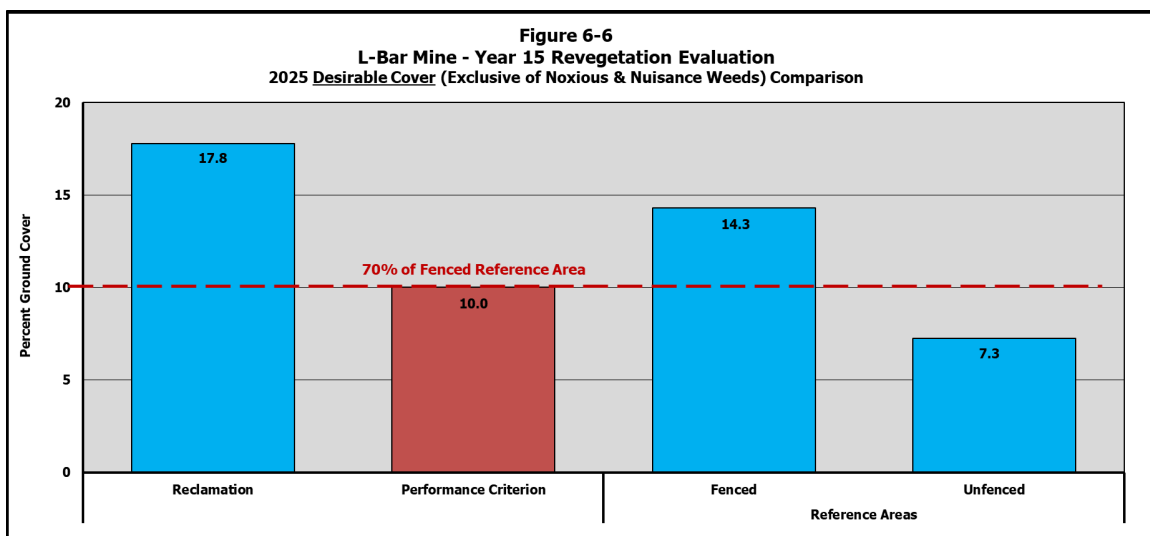
The woody plant density from the reclamation unit compared with the fenced and unfenced reference areas is shown on **Figure 6-7**, excluding non-qualifying sub-shrubs and succulents that do not contribute to the success standard. The qualifying woody plant density on the reclamation (925 full shrubs and trees per acre) well exceeds the success criterion for 2025 of 185 full shrubs and trees per acre (60% of the 308 full shrubs and trees per acre found on the fenced reference area). A mathematical comparison is suitable to demonstrate success.

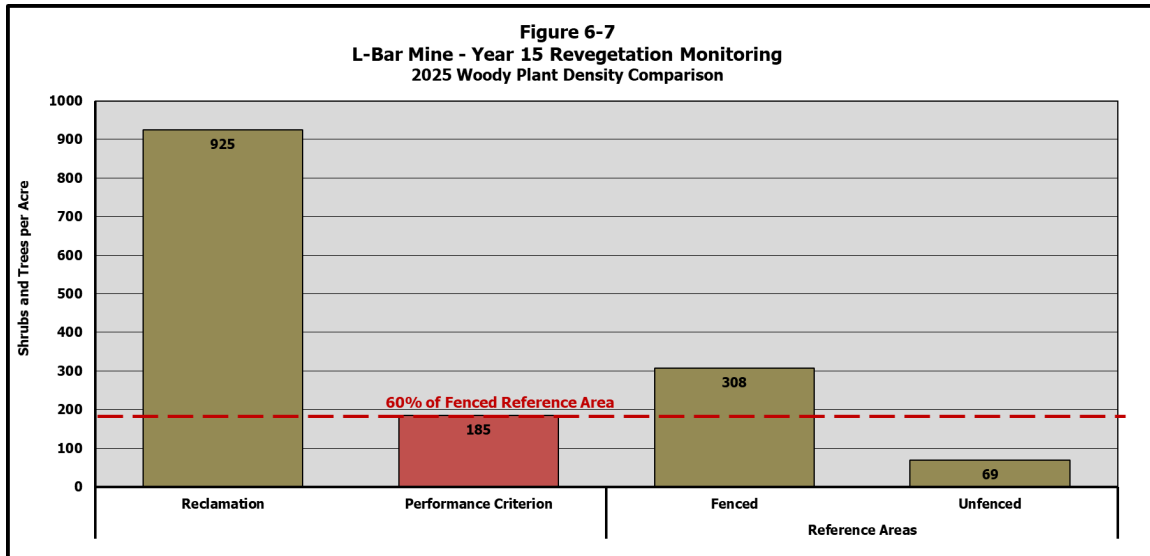
**Figure 6-8** displays the species diversity results from the reclamation compared with the fenced and unfenced reference areas. The number of important species ( $\geq 1\%$  average cover) on the reclamation was four, comprised of three grasses and one shrub. Year 15 results from the reclamation exceed the required three important species, based on 50% of the five important species from the fenced reference area. A mathematical comparison is suitable to demonstrate success.

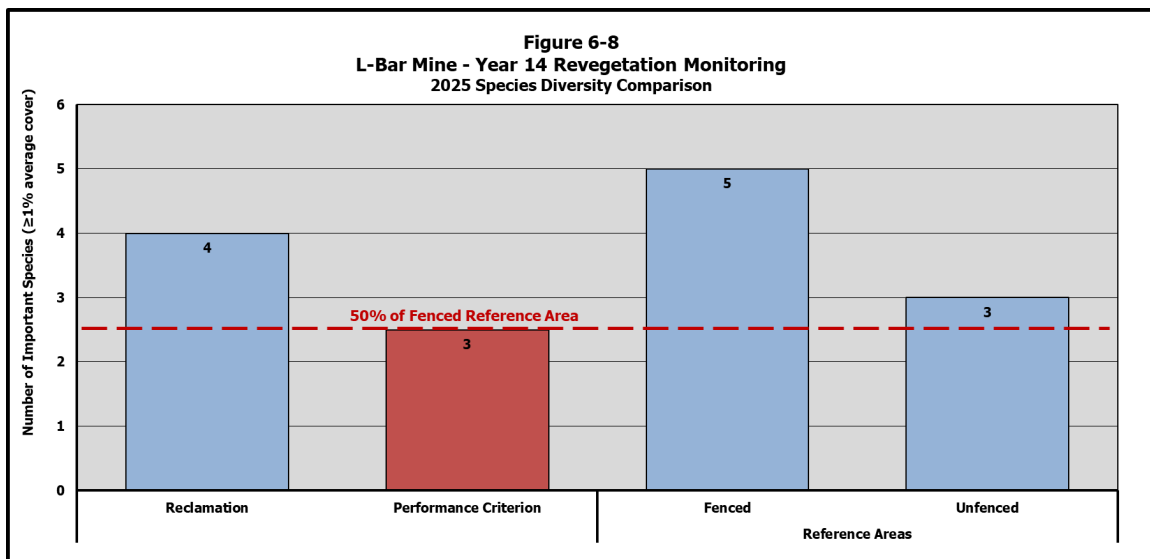
The vegetation in the reclamation area exceeded all four applicable standards in Year 15 including perennial cover, desirable cover, woody plant density, and species diversity.

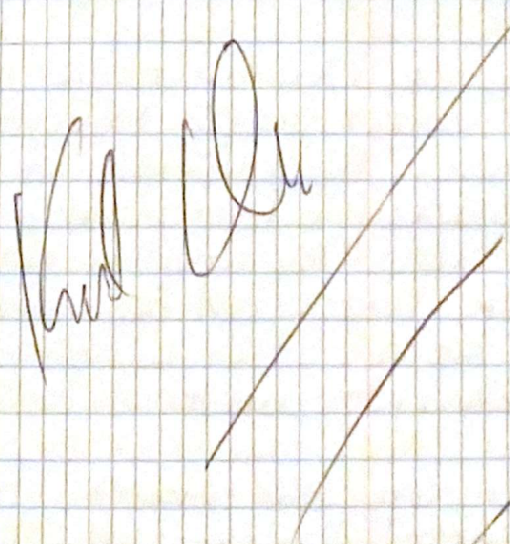
11/4/24 Id Mine Reclamation/Repair Erosion

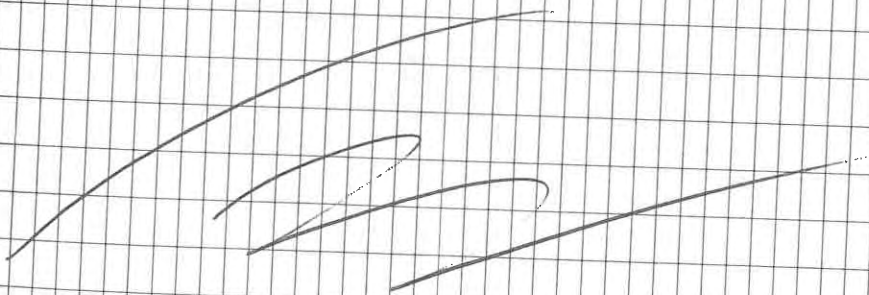
11/5/24 JJ Mine Reclamation / Repair Erosion mp  
0650 INTERA (M. R. Her) on-site. Enviroworks (EW)  
& RioTinto (RT) on-site.

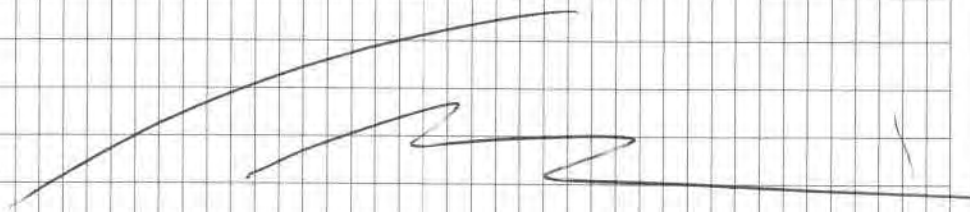
**DAILY FIELD LOG**  
**JJ No.1 / L-Bar**  
 Mine Site Closure Reclamation Repair / Erosion Mitigation

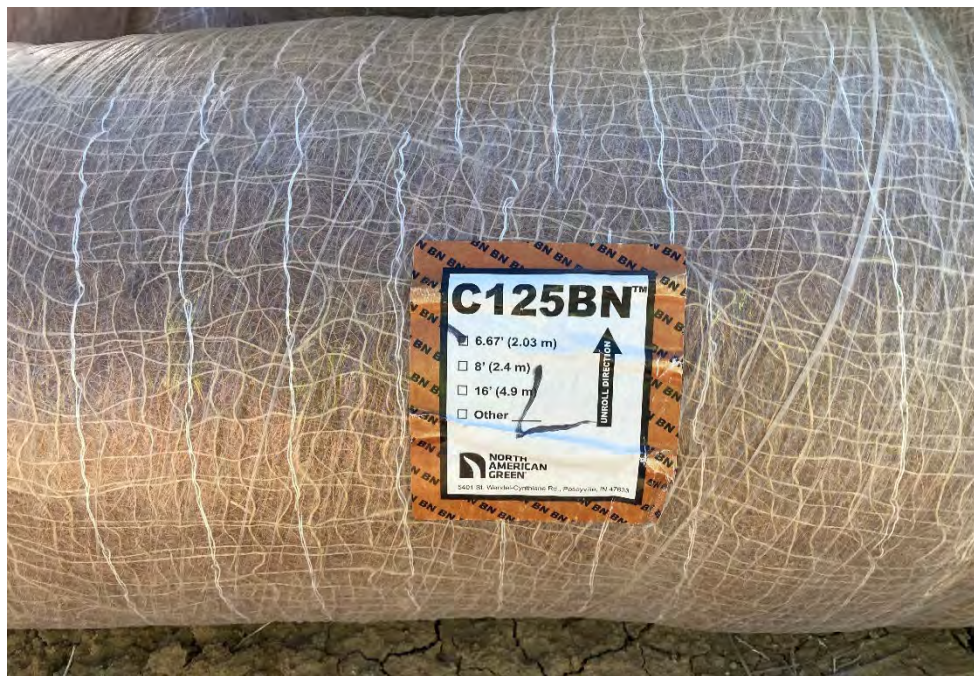
Photograph 2. Photo of the long-term, double-net, coconut matrix, biodegradable erosion control matting, BioNet® C125BN™, placed on the areas requiring reseeding. Supplied by North American Green / Western Green.

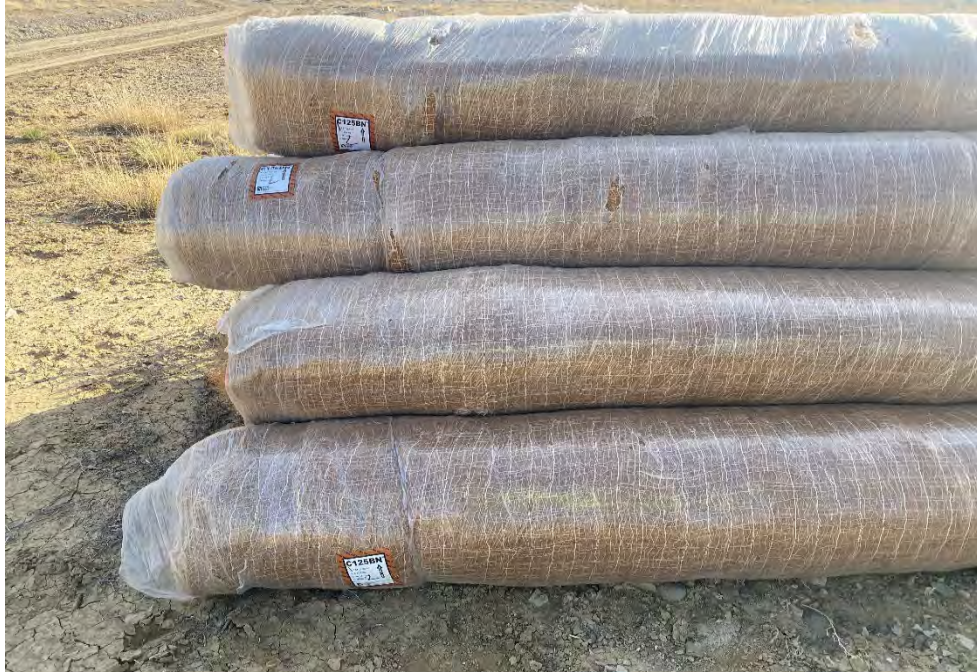
Photograph 3. BioNet® C125BN™, in the staging area. Supplied by North American Green / Western Green.

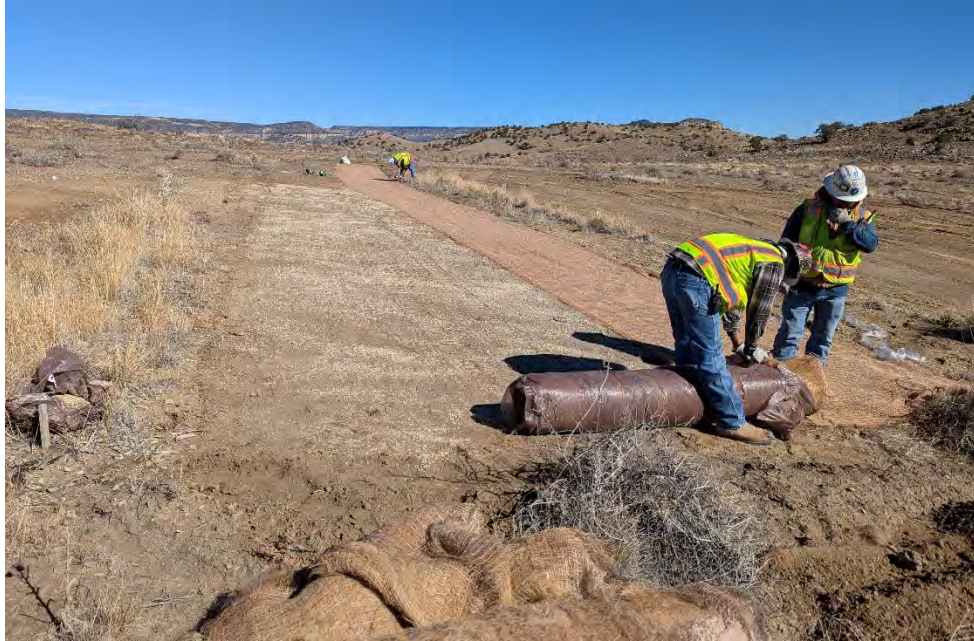
Photograph 16. View of biodegradable erosion control matting installation on prepared subgrade/surface, following broadcast seed application. Established vegetation was left in place (11-05-2024).

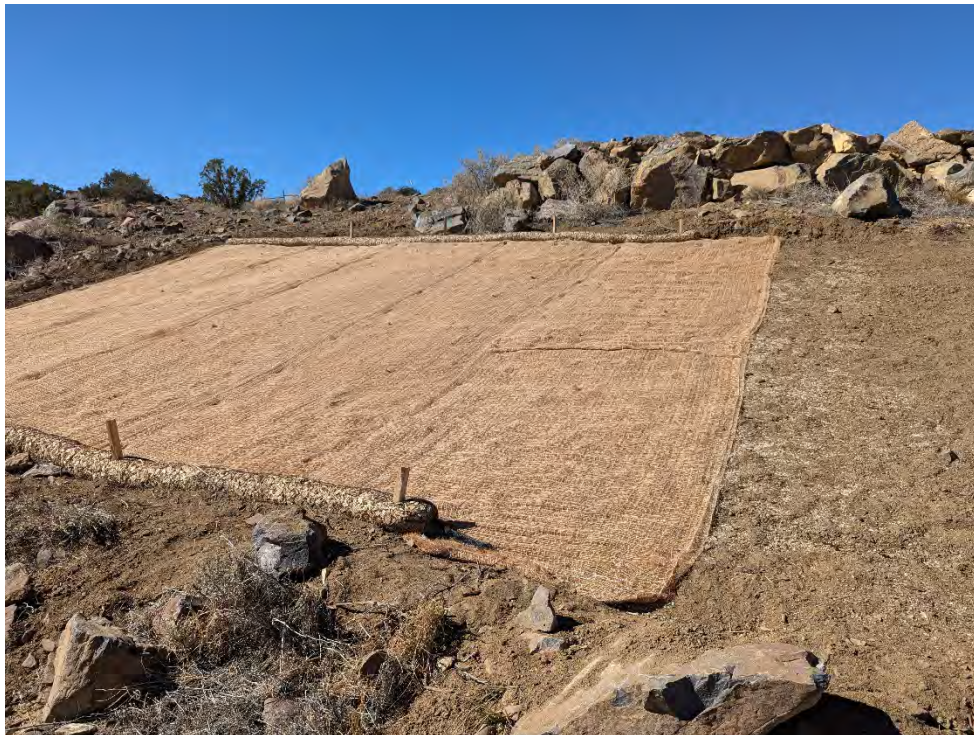
Photograph 17. View of biodegradable erosion control blanket and Eco Log, as installed down slope from VS-6 (11-05-2024).

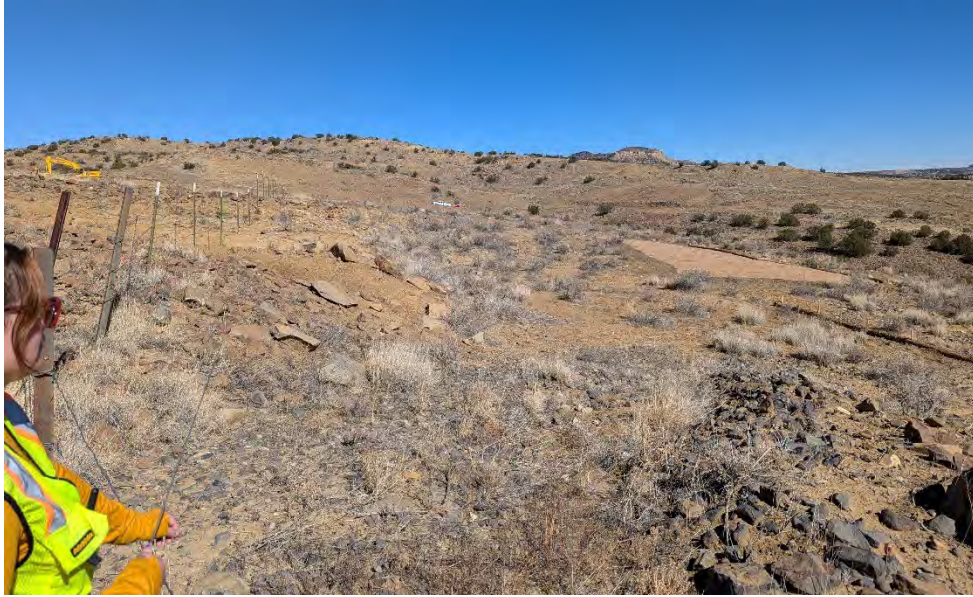
Photograph 18. View of biodegradable erosion control blanket and Eco Log, as installed at VS-5 (11-05-2024).

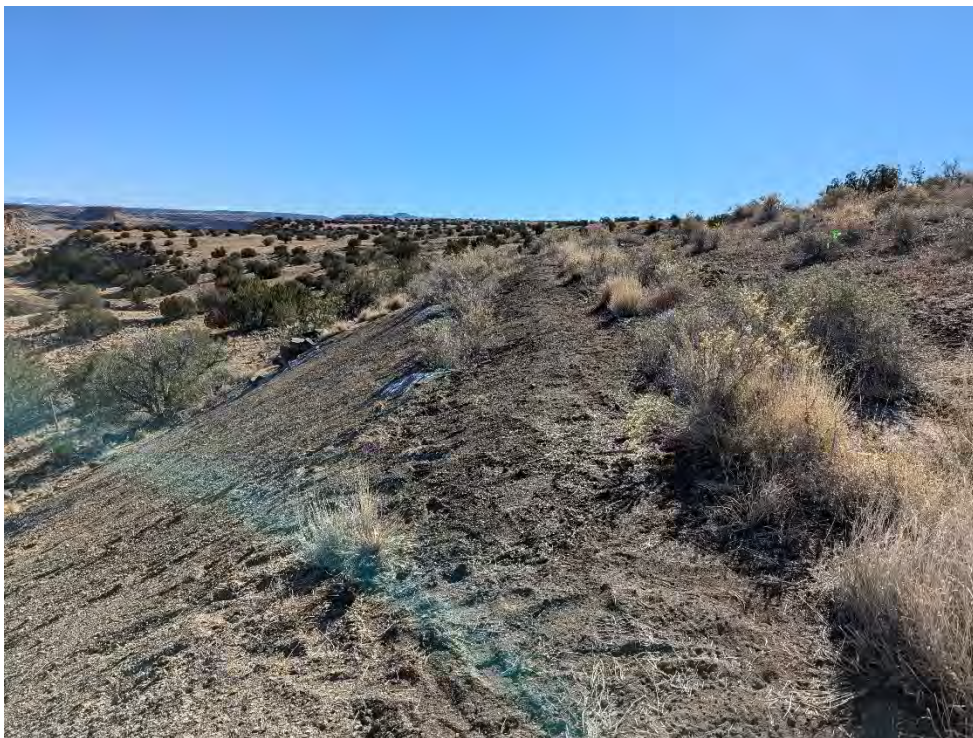
Photograph 19. View of slope requiring seeding and erosion protection at the reclaimed VS-12 area (11-05-2024).

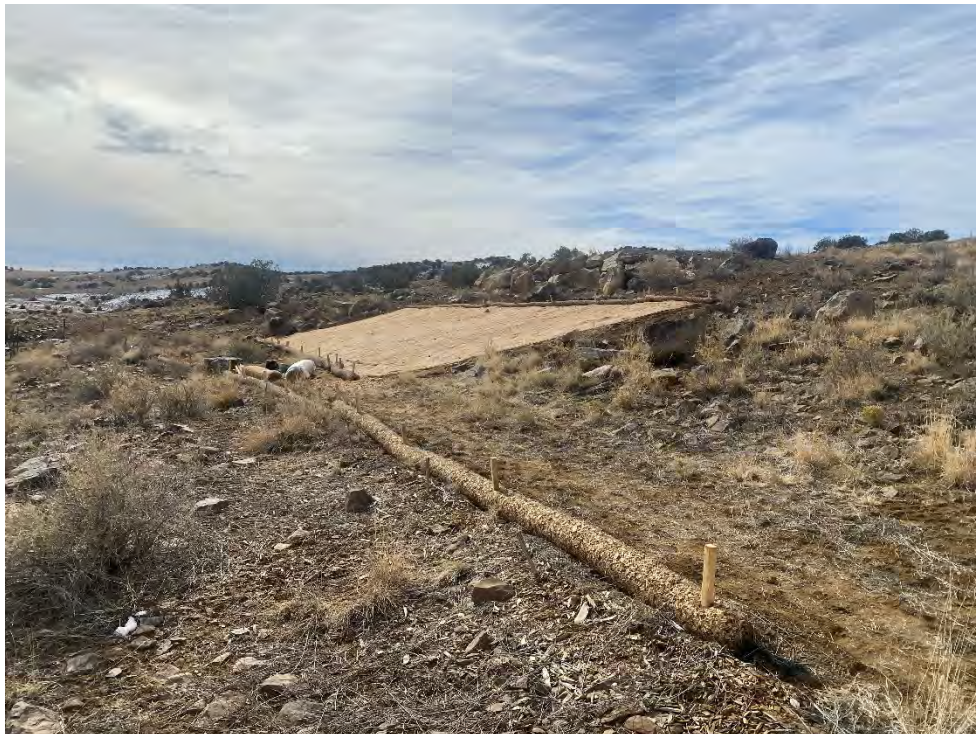
Photograph 22. Installation of biodegradable erosion control matting, below the hardscaping armor at Reclaimed VS-12 area.

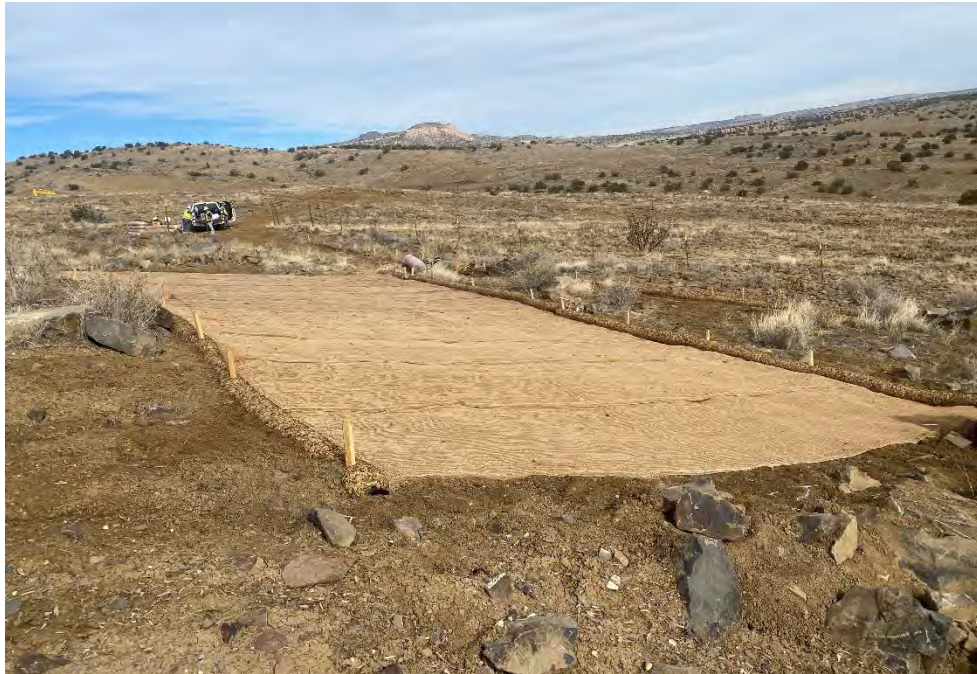
Photograph 23. View looking NNE at a portion of biodegradable erosion control matting, as installed, with the Eco Log wattles along the edges. The matting and wattles were placed parallel to the contour of existing topography onto a prepped surface (rocks removed).

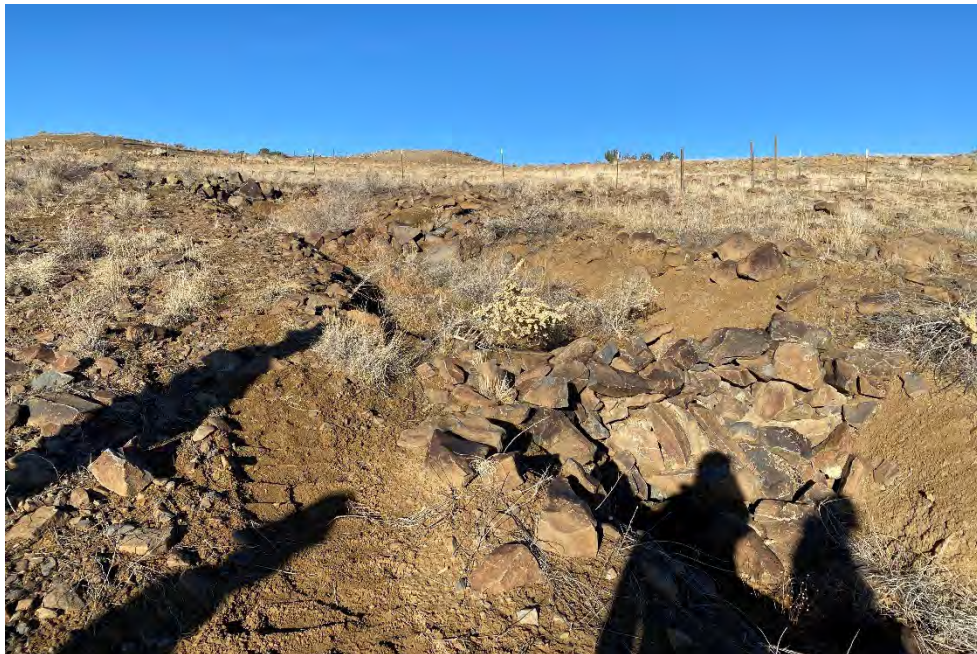
Photograph 24. Rock check dam maintenance utilizing on-Site available materials at reclaimed VS-6 area.

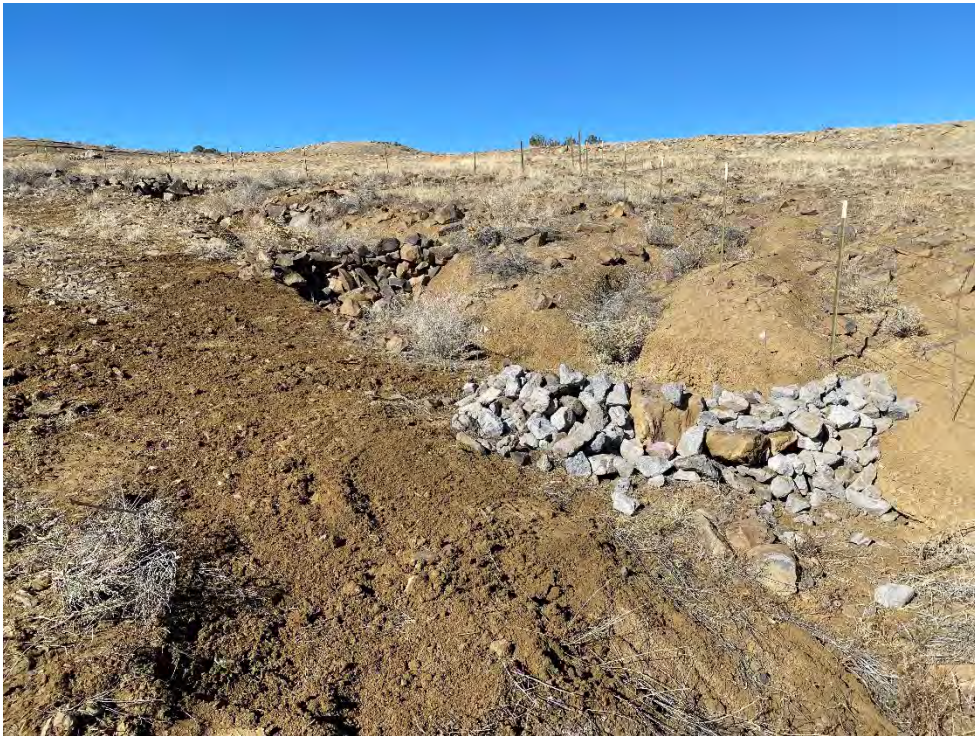
Photograph 26. View of bolstered rock check dams, installed and repaired at Reclaimed VS-6.

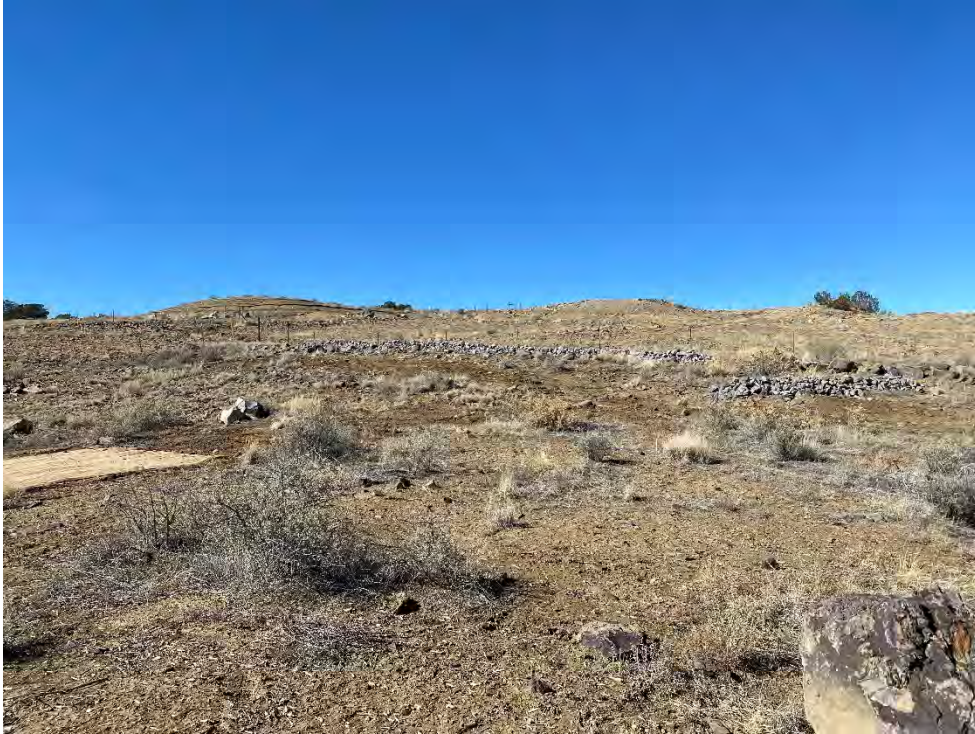
Photograph 27. View of bolstered rock check dams, installed and repaired at Reclaimed VS-6.

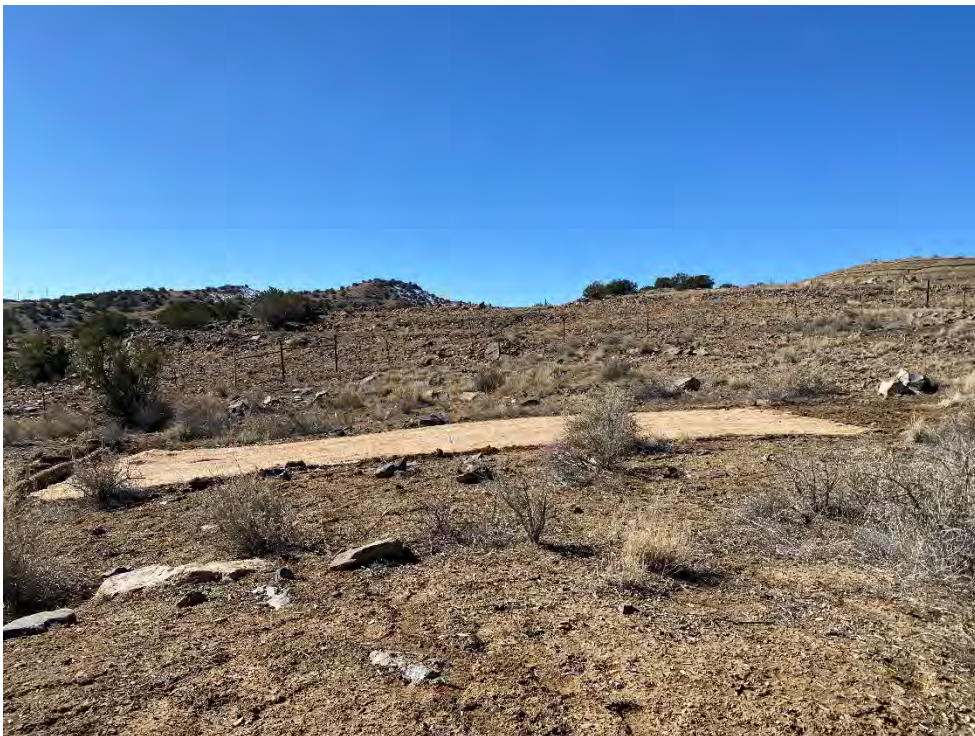
Photograph 28. View of installed biodegradable seed mat at Reclaimed VS-6.

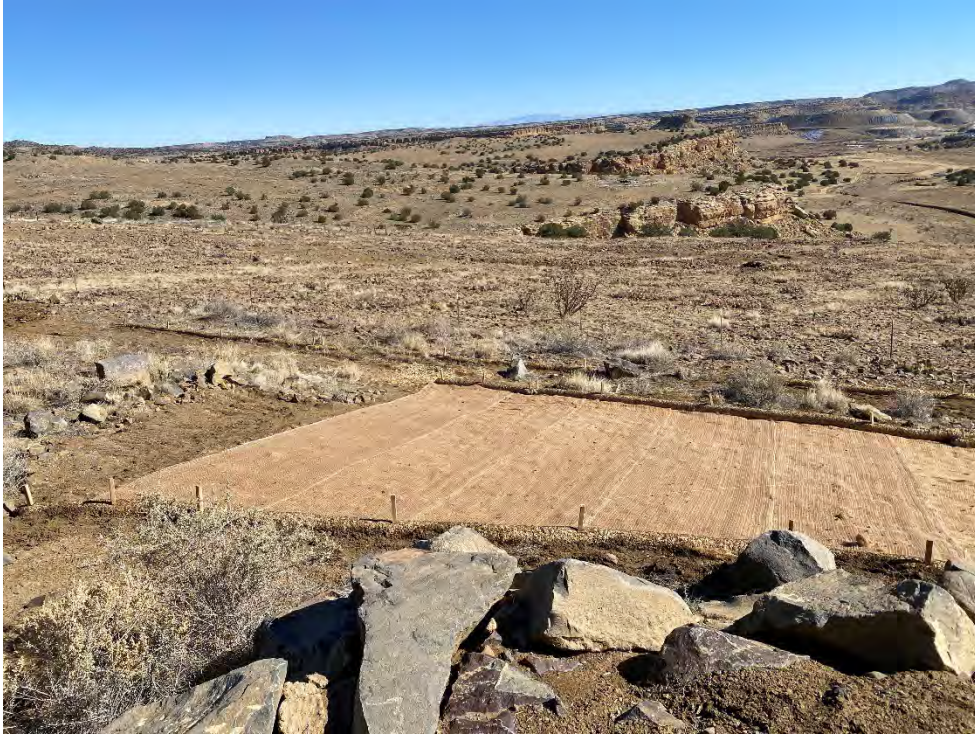
Photograph 29. View of installed biodegradable seed mat at Reclaimed VS-6.

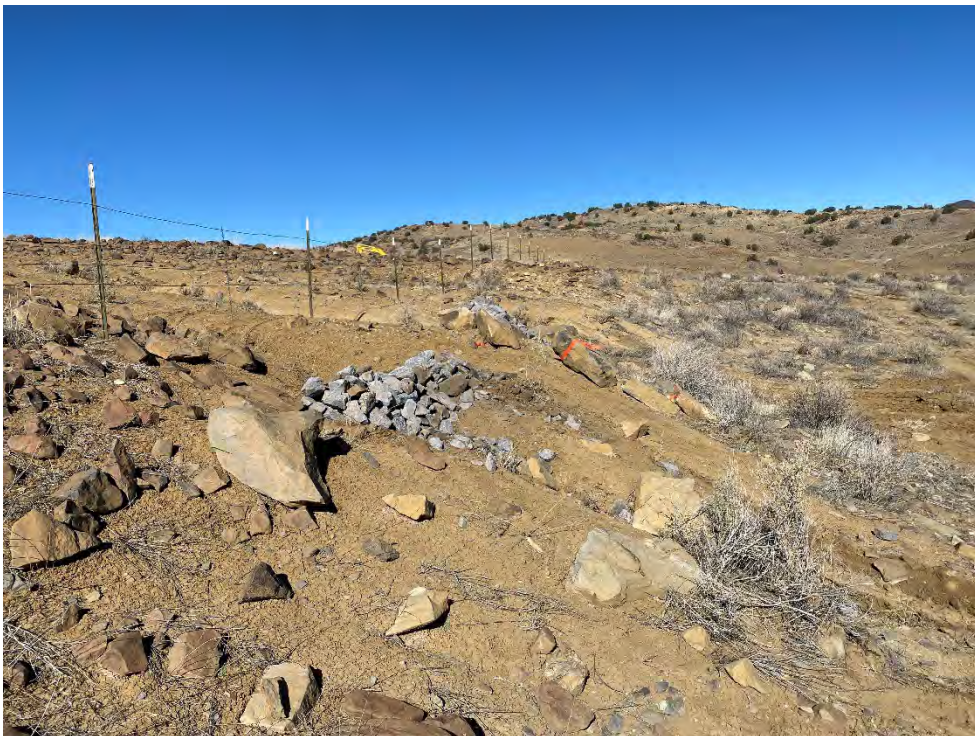
Photograph 30. View of installed biodegradable seed mat at Reclaimed VS-6.

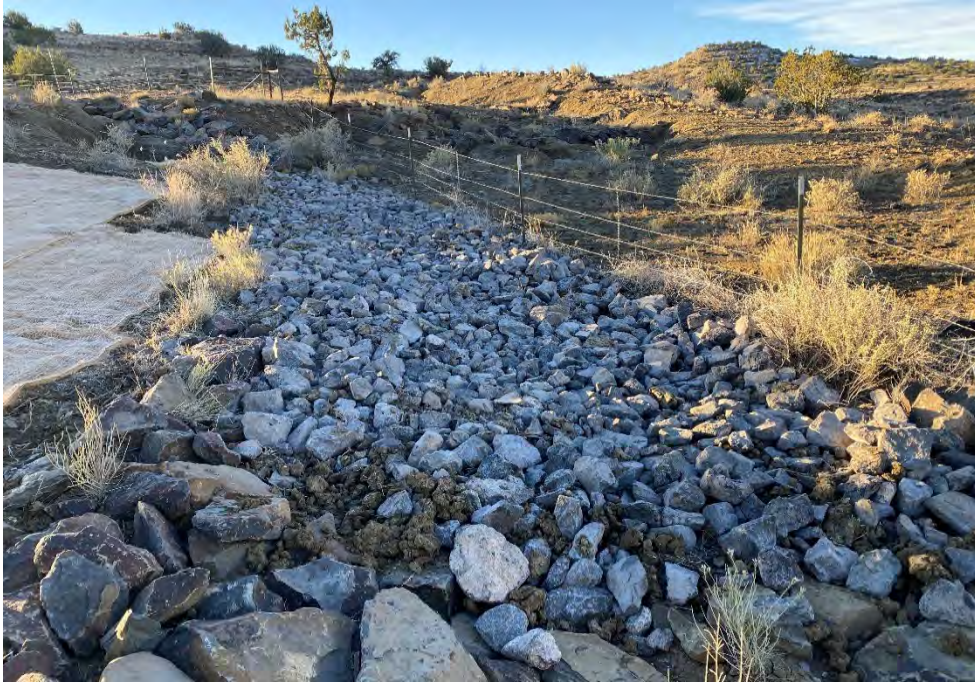
Photograph 31. 6–12-inch rip rap rock was installed upgradient of the existing rock armor at the Reclaimed VS-12 area.

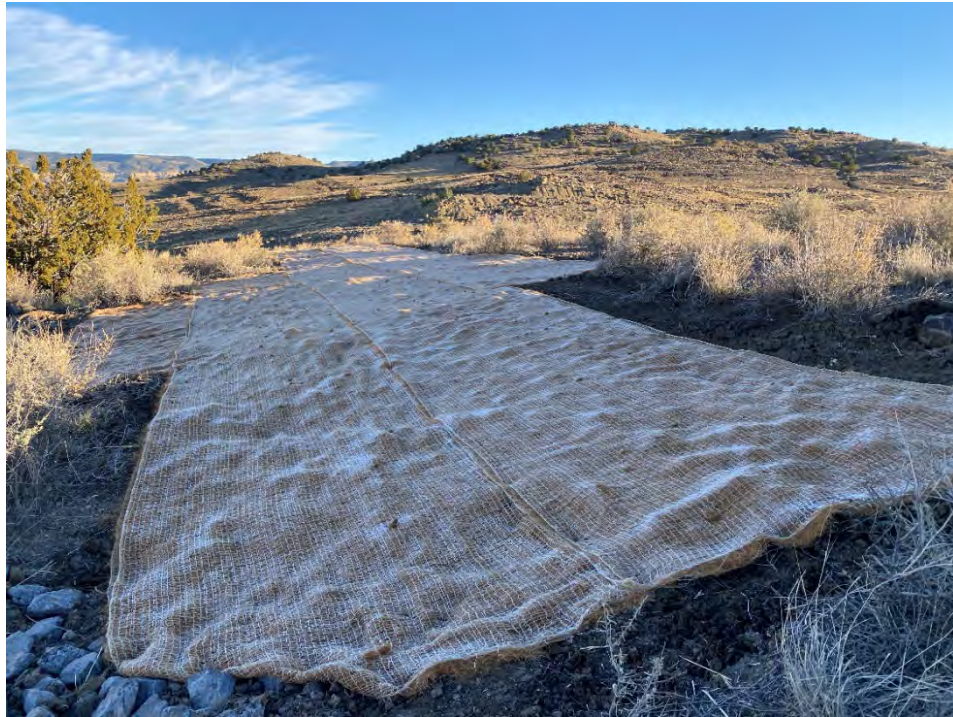
Photograph 33. View of Reclaimed VS-4 Area following seeding and biodegradable mat installation.

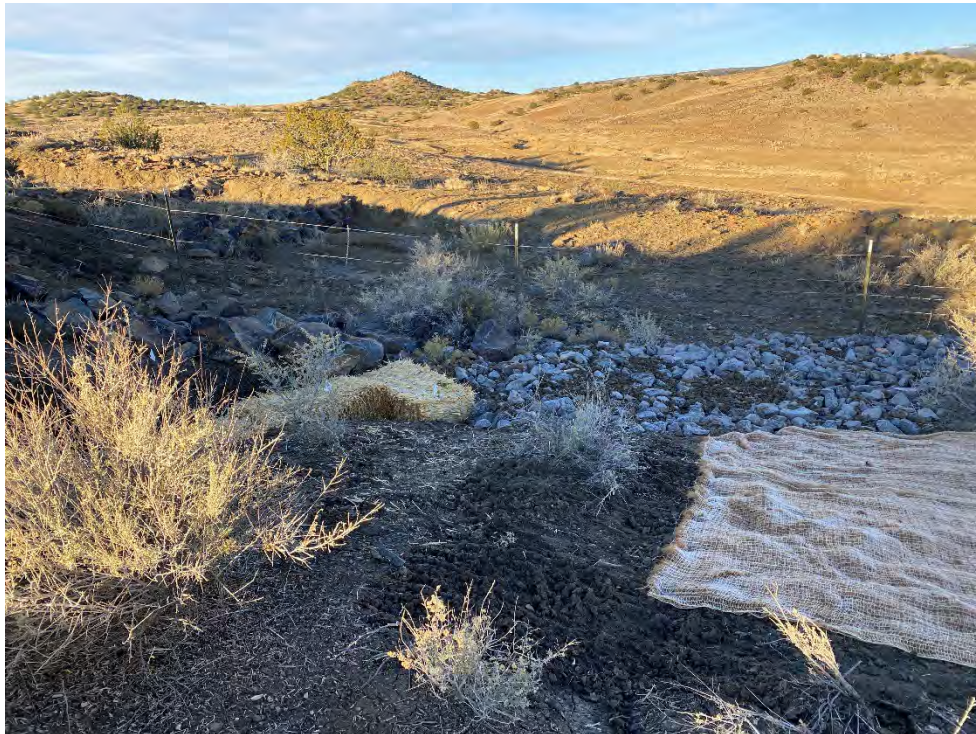
Photograph 34. View of Reclaimed VS-4 Area following seeding and biodegradable mat installation.

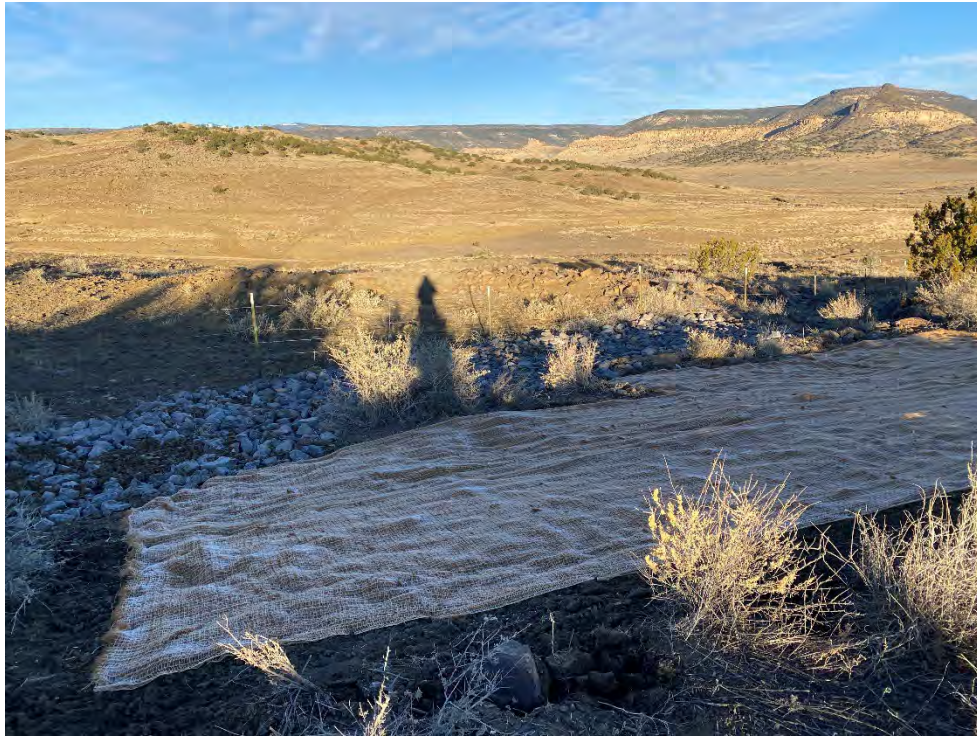
Photograph 35. View of Reclaimed VS-4 Area following seeding and biodegradable mat installation.

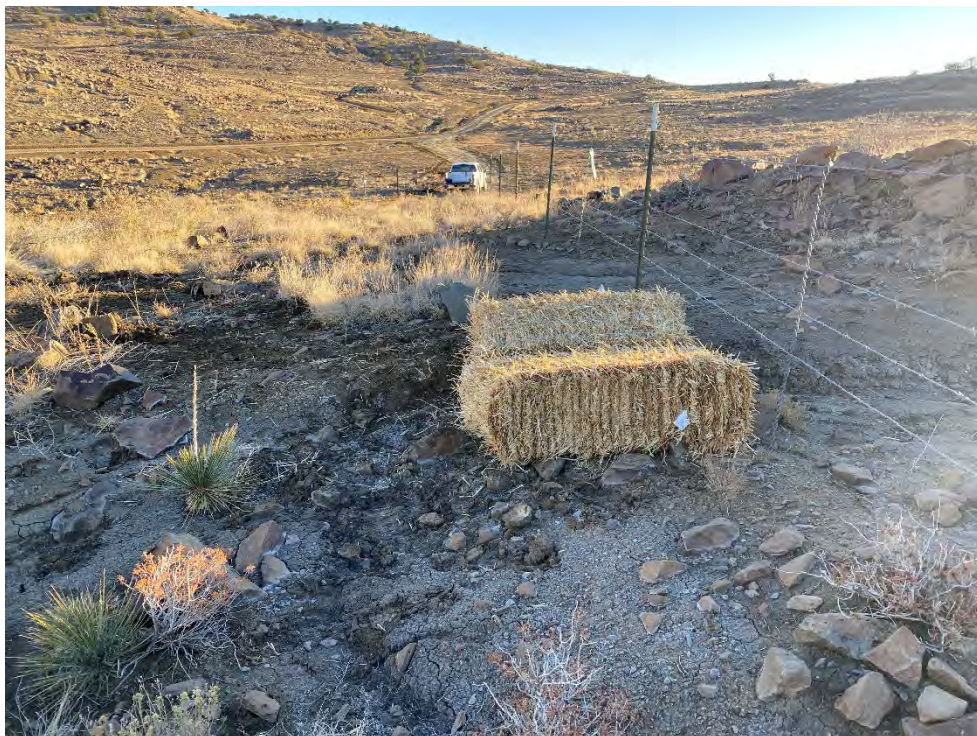
Photograph 36. View of strawbale installation at the Reclaimed VS-4 Area.

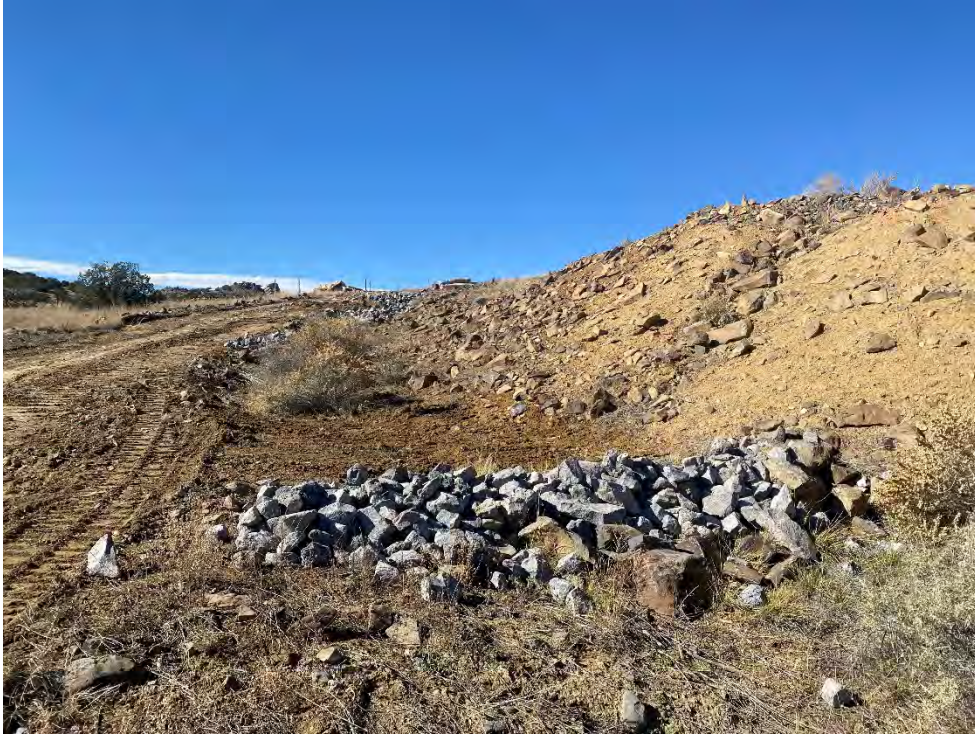
Photograph 47. View of bolstered rock check dams, installed and repaired at Reclaimed VS-10.

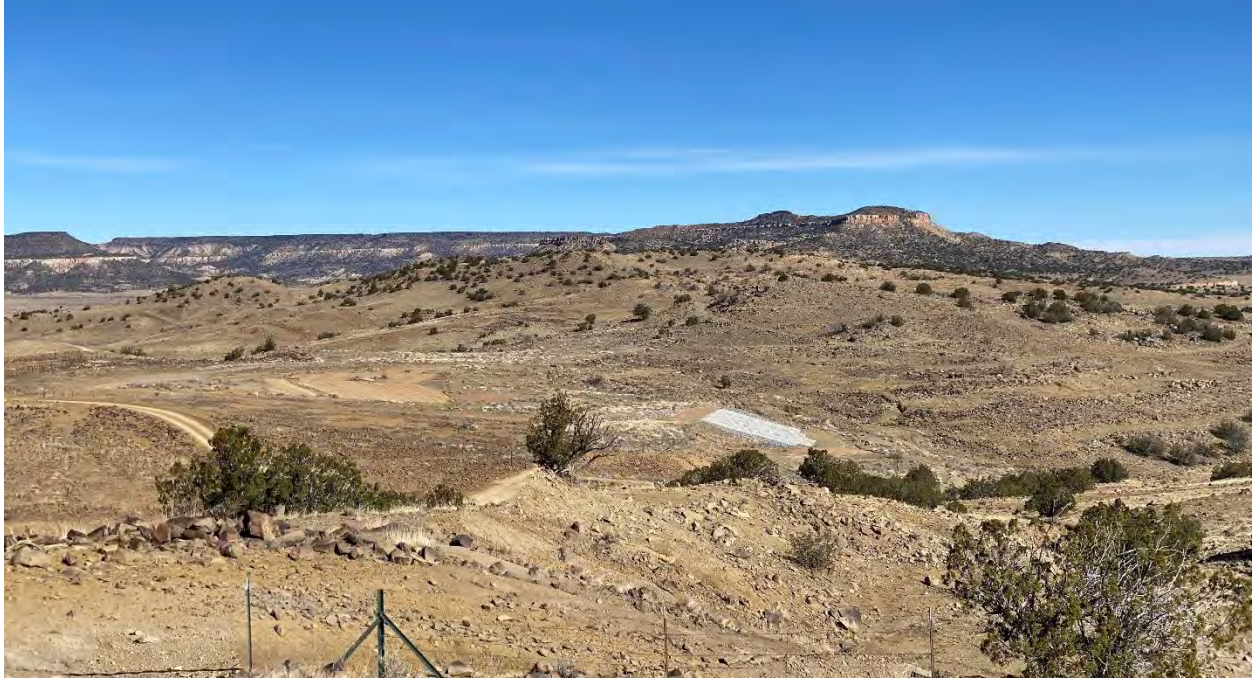
Photograph 48. View of the reclaimed Borrow Area and reclaimed VS-10 area from the reclaimed VS-11 area, looking east-northeast (Composite image, 11-26-2024).

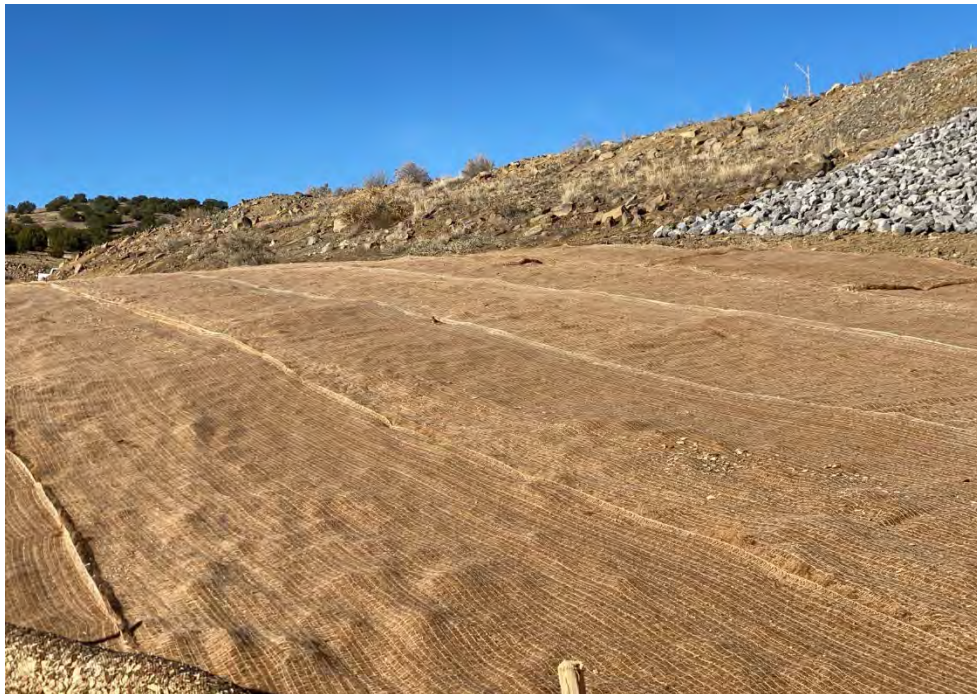
Photograph 49. View looking northwest from the area reseeded below the armored slope at the reclaimed VS-10 area. The area was roughened, reseeded, then covered with the biodegradable matting. Eco Log fiber rolls were placed on the downslope edge of the matting.

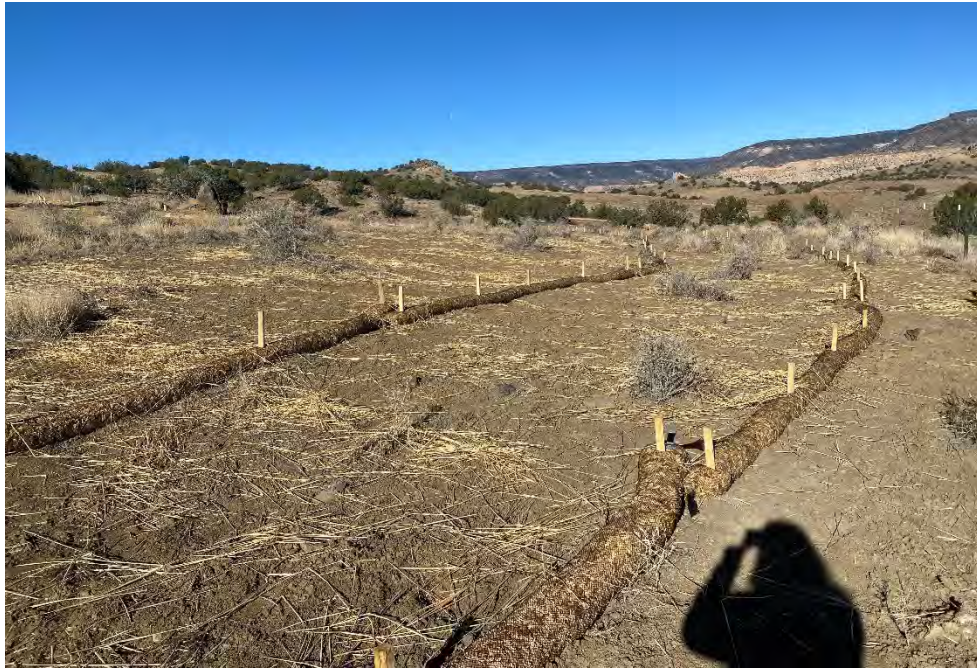
Photograph 50. Eco Log fiber rolls were placed along the contours of the slope at the Reclaimed VS-11 area. Seed was broadcast between the fiber rolls and covered with straw material.
