July 17, 2026

Clint Chisler  
Senior Reclamation Specialist  
NM EMNRD Mining and Minerals Division  
Mining Act Reclamation Program  
Wendell Chino Building  
1220 S. St. Francis Dr.  
Santa Fe, New Mexico 87505

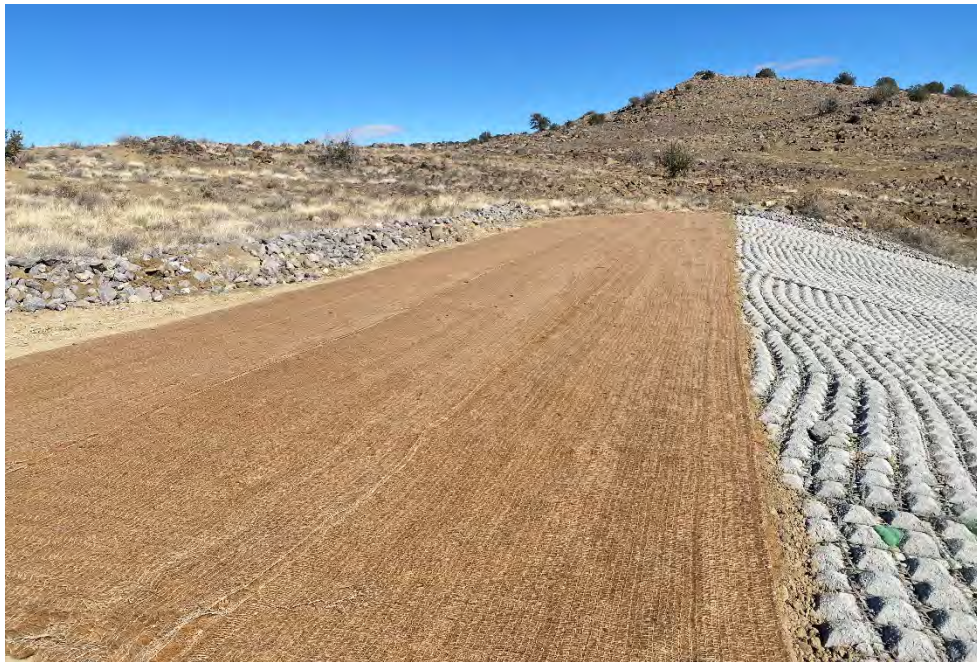
Photograph 51. View looking northeast from the area reseeded above the armored slope at the reclaimed VS-10 area where the surface was disturbed. The area was roughened, reseeded, then covered with the biodegradable matting. The media luna sheet flow spreader was installed upslope from the edge of the matting and concrete ECB.

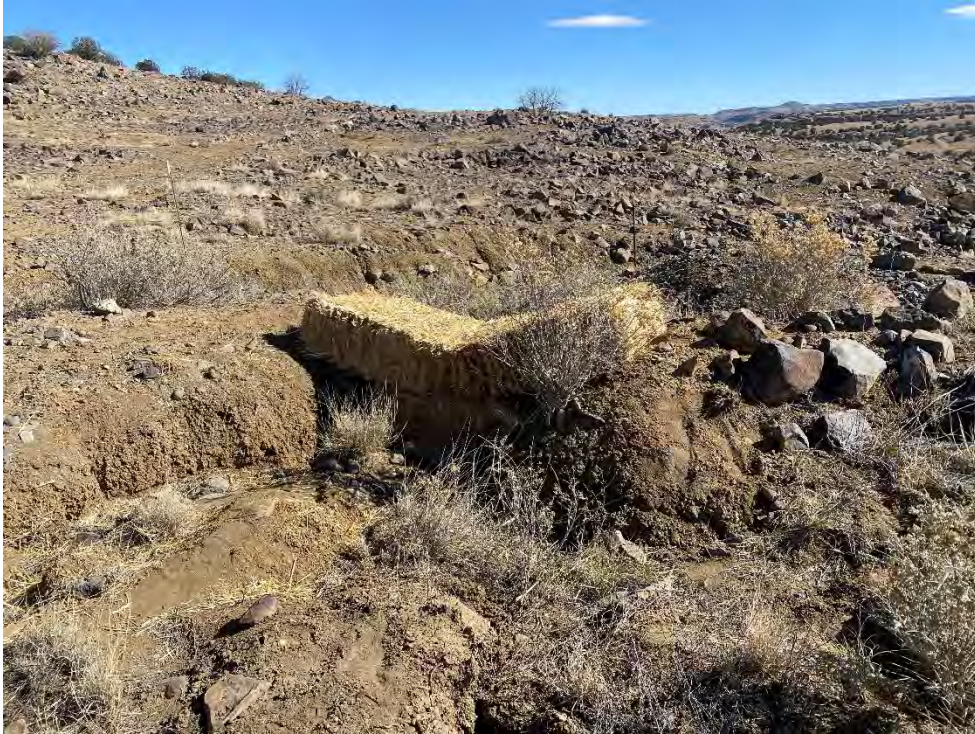
Photograph 52. Strawbales were placed within channels along the drainage on the eastern side of the Reclaimed VS-10 area.

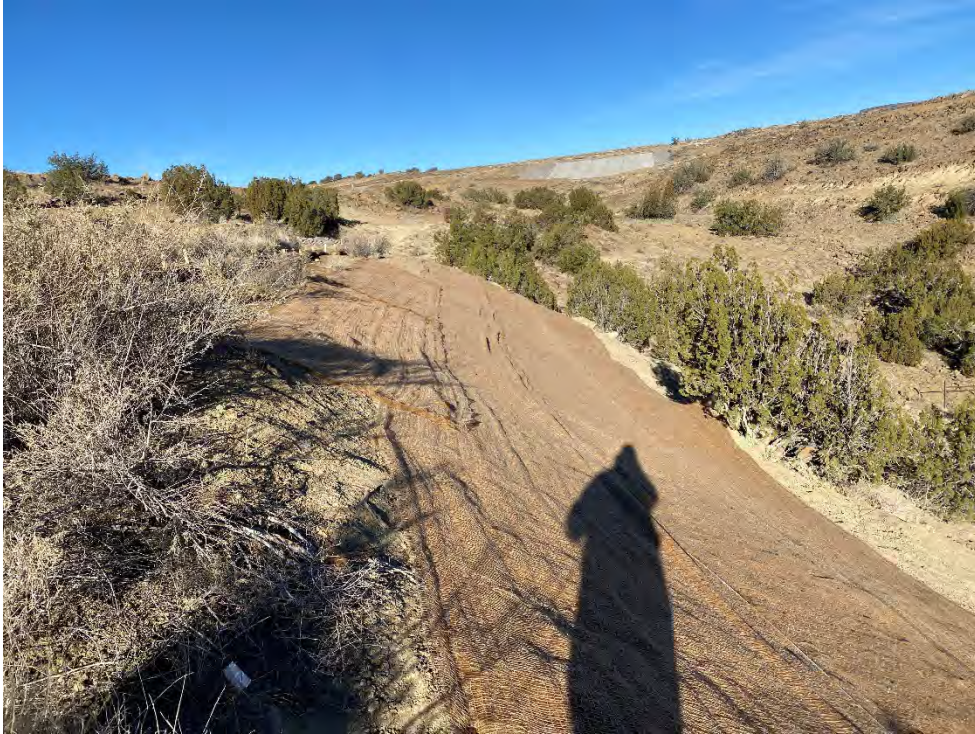
Photograph 54. View looking northwest from the reseeded lower slope at the reclaimed VS-12 area. The area was roughened, reseeded, then covered with the biodegradable matting.

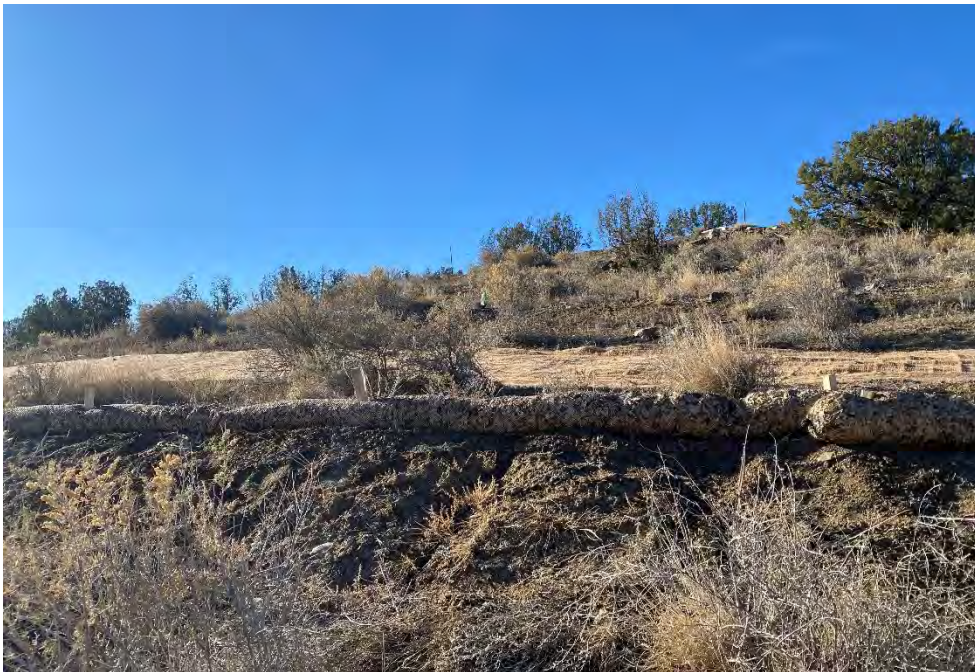
Photograph 55. Eco Log fiber rolls were placed on the downslope edge of the matting at the reclaimed VS-12 area.

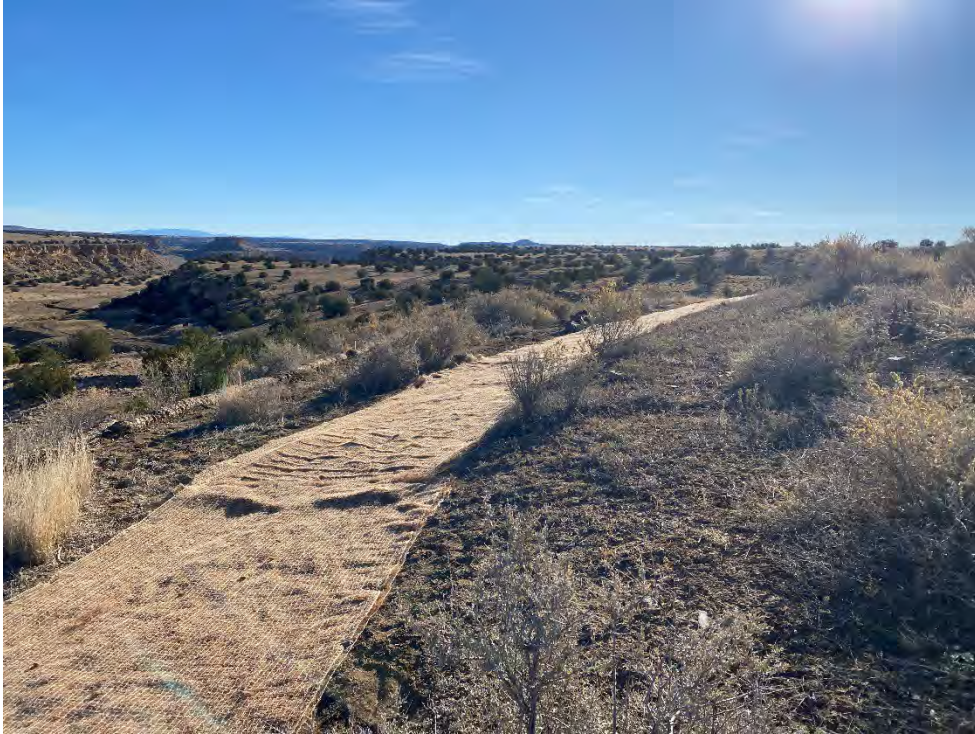
Photograph 56. View looking southeast from the reseeded slope at the reclaimed VS-12 area. The area was roughened, reseeded, then covered with the biodegradable matting.

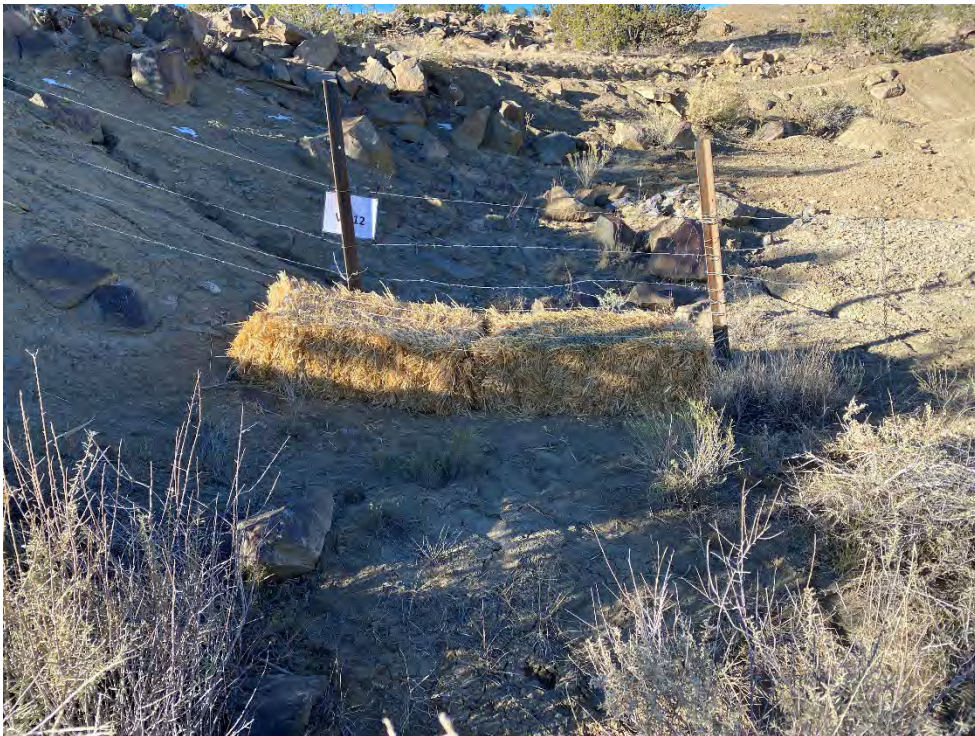
Photograph 57. Strawbales were placed within channels along the drainage on the eastern side of the Reclaimed VS-12 area.

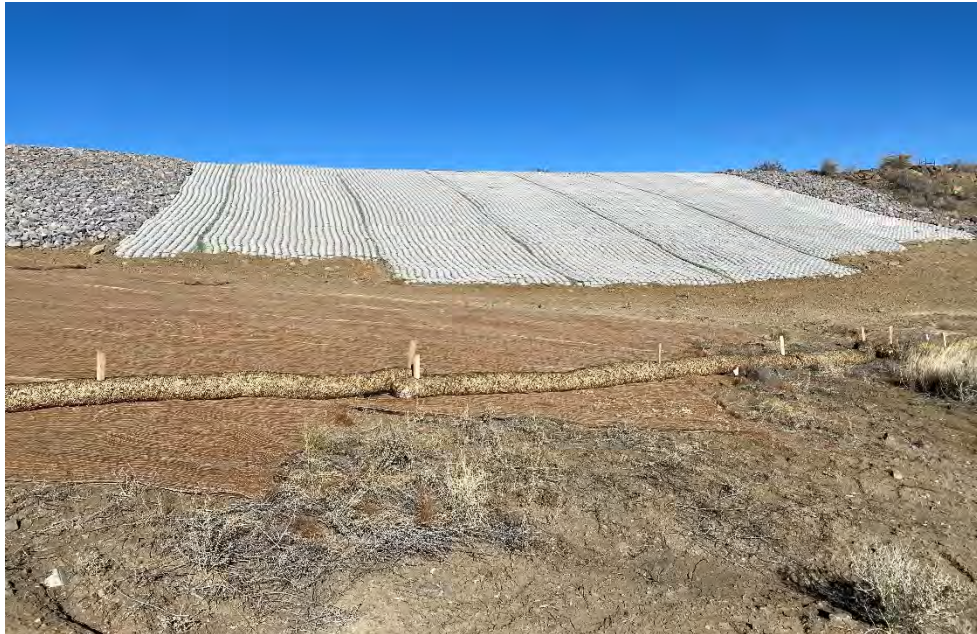
Photograph 60. View looking upslope from the area reseeded below the armored slope at the reclaimed VS-10 area. The area was roughened, reseeded, then covered with the biodegradable matting. Eco Log fiber rolls were placed on the downslope edge of the matting.

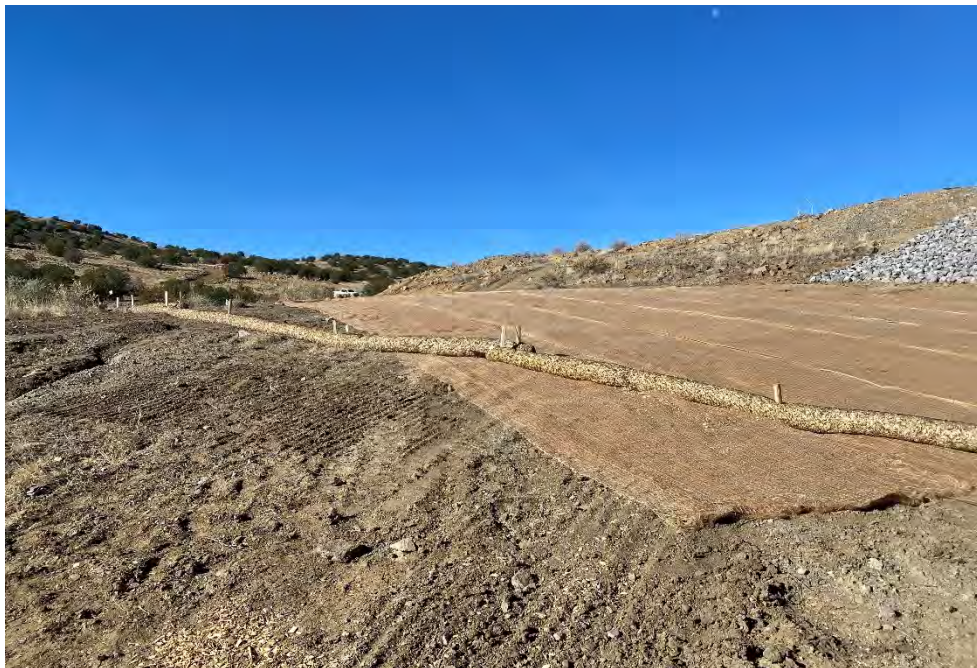
Photograph 61. View looking west from the area reseeded below the armored slope at the reclaimed VS-10 area. The area was roughened, reseeded, then covered with the biodegradable matting. Eco Log fiber rolls were placed on the downslope edge of the matting.

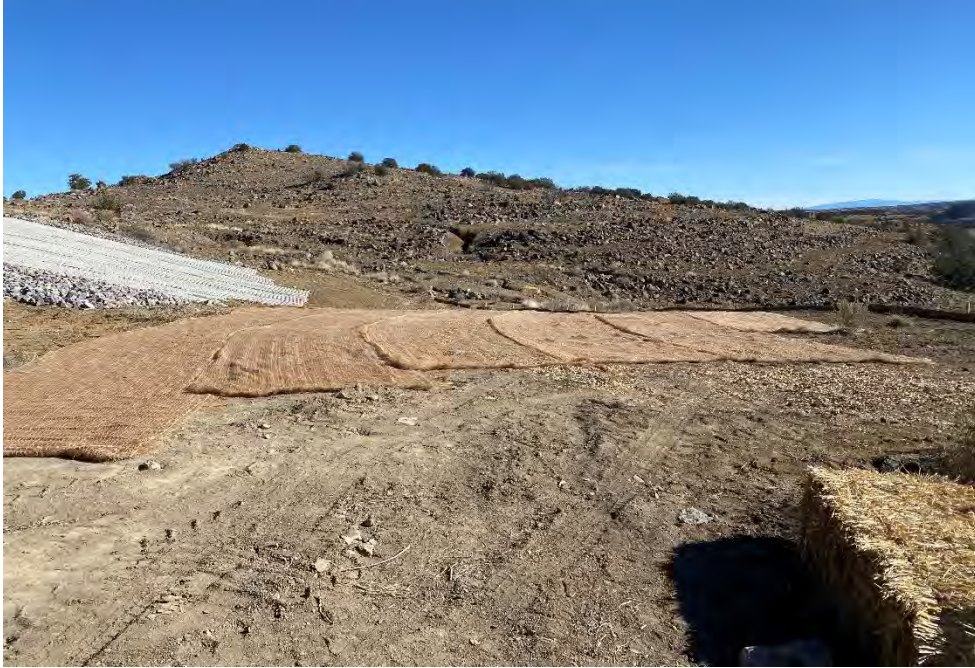
Photograph 62. View looking east from the area reseeded below the armored slope at the reclaimed VS-10 area. The area was roughened, reseeded, then covered with the biodegradable matting. Eco Log fiber rolls were placed on the downslope edge of the matting.

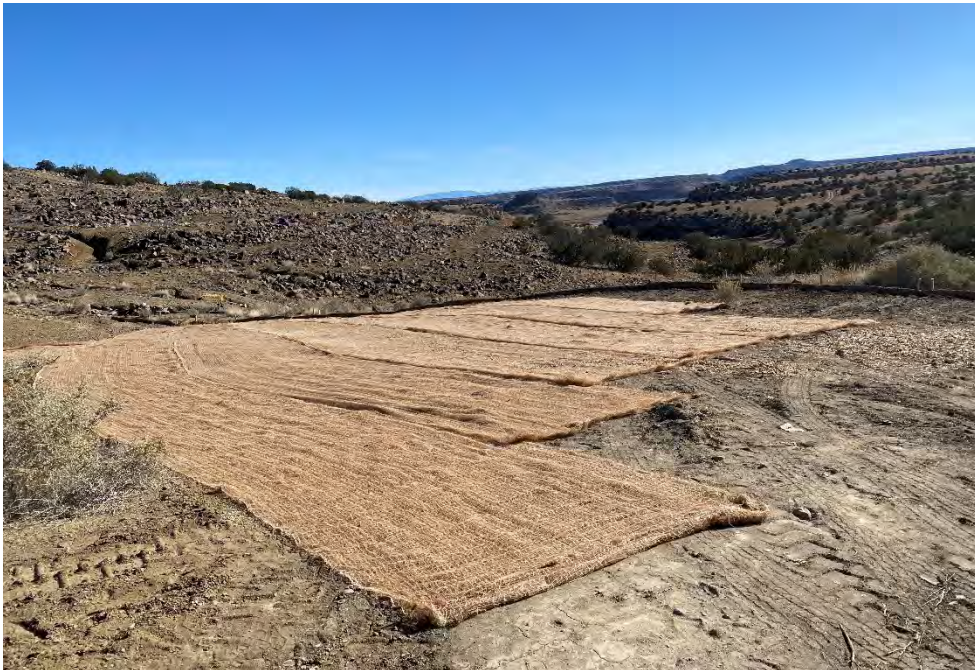
Photograph 63. View looking east from the area reseeded below the armored slope at the reclaimed VS-10 area. The area was roughened, reseeded, then covered with the biodegradable matting. Eco Log fiber rolls were placed on the downslope edge of the matting.

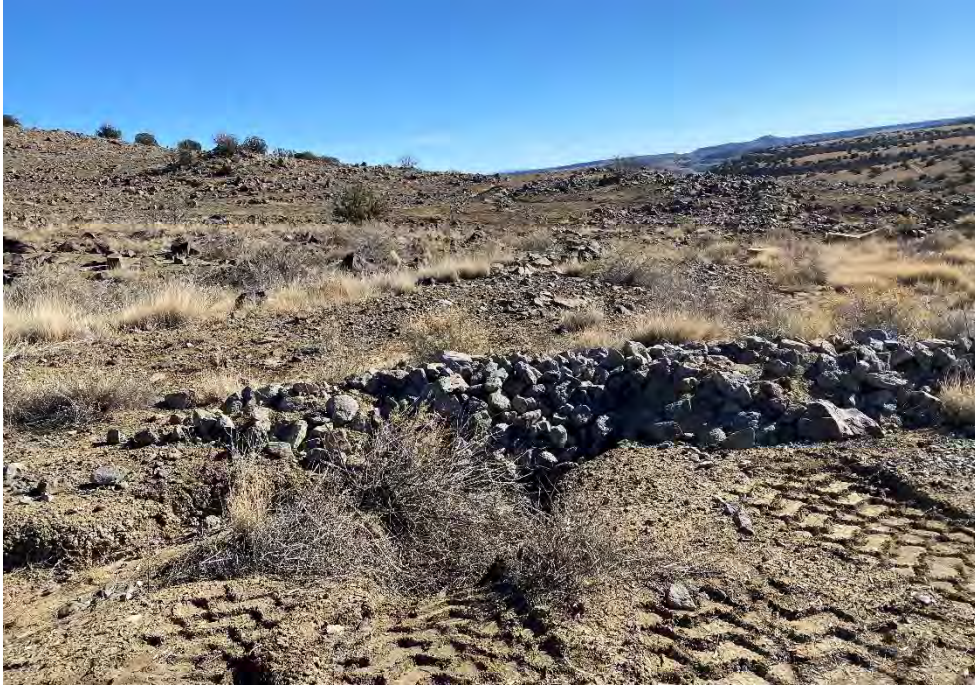
Photograph 64. Rock check dam maintenance utilizing on-Site available materials at reclaimed VS-10 area.

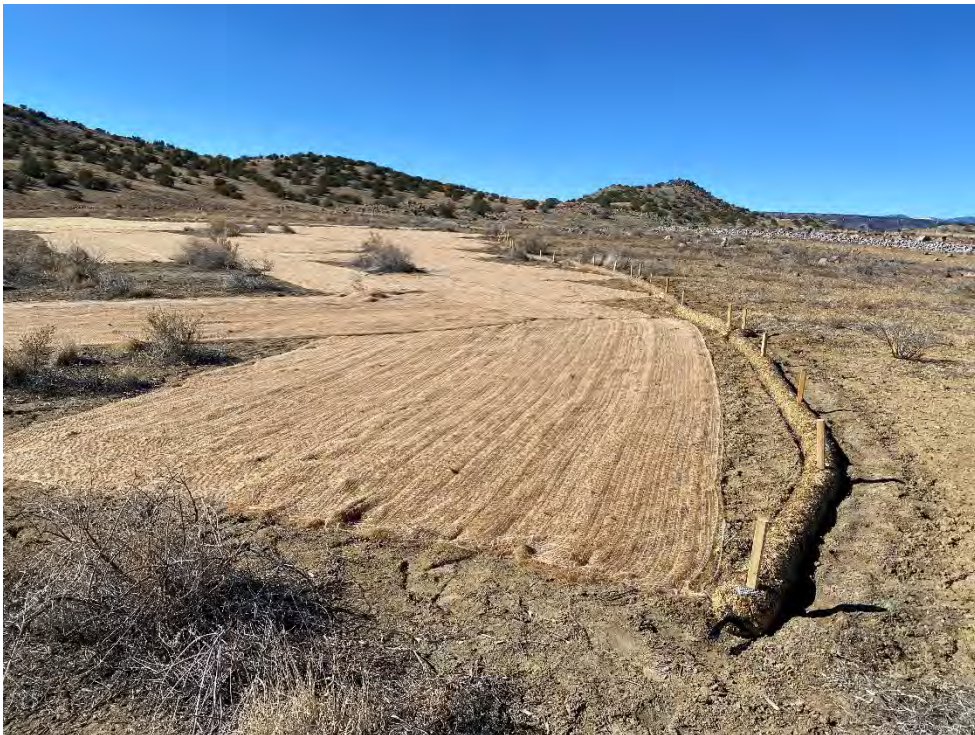
Photograph 65. View looking west from the area reseeded in the reclaimed Borrow Area. The area was roughened, reseeded, then covered with the biodegradable matting. Eco Log fiber rolls were placed on the downslope edge of the matting. Established woody shrubs were left in place.

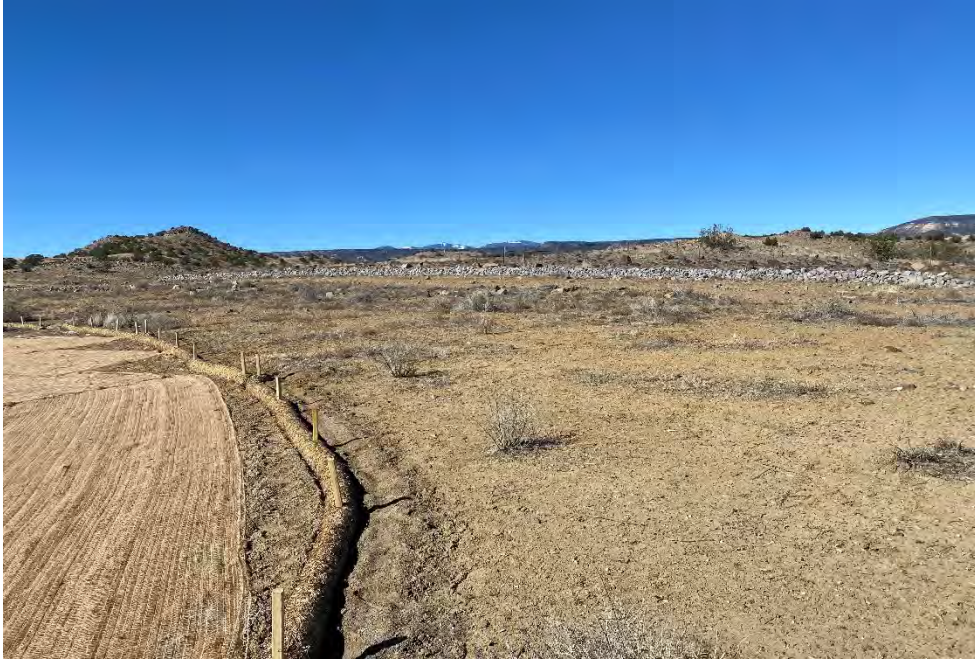
Photograph 66. View looking northwest from the within the upper portion of the reclaimed former Borrow Area toward the media luna sheet flow collector.

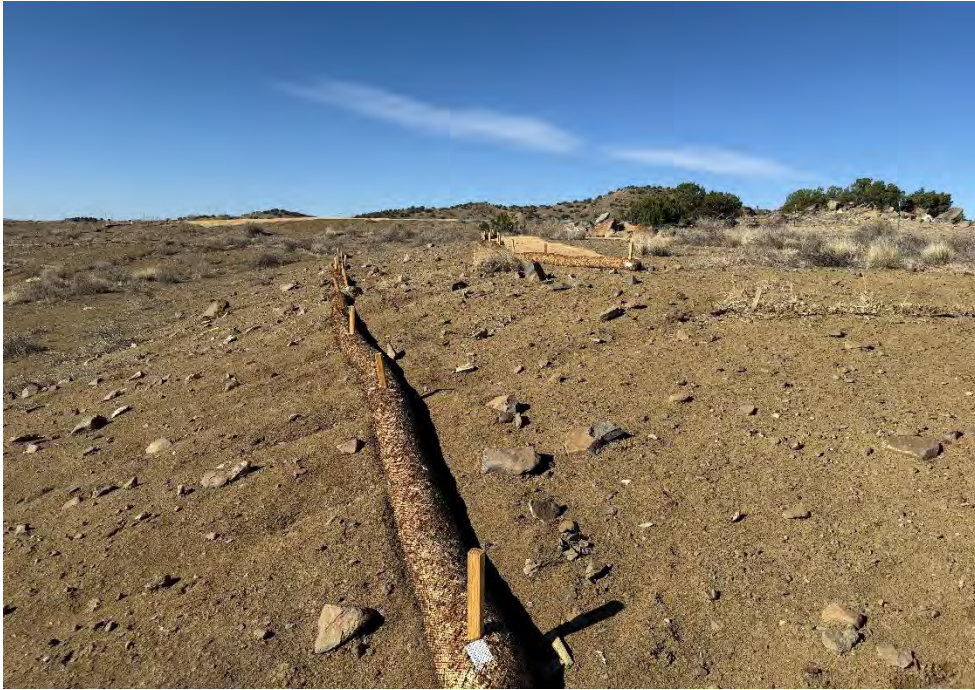
Photograph 72. View of slope located at reclaimed VS-5 (foreground) and VS-6 (background) with Eco Log and biodegradable matting (April 2025).

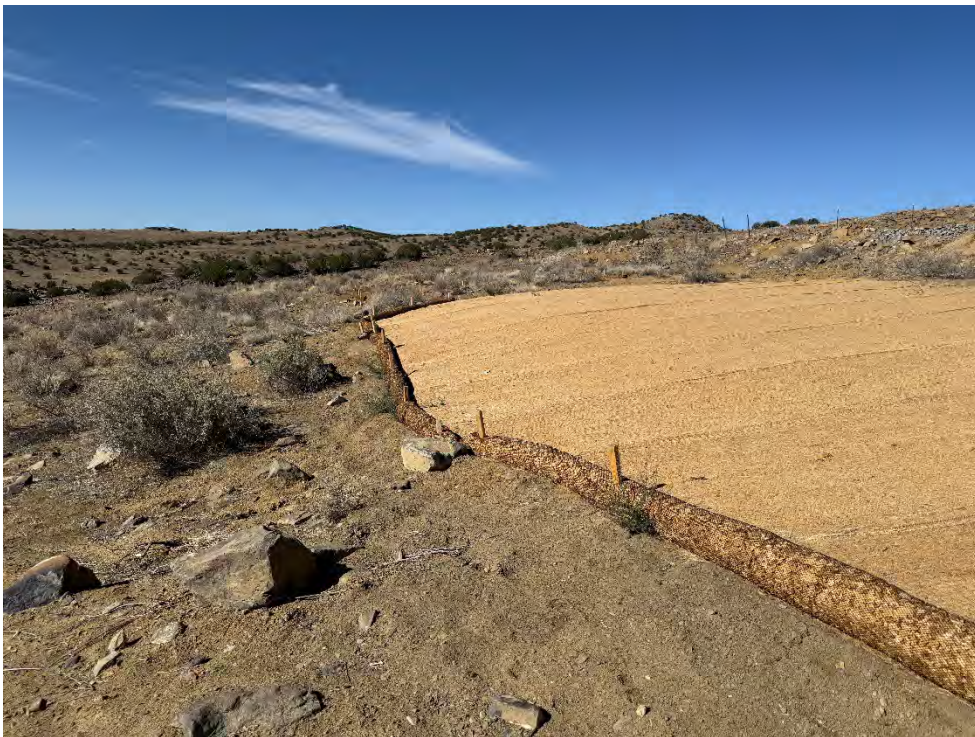
Photograph 73. View of slope located at reclaimed VS-6 with Eco Log and biodegradable matting (April 2025).

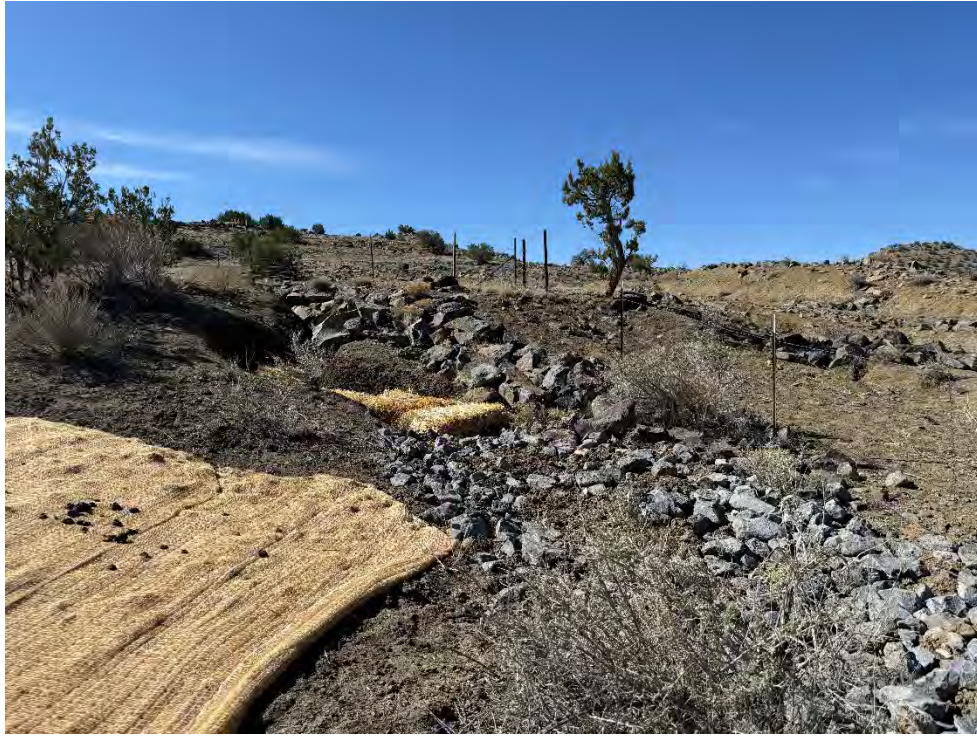
Photograph 74. View of slope armored channel at reclaimed VS-4, with strawbale and biodegradable matting (April 2025).

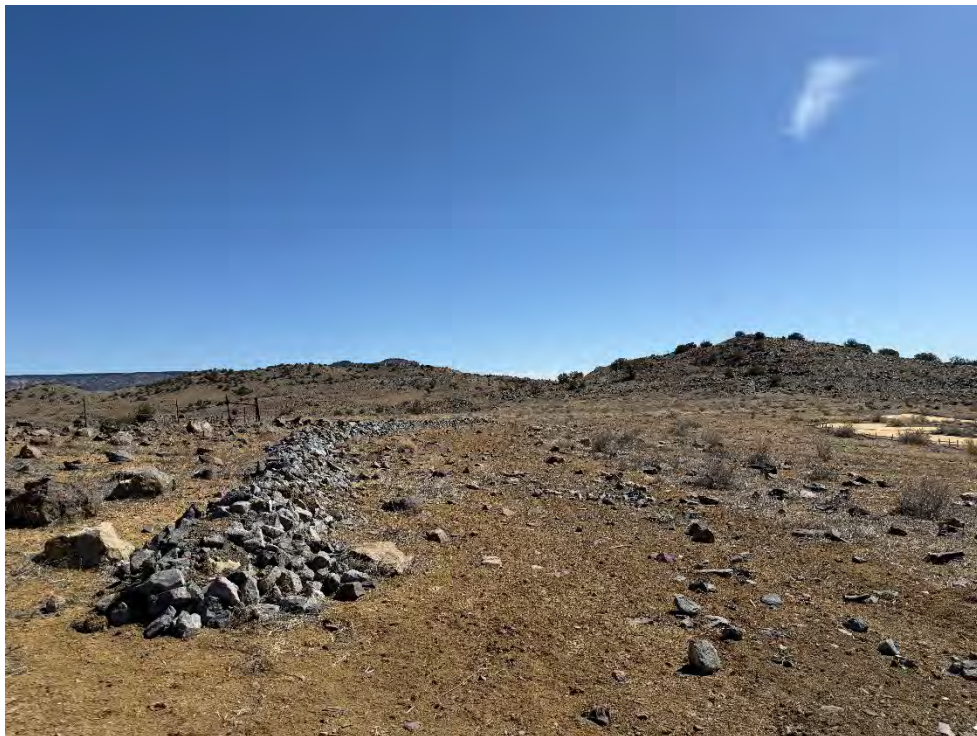
Photograph 75. View of sheet flow collector media luna (April 2025).

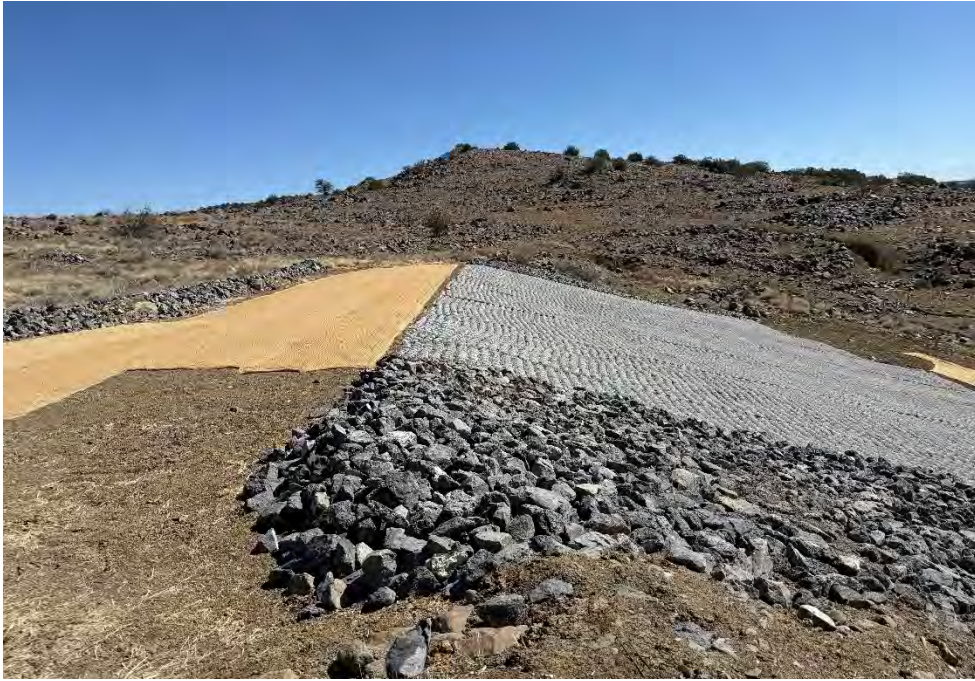
Photograph 76. East-northeastern view of sheet flow spreader, biodegradable matting, and regraded, armored slope located at the transition from the reclaimed former Borrow Area to the reclaimed VS-10 (April 2025).

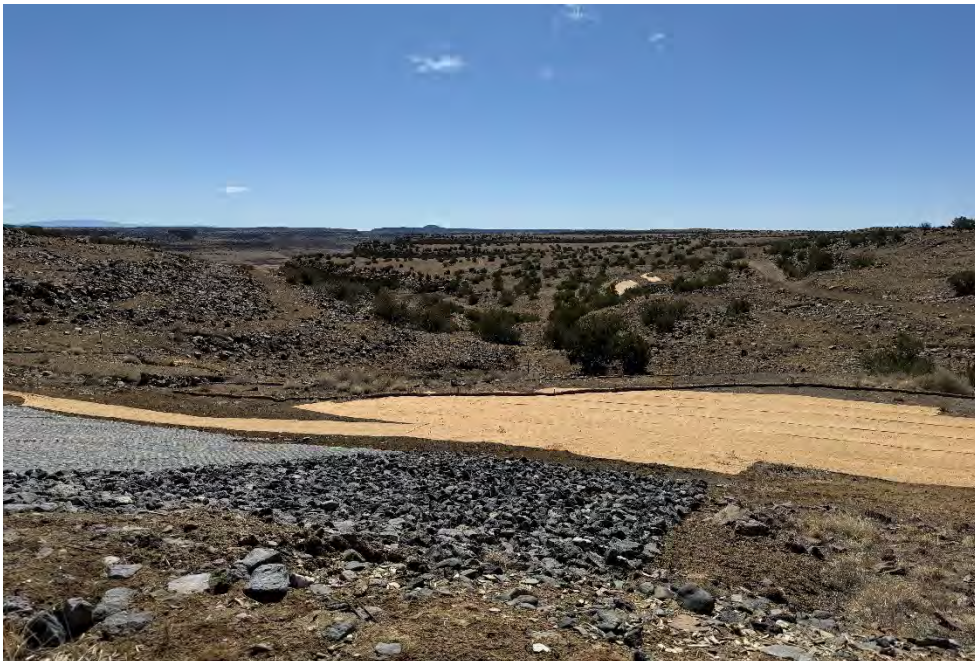
Photograph 77. Southeastern view, downslope, of the regraded, armored slope located at the transition from the reclaimed former borrow area to the reclaimed VS-10 (April 2025).

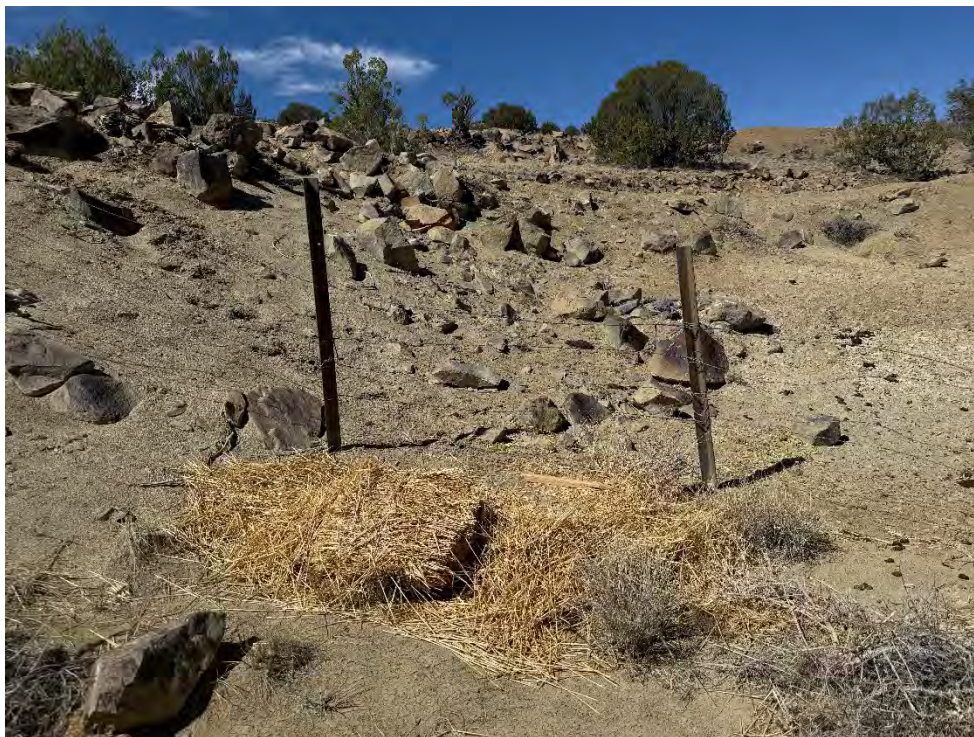
Photograph 81. Strawbales placed within channels along the drainage on the eastern side of the Reclaimed VS-12 area have started to degrade (April 2025).

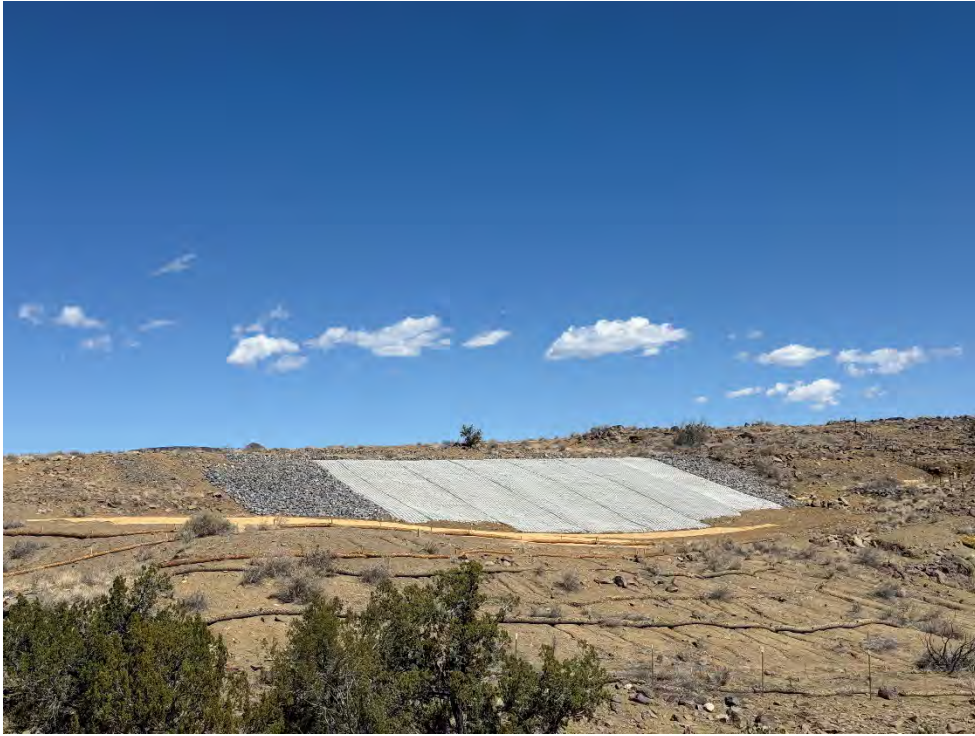
Photograph 82. Northwestern view, upslope, of the regraded, armored slope located at the transition from the reclaimed former borrow area to the reclaimed VS-10 (April 2025).

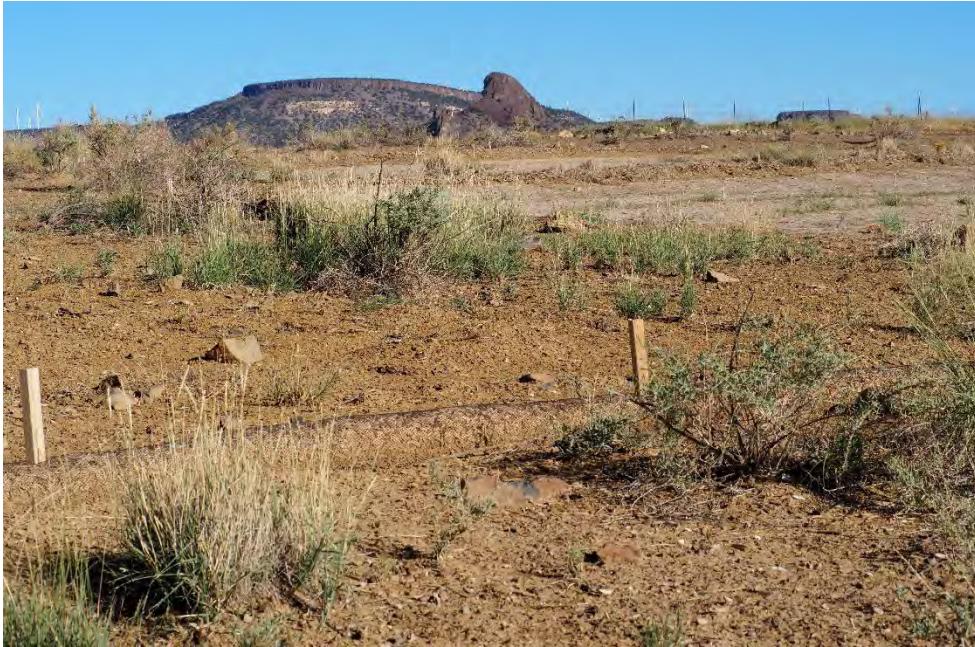
Photograph 84. Northwestern view of the reclaimed former borrow area with vegetation, progression of sediment infill to the Eco Log fiber rolls and degrading erosion control matting (September 2025).

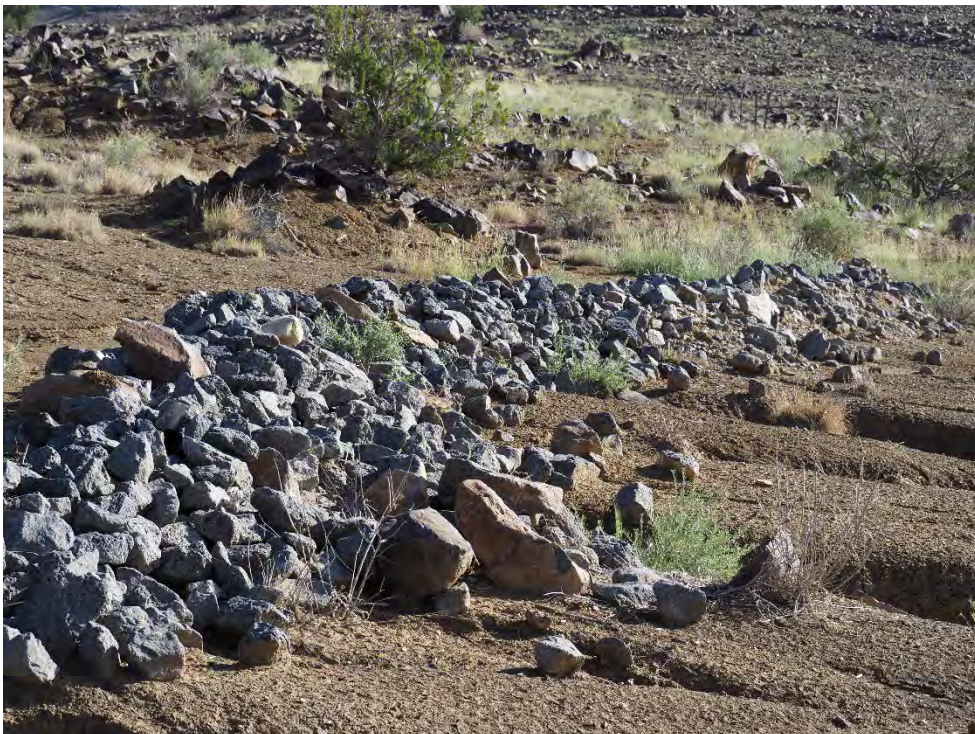
Photograph 85. View of the eastern portion of the sheet flow collector media luna. Some vegetation and rilling (September 2025).

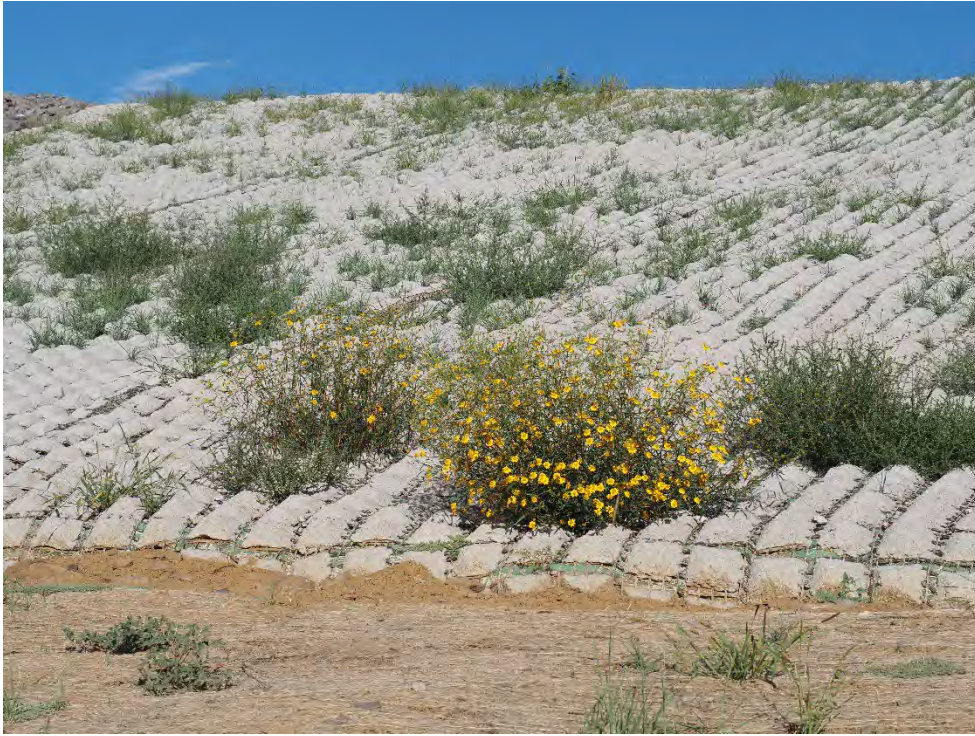
Photograph 86. Northwestern view, upslope, of the regraded, armored slope located at the transition from the reclaimed former borrow area to the reclaimed VS-10 (September 2025). Vegetation present on the concrete ECB. Some scouring noted at the slope toe.

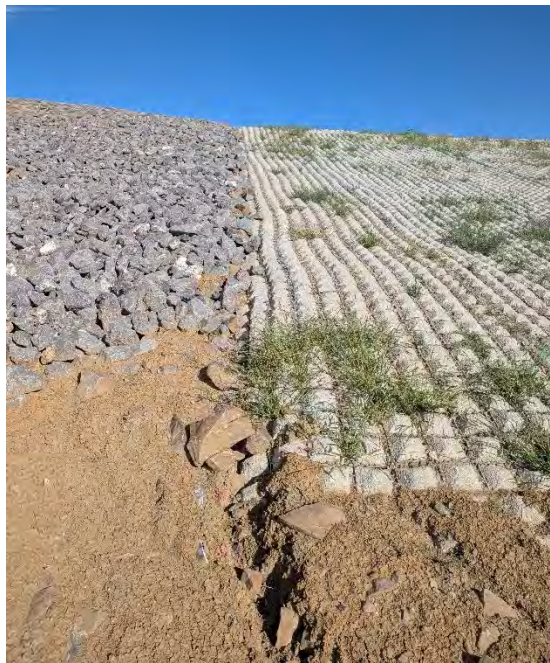
Photograph 87. View of the scouring present at the slope toe and concrete ECB anchor trench.

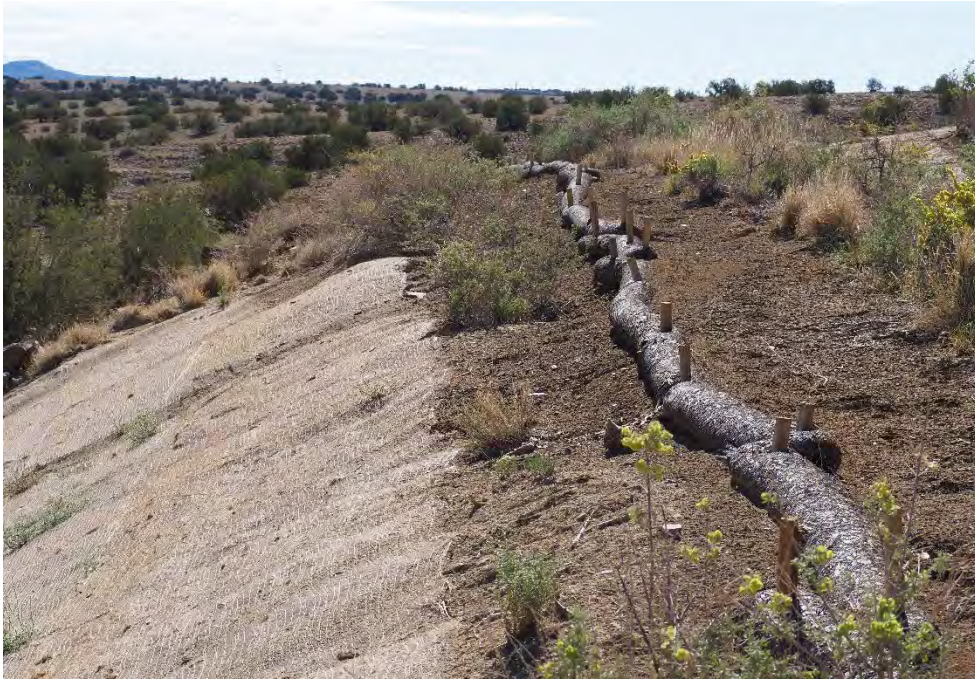
Photograph 96. View looking southeast from the reseeded slope at the reclaimed VS-12 area. The area was roughened, reseeded, then covered with the biodegradable matting (September 2025).

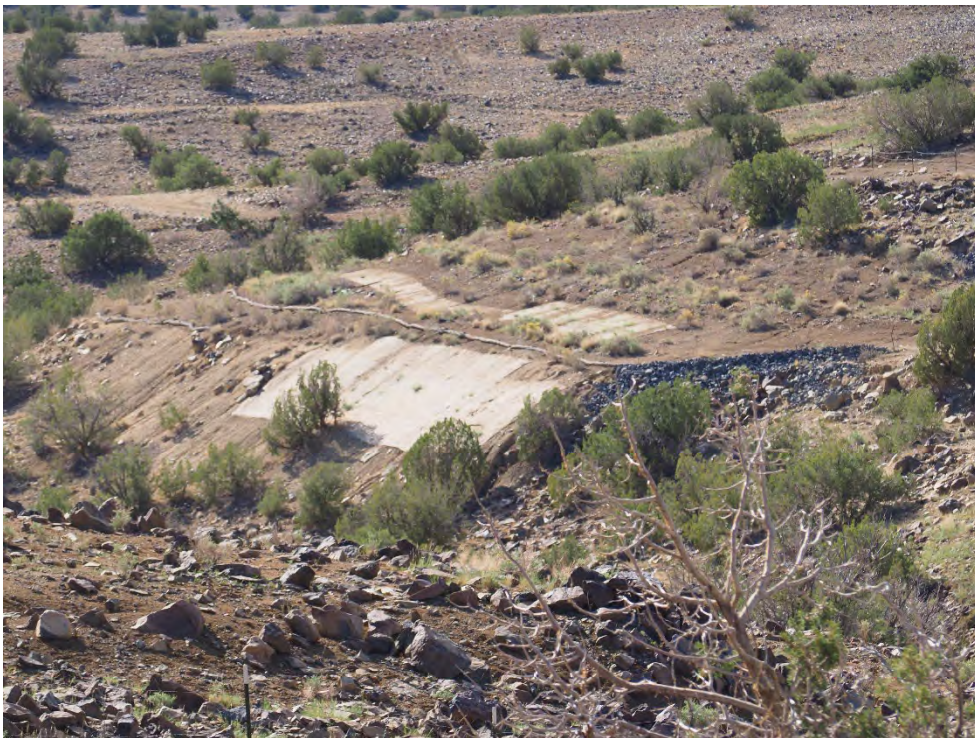
Photograph 97. View looking southeast from the within the VS-10 reclamation area to the reclaimed VS-12 area, including the armored slope, biodegradable matting, and Eco Log fiber rolls (September 2025).

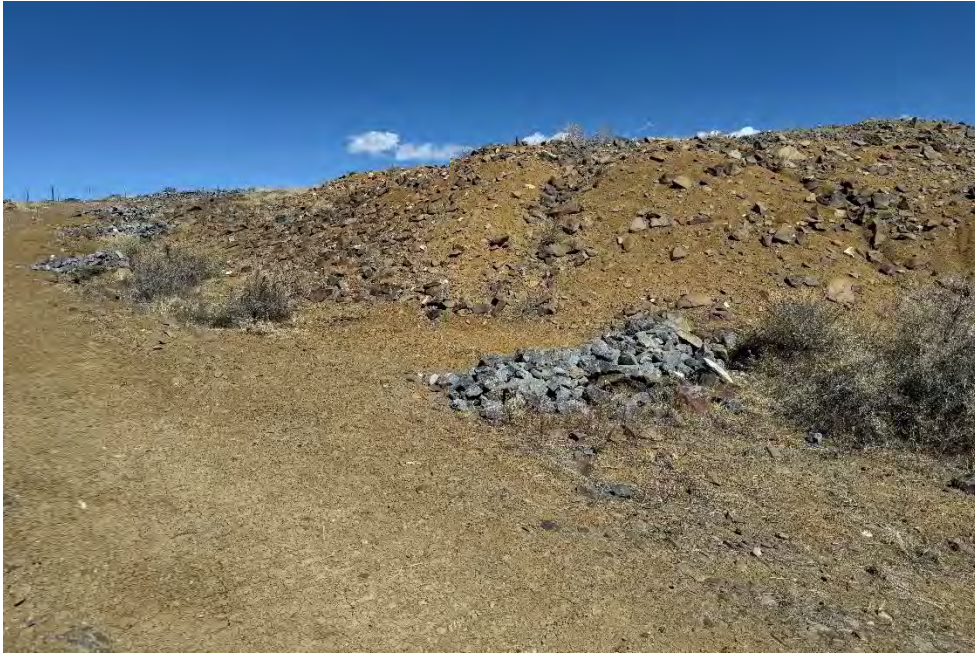
Photograph 98. View of rock check dam bolstering installed downslope of the reclaimed VS-10 area (September 2025).

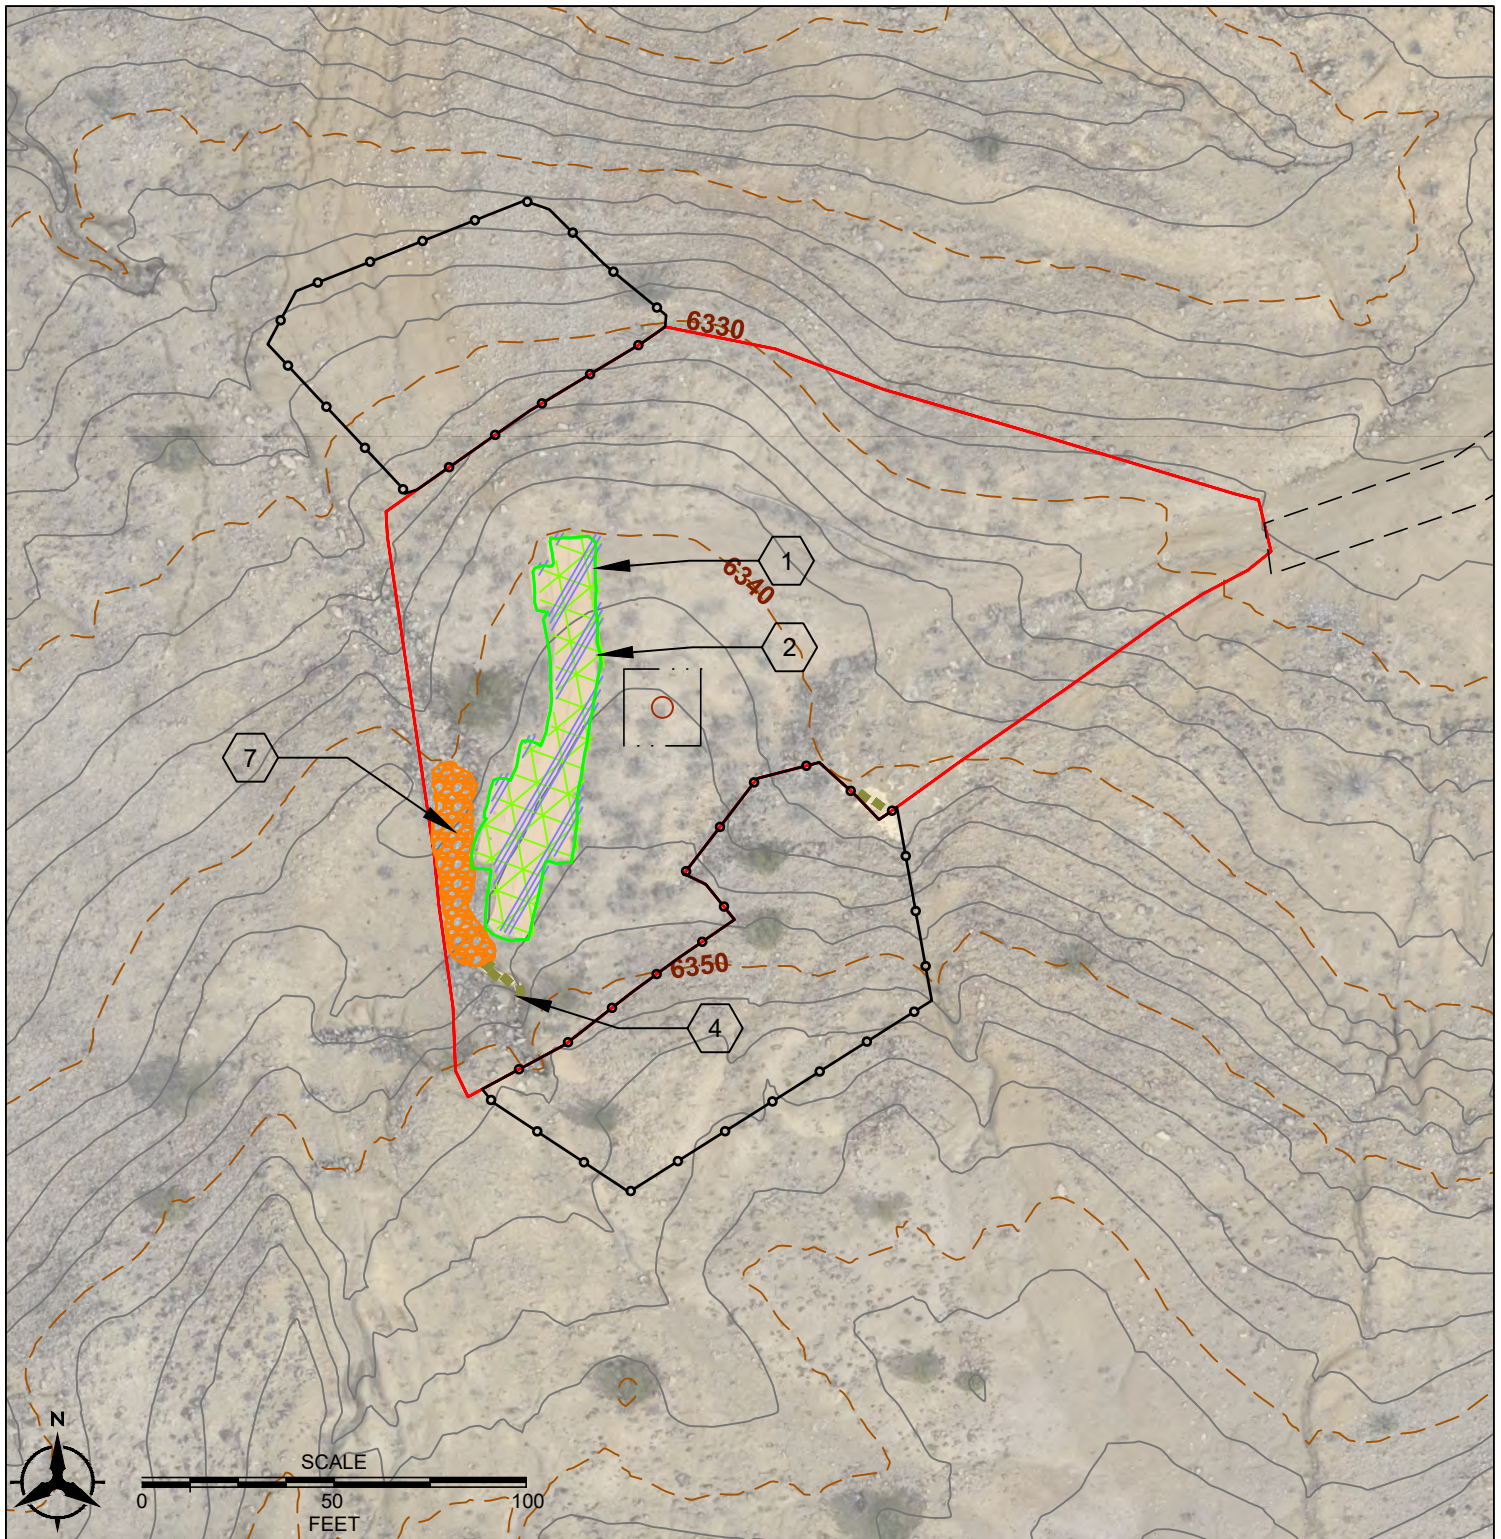
### INSTALLED MATERIAL SUMMARY
