July 17, 2026

Clint Chisler  
Senior Reclamation Specialist  
NM EMNRD Mining and Minerals Division  
Mining Act Reclamation Program  
Wendell Chino Building  
1220 S. St. Francis Dr.  
Santa Fe, New Mexico 87505

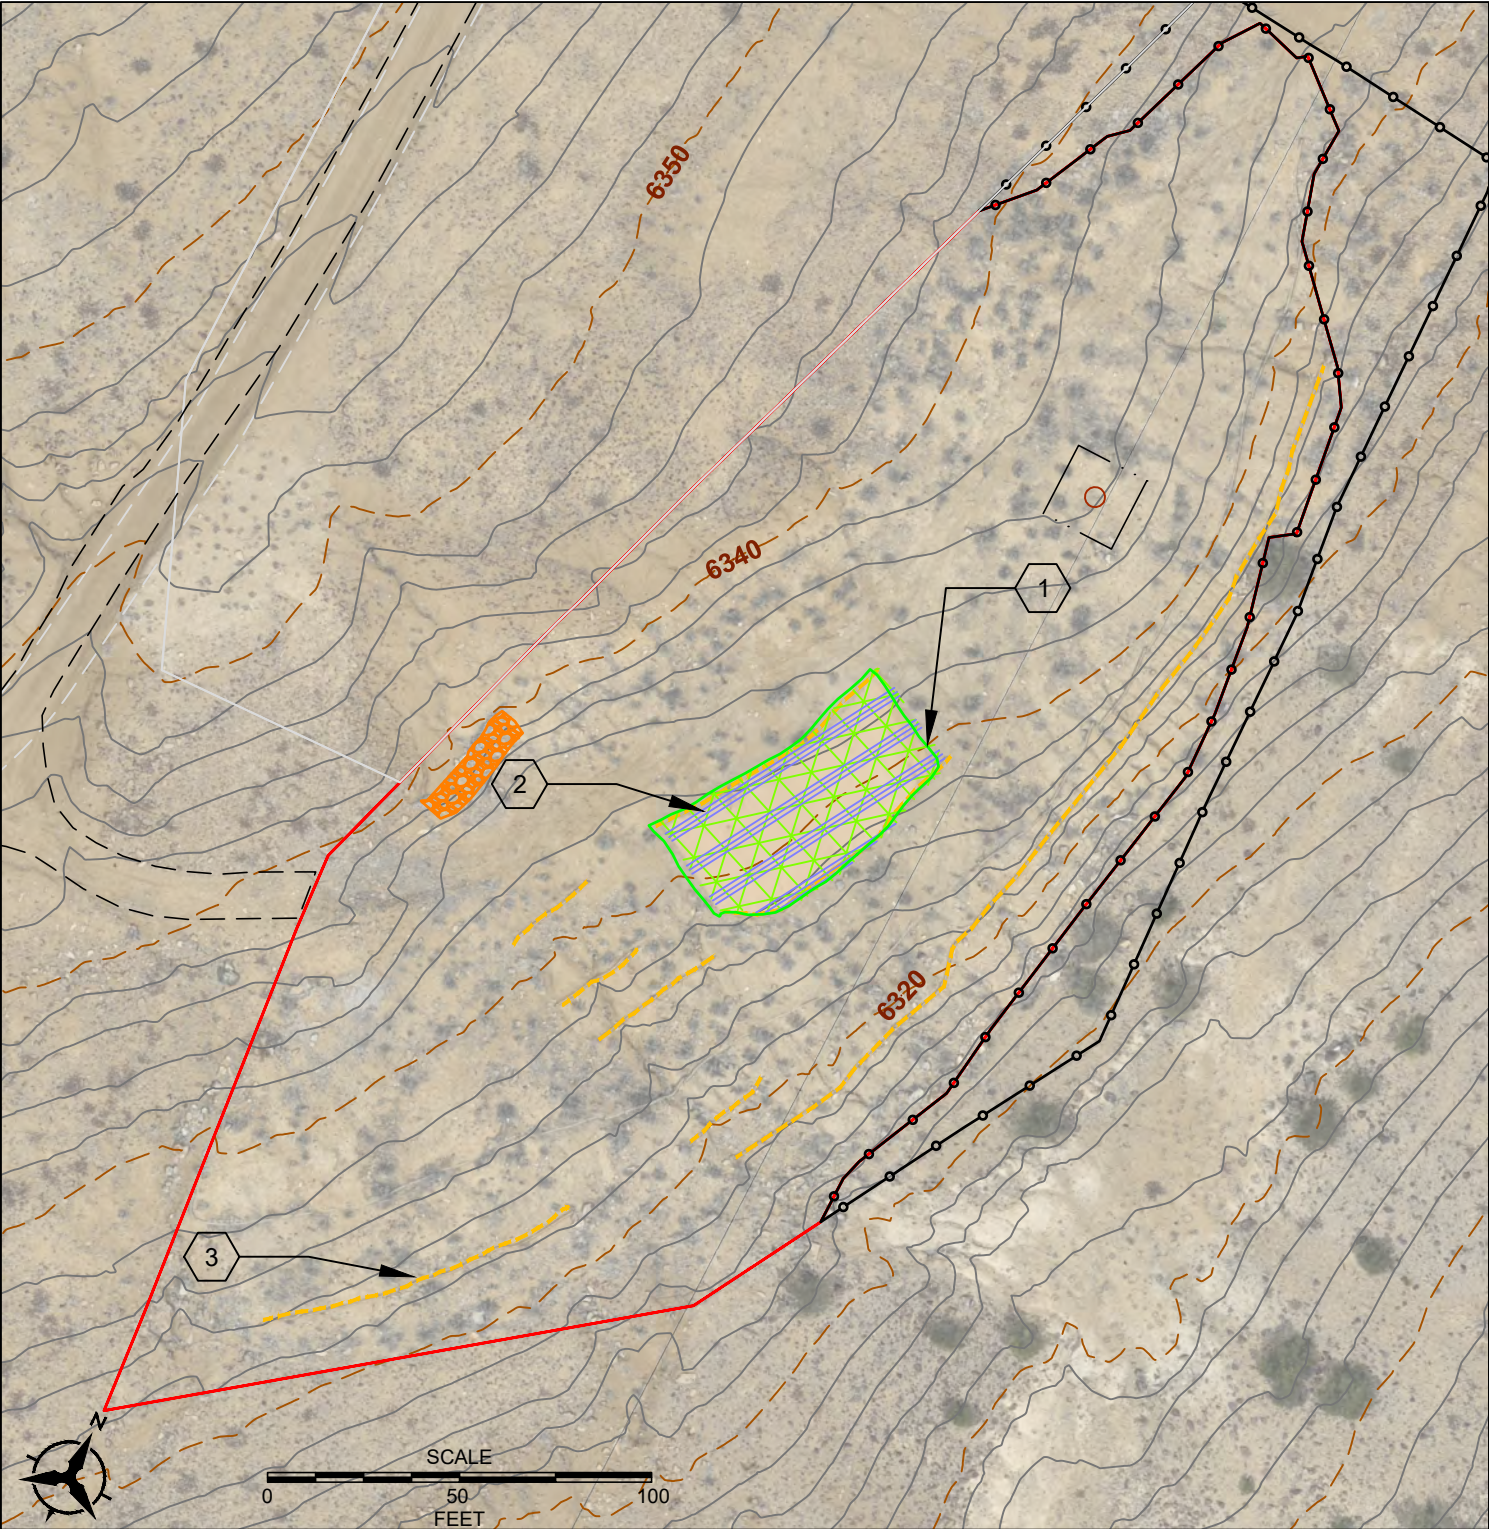
INSTALLED MATERIAL SUMMARY

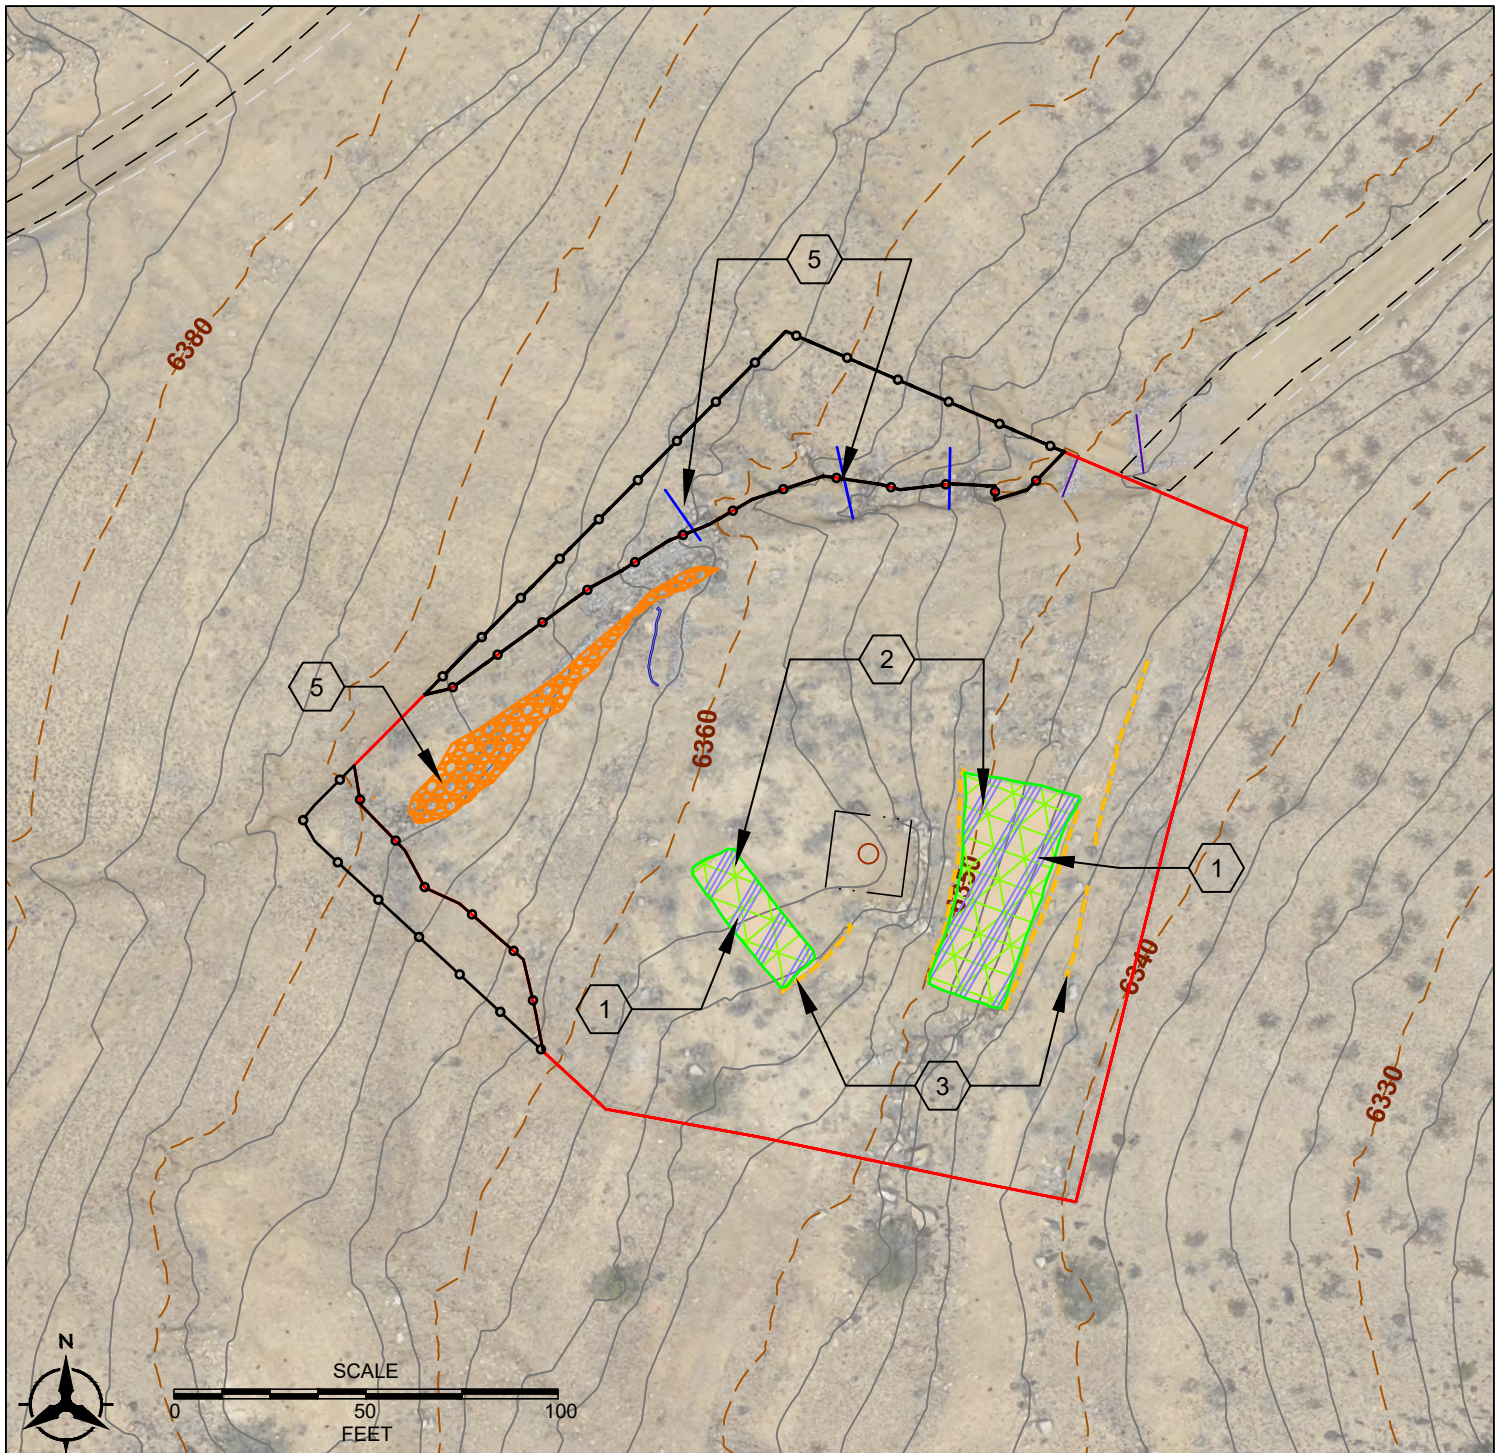
### INSTALLED MATERIAL SUMMARY

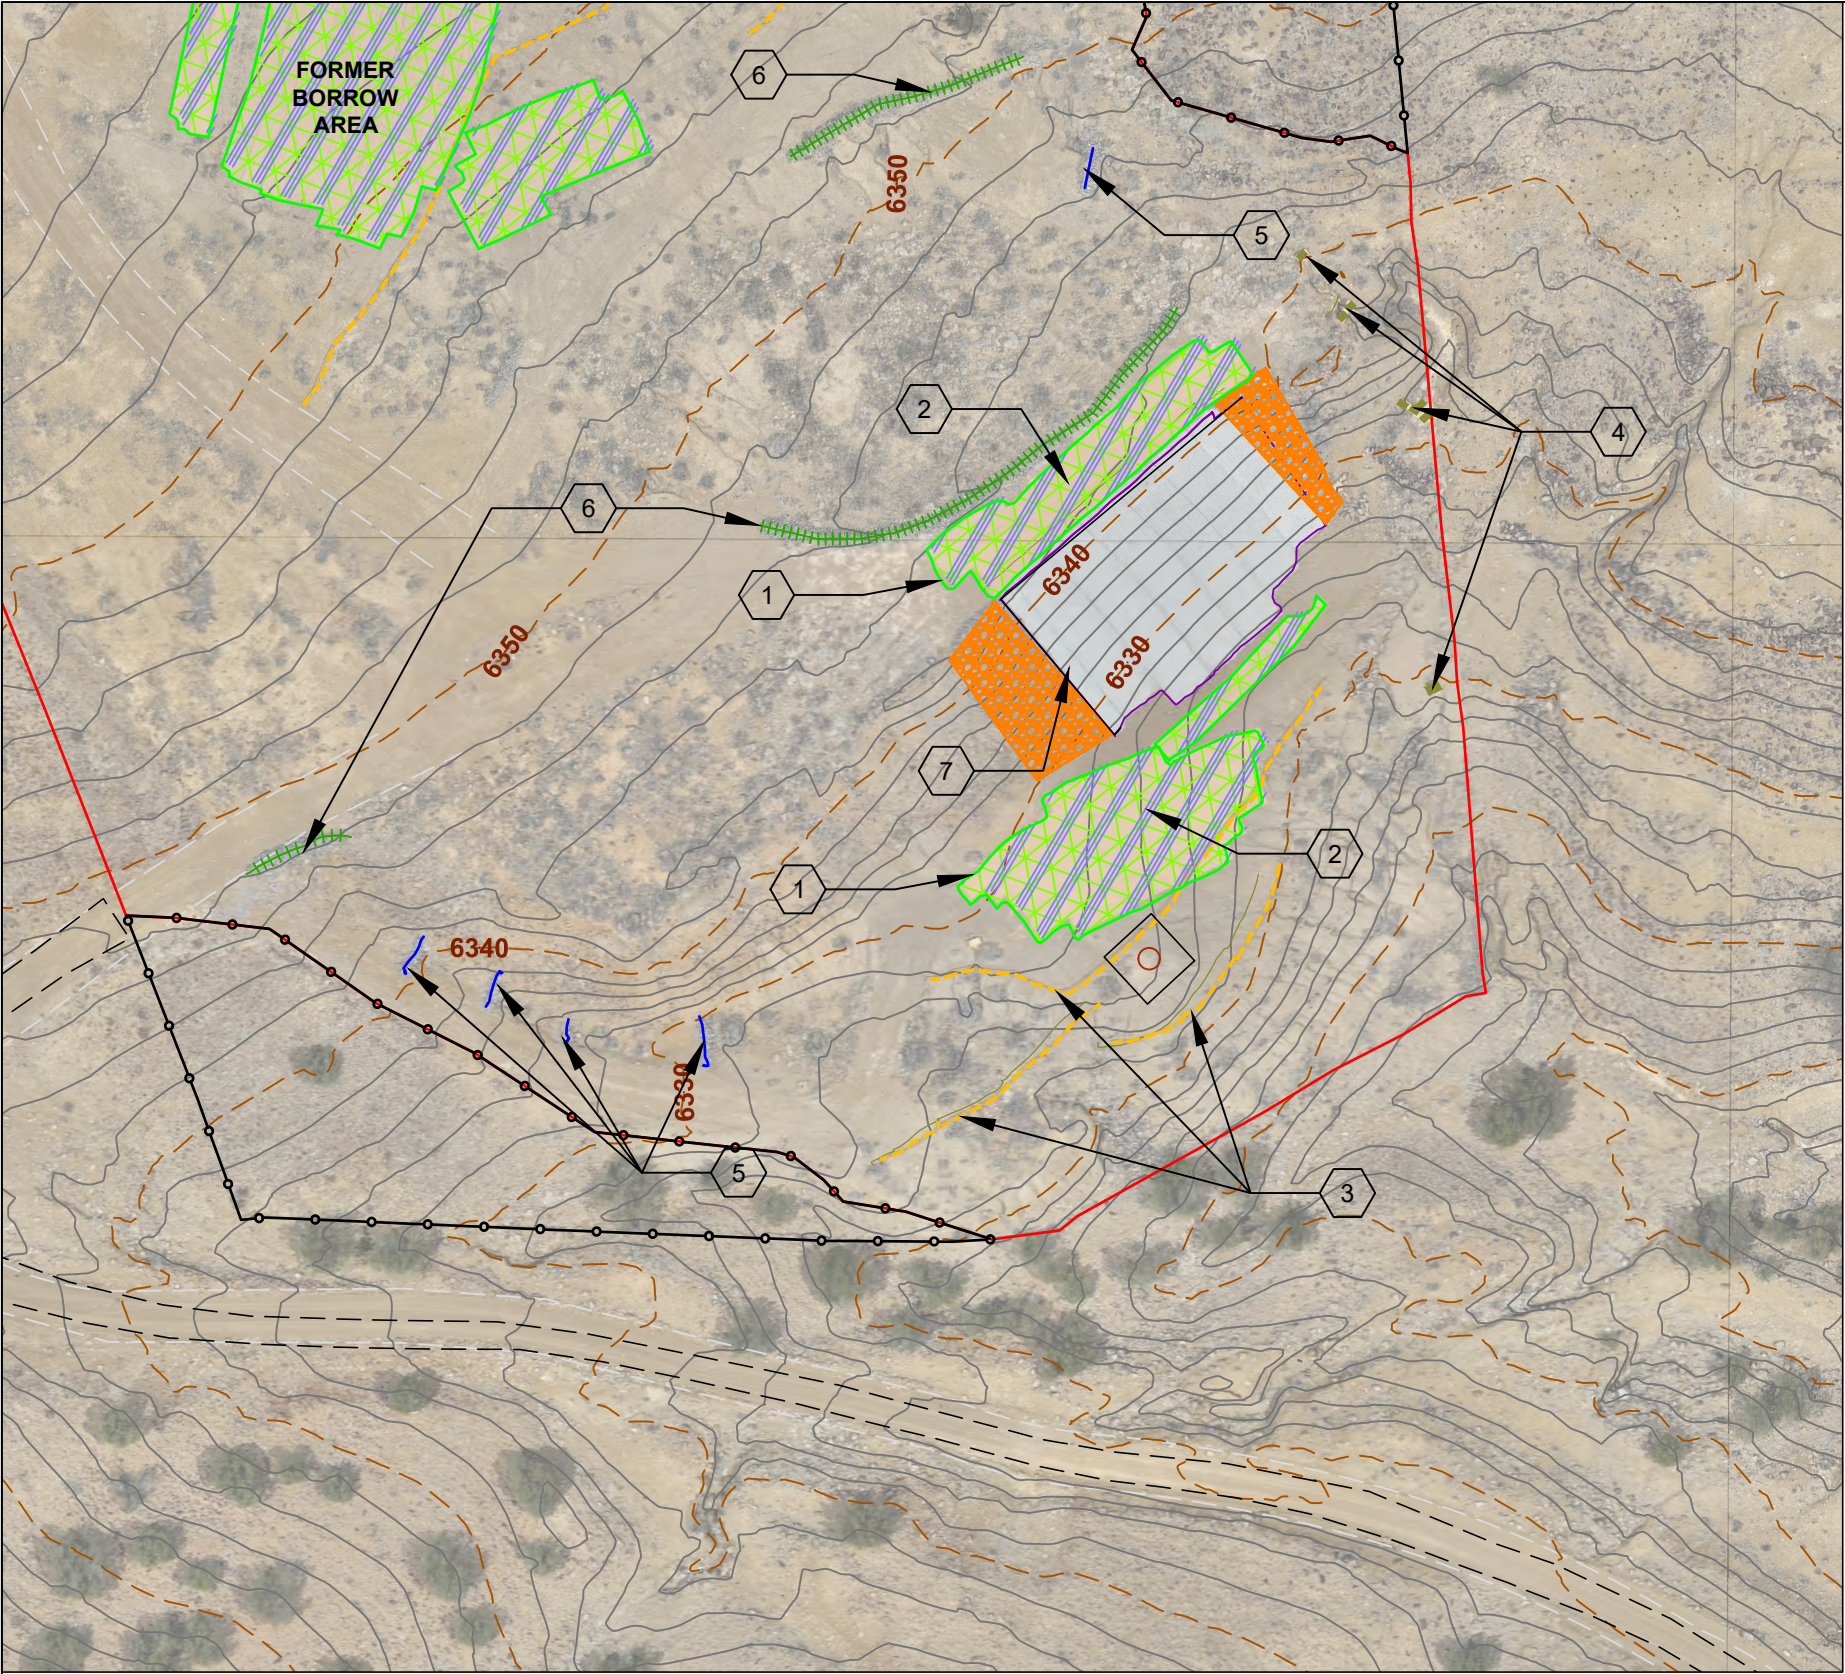
INSTALLED MATERIAL SUMMARY

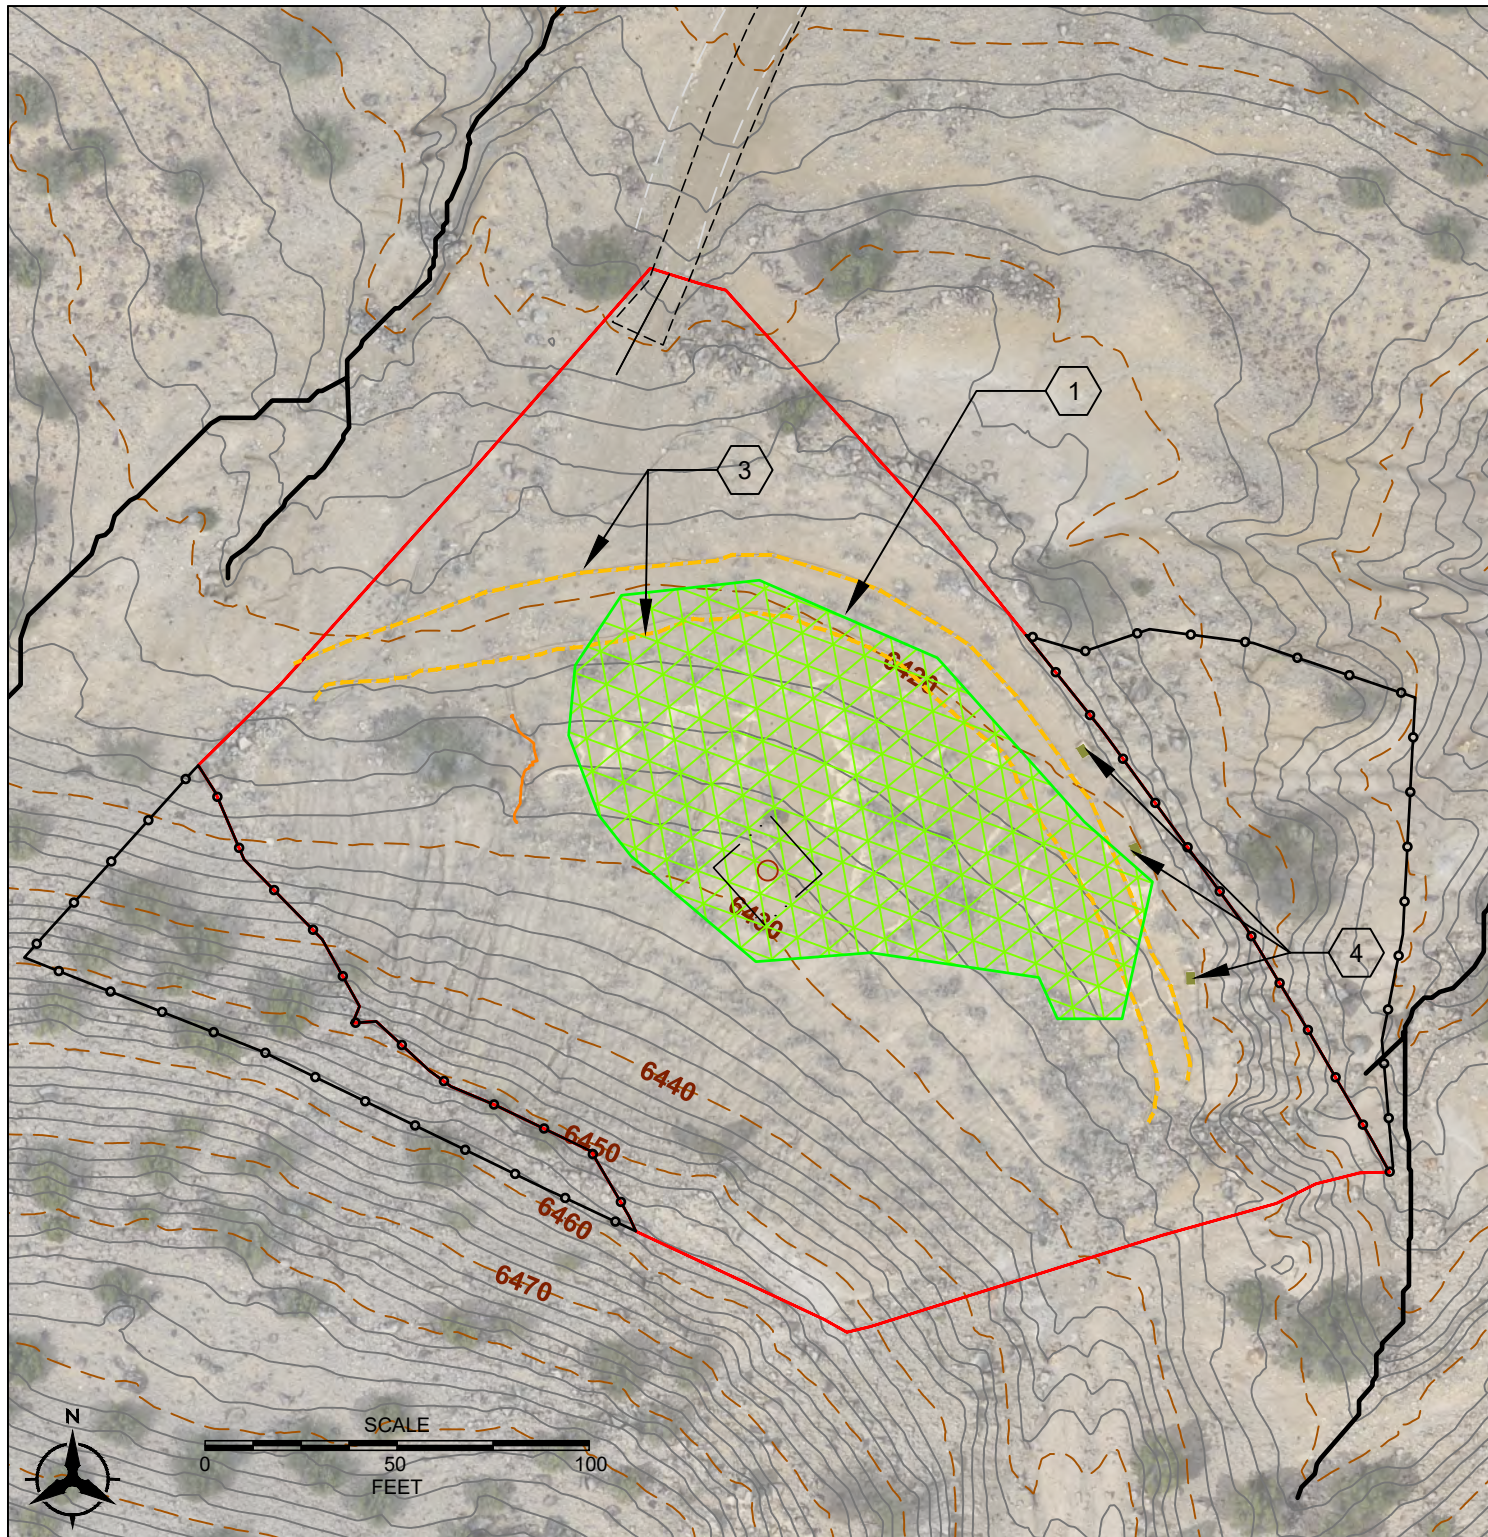
### INSTALLED MATERIAL SUMMARY

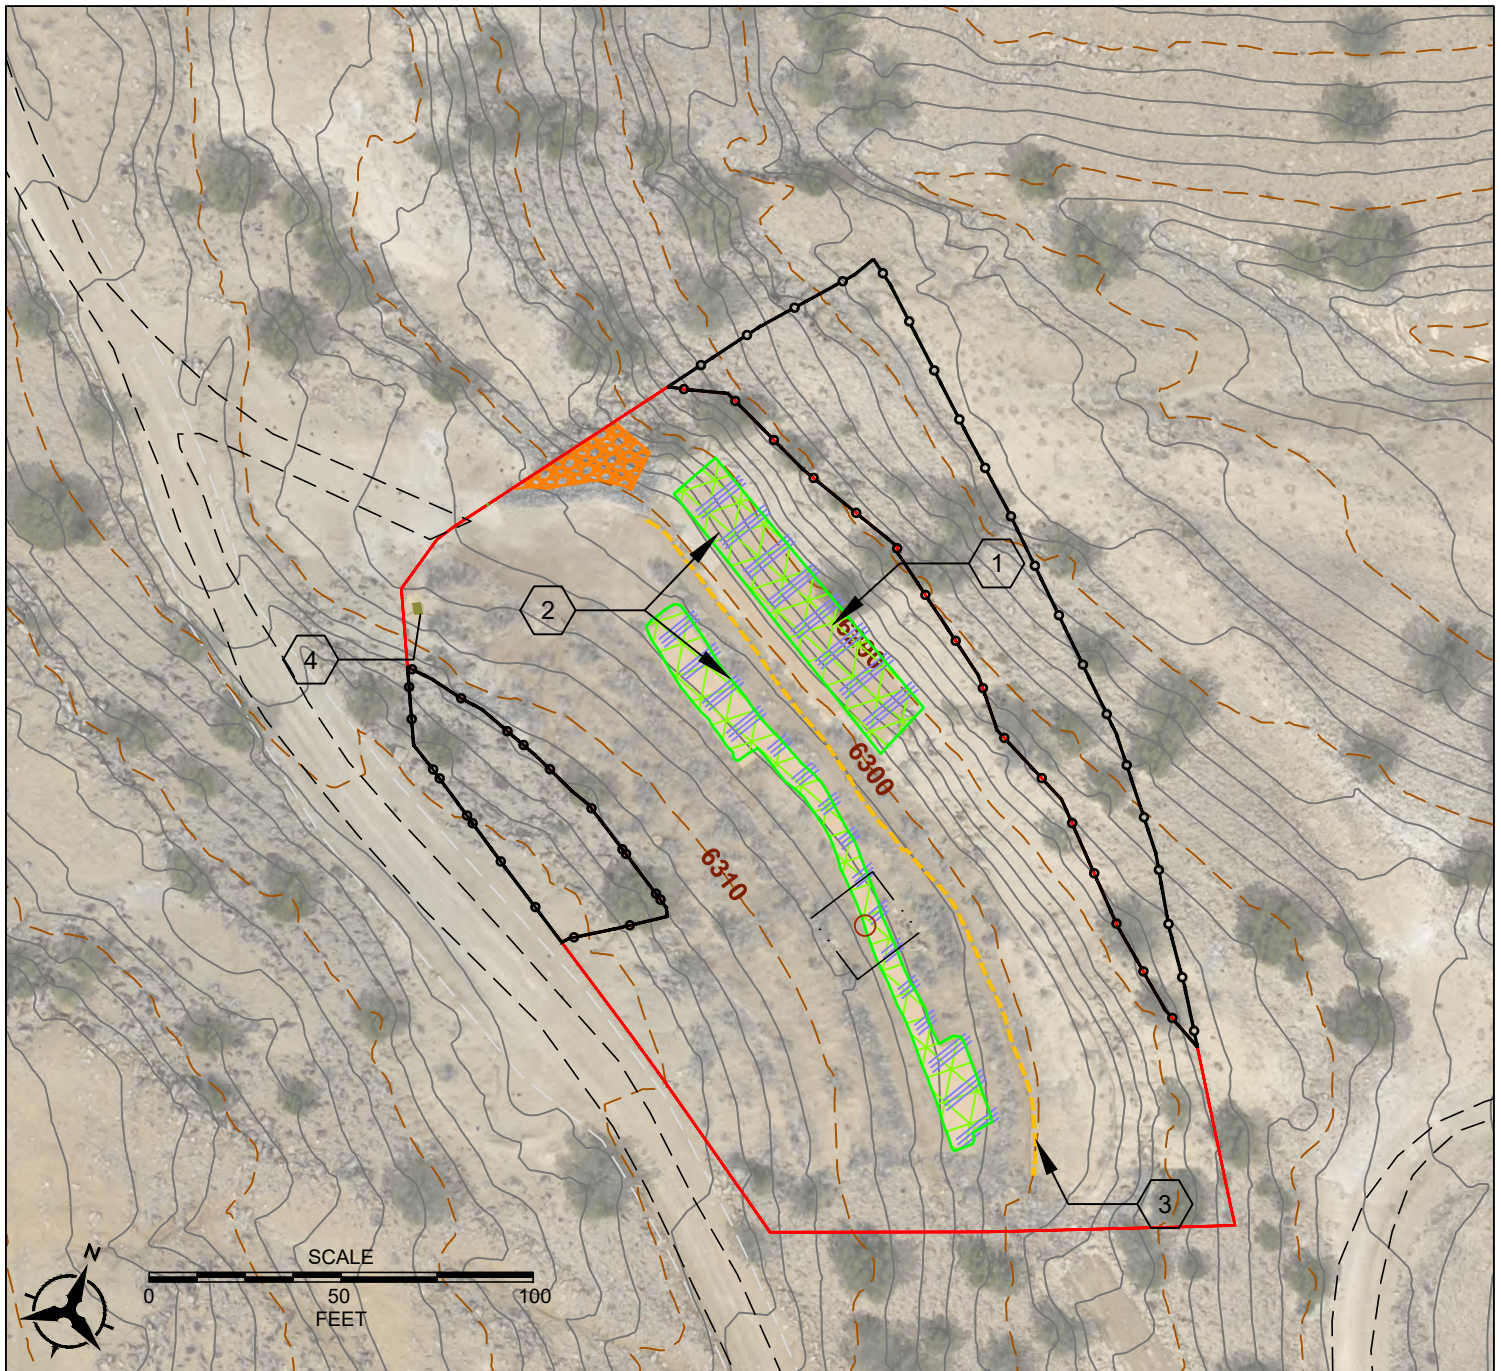
### INSTALLED MATERIAL SUMMARY

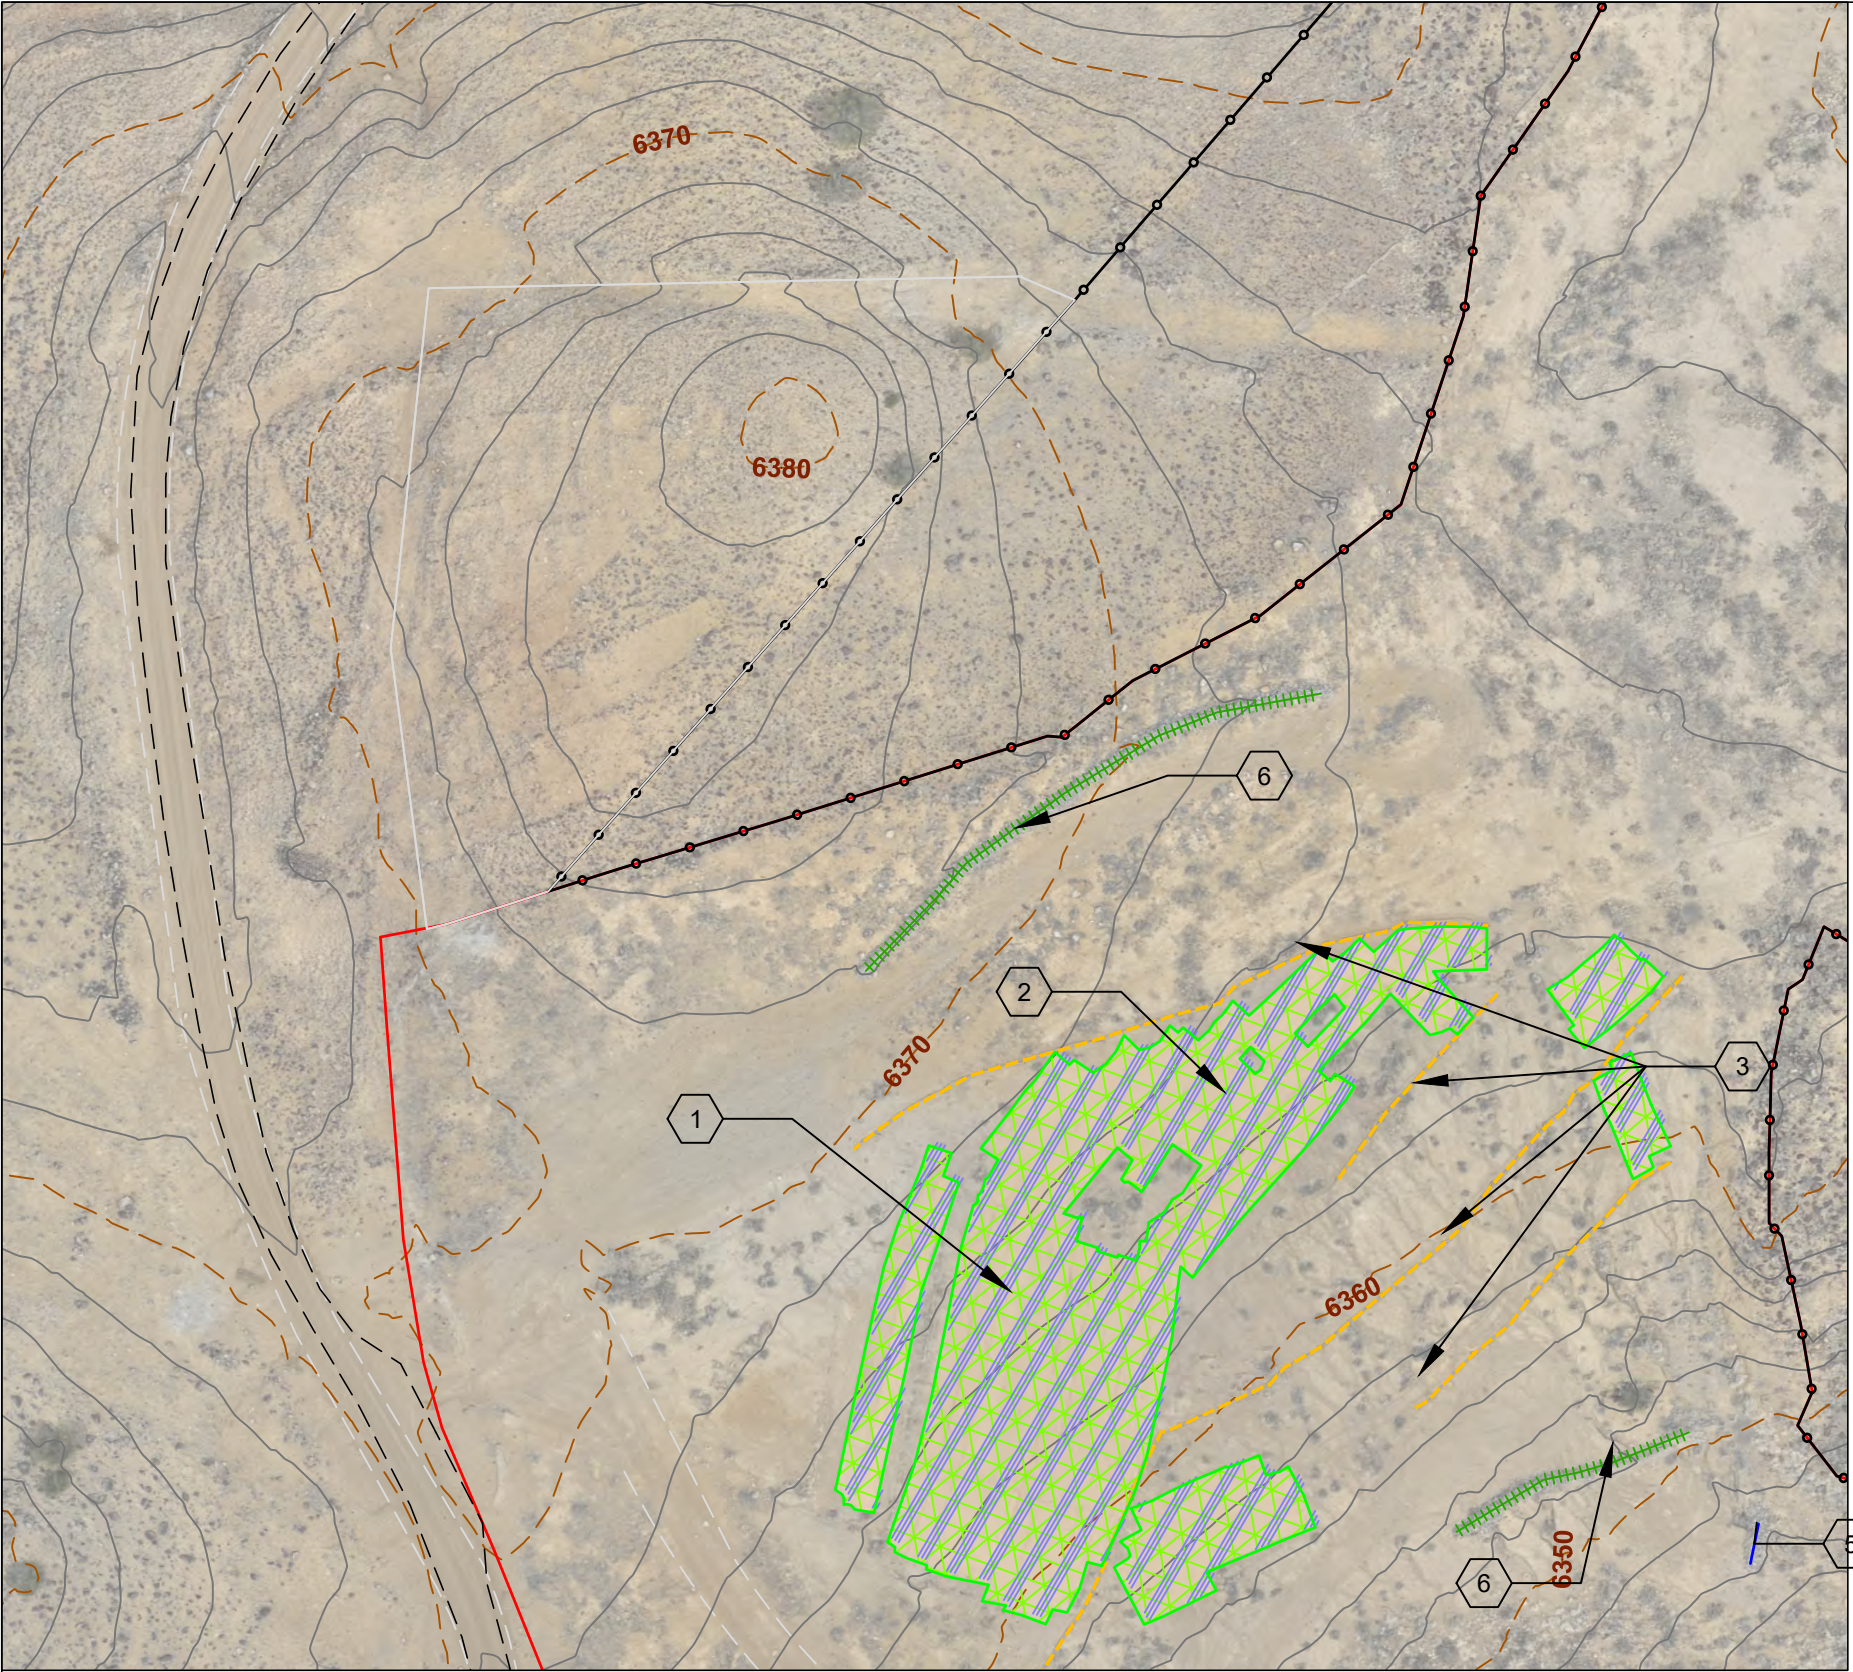
| INSTALLED MATERIAL SUMMARY | | | | | | | | | |

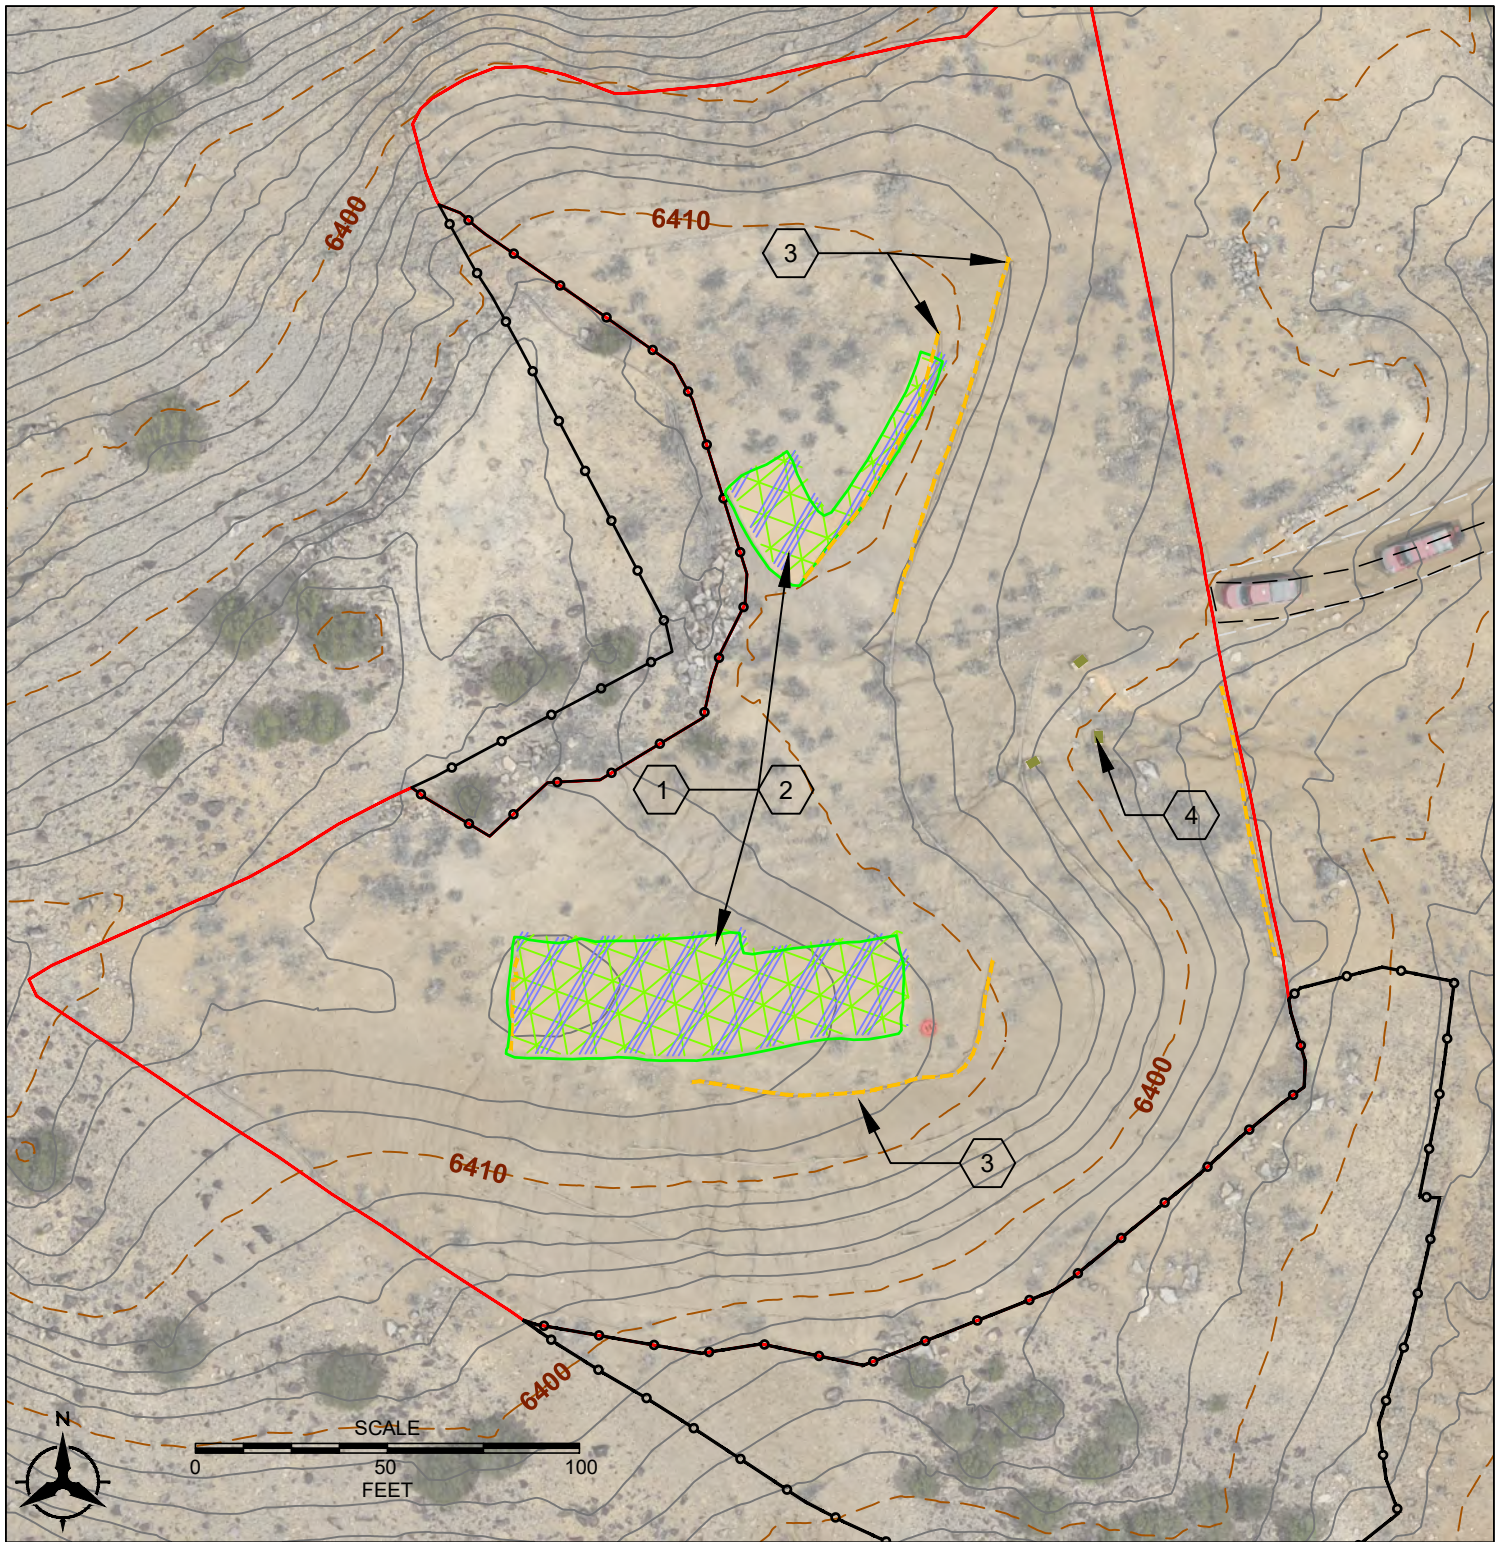
- KEYED NOTES:
1. SEE SEED MIXTURE SHEET 12.
  2. BIODEGRADABLE MATTING INSTALLED ALONG SLOPE ACCORDING TO SPECIFICATIONS IN APPENDIX D. SEE SHEET 13.
  4. STRAW BALES INSTALLED ACCORDING TO APPROVED SPECIFICATION. SEE SHEET 13.

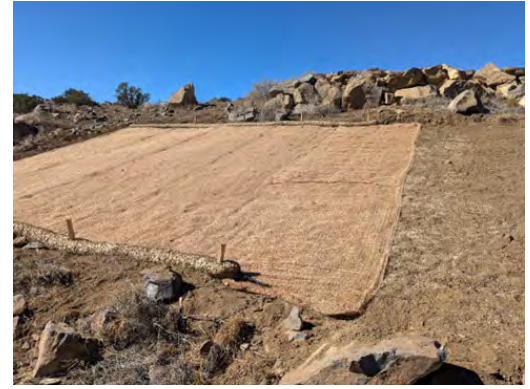
PHOTOGRAPH DEPICTING TYPICAL WATTLE AND BIODEGRADABLE MATTING.

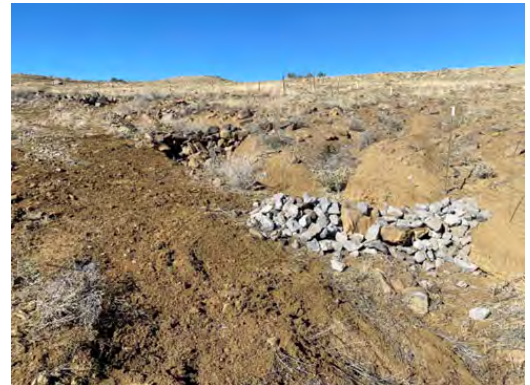
PHOTOGRAPH DEPICTING TYPICAL ROCK CHECK DAM REPAIR WORK.

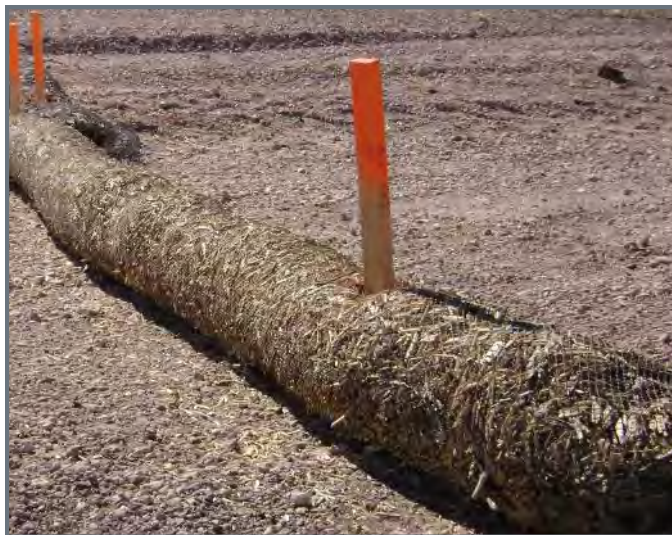
Titan ECO LOG wattles and socks are used as an effective and economical method of sediment control for newly constructed or disturbed areas. Titan produces ECO LOG wattles and socks by tightly packing wood chip compost media into a durable, photodegradable 9 inch diameter net or fabric sock, typically in 25 foot lengths. Additional sizes include 12 inch diameter in 15 foot lengths and 18 inch diameter in 10 foot lengths. Other diameters and lengths can be produced upon request.

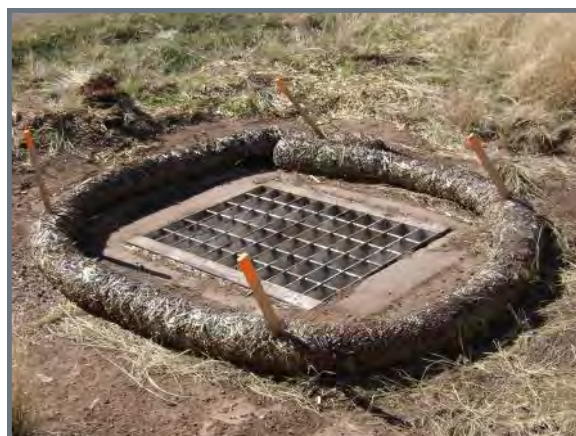
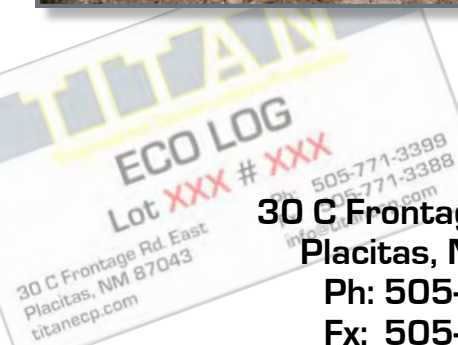
30 C Frontage Rd. East  
Placitas, NM 87043  
Ph: 505-771-3399  
Fx: 505-771-3388

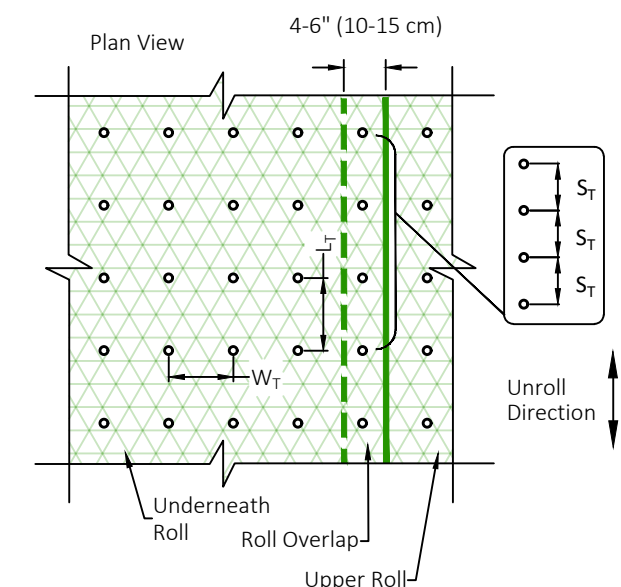
- Pin / Staple / Twist Pin, as appropriate for field conditions

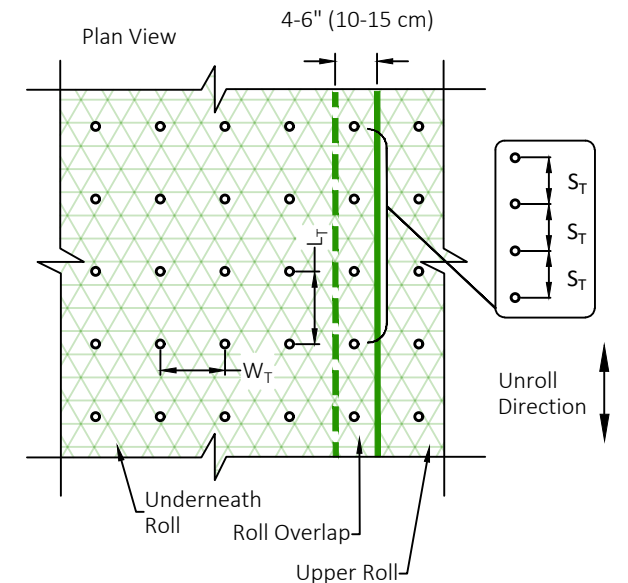
- Pin / Staple / Twist Pin, as appropriate for field conditions

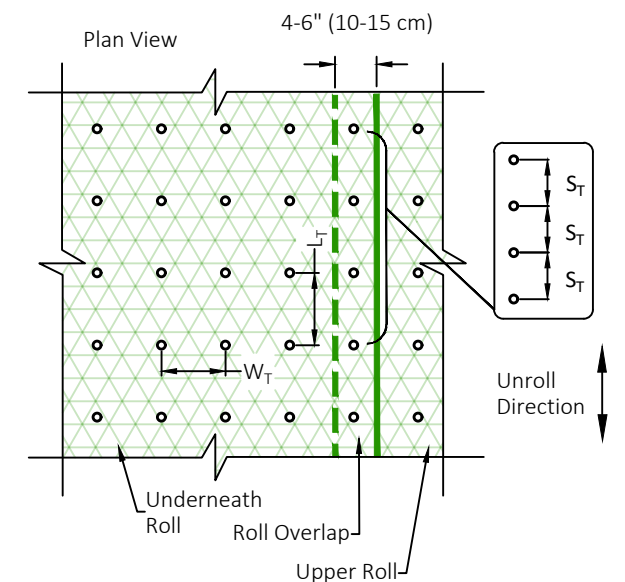
• Pin / Staple / Twist Pin, as appropriate for field conditions

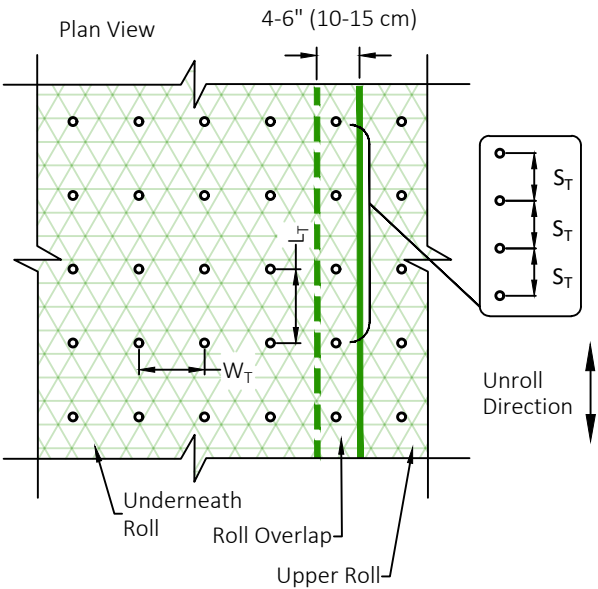
• Pin / Staple / Twist Pin, as appropriate for field conditions
