Gold Hill Mine Safeguard Project

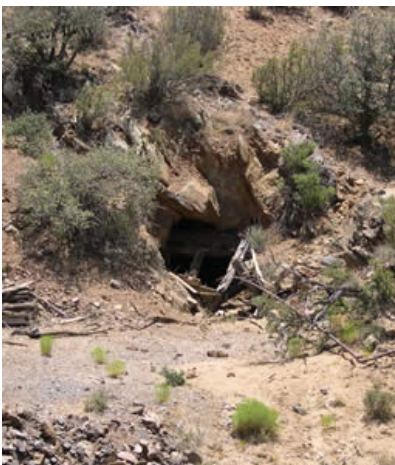
Crescent Mine

A very dangerous mine adit with unstable rock at

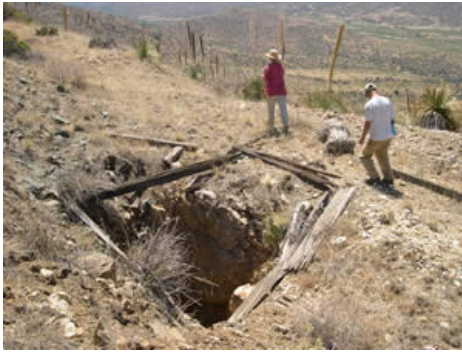
Comet Mine

A 40-ft shaft that turns into a lateral opening on the bottom. Bat were found to be using this feature.

The bat gate is built to allow bats to come and go while keeping curious humans out.

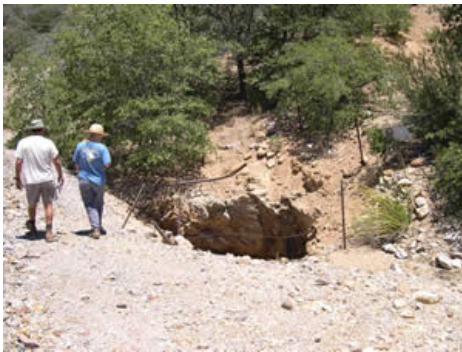
COOP Decline

Steeply declined adit that went down over an unknown depth. The limits were not explored for safety reasons.

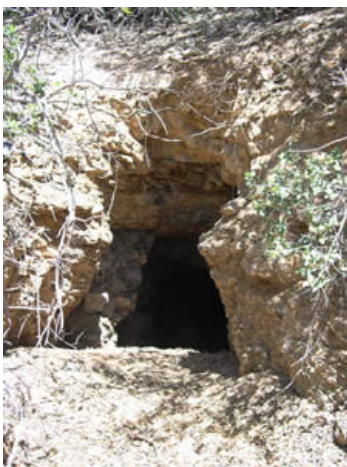
COOP Adit

Adit at the COOP Mine left in a dangerous condition.

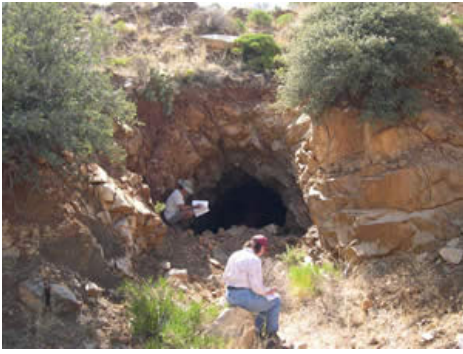
Abandoned adit with collapsing rock at the entrance.
