**REVISED OPEN PIT REMEDIATION PLAN,  
CUNNINGHAM HILL MINE RECLAMATION PROJECT  
ABATEMENT PLAN AP-27**

Steven T. Finch, Jr., CPG

**JOHN SHOMAKER & ASSOCIATES, INC.**  
Water-Resource and Environmental Consultants  
2611 Broadbent Parkway NE  
Albuquerque, New Mexico 87107  
505-345-3407  
[www.shomaker.com](http://www.shomaker.com)

August 2011

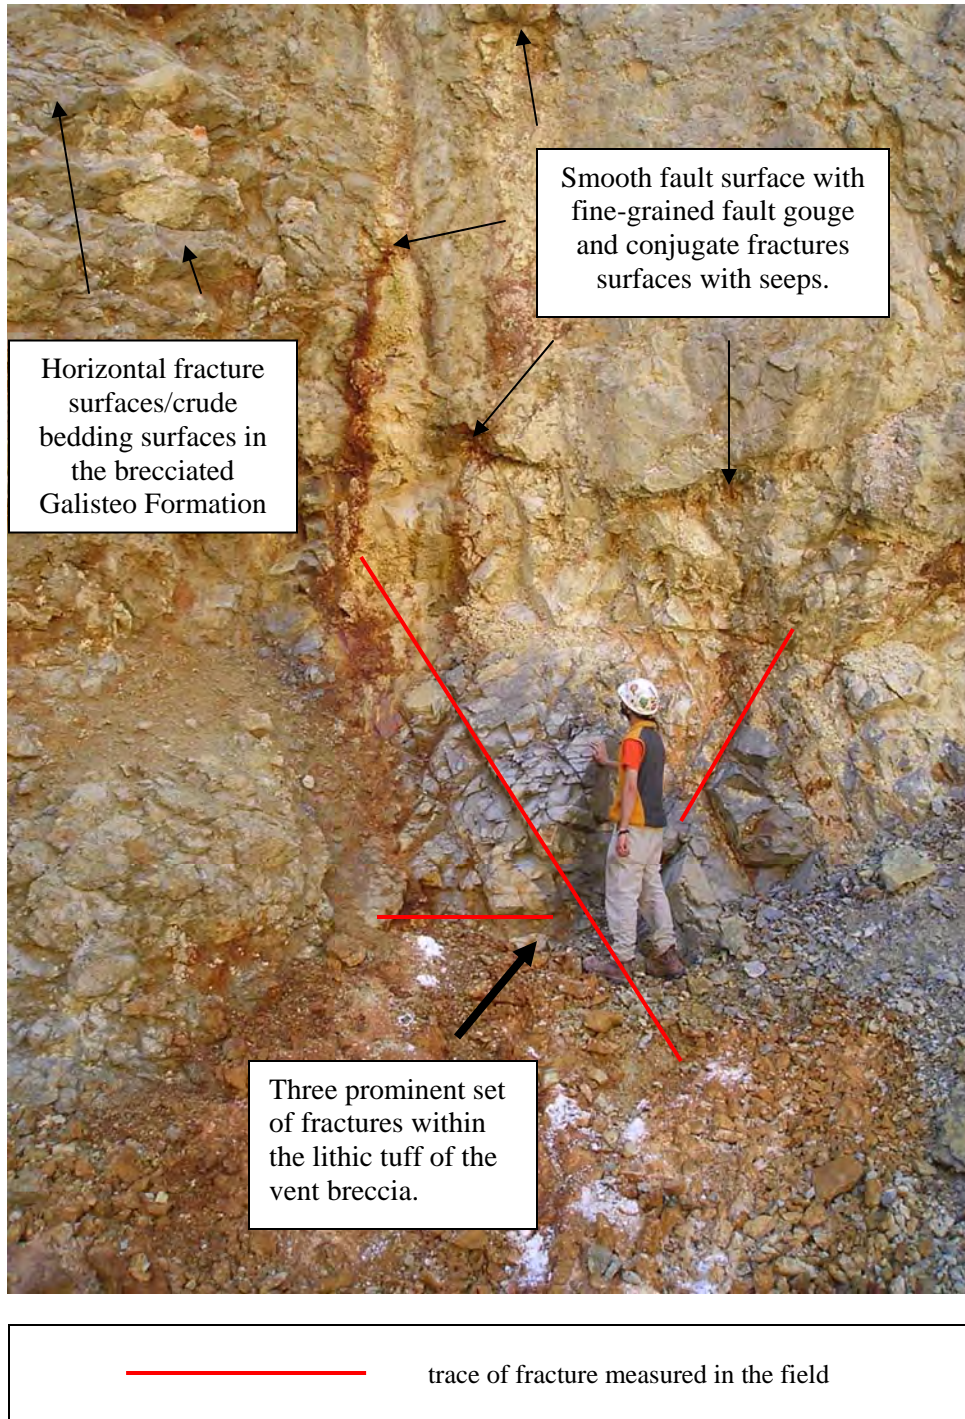
The easternmost of the north-trending faults cuts the eastern pit wall above the seep identified along the northeast pit wall (about 20 ft above pit lake level; Figure 1). JSAI's mapping in addition identified a northeast-southwest (070°) sub-vertical fracture surface cutting the northeast pit wall. Its intersection with the north-trending fault above the northeast pit wall seep, in addition to intersecting bedding planes in the sedimentary rocks that dip to the southwest, toward the pit may result in seepage at the northeast pit wall.

Figure 1. Photograph of fault surface and three set of fractures found within the Galisteo Formation near the intrusive contact with the quartz latite, at the northeast Cunningham Hill Mine pit wall, Santa Fe County, New Mexico.

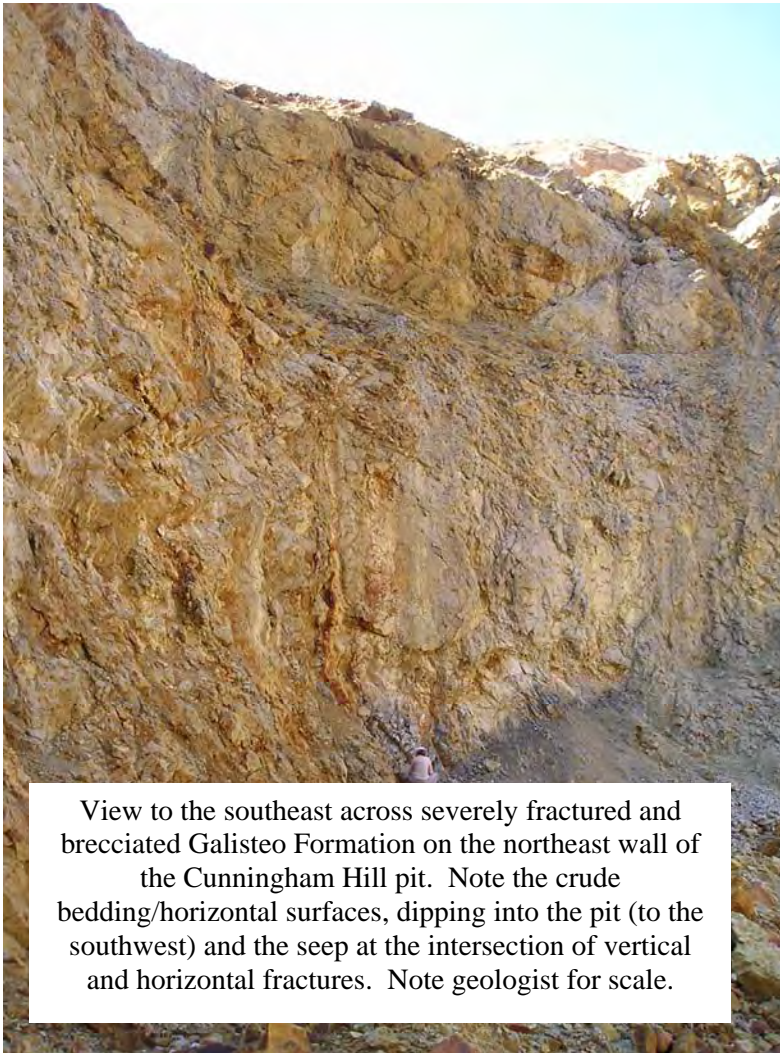
Figure 2. Photographs of fractures found within and near the Cunningham Hill Mine, Santa Fe County, New Mexico.

The fracture orientations measured in the field were analyzed statistically using the freeware EZ-ROSE 1.0 (see Baas, 2000). The sum of the data is statistically uniform, showing no preferred orientation. Separated out by lithology the data are also uniform. The Galisteo Formation data fall into three sub-vertical orientations including the following: 1) north-south 160° to 208°, 2) northwest-southeast 105° to 110°, and 3) northeast-southwest 053 to 070° azimuth. The third orientation corresponds closely to the fracture orientation of between 060° and 070° identified by Myers (2008). The primary fracture orientation in the lithic tuff is north-south, and includes a set of conjugate fractures. In addition to these sub-vertical orientations, a sub-horizontal fracture surface was identified in the metamorphosed sedimentary rocks and loosely corresponds to a bedding surface that according to Maynard (2002) dips variably to the west and south. Intersections between the sub-horizontal surface and sub-vertical fractures may provide preferential pathways for fluid-flow. Indeed, seeps are located near these intersecting fractures (Figure 2).

View to the southeast across severely fractured and brecciated Galisteo Formation on the northeast wall of the Cunningham Hill pit. Note the crude bedding/horizontal surfaces, dipping into the pit (to the southwest) and the seep at the intersection of vertical and horizontal fractures. Note geologist for scale.

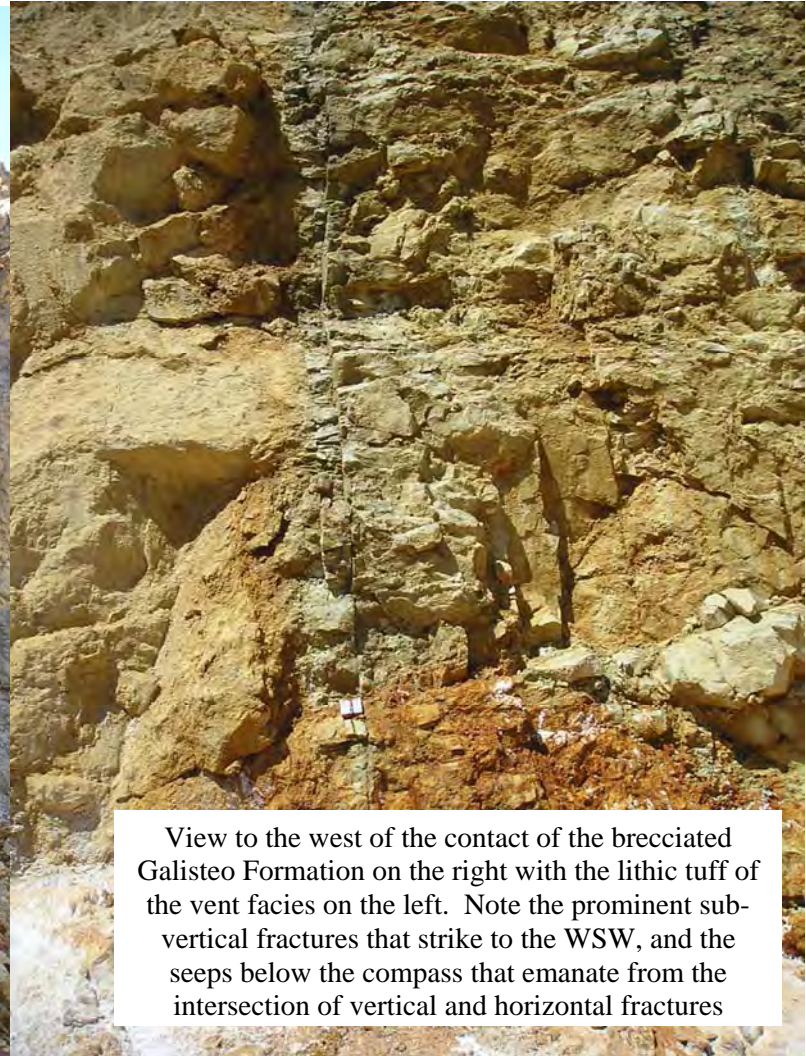
View to the west of the contact of the brecciated Galisteo Formation on the right with the lithic tuff of the vent facies on the left. Note the prominent sub-vertical fractures that strike to the WSW, and the seeps below the compass that emanate from the intersection of vertical and horizontal fractures

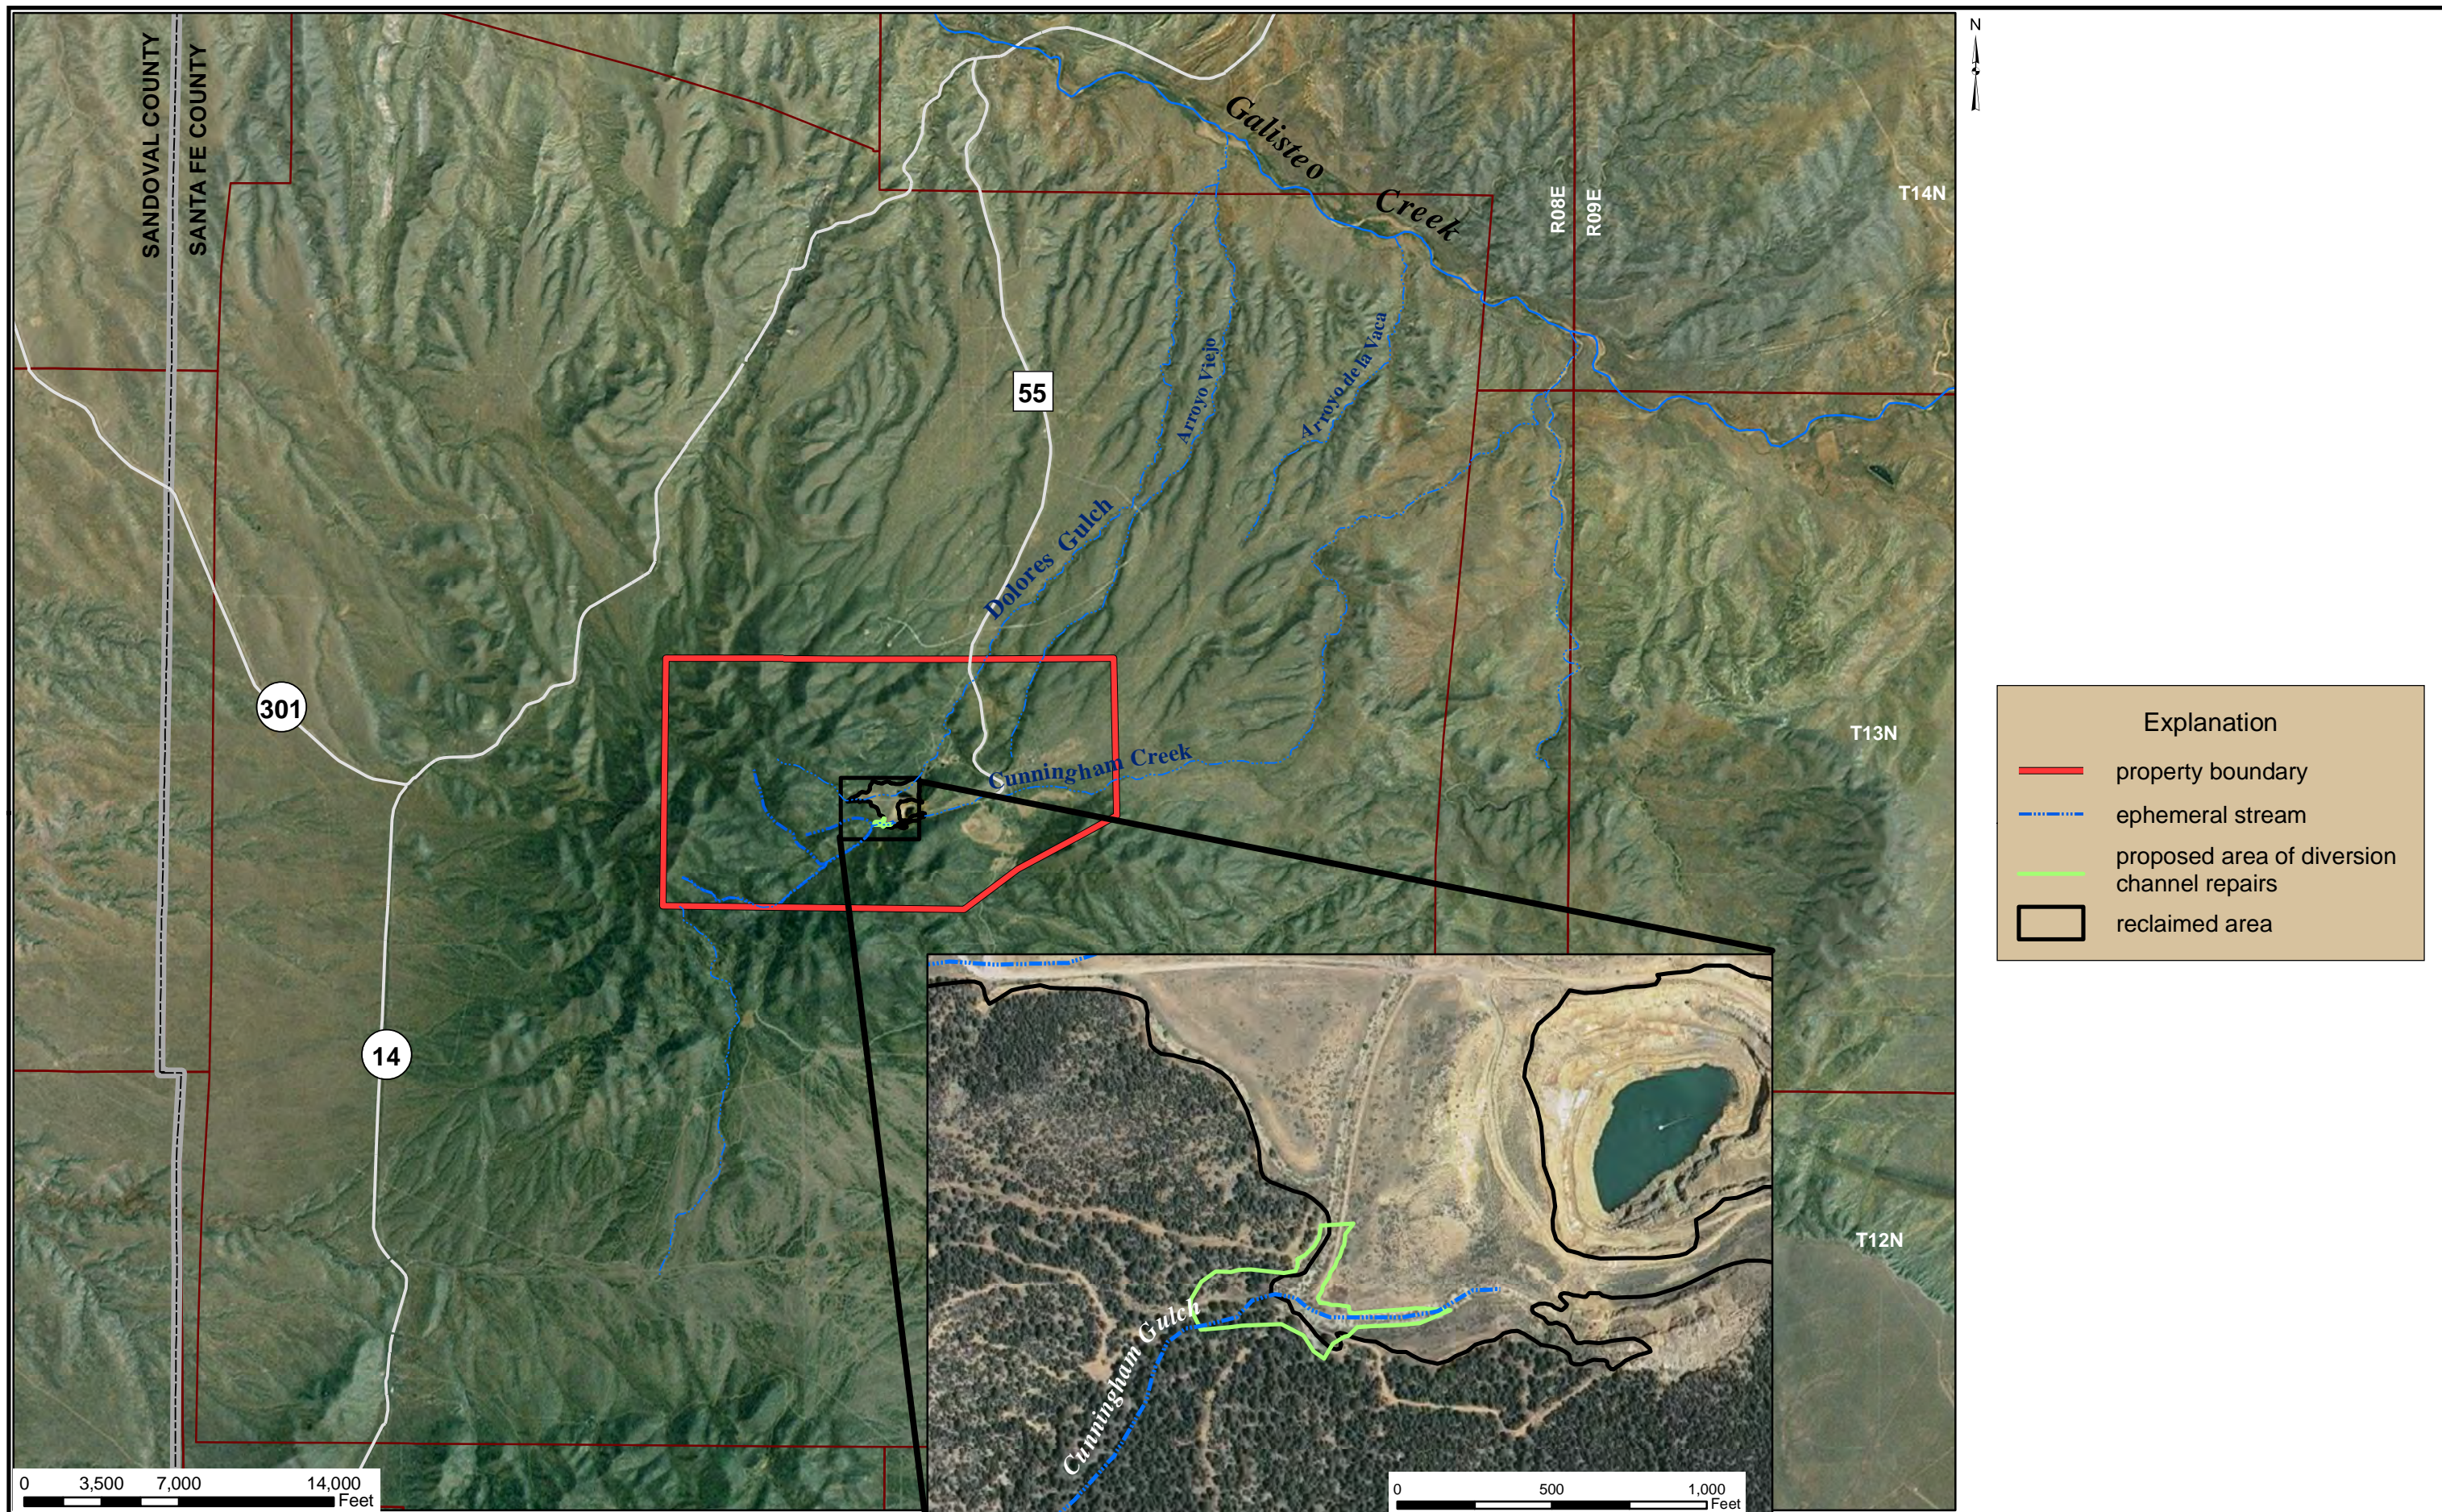
NMED AP-27 permit condition 3 states "LAC shall routinely inspect the Upper Cunningham Gulch diversion, and perform maintenance as necessary, to insure protection of water quality." LAC has identified a land surface depression near the Upper Cunningham Gulch diversion that ponds and infiltrates stormwater. The infiltrated stormwater reports as acid wall seepage in the open pit. The depression is a result of subsided disturbed topography related to the former open pit mine that was not adequately addressed during the 1996 post-mining land surface reclamation. LAC proposes to fill in the land surface depression to improve stormwater flow in the channel. The proposed diversion channel maintenance is within the area shown on the attached map.

Map showing location of proposed area of diversion channel repairs in Upper Cunningham Gulch, Cunningham Hill Mine Reclamation Project, Santa Fe County, New Mexico.

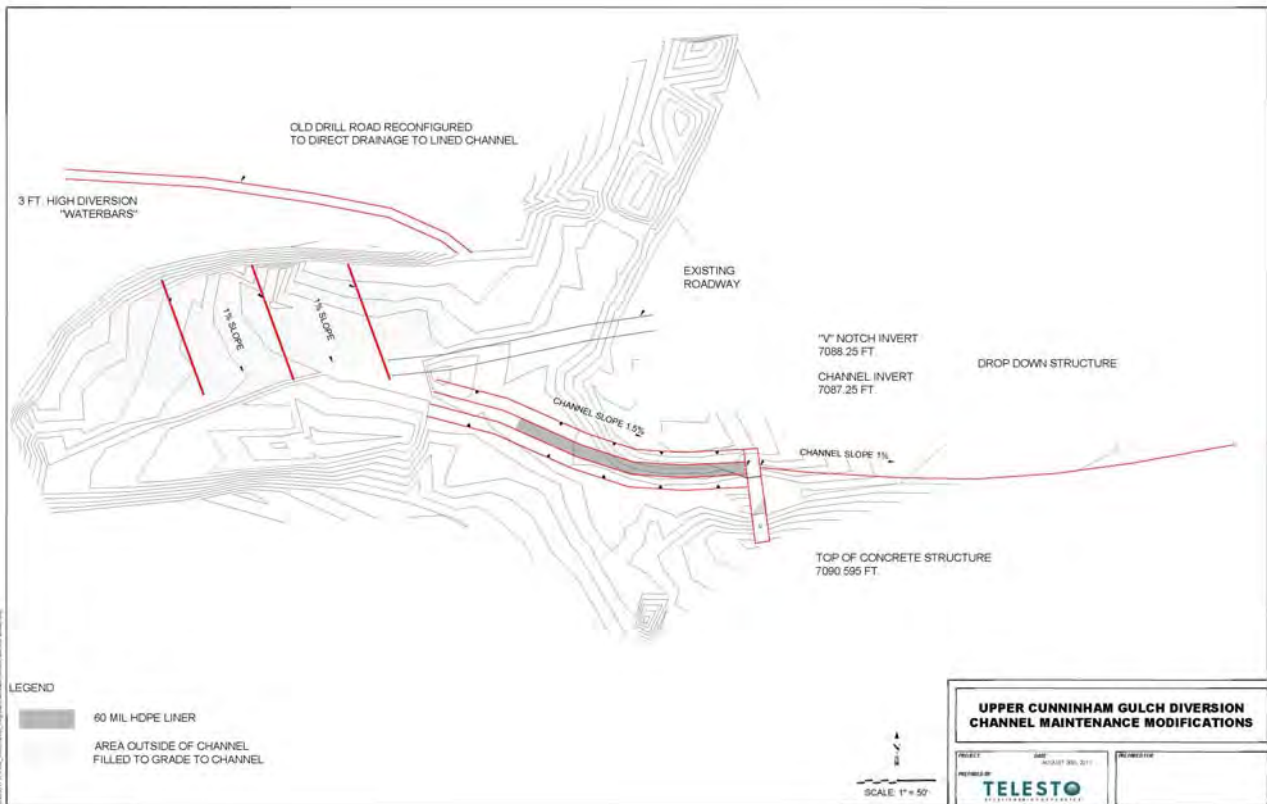
**Figure 1. Cunningham Gulch Drainage and Weir Maintenance Project**

A depression outside and to the north of the channel upgradient of the weir was believed to be retaining storm water. During high storm events water would infiltrate into the ground and was believed to migrate downgradient and contact a near vertical, structural mineralized vein system before emptying into the pit.

To complete the project, an old roadway located at the top of the ridge above the channel to the north was reworked to route any flows into the main lined channel that leads to the Upper Cunningham Gulch Diversion Channel, downgradient of the existing constructed berm in that channel. This will prevent water from the old roadway from discharging into the fill area below which is north of the main Cunningham Gulch Channel, and will not be directed into the lined and armored channel of Cunningham Gulch.

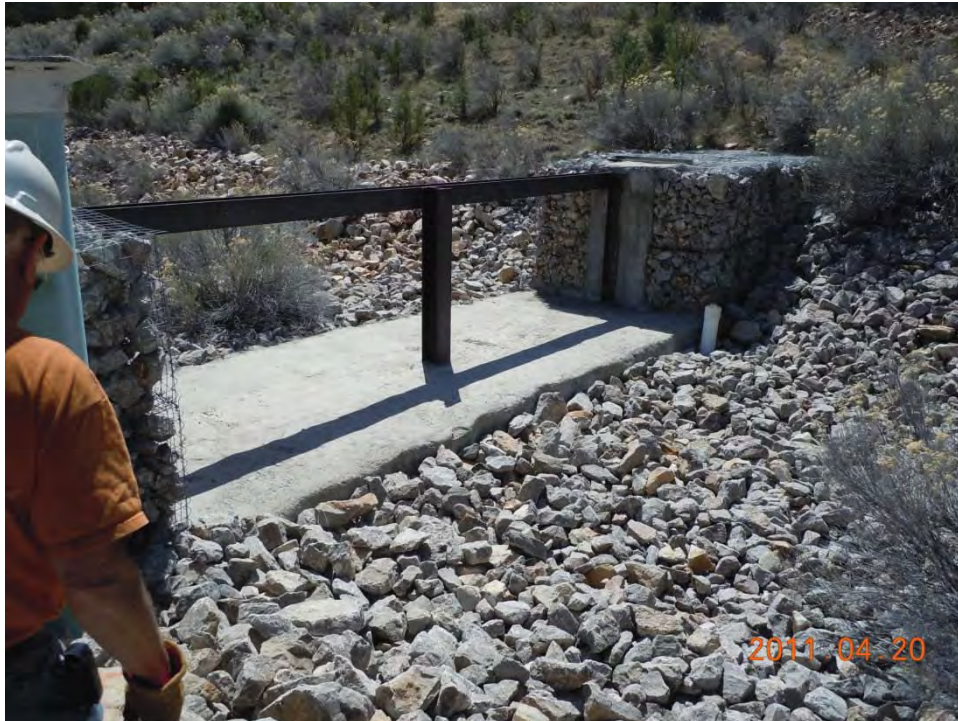
Cunningham Gulch Channel concrete weir with riprap prior to maintenance work.

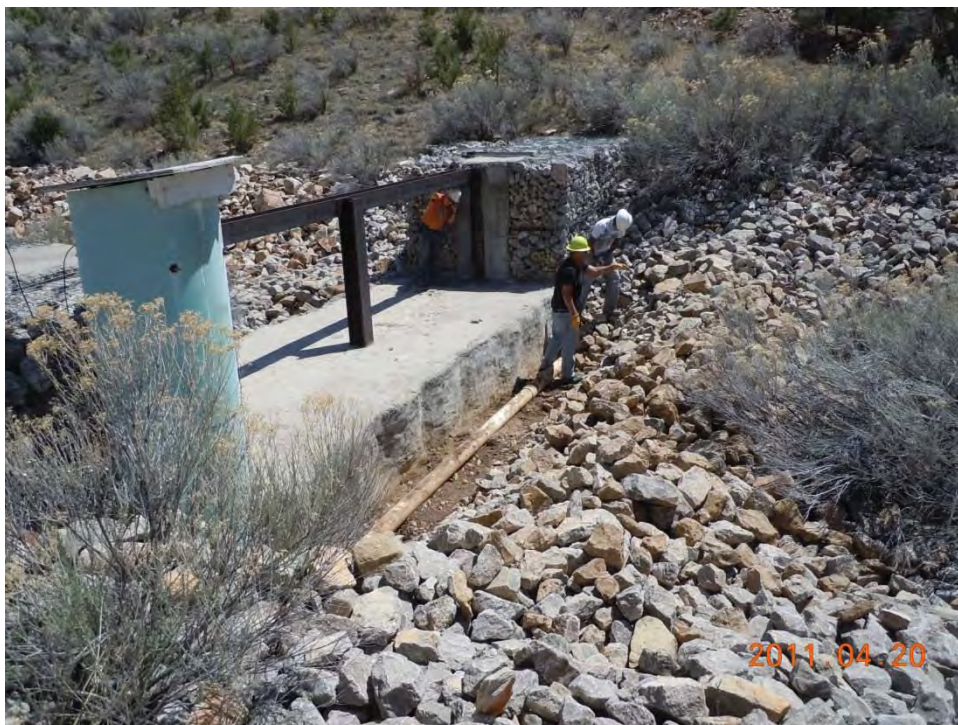
Upgradient face of existing concrete weir with riprap removed.

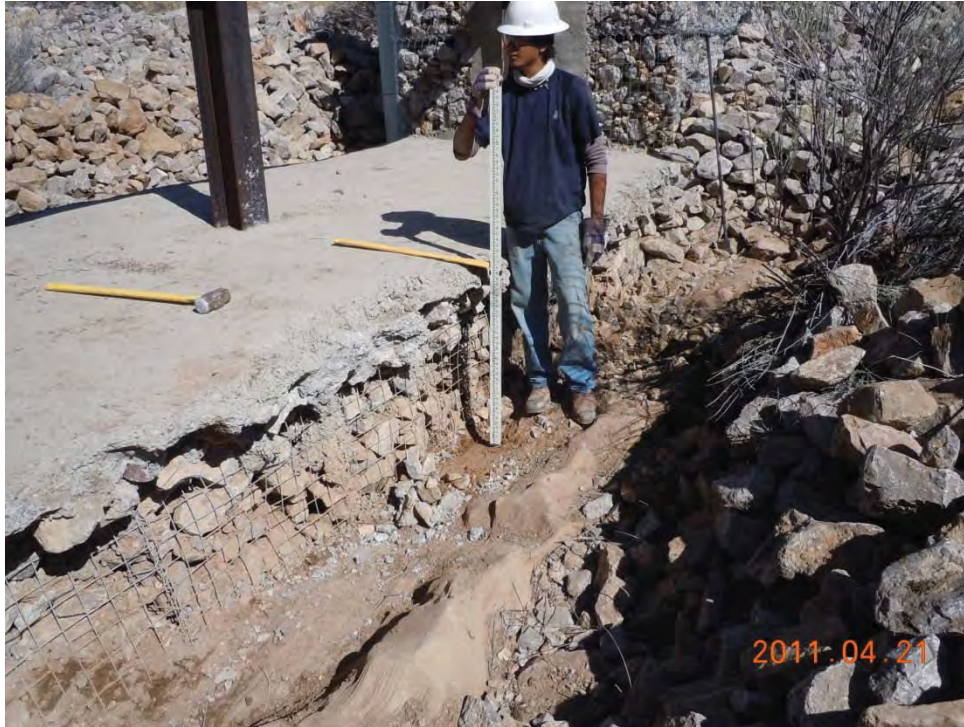
Downgradient side of existing weir. Concrete over gabion basket with riprap.
