TECHNICAL MEMORANDUM

To:	Andrew Conover
From:	Marcus Erdmann
Reviewed B	y: Ryan T. Baker, P.E.
Project:	Summit Mine DMS Slide Corrective Action
Project No:	475.0386.000
Subject:	Summit Mine QA/QC Report
Date:	25 January 2019

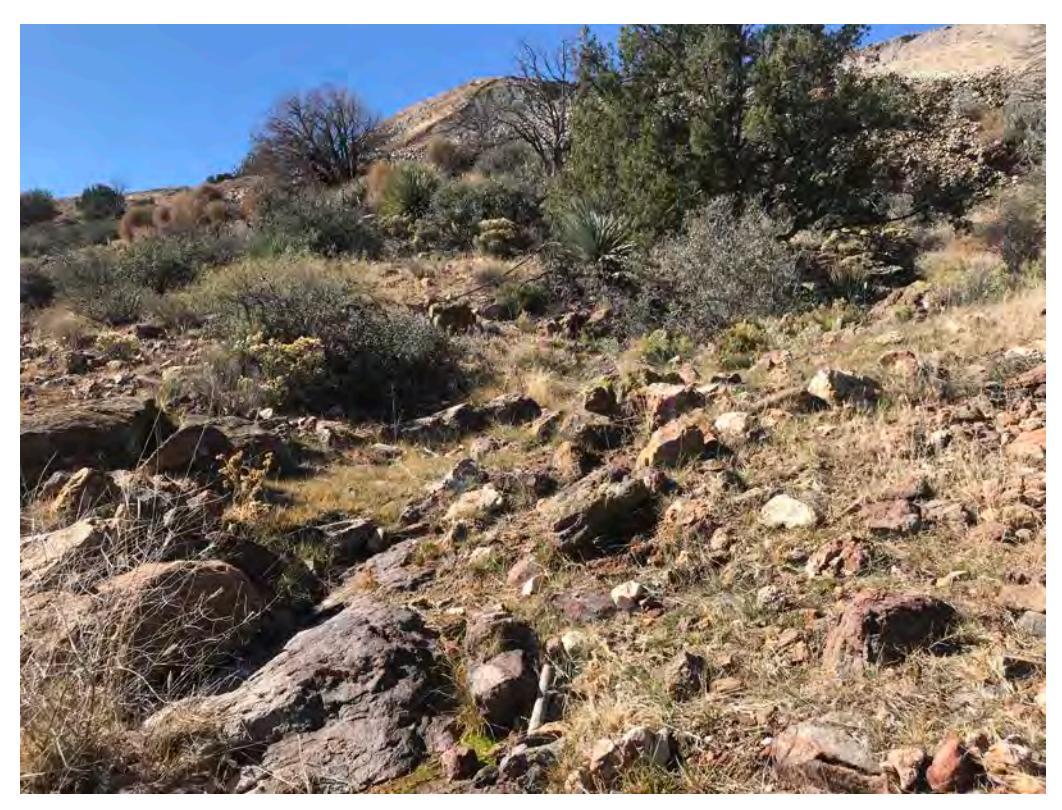
Moisture at the Toe of the Slope

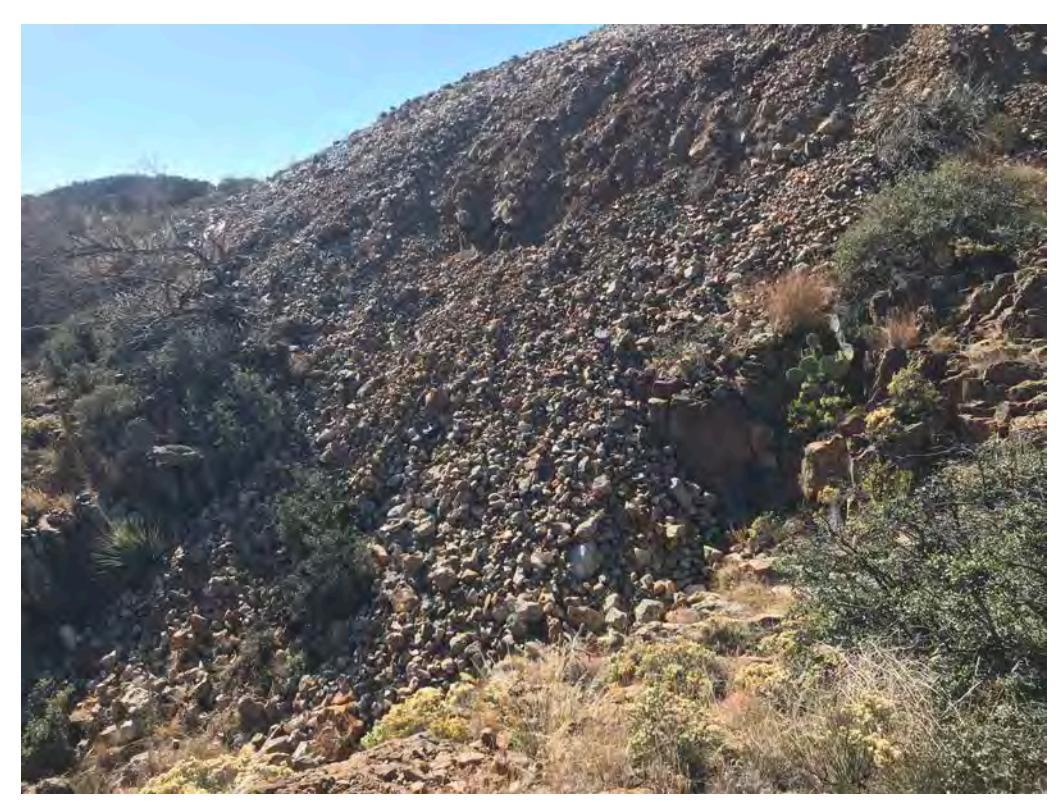
Spilled Slide Material on BLM Land

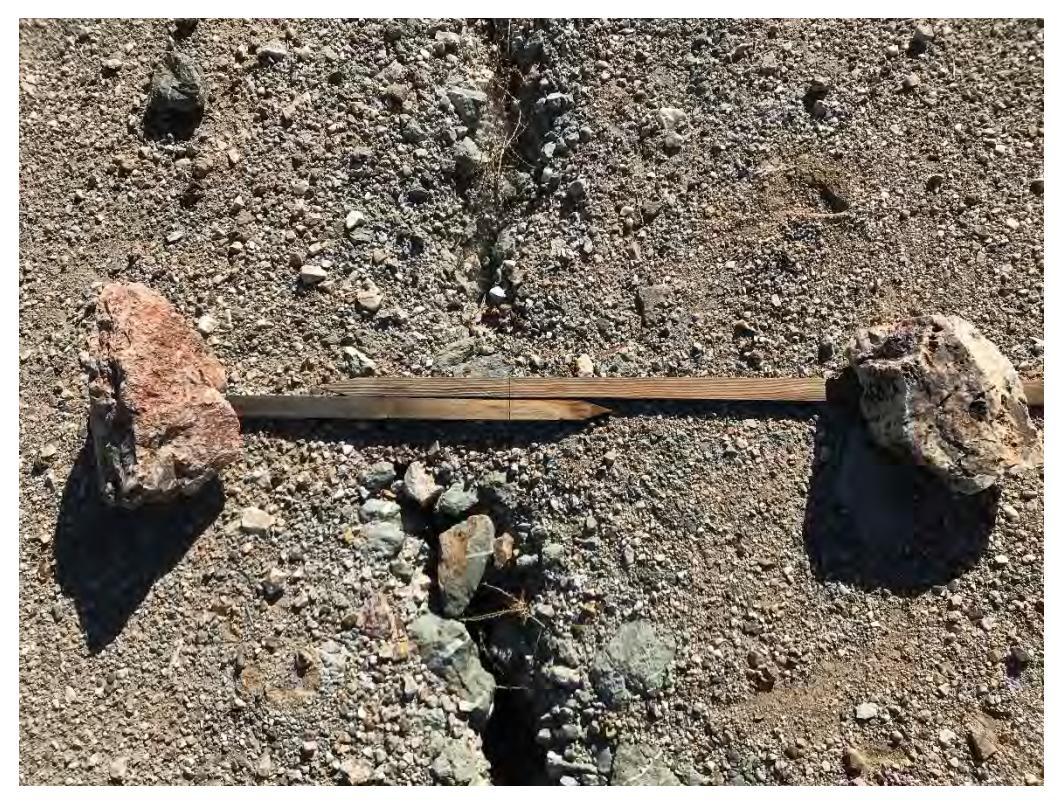
Lath Used to Measure Tension Crack Movement

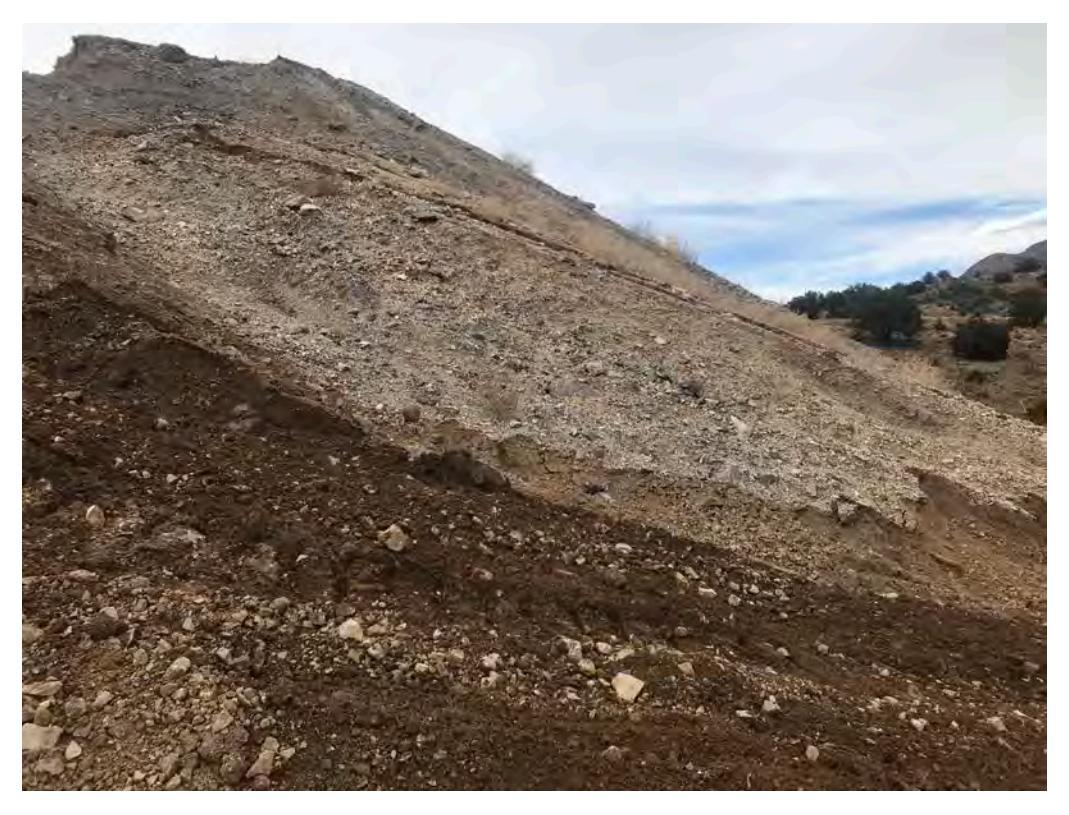
Movement in Previously Failed Slope

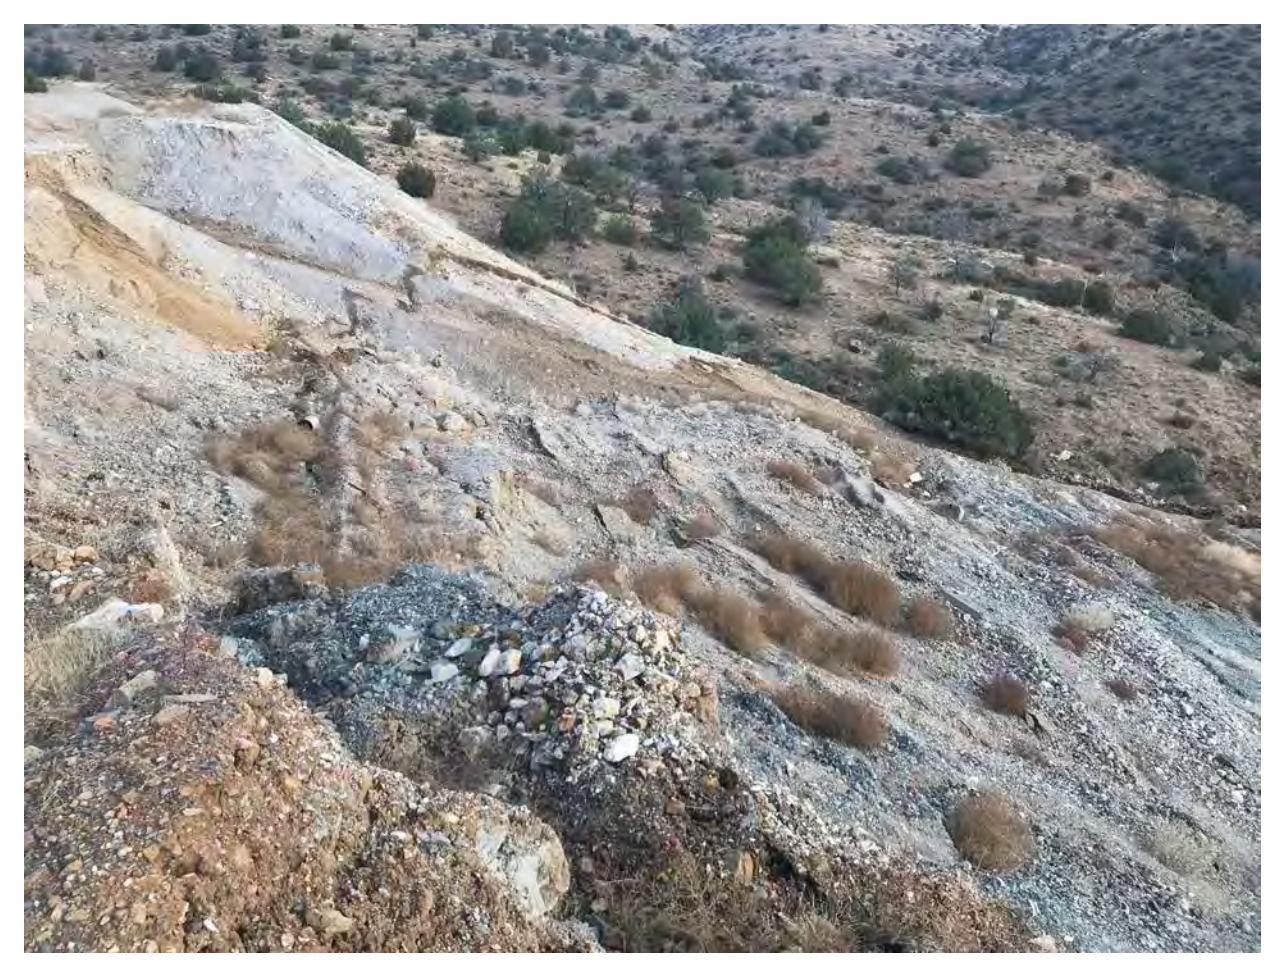
Slide Movement

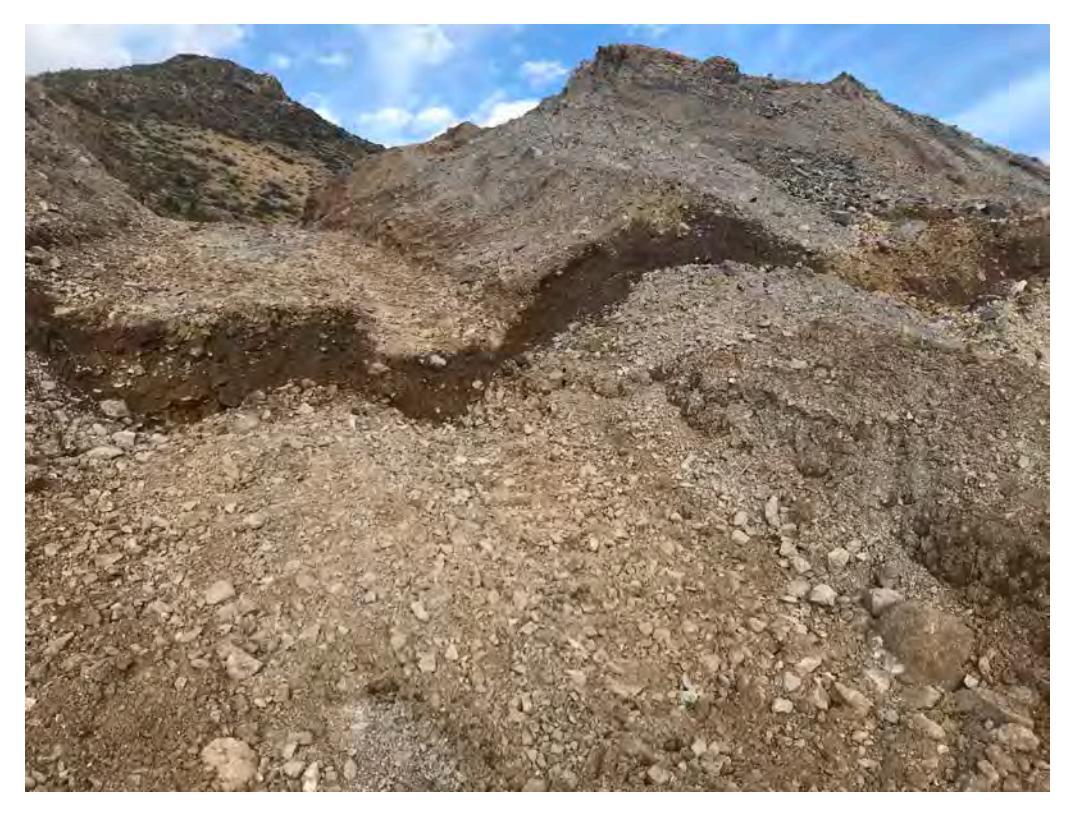
Movement through Cut Road

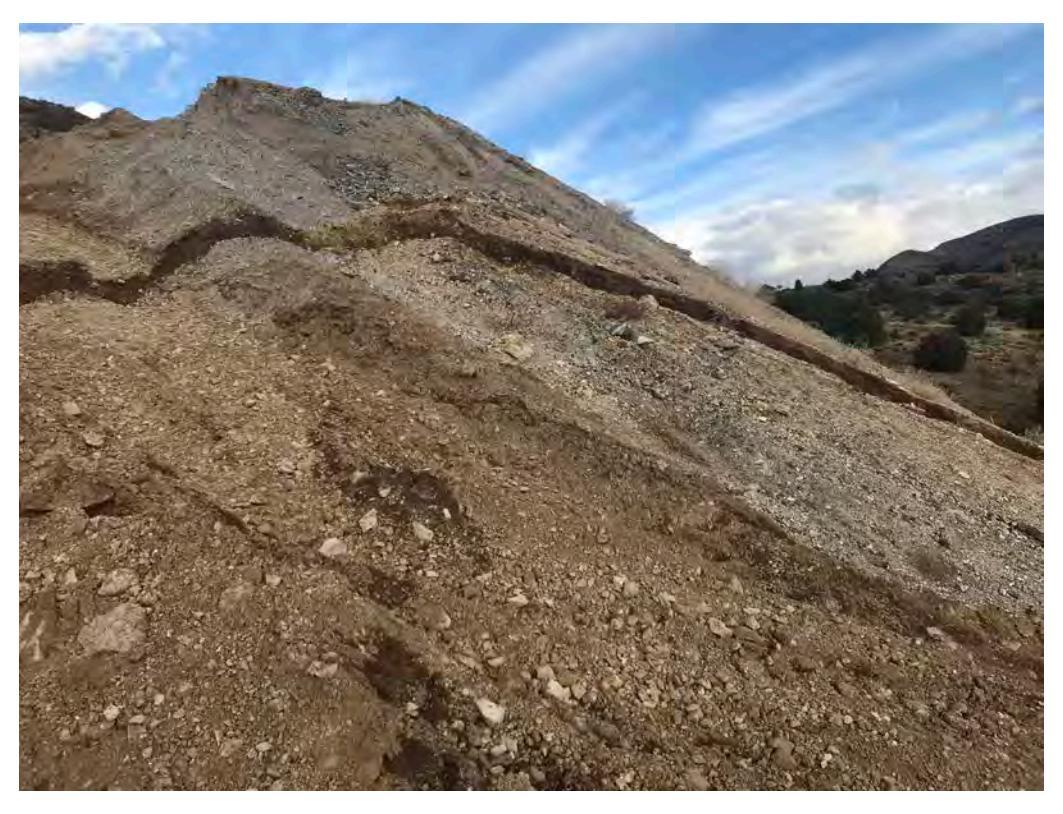
Significant Cracking North of Cut Road

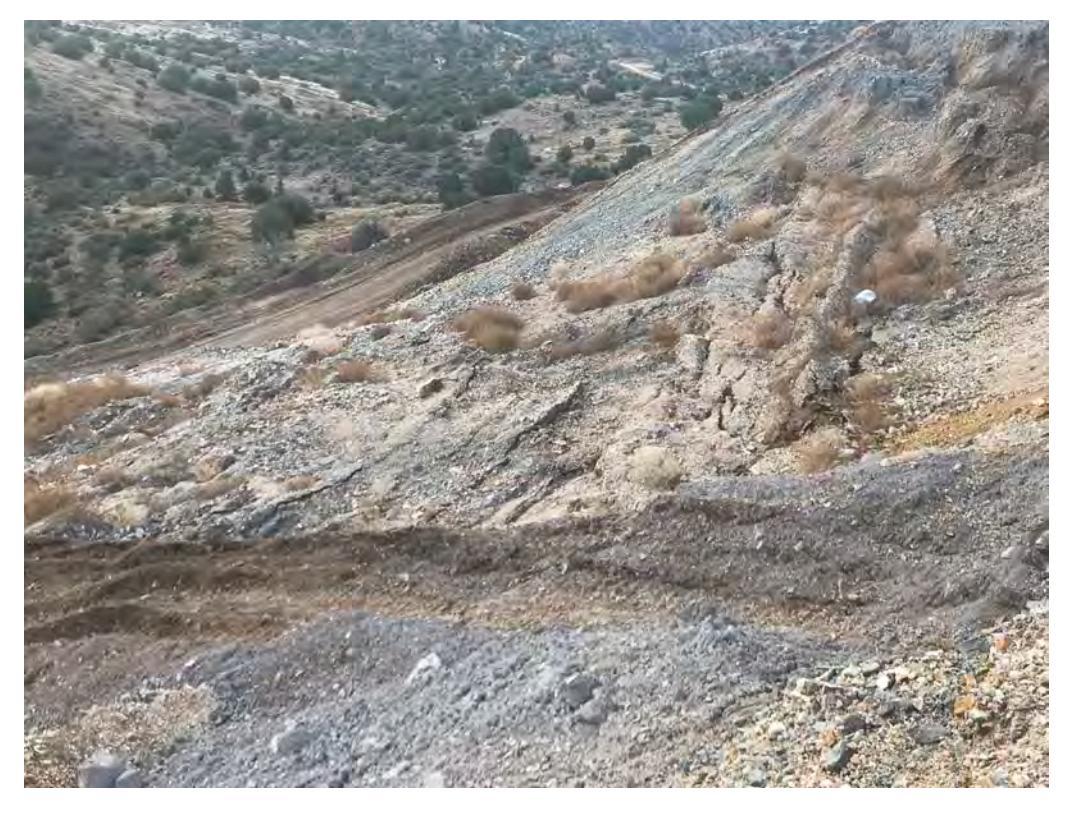
Tension Cracks in Central Section of Slide

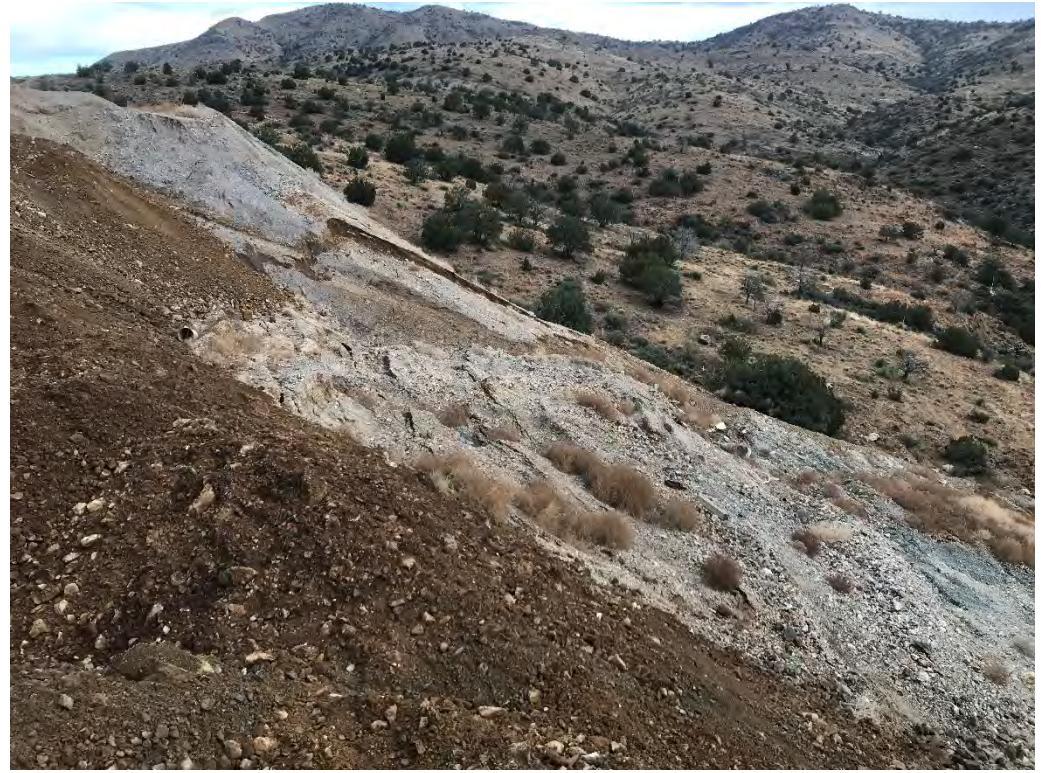
The north slope showed significant movement throughout the morning. Sounds of cracking and popping were heard from the slope. With the addition of rain overnight and throughout the day today, McCauley has elected to not mobilize equipment on site today.

Continued Movement in Slope

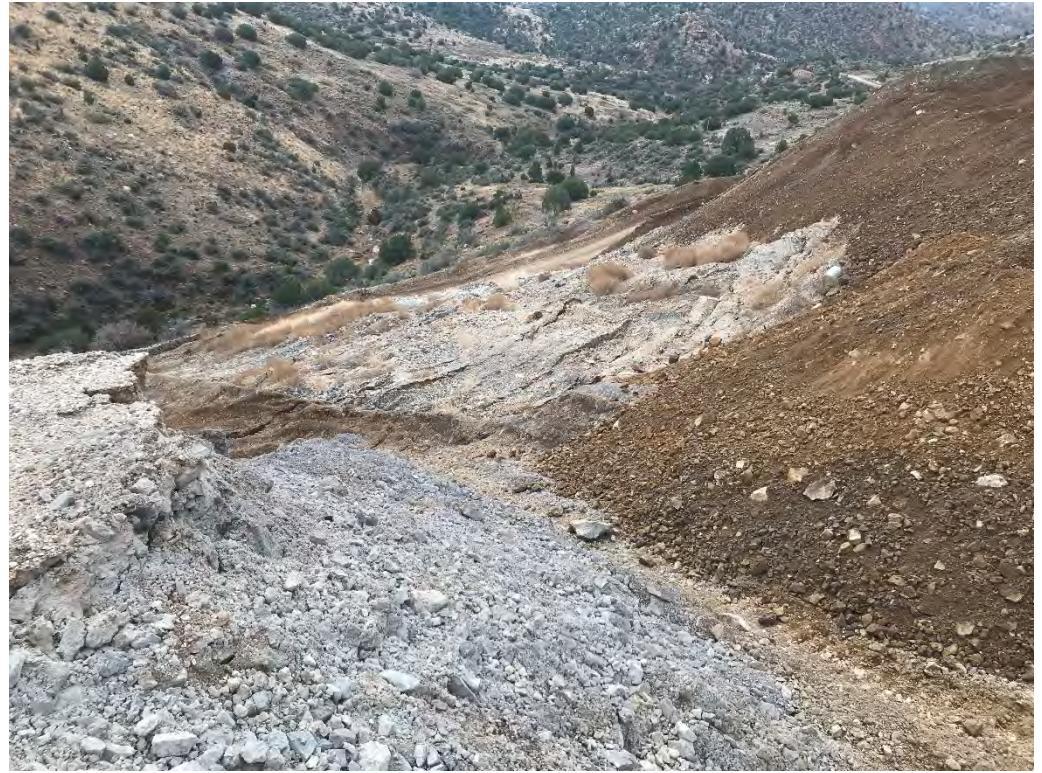
Cracking in Slope

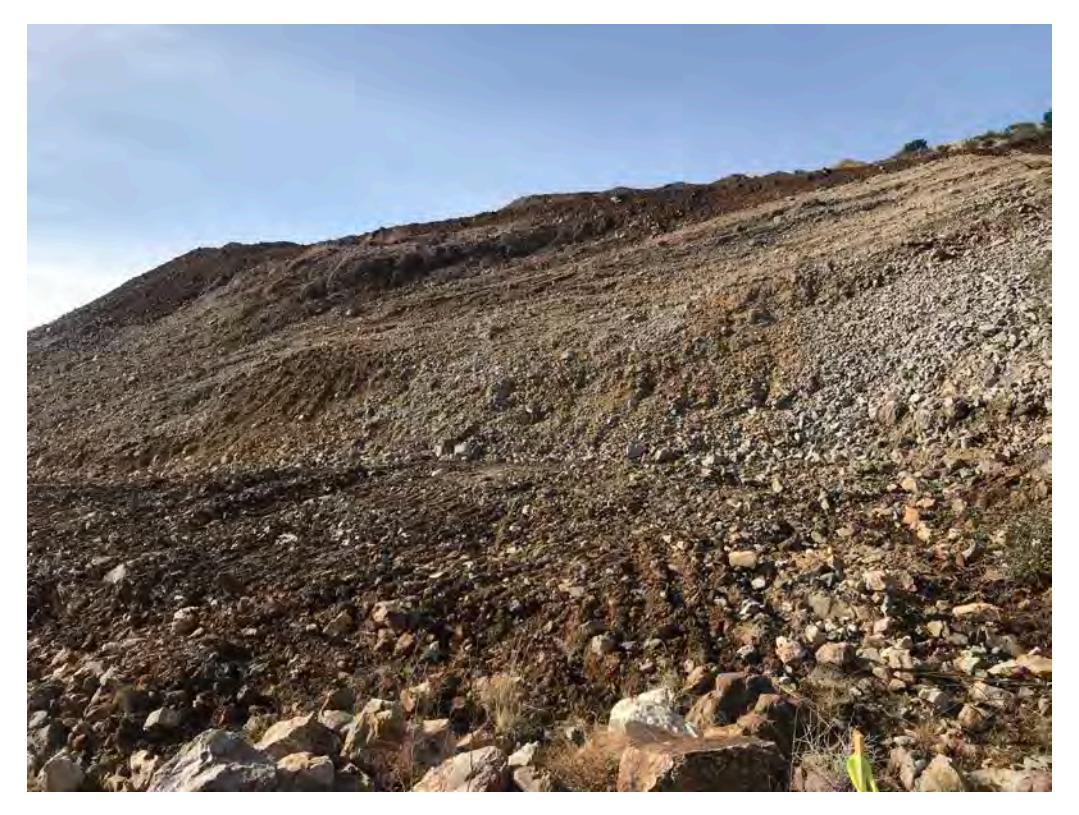
Movement in Northern Slope

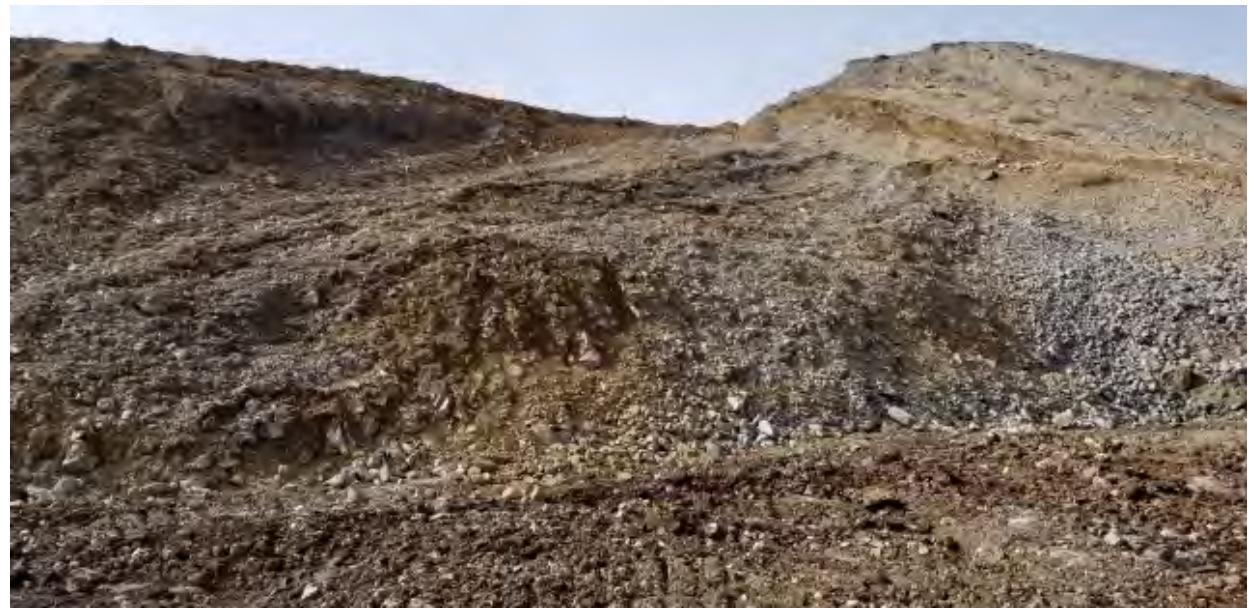
Tension cracking observed at the toe of the north end of the failure mass (photo 2).

Photo 2: Cracking of the north slope toe.

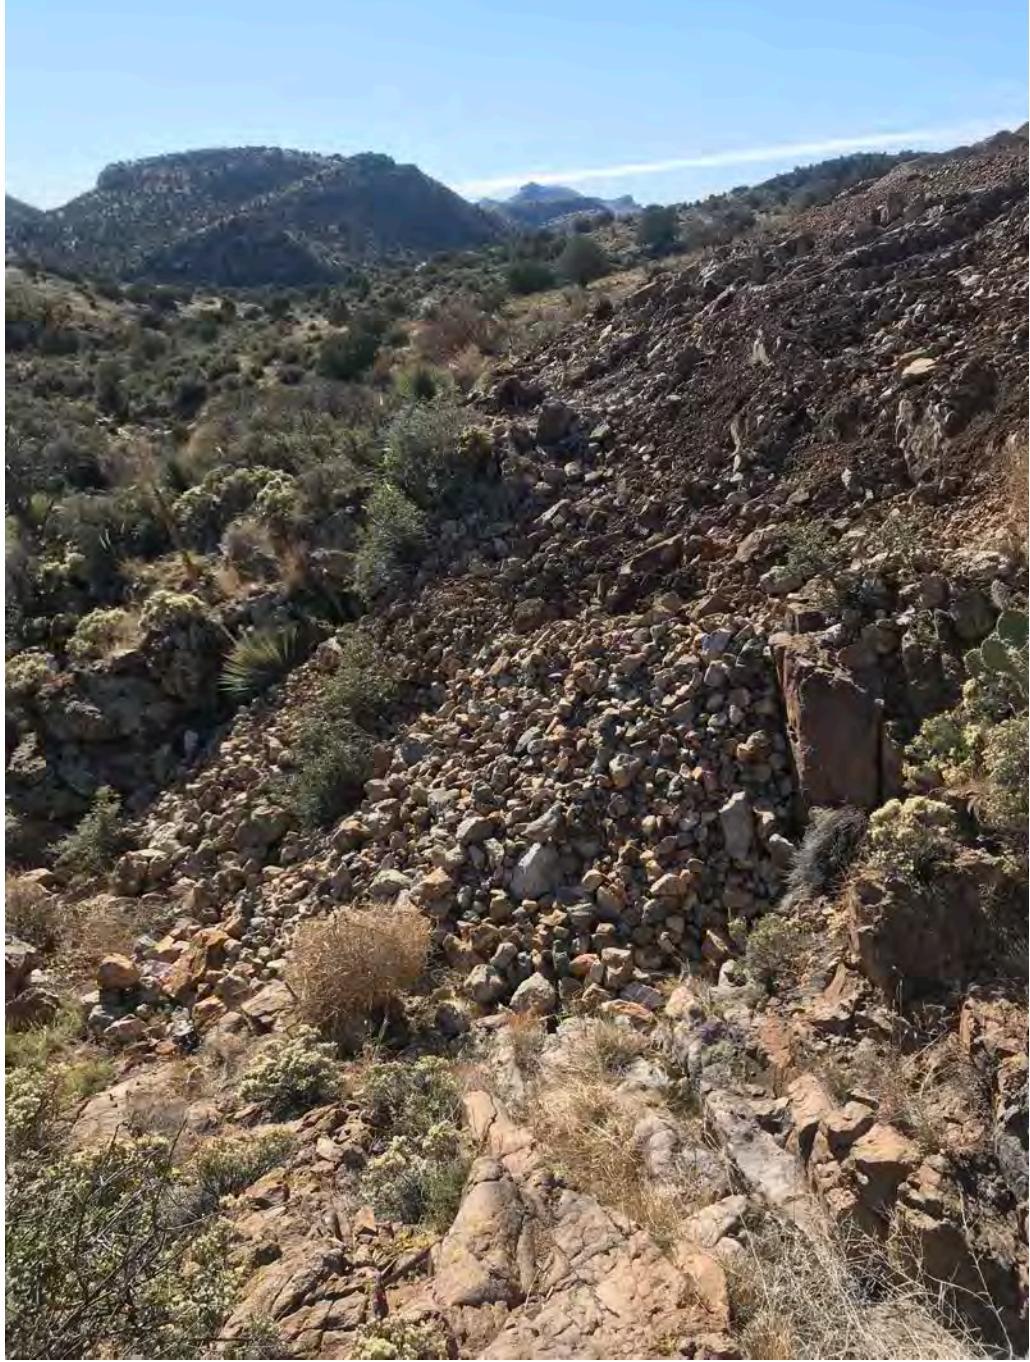
Remaining Spilled Material

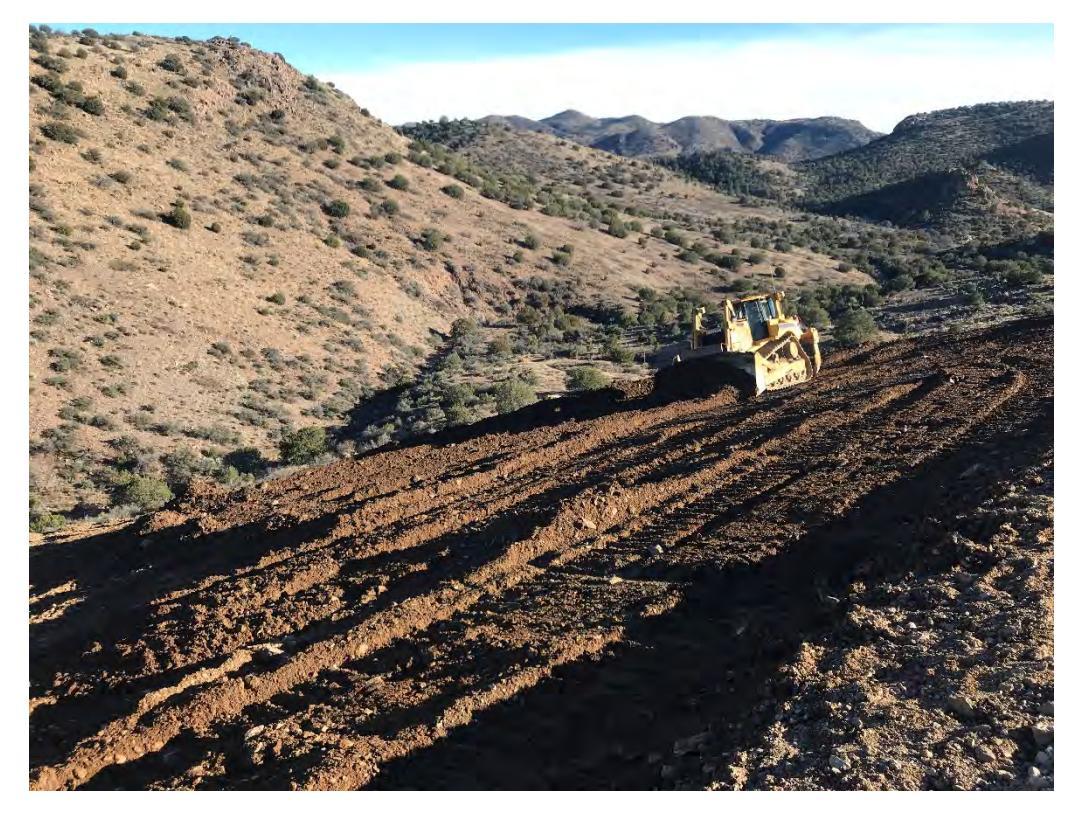
The southern slope of the project did not line up with the toe stakes properly. NewFields and McCauley discussed corrective action, which involved using the D8 to properly define a crest by cutting the slope.

D8 Cutting South Slope
