FINAL DRAINAGE REPORT ALLISON, NEW MEXICO

FINAL DRAINAGE REPORT

PROJECT NO.: LT2043298.01

DATE: AUGUST 2020

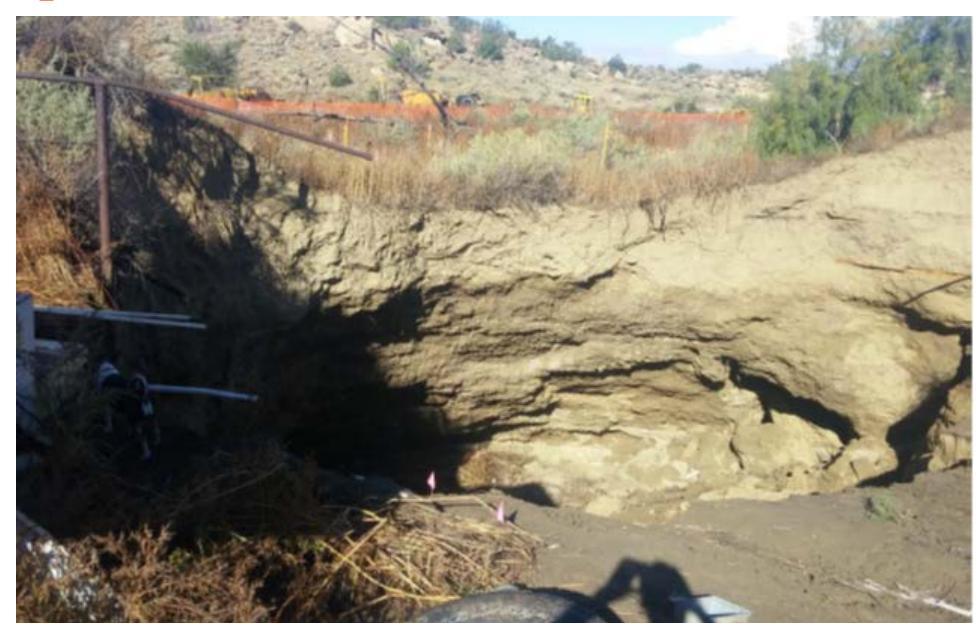
In 2015, the AML Program was notified that a sinkhole approximately 40'x20'x30' (Length x Width x Depth) developed within a drainage channel on private property (Figure 4). The sinkhole quickly advanced and had grown to 90'x45'x30' (Length x Width x Depth) in a matter of weeks. AML contracted Alan Kuhn Associates to investigate subsurface conditions of the subsidence and its margins, and profile the conditions underground (Figure 5).

Figure 4 - Photo of Initial Sinkhole, 2015 (NM AML Program)

To impede the development of future sinkholes, AML filled the subsidence and tension cracks and rerouted surface water away from the sinkhole.

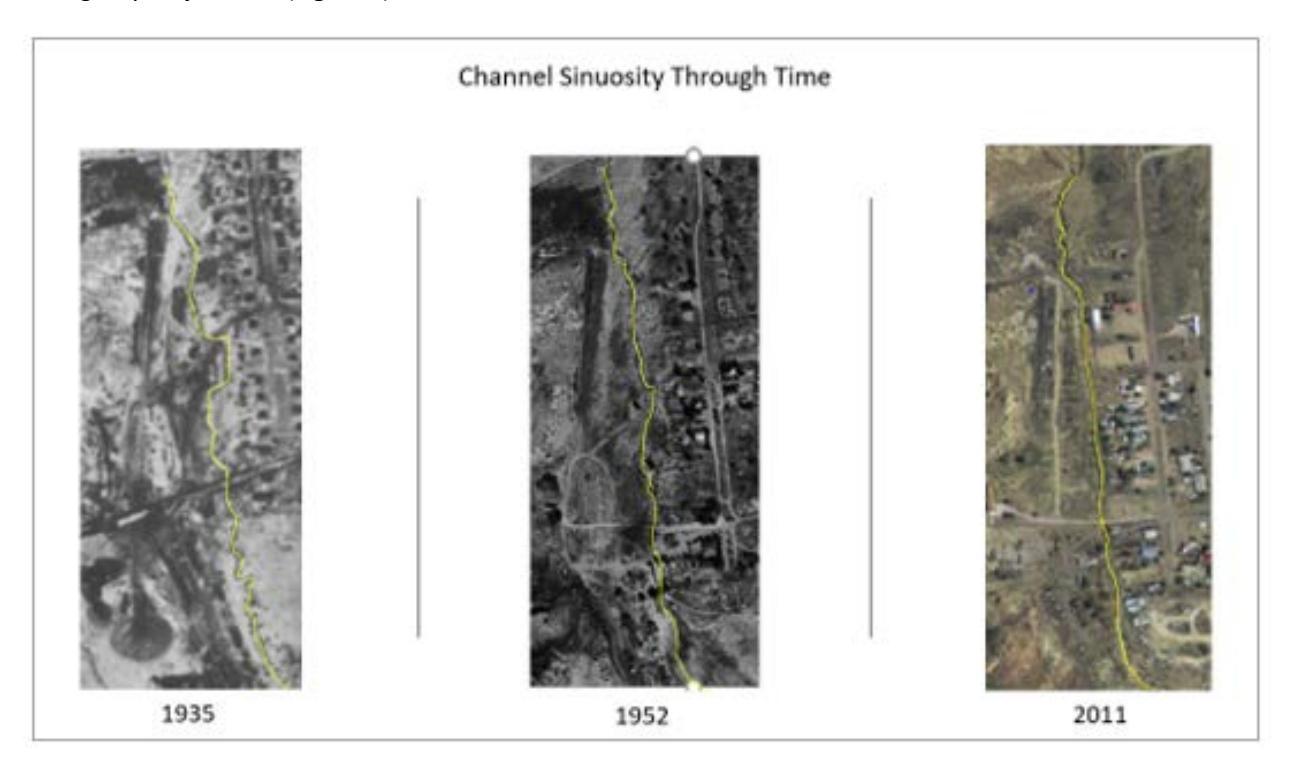
The project footprint is mostly found on private property. Evidence that landowner activities have altered the historic alignment of the drainage channel was seen both upstream and downstream of the Phase III Emergency Project area (**Figure 7**) ".

Figure 7 - Image of Landowner Effects on Channel Sinuosity Through Time

Changes to the upstream section included a new "Fill Pad Area" above town that appears to be a landfill made from construction debris and channel armoring in the drainage channel below the Fill Pad Area made from concrete fragments purposefully placed along the channel banks. WSP and AML inspected the Fill Pad Area, built by a landowner, that is suspected of exacerbating downstream flooding and erosion. The "Fill Pad Area" appears to include a landfill of construction debris from a road project (concrete slab remnants, rebar, asphalt millings and/or base course material). The AML team members believe the "Fill Pad Area" was constructed sometime in 2012. The landfill disrupts, and likely slows, the historic flows through Allison.

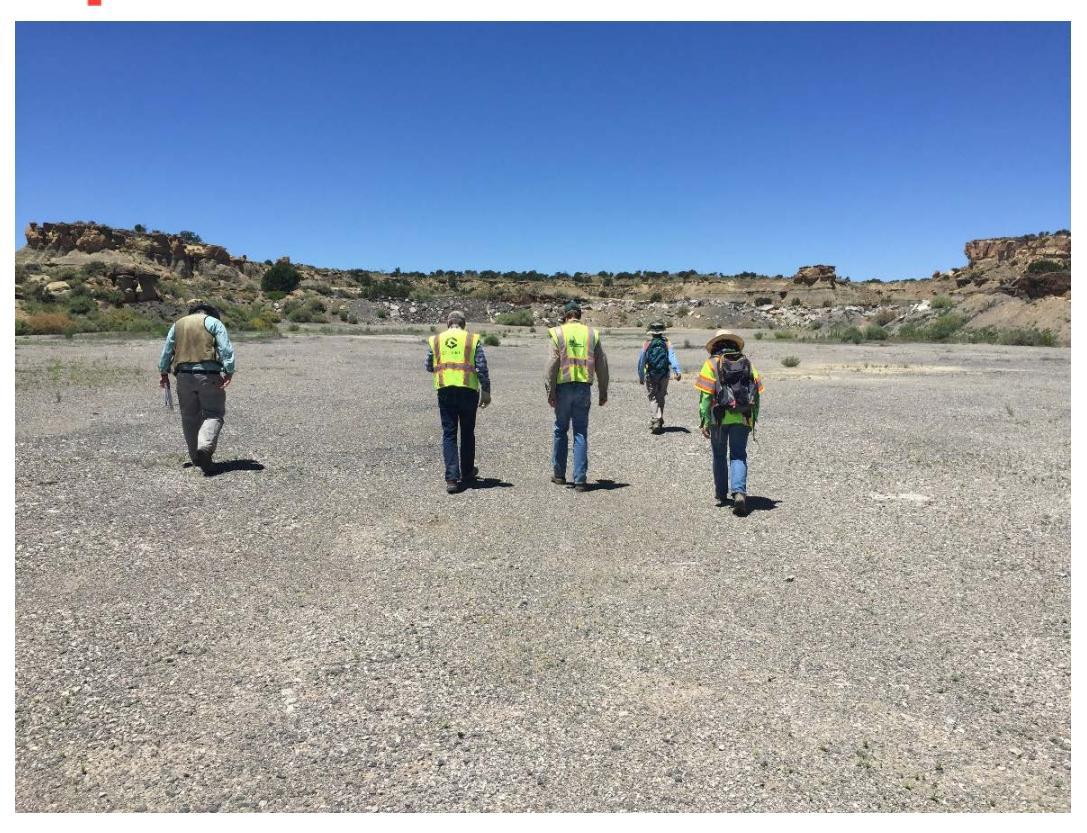
The Northwest Fill Pad Area appears to be a manmade graded and flattened landfill built in 2012 comprised of construction debris. The Fill Pad Area is made of asphalt millings and/or base course material. At the upstream edge of the Fill Pad Area a "dam" made out of construction debris extends across the valley floor. **Figure 15** depicts the flat Fill Pad with the debris "dam" visible in the background. The debris dam, shown in **Figure 16**, is made of large fragments of broken up concrete and large fragments of broken up asphalt pavement. The material is assumed to have been dumped loosely in place as it has large voids between adjacent fragments. Due to the lose placement of the debris with no filler material to seal the voids, storm runoff can directly enter the material that makes up the Fill Pad Area.

Figure 15 - Fill Pad Area Walking Towards the "Dam"

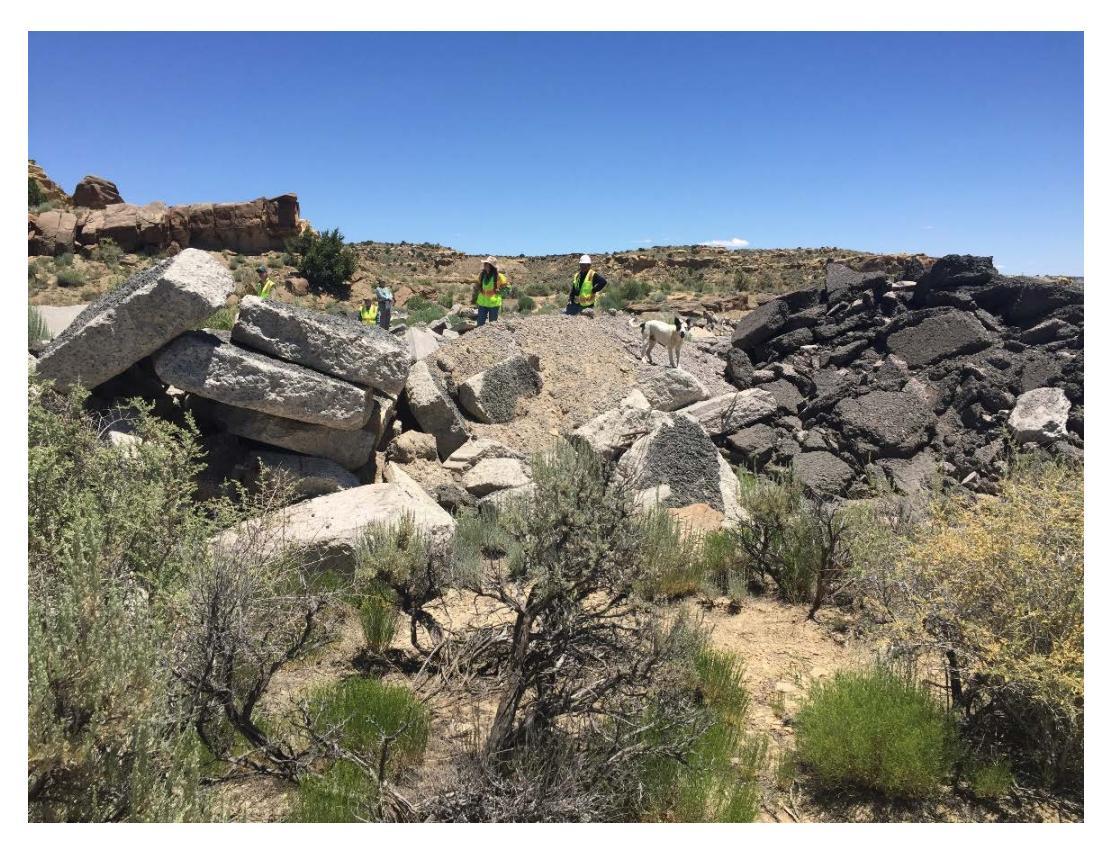
Figure 16 - Fill Pad Area "Dam" as Viewed from Upstream

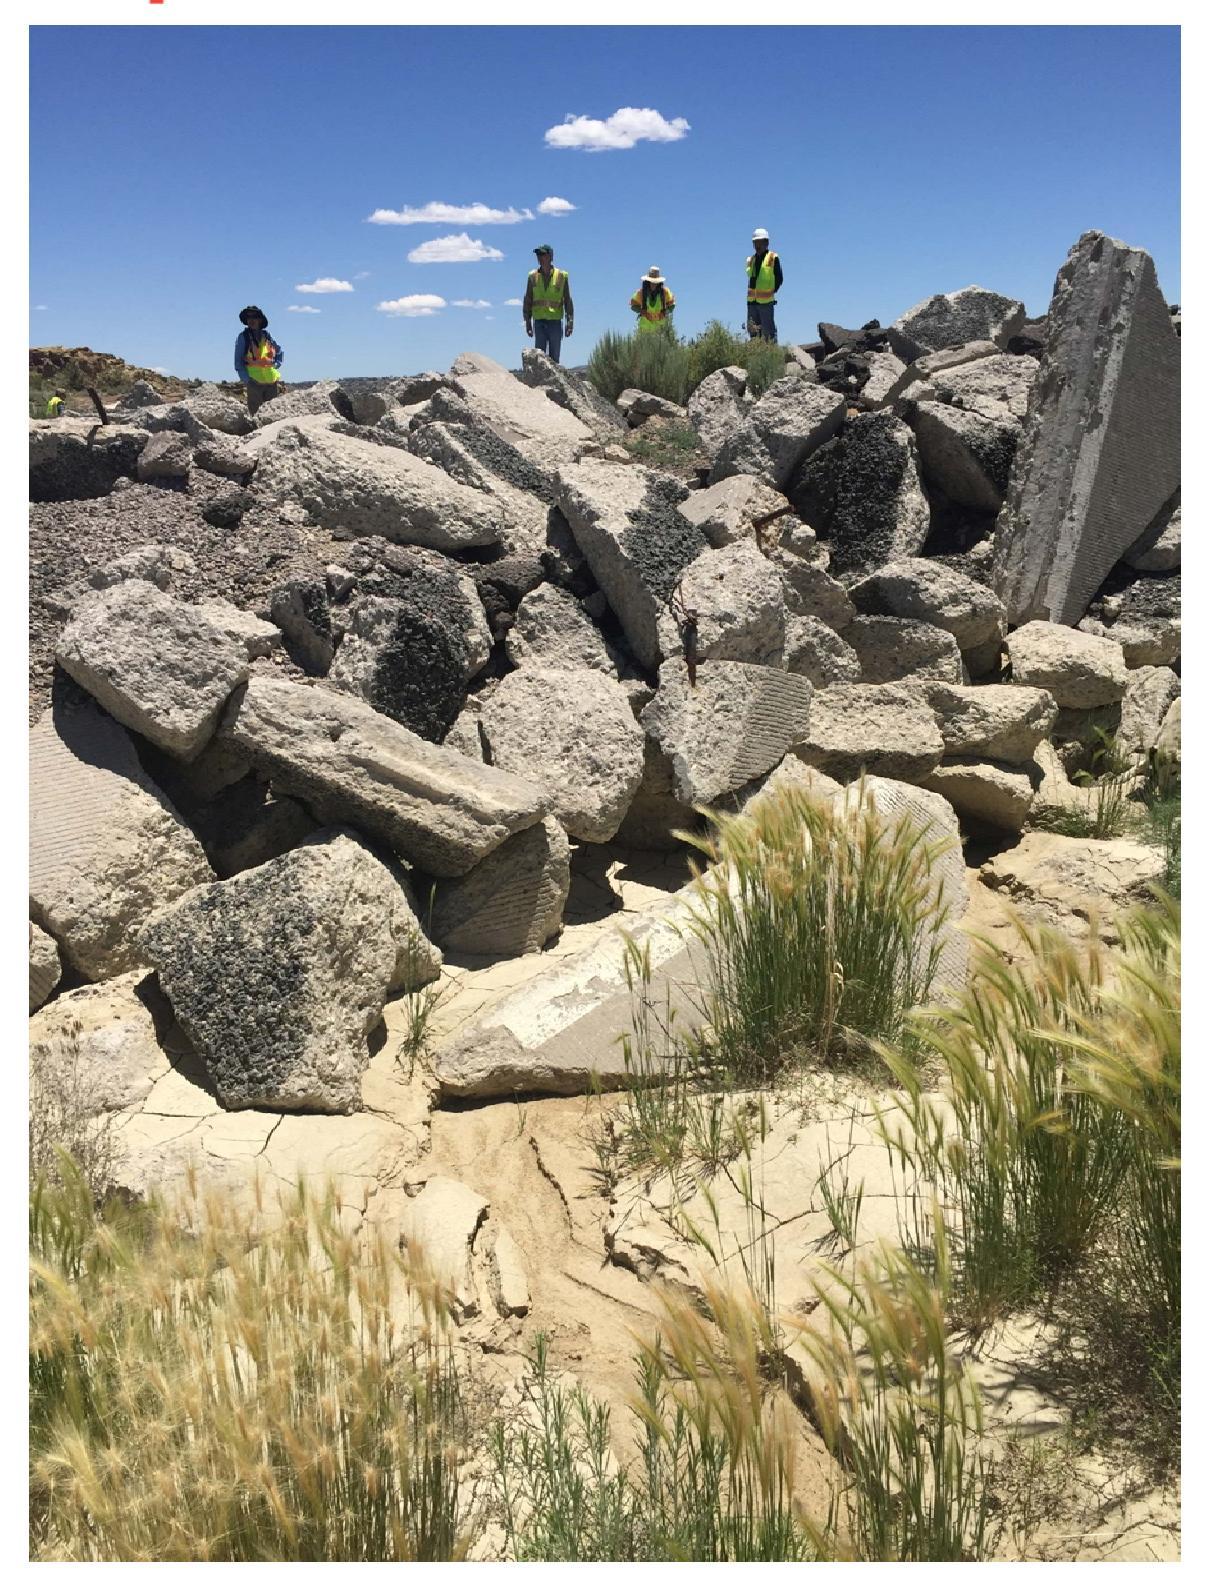
Figure 17 shows the drainage channel from the upper valley disappearing into the "dam". After storm water enter the debris dam, it continues as subsurface flow through the Fill Pad Area. Surface waters entering the Fill Pad Area as subsurface flows are assumed to contribute to the subsidence issues of Allison. Two alternatives, described below, were developed to convey the surface waters through the Fill Pad Area without allowing the waters to percolate into the subsurface soils.

Figure 17 – Upstream Channel Entering the Base of the Fill Pad Area "Dam"

Alternative No. 1 attempts to restore the alignment and grade of the historical drainage channel through the Fill Pad Area. A trapezoidal open channel (8' bottom width, 3' minimum depth with 2.5:1 side slopes) is recommended on north east side of the fill pad to convey flow coming from the upstream valley above the debris dam. The open channel would extend from above the fill pad down to the main drainage channel downstream. The channel should be lined with a geosynthetic clay liner to prevent infiltration, 6" of protective bedding material and a 12" layer of Class B Riprap (6-inch minimum dimension). The membrane liner would help impede vegetation growth and any subsequent slowing of water. The purpose of the riprap is to minimize erosion of the channel bottom. However, compacted earthen lining might be considered to reduce the cost of lining. A guide bank with a geosynthetic clay liner is recommended just upstream of the fill pad area to direct or funnel the flow into the open channel. Two concrete rundowns below the fill pad, at two steep drops along the proposed open channel, are needed to tie into the main channel below.

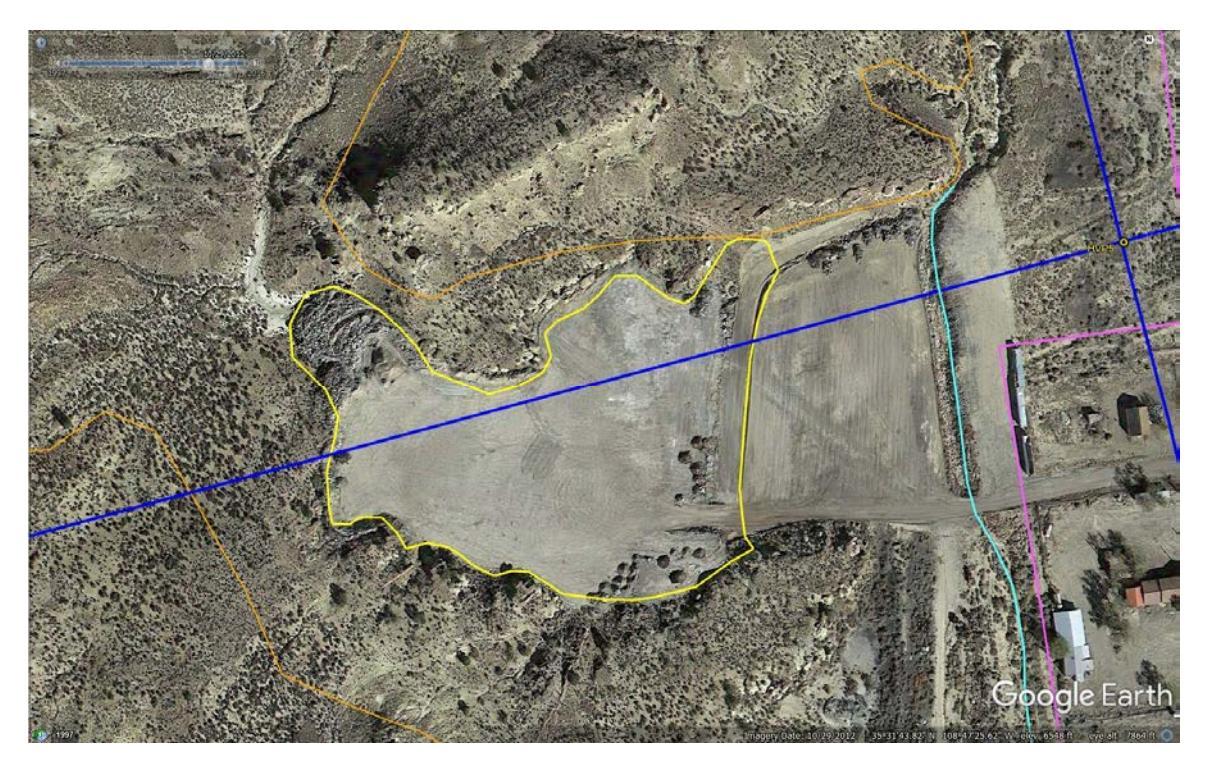
Figure 19 – Fill Pad Area (Source: Google Earth 10/29/2012)

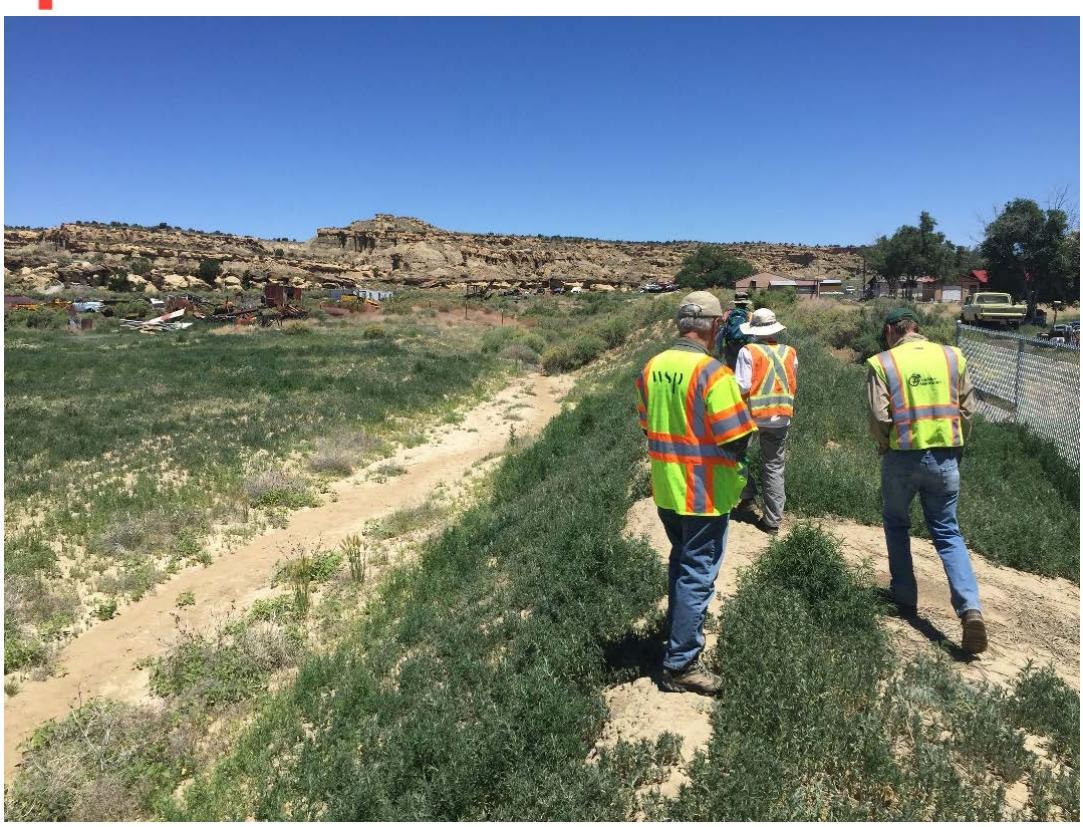
Existing Channel at the Phase III Emergency Project

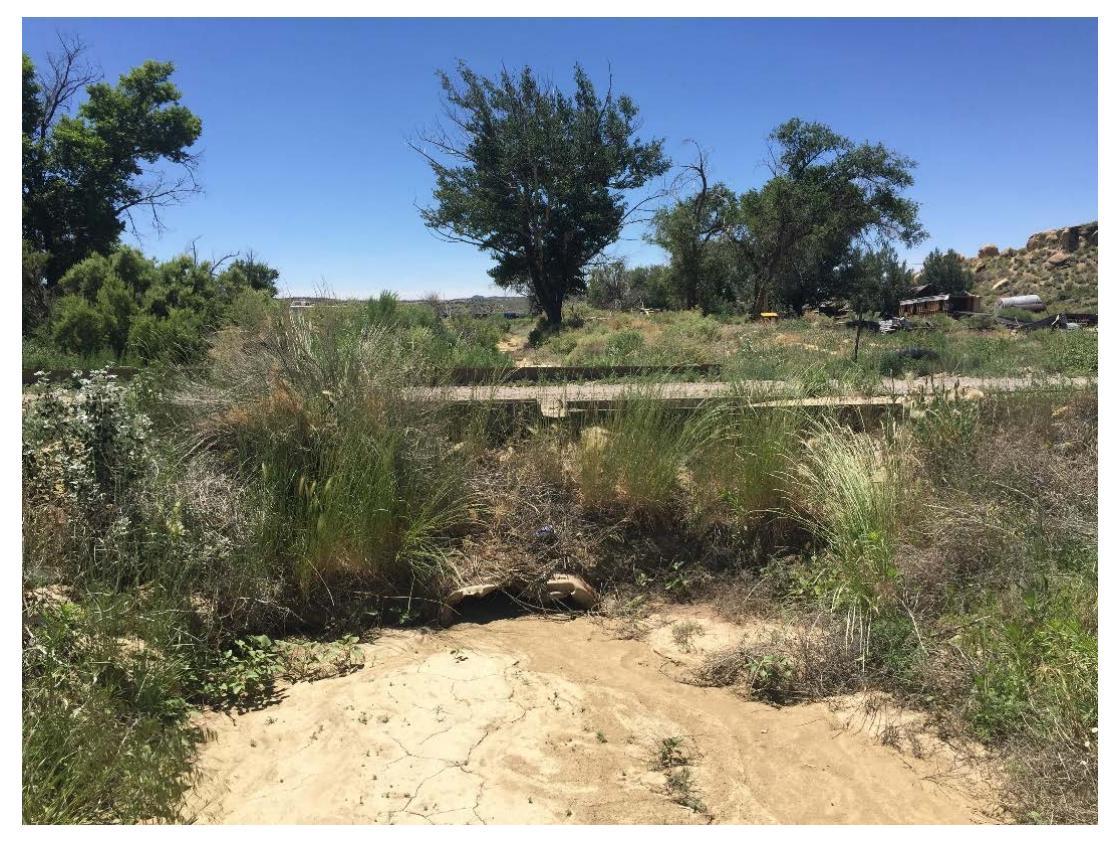
Culvert at Acoma Street (Looking Upstream)

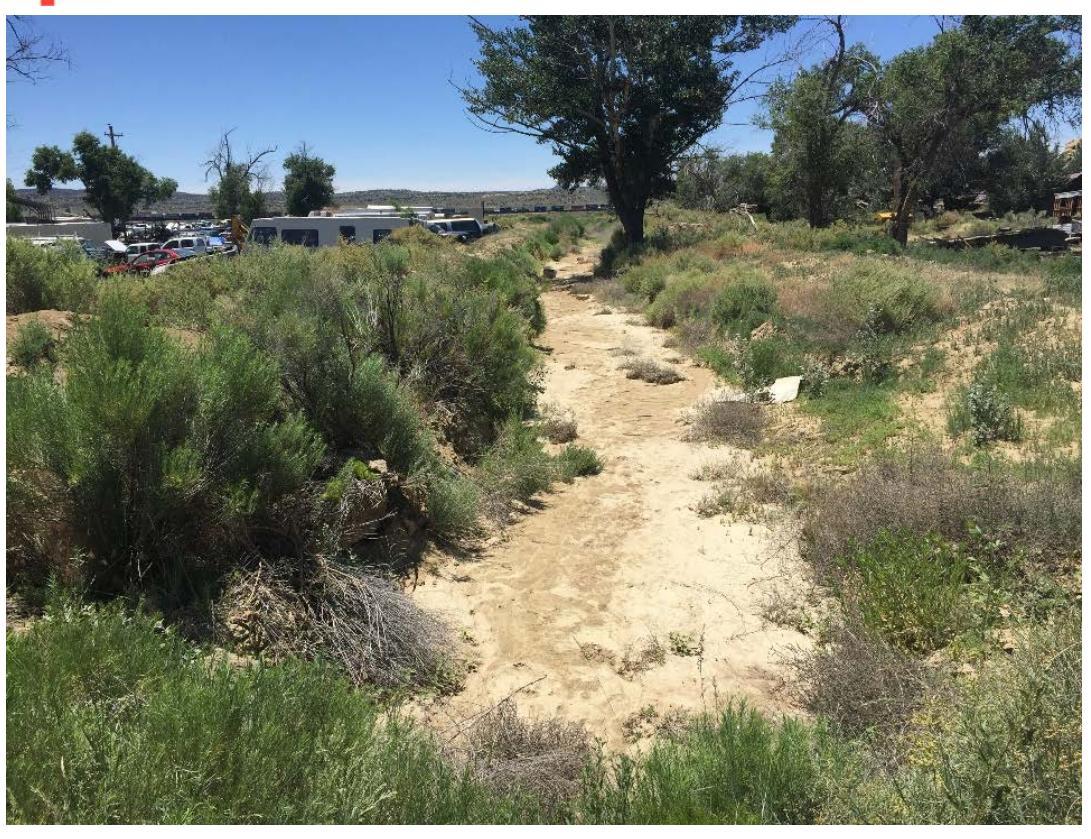
Channel Below Acoma Street (Looking Downstream)

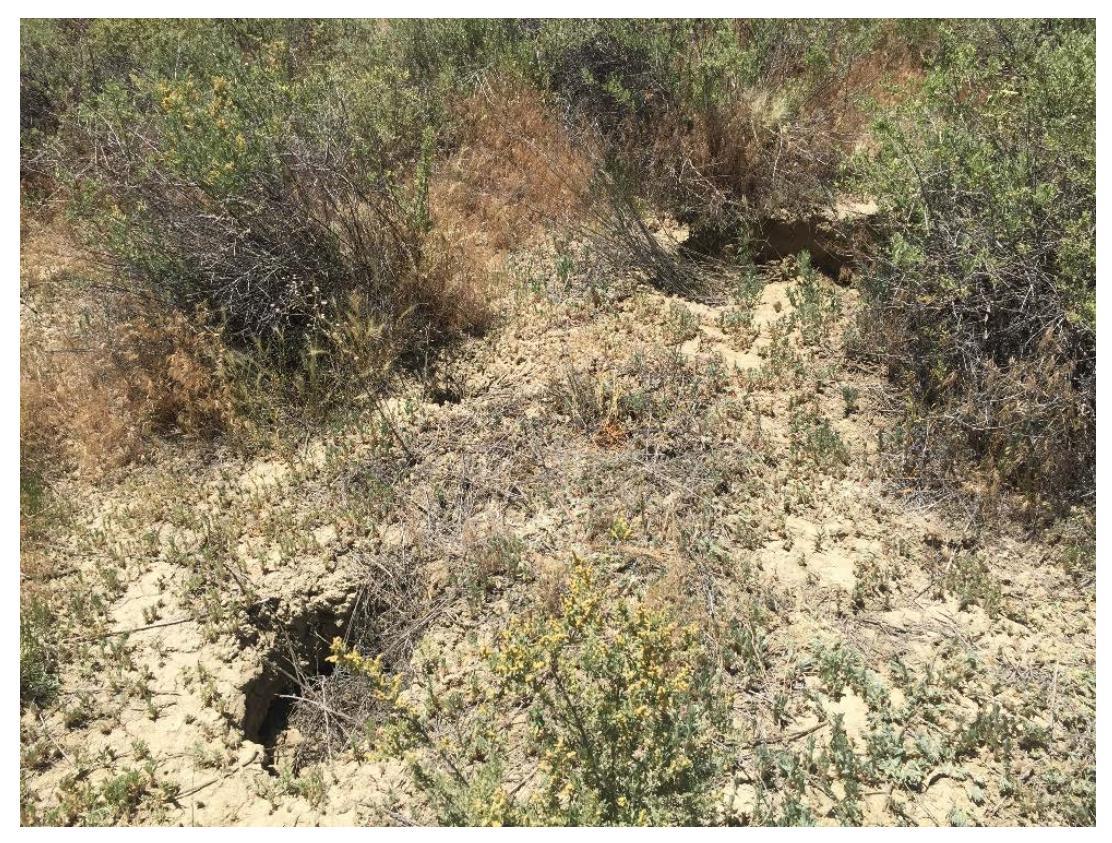
Ground Holes North of Acoma Street

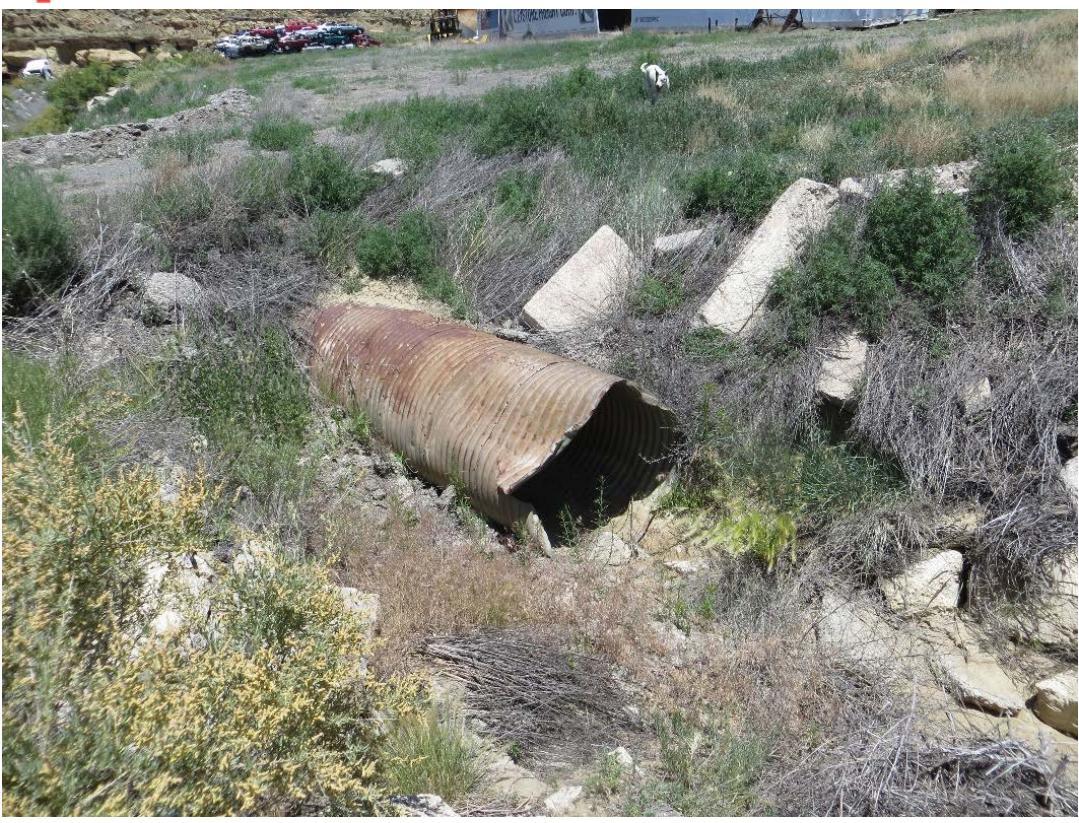
Drainage Channel Upstream Culvert

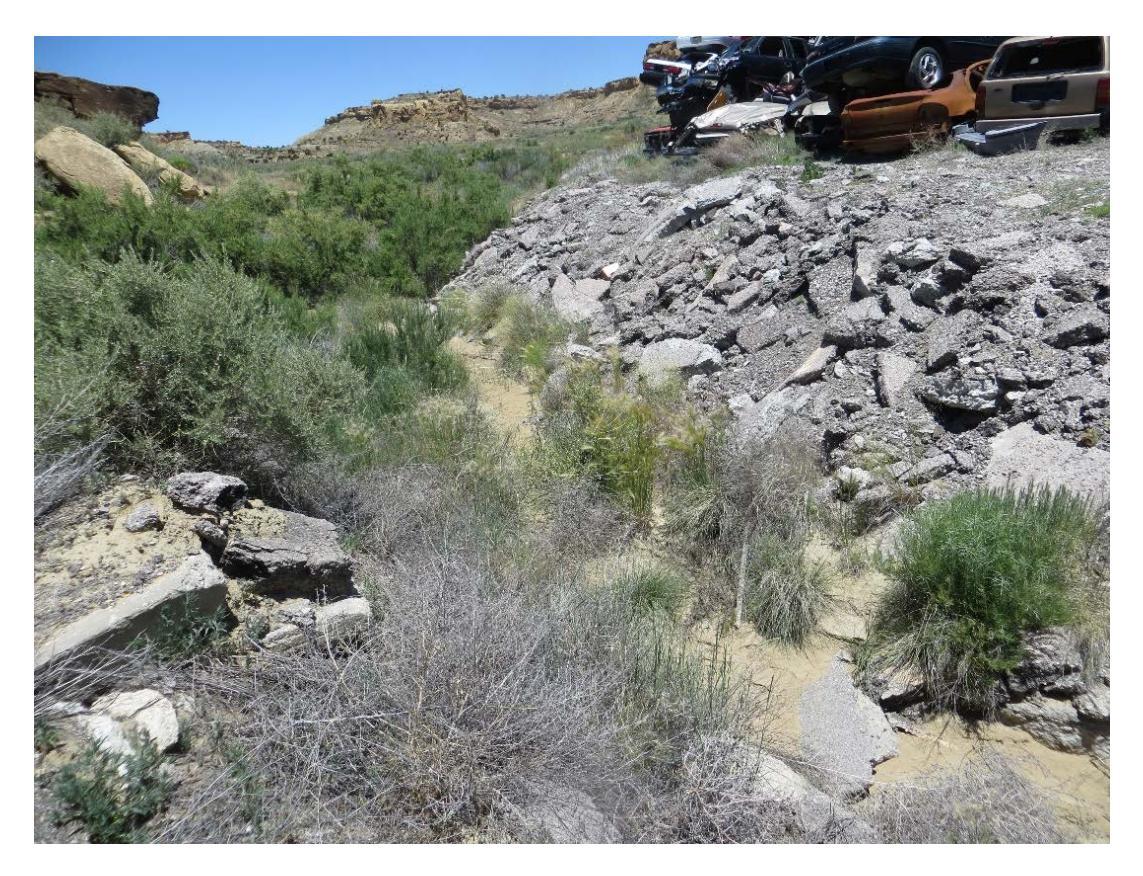
Upstream Channel with Rubble Armoring

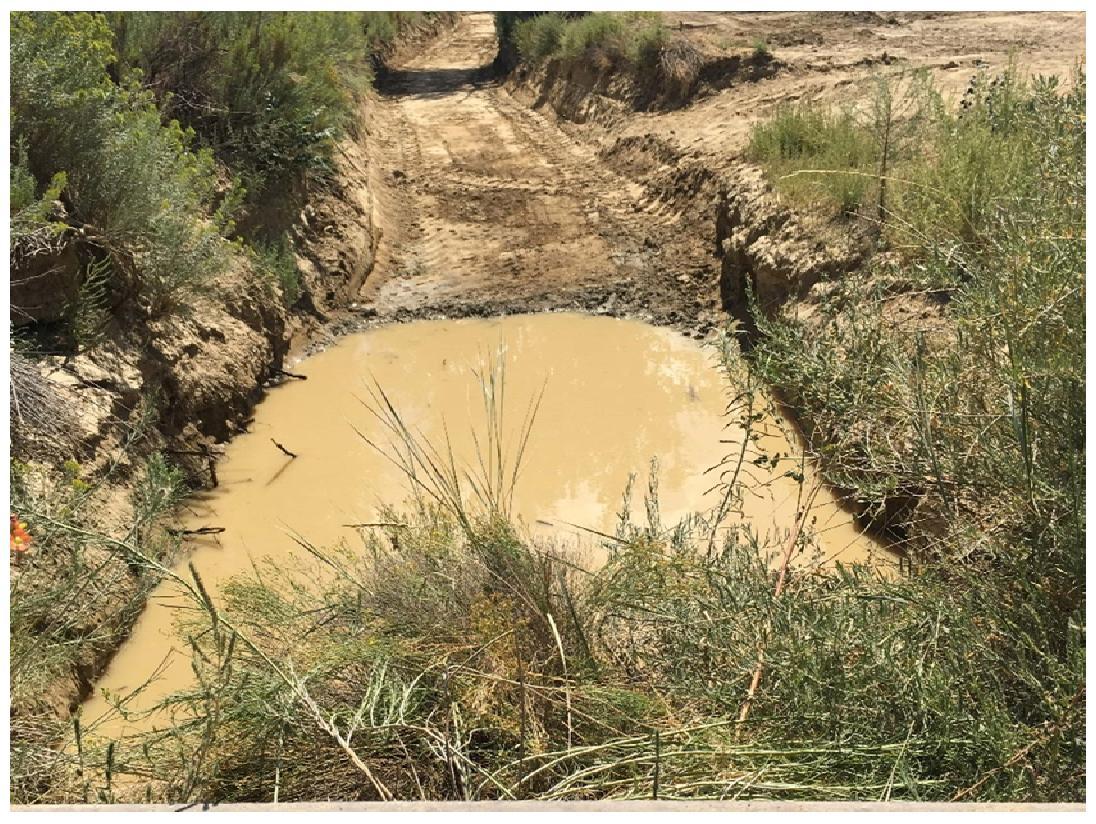
Graded Channel D/S of Acoma Street

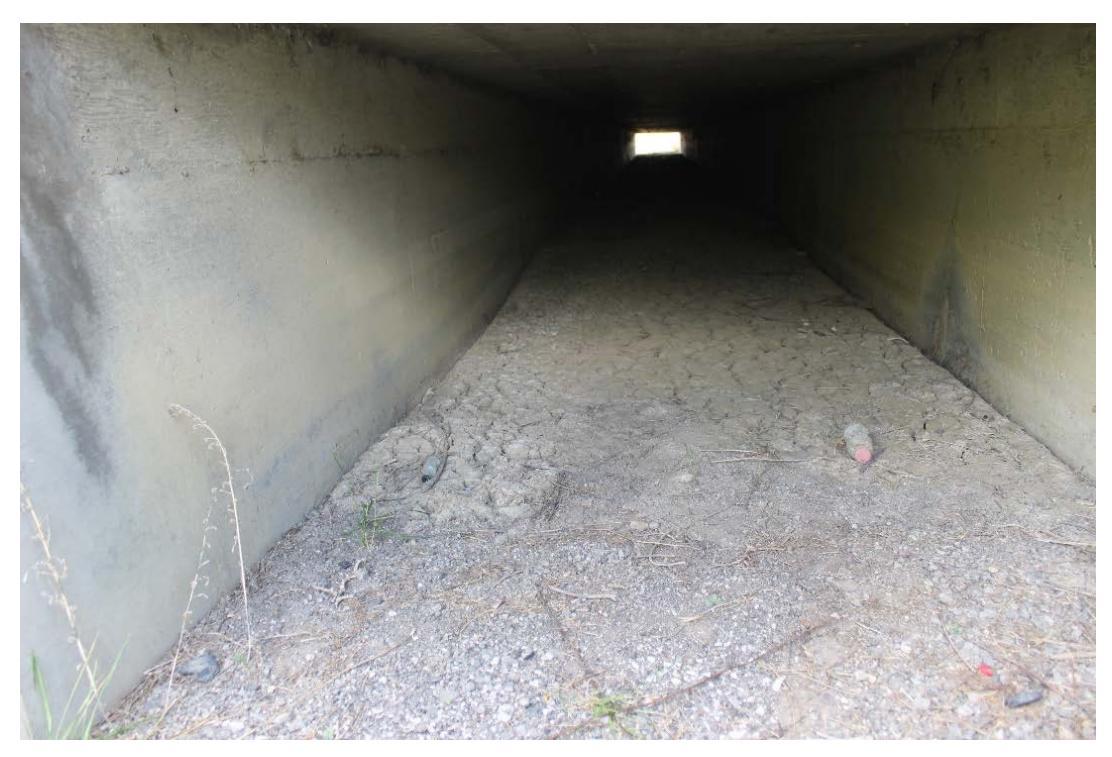
The hydraulic analysis of NMDOT drainage structures (Allison Road and I-40) were evaluated and found that they adequately sized to convey the design and check flood. These structures appear to be sound and hydraulically functional; however, cleaning of the inlet and outlet is required for both structures to remove the deposited silt at the bottom of the structures. Cleaning the structures should include grading the outlets to drain with a positive slope all the way to the Rio Puerco. The bridge inspection report for BR #6729, attached in **Appendix D**, suggests cleaning and tree removal (**Table 20**). WSP suggests that the analysis and the recommendations in this report be coordinated with the NMDOT Drainage Design Bureau to ensure that the proposed improvements will not adversely impact their facilities.

Bottom of CBC at I-40

The NMDOT structures are suitable. It is recommended they be cleaned to maintain flows and limit further sedimentation. Existing dikes within the NMDOT right-of-way and along the historical railroad bed should be reestablished.
