**TAILING TEST PLOTS ANNUAL REPORT  
REPORT-NO. 1**

**PHELPS DODGE TYRONE INC.  
AND  
CHINO MINES COMPANY**

January 31, 2007

053-2365

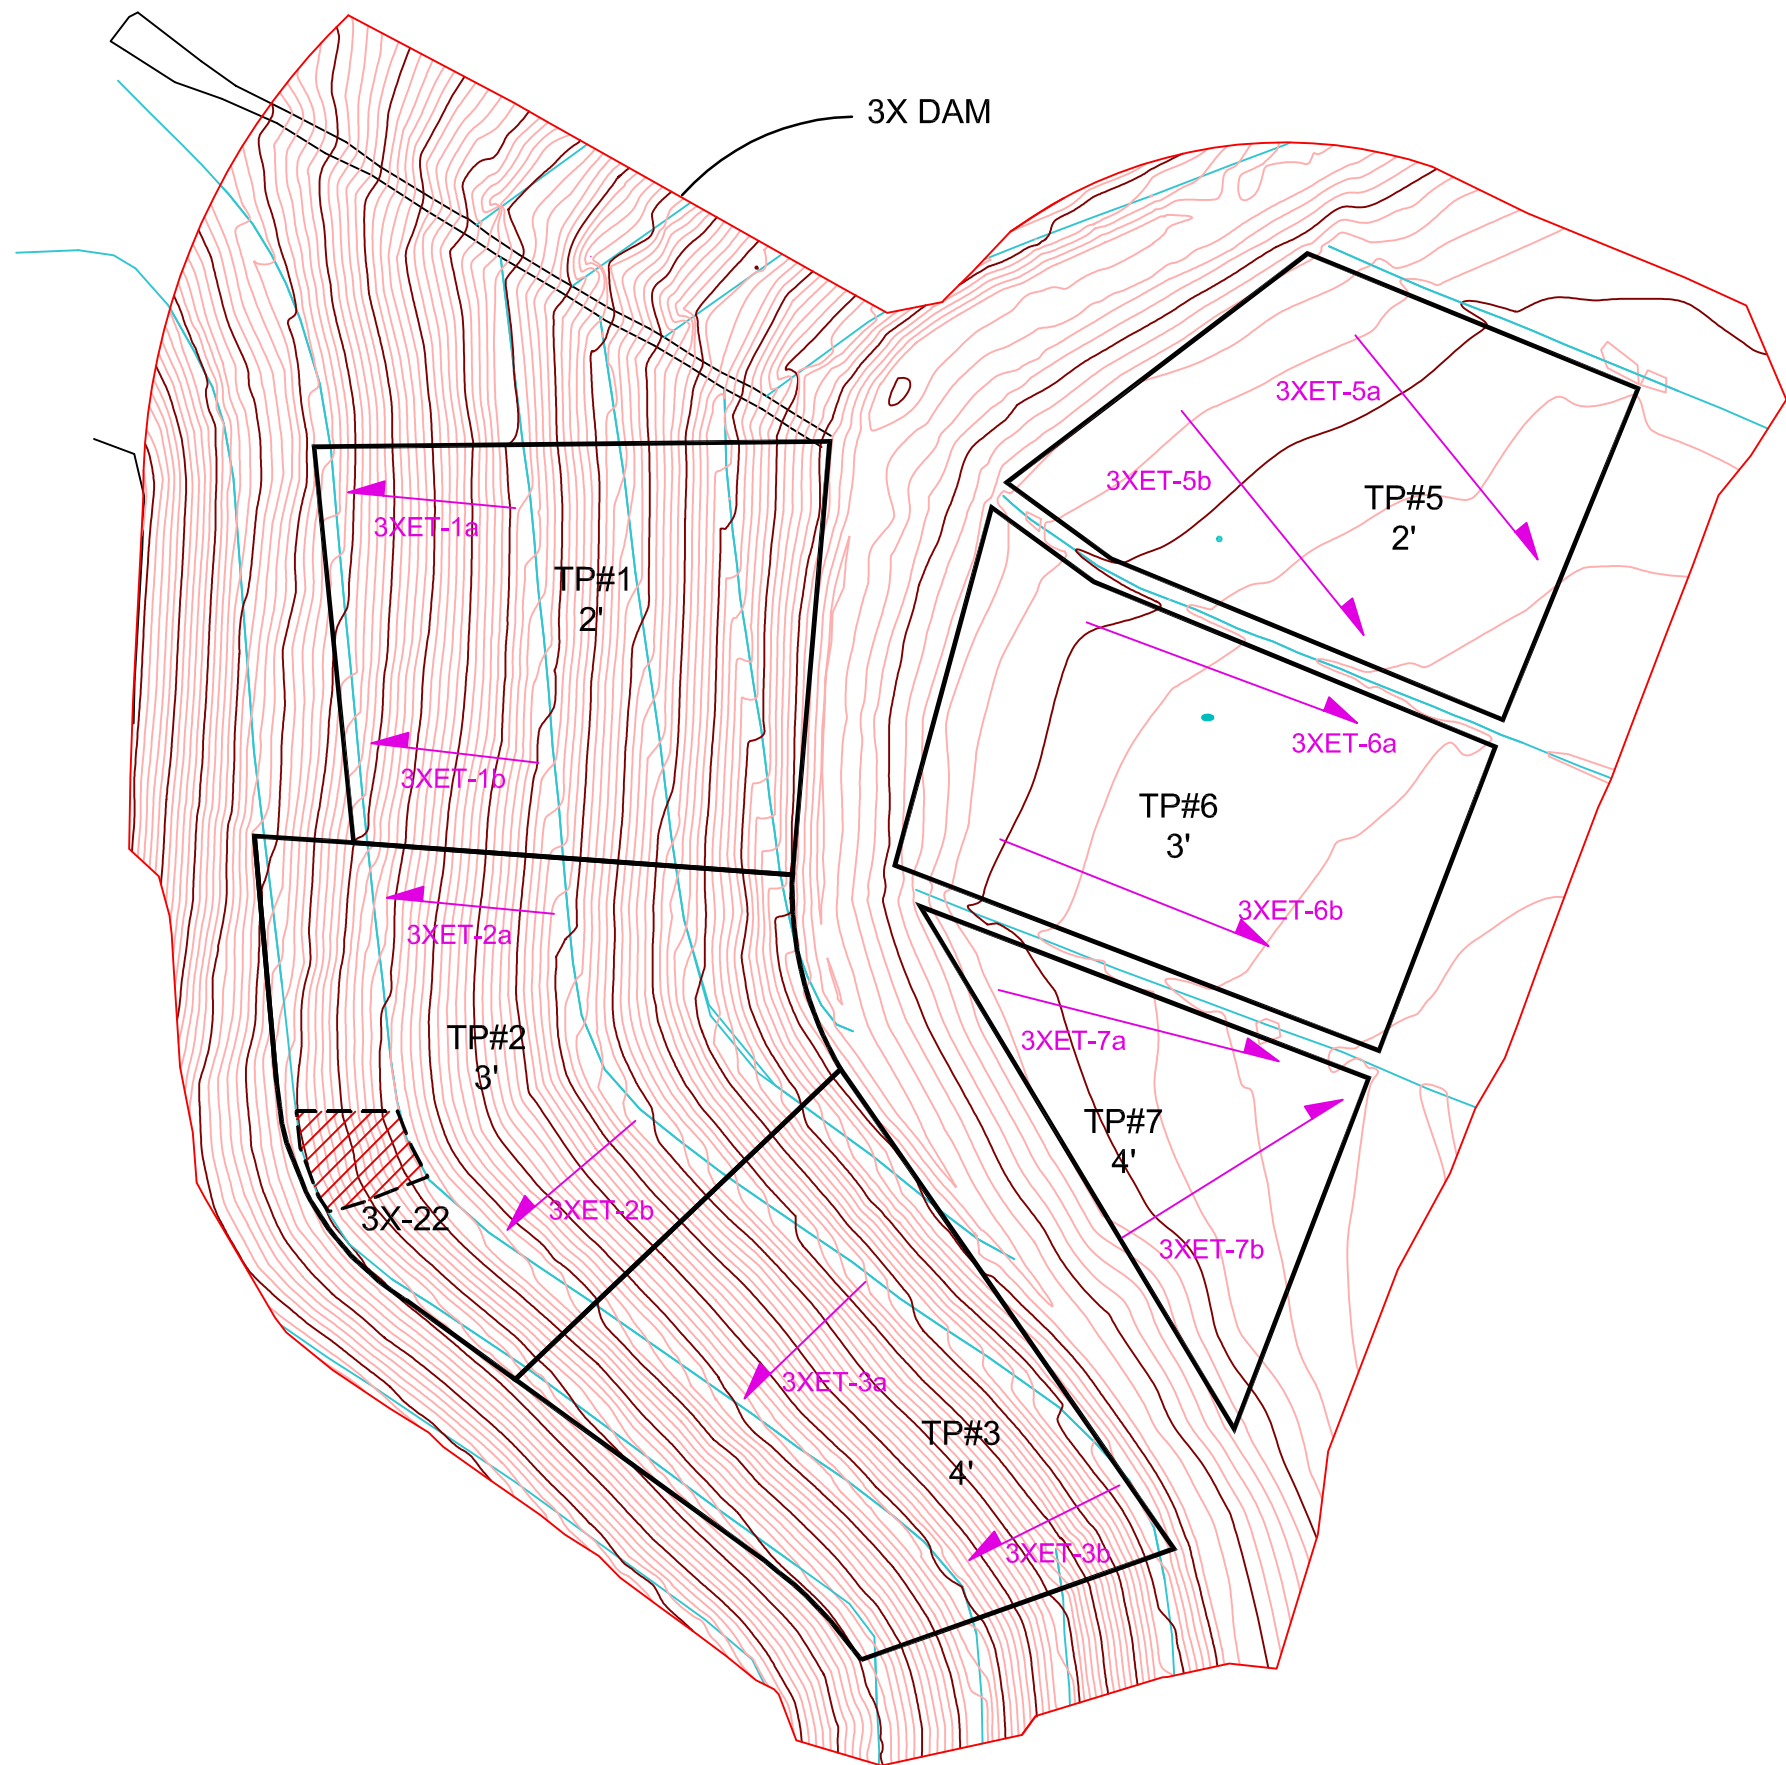
Figure 2 is an updated map showing the approximate location of the erosion transects, corrective action area on Dam 3X and approximate lysimeter subsidence zones.

During a field inspection in August 2006, surface depressions were observed above both lysimeters on the top surface test plots (2-foot and 3-foot cover plots). Surface water from recent rainfall was observed in the depression above the 3-foot cover test plot. The surface depressions are believed to have been caused by settling of the tailing and/or cover material following the heavy summer rains. The subsidence appears to be centered along the axis of the discharge pipe from the lysimeter barrel to reservoir. The subsidence occurred despite efforts made to compact the tailing during installation of the lysimeters. Heavy equipment were generally routed away from the area immediately above the discharge pipe, which may have resulted in lower levels of compaction than the surrounding areas. Golder proposes to construct a small earthen berm upstream of the subsidence areas to prevent runoff and ponding above the lysimeters.

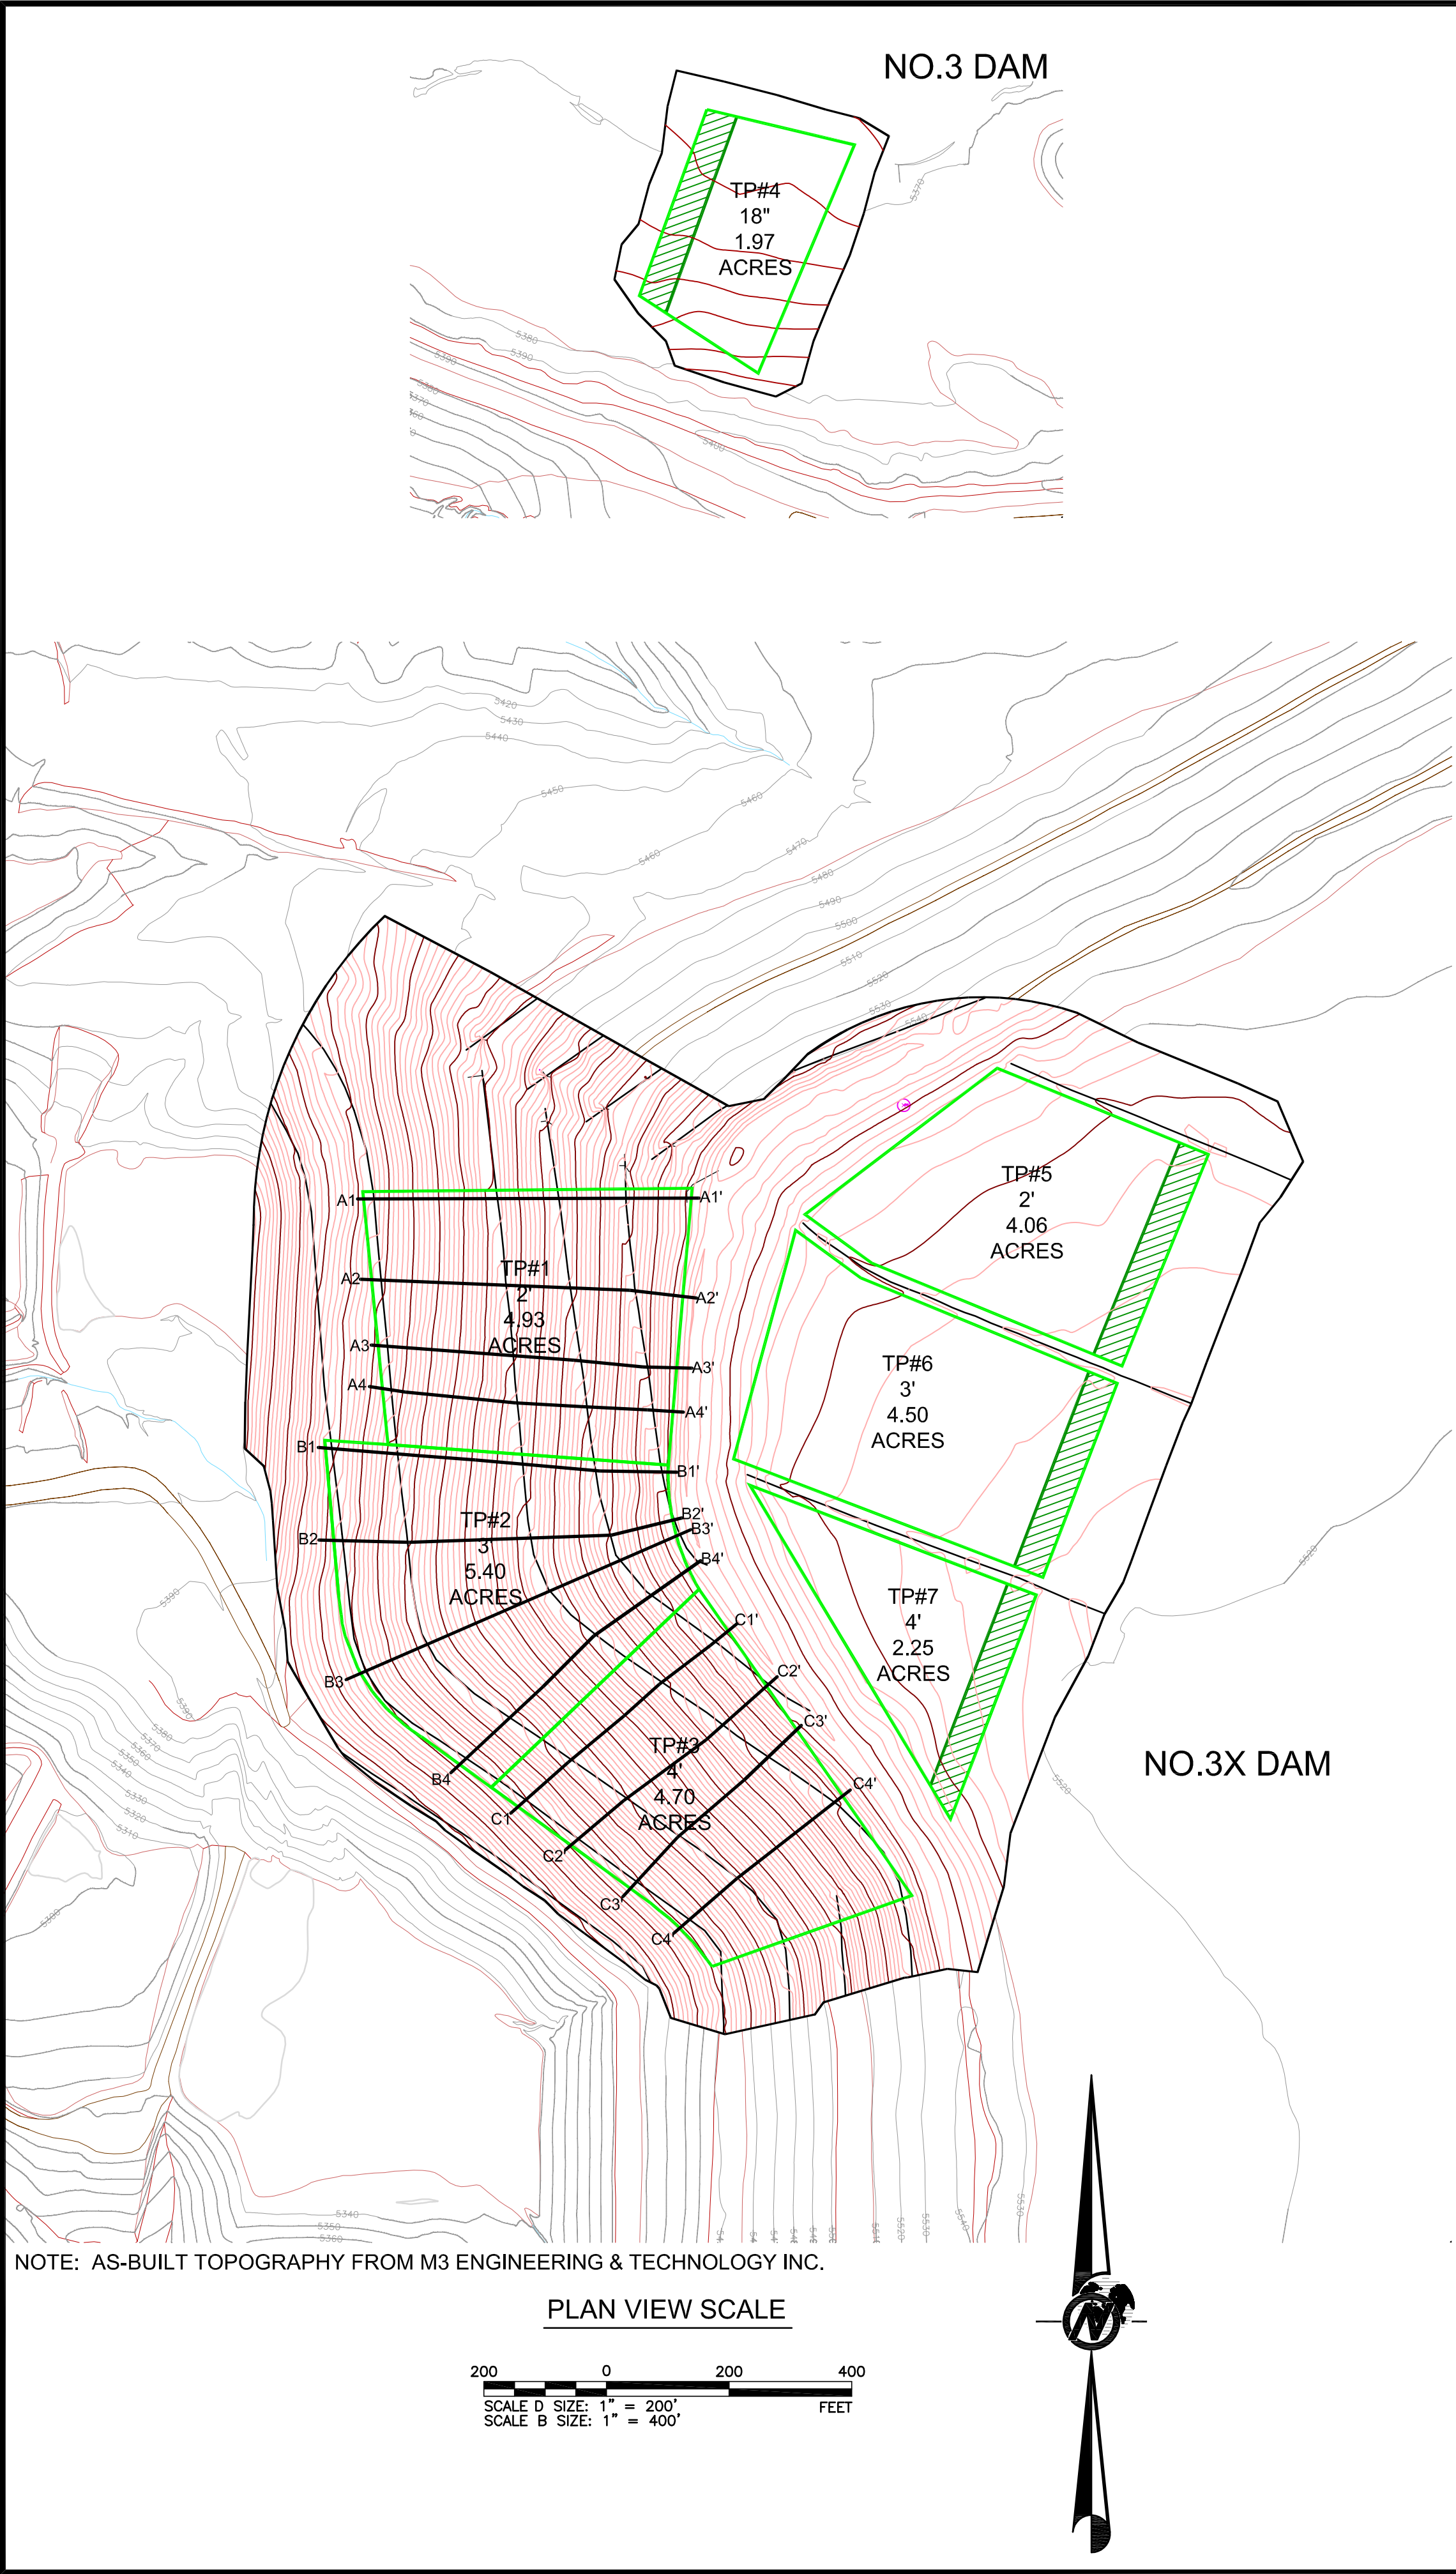
| CHECK | DR | 01/31/07 | PLATE 1 | |

The slope lengths on the test plots are generally shorter than originally proposed since the designs did not fully consider the slope length reductions associated with the construction of the v-ditches. Plate 1 provides additional cross-sections.

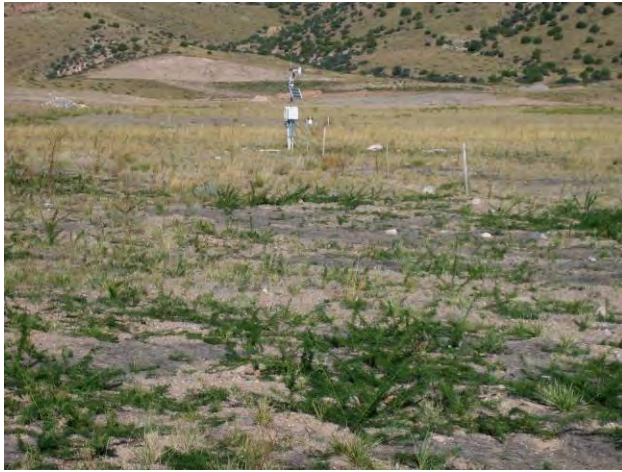
Vegetation establishment is considered satisfactory on the Dam 3X test plots based on qualitative assessments of cover, density, and diversity. Canopy cover is relatively low, but is consistent with the levels expected for the early establishment phases of reclamation in this region. Plant density generally exceeds about 1 plant/square foot, which is considered appropriate for this stage in the reclamation. The seeding operation resulted in the initial establishment of shrubs, forbs, and warm and cool season grasses. With the exception of mountain mahogany (*Cercocarpus montanus*), all the seeded species are expressed in the test plots on Dam 3X. Because of the nearly complete failure of mountain mahogany to establish on the Dam 3X test plots and elsewhere, it was been replaced by four-wing saltbush (*Atriplex canescens*) in subsequent seeding operations after consultation with the Agencies. Colonization of the site by native species is evident through the occurrence of non-seeded species. While some weedy annuals are present in the test plots, they are not widespread. Because of the deferred seeding date, the vegetation response of the 1.5 foot test plot on Dam 3 is lagging behind the Dam 3X test plots. Quantitative vegetation monitoring will be conducted in accordance with the approved work plan.

**Vegetation TP#5 - Oct 06**

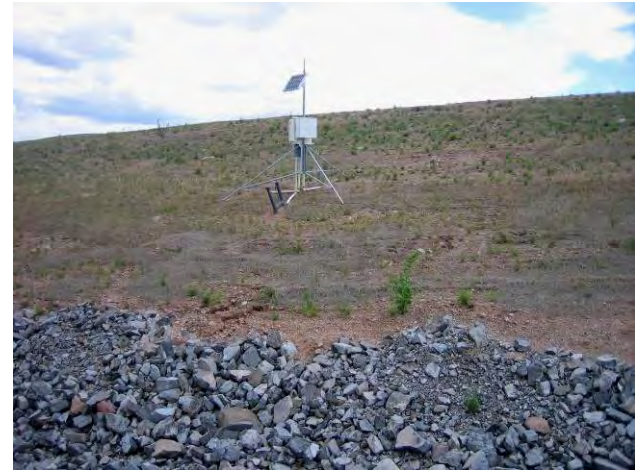
**Vegetation TP#1 – Aug 06**

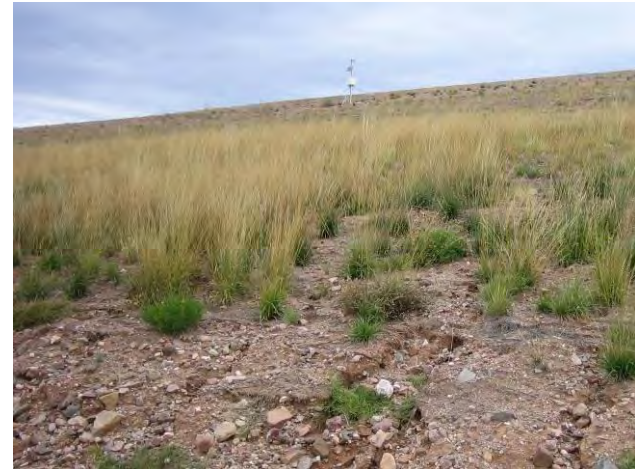
**Vegetation TP#1 – Oct 06**
