#### GAGE MINE SAFEGUARD PROJECT Deming, New Mexico

#### NARRATIVE DESCRIPTION

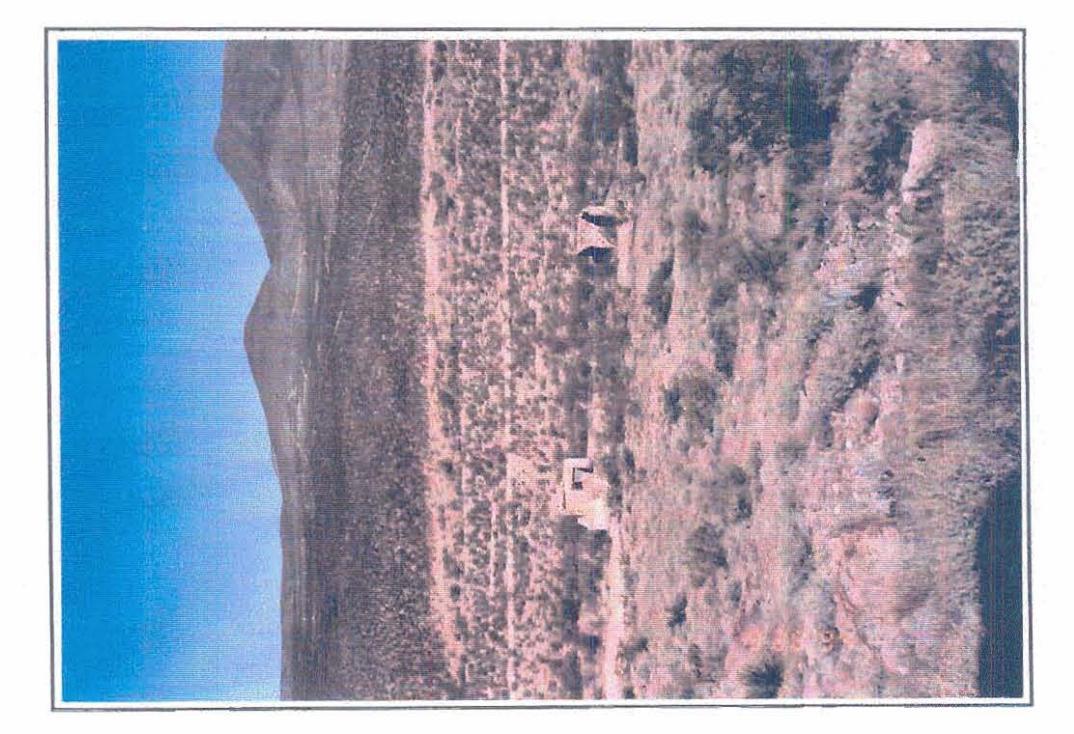
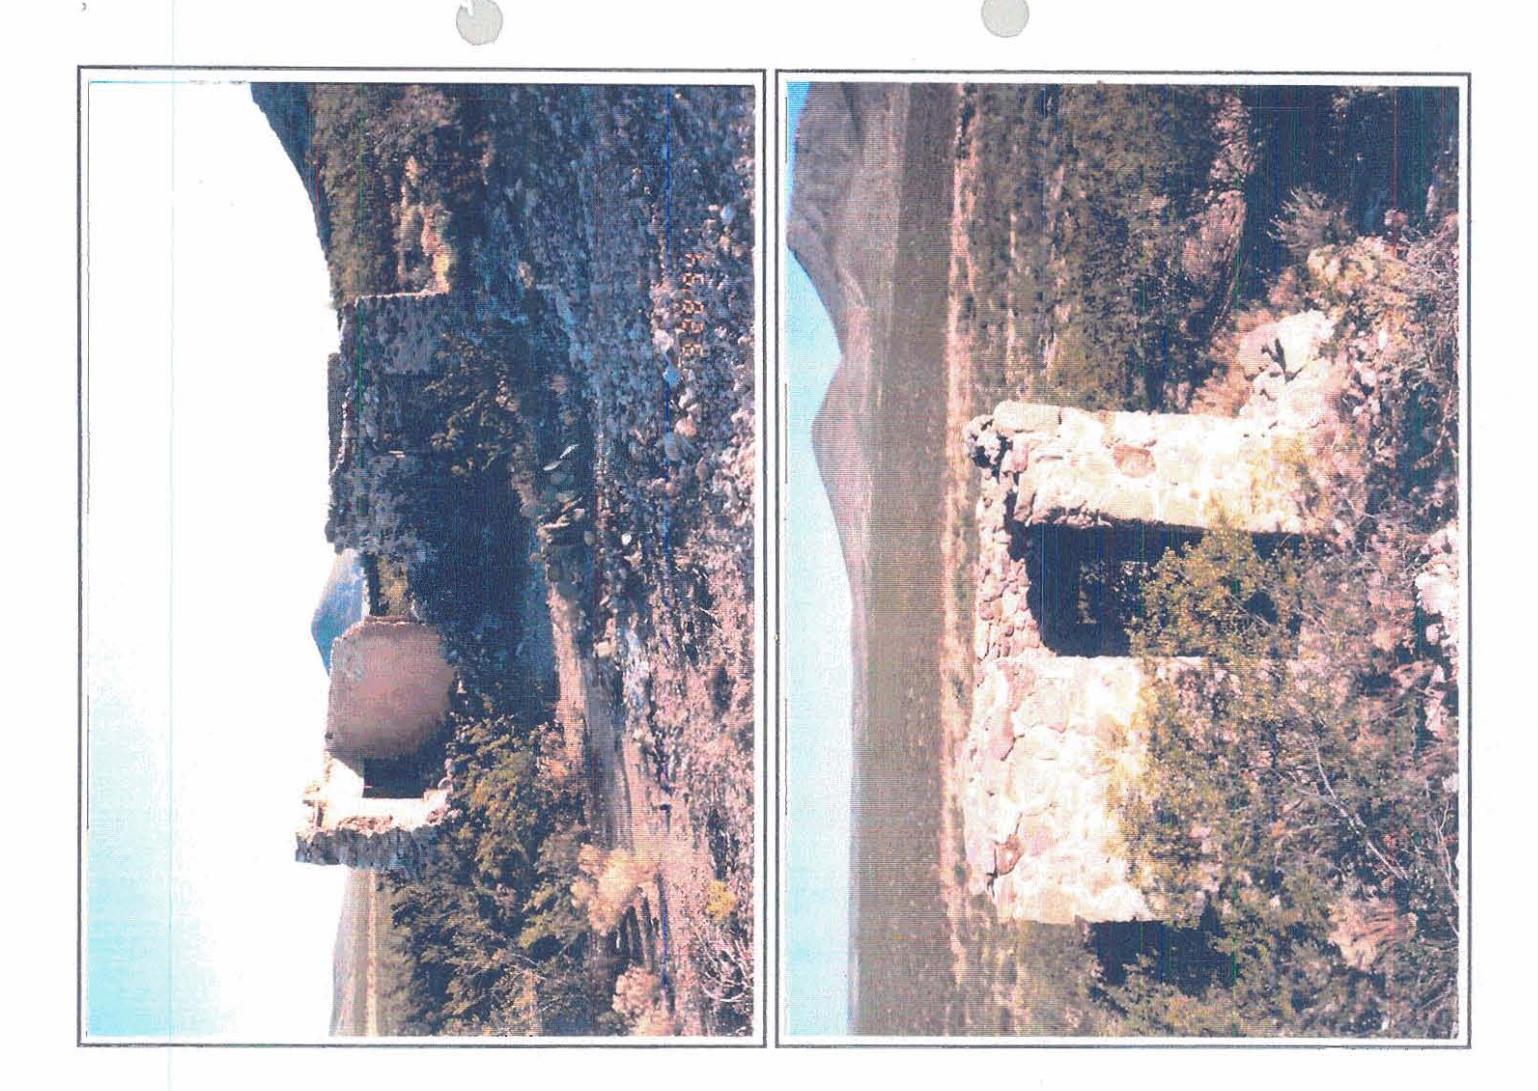
Below: Overview of town site (Structures C & D visible) Upper Right: Closeup of masonry house ruins (Structure C) Lower Right: Closeup of masonry house ruins (Structure D)

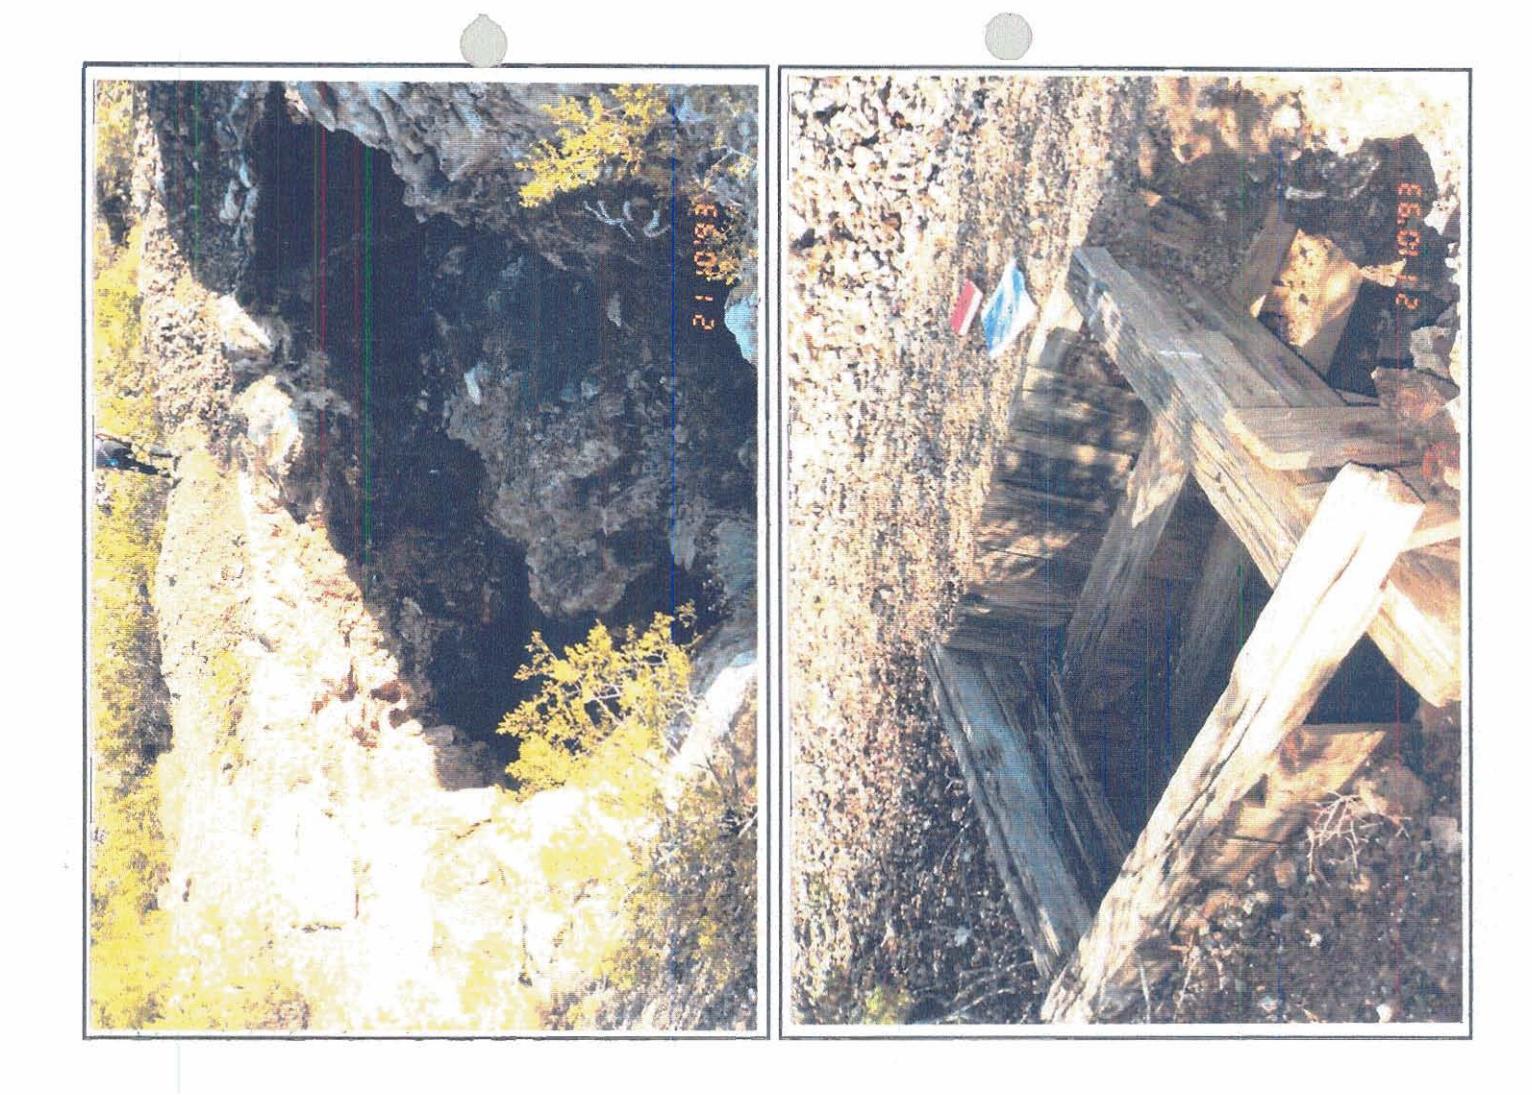
Below: Open shaft, later backfilled (Feature 47) Upper Right: Open glory hole, later backfilled (Feature 42) Lower Right: Open shaft, 31 feet deep, later backfilled (Feature 44)

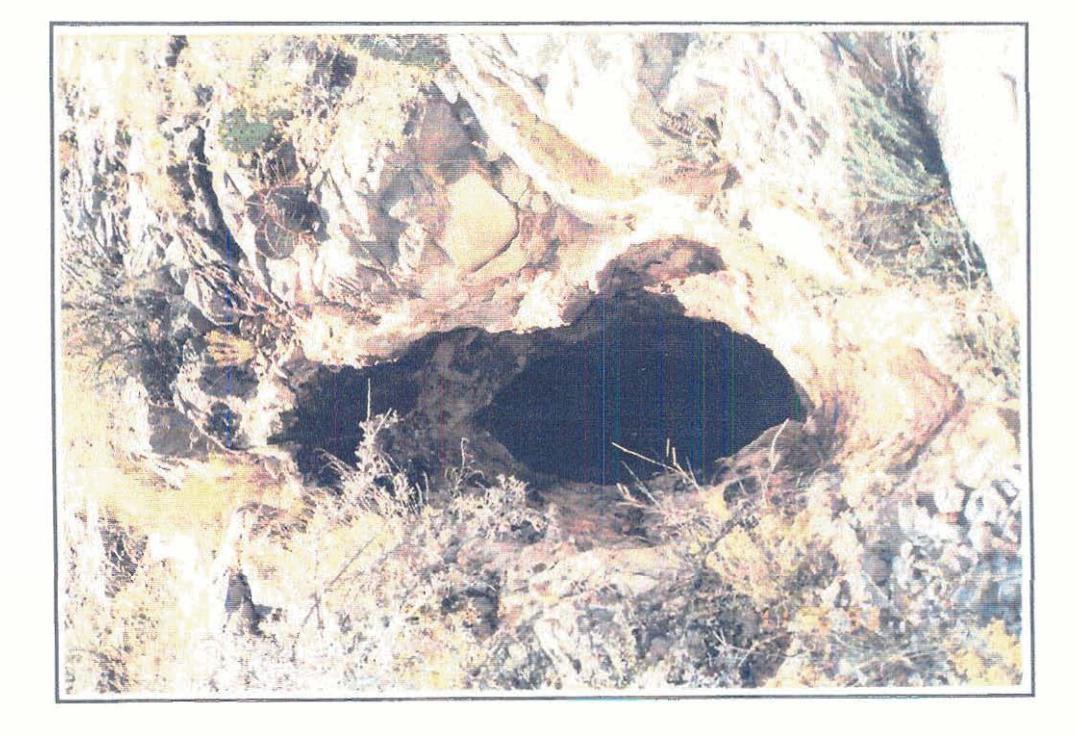
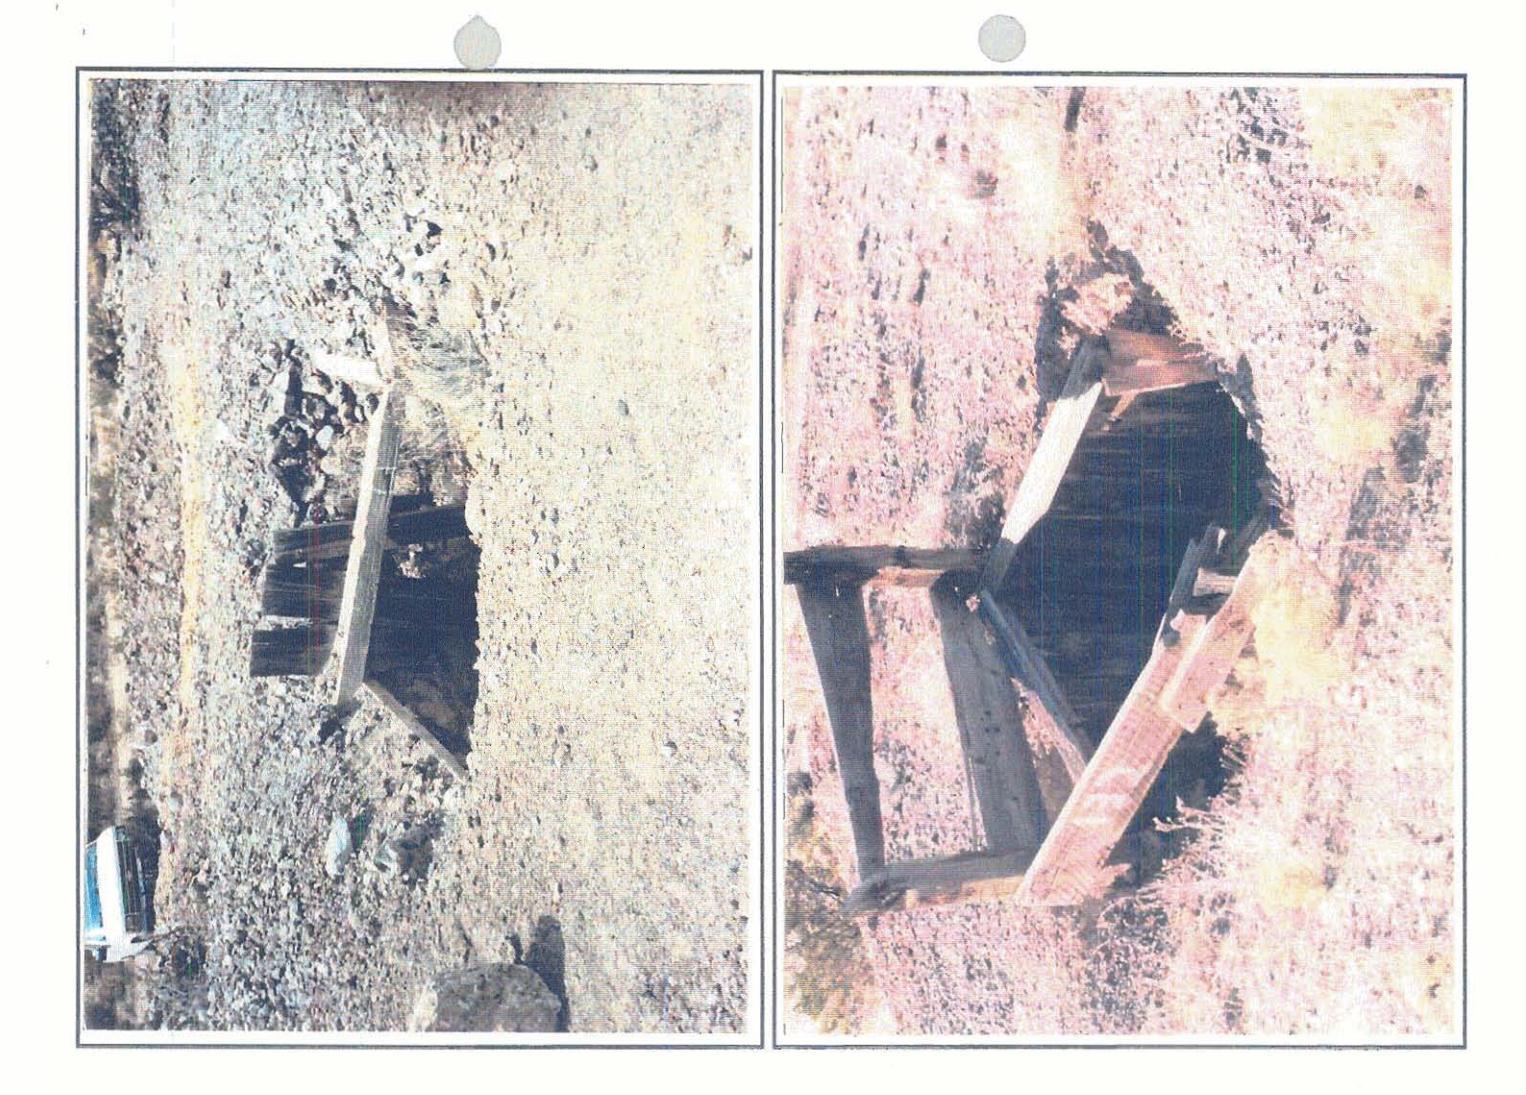
Below: Open shaft, later safeguarded with horizonal bat grate (Feature 160) Upper Right: Open shaft, 70 feet deep, later backfilled (Feature 57) Lower Right: Open shaft, 56 feet deep, later backfilled (Feature 132)

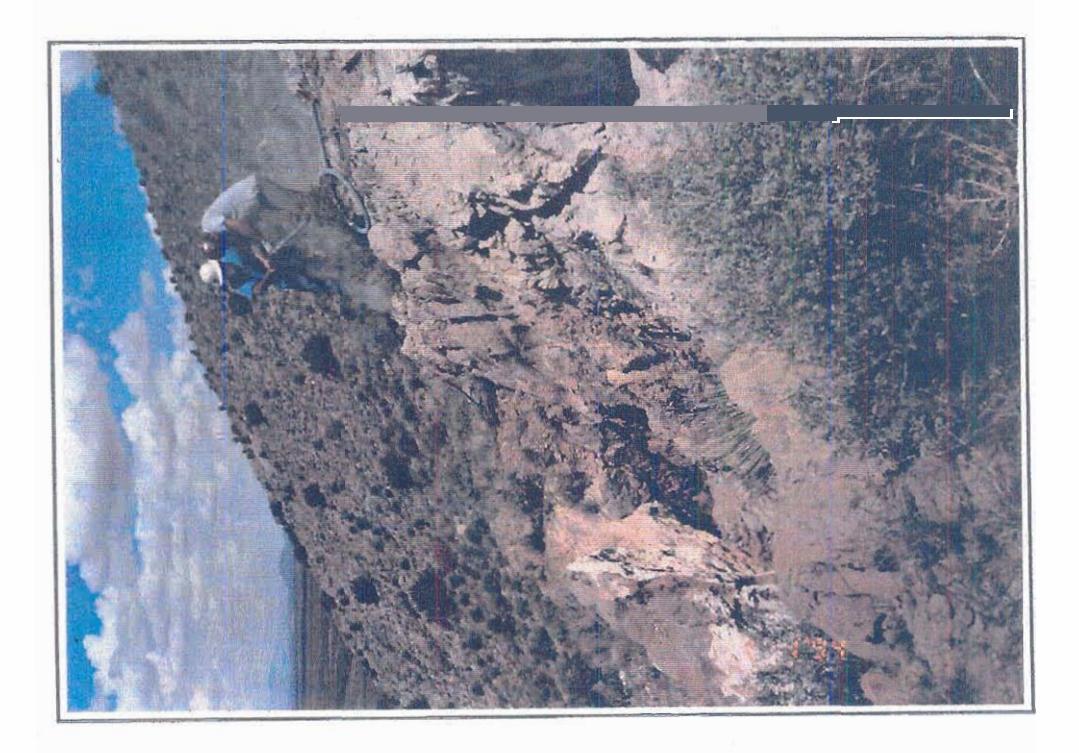
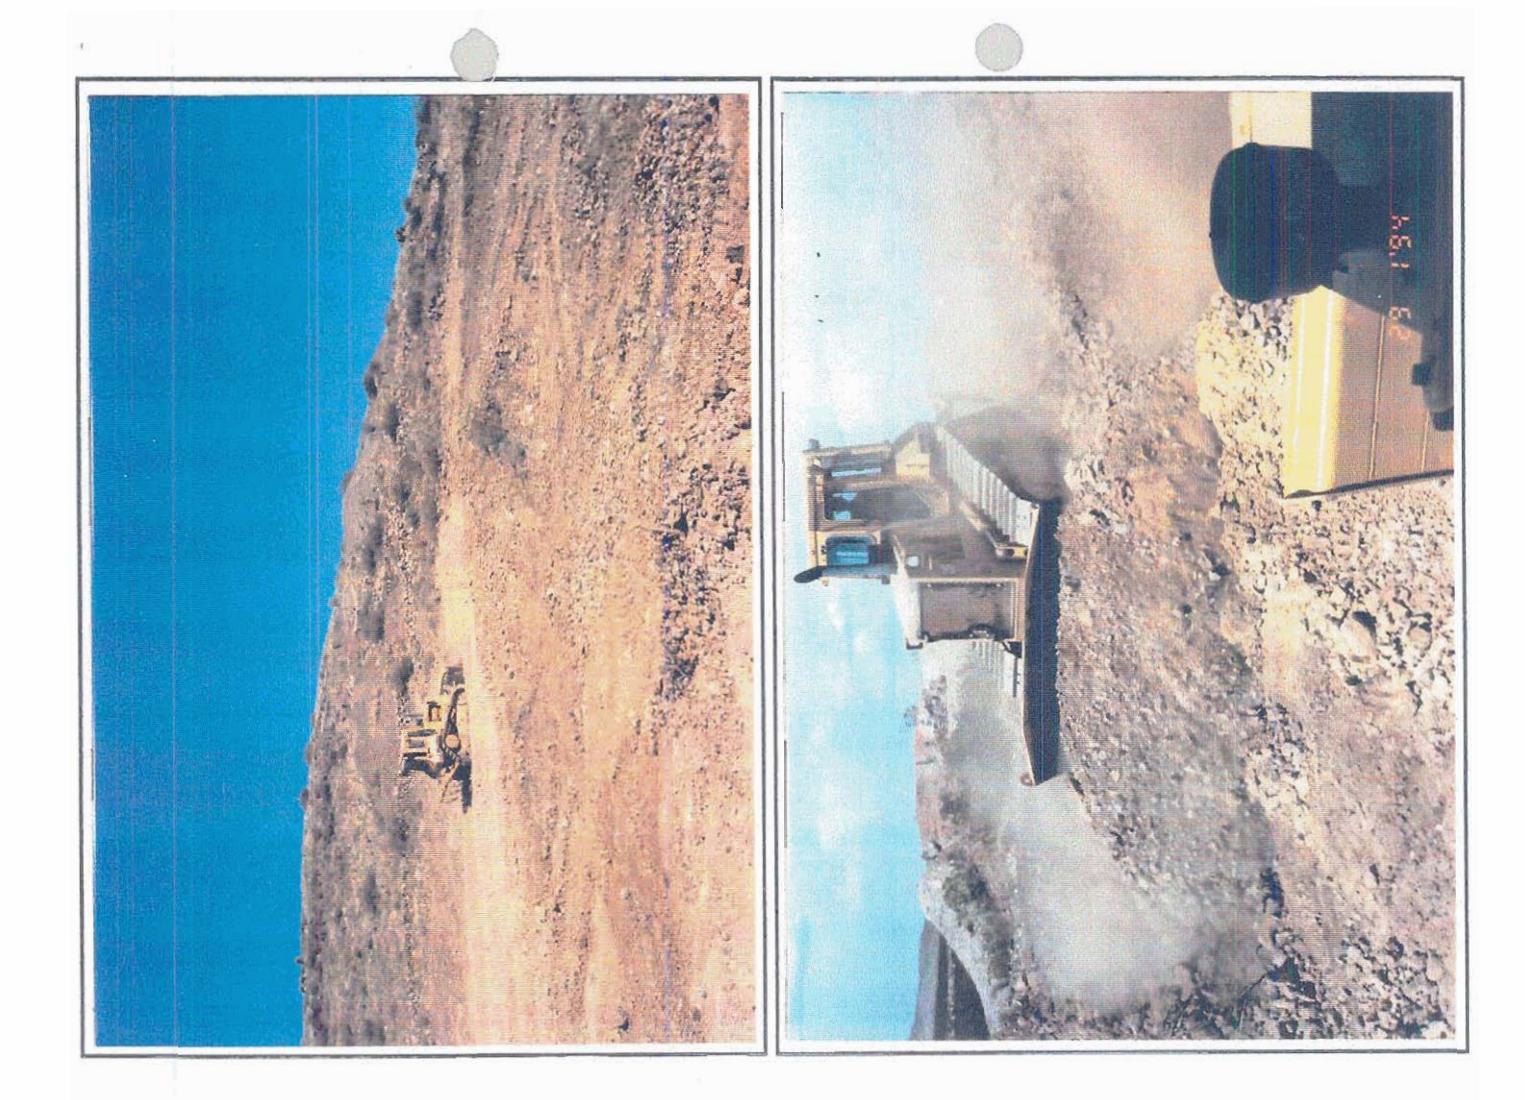
Below: Drilling for blasting at epen stope (Feature 116)

Upper Right: Dezing mine waste to fill open stopes (Features 49 to 56) Lower Right: Dozing mine waste to fill glory hele (Feature 42)

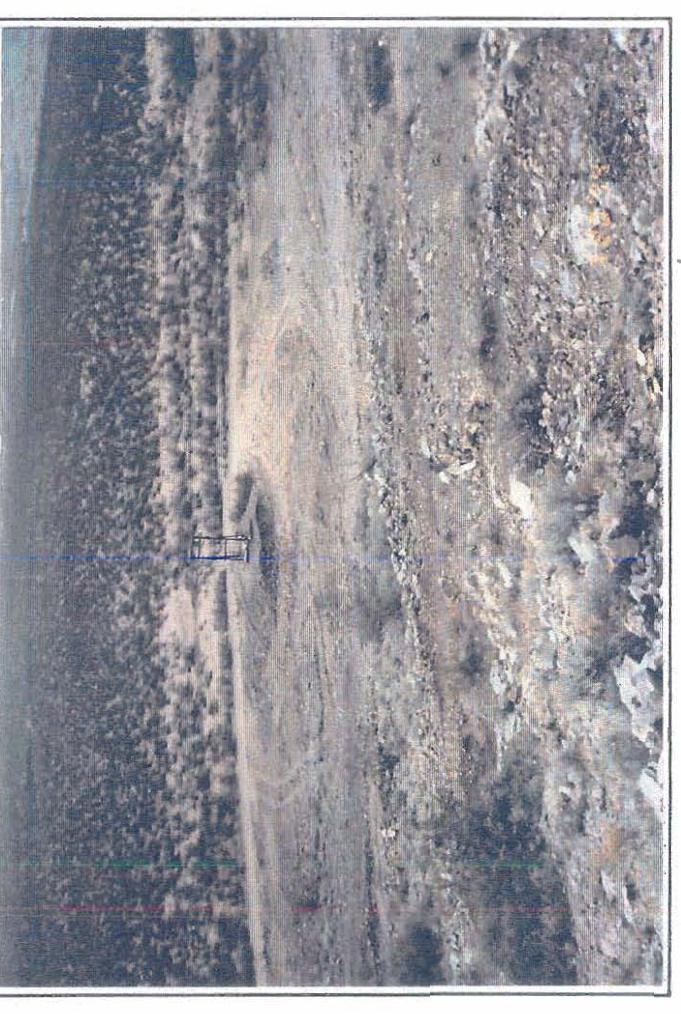
Backfilled and graded area where there were many open shafts and stopes (headframe at Rambler Shaft, Feature 69, at center)

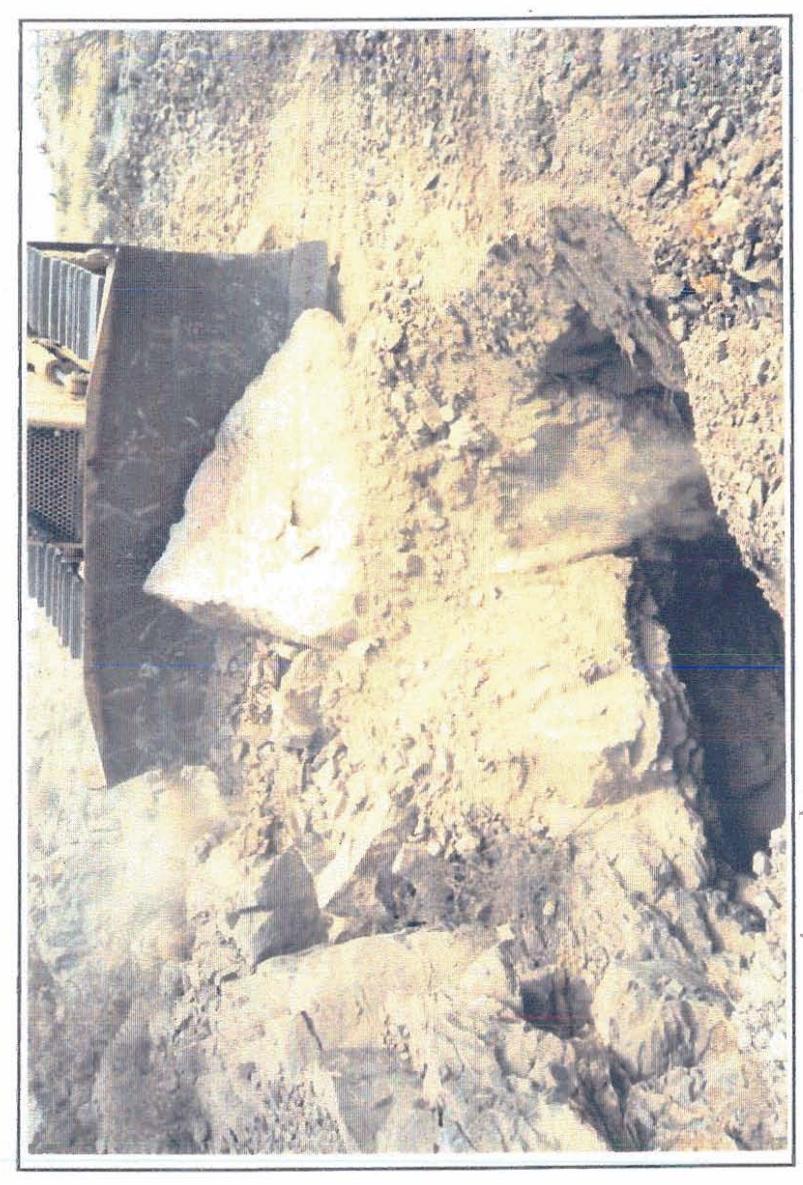
Backfilling open shaft (Feature 808)

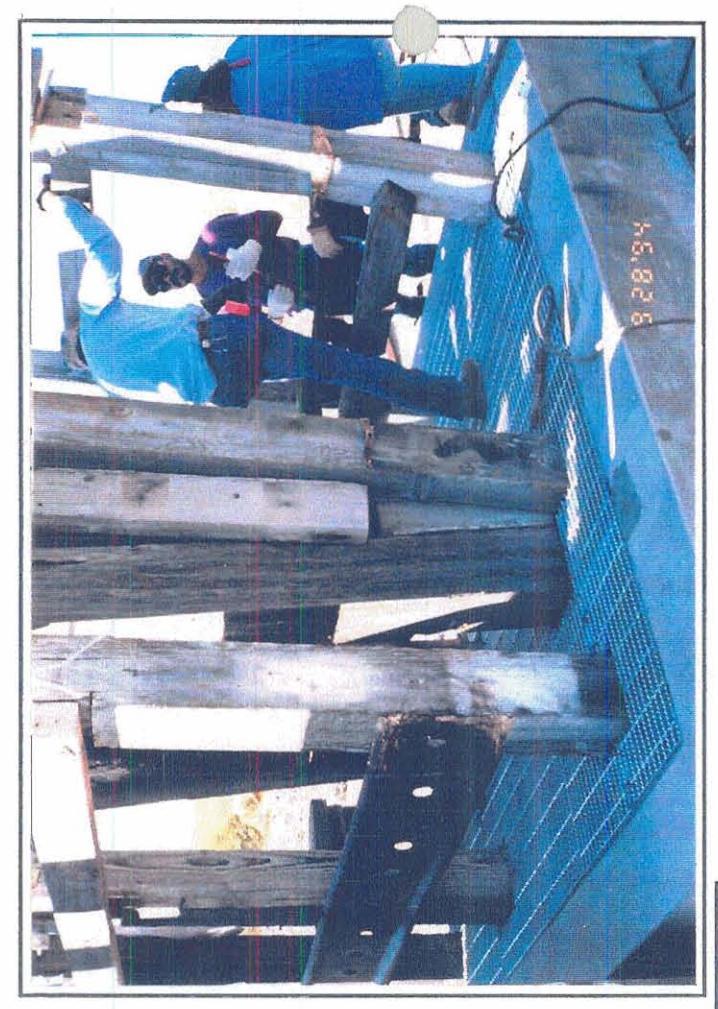
# GRATED SHAFT CLOSURE AT THE HELEN SHAFT (FEATURE 1)

Below: Prior to construction, access to shaft is available down a ladder on right side

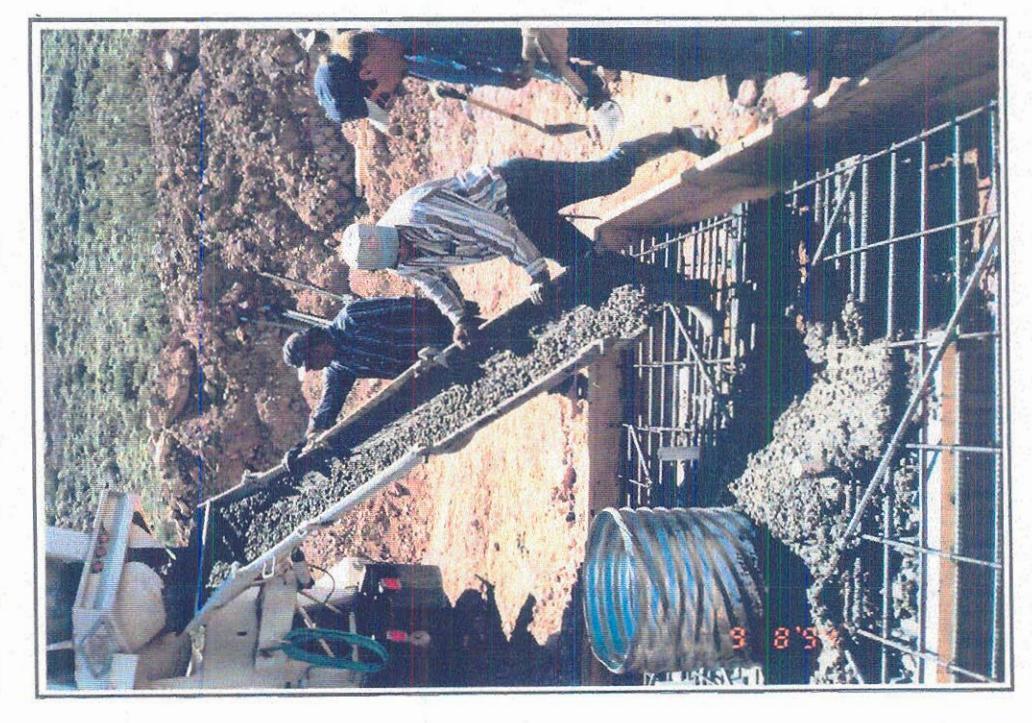
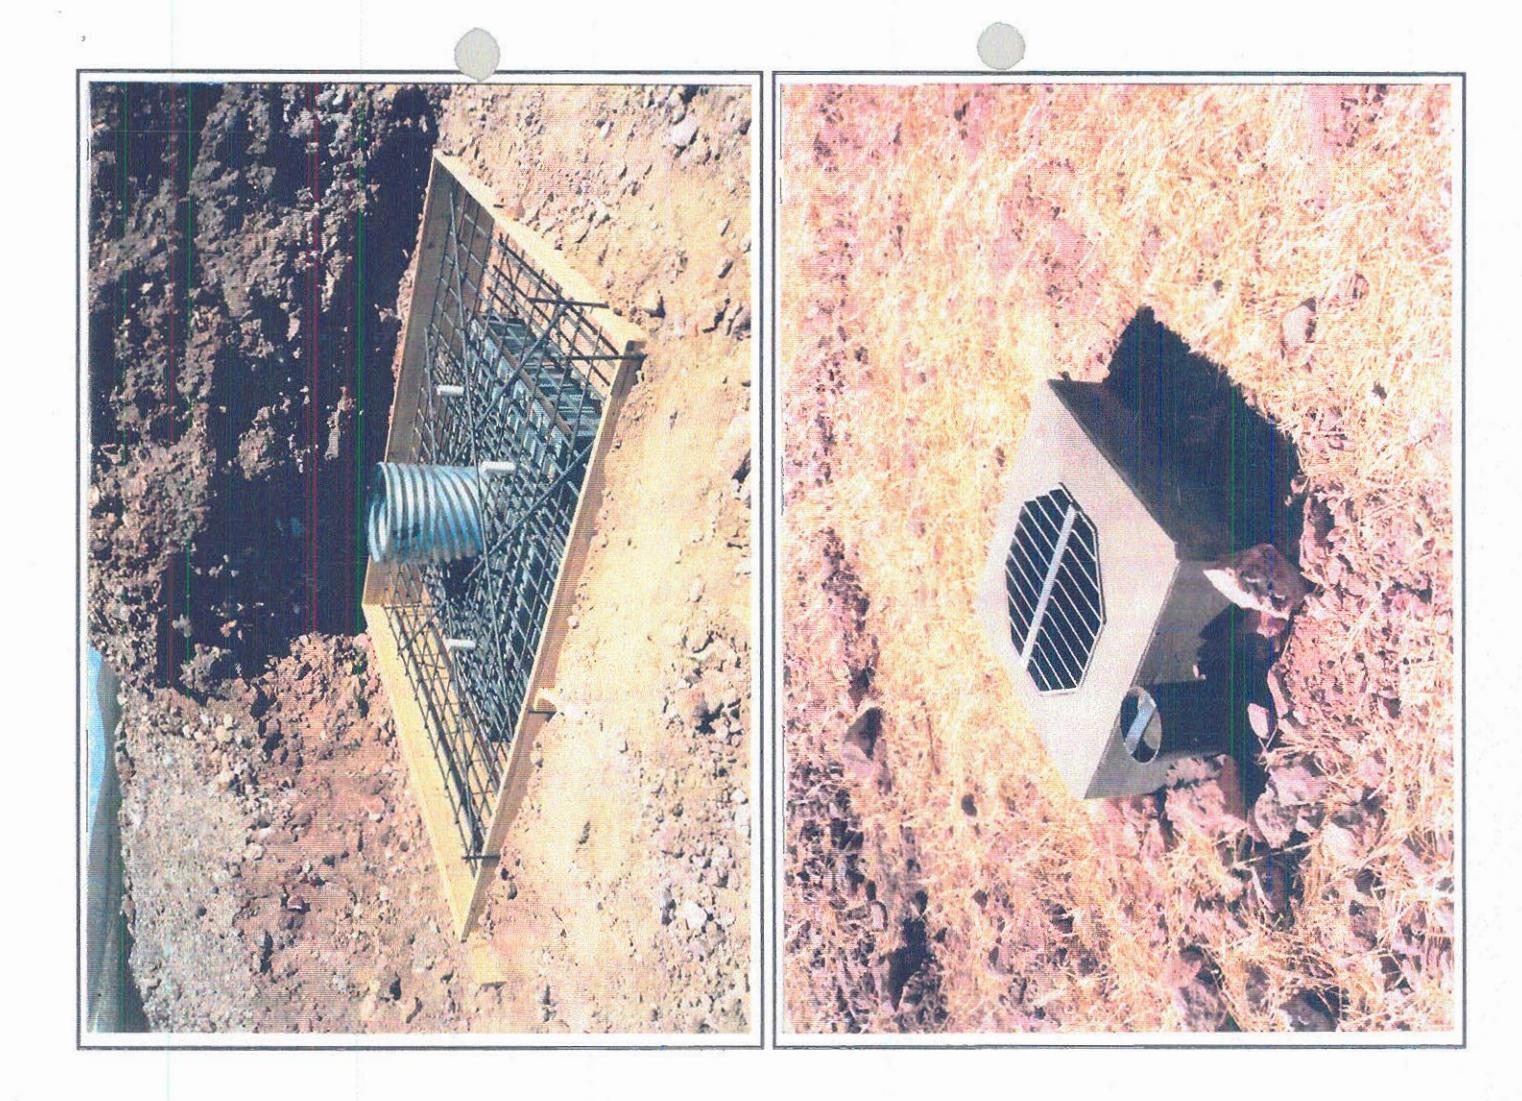
### CAST-IN-PLACE CONCRETE CAP AND GRATED VENT AT THE RAMBLER SHAFT (FEATURE 69)

Below: Placing concrete into the forms

Upper Right: Formwork, reinforcing steel, lower portion of vent pipe prior to concrete placement

Lower Right: Completed grate at top of vent pipe

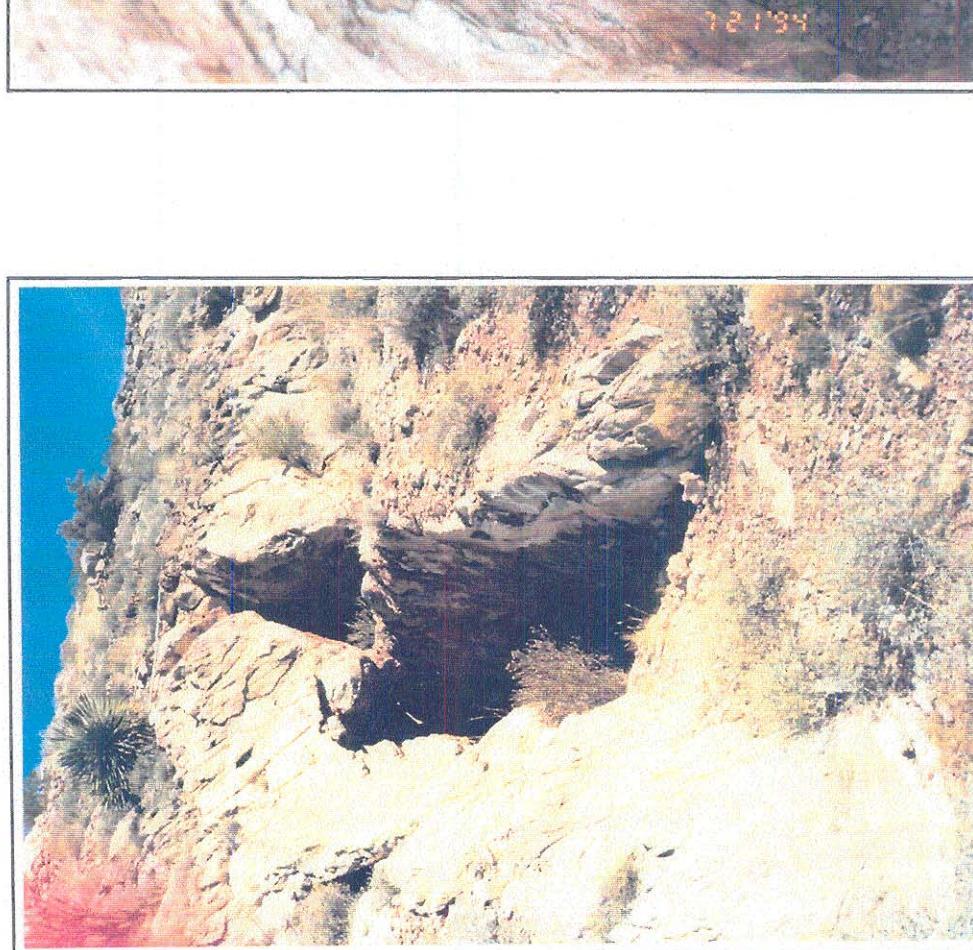
Below Left: Adit entry before construction

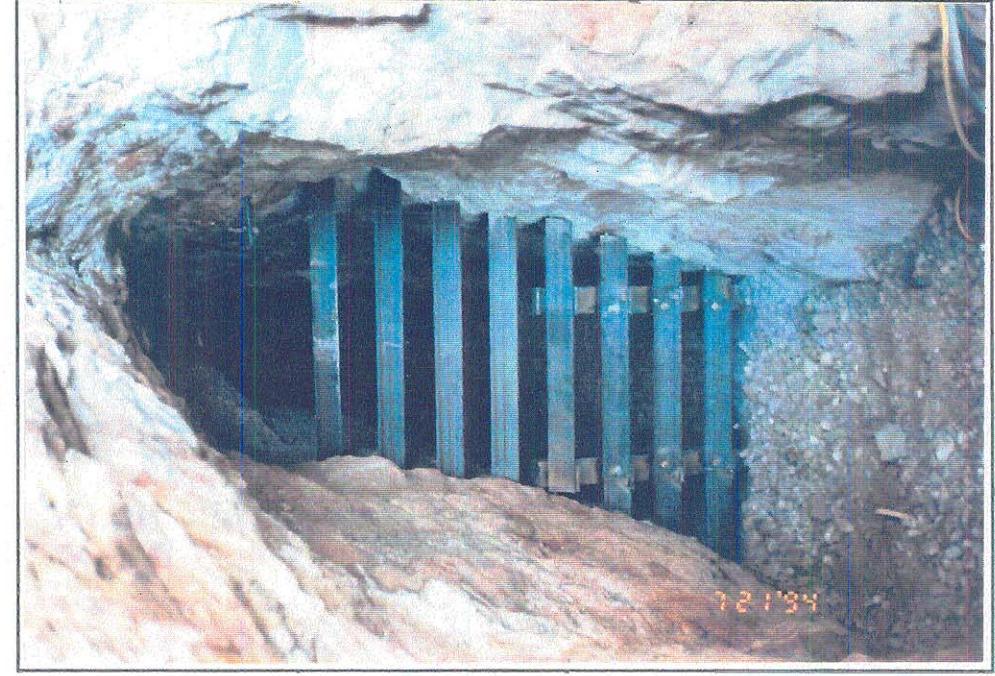
Below Right: Bat grate under construction inside adit

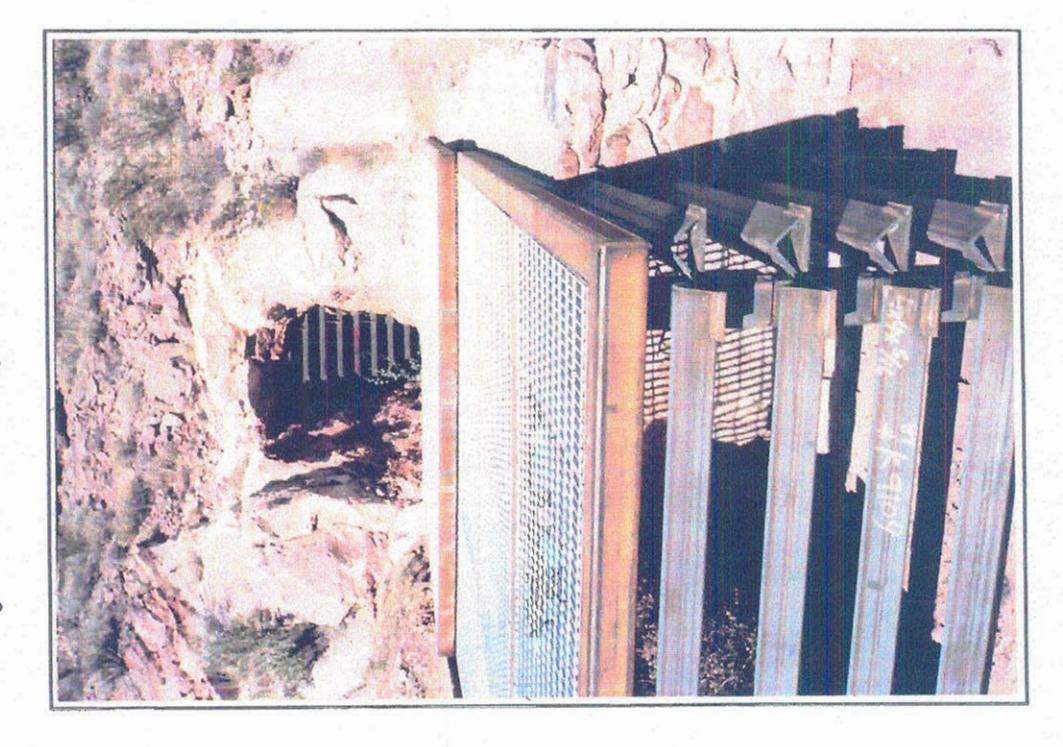
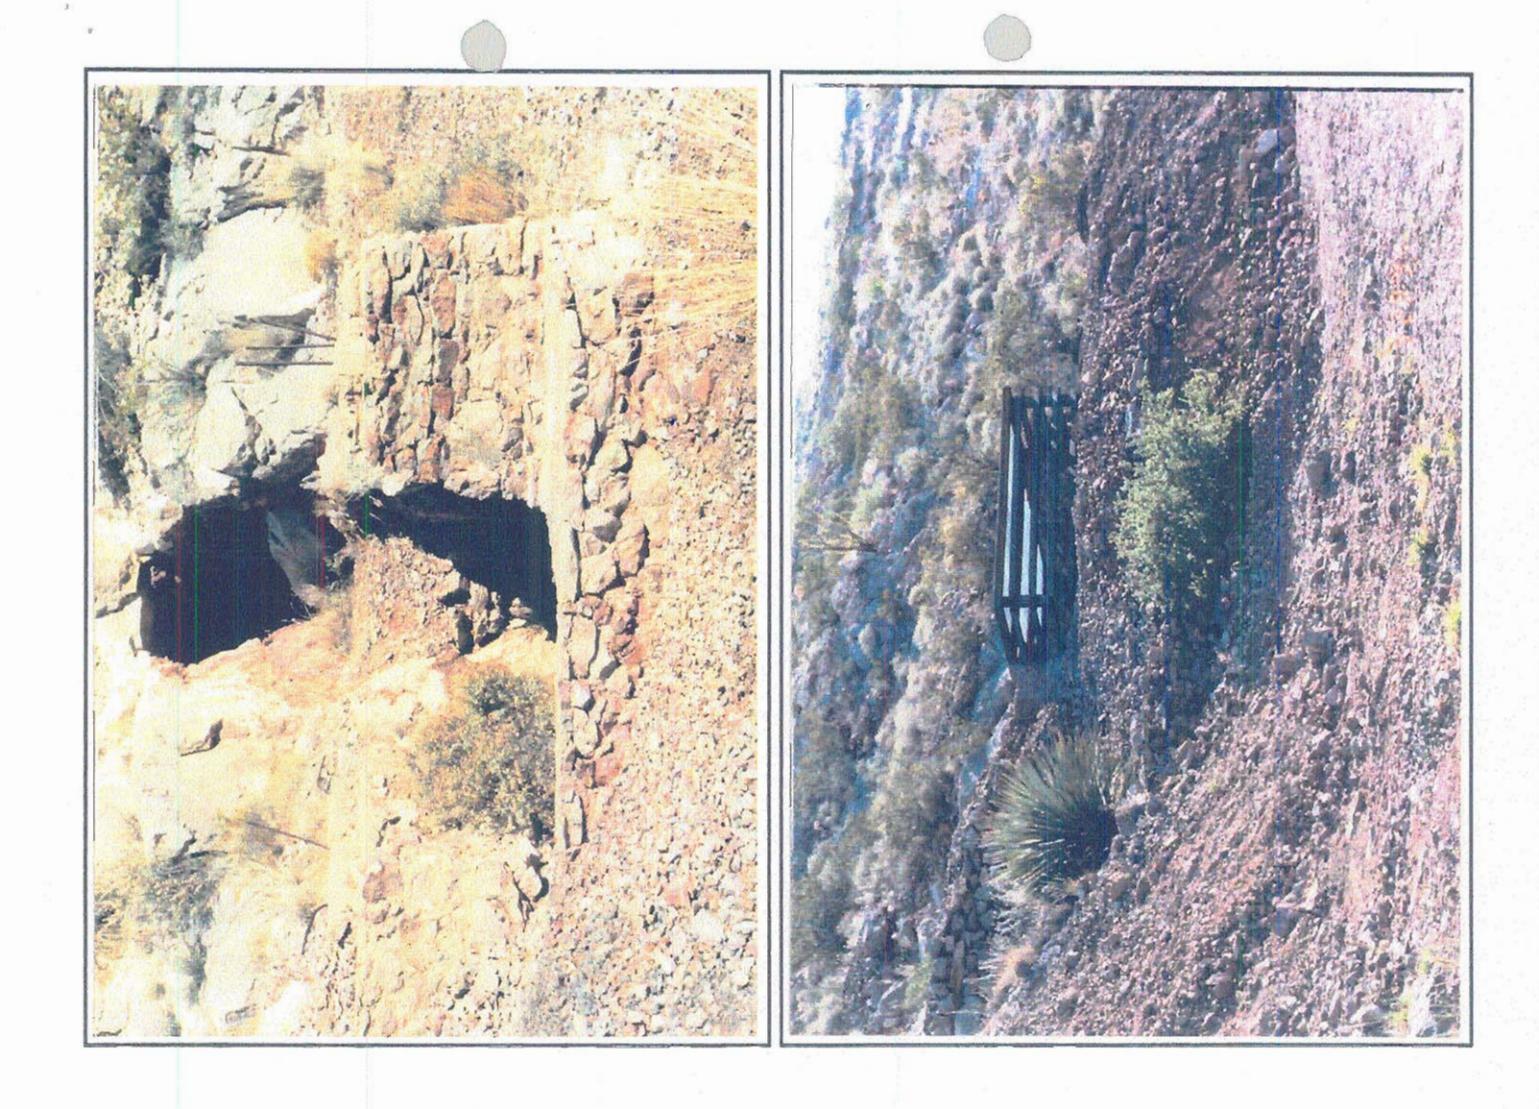
BAT CLOSURES AT THE CHANCE SHAFT AND ADIT [FEATURES 92 & 93]

Below: Nearly complete bat closures

Upper Right: Open shaft and adit before construction

Lower Right: Another view of completed bat closure at Chance Shaft
