MK018PR SECTION 17 MINE

Santa Fe Pacific Gold Corporation's Prior Reclamation Status, Faith Mine et al, McKinley Mine

PRIOR RECLAMATION INSPECTION REPORT AND RECOMMENDATION FOR RELEASE OR PERMIT REQUIREMENT

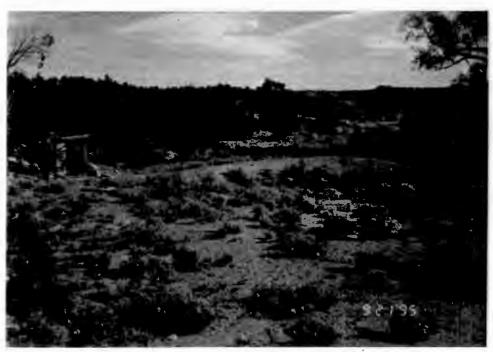
Section 13 T1N R6W, Powder Magzine, September 21, 1995

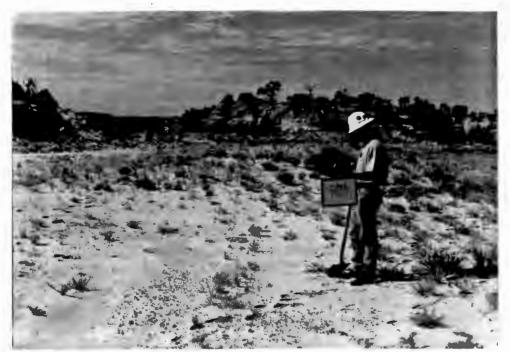
Section 1 T13N R9W, Shaft Site looking South, 9/13/95

Essentially, the site had been safeguarded but not topsoiled or reseeded. The site is characterized by white fine grained sandstone covered by a few inches of fine white sand. The sand is subsequently being eroded away by wind and water. A mine access road had significant erosion. An impoundment had been constructed to impound sediment from the mine site, however, erosion from the access road was bypassing the impoundment and was entering the mine site. Photographs documenting vegetation and the general condition of the site are presented in Appendix C.

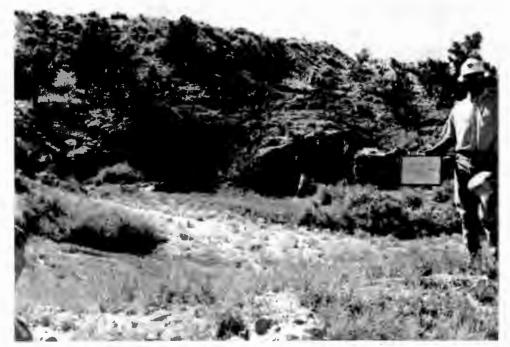
Section 1 T13N R9W, Sediment Pond, 9/13/95

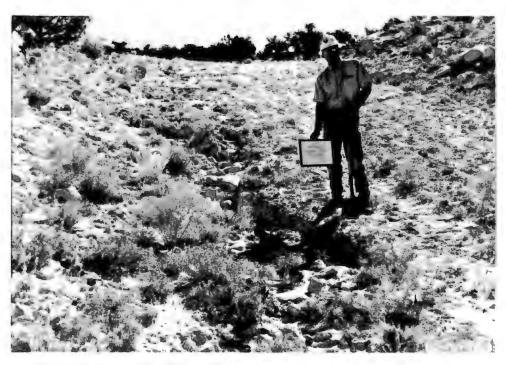
Section 1 T13N R9W, Access Road, 9/13/95

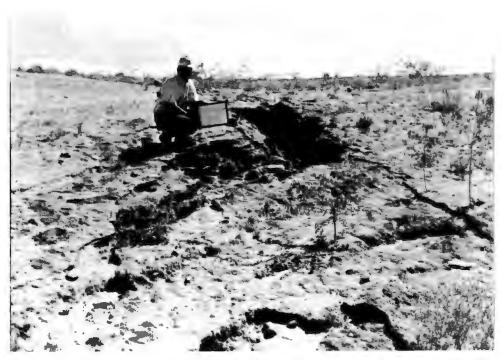
The Section 25 mine is located 14 miles northwest of Grants, New Mexico. This 8-acre site was a surface mine operated by Reserve Oil and Minerals. It was reclaimed and reseeded by Santa Fe Pacific Gold in 1993. Additional reclamation activities were performed in 1994. A barbed wire fence surrounded the site. All structures, trash or junk had been removed from the site. There were no piles or accumulations of toxic or waste material on the site. There were no apparent hazards that could effect public health and safety. There were several topsoil mounds left by Santa Fe because small mammals had extensively burrowed into them and were using them for habitat. Photographs documenting the vegetation and the general condition of the site are presented in Appendix F. The regrading included construction of three large depressions that impounded rainwater for livestock. There was one significant erosion feature and several areas of minor erosion on the sides of these depressions. Topsoil depths across the site were greater than 12 inches. An earthworm found while measuring soil depths at this site is a good sign that the soils are generally non-toxic.

Section 25 Mine, Erosion Feature, 9/12/95

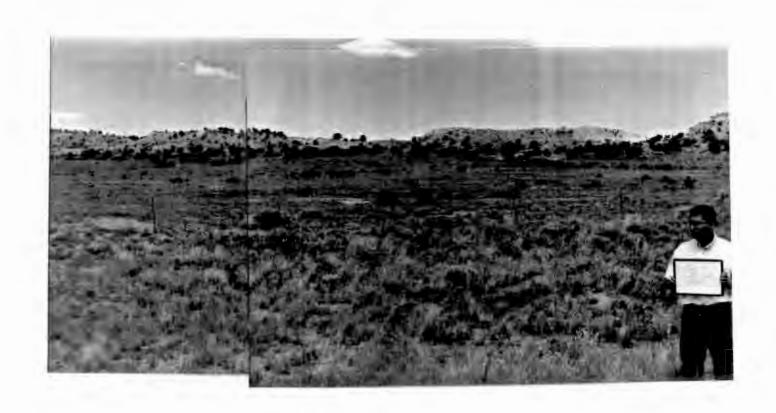
This was a surface mine located 14 miles northwest of the Grants, New Mexico. The mine was operated by United Nuclear Corporation until termination of the lease in 1975. Open adits and shafts were backfilled and otherwise safeguarded in 1987. The site was reclaimed and reseeded by Santa Fe the fall of 1994 (Santa Fe, 1994). All structures, trash or junk had been removed from the site however, trespass dumping has since taken place. There were no piles or accumulations of toxic or waste material on the site. There were no apparent hazards that could effect public health or safety. There were minor erosion features where water had flowed into depressions. Twenty foot slopes of limestone cobble were left on the south side of the reclaimed area to blend in with a natural limestone outcropping. Several 6 foot high, 50 foot long topsoil stockpiles were left because small animals were burrowing into them and were using them for habitat. Photographs documenting vegetation and general condition of the site are presented in Appendix G.

Section 31 T13N R9W, Reconstructed Limestone Bluffs, 9/12/95

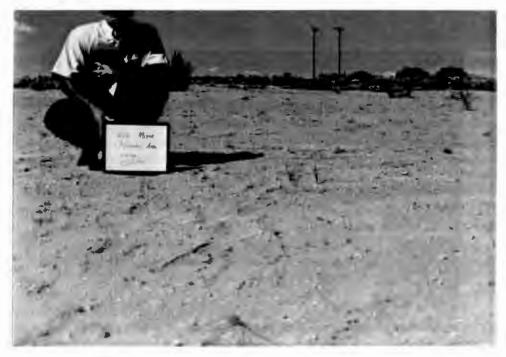
Faith Mine Regraded Area, 9/12/95

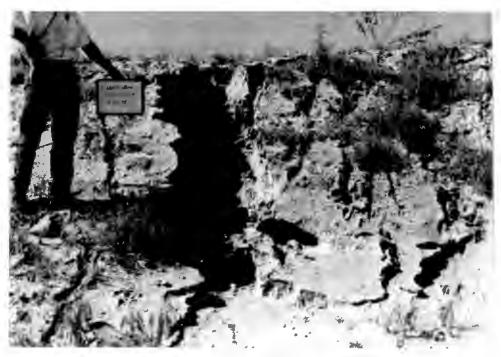
Isabella Mine, Erosion Feature, 9/12/95

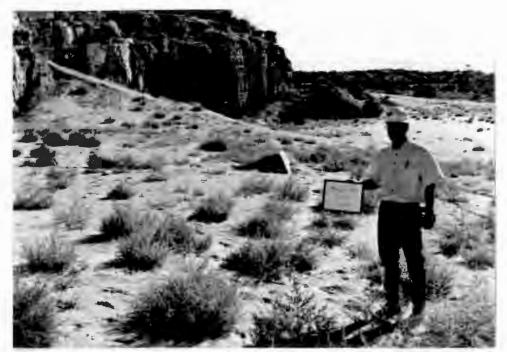
Marquez Mine, Reclaimed Declined Shaft, 9/12/95

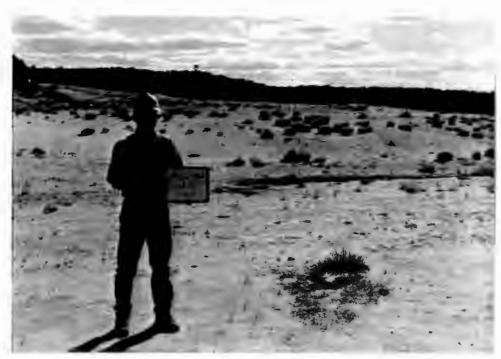
Marquez Mine, Waste Pile, 9/12/95

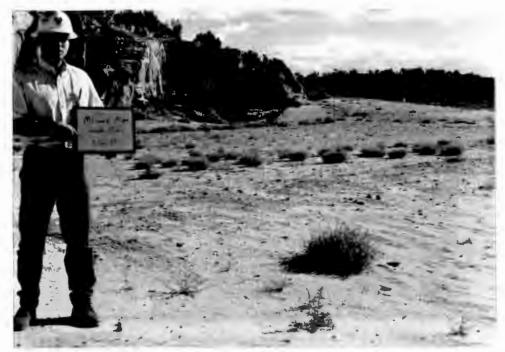
Marquez Mine Waste Pile, 9/12/95

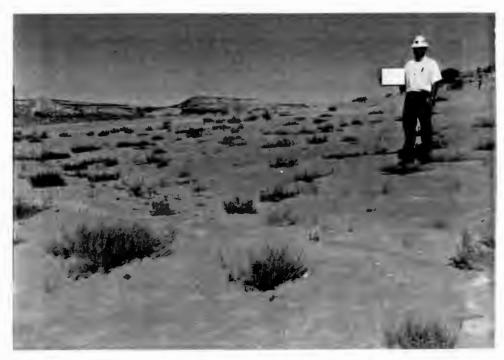
Marquez Mine, Waste Pile, 9/12/95

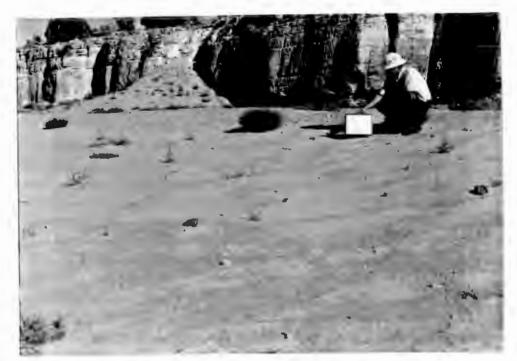
Marquez Mine, Waste Pile, 9/12/95

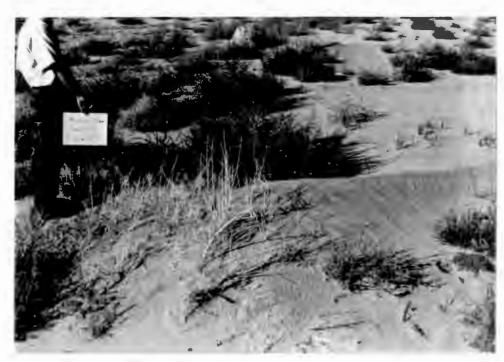
Marquez Mine, Sand Dune, 9/12/95

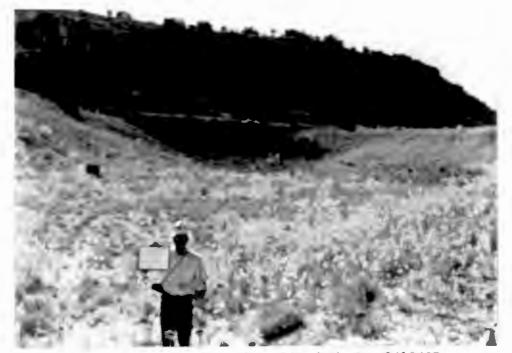
Poison Canyon Mine, Reclaimed Declined Shaft, 9/12/95

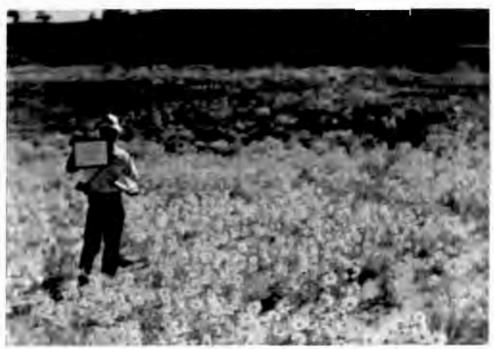
Poison Canyon Mine, Small Depression, 9/12/95

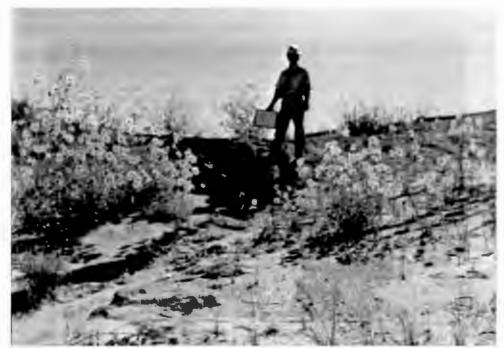
Poison Canyon Mine, Erosion Feature, 9/12/95
