January 26, 2018

RE: Summit Mine; Permit No. GRO11ME; Waste Facility Slide; Corrective Action Plan

STABILITY ANALYSIS AND CORRECTIVE MEASURES DESIGN

SUMMIT MINE WASTE ROCK STOCKPILE

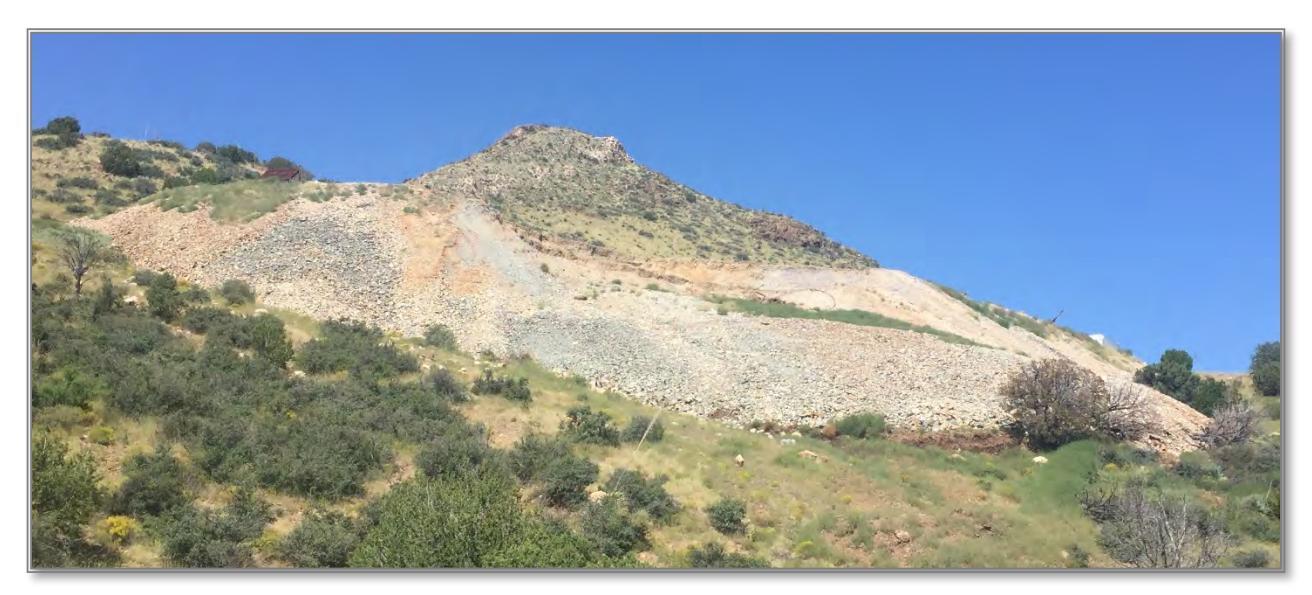
The DMS has undergone two separate failures. The first and most significant occurred during early 2017. An approximately 250-foot wide section of the facility toe moved downgradient a maximum of 150 feet. The slide is shown in **Photograph 1.** All photographs are contained in **Attachment A**. The slope failed at the highest point of the facility and toe movement resulted in a highwall forming in the facility crest (**Photograph 2**). Tension cracks formed on the DMS surface after the slide (**Photograph 3**). In the aftermath of the slide, PPM initiated a monitoring program on the tension cracks to identify the risk of further movements. In addition, equipment which was located near the slide area was relocated to the north.

Photograph 1: DMS Slide Looking Northwest

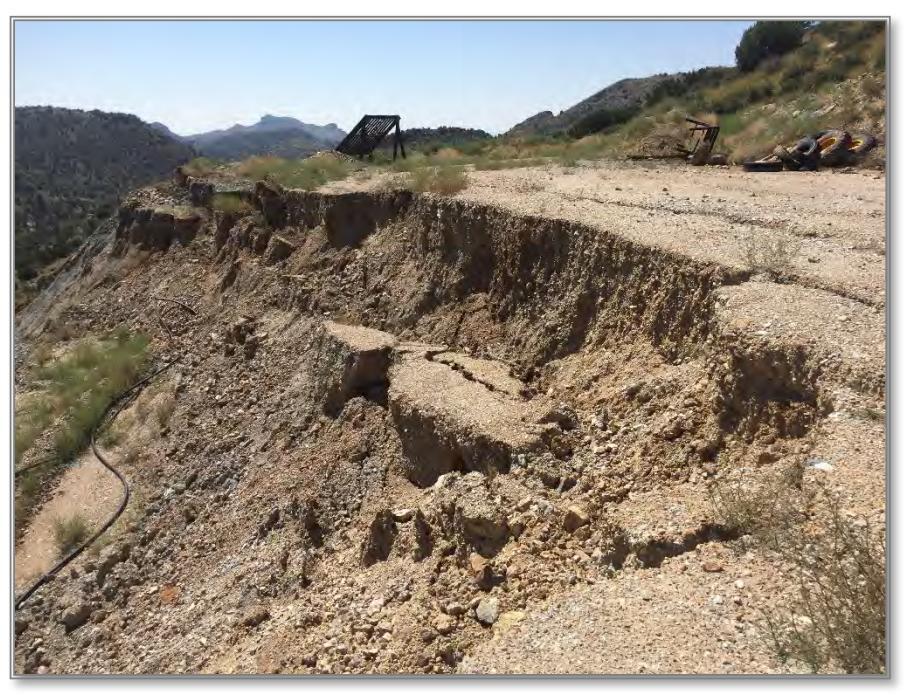
A second lessor slide occurred during the fall of 2017 during the rainy season. The second slide was limited in extent and consisted of minor downgradient movement of the toe and additional failures of the highwall. Additional tension cracks became visible on the facility surface.

Photograph 2: Highwall and Tension Cracks

The crest of the DMS will be graded to stabilize the highwall and reduce tension cracks. Material will be pushed down from the crest to create a stable slope. The estimated area of grading is shown on **Figures 3** and **4**. More detailed drawings of the anticipated grading are shown on Figures 3 and 4 in the Report (**Attachment C**). A safety berm will be constructed at the regraded crest to control access.

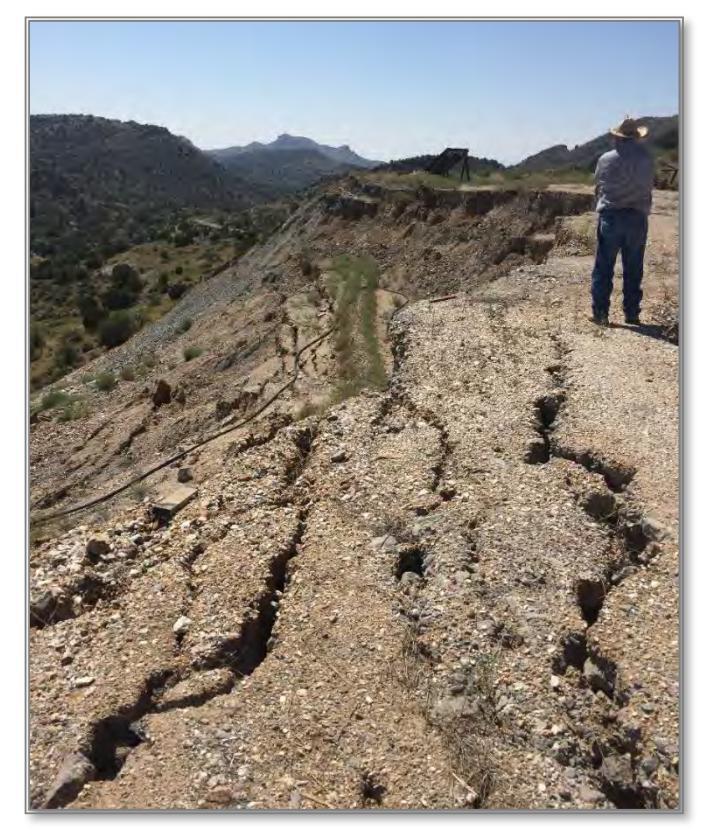
Photograph 3: Surface Tension Cracks

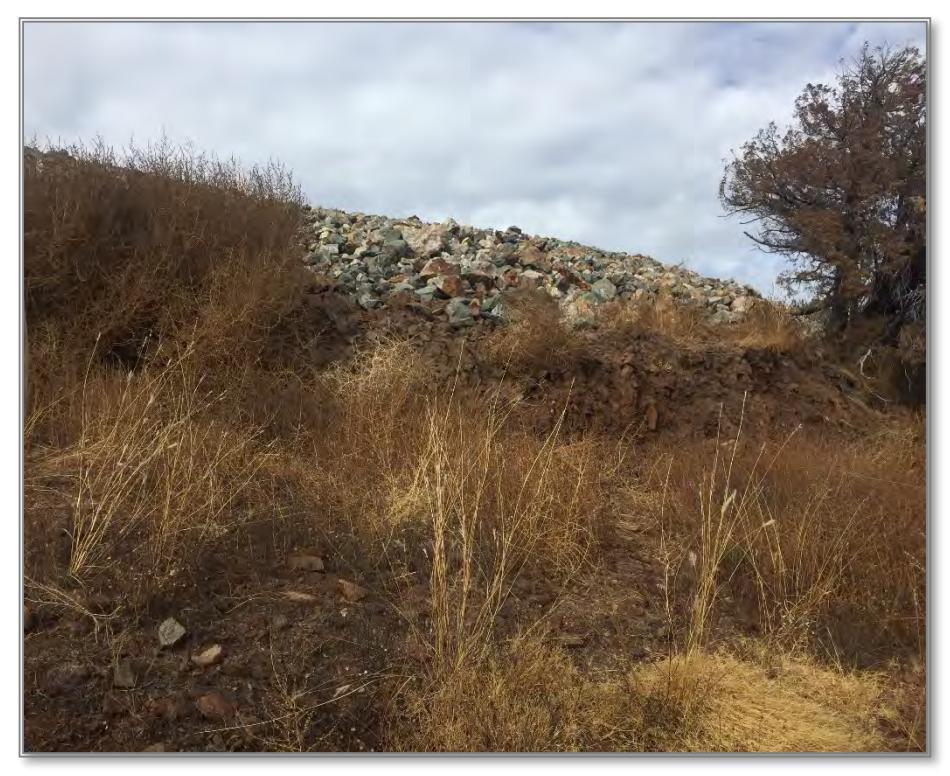
As the DMS moved, alluvial materials were pushed in front of the advancing face creating a thick visible layer under the toe (**Photograph 4**). The soil was found to be saturated and in some location actively seeping (**Photograph 5**). Based on inspections of the stockpile toe and soil analysis PPM concluded that the slides were likely the result of meteoric water infiltration through the facility which wetted up the native alluvial material reducing cohesion and strength. The alluvial material remains saturated, but seeping has stopped with decreased precipitation.

Photograph 4: Alluvial Material at Toe

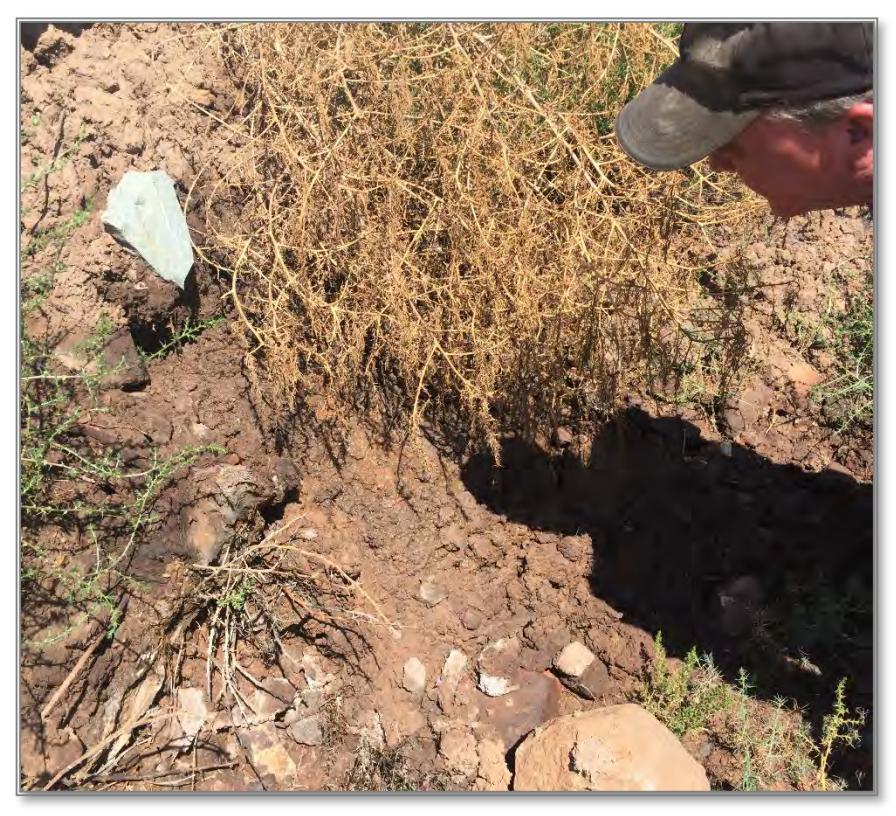
Photograph 5: Seepage at Toe

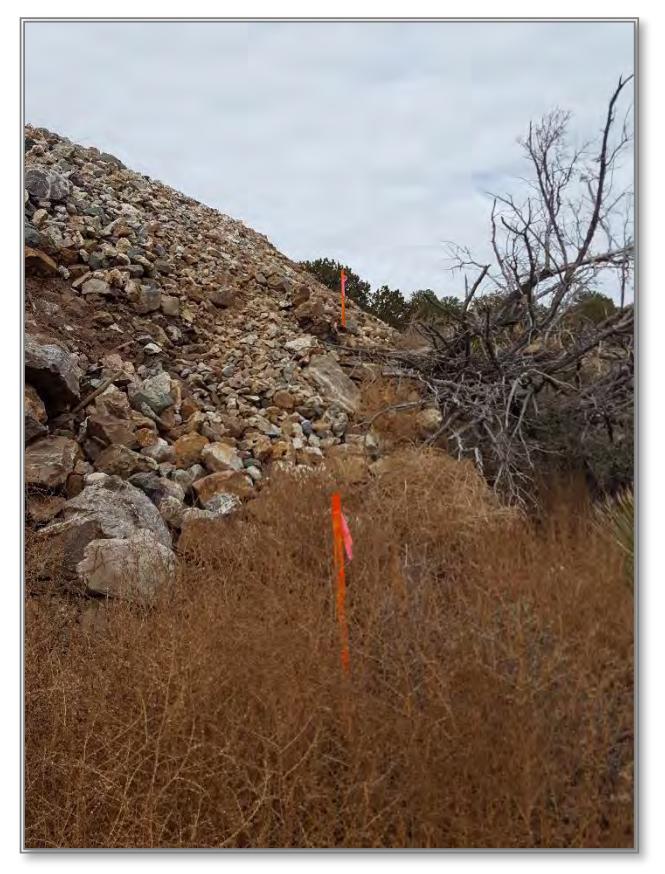
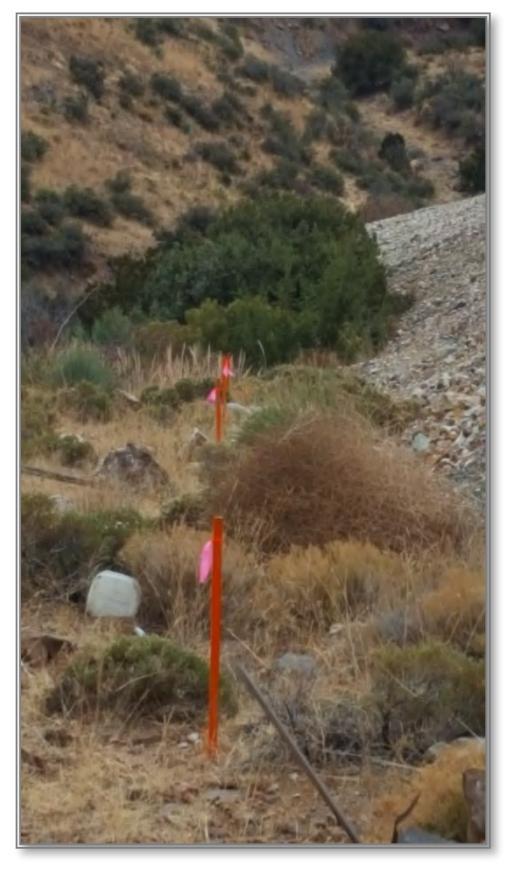
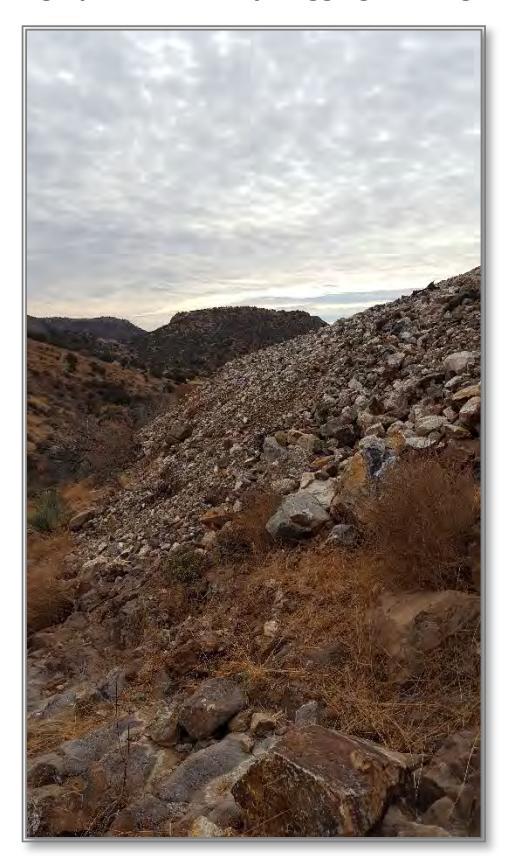
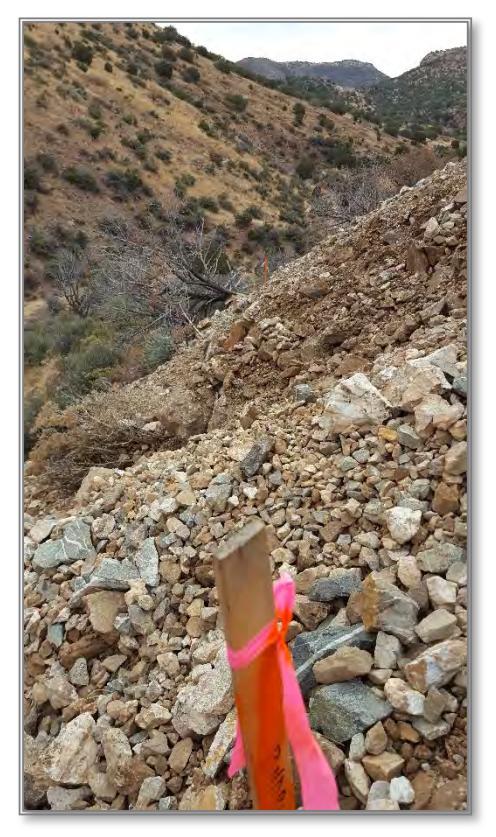
After the second slide PPM determined that a formal survey should be performed for use in developing the CAP. As part of the pre-survey research and field work, PPM discovered the available PLSS data was inaccurate and that there had been a mineral patent resurvey conducted by the BLM in 2014 (#1010). A survey was conducted in November 2017 in which the 2014 BLM survey was retraced. The surveyed extent of the slide was compared to retraced land boundaries. Results indicated that approximately 0.25 acre of the slide had encroached onto public land (**Figure 2**) on unpatented claims controlled by PPM. The BLM was notified of the discovery and a site visit to review the encroachment was conducted in January 2018. Areas of encroachment were staked for the site visit and are shown in **Photographs 6** through **9**.

Photograph 6: Boundary Flagging Looking North

Photograph 7: Boundary Flagging Looking South

Photograph 8: Boundary Flagging Looking South

Photograph 9: Boundary Flagging Looking South

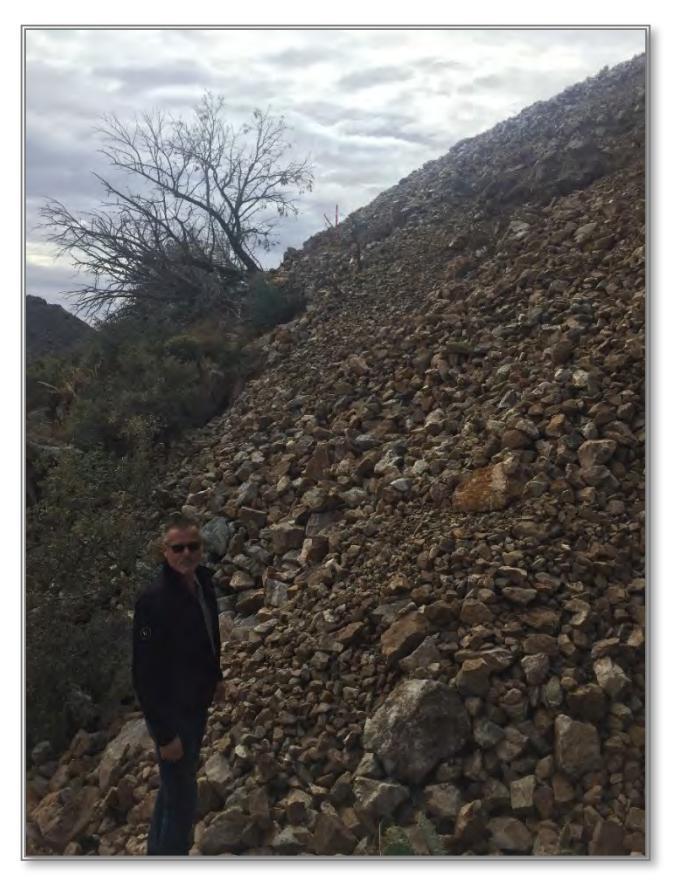
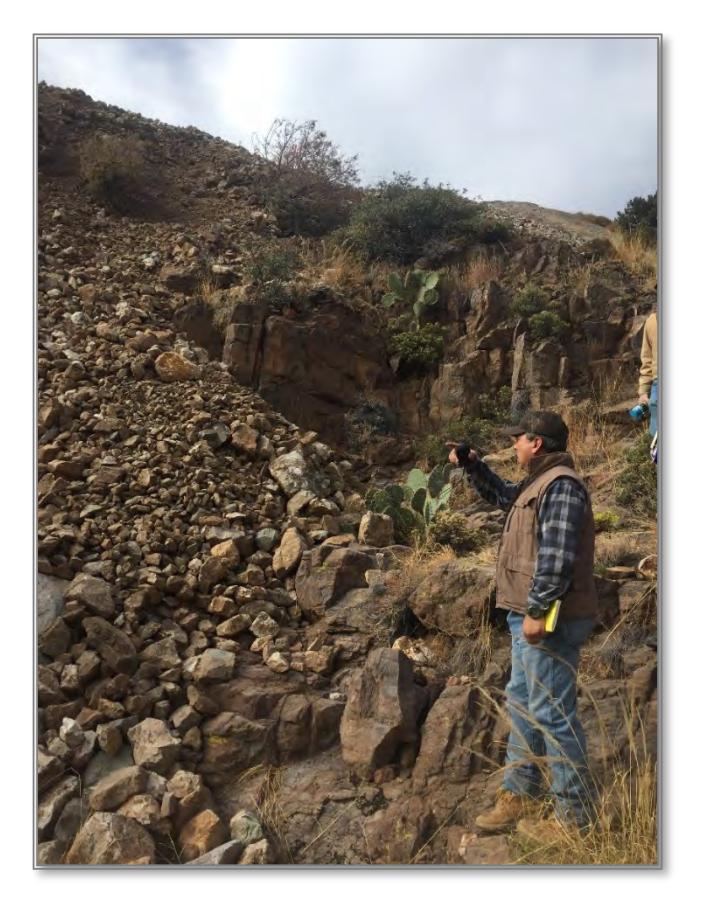
Under both options presented, the area between Buttress 1 and Buttress 2 will require a treatment to prevent the unconsolidated rock face of the facility from eroding further onto public land. The area in question is on public land and the downgradient area is not accessible by machinery due to the presence of steep rock outcrops. The outcrops serve to help stabilize the facility in place and further movement is not expected; however, the material itself is unconsolidated and could continue to fall. The area in question is shown in **Photographs 10** and **11**. The topography of the area is so severe that construction of buttresses will require access from both the north and the south as machinery will not be able to safely cross the area.

Photograph 10: Base of Slope Treatment Area

Photograph 11: Base of Slope Treatment Area

The slope treatment will consist of some retaining feature (i.e. fence or cable) that will likely be secured to the bedrock. The feature will be designed to hold material in place as opposed to stabilize the facility (which will be performed by the buttresses). Final design of the slope treatment will be completed with the buttresses.

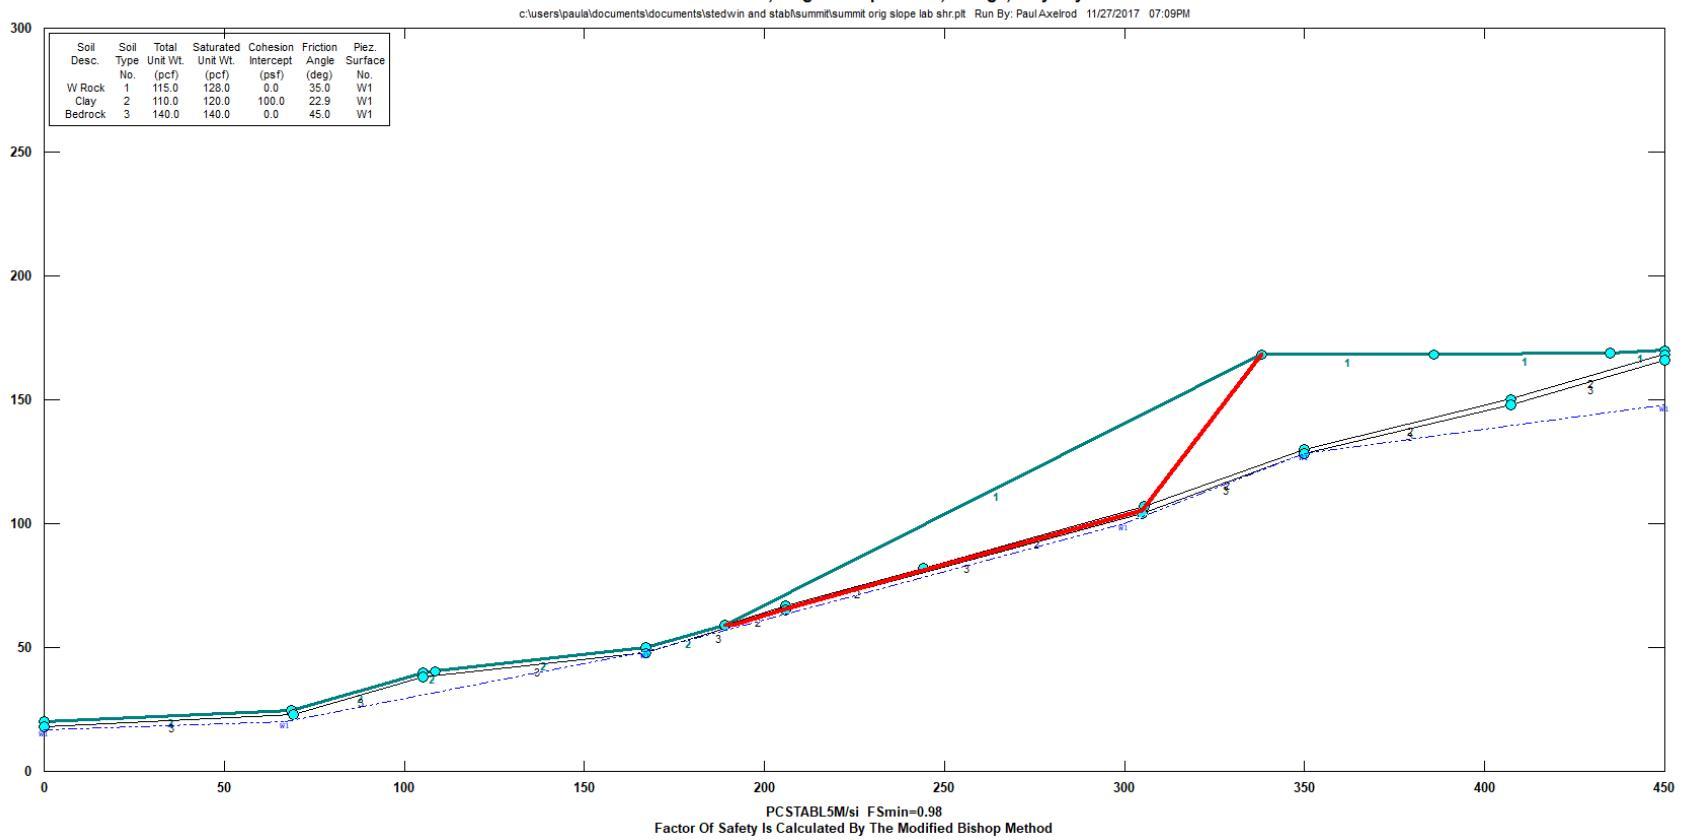
Figure 5 – Original Slope at Slide Section 1

The stockpile failure was potentially caused by the wetting up of the clay layer over a period of years. The wetting of the clay resulted in a loss of cohesion and consequent reduction in strength which promoted sliding of the stockpile along the clay layer at its base.

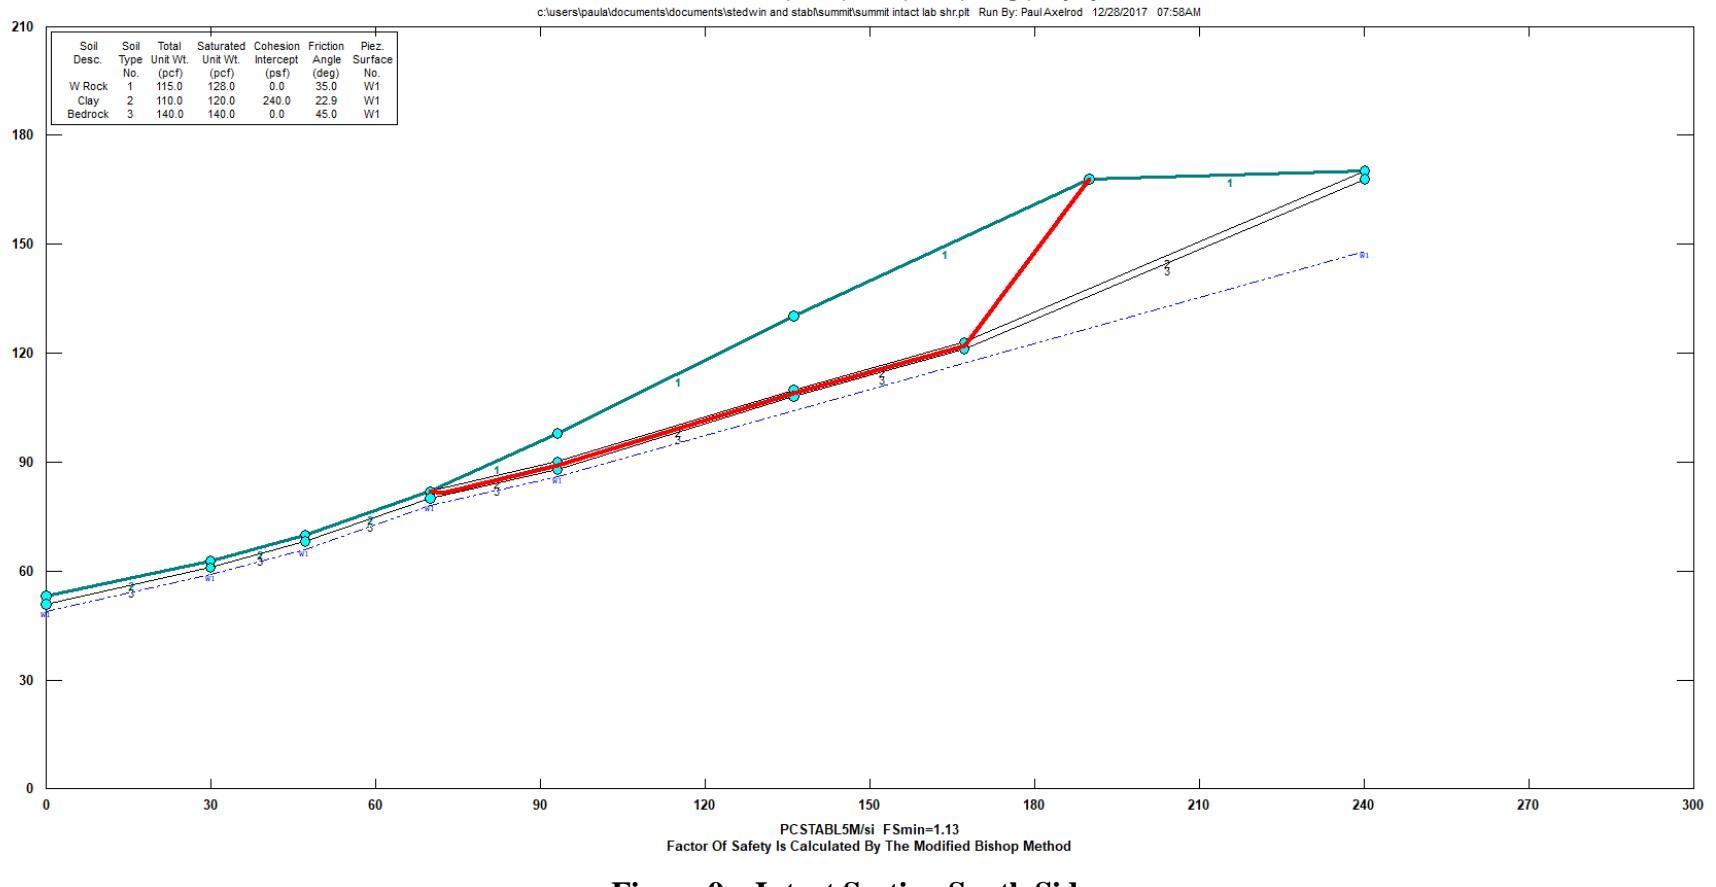
Figure 9 – Intact Section South Side

The static factors of safety for the waste rock stockpile at the slide and intact (south) locations are less than the normally accepted minimum of 1.3 for similar facilities. The factor of safety of 1.3 is acceptable when there is site specific geotechnical data available to minimize uncertainties in the parameters used for the analyses. A factor of safety of 1.5 is the normally accepted minimum when site specific geotechnical data is not available. In this case a minimum factor of safety above 1.3 is recommended because of the limited amount of site specific data, fieldwork and testing.
