BASELINE DATA REPORT

Section 3.0

Topography

Roca Honda Resources, LLC
4001 Office Court, Suite 102, Santa Fe, NM 87507

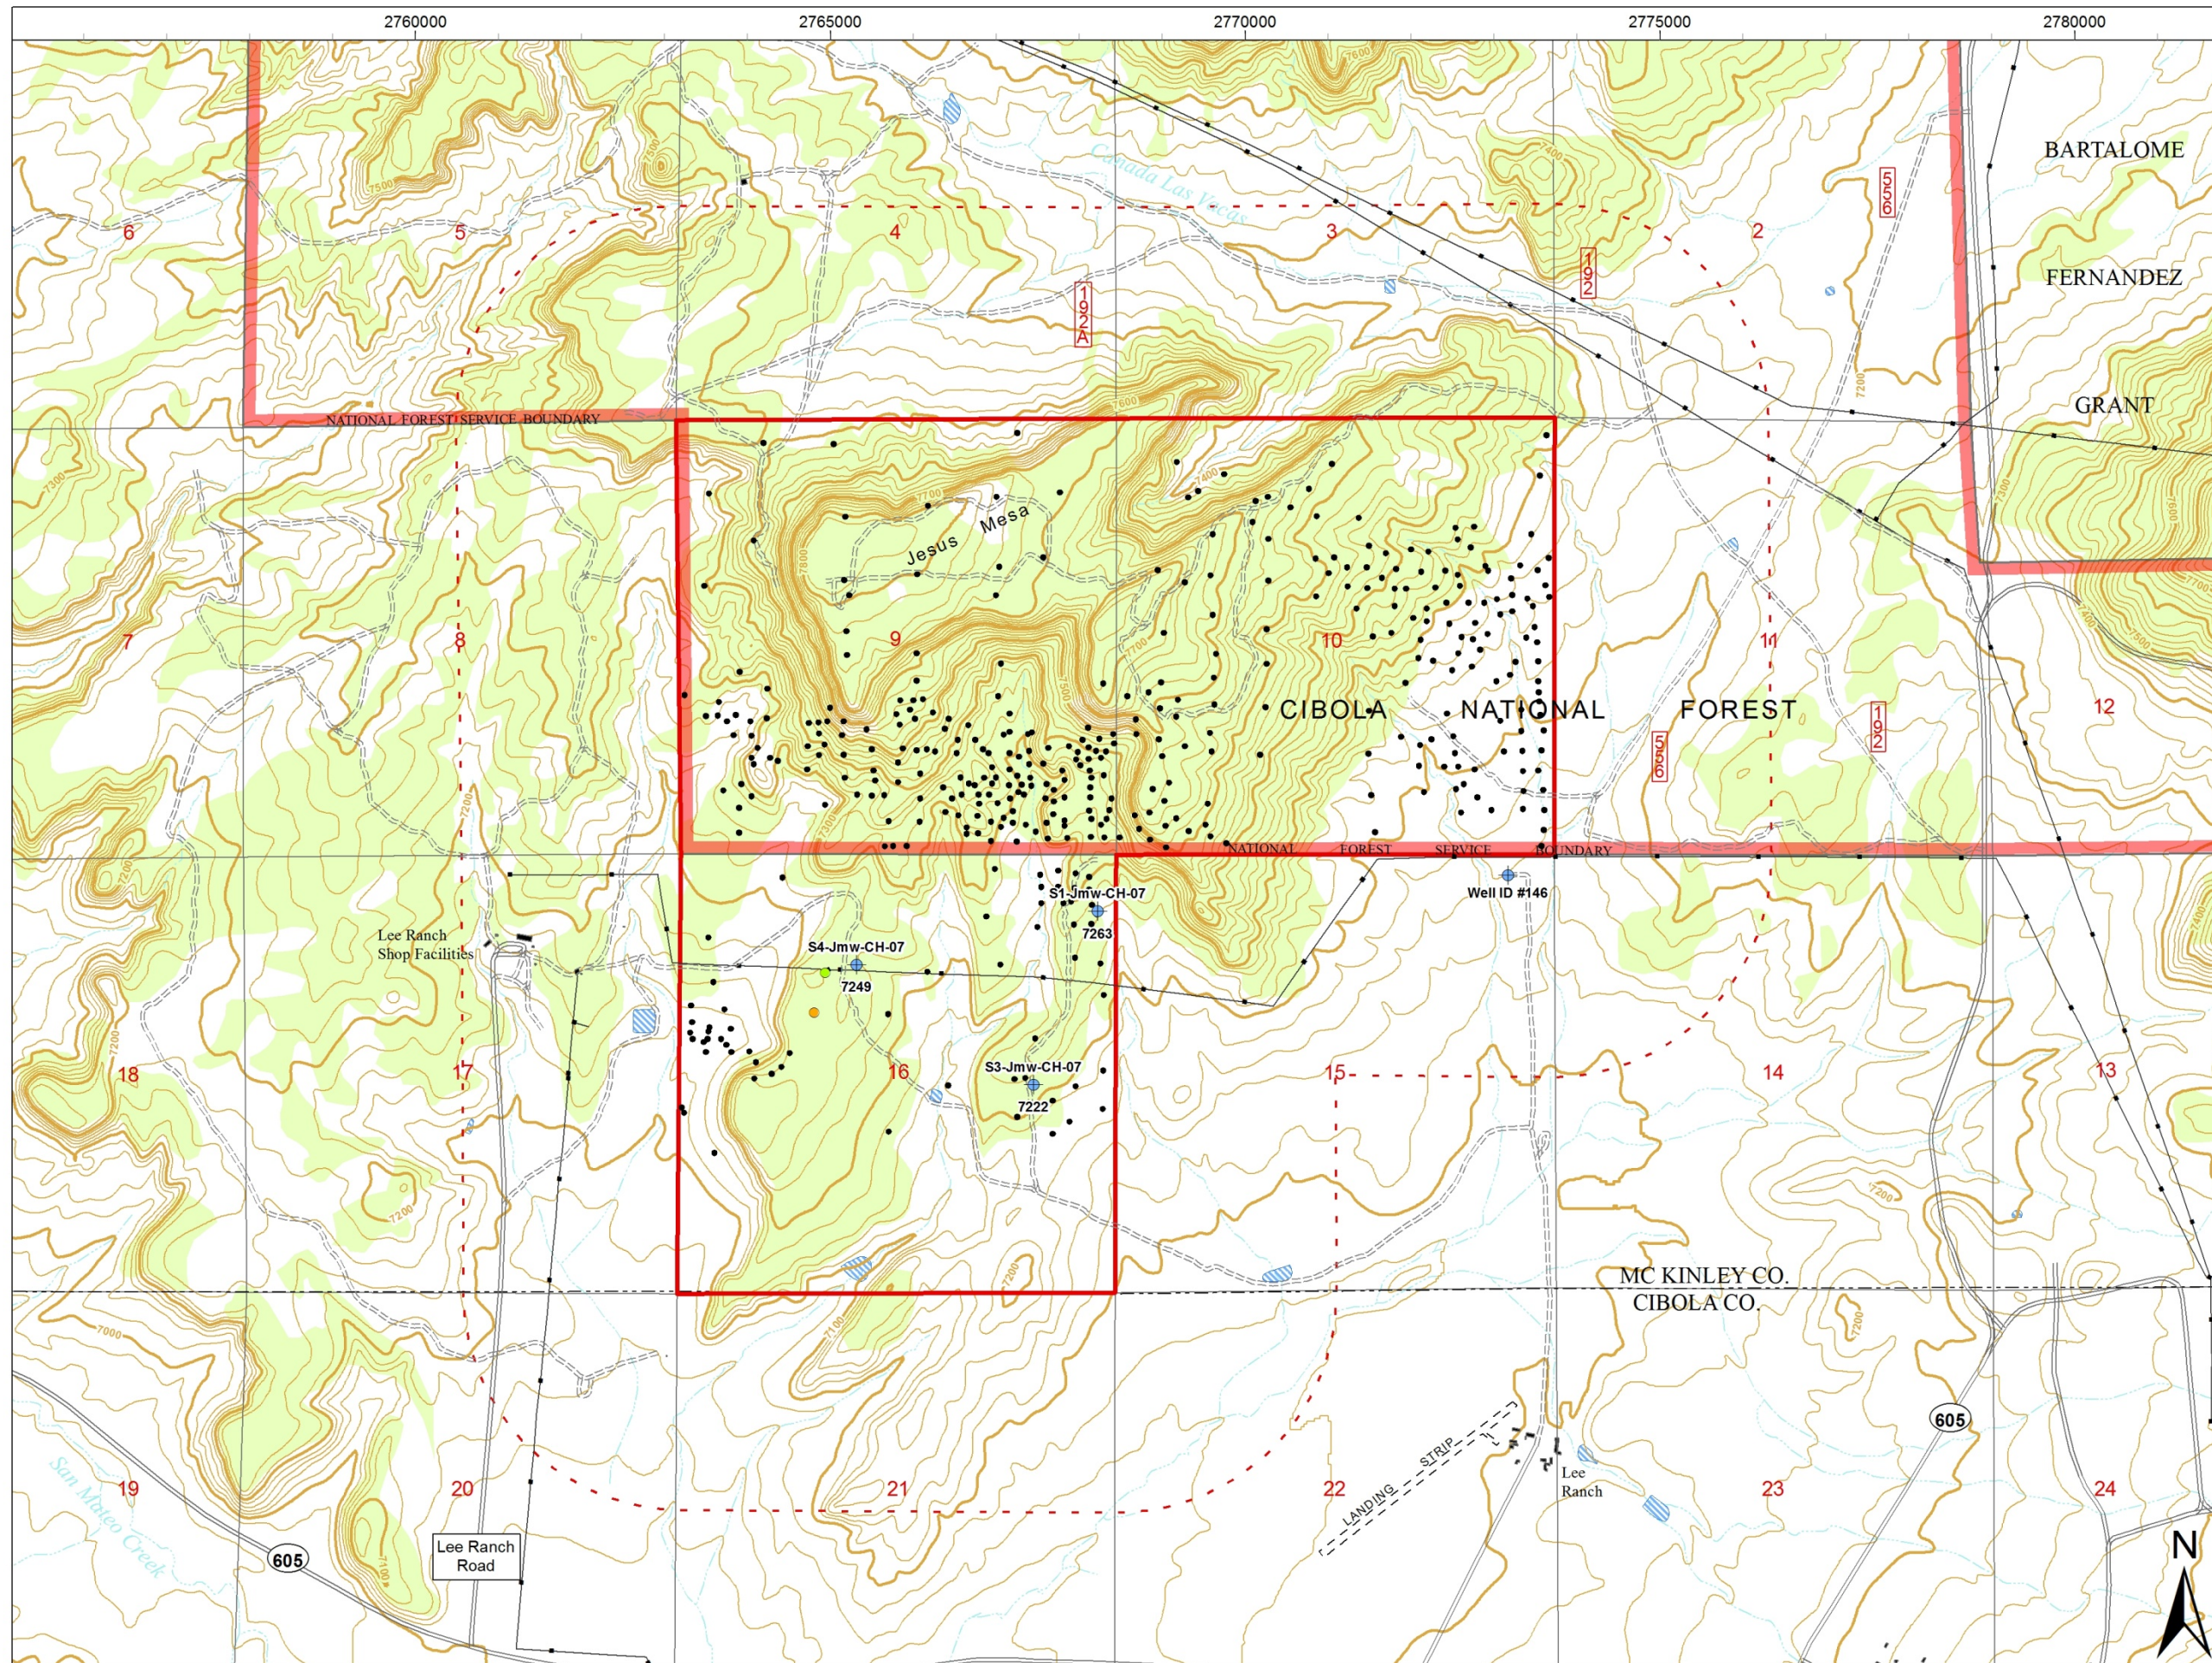
Figure 3-1. Permit Area Boundary and Man-made Features (1:24,000 scale)

The boundary of the permit area and topographic features of the three-section Roca Honda permit area and a half-mile margin around the permit area are shown in Figure 3-1. All buildings within 0.5 miles of the permit area boundary are also identified in Figure 3-1, as are all man-made features within the permit area that existed at the date of application.

All man-made features shown in Figure 3-1 were compiled from RHR aerial photos flown in the summer of 2008. All ponds shown in Figure 3-1 are man-made. Not all of them contain water or are still in use, but evidence of their existence is still visible. All of these ponds have been constructed by either damming arroyos or creating berms.

A monitoring well network of three wells completed in the Westwater Canyon member of the Morrison formation was installed in 2007-2008 by RHR. Other objects installed by RHR include a solar powered weather station and small air monitoring station that is powered by a nearby electrical line (Figure 3-1). The electrical line transects the northern half of Section 16 in the permit area and continues on the west side of the permit area in the NE $\frac{1}{4}$ of Section 17 where it terminates. It continues on the east side of Section 16 through the NW $\frac{1}{4}$ of Section 15 and along the southern section boundary of Section 10 (Figure 3-1).

The Roca Honda permit area is located in the northern half of the U.S. Geological Survey (USGS) San Mateo 7.5 minute and extreme southern half of the USGS San Lucas Dam 7.5 minute quadrangles. Contours for the Figure 3-1 topographic map were compiled from Digital Elevation Models of these two quadrangles obtained from the New Mexico Resource Geographic Information System Program. Features on Figure 3-1 are derived from a series of fourteen 1:12,000 aerial photos with 0.5 foot resolution flown for RHR in the summer of 2008. This information is consistent with the information contained on the USGS topographic maps and has been updated.

There are several buildings within 0.5 miles of the permit area belonging to the Lee Ranch in the NE ¼ of Section 17. The buildings are used as a shop and living area for the Lee Ranch. There are no buildings within the three sections of the permit area. Additional structures located around the site include power lines, scattered livestock tanks, and an old windmill just east of the Lee Ranch shop facilities. In addition, RHR assisted the Lee Ranch in constructing a well in the northeast corner of Section 15 (see Figure 3-1).

No prior mining operations which may have affected the permit area exist on the proposed permit area. There were, however, more than 400 historic exploration boreholes drilled from the late 1960s to the early 1980s in various locations of the permit area as identified in Figures 3-1 and 3-2. These figures, together with Figure 3-3, show the density of drilling, particularly in Sections 9 and 10 of the permit area. Additionally, some of the property immediately surrounding the permit area contains exploration drill holes to varying degrees. However, RHR has no knowledge of particular drilling locations in those sections. Field inspections of the area conducted in conjunction with other field activities revealed occasional pipe and other markers that may identify possible drill-hole locations but cannot be confirmed as such. The USGS mapped a network of drill roads present mainly in Sections 9 and 10 that accessed the drill sites, most of which have naturally re-vegetated. The roads shown in Figures 3-1, 3-2 and 3-3 are largely still passable.

As discussed above, the Section 17 Lee Ranch shop facilities can also be seen in Figures 3-1, 3-2 and 3-3. This is the location of a mine shaft that was constructed in the late 1970s and early 1980s but was never finished. Additionally, as identified in Figures 3-2 and 3-3, approximately 3 miles southeast of the permit area is the Rio Grande Resources (aka, Gulf Mt. Taylor underground uranium mine) facility. This mine has been on standby since the early 1990s. Also, shown on Figures 3-2 and 3-3 at a location southwest of the permit area approximately four miles and across the San Mateo Creek, is the San Mateo underground uranium mine. This mine has not been in operation for many years.
